Estover Community College Campus

Innovate UK project number	450026
Project lead and authors	AECOM, University of Exeter and University of Bath for Kier Construction
Report date	2014
InnovateUK Evaluator	Ian Mawditt (Contact via www.bpe-specialists.org.uk)

Building sector	Location	Form of contract	Opened
Schools	Plymouth	Design and build	2012

Purpose of evaluation

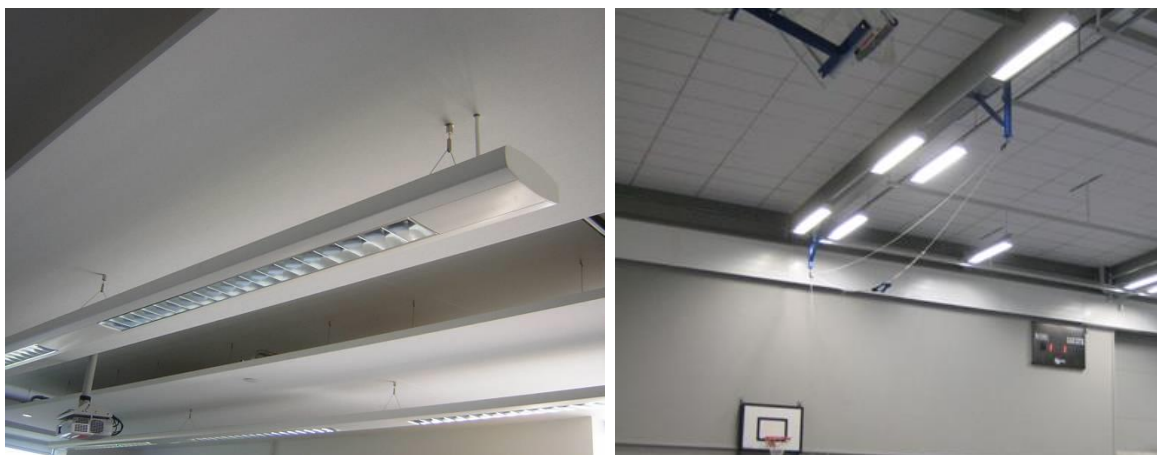
Electric lighting throughout classrooms and general areas is provided by suspended linear fluorescent ('T5') luminaires providing direct and indirect lighting. Figure 3.1 shows an example of the typical lighting installed in classrooms. Typical installed room lighting loads range from 0.6 kW_e to 1 kW_e depending on room size. Luminaires within all classrooms have control gear so that lighting levels can be automatically regulated according to natural daylight levels. In general lighting is intended to be switched on manually with passive infra-red (PIR) movement detectors switching the lighting off when a room becomes unoccupied again (see Section 7.10). These typically have a 20 minute delay, although in practice the precise time varies, depending on commissioning.

The Sports Hall has a relatively high installed load (10 kW_e) to allow sufficient lighting levels for indoor cricket and is manually controlled. The manual light switch is not in the Sports Hall and is instead located in the reception area which does not provide a view of the Hall itself (see Section 6.5.4).

Figure 3.1. General electric lighting installed in classrooms (left) and Sports Hall (right).

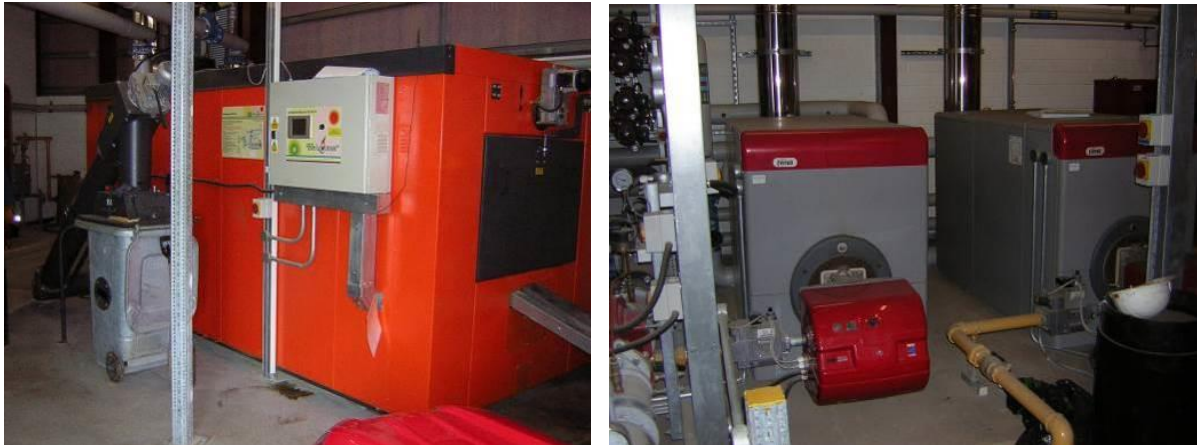
The school campus is heated through a combination of a Heizomat RHK-AK 500 Biomass Boiler (500 kW_{biomass}) and 2 no. Ferrolli GN4/12 fully modulating, condensing gas fired boilers (516 kW_{gas} and 452 kW_{gas}) - See Figure 3.2. The biomass boiler provides heat to a primary low temperature hot water (LTHW) circuit. The biomass boiler is intended to act as the lead heating source with the gas fired plant, which is also connected to the primary LTHW circuit, acting to provide additional heat as required. The primary boiler plant provides low temperature hot water to meet the space heating demand of the buildings and provides hot water to the air handling unit heater batteries and hot water calorifiers via a 10,000 litre thermal store located in the Energy Centre between the biomass boiler and the primary flow and return header. The thermal store is intended to reduce inefficient cycling of the boiler plant. The LTHW boilers are located in the Energy Centre at the northern end of the Sound House.

Figure 3.2. Heizomat RHK-AK 500 Biomass Boiler (left) Ferrolli Gas Boilers (right).

The most significant issue arose when a fault in the control system meant that the biomass boiler was not operational for 5 months and gas back-up had to be used in its place. Additionally, the fuel feed jammed and fuel burnt back into the feed mechanism. The automatic dousing system operated as designed to quench the hot fuel, but as a result flooded the floor of the plant room, which whilst preferable to a fire, did cause considerable work for the FM team.

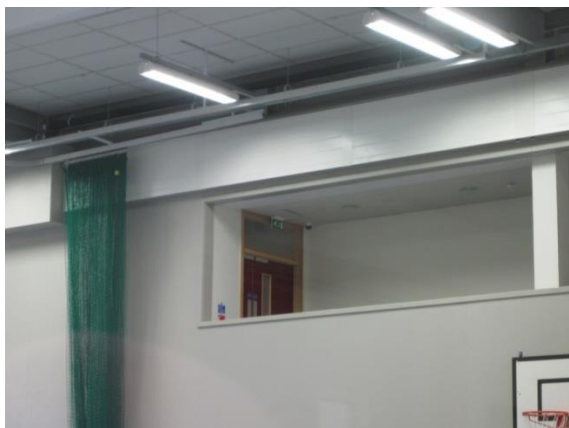
The hall in the Sports Centre is heated through high level radiant panels (Figure 3.4). Space heating temperature control for individual spaces is provided through heating schedules and temperature setpoints defined through the BMS. Local control is provided through thermostatic radiator valves (TRVs) on radiators.

Figure 3.4. High level radiant panels in the main hall in the Sports Centre.

A specific area of concern within the campus is in the Sports Hall which frequently overheated even during winter and spring periods. While this is in part due to ventilation issues, the situation is exacerbated by the radiant heating panels being supplied by the same constant temperature circuit as the air handling units. The result is that when the BMS considers outside temperatures equate to 'winter' operation, the panels are provided with a constant supply of heat irrespective of the conditions in the specific space being served. Also, despite radiant panels being installed, there do not appear to be any 'black bulb' radiant heat sensors installed, which may be contributing to the control issues here.

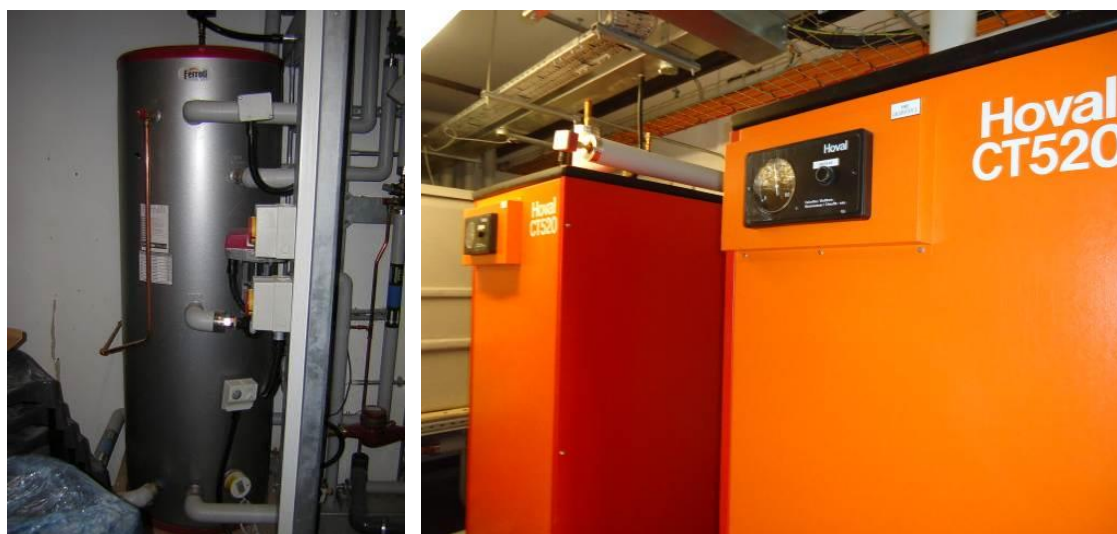
Domestic hot water (DHW) is provided to all blocks via storage calorifiers in each of the block plant rooms. The calorifiers in turn receive heat from the local heat network LTHW circuit from the Energy Centre. A secondary return system is provided on the domestic hot water system with connections within 300 mm of each outlet to maintain system temperatures at acceptable levels and minimise bacterial proliferation during periods of low usage.

Each plant room contains a storage calorifier sized for the requirements of the block it serves. DHW is used for hot taps in all toilets and 22 no. showers in the Sports Hall. The DHW system operating temperatures are maintained through the LTHW circuit at all times through the year, even during school holiday periods.

Figure 3.5. Storage calorifier in the Faraday / Austen plant room (left) and Sports Centre plant room (right).

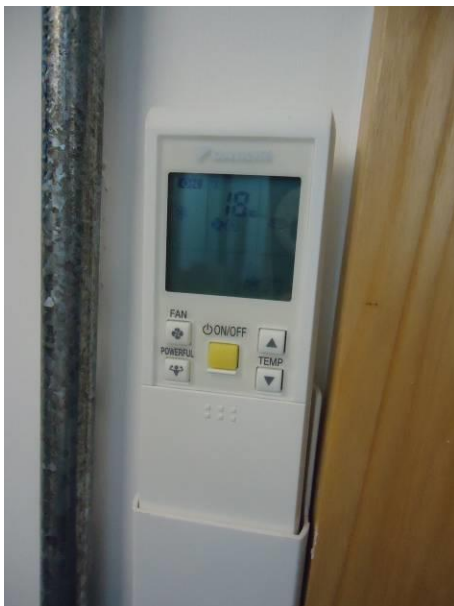
No local control is provided for cooling in the Dance Studio and Fitness Suite. Instead the BMS will initialise cooling if the internal temperature rises above 22°C. The main server room, IT office, and server hub rooms all have local control (Figure 3.6) with particularly low set points selected.

Figure 3.6. Cooling manual control system for main IT and hub server rooms.

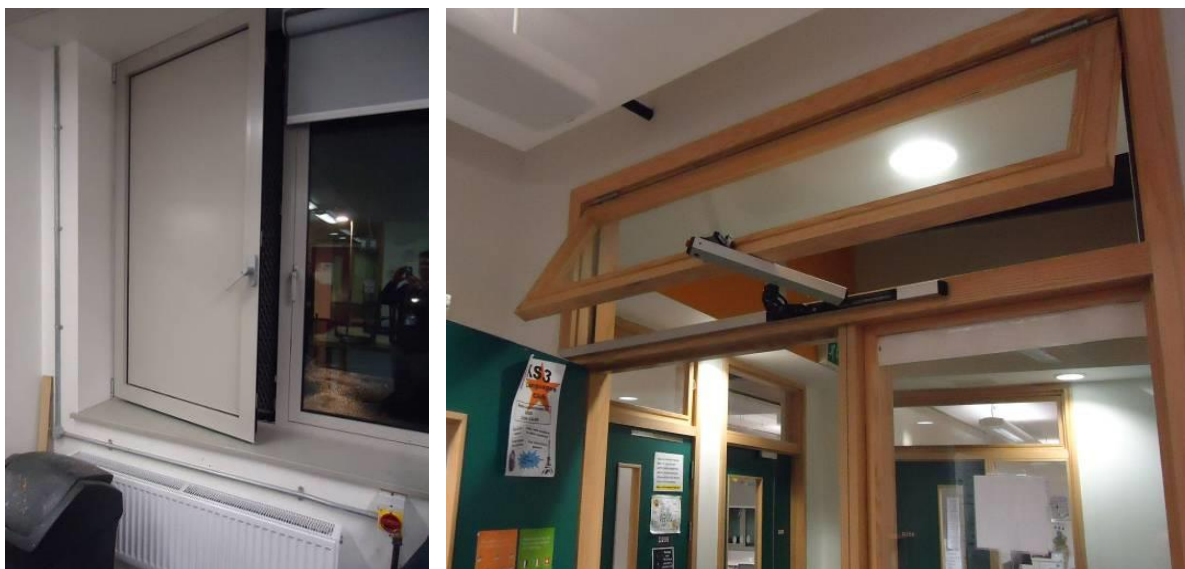
Figure 3.7. Night ventilation window (left) and fanlight above door (right).

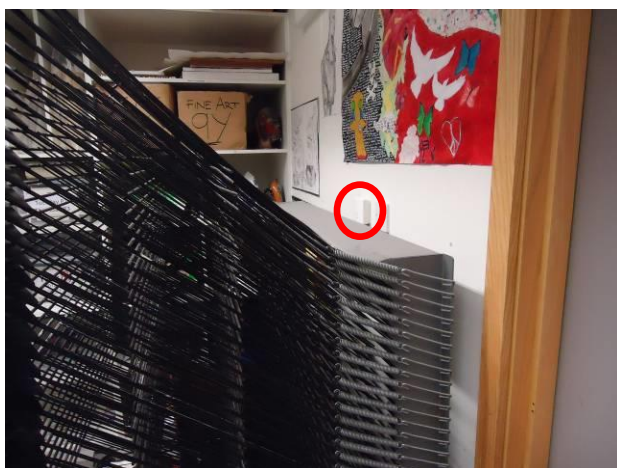
Classrooms have carbon dioxide (CO₂) sensors fitted, which have 'traffic light' displays to indicate to the occupants when it would be appropriate to open windows, at least in terms of internal CO₂ levels as a general indicator of indoor air quality (Figure 3.8). These displays take the form of three 3 mm LEDs, which are difficult to interpret from a distance. They were also observed to be obstructed by furniture and clutter in a number of classrooms (Figure 3.9).

Figure 3.9. CO₂ sensor on wall in room L210 Cade North block highlighted in red, obscured by general clutter.

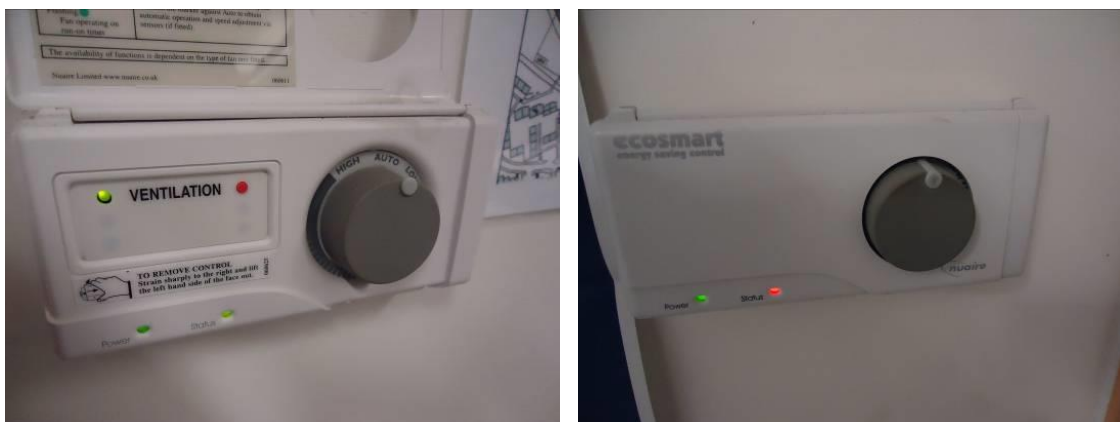
Mechanical ventilation is installed in areas where the use of the space or processes require it – such as in rooms with no external wall, science laboratories and coupled with active cooling in areas with potentially high heat gains. Classrooms in Faraday block (science) and Cann Bridge block (Severe Learning Difficulty unit) have additional supplementary mechanical ventilation systems. These are controlled through manual controls (Figure 3.10). Heat recovery to reclaim heat from the exhaust air stream and minimise energy requirements is only included in the air handling units (AHUs) in the Kitchen and Dining room. Local extract ventilation is provided to various areas including individual toilets and kitchenettes.

Figure 3.10. Supplementary mechanical ventilation control used in the Faraday science laboratories with the shutter open and closed respectively (left). Note that when this is closed the user cannot see the labels that indicate the operational mode (right).

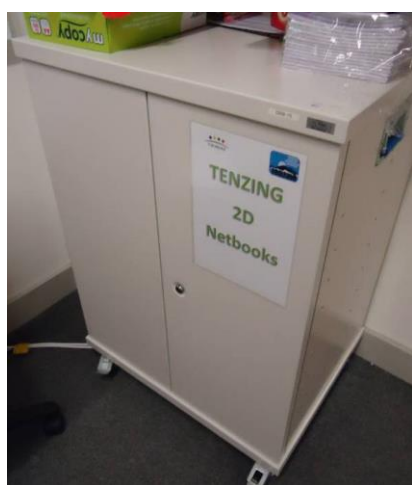
Typically classrooms have the following small power loads: one computer for the teacher, a projector, an interactive whiteboard, and a sound system. Classrooms in the Tenzing and Austen blocks each also contain a netbook charging station (Figure 3.11), housing netbooks that can be distributed to pupils in the classroom as required. There are between 15 and 20 netbooks in each charging station, roughly equating to one for every two pupils.

Figure 3.11. Netbook charging station in room D207 Tenzing block.

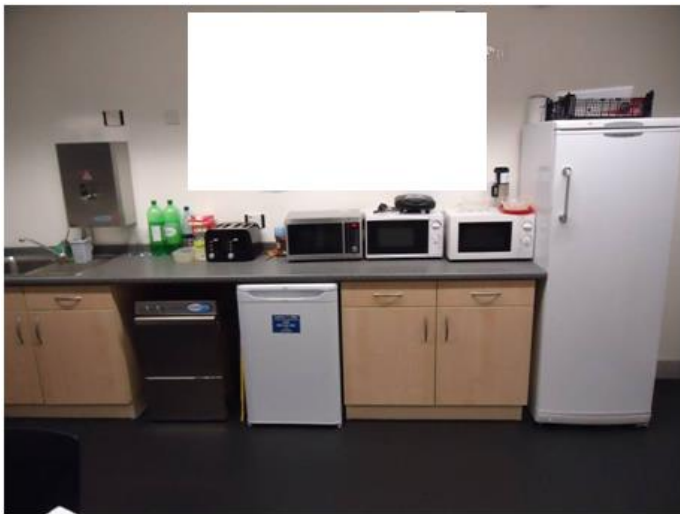
A Staff room is located in Tenzing block Level 1. Here there is a 2.2kW_e water boiler, 2 fridges, 3 microwaves and a toaster. Teachers tend to occupy this room during breaks.

Figure 3.12: Kitchen appliances in Staff Room, Tenzing block.

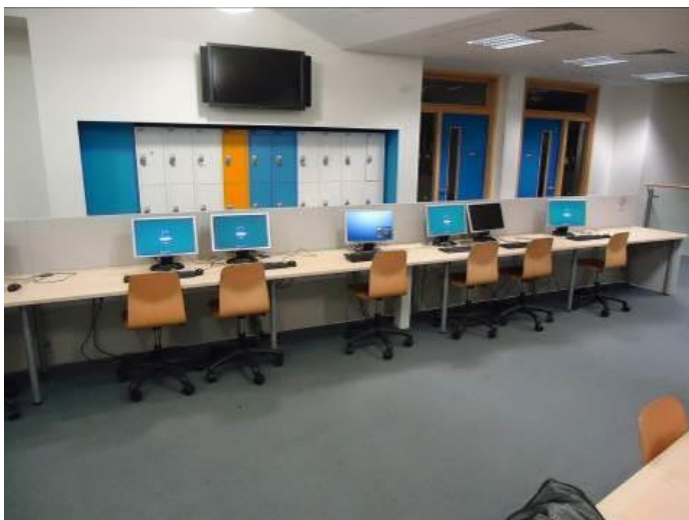
Austen, Tenzing, and Faraday blocks all contain IT hubs in their central atrium areas. These have around 12 thin client PCs and one photocopier.

Figure 3.13: IT hub in Tenzing block.

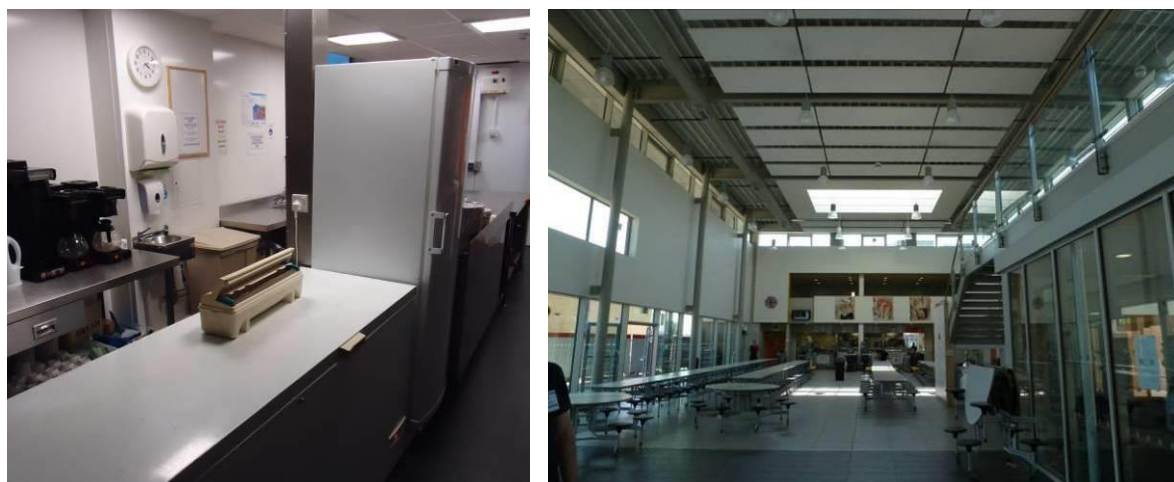
The school campus has catering facilities on site serving hot and cold food, with approximately 250 - 350 meal covers per day. The Kitchen is located in CADE South adjacent to the Dining Room. On a typical term time weekday, breakfast is served from 07:30 until 08:30, the main lunch service runs from 13:20 till 14:00. After this the kitchen is shut and catering staff leave from about 15:00. This was observed to be the case during several site visits. The majority of kitchen appliances are electrical (approximately 123 kW_e total installed load), although there is an oven and a large 12 ring gas hob (30 kW_{gas}), 2 gas fryers (each 15 kW_{gas}), and 2 gas brat pans (10 kW_{gas} and 7kW_{gas}), representing a significant installed gas load also (approximately 92 kW_{gas} total). The kitchen has a dedicated AHU with 4 kW_e supply fan, and 5.5 kW_e extract fan.

The Dining Hall is a double height space with a heated volume of 2748 m³. It is used for breakfast and lunch periods. The Dining Hall has an installed electric lighting load of 5.4 kW_e and has a 2.6 kW_e AHU.

Figure 3.14: Kitchen (left) and Dining Hall (right) in Cade South.

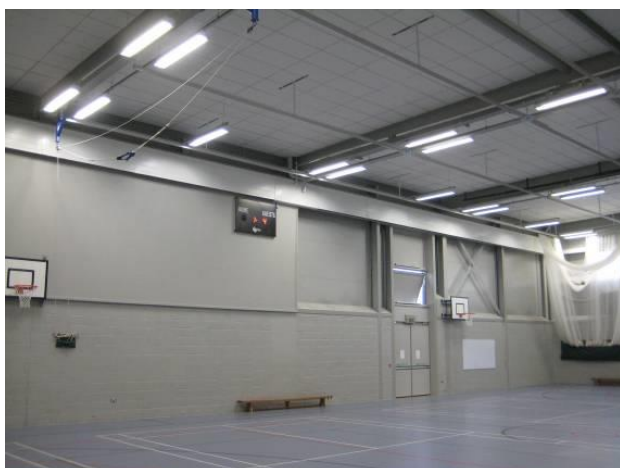
The Sports Centre was completed in Phase 2. It contains a double height Sports Hall with a heated volume of 4514 m³, a fitness suite, a dance studio, and classroom facilities. After school hours and on weekends the Sports Block provides facilities for after school sports clubs. It is noted there is no swimming pool on the campus.

Figure 3.15. Sports Hall.

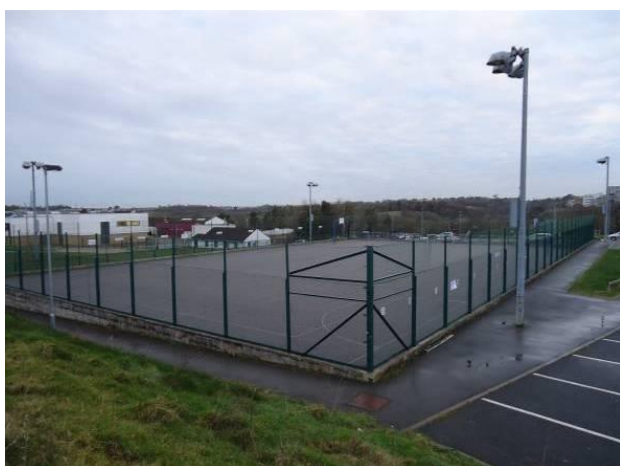
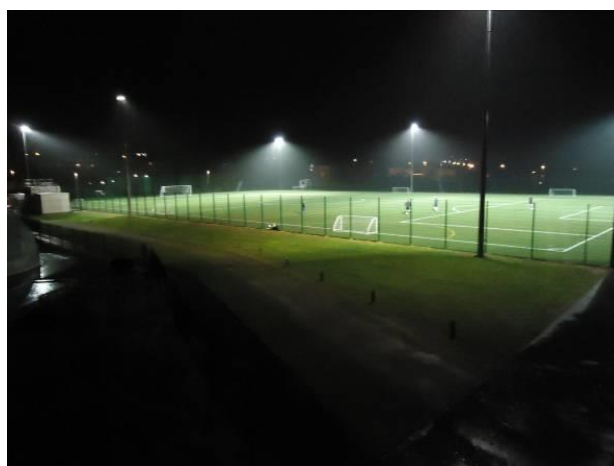
There are also two outdoor sports pitches served with floodlighting. A multi-use games area (MUGA) provides a playing surface for a variety of sports including 5-a-side football and netball. It is mainly used for school sports lessons. The 3G pitch is mainly used for football and is regularly in use after school hours. The floodlighting for both is enabled via a timeswitch from 15:00 until 22:15, but is not necessarily switched on as a photocell ensures the luminaires are off during daylight hours. In practice, lighting typically comes on for the 3G pitch from 18:00 until 22:15 in winter. Installed lighting loads for both pitches are 18 kW_e each.

Figure 3.16. MUGA pitch (left) and 3G pitch (right).

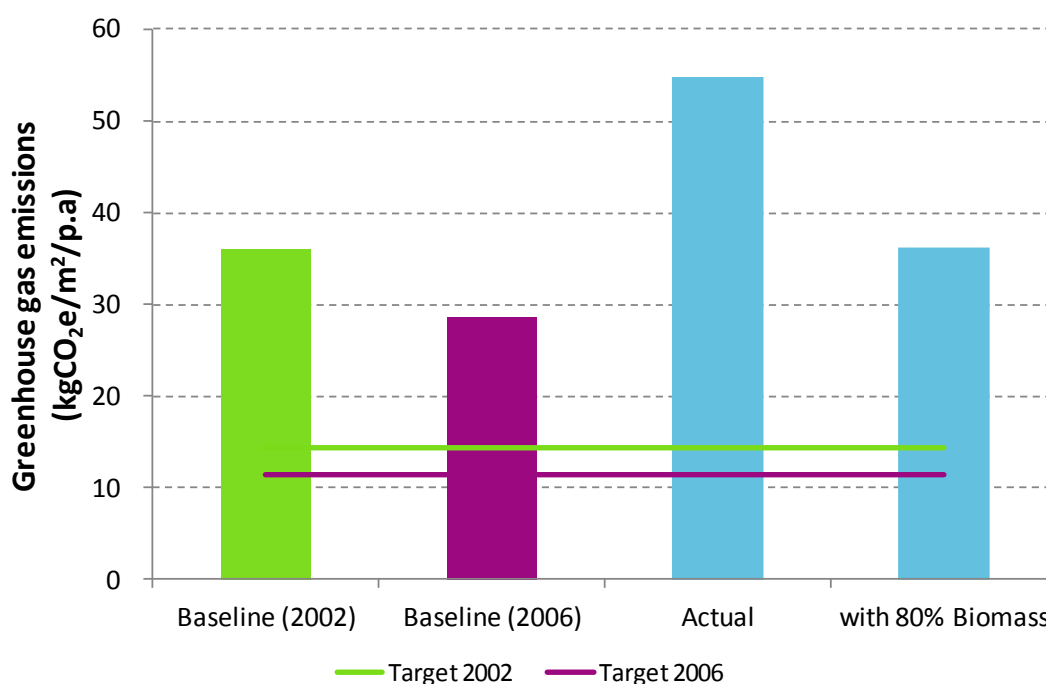
Figure 6.3. Bar chart showing the 60% GHG emissions design target based on 2002 and 2006 Building Regulations against actual emissions, and theoretical emissions if 80% of gas consumption were to be met instead with biomass.

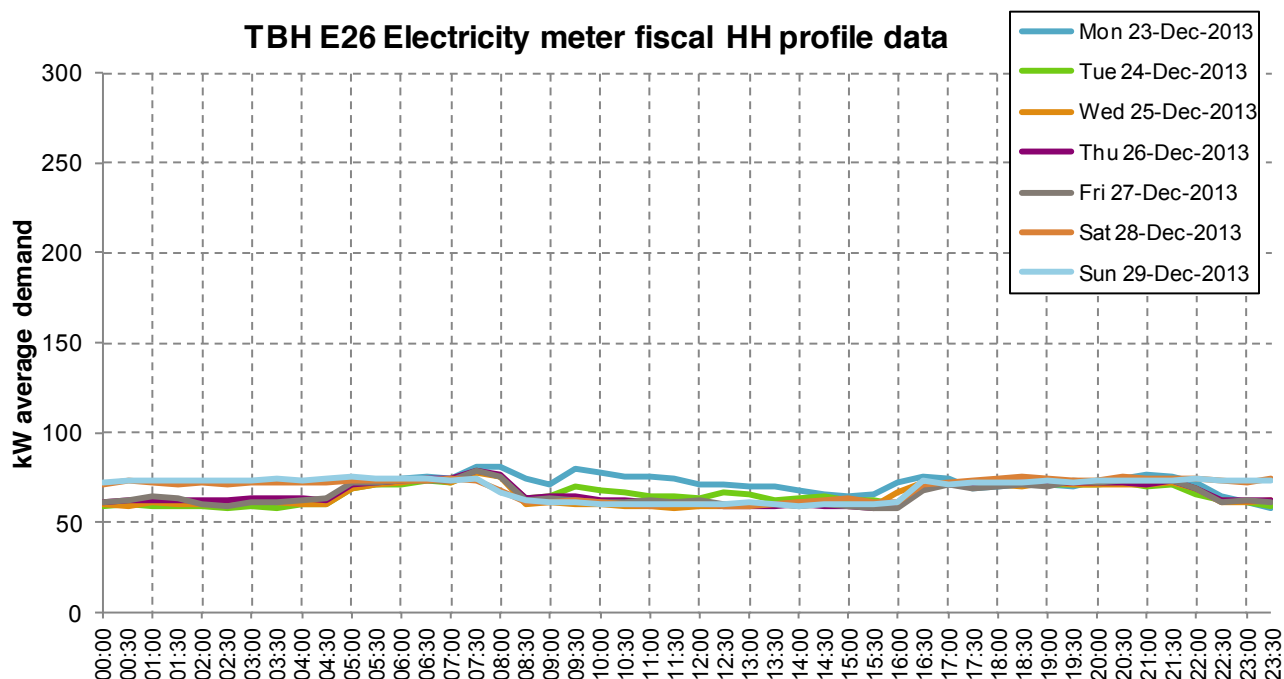
Figure 6.15 shows the daily profile for the week over Christmas 2013. The baseload is nearer to 60 kW indicating that the occupants have deliberately turned off equipment for the Christmas period. This suggests a maximum baseload target that the school campus should aim to achieve over the summer out of term also.

Figure 6.15. Daily profile showing average kW consumption for each half hour period over Christmas in 2013.

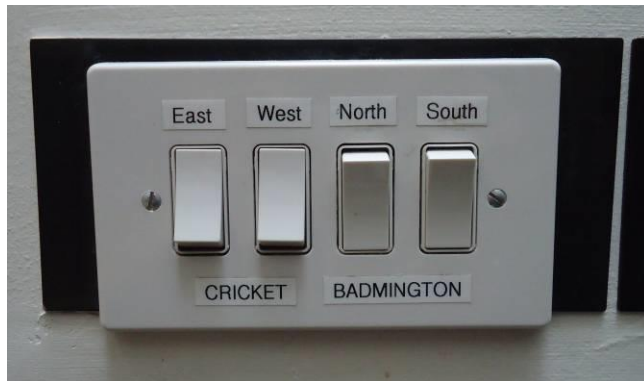
The Sports Block has multiple submeters for the various circuits. The installed lighting load is 20 kW with 10 kW of this for the Sports Hall (the Sports Hall requires a high lighting level for playing indoor cricket). Two

different lighting levels can be selected using a light switch located in the reception area (Figure 6.27). The placement of this light switch is questionable as the occupant must leave the Sports Hall to change the light level. This may be contributing to the lights being turned on at 06:00 and remaining on all day until around 22:00. The weekly profile is for a period during summer so there is no capacity for daylight dimming. The labelling of the light switch also seems somewhat confusing.

Figure 6.27. Light switch for Sports Hall located in reception area.

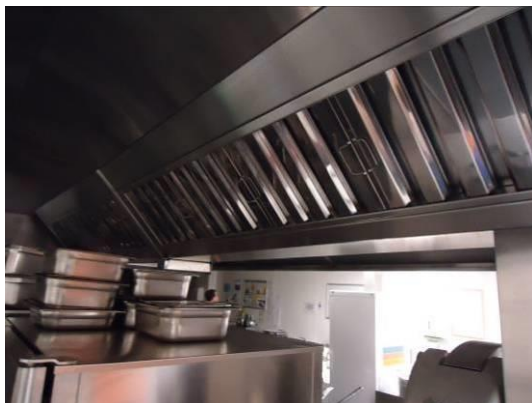
Figure 6.34. Kitchen extract which was observed to be running continuously.

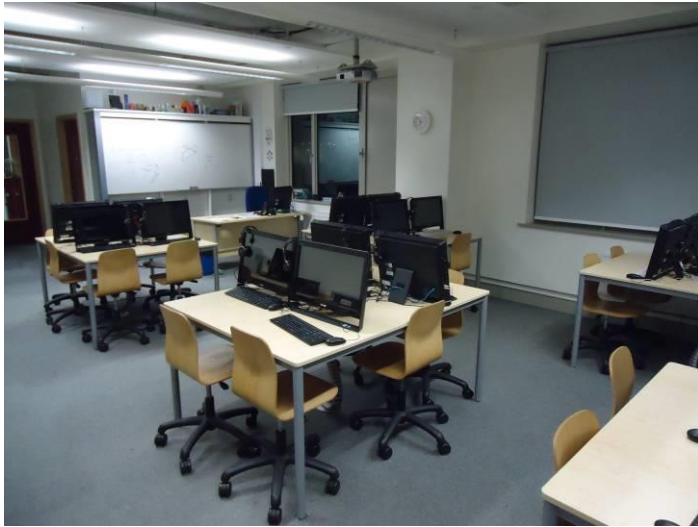
There are around 6 dedicated computer rooms scattered around the school. These contain a high density of PCs which are typically thin client. During the walk through survey it was observed that the vast majority of these were switched off. The FM indicated that there is software in place to automatically turn off these computers when they are not needed. However, this software does not seem to extend to other PCs on the site such as those in the IT Hubs.

Figure 6.36. ICT room in Faraday block.

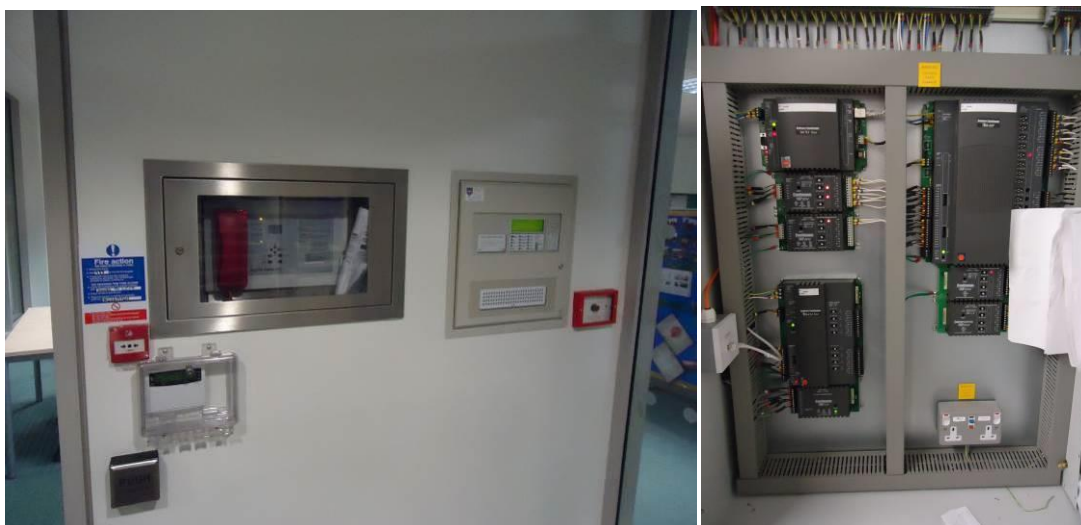
Analysis of weekly profiles for the various block revealed baseloads on IT and Power submeters (refer to Section 6.5.3 for a definition of these terms as they relate to this study). Investigation of connected loads on the Power submeters revealed that alarm and fire systems and BMS communications (Figure 6.39) are also monitored through them. These items are present in each block and seem to account for the majority of the baseload for each Power submeter.

Figure 6.39. Alarm and fire systems, and BMS communications systems.

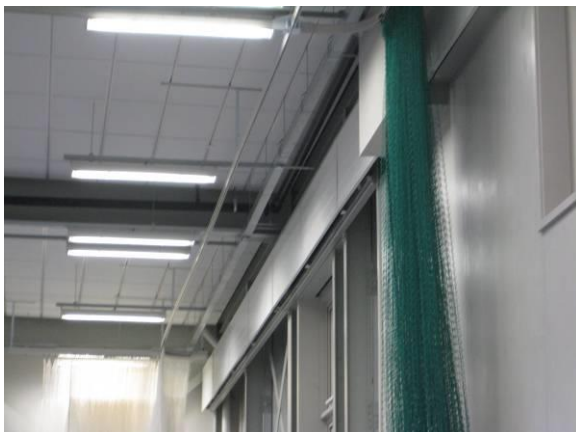
Figure 7.1. High level radiant heat panels in the Sports Hall.

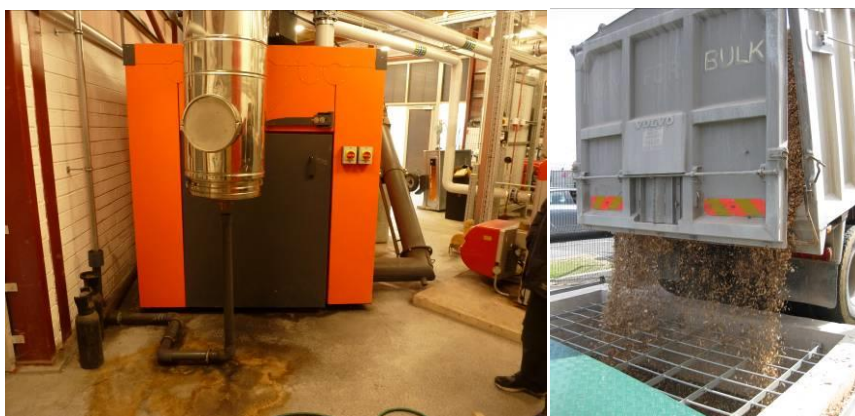
Figure 7.2. Biomass boiler (left) with the stain on the floor in front of the boiler indicating blow back and biomass delivery (right).

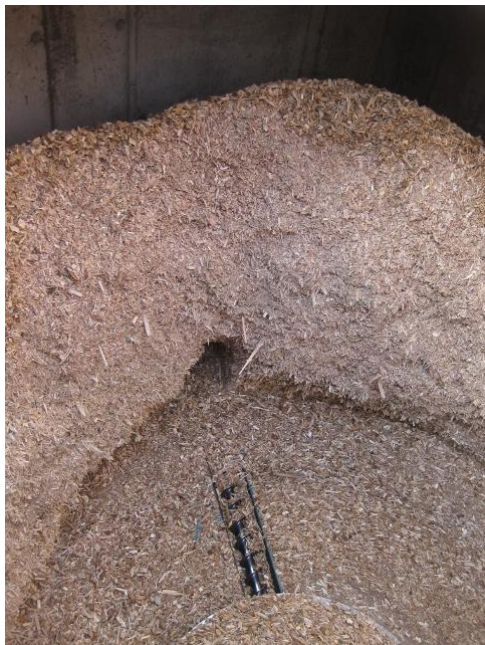
Figure 7.3. Photograph showing build up of woodchip in corners of storage pit.

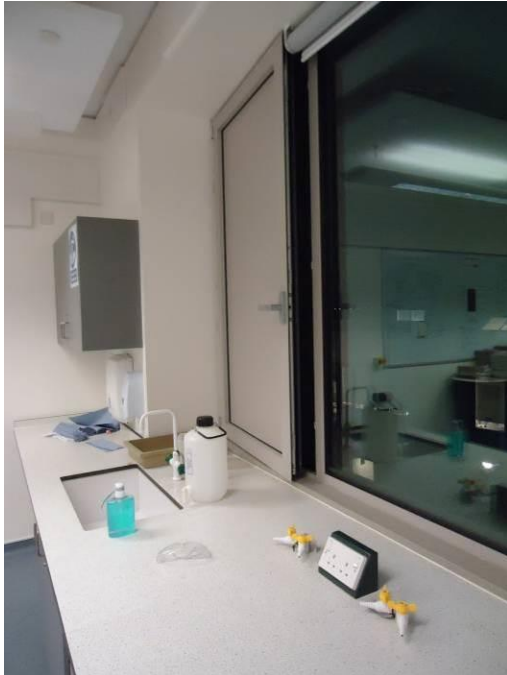
Figure 7.7. Night vents left open overnight in winter.

A significant part of the natural ventilation strategy is the operable window vents provided in each classroom. These provide both ventilation and a means to limit overheating through the introduction of fresh air during warm periods. Some of the openings have the added benefit of being able to be left open overnight due to an externally fixed security grille providing the ability to use a night cooling strategy where the temperature of exposed concrete soffits are reduced overnight. This provides a store of coolth that will off-set heat gains in the space during the occupied period. As outside air is usually cooler than that inside overnight (in naturally ventilated buildings), it will generally be the case that the soffit will be cooled to some degree during this period. While this is beneficial in the summer, this can present significant additional heat load to the space heating system if used inappropriately in the winter, spring and autumn.

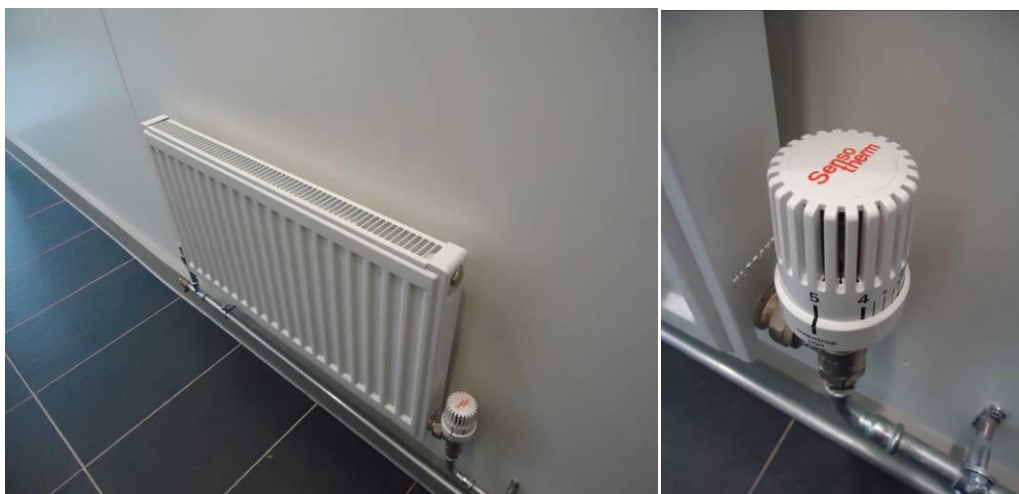
Figure 7.8. Radiator in circulation space in Austen block. TRV was set to maximum of 5, which was typical for many radiators in circulation areas.

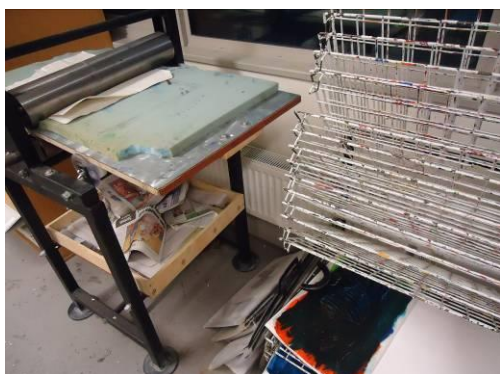
Figure 7.9. Radiators in L210. Art room Cade North obscured by various equipment.

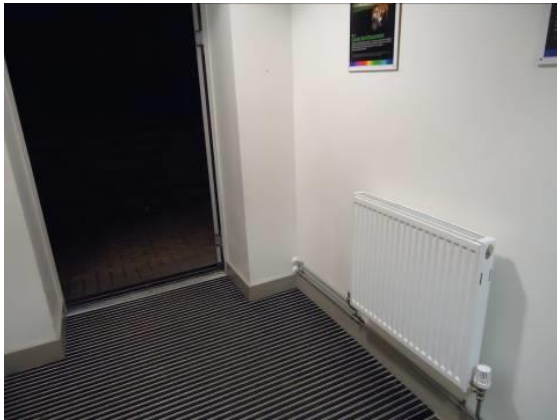
Figure 7.10. Door to outside in Sports block. Observed during several site visits to be left open for much of the day even though the heating is on.

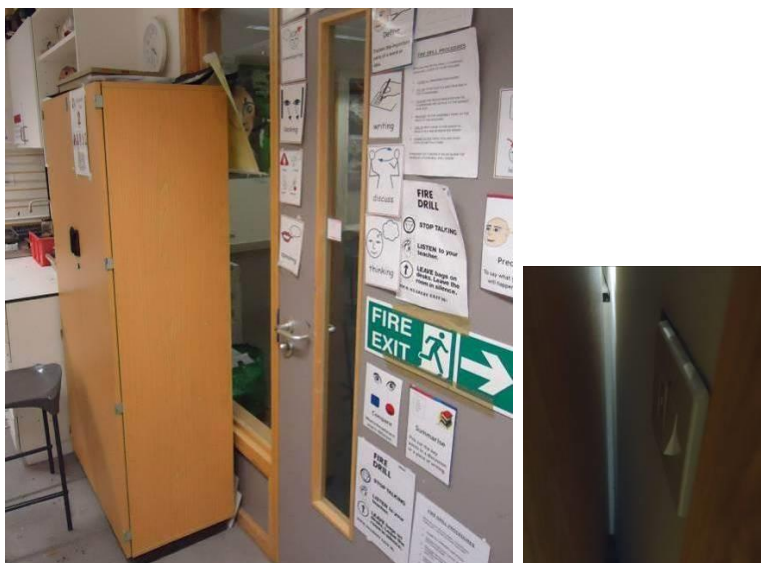
Figure 7.11. Light switch in classroom obscured by cupboard.

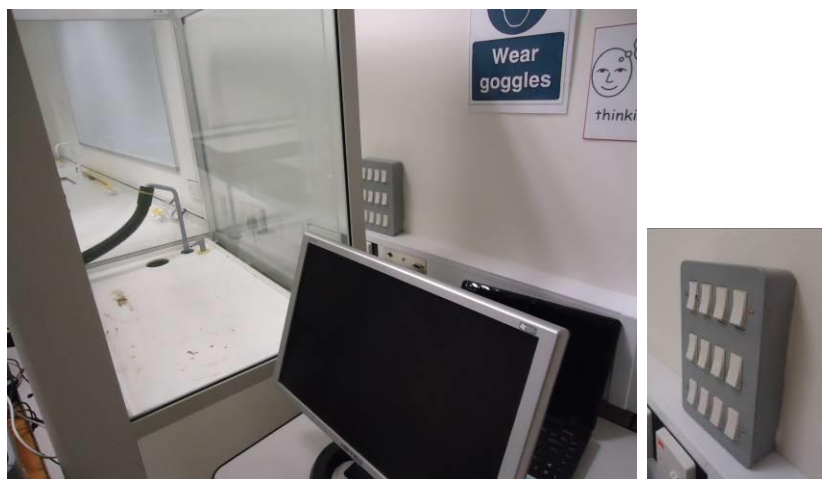
In the Science Opportunity Centre in Faraday block ground floor, a manual lighting control was discovered obscured by a fume cupboard and without any labelling. It was unclear what this control was for (Figure 7.12).

Figure 7.12: Lighting control in Science Opportunity Centre obscured by fume cupboard and PC. Note there are no labels to inform the user which lights the control is for.

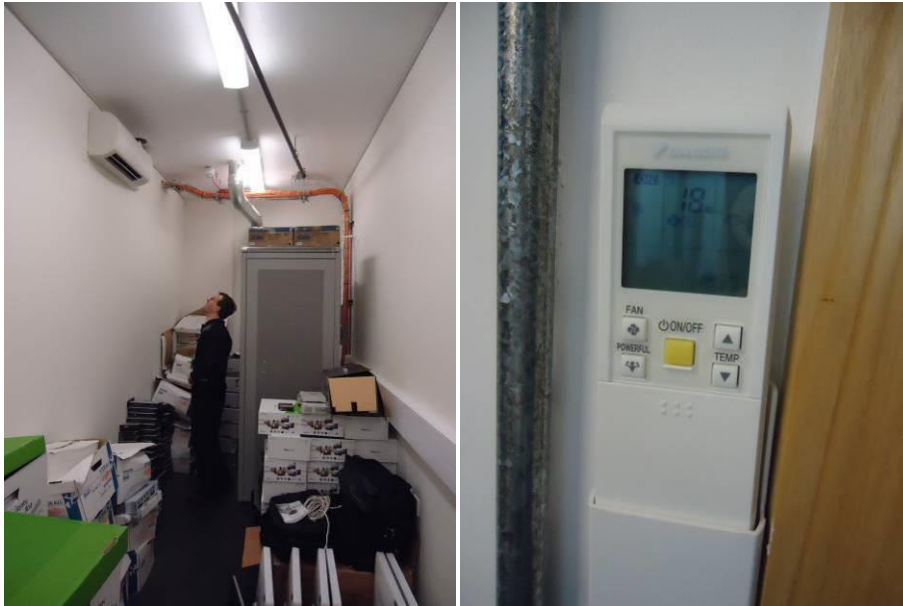
Figure 7.14. Small server room in Tenzing block and 18°C set point.

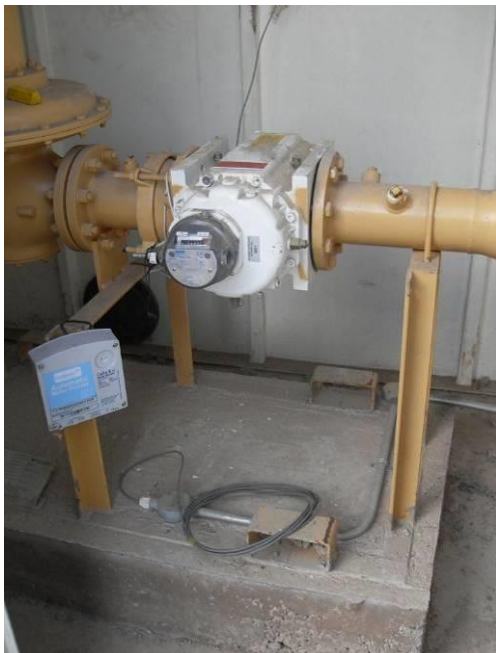
3. Although listed on the BMS, electrical connections have not been made to the Tamar Centre gas meter, nor the two fiscal incomers (although these do have fiscal dataloggers with the potential to provide half-hourly data) (Figure 10.8). The Faraday labs meter is physically wired to the BMS panel, but does not appear as a channel in the software.

Figure 10.8. Site (north) fiscal gas meter with fiscal datalogger wired and the unterminated BMS data cable.

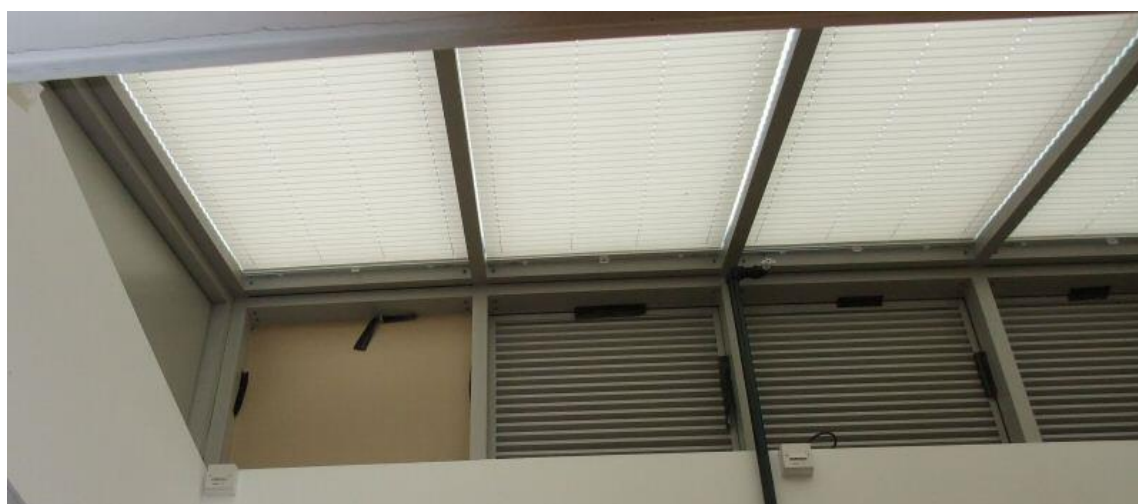
Figure 10.9. High level mechanically actuated vents in room L222 / L226, with evidence of them having been blocked up and isolated using local switches when building in summer control mode during the winter as a result of failure of the controlling PC.

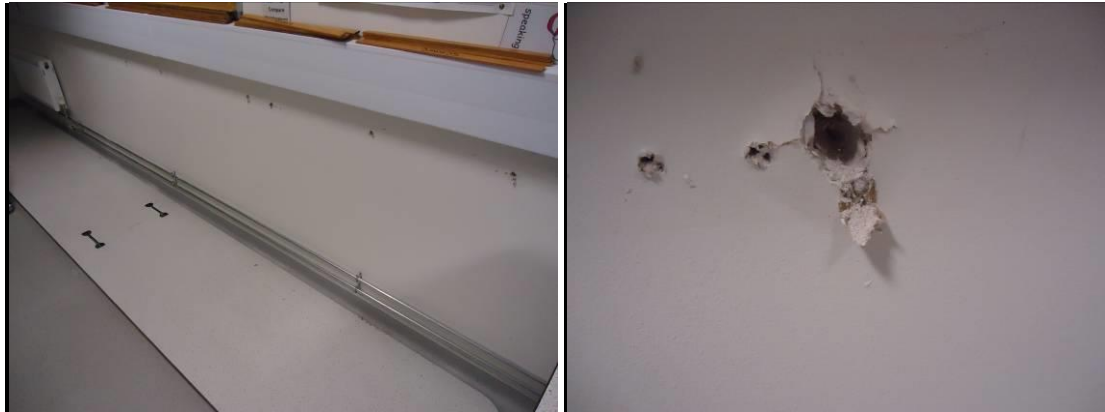
Figure 10.16. Fallen bench in Science Opportunity Centre in Faraday block.

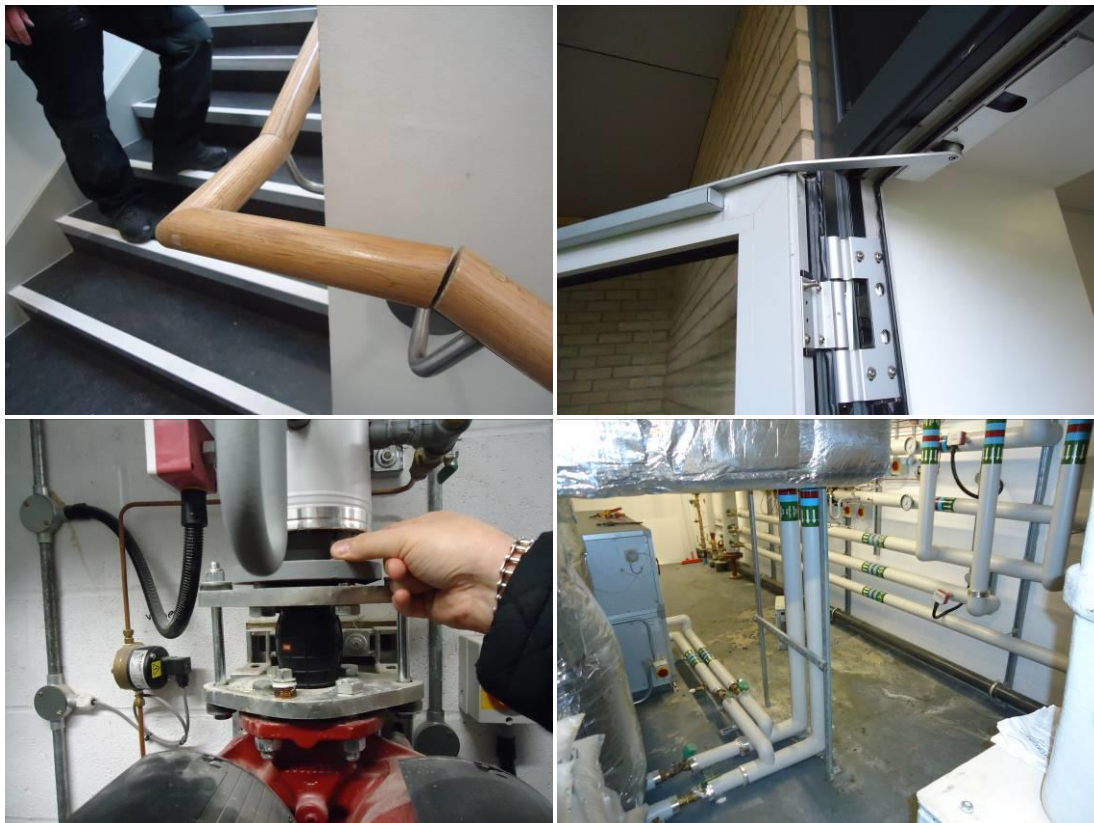
- There seems to have been several concerns with the quality of the fit out, particularly in plant rooms. The FM team have reported that pumps were not installed securely enough (only bolted hand tight) and burst pipes. Installation of fixtures and fittings in other areas of the school is sometimes of low quality with hand rails and benches not being securely fixed to the structure, but attached to plaster board. ***Quality of installation of fixtures and fittings needs to be high, especially in areas where pupils will cause high levels of wear and tear.***
- The school campus has experienced operational issues with several specialised systems, including the BMS and fire sprinkler system, due to the lack of maintenance contracts placed by the client. ***Specialised systems should have maintenance contracts in place at the point of handover.***

Figure 10.17. Clockwise: Loose hand rail, bent door opener, loose bolts on pump fitting, and floor damage from burst water pipes in plant room.

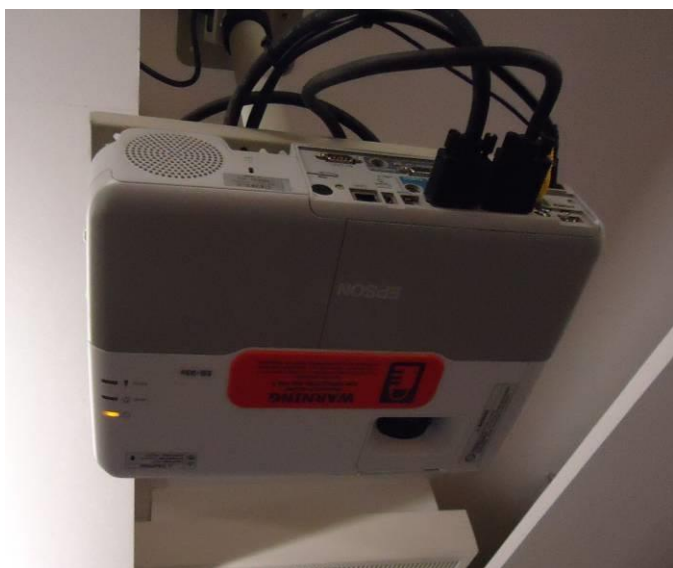
Figure 10.23. Projector left on stand-by, this was common to all classrooms.

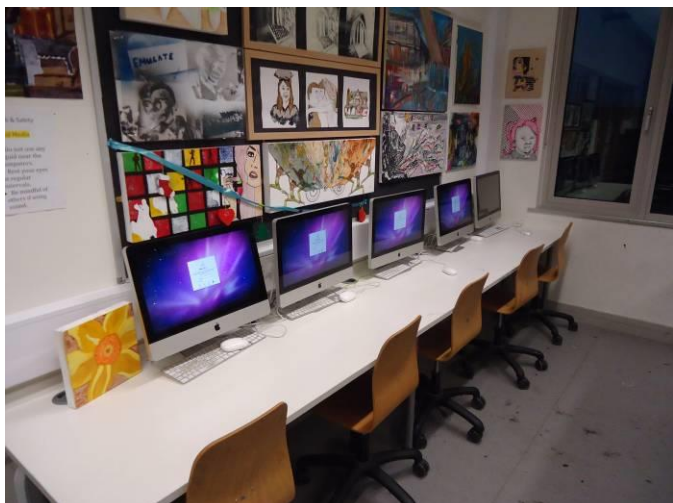
During the walk through it was discovered that computers located in the IT hubs for each block were often left in sleep mode as well as netbook stations left charging. Additionally, every classroom that was visited had at least one laptop or PC left in sleep mode and the majority had a whiteboard and projector left on stand-by (Figure 10.23). Some rooms also had additional PCs which were typically left on (Figure 10.24). Although these loads are individually small, when combined they are likely to be the cause of the base loads seen on the IT submeters for the various blocks.

Figure 10.24. Art room L210 with four out of five PCs left in sleep mode.

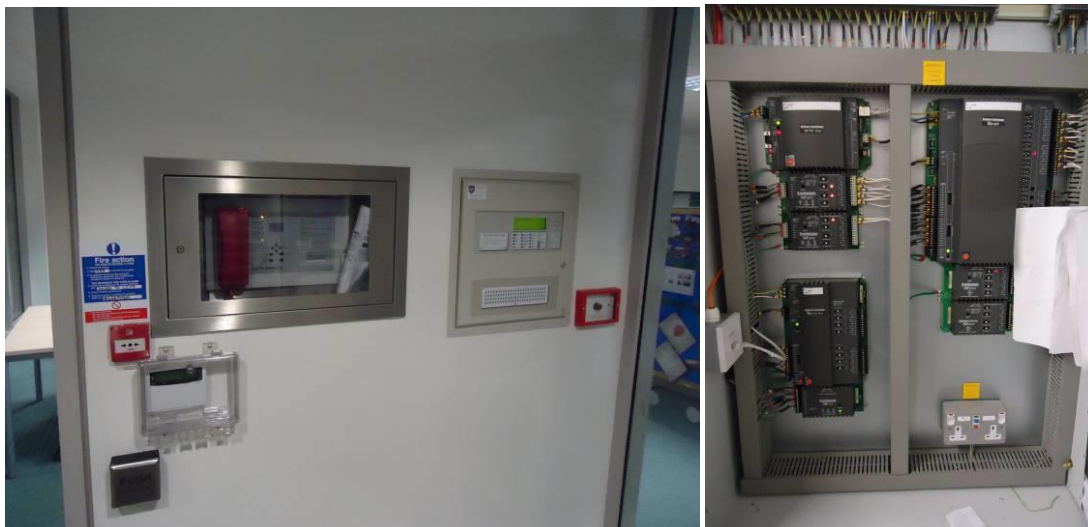
Examination of items on the Power submeters for the various blocks revealed that these are mainly cleaning sockets. However, there are some pieces of equipment hard-wired into supplies monitored by the Power submeters. These include alarm and fire systems, BMS communications (Figure 10.25) and Premier PSU200XP power supplies (Figure 10.26). These items are present in each block and seem to account for the base load for each Power submeter.

Figure 10.25. Alarm and fire systems, and BMS communications systems.

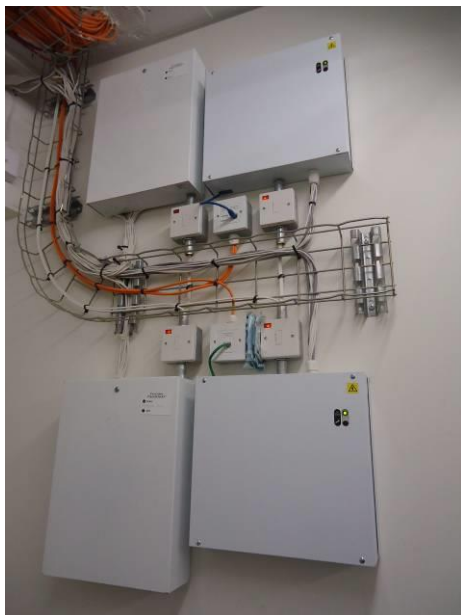
Figure 10.26. Premier PSU200XP power supplies.

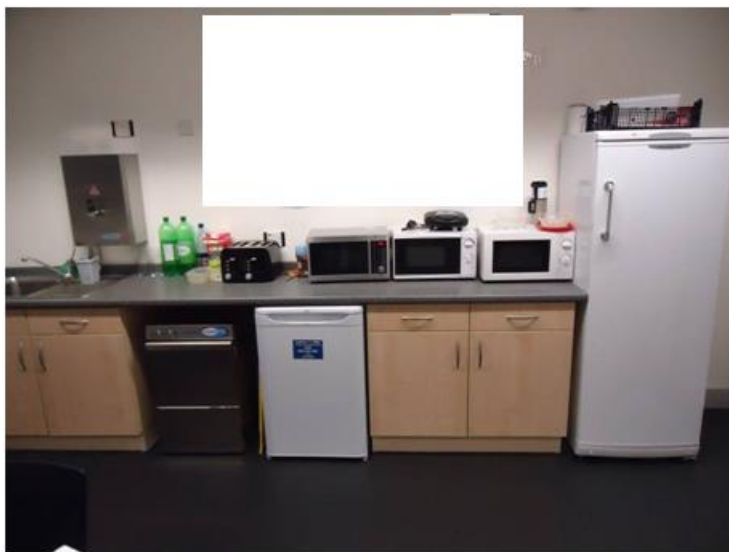
Additionally, in the Staff room Tenzing block Level 1 there is a 2.2kW water boiler, 2 fridges, 3 microwaves and a toaster, the supplies to which are all connected to the Power submeter for Tenzing block. This may explain why the Power submeter daily profile for Tenzing (see Figure 10.22) seems to follow occupancy more closely than Austen's Power submeter daily profile which is flatter (Figure 10.21).

Figure 10.27. Kitchen appliances in Tenzing's Staff Room. These are all wired into supplies monitored by the Power submeter.

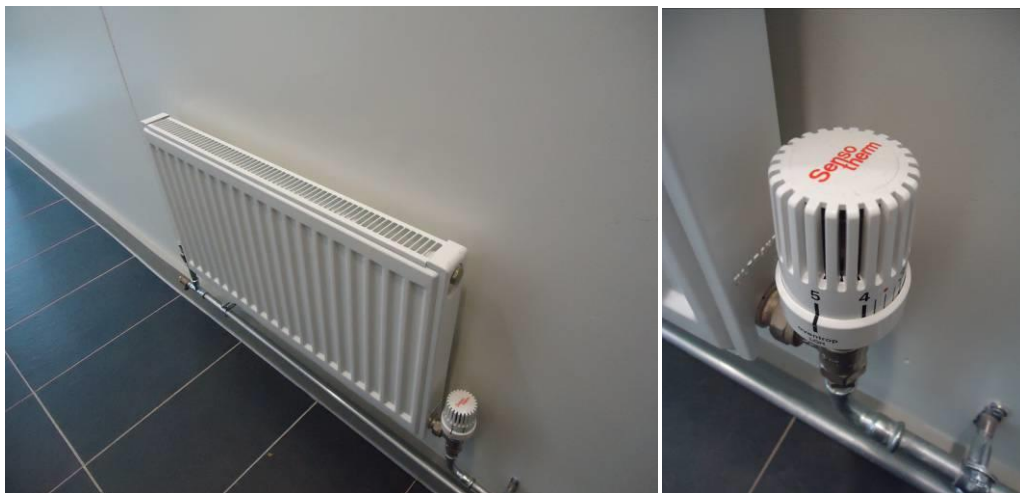
Figure 10.29. A radiator in a circulation space. The TRV was set to maximum of '5', which was typical for many radiators in circulation areas.
