Estover Community College Campus

Innovate UK project number	450026
Project lead and authors	AECOM, University of Exeter and University of Bath for Kier Construction
Report date	2014
InnovateUK Evaluator	Ian Mawditt (Contact via www.bpe-specialists.org.uk)

Building sector	Location	Form of contract	Opened
Schools	Plymouth	Design and build	2012

Purpose of evaluation

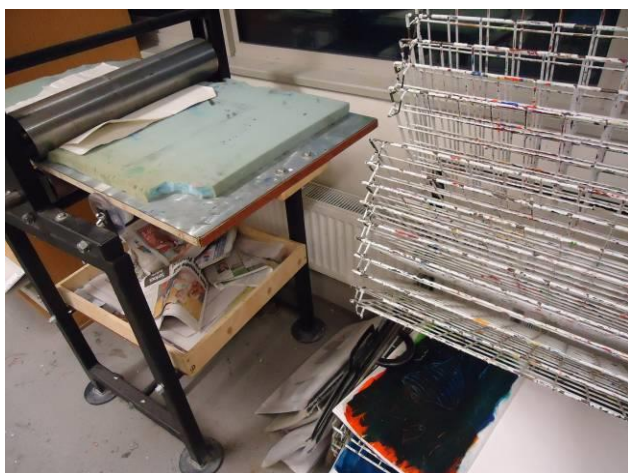
During the walk through it was observed that many radiators, especially those in circulation areas had their TRVs set on the maximum of '5' (Figure 10.29). Many radiators in classrooms were blocked by various equipment preventing heat flow (Figure 10.30).

Figure 10.30. Radiators in L210 Art room Cade North obscured by various equipment.

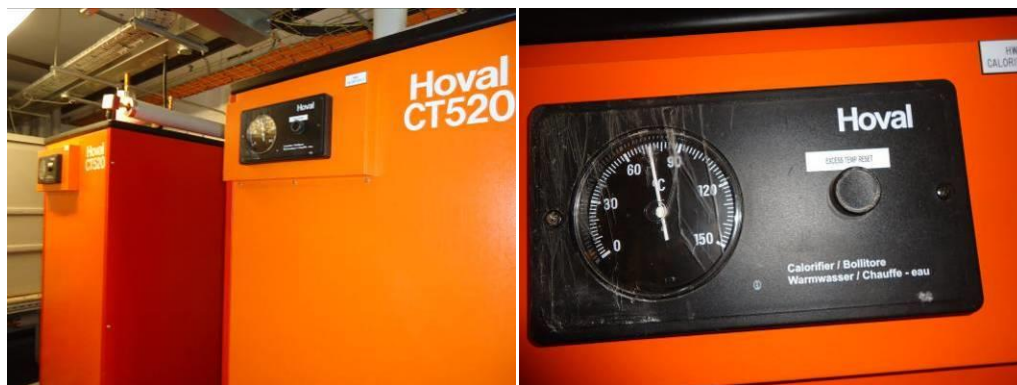
Domestic hot water is supplied by calorifiers for each block situated in the relevant plant room. The Facilities Manager indicated that showers are only rarely used by pupils or adults using the sports facilities. There seems to be a large amount of hot water being stored for this purpose.

Figure 10.31. 2 No. Hoval calorifiers in Austen block plant room and temperature dial on one. Note the temperature is being kept over 75°C.

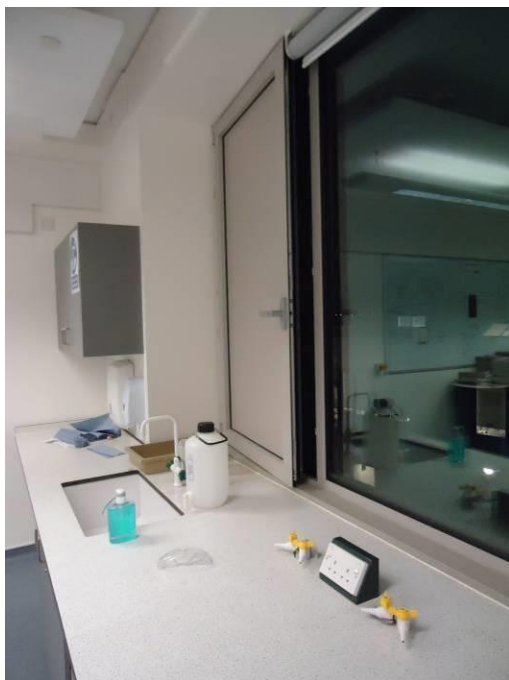
Figure 10.33. One of the night vents left open in F210 Faraday block while extract ventilation left on high.

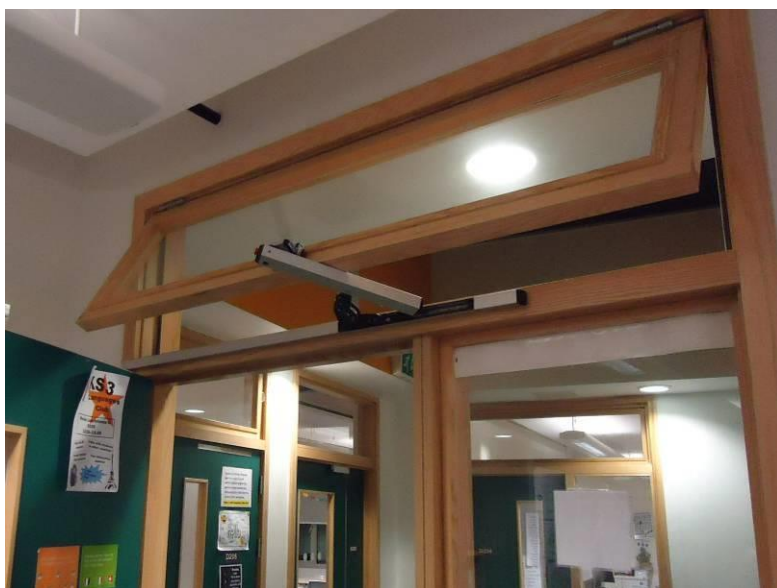
The building Log Book indicates to users that night vents should always be left open at night time and makes no mention that this action is inappropriate during winter. It also says the fanlight above the door should also be left open to aid night time ventilation. It was observed though that only 2 classrooms actually completed this action (Figure 10.21).

Figure 10.35. Fanlight vent above door leading to corridor in open state.

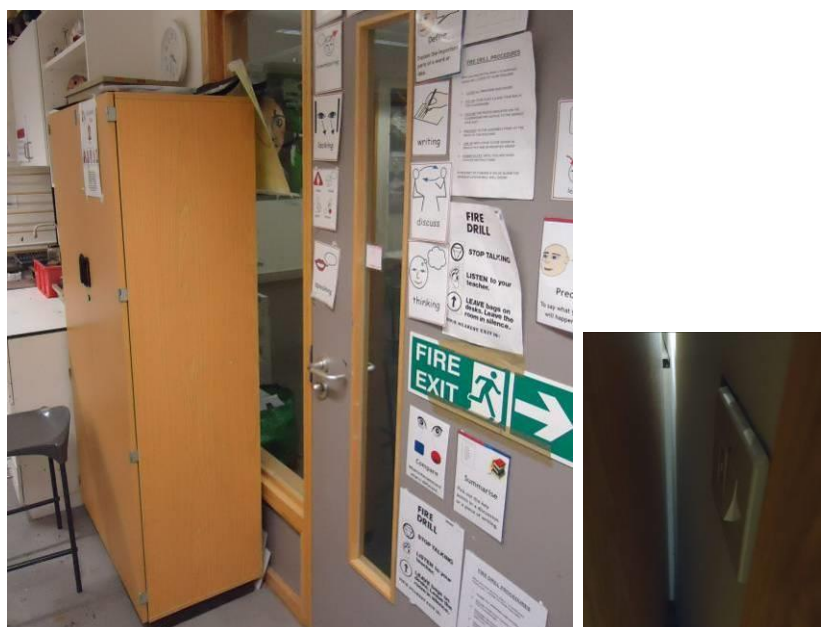
Figure 10.36. Art room L210 Cade North, note the light switch obscured behind a cupboard

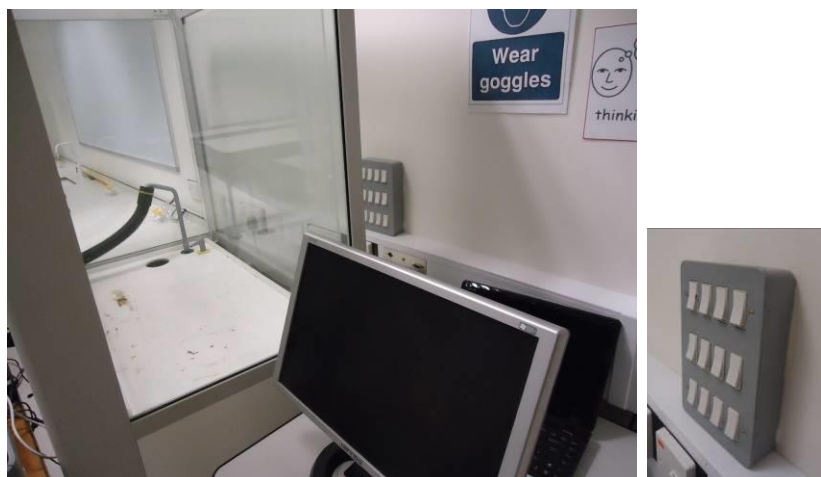
In the Science Opportunity Centre in Faraday block ground floor, a manual lighting control was discovered obscured by a fume cupboard and without any labelling. It was unclear what this control was for (Figure 10.37).

Figure 10.37. Lighting control in Science Opportunity Centre obscured by fume cupboard and PC, note there are no labels to inform the user which lights the control is for.

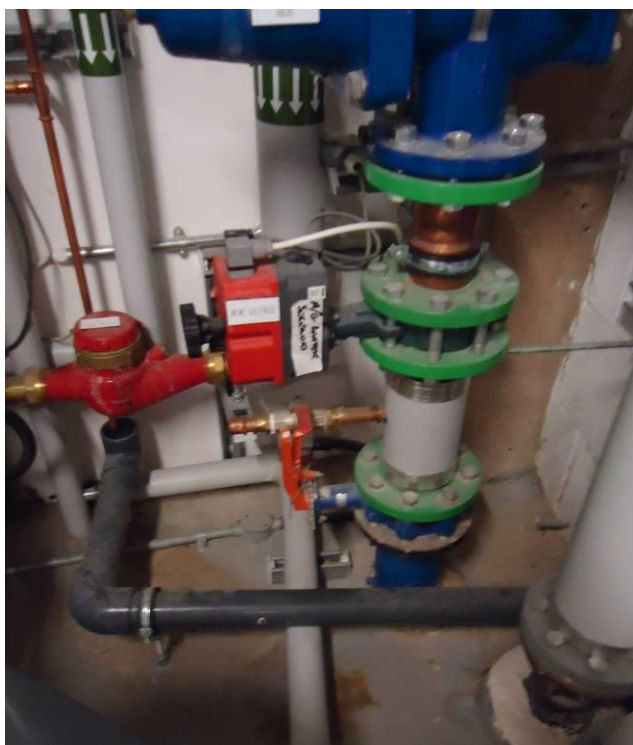
Figure 10.38. Location of incoming cold water supply pipes close to heating flow and return pipes in plant room Faraday block. This could possibly be the cause of the elevated cold water supply temperature.

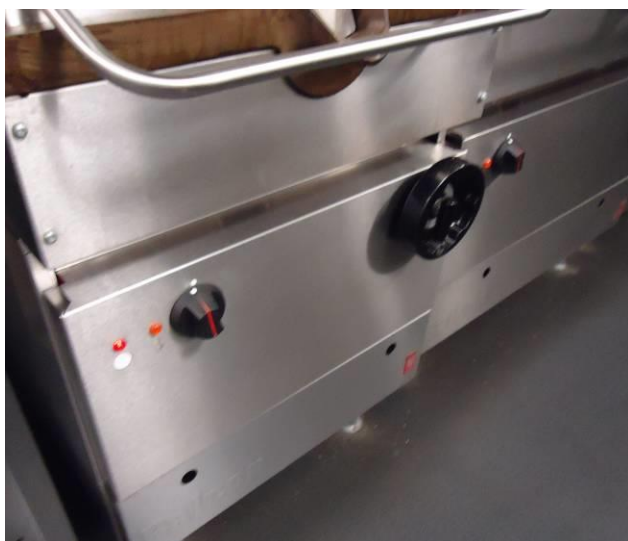
Figure 10.39. Brat pans in the kitchen turned off, but red lights indicate they are still on standby.

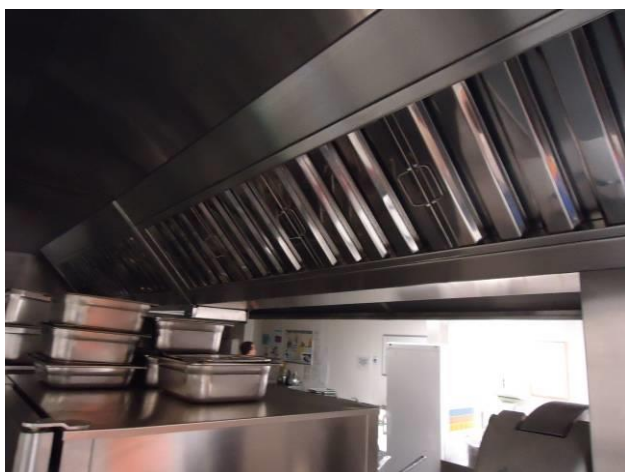
The kitchen extract system (Figure 10.40) was running continuously which the Facilities Manager had already explained would be the case. It is understood this is the result of a fault with the BMS and there is no local control to switch the extract system off. This has been the situation since the start of the school year in September 2013.

Figure 10.40. Kitchen extract fan which is on continuously throughout the day.

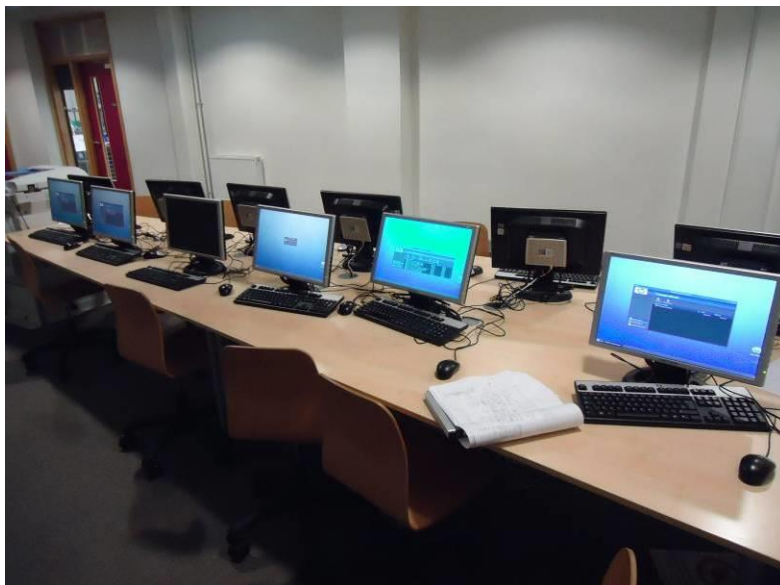
Each block has an IT hub located in the central area. These typically have around 10 thin client PCs and 1 photocopier. When visited during the walk through about two thirds were left in sleep mode in total.

Figure 10.41. IT hub in Faraday block, note 8 out of 12 PCs were left in sleep mode.

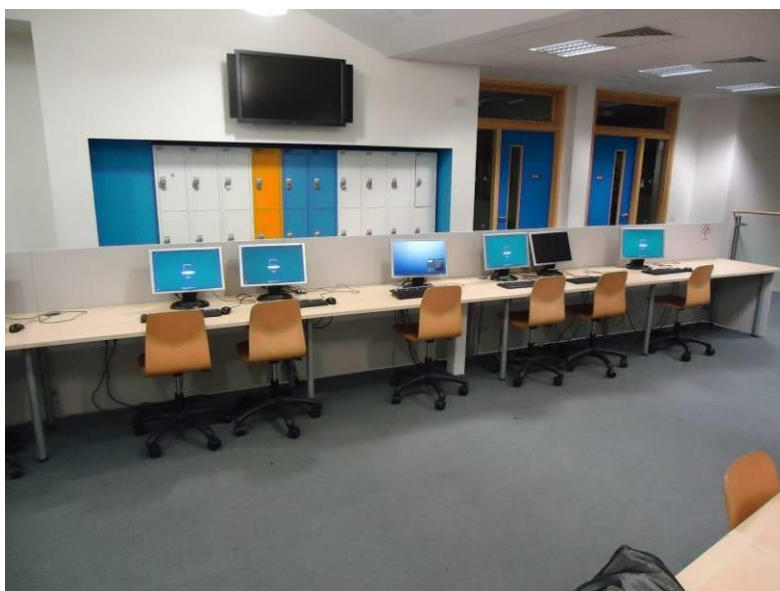
Figure 10.42. IT hub in Tenzing block, here 8 out of 10 PCs were left in sleep mode.

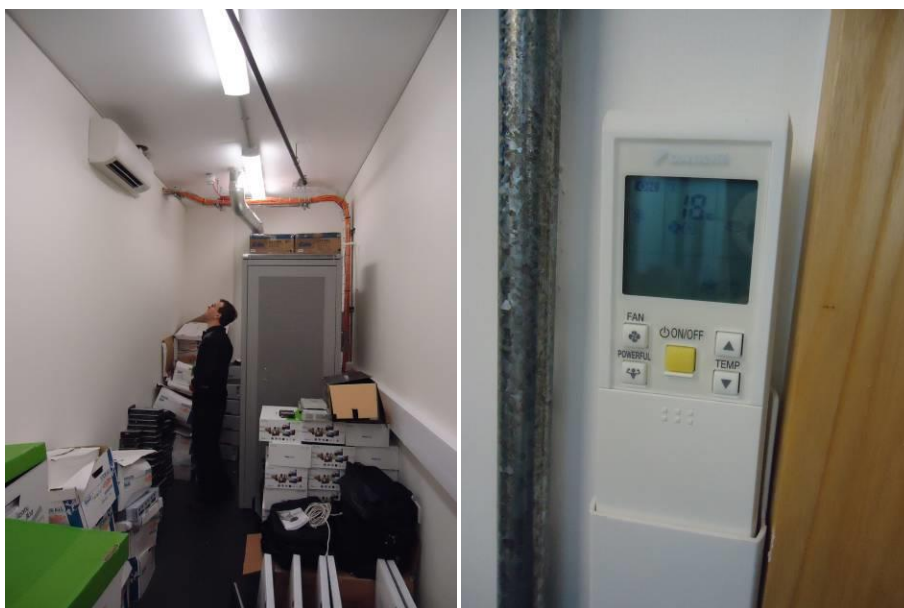
Figure 10.43. Small server room in Tenzing block and 18°C set point.

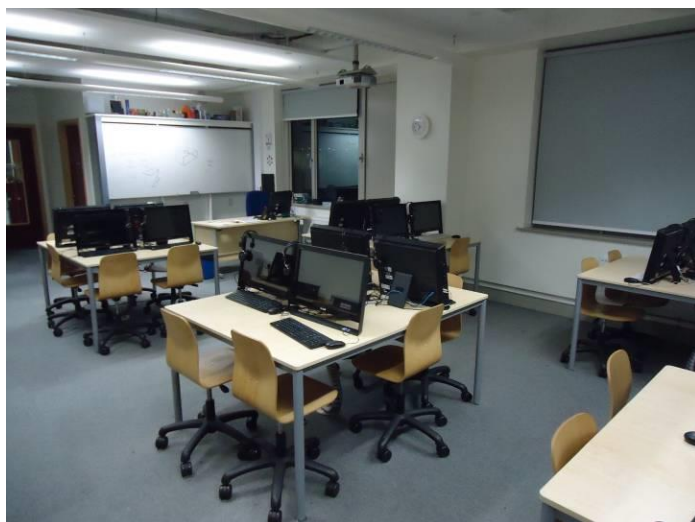
There are dedicated computer rooms scattered around the school campus. These contain a high density of PCs which are typically thin client. During the walk through it was observed that the majority of these were switched off. The Facilities Manager indicated that there is software in place to automatically turn off these computers when they are not needed. However, this software does not seem to extend to other PCs on the site.

Figure 10.44. Computer room in Faraday block, all PCs were switched off.

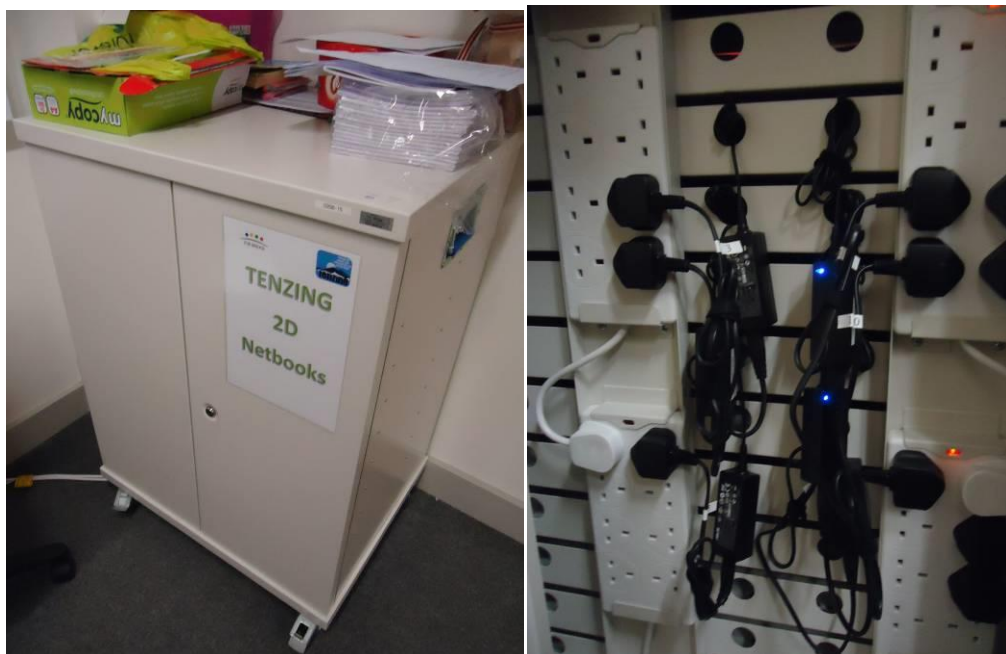
Figure 10.45. Netbook station in Tenzing block and chargers plugged in, note that only two of the adaptors are on and charging.

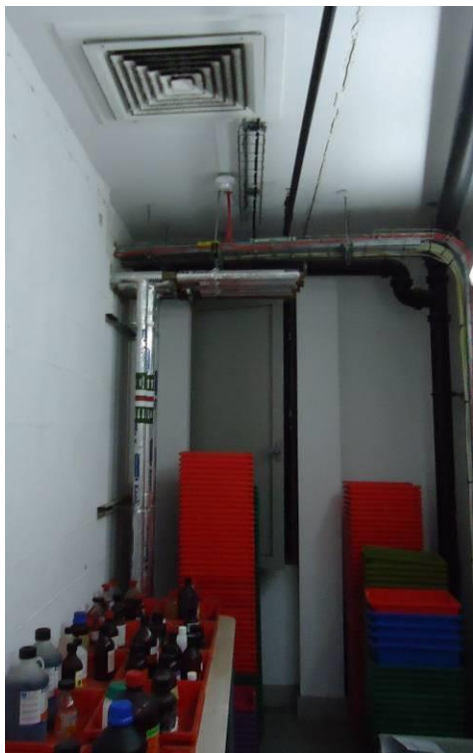
Figure 10.46. F201 Chemical store Faraday block, note open night vent and mechanical ventilation panel which was extracting.

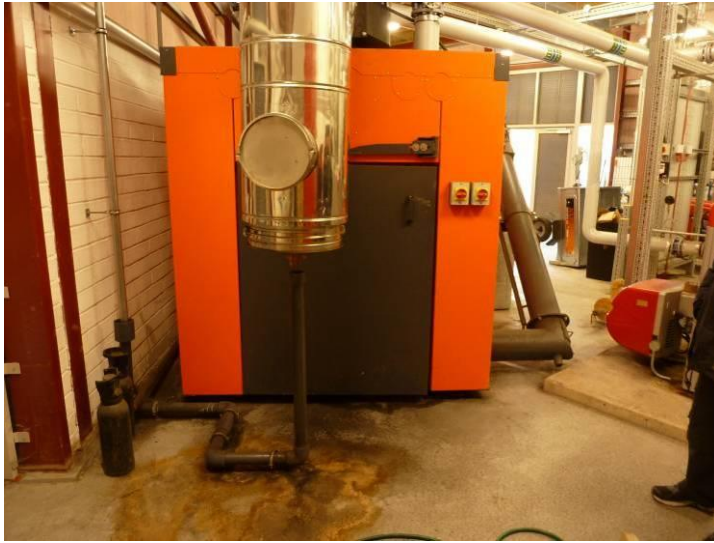
Figure 10.47. Biomass boiler, note the stain on the floor in front of the boiler indicating blow back.
