Greenfields Community Housing Headquarters

This document contains a Building Performance Evaluation report from the £8 million Building Performance Evaluation research programme funded by the Department of Business Innovation and Skills between 2010 and 2015. The report was originally published by InnovateUK and made available for public use via the building data exchange website hosted by InnovateUK until 2019. This website is now hosting the BPE reports as a research archive. As such, no support or further information on the reports are available from the host. However, further information may be available from the original project evaluator using the link below.

Innovate UK project number	450007
Project lead and author	Studio Partington
Report date	2014
InnovateUK Evaluator	Tom Kordel (Contact via www.bpe-specialists.org.uk)

Building sector	Location	Form of contract	Opened
Office	Braintree	Traditional (2-stage)	2009
Floor area (GIA)	Storeys	EPC / DEC	BREEAM rating
2180 m ²	3	B / N/A	Very good

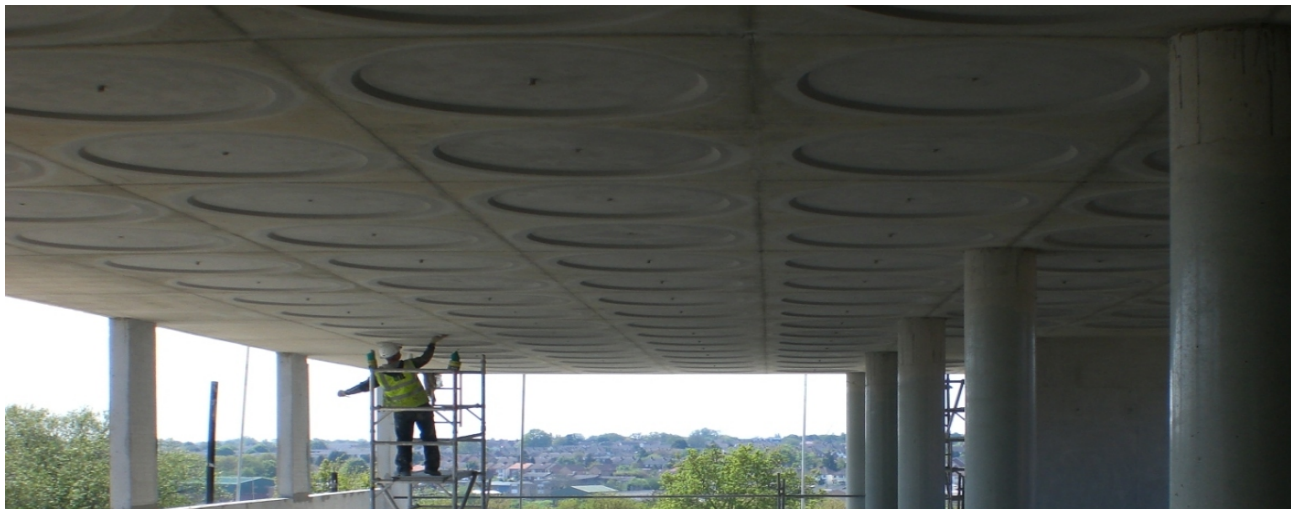
The lower two floors of the office building are constructed out of ins-situ concrete that is externally insulated and clad. The ceiling soffits in the open plan offices are exposed concrete to act as a thermal sink and help regulate extreme temperature modulations across the space in all weathers. The high level hoppers have been installed to couple with this exposed thermal mass and help make the night purge strategy more effective.

Figure 2 Concrete slab with a soffit profile to maximise exposed surface area

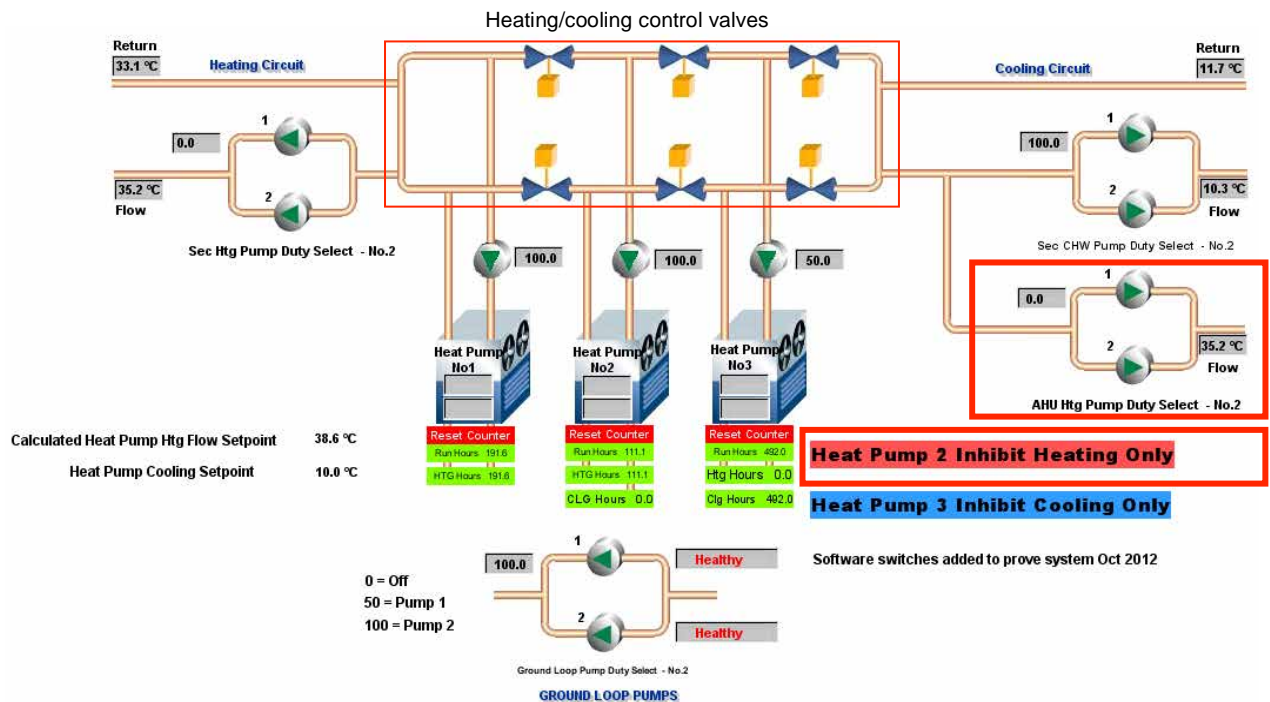
Also, there is a label indicating that GSHP2 has been set to only run in heating mode; however, the BMS data analysed in Section 7 suggests that GSHP2 has also been running in cooling mode, albeit for short period of time, supposedly to supplement GSHP3. The review of the GSHP has established other technical issues, which have been detailed in Section 7.

Figure 13 Screenshot of the BMS graphical interface showing the heating and cooling system

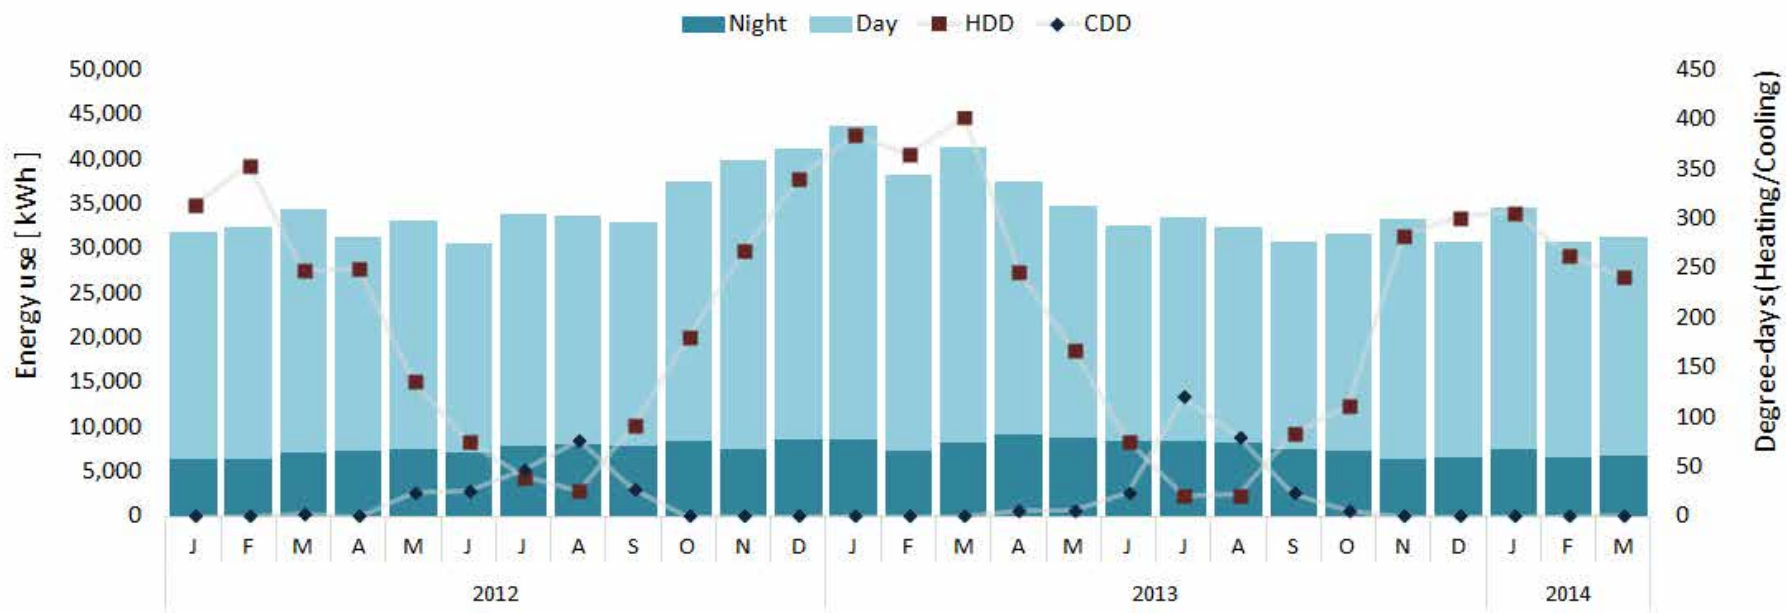
The electricity provision to the building has changed between several suppliers and tariffs. However, all consumption reporting are consistent and good quality billing data could be obtained for this analysis. **Error! Reference source not found.**¹⁸ shows the billed energy consumption for 1st January 2012 to 31st March 2014, broken down into day and night consumption. Included in the graph are the corresponding local heating and cooling degree-days based on a base temperature of 15.5°C.

Figure 19 The GCH building billed electricity consumption for the period January to December 2013, including the corresponding local Heating and Cooling Degree-Days

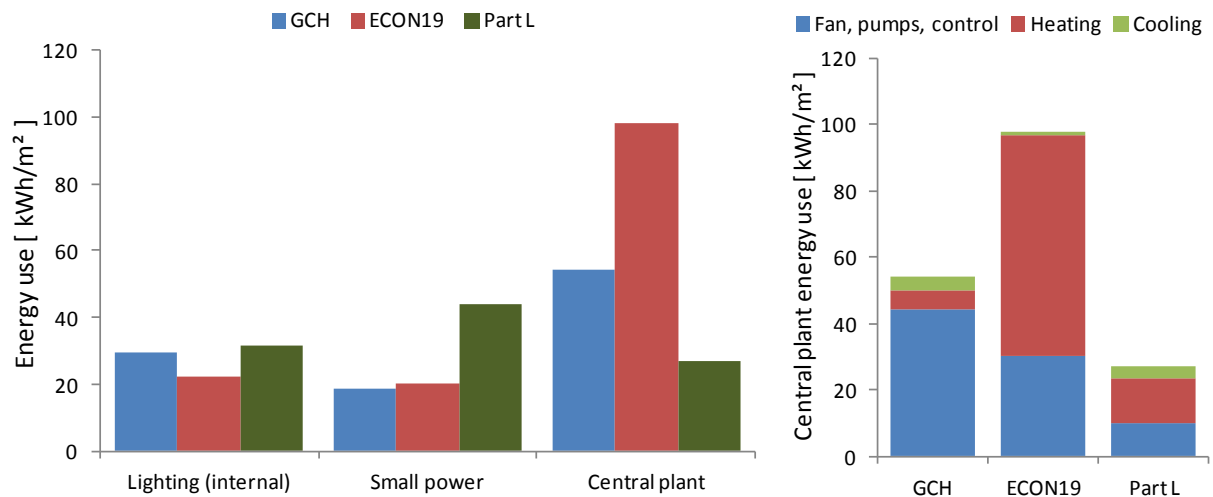
breakdown in central plant energy suggests potential energy waste in the constant provision of mechanical ventilation in the building, which the building manager is strongly advised to investigate. The TM22 detailed assessment, which is described next, will help identify potential area of energy waste as such relevant energy saving opportunities can be subsequently recommended through the review of the building installation and commissioning documents.

Figure 30 Comparison between GCH building actual metered energy use, ECON19 benchmarks and that predicted via the Part L (as-build) assessment, including the breakdown of the central plant energy use
 “Note: The GSHP ground-loop, which should be part of the heating and cooling plant energy use, is embedded within the total energy use for “fan, pumps and control” recorded on the DB Main Panel sub-meter. It has not been possible to accurately extract the ground-loop energy use from the sub-metered data for reassignment under the heating and cooling plant energy use.”

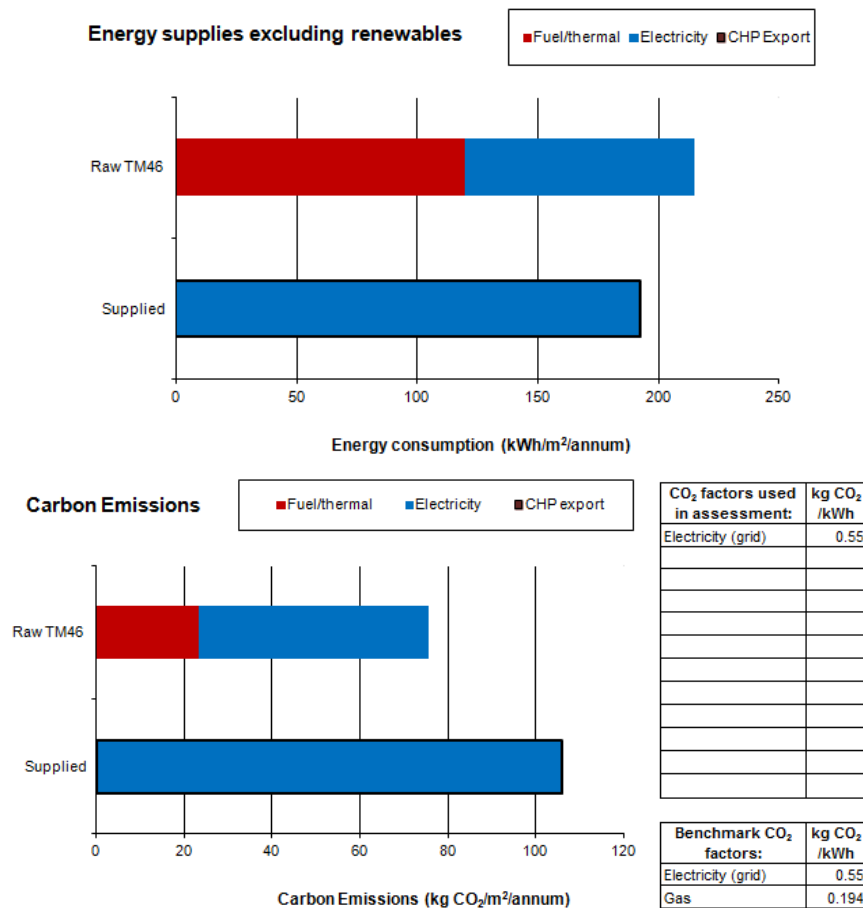
calculations and the outputs presented are a direct representation of the data entered. **Error! Reference source not found.** shows the output for the simple assessment comparing the building's metered energy consumption against its equivalent CIBSE TM46 benchmark for a general office. Whilst the total energy use of the building is less than its TM46 benchmark, it exceeds the benchmark by approximately 40% in terms of CO₂ emissions due to its all-electricity energy source, which has a higher CO₂ intensity factor than natural gas.

Figure 31 TM22 output showing the GCH building equivalent CO₂ emissions against the TM46 benchmark

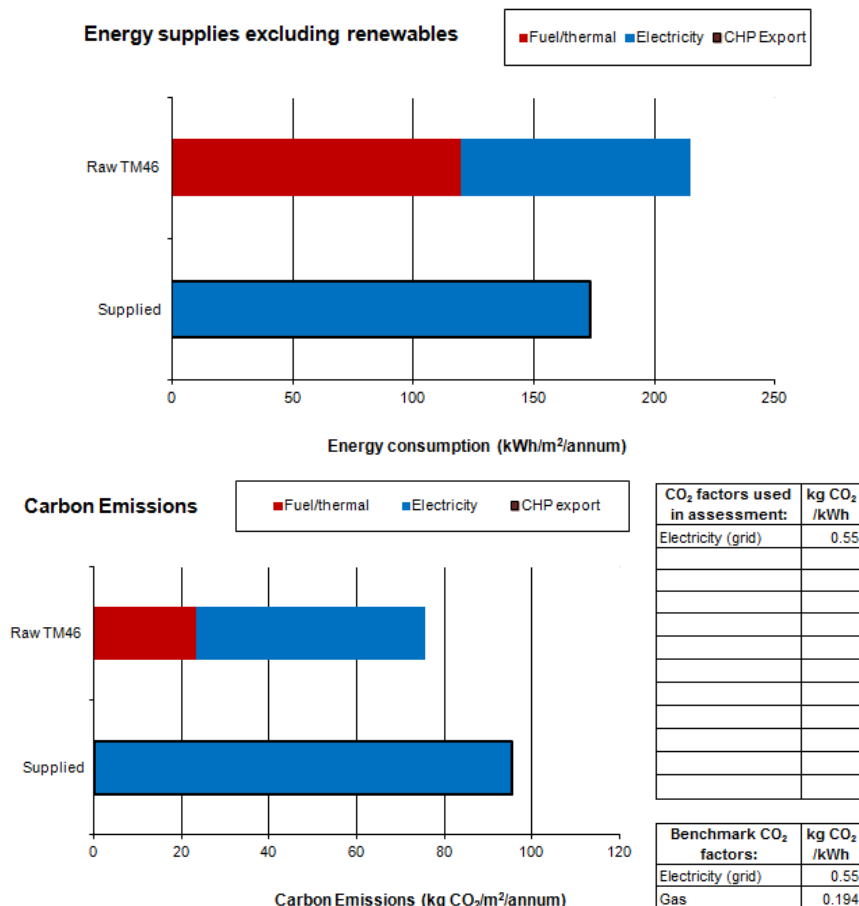
With the weather-normalisation adjustment, the building's energy consumption is lower than metered. This normalisation better illustrates its true energy performance relative to other equivalent buildings in the existing stock. The preferable normalisation methodology would be to degree-day adjust the CIBSE TM46 benchmark energy data instead; however, for the purpose of generating consistent charts on the TM22 spreadsheet the actual building's metered energy data has been adjusted and **Error! Reference source not found.** shows the corresponding outputs.

Figure 32 Degree-day normalised TM22 output for the GCH building in-use CO₂ emissions against the TM46 benchmarks

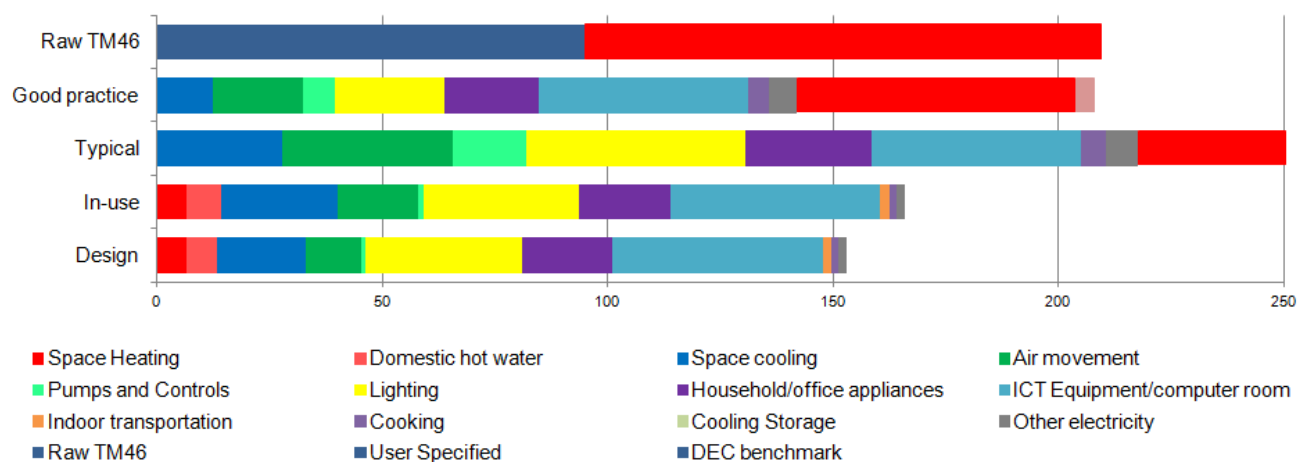
One of the TM22 detailed assessment outputs is presented in **Error! Reference source not found.**, which shows consumption in (kWh/m²) categorised by end-use. The “Raw TM46”, “Good Practice” and “Typical” are benchmark figures. The “Design” energy use was derived from the input data of plant and appliances power wattages and usage profile, which were estimated based on site survey and product and design information. The “In-use” energy use was retrospectively derived by adjustments made in order to reconcile the “Design” energy use against the sub-metered energy. The adjustments were made to the usage factors for the respective items of plant and appliances in the building to account for difference in the duration of operation.

Figure 33 TM22 detailed assessment output showing electrical and thermal energy use in kWh/m² by end-use categories for the building against available benchmarks

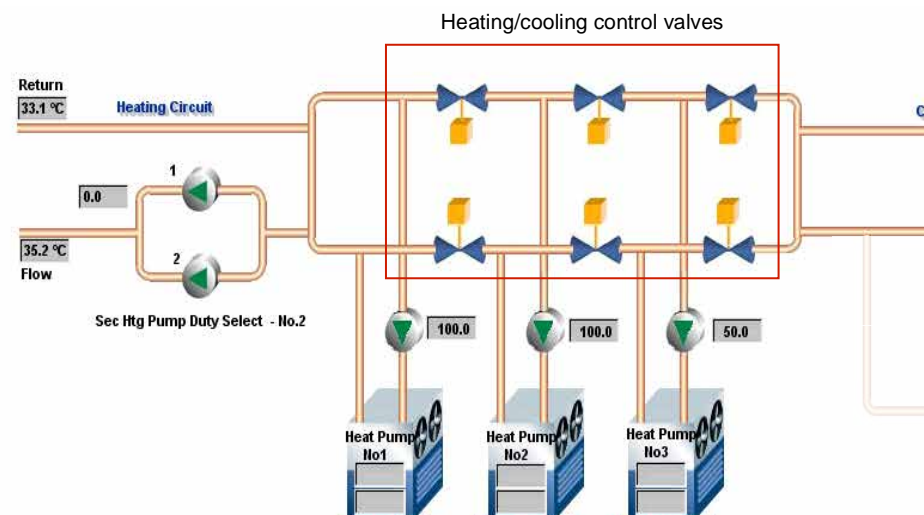
Figure 36 Screenshot of the BMS graphical interface showing the heating and cooling

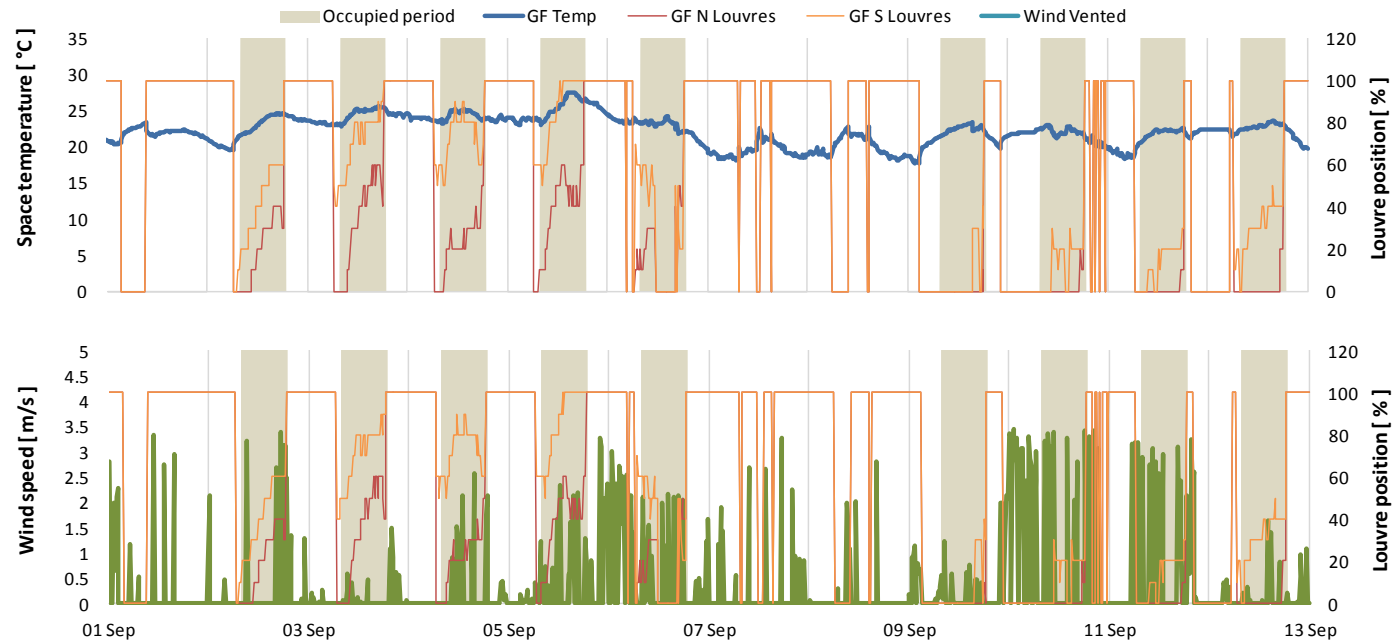
Figure 41 Hourly ground floor average temperature against façade louvre position, GSHPs heating and cooling operation and relevant wind speed
