Malmesbury Gardens

Innovate UK project number	450050
Project lead, authors, and client	Swindon Council, Oxford Brookes University
Report date	April 2015
InnovateUK Evaluator	xxx (Contact via www.bpe-specialists.org.uk)

No of dwellings	Location	Type	Constructed
13 (2 plots sampled)	Swindon	Terraced houses	2011
Area	Construction form	Space heating target	Certification level
94 m ² (typical)	Timber frame with solid external walls and Hempcrete	N/A	Code for Sustainable Homes (5)

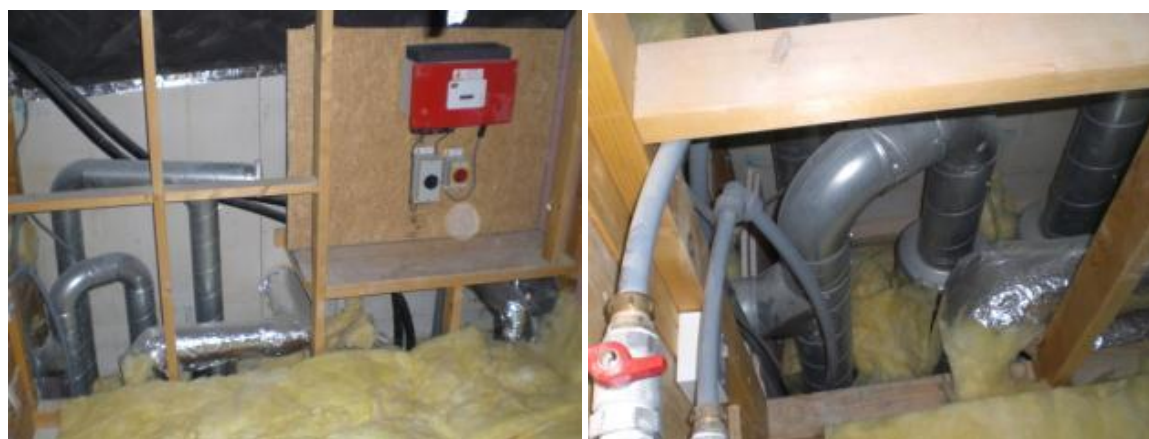
Smoke pencil tests carried out revealed significant levels of volume flow entering the NIBE and solar cupboards, as well as flows into electrical cabinets/cupboards (Figures 5 and 6). Other air leakage paths were revealed around: cracks in window frame joints, electrical outlets, skirting to floor junctions, services cupboards penetrations, under window cill boards, ceiling access hatches.

Figure 5 NIBE cupboard. Gaps in insulation and air leakage paths.

Significant levels of volume flow entering the NIBE and solar cupboards were observed, as well as flows into electrical cabinets/cupboards.

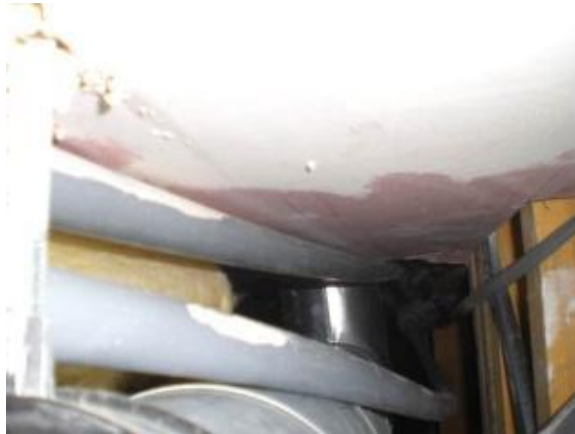
Figure 6 View into roof from NIBE cupboard

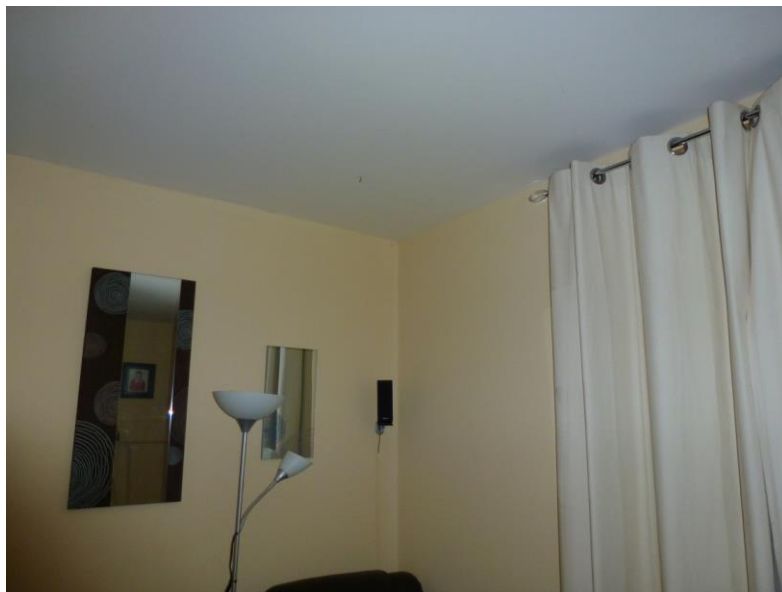
Figure 8 Living room ceiling digital photograph.

Figure 7 Living room ceiling thermogram. Image shows heat loss through the exposed wall. Cold spot identified on wall.

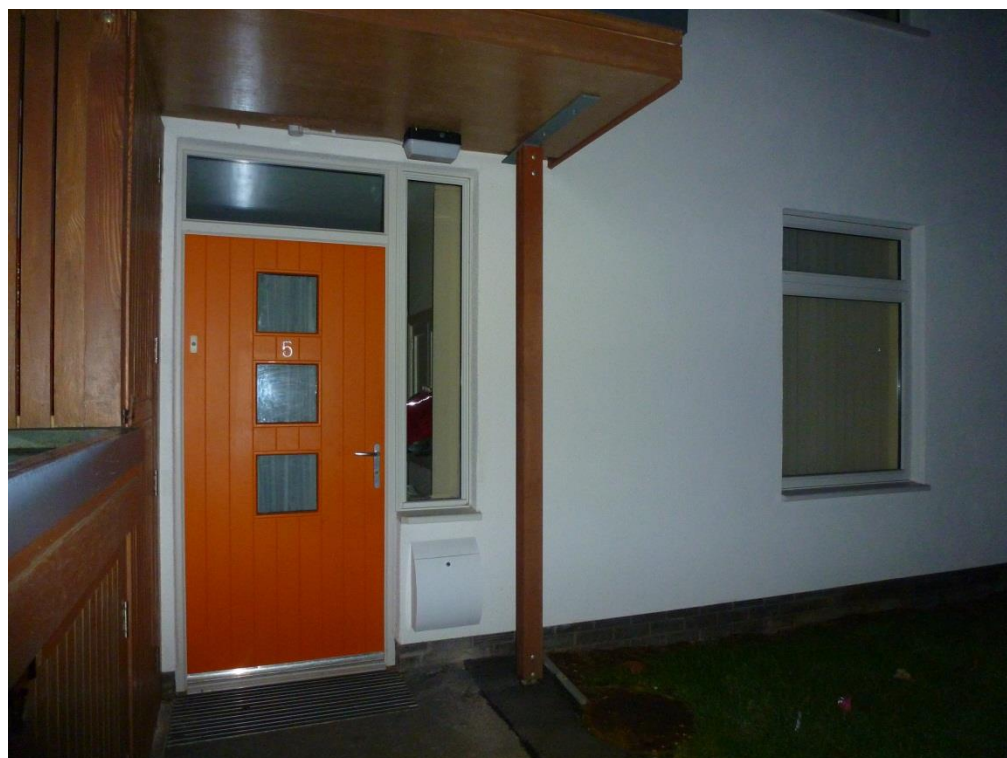
Figure 12 North elevation main entrance digital photograph (taken from outside).

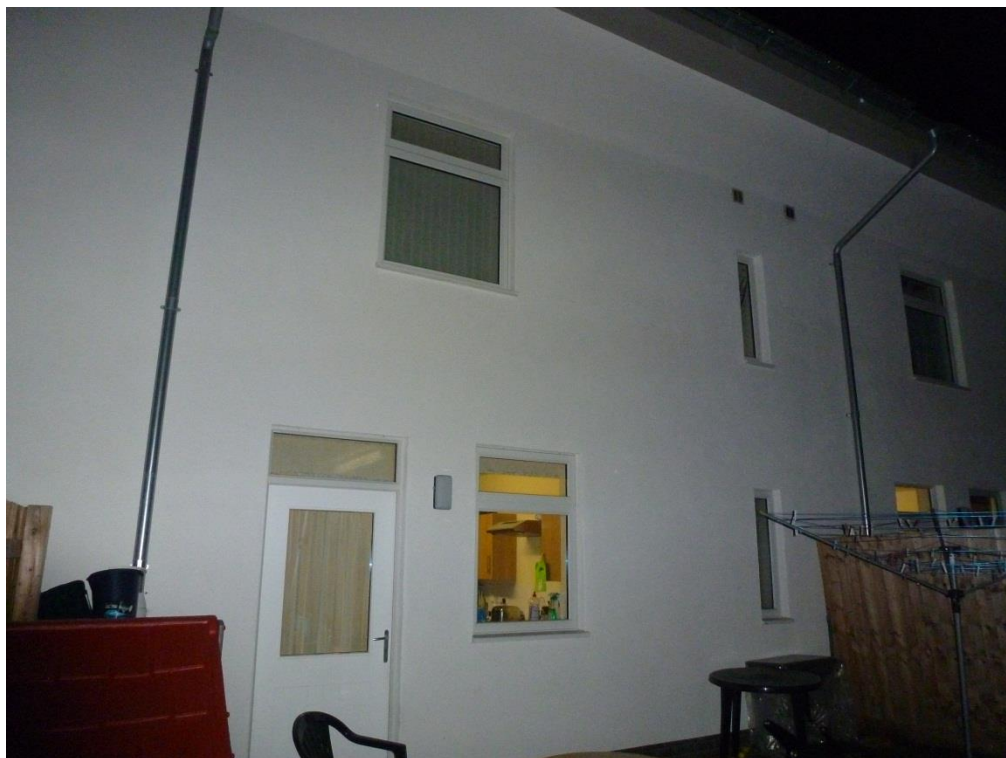
Figure 14 South elevation digital photograph.

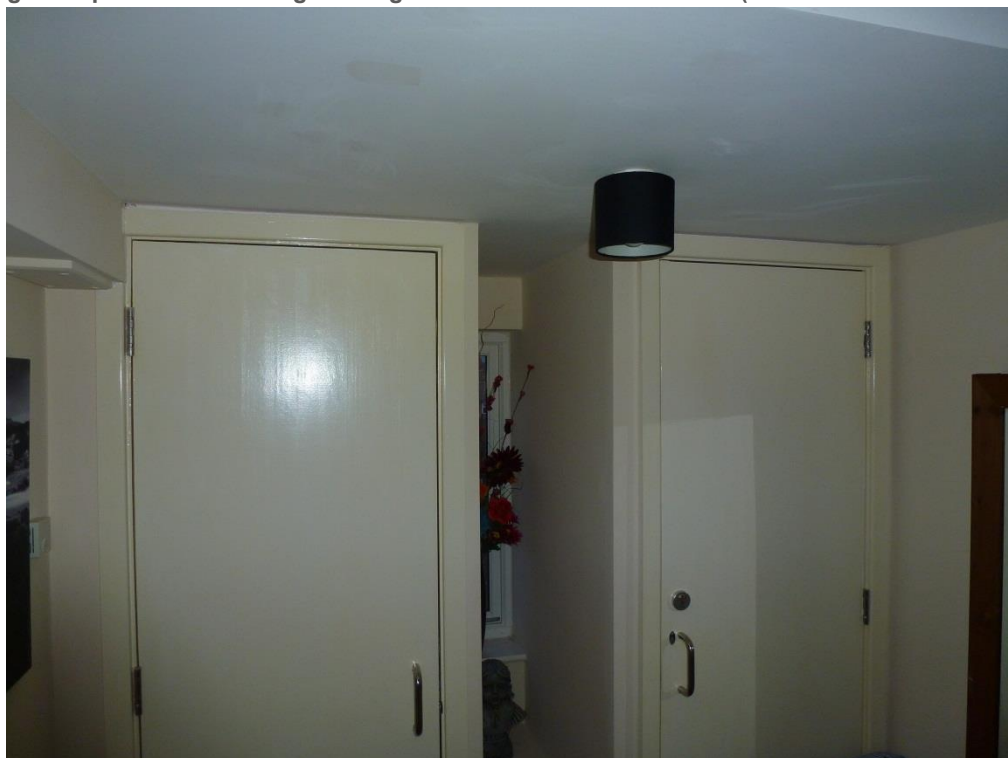
Figure 18 First floor landing digital photograph.

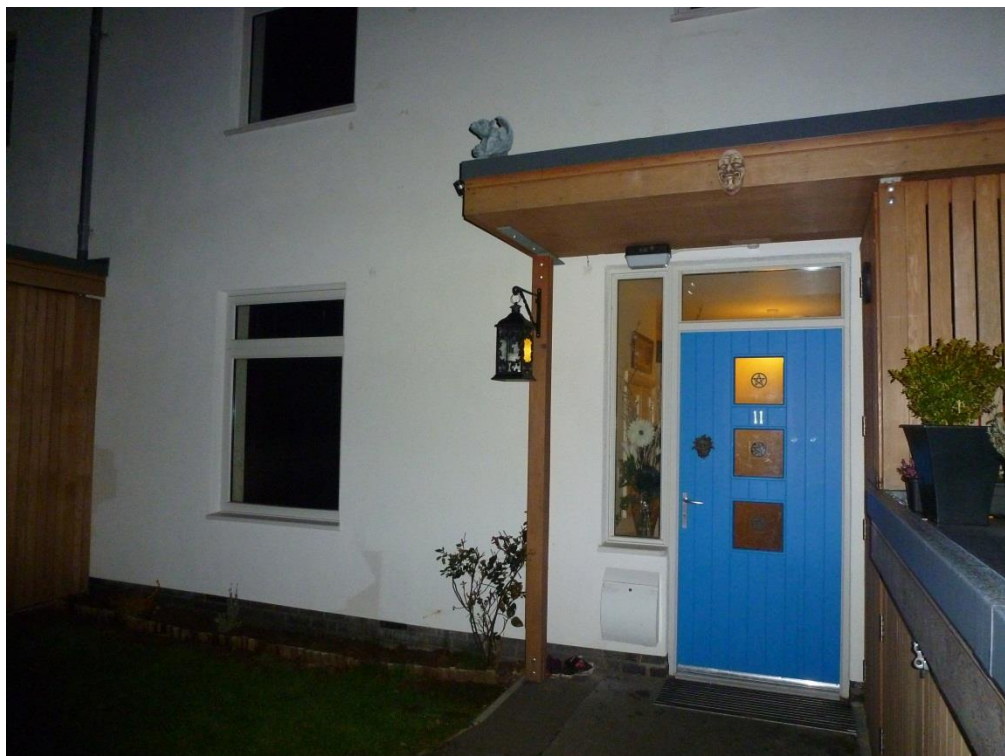
Figure 22 South elevation main entrance digital photograph.

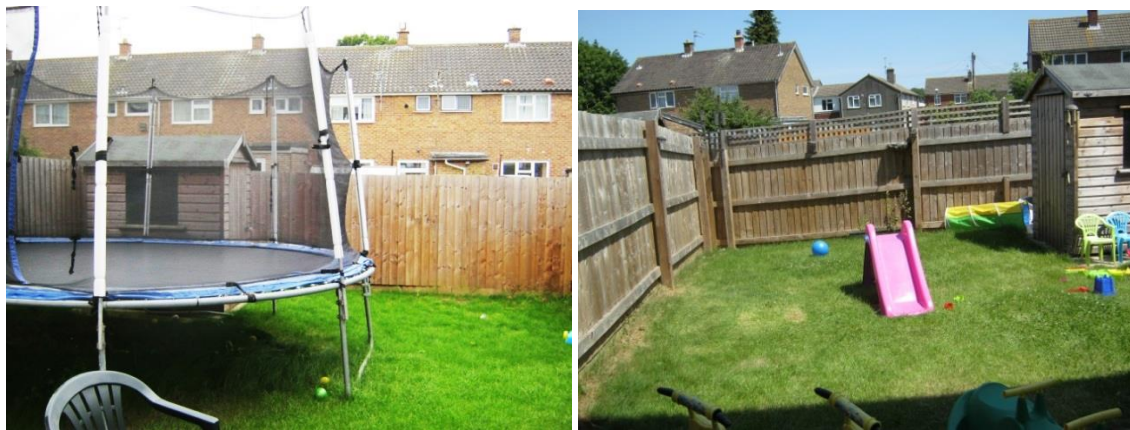
Figure 54 House 5 back yard (left). House 11 back yard (right) Occupants are satisfied with the appearance and size of the garden.

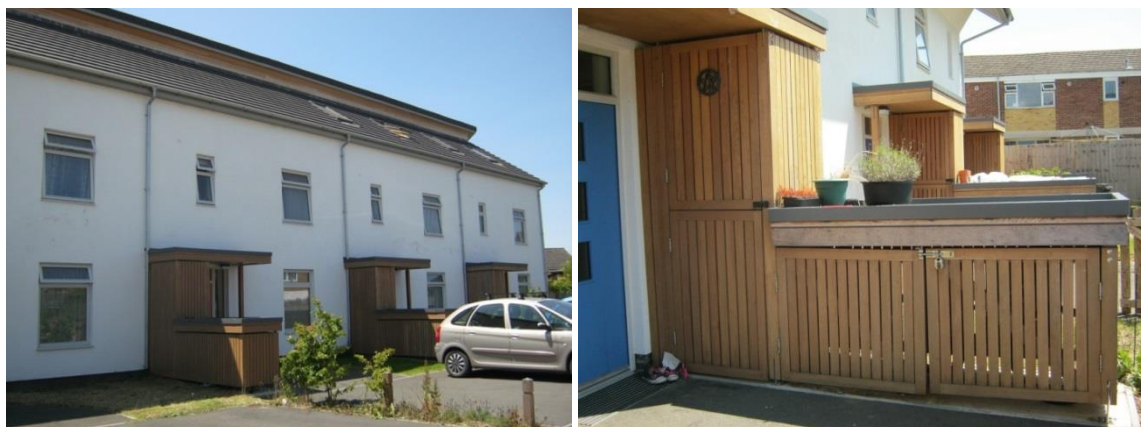
- Occupants in both houses agree that all spaces in the house are easy to clean and maintain.
- Occupants in House 11 are very pleased with the design, layout and overall appearance of the house, in contrast to the occupants in House 5 who do not like the open plan kitchen and are not satisfied with the appearance of the house (Figures 54-55). Occupants in both houses agree that room spaces are satisfactory.

Figure 55 House 5 front (left). Occupants are not very satisfied with the appearance of the house. House 11 front (right). Occupants are satisfied with the size of the front space and storage.

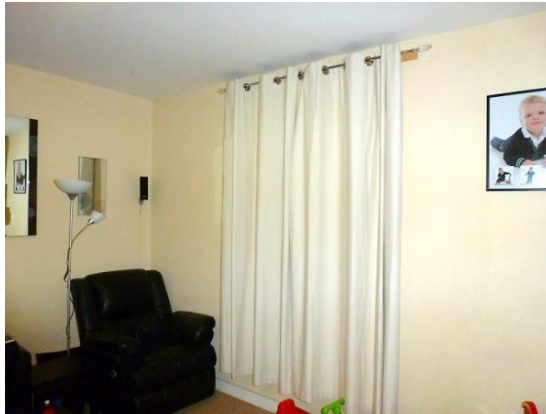
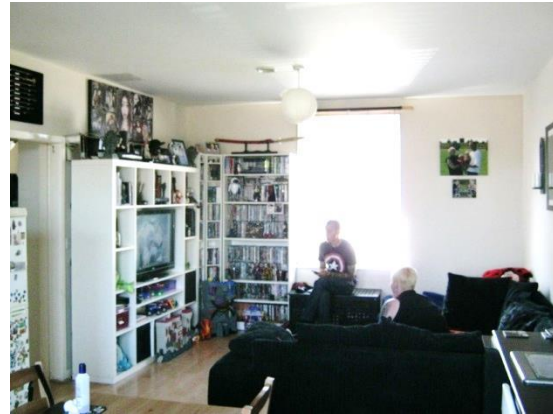
Figure 56 House 5 living room (left). Occupants reported that the heating in this space can be very high and that they find it difficult to adjust the thermostats. Room thermostats fail to provide good levels of fine control. House 11 living room (right). Occupants enjoy the open plan space and are satisfied with the size and daylight of the room.

- Occupants in House 5 leave the heating system on throughout the year, whereas occupants in House 11 turn it off during summer. This indicates that they had not received proper guidance during the induction phase and underlines the fact that the Home User Guide does not include direct instructions on how to operate the heat pumps.

- Occupants in House 11 reported that the Home User Guide gives inaccurate information on how to operate the thermostat dial. This has been verified through the review of the Home User Guide.

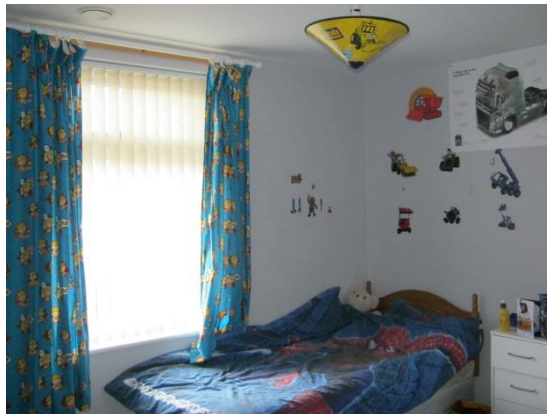
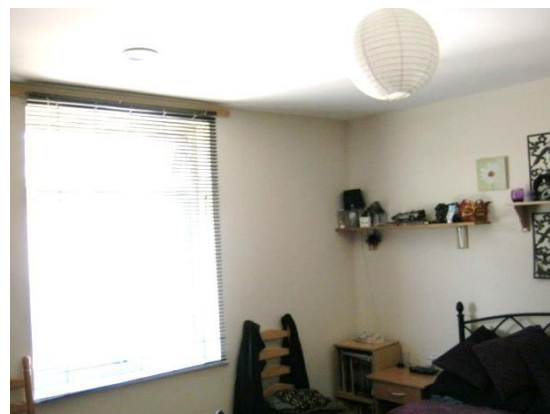
Figure 57 House 5 south bedroom (left). Occupants are satisfied with the room size and daylight but report that the heating is high. House 11 south bedroom (right). Occupants are satisfied with the room size, air quality and daylight levels but report noise from the MVHR.

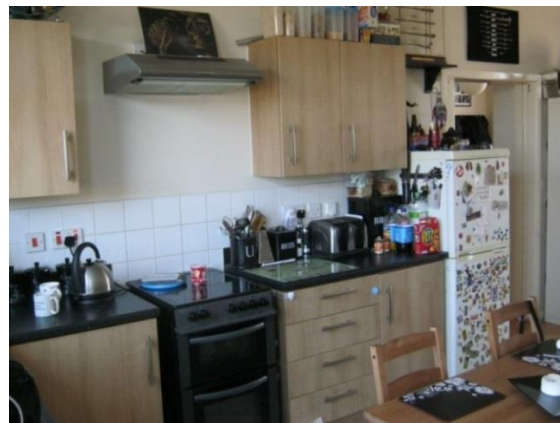
- Occupants in House 11 rarely feel the need to open the windows during winter and mention that the air quality in the house is always good, whereas occupants in House 5 tend to open the kitchen window even during the winter and complain that the air can be stuffy at times (Figures 58). This might be related with the fact that House 5 is more airtight ($5.3\text{m}^3/\text{m}^2\text{h}$) than House 11($15.8\text{m}^3/\text{m}^2\text{h}$).

Figure 58 House 5 kitchen (left). Occupants are not satisfied with the open plan and report that the air quality is poor as cooking smells are dispersed. House 11 kitchen (right). Occupants are satisfied with size and storage space and do not have any problems with cooking smells when using the hood.

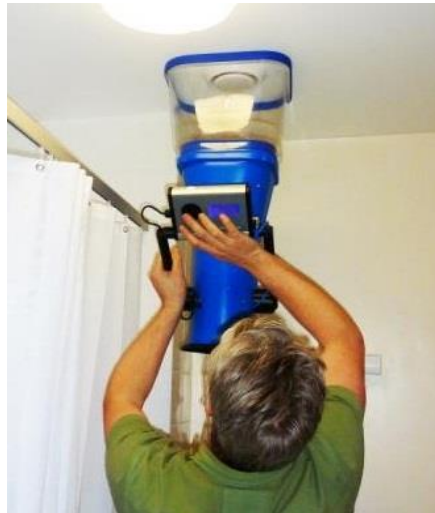
The airflow of all extract and inlet vents was measured in both houses. Measurements were taken on 2nd July 2013 for House 5 and on 16th April 2013 for House 11 (Figure 60).

Figure 60 MVHR testing. Measuring the extract rate in the bathroom vent.

The tests revealed a great discrepancy between the supply and extract rates (Tables 4 and 5), suggesting that commissioning of the system was not done properly. Also, the fact that the vents are not locked in a fixed position allows the occupants to shut them off completely, interfering with the balance of the system.

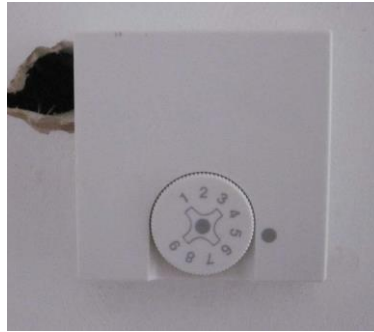
Figure 121 Master thermostat

The master thermostat (Figure 121) was also operated by a rotary switch with a numeric scale from 1 to 9, setting the temperature range in which all the individual stats will operate. However, a temperature indication to provide tenants detailed information on their heating status was missing. It could not provide a clear feedback indicating to the user the control's operation since there was no light, sound or temperature indication on it.
