# Marks & Spencer Cheshire Oaks Store

This document contains a Building Performance Evaluation report from the £8 million Building Performance Evaluation research programme funded by the Department of Business Innovation and Skills between 2010 and 2015. The report was originally published by InnovateUK and made available for public use via the building data exchange website hosted by InnovateUK until 2019. This website is now hosting the BPE reports as a research archive. As such, no support or further information on the reports are available from the host. However, further information may be available from the original project evaluator using the link below.

<b>Innovate UK project number</b>	450109
<b>Project lead and author</b>	Faithful+Gould for Marks & Spencer plc.
<b>Report date</b>	2014
<b>InnovateUK Evaluator</b>	Robert Cohen (Contact via <a href="http://www.bpe-specialists.org.uk">www.bpe-specialists.org.uk</a> )

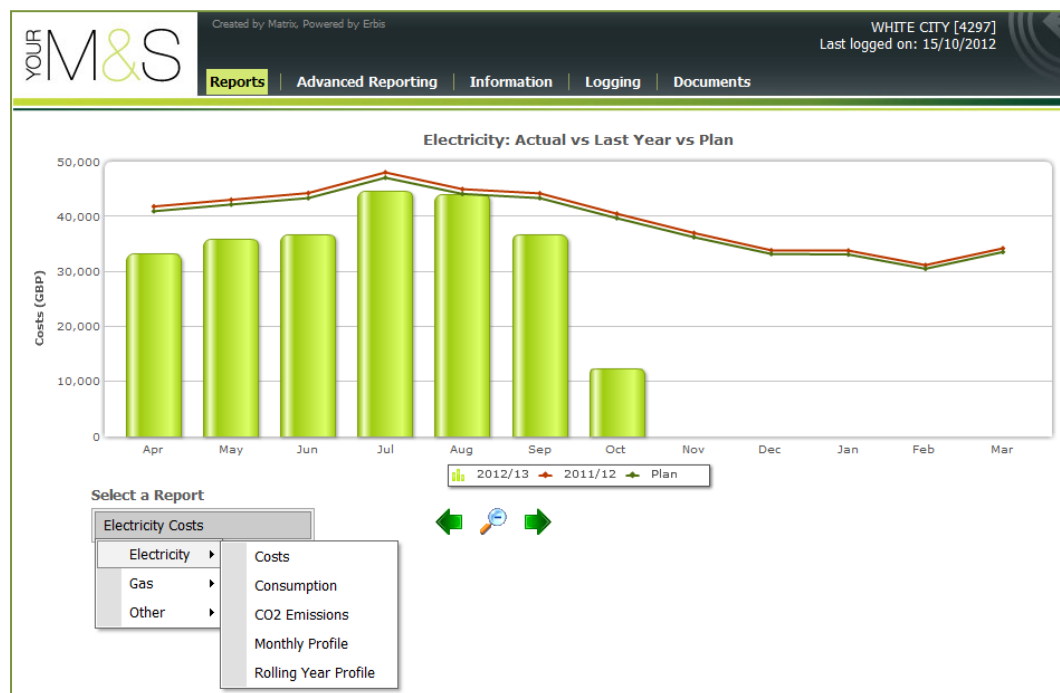
Figure 20 - Example of the data available from 'MS Energy'

The MS Energy system has a web interface that allows users to view and download consumption data from any Marks & Spencer store. Figure 20 shows an example of the type of information available through Marks & Spencer Energy.

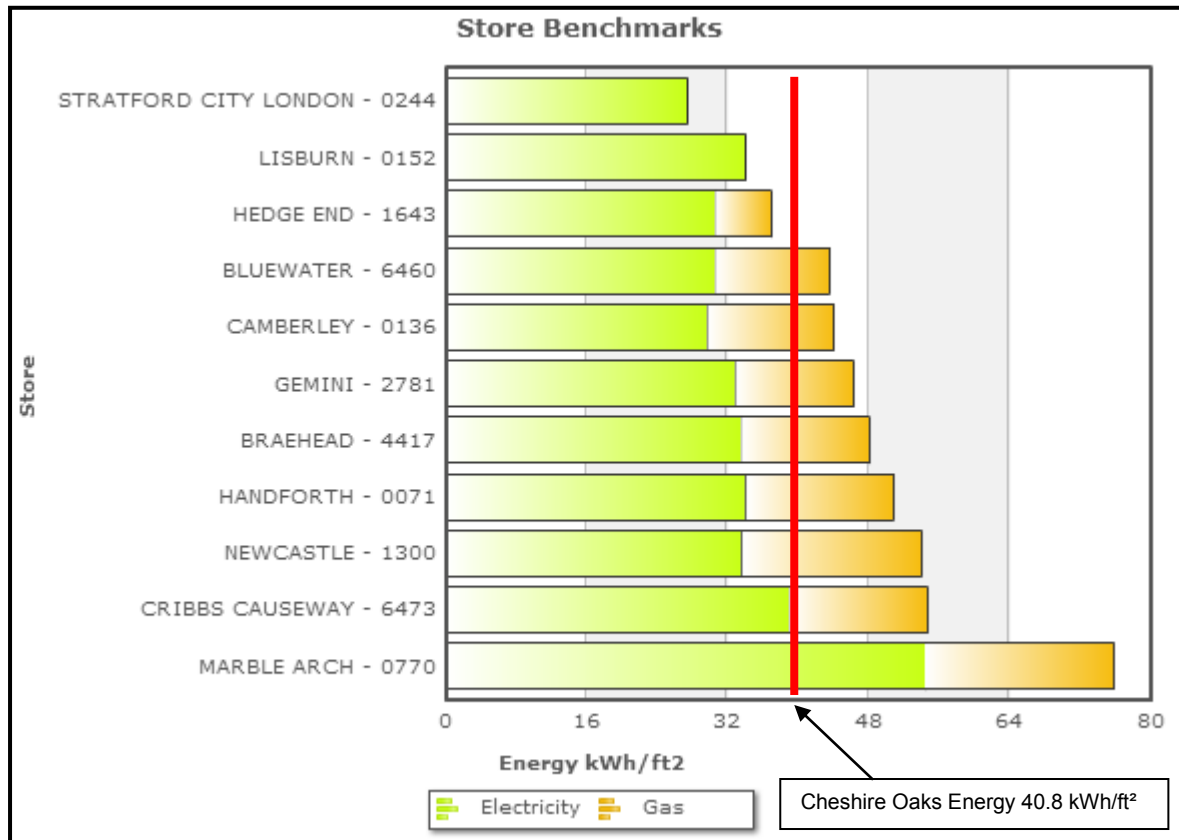
Figure 24 – 12 month energy consumption benchmarks (kWh/sales floor area) for other Premier M&S stores

The MSEnergy portal has been used to obtain energy consumption figures for other “premier” style M&S stores over the same period. The results are shown in Figure 24.

- The **Stratford City** figures do not include the heating or the chiller loads.
- **Lisburn** is heated by fuel oil which is not included in the figures.
- A metering issue at **Hedge End** that caused the winter 2012/2013 gas consumption not to be counted.
- Many of the stores shown in the graph are part of larger malls and therefore do not have the same proportion of external walls to lose heat through as there is in Cheshire Oaks.
- Most of the stores do not have any external lighting loads.

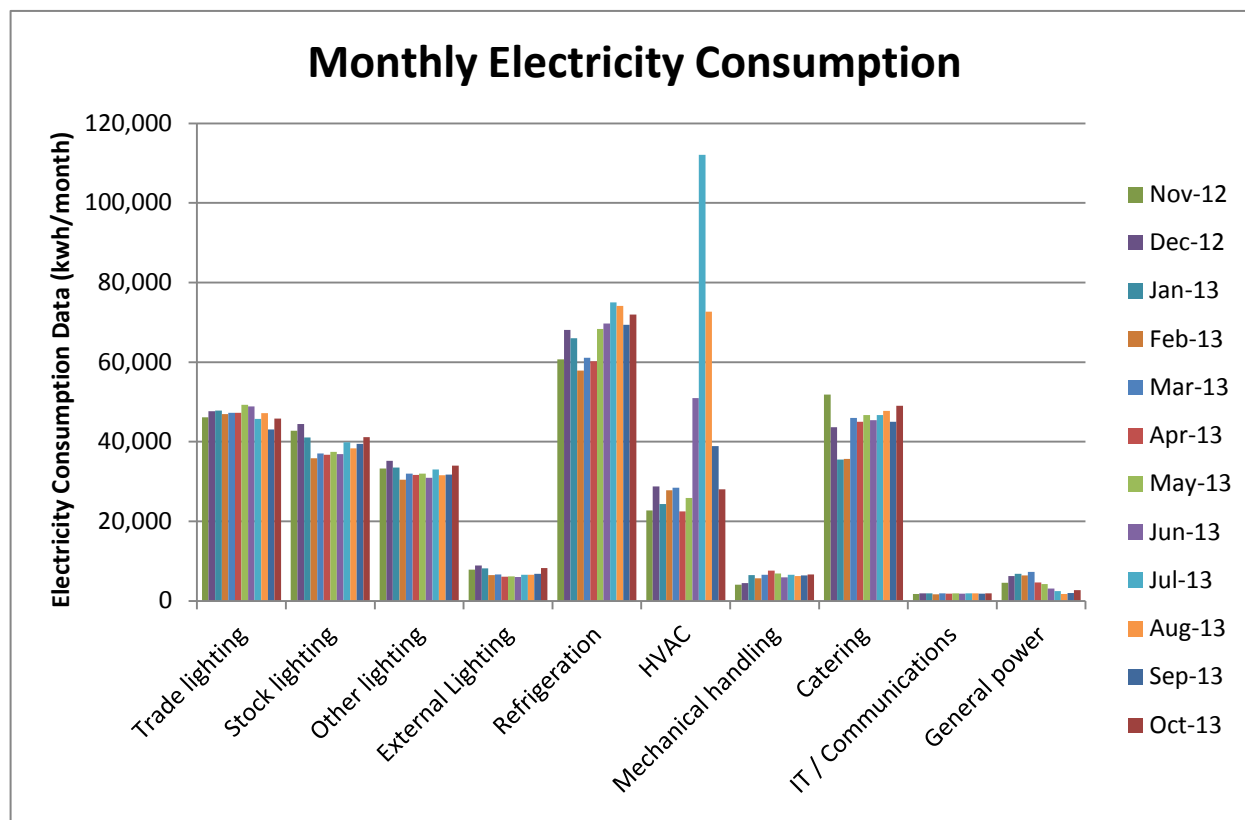
Figure 25 – Monthly electricity consumption per sub meter category

The electricity consumption as read by these sub-meters is shown in Figure 25. The data is divided up by month to allow easier comparison of the data over the changing seasons.

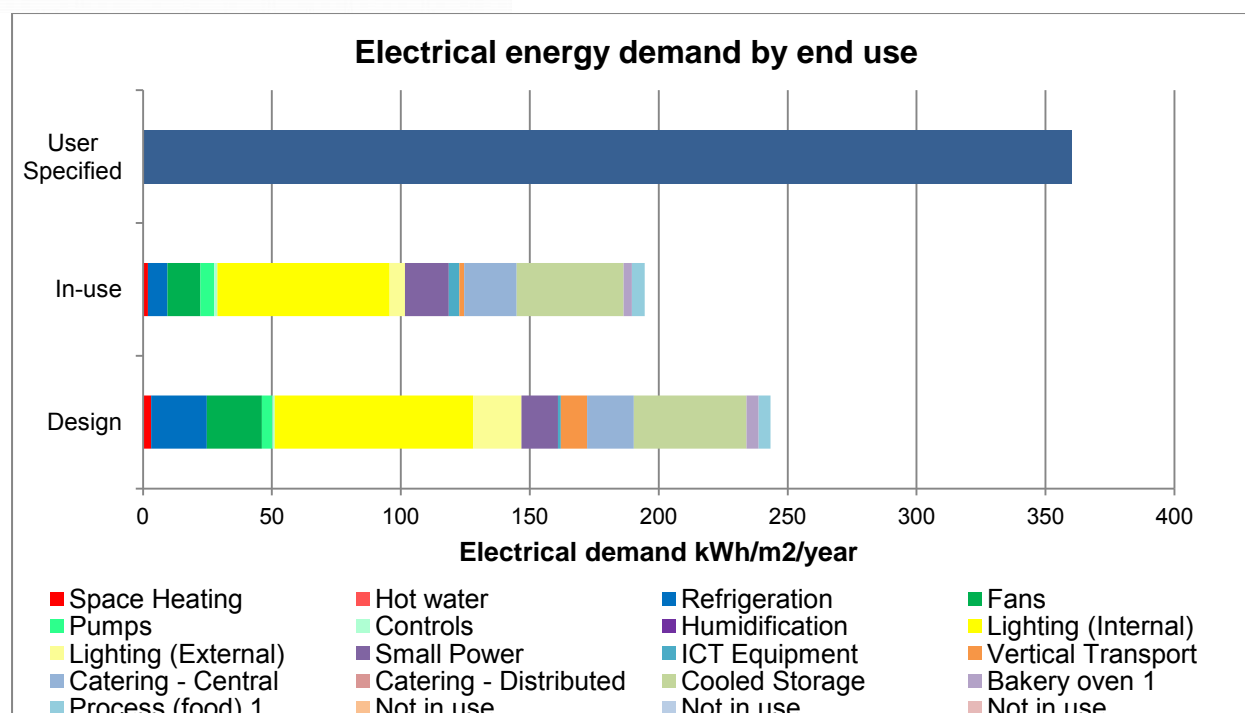
Figure 26 – TM22 detailed assessment of electricity use

Annual totals compared to the design predictions and user specified benchmarks are shown in the TM22 detailed assessment shown in Figure 26 and Table 2.

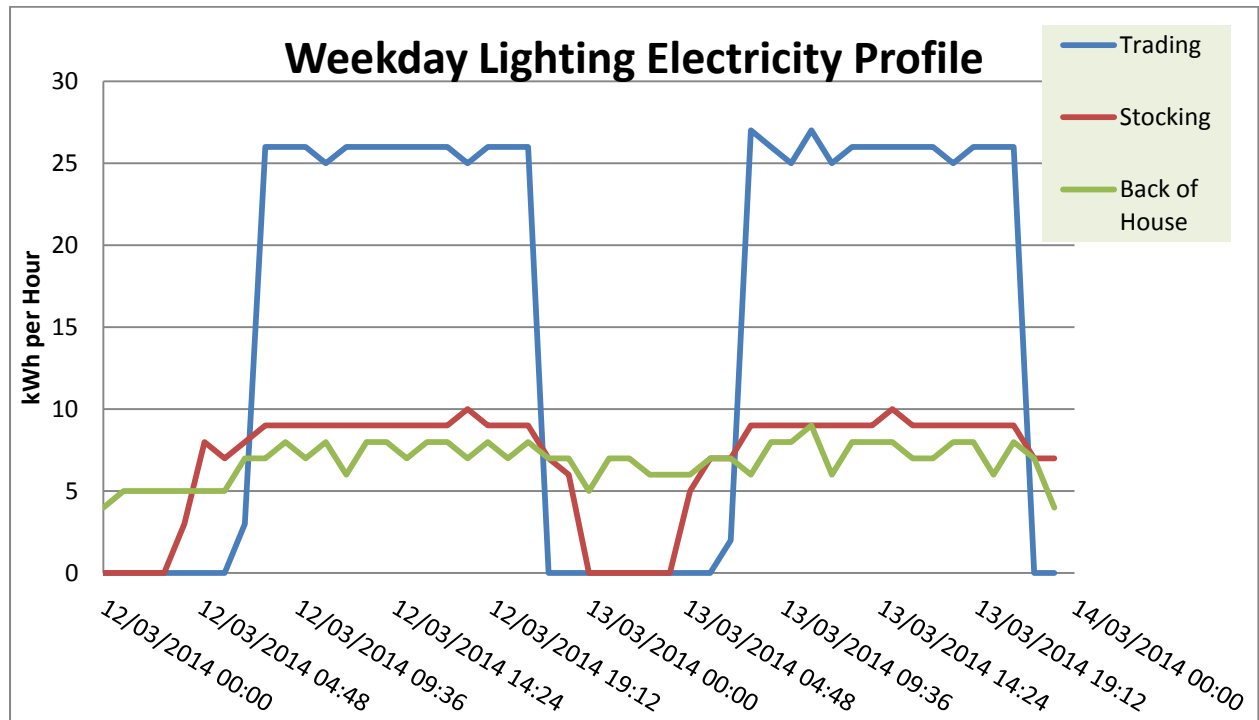
Figure 27 – Weekday profile for selected lighting use (a single trading, stocking and back of house circuit used for each line)

As the lights play such a significant part in the overall energy consumption, it is important to ensure that their use is well managed. Figure 27 shows how well controlled the lighting is for the store. There is very effective switching on and off of the trading lights to match trading hours. The stocking lights come on a few hours earlier than opening time in the morning and stay on for an hour or so after the store has closed. The back of house lighting electricity consumption is fairly consistent partly because the lights are left on most of the time.

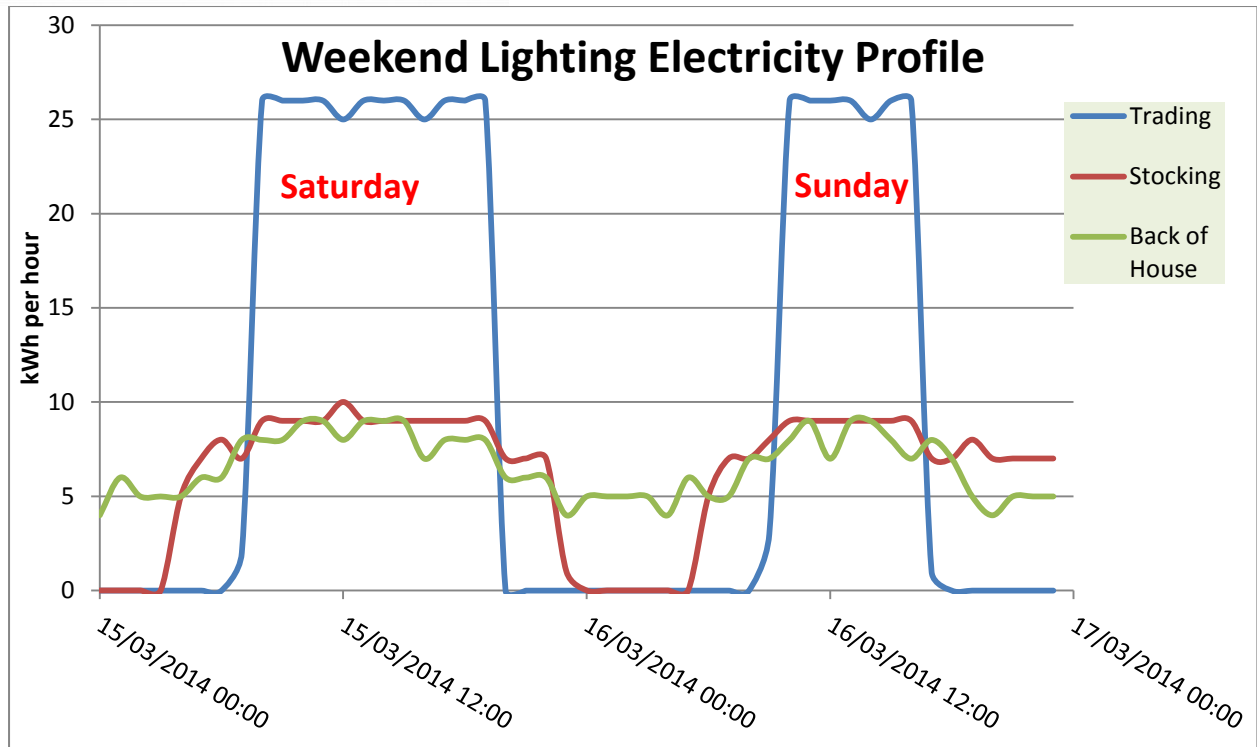
Figure 28 – Weekend profile for selected lighting use (a single trading, stocking and back of house circuit used for each line)

The profiles for the weekend show a similar story except the operating hours are clearly shorter for Sunday.

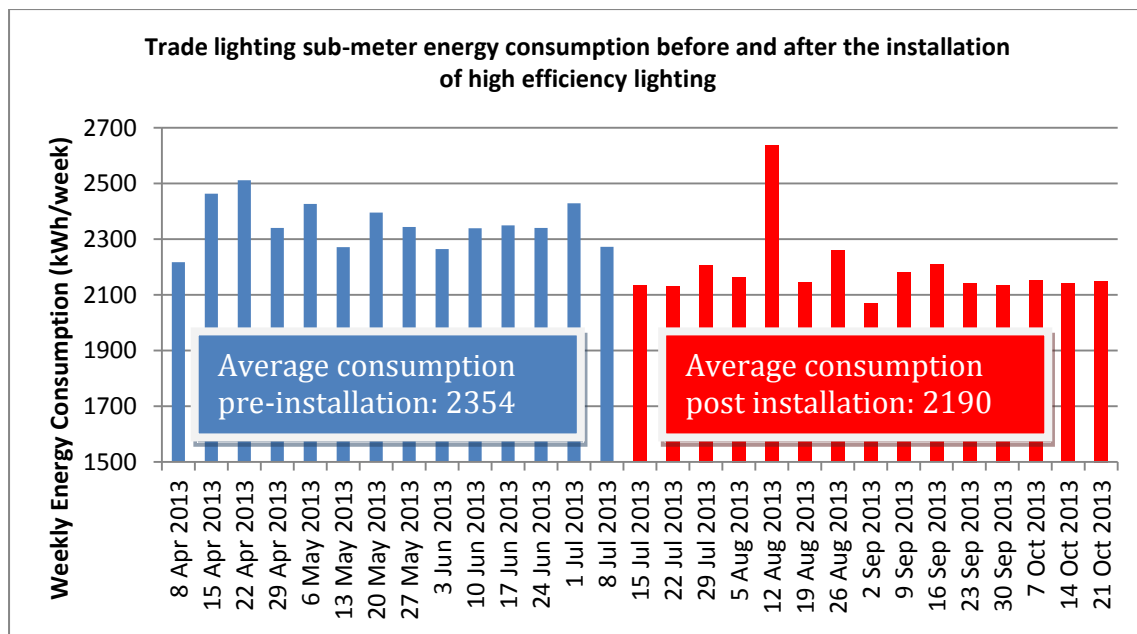
Figure 29 – Weekly total electricity consumption from a trade lighting sub-meter

During July 2013 a number of the metal halide spots in the front of house were exchanged for more efficient metal halide spot with the same light output. Figure 29 shows the electricity consumption from a trade lighting sub-meter before and after the installation.

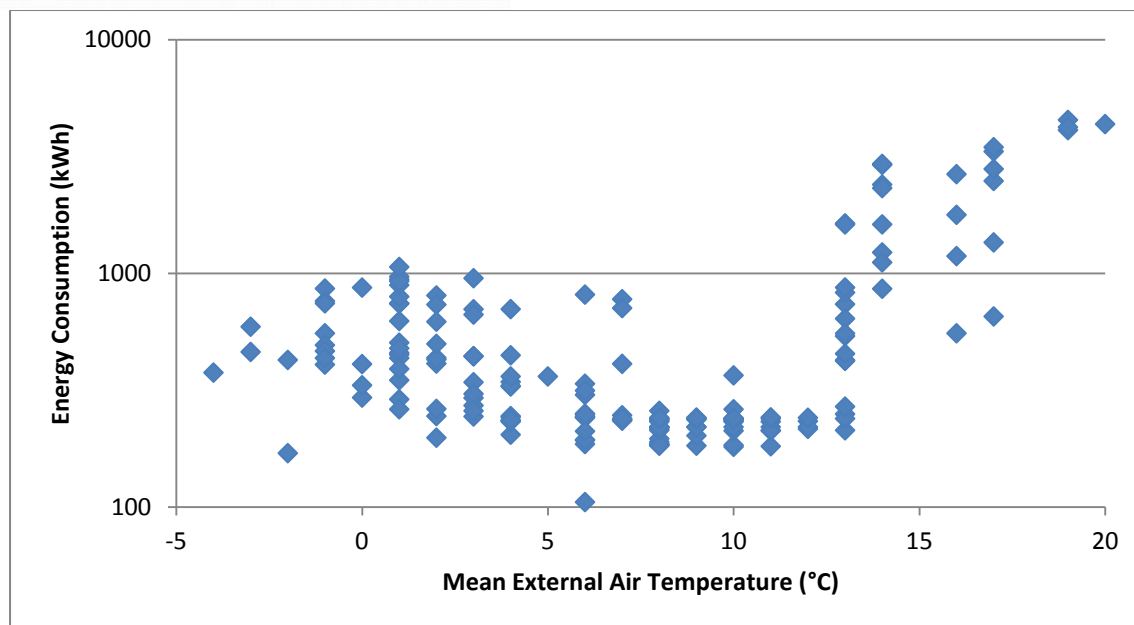
The HVAC energy consumption is reasonably consistent throughout the monitoring period with the exception of the summer months of June to August when the monthly consumption more than doubles from the average. This increase in energy consumption was tracked down to the main AHUs. Figure 30 shows how the energy consumption of the main AHUs varies with the external air temperature. It clearly shows that there is significant increase in energy consumption when the external air temperature rises above 14°C. This is due to the compressors being used to provide cooling to the air supplied to the store. The energy consumption is fairly consistent when the external air temperature is between 7 – 12°C, but there is a clear increase in power as the temperature gets cooler, with a peak at 0°C. This has been found to be due to the increase in power arising from the increased use of recirculation air fans and the AHU heaters.

Figure 30 – AHU electricity consumption measured against external air temperatures – weekdays only (Note: a logarithmic scale is used on the vertical axis)

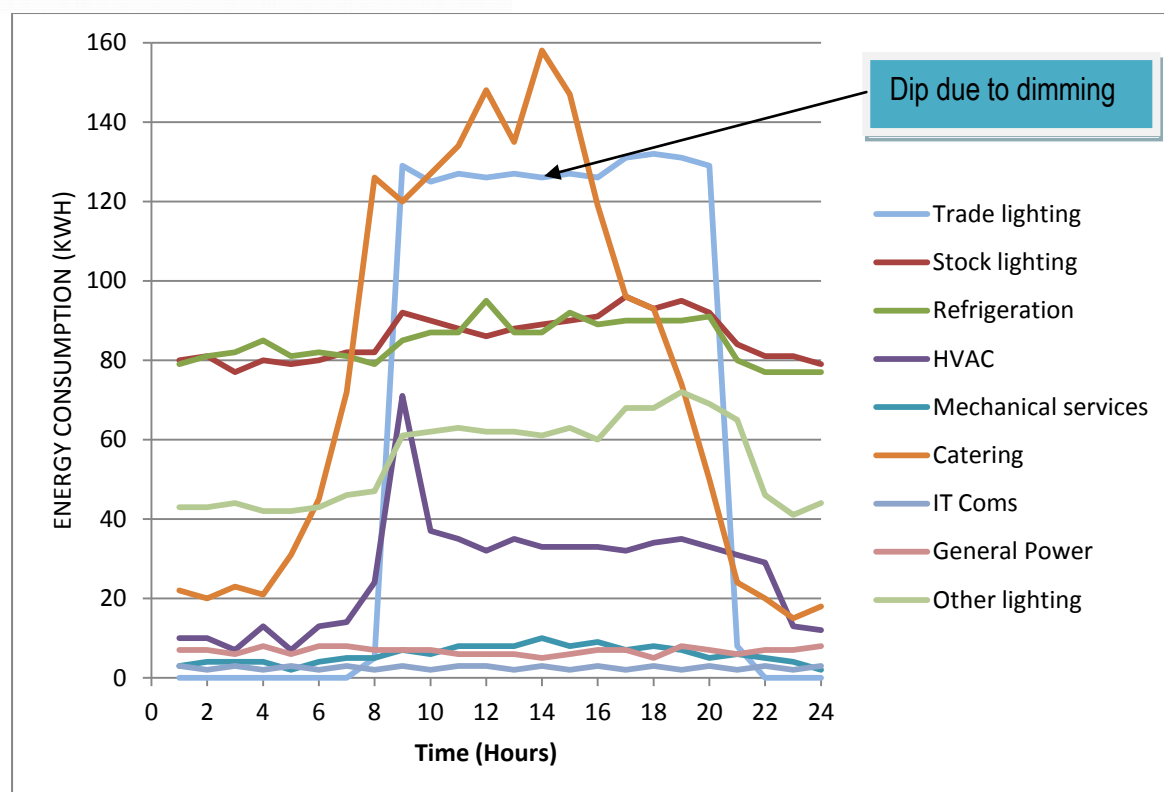
Figure 32 – Electricity consumption for Saturday 3<sup>rd</sup> November 2012

As would be expected, controls and ICT show high utilisation figures as they are always on, and infrequently used, or part loaded systems such as pump and lifts show low utilisation. In order to get a fuller picture of utilisation the energy consumption for individual days can be observed such as shown in Figure 32

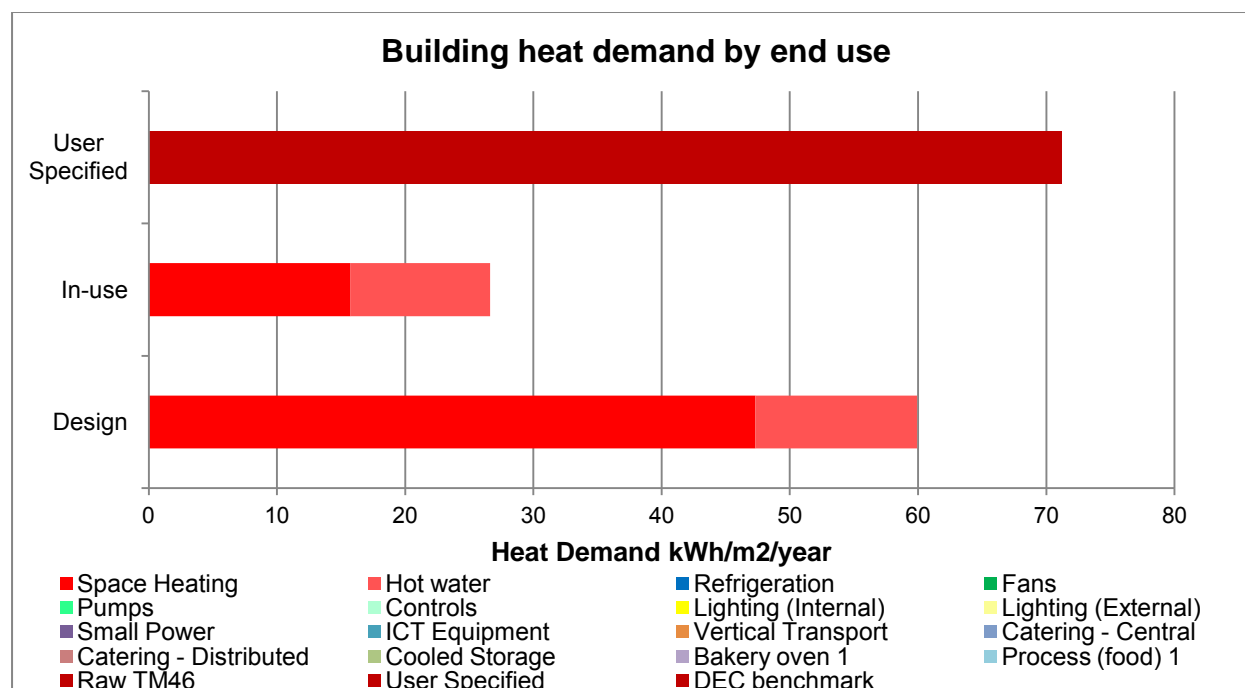
Figure 38 – Building heat demand by end use

The chart clearly shows that the in use heating energy use was considerably lower than anticipated in design and also when compared against the user specified benchmark. It is felt that this is due, in part, to the insulation of the Hempclad wall being better than expected, and also that the revolving doors reduced infiltration. In the discussion had during the final POE workshop it was stated that one of the reasons why the actual HVAC performance was better than predicted was because the hempcrete walls provided better than expected levels of insulation and a high level of thermal mass. This resulted in the building staying warmer in the winter and cooler in the summer when compared to the estimates made at design stage. For example, the BMS showed that the internal air temperature dropped by less than 1 °C when the external air temperature was 0°C over night. Other stores investigated lost on average 7 °C overnight for the same period.

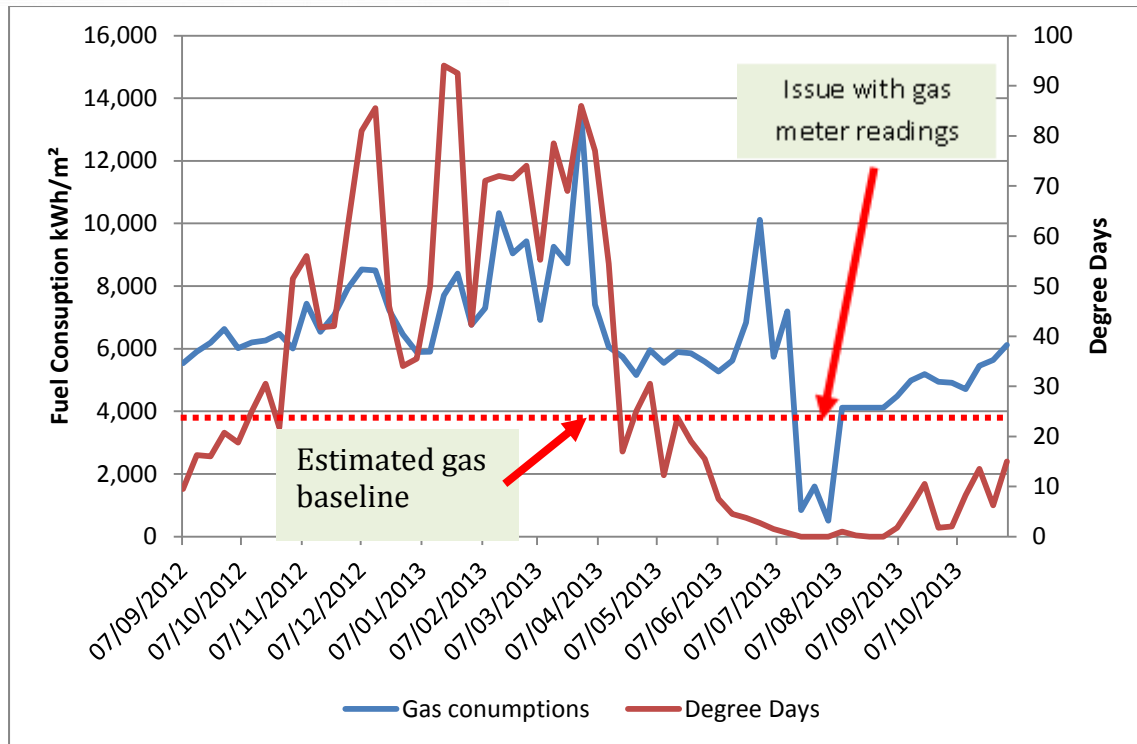
Figure 39 – Cheshire Oaks gas consumption against degree days

The gas consumption typically tracks the degree days fairly well with peaks in consumption coinciding with peaks in degree days. An issue can clearly be seen with the gas consumption in late June 2013 and early July 2013. This was traced to an issue with the burners in the air handling units and has subsequently been fixed. There was an error with the gas meter in August which resulted in the low readings seen on the graph. This too was resolved quickly when spotted. Figure 40 shows how the weekly gas consumption correlates with degree days.

As part of the POE, the gas consumption was regularly checked against degree days for the area in order to assess how the building's heating system performs with different external temperatures. In both September 2012 and July 2013 it was noted that the gas consumption seen was higher than expected compared to the actual degree days. Further investigation showed that the gas burners on the AHUs were firing more than necessary, wasting gas in the process. This issue was quickly corrected once spotted and the gas consumption quickly returned to normal levels.

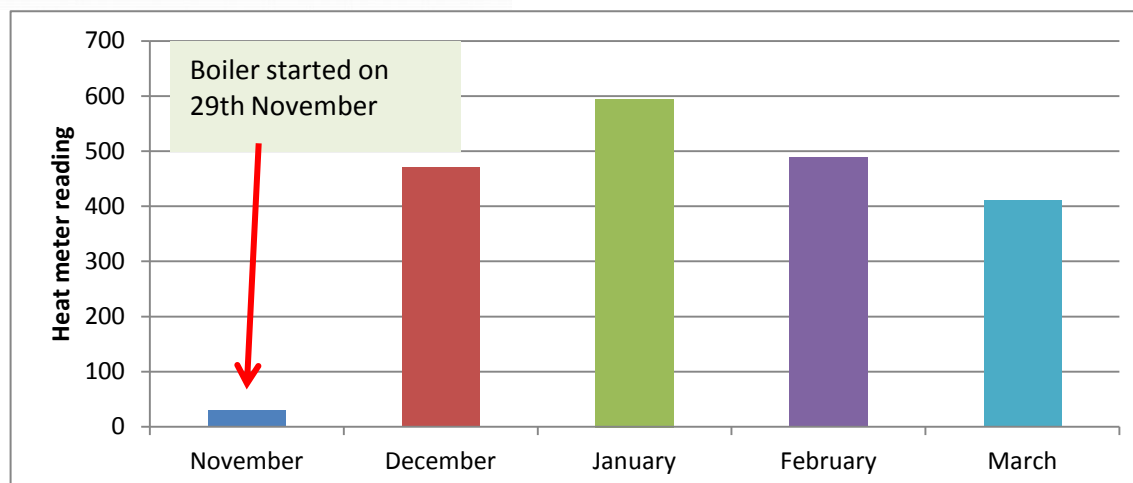
Figure 42 – Monthly biomass boiler heat meter readings

The biomass boiler was scheduled to operate from 1<sup>st</sup> November, however, due to an issue with the pellets being delivered at too high a pressure, it was not started until 29th November. It was found that the store was well heated throughout November without the boiler and therefore the scheduled boiler operation period is being re-assessed to see if there is an opportunity to reduce it in the future.

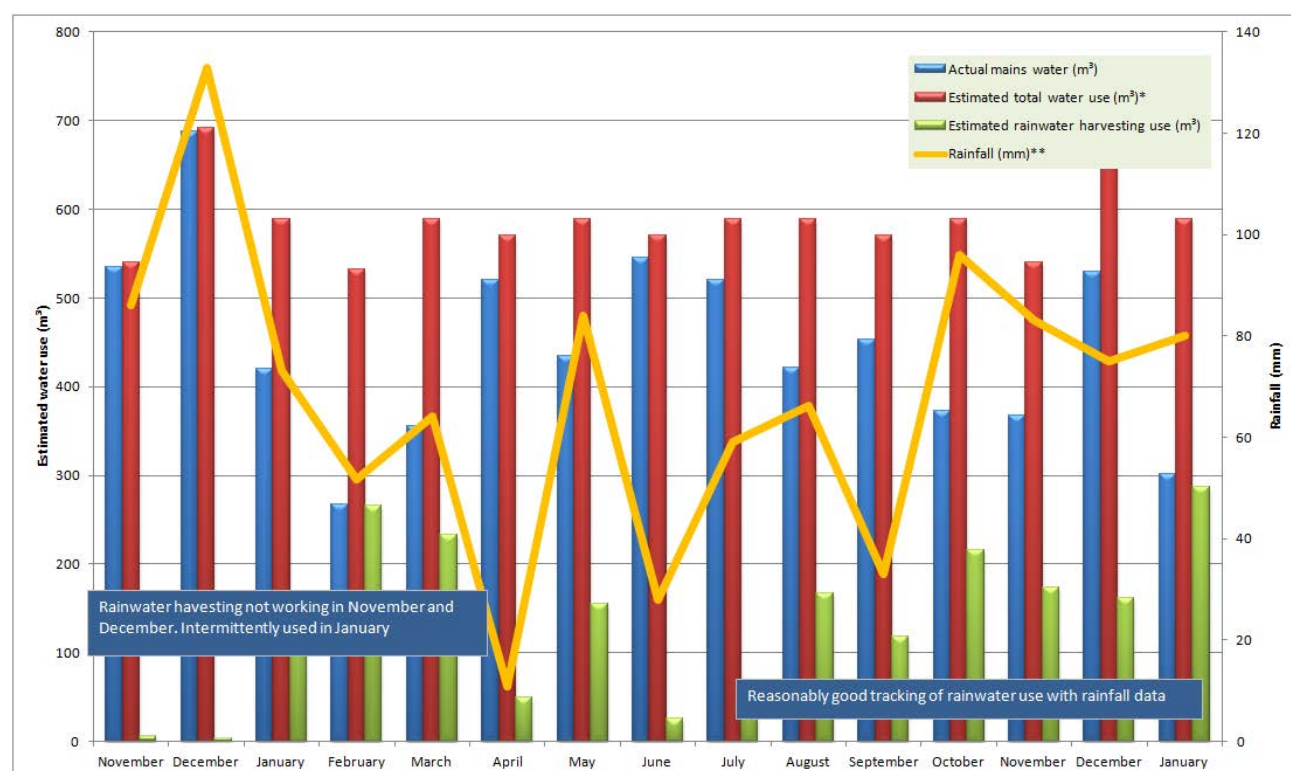
Figure 43 – Estimated water consumption and rainwater harvesting system use.

In addition to this, the level of water in the rainwater harvesting tank was not freely available through interrogation of the BMS. Again this limited any assessment on how the tank's volume was affected by rainfall and customer footfall. Easy to access in-tank level monitoring would have allowed the operators to know if the tank was regularly full, suggesting that a larger tank may have allowed even more rainwater to be utilised. Conversely, if the tank was found to be regularly low on water, this would have suggested that a smaller and cheaper tank could have been installed without significant impact on the overall contribution of rainwater to the total demand.

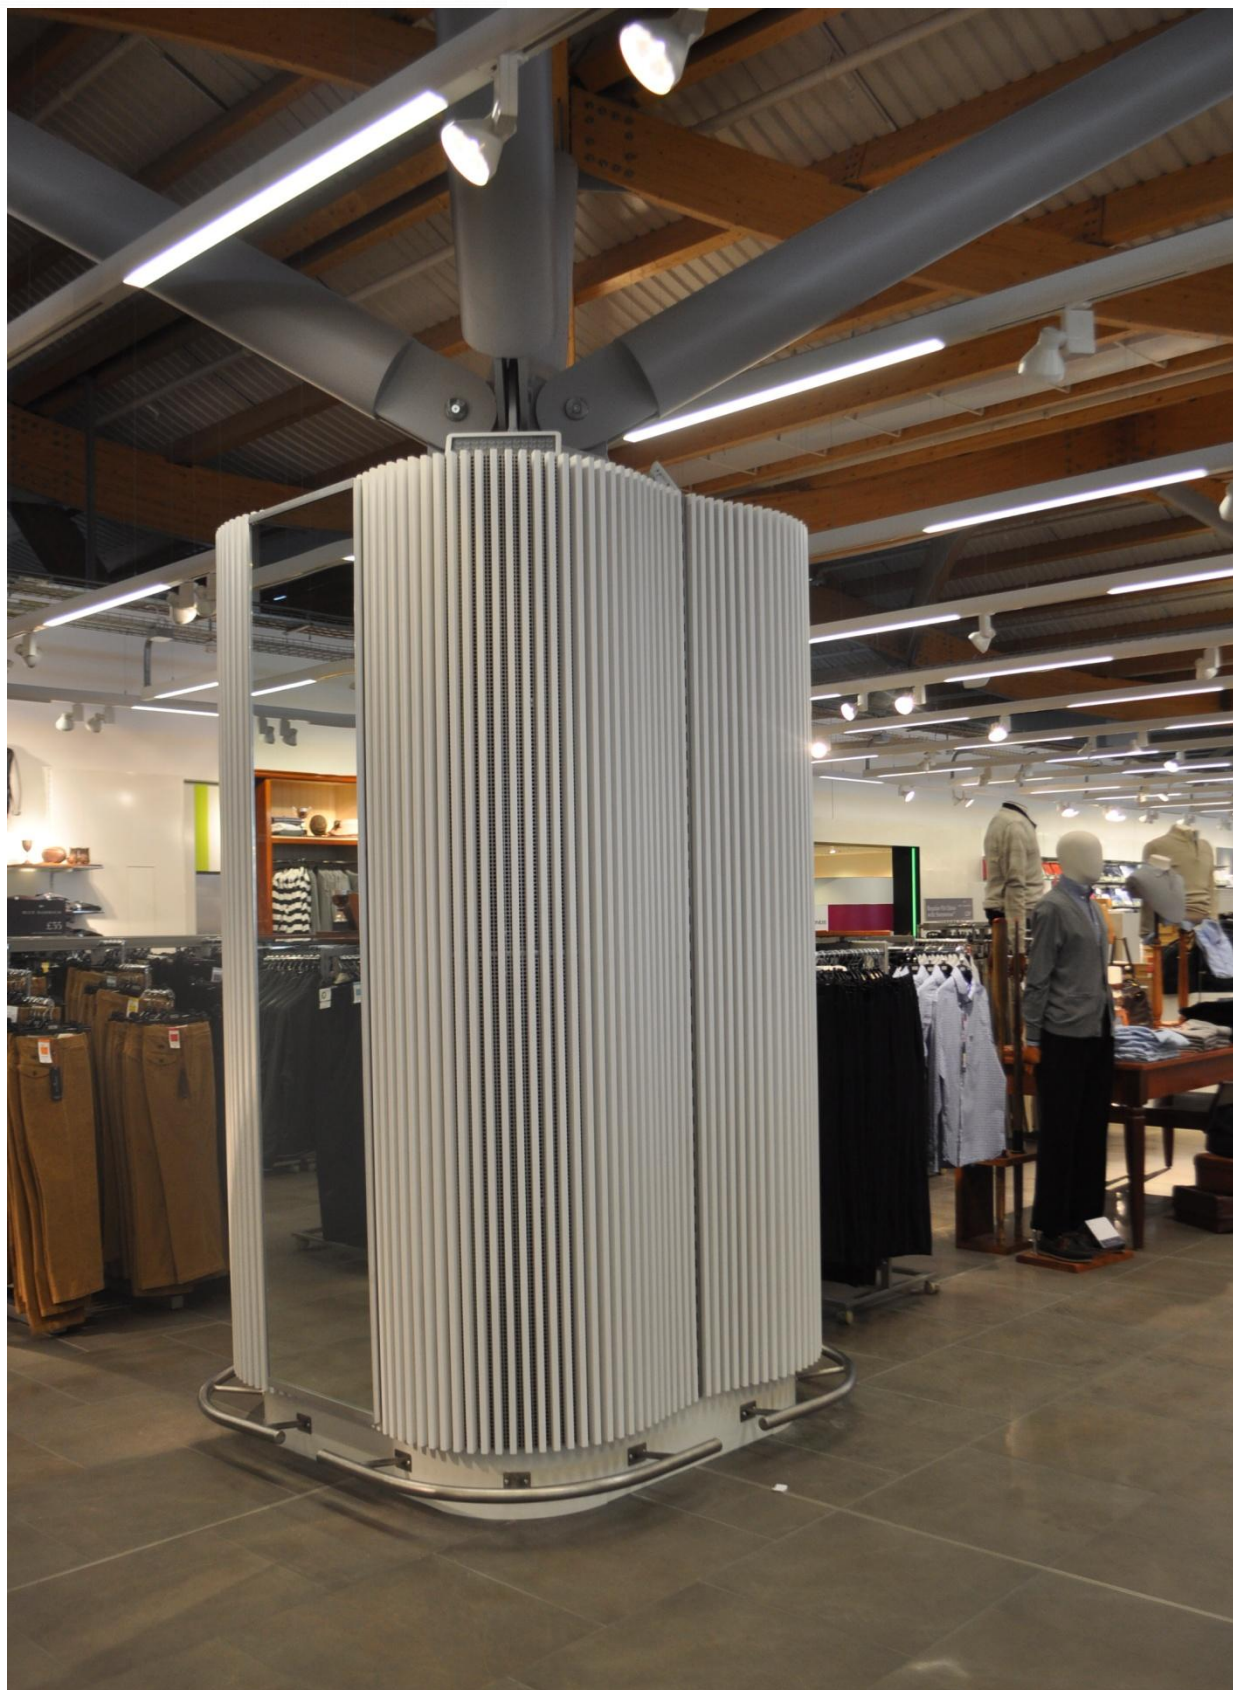
*Figure 59 – Displacement ventilation column*

- A brise soleil is used to reduce the solar gains from the high summer sun whilst allowing the low winter sun through.
- The sales floor is heated, cooled and ventilated via displacement air ventilation columns. Each one is connected to 2 m diameter, below ground, earth ducts and the system is capable of providing free cooling in the appropriate conditions.

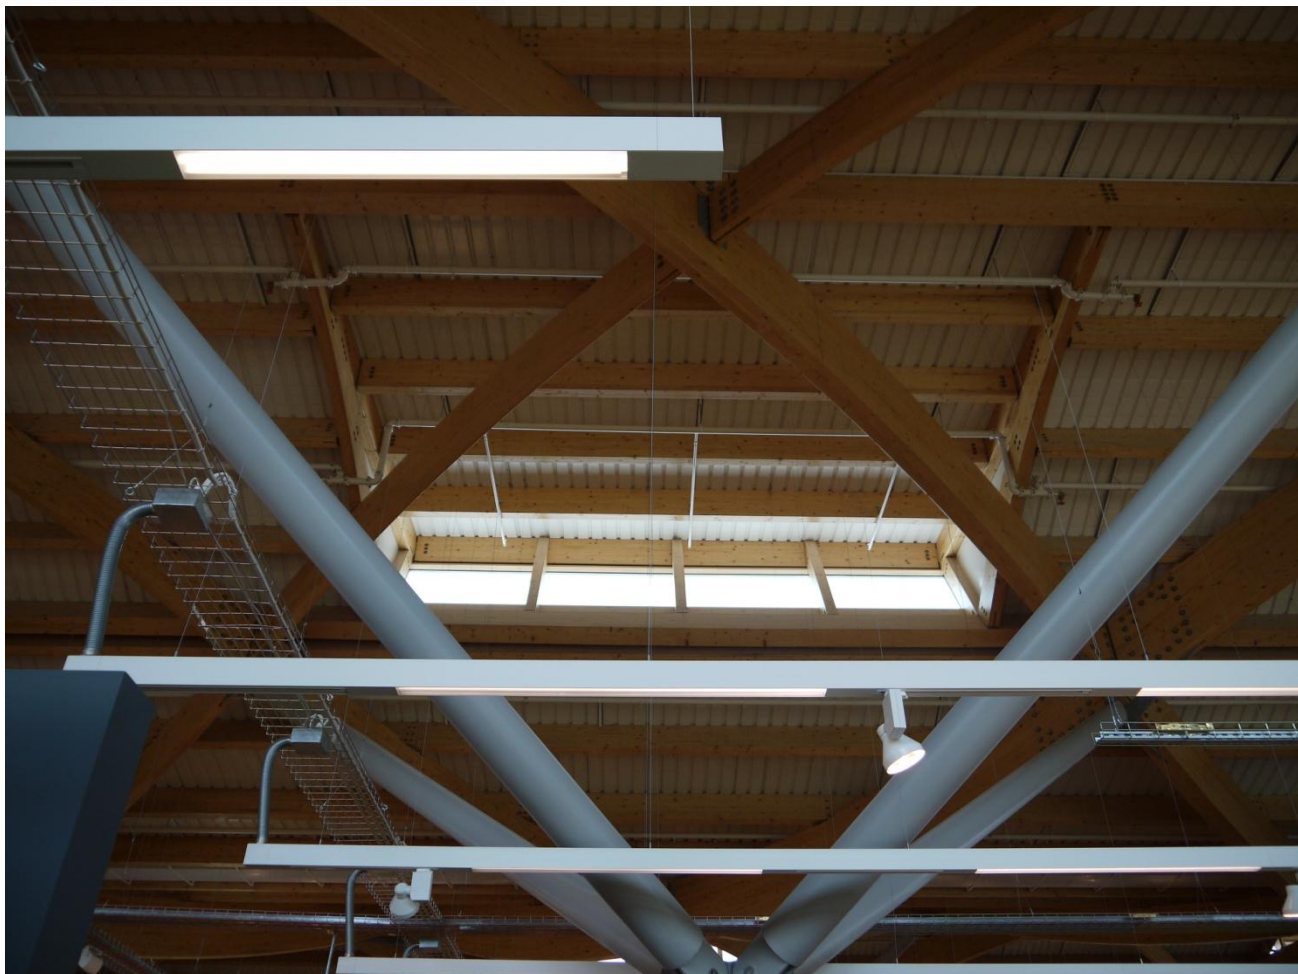
*Figure 60 – Internal roof showing steel support tree, glulam roof frame, track lighting and north light*

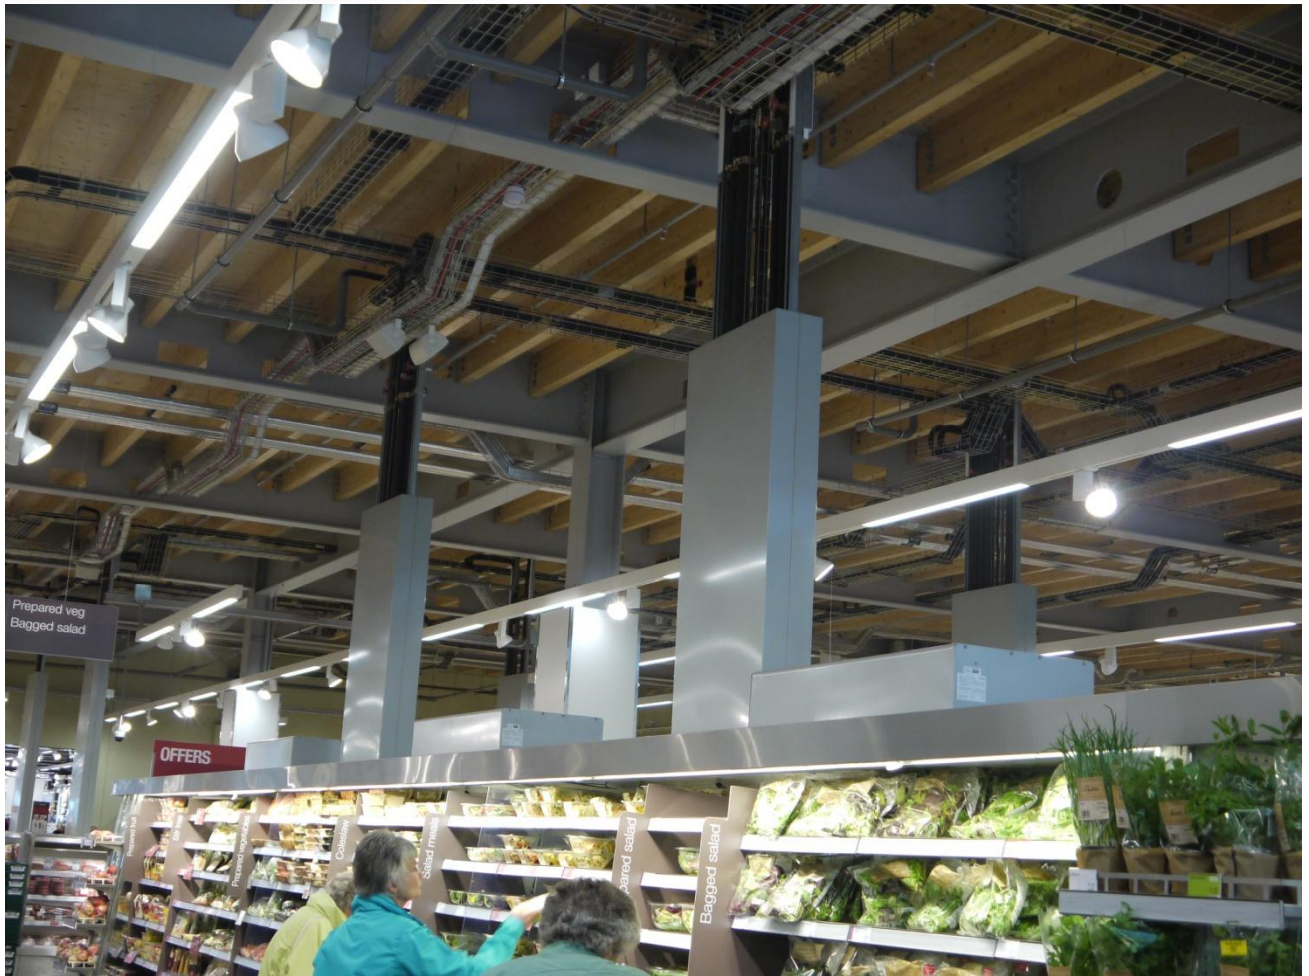
Figure 62 – Chilled food cabinets with top entry CO<sub>2</sub> connections

The food hall, which traditionally can be found to be too cold, was also found to be of an acceptable temperature. Many of the chilled food cabinets on the shop floor use a direct expansion CO<sub>2</sub> refrigerant system where the compressor and condenser is located outside the building and the waste heat is supplied to the aisles in a controlled manner. Traditional chilled food cabinets have the compressor and condenser integrated into the cabinet themselves and so there is much less control as to how the waste heat is pushed out into the shop floor, making the shop floor temperature much less consistent. This was reflected in the feedback from customers at the Warrington store who commented that the temperature around the chilled food cabinets in the food hall was particularly cold. Where traditional chilled food cabinets are used there is a good case for installing doors on them, both from an energy efficiency point of view and for reasons of comfort.

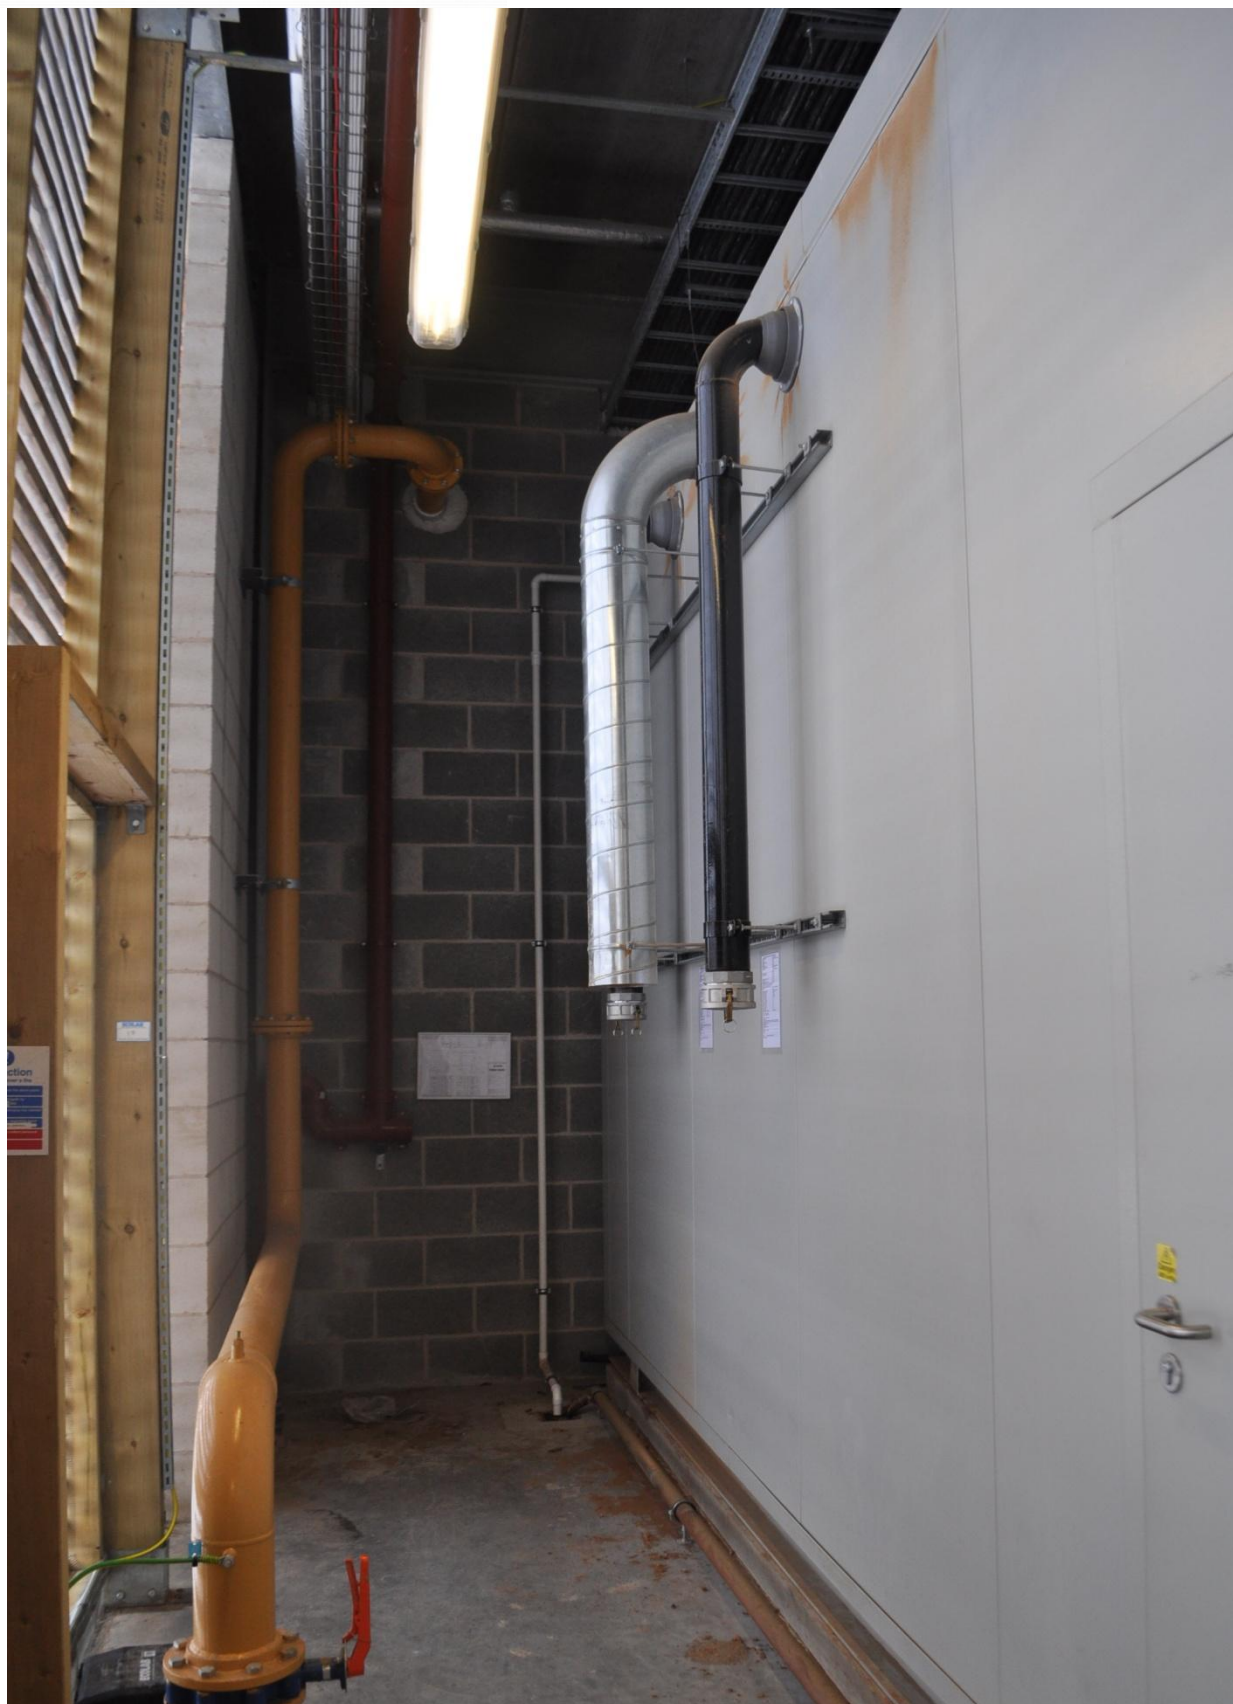
*Figure 64 – Biomass boiler wood pellet delivery chute*
