# National Composites Centre

This document contains a Building Performance Evaluation report from the £8 million Building Performance Evaluation research programme funded by the Department of Business Innovation and Skills between 2010 and 2015. The report was originally published by InnovateUK and made available for public use via the building data exchange website hosted by InnovateUK until 2019. This website is now hosting the BPE reports as a research archive. As such, no support or further information on the reports are available from the host. However, further information may be available from the original project evaluator using the link below.

<b>Innovate UK project number</b>	450090
<b>Project lead and authors</b>	AECOM and University of Reading
<b>Report date</b>	2014
<b>InnovateUK Evaluator</b>	Unknown (Contact <a href="http://www.bpe-specialists.org.uk">www.bpe-specialists.org.uk</a> )

<b>Building sector</b>	<b>Location</b>	<b>Form of contract</b>	<b>Opened</b>
Industrial	Bristol	Design and build	2011
<b>Floor area (GIA)</b>	<b>Storeys</b>	<b>EPC / DEC</b>	<b>BREEAM rating</b>
8413 m <sup>2</sup>	2	B (39) / N/A	Excellent

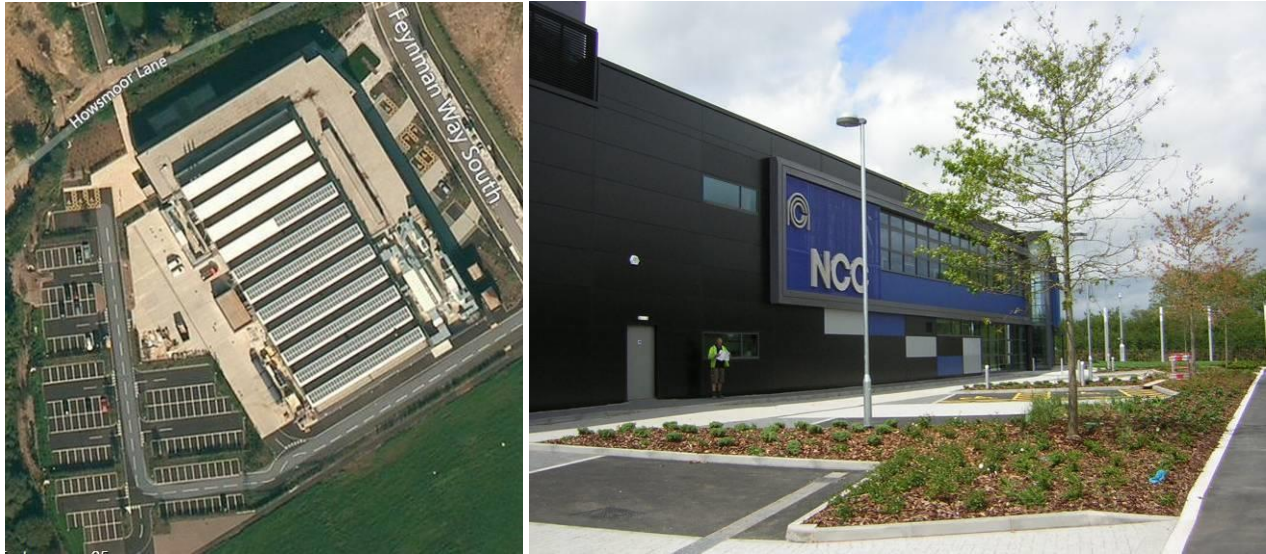
Figure 1.1. National Composites Centre - general site plan (left) and external view (right).

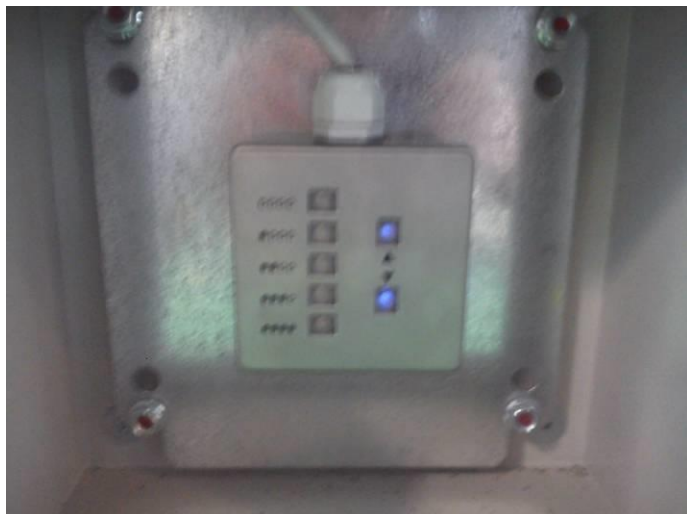
The design of the double height workshop allows daylight through 11 rows of north lights in the roof. This would reduce the need to use electric lighting (through daylight dimming) provided by 105 high level suspended 'T5' fluorescent fittings (320 W per fitting) and 16 low level (80 W per fitting), giving an installed load of around 35 kW. The workshop space was designed to achieve a 2% average daylight factor to minimise lamp burnout and reduce maintenance costs. The lights can be controlled automatically through the central lighting control system and there is a single manual override light switch located at the entrance to the workshop from the main reception area (Figure 3.1).

Figure 3.1: Manual lighting control for the workshop area.

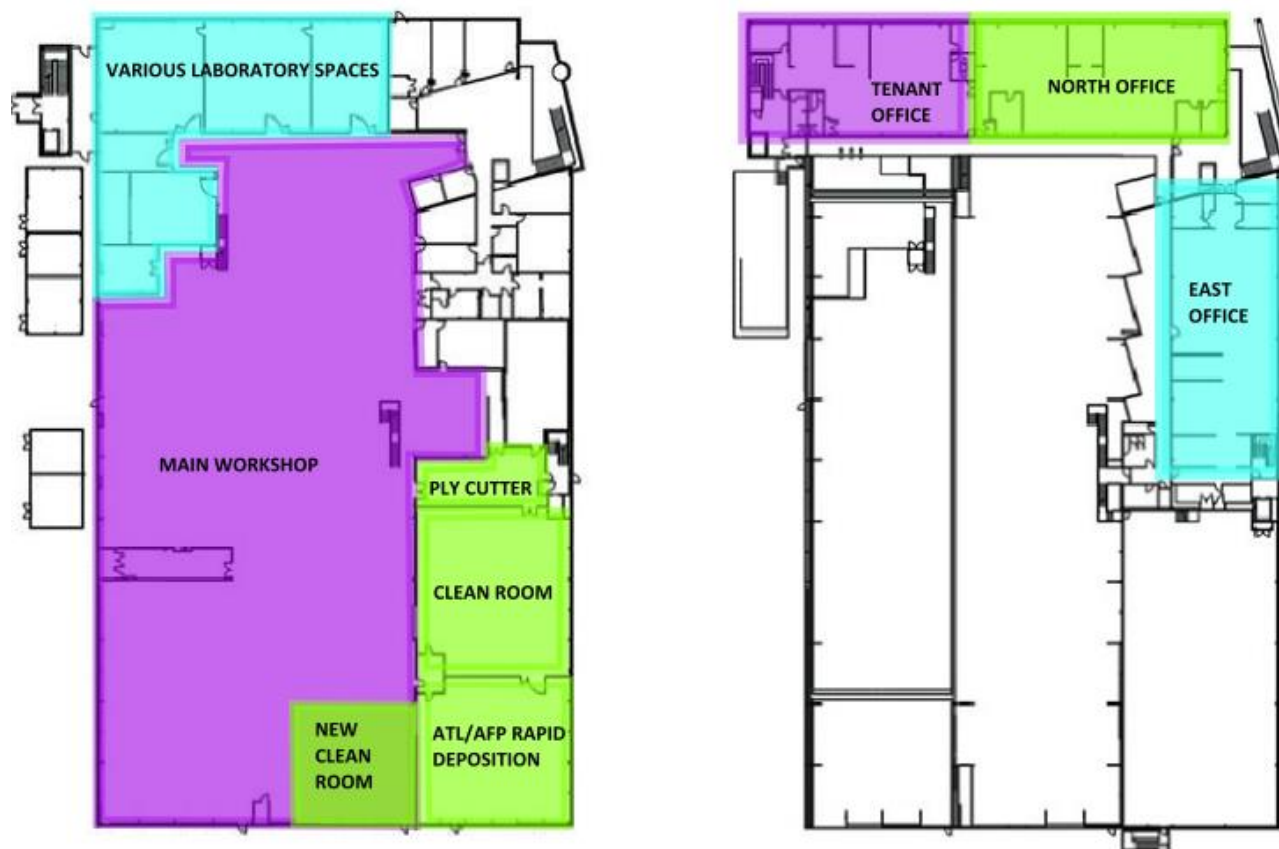
Figure 3.3: Annotated ground floor (left) and first floor (right) layouts of NCC with main workshop and other laboratory spaces and open plan offices highlighted.

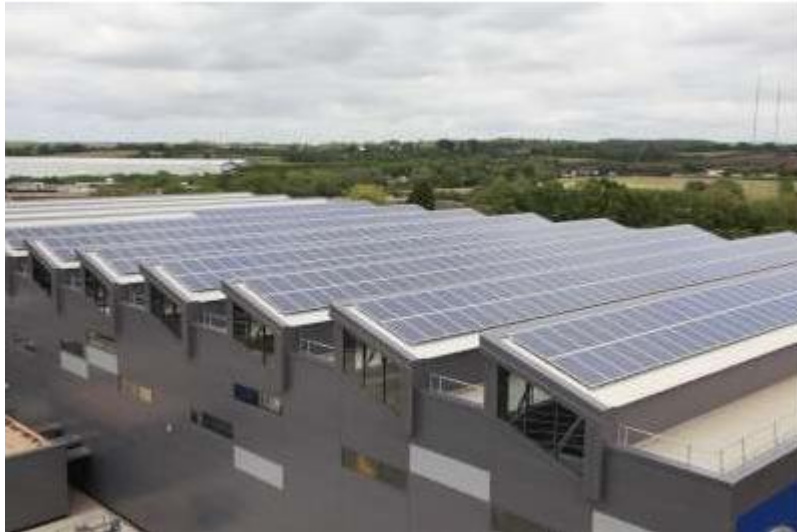
There is a 138 kWp PV roof mounted array at the NCC (Figure 3.4). Details of the PV performance can be found in Section 6.4.6.

Figure 3.4: Photovoltaic array mounted on the roof of the NCC.

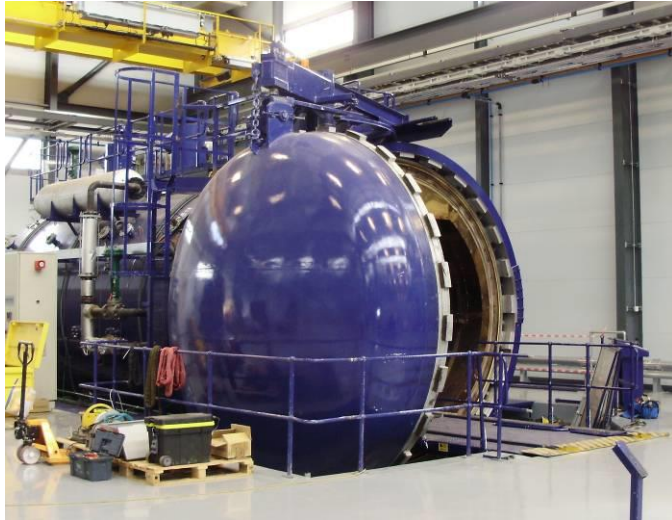
Figure 3.5: The large autoclave (Autoclave 1).

There are two autoclaves at the NCC; one large (224 kW) and one small (16 kW). Somewhat confusingly, these are labelled 'Autoclave1' (Figure 3.5) and 'Autoclave' respectively on the BMS and other systems at the NCC. The same convention has been adopted here. Both use a combination of natural gas and electricity to achieve the required thermal and pressure conditions. Autoclave1 also uses an inert nitrogen atmosphere that reduces the risk of fire occurring when superheating composites under high pressure.

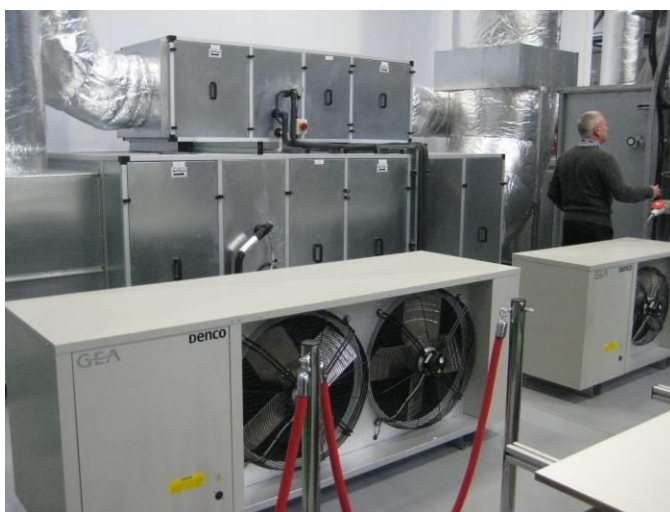
A new Clean Room, complete with airlock, has been created in the south east corner of the main workshop space. This was commissioned early on during the operation of the NCC when the client realised that the tenants required more space for specific tasks. This Clean Room has its own independent AHU (Figure 5.3) which has been installed within the main workshop. This will contribute to heat gains in the space.

Figure 5.3: New clean room AHU unit inside the Main Workshop.

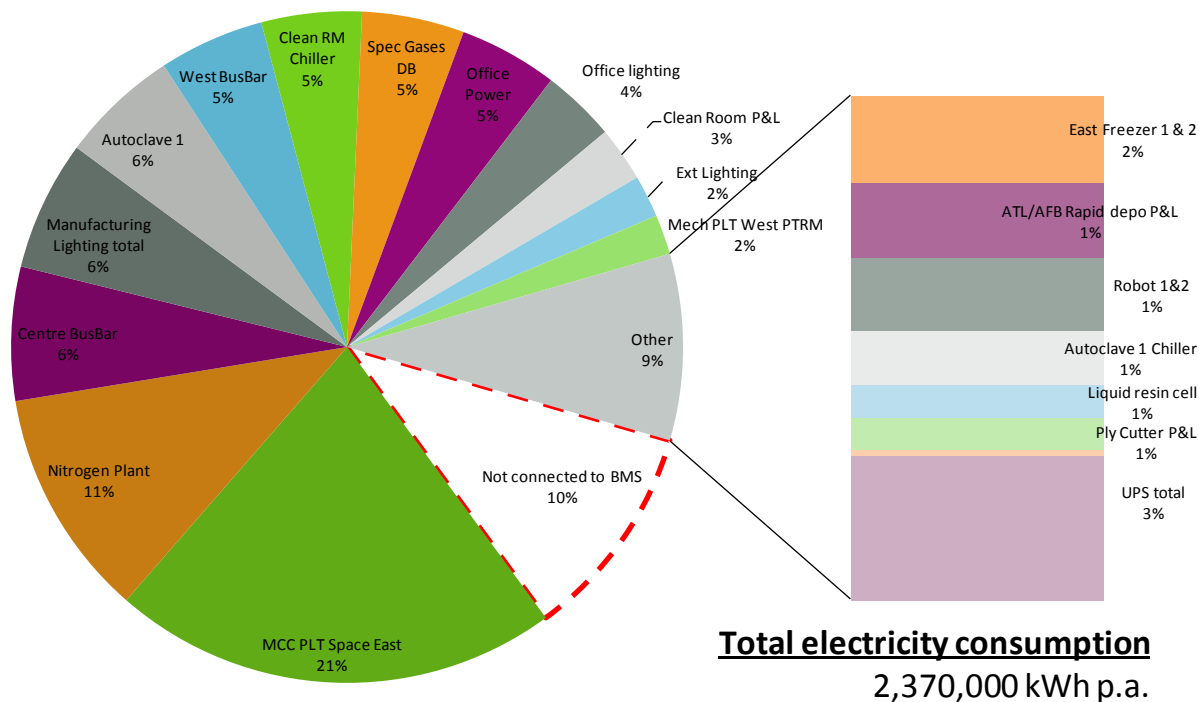
Figure 6.3: Proportions of electricity consumption from each high level submeter.

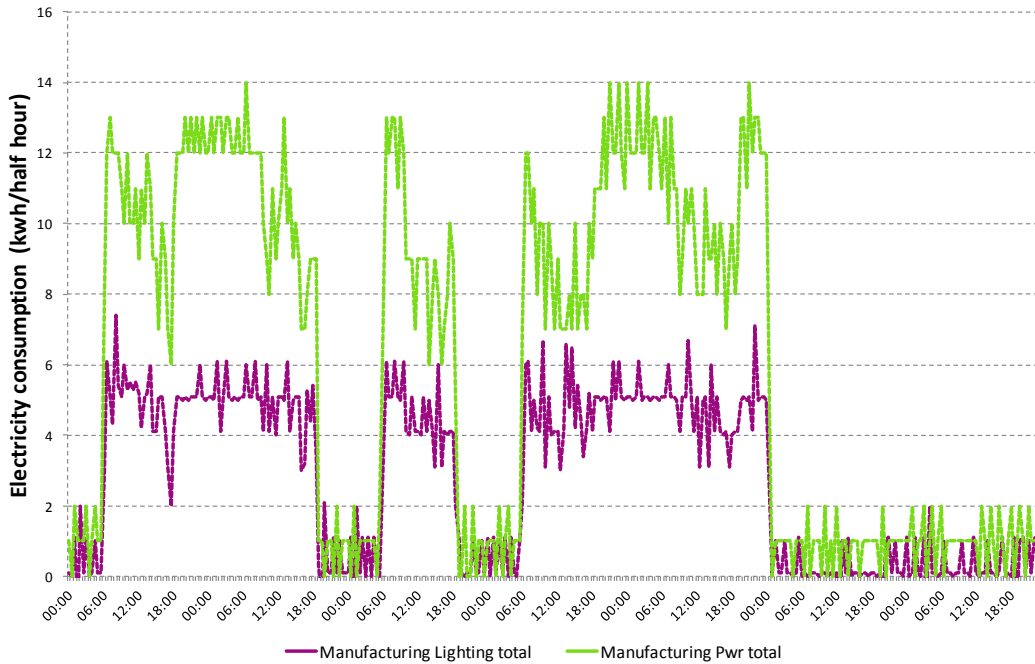
**NCC weekly profile Mon 20/5/13 to Sun 26/5/13**

Figure 6.10: NCC - Weekly electricity profile for 20<sup>th</sup> May 2013 to 26<sup>th</sup> May 2013 showing manufacturing lighting and manufacturing power submeters consumption.

Examining the electricity consumption weekly profiles for the virtual submeters 'manufacturing lighting' and 'manufacturing power' (shown in Figures 6.9 and 6.10), it can be seen that they follow each other very closely. In fact, it is likely that the manufacturing lighting and manufacturing power virtual meters both actually represent lighting circuits. There seems to have been some confusion in the labelling of these submeters during commissioning. Discussions with the FM during a site visit (15<sup>th</sup> October 2013) confirmed that the light switch is the only control that is regularly used at 19:00 and that there is no common 'kill' switch for workshop appliances. This can be confirmed by looking at Figure 6.11, which indicates that the combined load of the virtual meters would be around 36 kW. This matches the total installed load for the workshop lighting. Consequently, it is concluded that 'manufacturing power' should be re-labelled as 'manufacturing lighting 2'.

The issues with part of the submetering for the main workshop lighting being incorrectly labelled as 'Manufacturing Power' and presented as such in the BMS front end has been described above. Analysis of the TM-22 model clearly shows this discrepancy (Figure 6.11), where the in-use consumption (predicted by TM-22) for the submeter Manufacturing Lighting is greater than its actual metered consumption by a factor of around 2. Conversely the submeter Manufacturing Power shows a large actual metered consumption but no prediction from TM-22. Here it should be noted that the metered consumption for both submeters combined is greater than the in-use consumption (predicted by TM-22) for the submeter Manufacturing Lighting. As the rating of the installed lamps on this circuit was verified during a site visit, this indicates that the lighting is operational for longer than the TM-22 model suggests, which should be Monday to Friday 07:00 until 19:00.

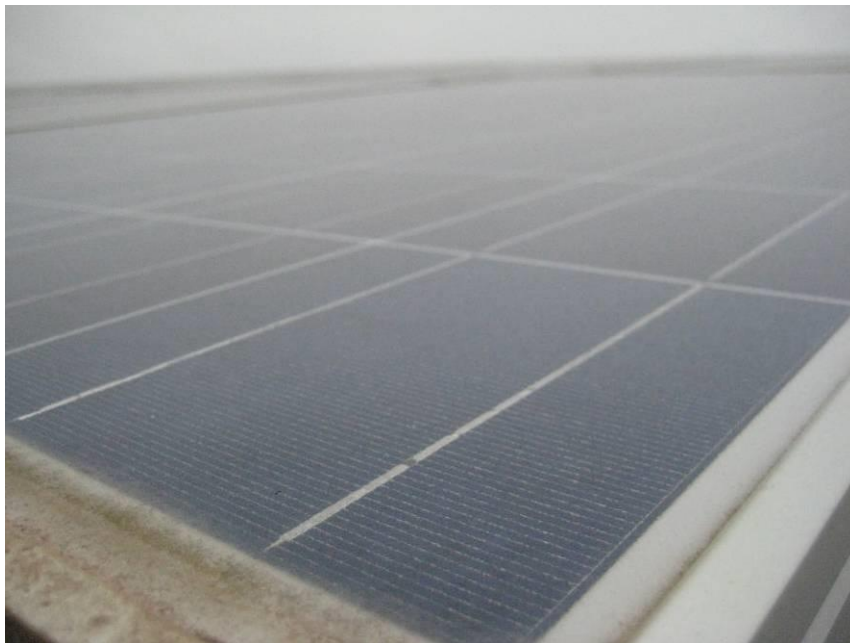
Figure 6.19: PV array on roof of NCC. Note the dirt covering the panels which will reduce the performance.

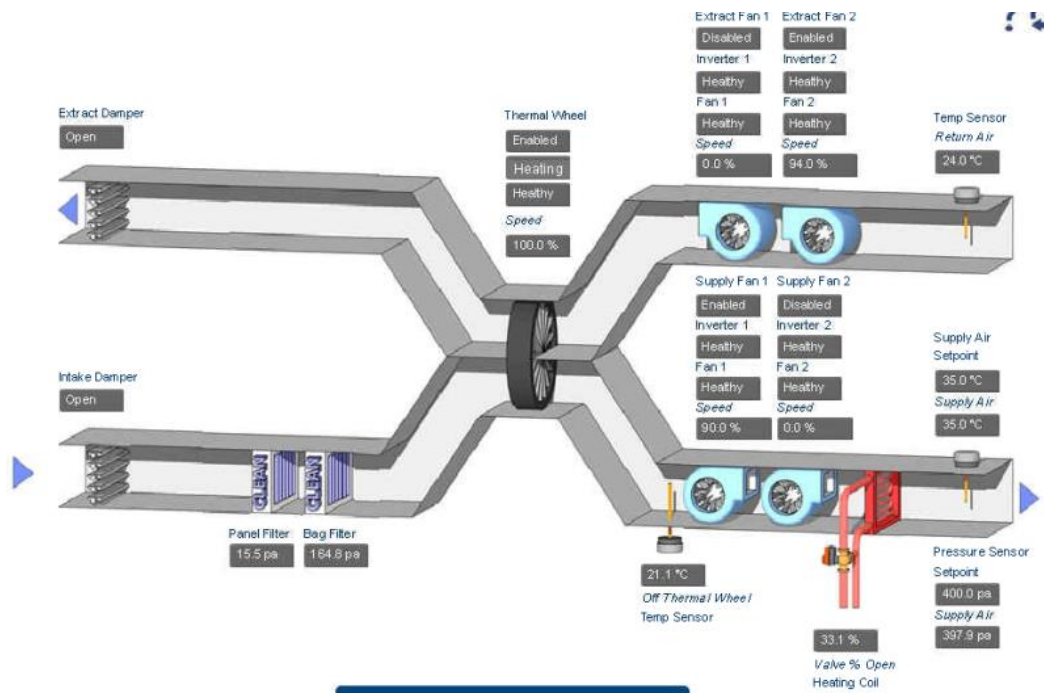
Figure 6.34: Screen shot of East Office AHU as it appears on the BMS. Note the thermal wheel.

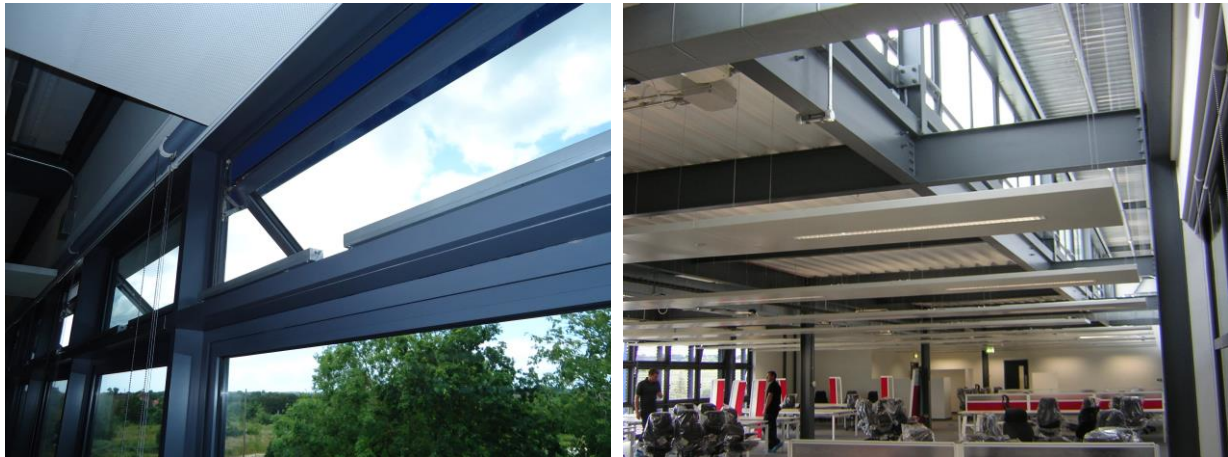
Figure 7.9: (Left) Automated windows in a first floor office area and (right) East Office.

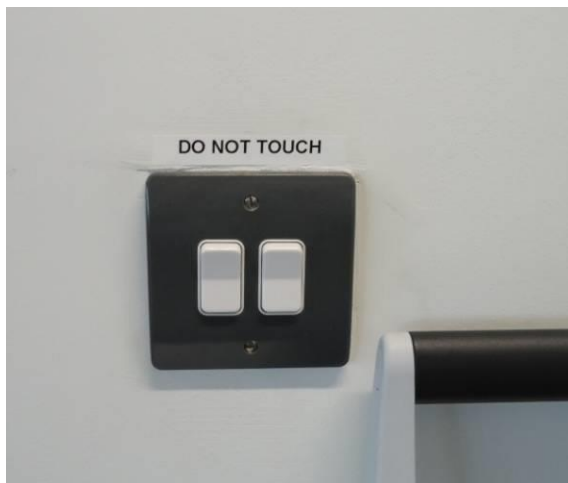
Figure 7.10: Manual override for automated windows.  
Note the text discouraging occupants from using the control and the lack of explanatory labelling explaining.
