# Oakham Church of England Primary School

<b>Innovate UK project number</b>	450044
<b>Project lead and author</b>	White Design Associates Ltd
<b>Report date</b>	2013
<b>InnovateUK Evaluator</b>	Unknown (Contact <a href="http://www.bpe-specialists.org.uk">www.bpe-specialists.org.uk</a> )

# Oakham C of E Primary School

## Building Performance Evaluation (BPE)

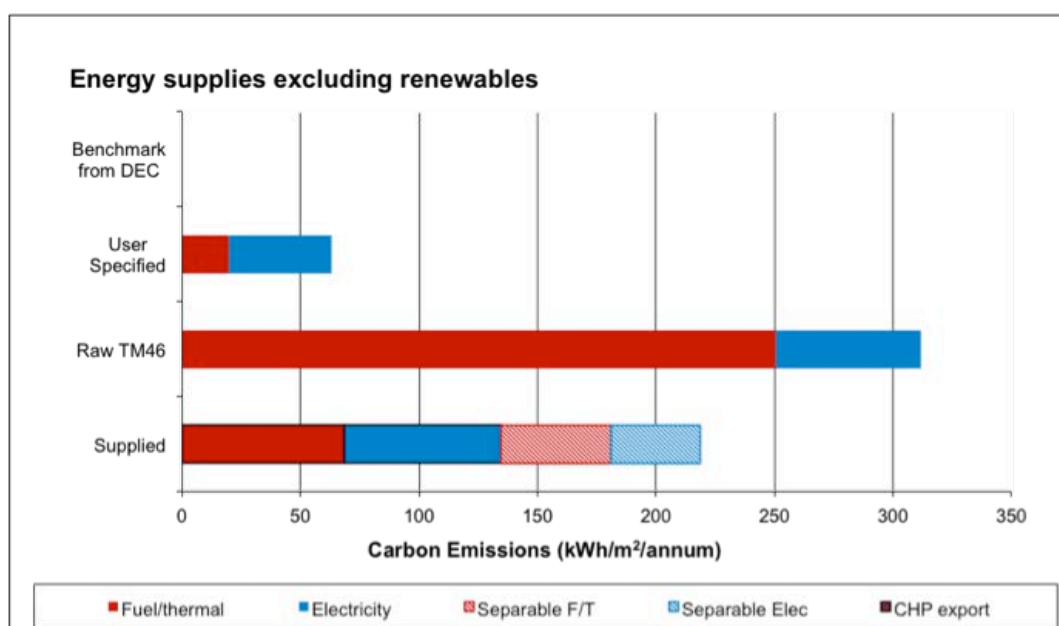
**Figure 3a: TM22 Simple Assessment Results**

- there is a very marked contrast between the very low energy usage from the EPC calculations and the much higher raw TM 46 figure (this is a published benchmark for this building type);
- the raw TM 46 energy usage is dominated by heating fuel, whilst the EPC figure is dominated by electricity (Figure 3a);
- the building's energy usage lies between the two benchmarks with or without the swimming pool energy usage – suggesting the benchmarks are not very helpful;
- electrical and gas energy usage in the building are approximately equal;
- swimming pool gas and electricity energy usage are similar and amount to about 40% each of the total gas and electricity usage of the building (Figure 3a);
- the building's gas energy usage is more than three times the BRUKL figure, whilst the electrical usage is about 1½ times the BRUKL figure.

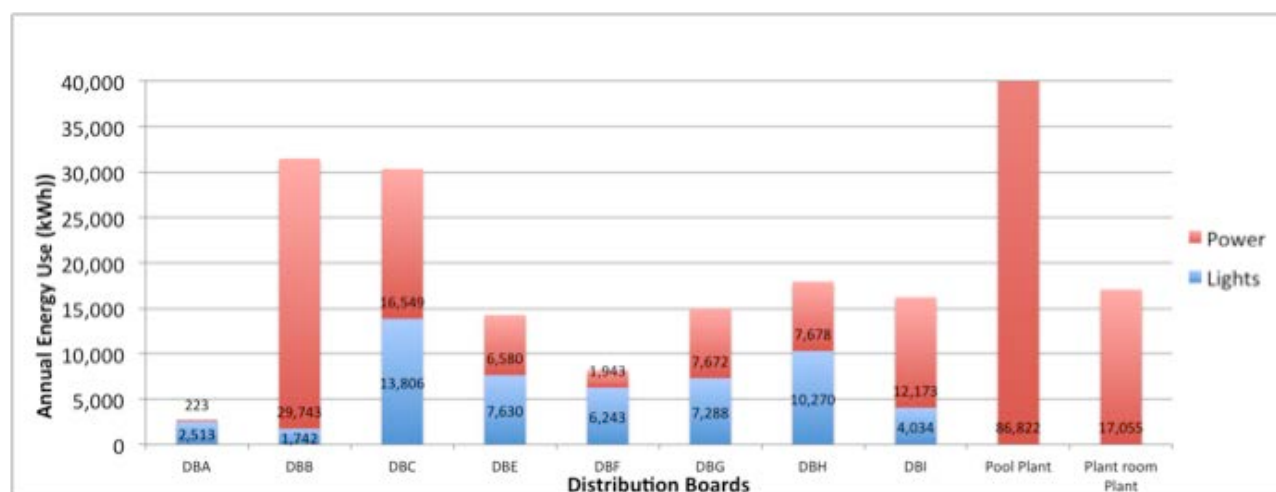
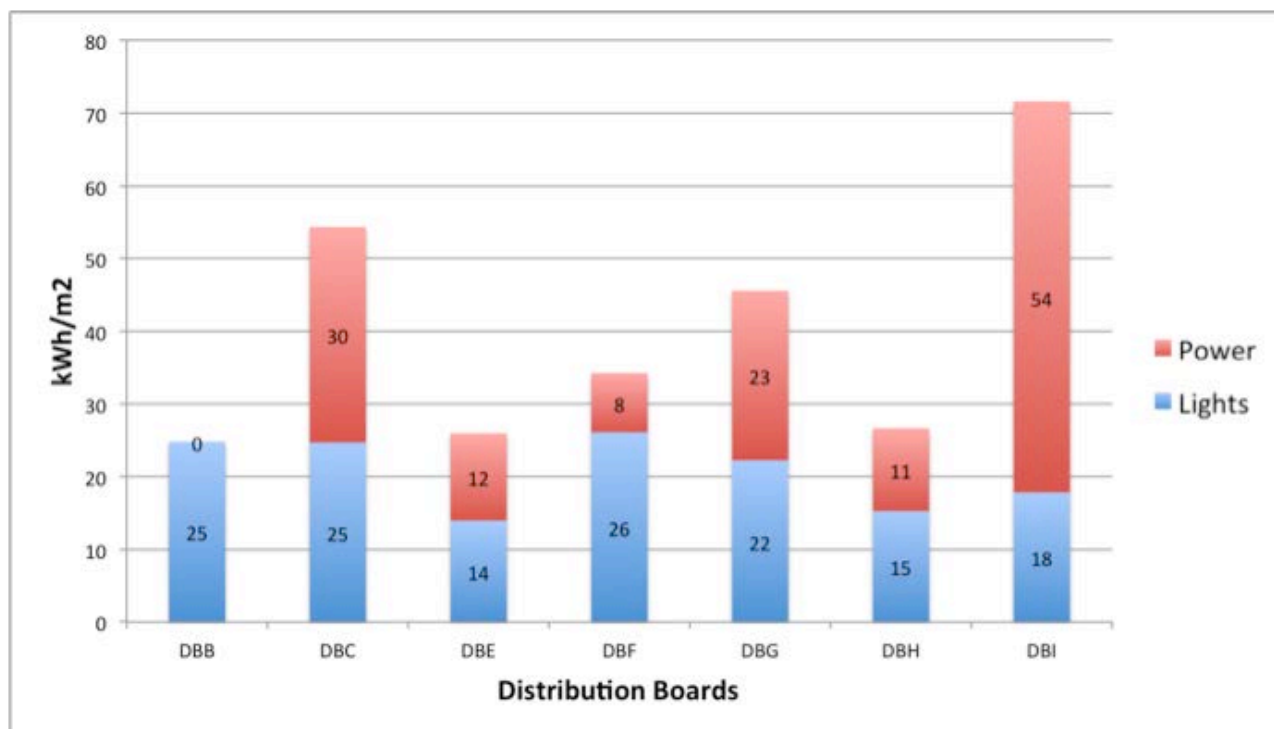
- Comparing the other areas DBG uses a lot of power compared to the main teaching areas, even though several rooms in this area are not in constant use. This could at least in part be due to the Sensory Room cooling unit.

- The power usage of the LCD screens in each classroom is also considerable. The absence of a screen in DBF may be the reason for the lower power usage in this area despite the longer operational hours.

Recommendations on general electrical usage are as follows:

- A more detailed investigation of lighting usage including installed wattage and operational hours is warranted by the findings of the Zone C calculation. Investigation of the differences in behaviours in Zones E and H compared to other areas may also yield some savings. A saving of 10% of the >50,000kWh/yr lighting energy usage would save about £500/yr.
