# Pines Calyx

This document contains a Building Performance Evaluation report from the £8 million Building Performance Evaluation research programme funded by the Department of Business Innovation and Skills between 2010 and 2015. The report was originally published by InnovateUK and made available for public use via the building data exchange website hosted by InnovateUK until 2019. This website is now hosting the BPE reports as a research archive. As such, no support or further information on the reports are available from the host. However, further information may be available from the original project evaluator using the link below.

<b>Innovate UK project number</b>	450115
<b>Project lead and author</b>	University of Kent for the Bay Trust
<b>Report date</b>	2015
<b>InnovateUK Evaluator</b>	Peter Tse (Contact via <a href="http://www.bpe-specialists.org.uk">www.bpe-specialists.org.uk</a> )

<b>Building sector</b>	<b>Location</b>	<b>Form of contract</b>	<b>Opened</b>
Events building	Dover	Traditional	2006
<b>Floor area (GIA)</b>	<b>Storeys</b>	<b>EPC / DEC</b>	<b>BREEAM rating</b>
370 m <sup>2</sup>	2	N/A / N/A	N/A

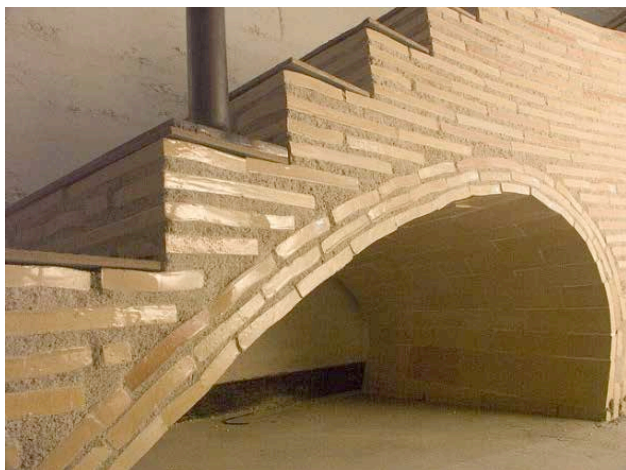
**Figure 2.8** Timbrel vaulted clay tile staircase

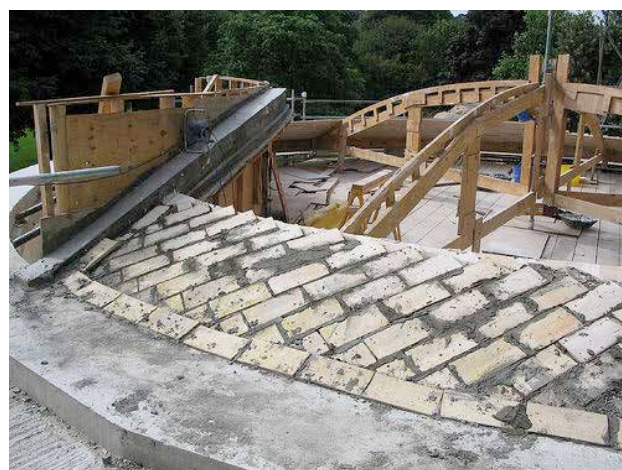
**Figure 2.9** First vaulted roof section (from above) showing 2nd diagonal layer of tiles and the first row of the 3rd (horizontal) layer

The master mason simply holds the latest tile in position for a few seconds until the plaster can take its weight, then repeats the operation all the way around. After three rings of the first layer are complete a second is begun, bedded on a mortar base. Then a third layer follows close behind. Each layer uses a different bond pattern for extra stability and strength. A final layer of mortar takes the total thickness to no more than 150mm. The domes were constructed without any heavy machinery, yet were completed in just two weeks. This technique has also been used for the staircase. As a result of the domed roof shape, there is now more grass growing on the site than before original excavations took place.

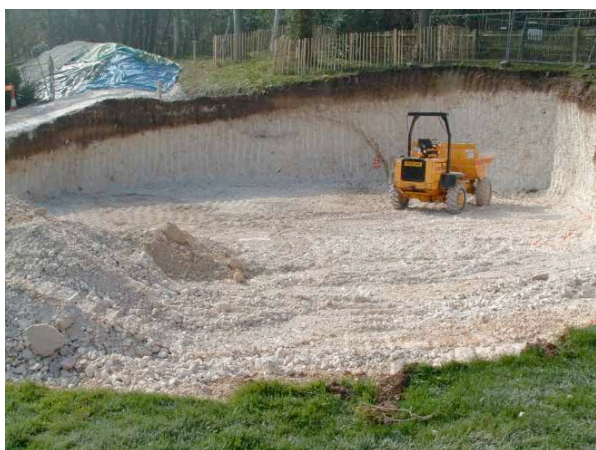
**Figure 2.9** Chalk excavated from the site **Figure 2.10** Slab drying with insulation part laid

**May 2005** : The excavated chalk was put to use as the building's external and internal walls. Some concrete was used to spread the load of the upper floor and the roof : 8 beams and the wall around the kitchen (shown dark grey in Fig 2.13 below).

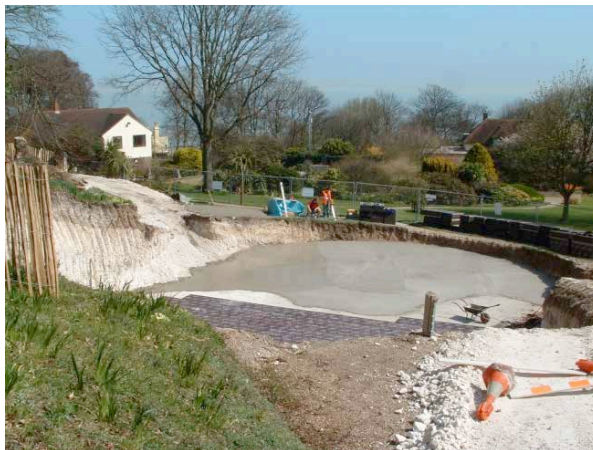
**April 2005** : The incline was cut away, and the 300mm initial reinforced concrete layer placed to provide a thoroughly level base. The next layer of reinforced concrete is 175mm thick, sitting on top of 100mm of “Foamglas”<sup>5</sup> to protect the building from excessive heat loss, 60% of which is recycled windscreen glass. Foamglas is a cellular glass insulation material that's impervious to moisture, inert, resistant to insects and vermin, strong, and reasonably well-insulating (R-3.44 per inch).<sup>6</sup>

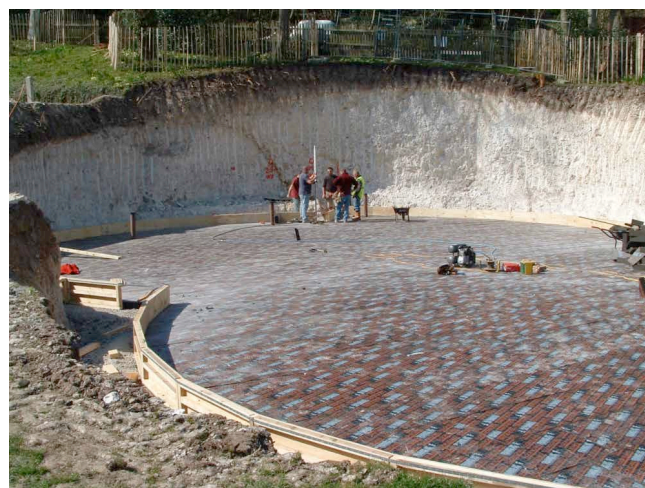
**Figure 2.11** Insulation over the lower ground slab

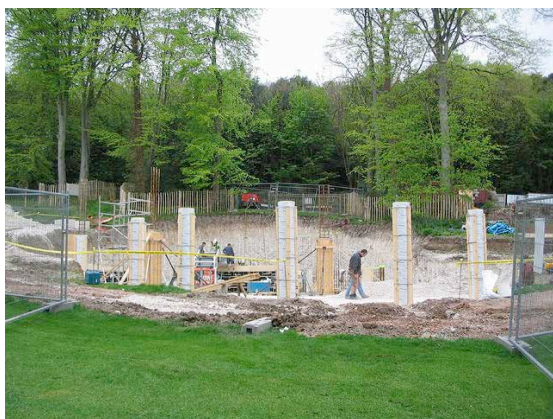
**Figure 2.12** Lower roundel columns

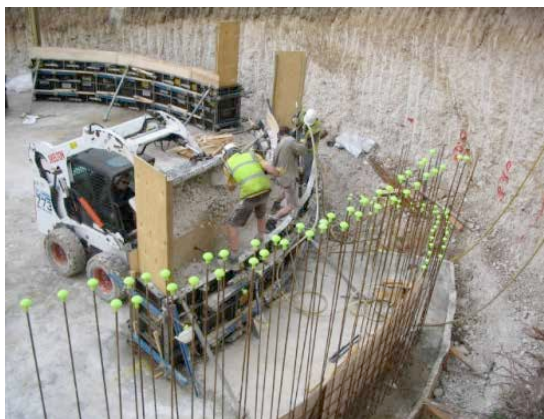
**Figure 2.13** shuttering for reinforced concrete retaining wall and internal rammed chalk walls (Lower roundel rear wall)

The walls in the Pines Calyx range from 300 to 600 mm in thickness depending on their load bearing requirements in the building. With uncertainty as to the ability of the rammed chalk to act as a retaining structure for the hillside behind the Calyx, reinforced concrete walls (amounting to approximately 30% of the external wall circumference) were constructed (as the rear wall to the plant room, kitchen and lift shaft) to provide engineering certainty for this function (see figure 2.13). Inside this, 600mm thick internal chalk walls were constructed (e.g. the inner wall of the kitchen and plant room) which also provide an added mass for thermal and moisture control in the building. Windows and doors were easily installed by putting lintels into the rammed chalk during construction.

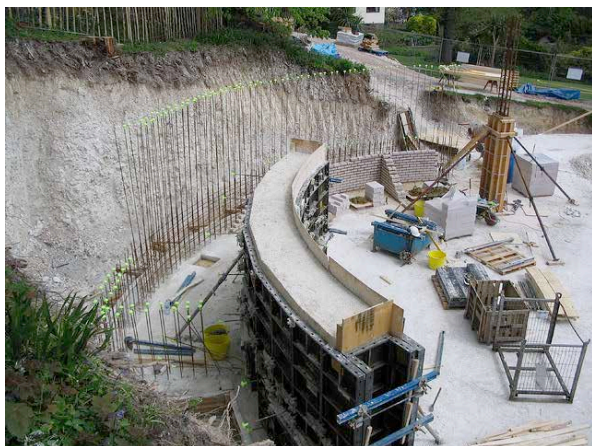
**June 2005** : The walls were built with a swift and straight-forward process, only requiring 8 weeks of work. All the rammed chalk internal walls were eventually sealed with a stabilising solution of Calcium Silicate to prevent dusting.

**Figure 2.15** First rammed chalk internal wall

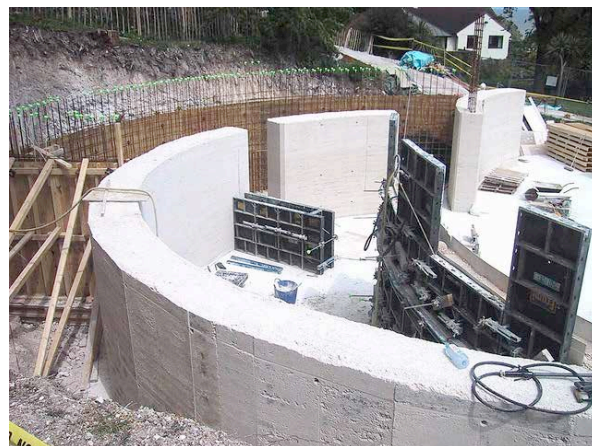
**Figure 2.16** Rammed chalk internal walls, lower roundel

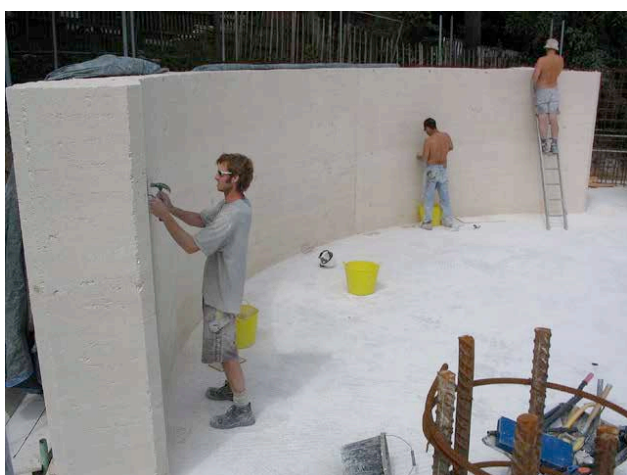
**Fig 2.17** Finishing internal rammed chalk walls

To construct the chalk walls at the Pines Calyx, loose chalk was placed into layers of around 100-150 mm depth in the formwork and then compacted using a pneumatic (air compressed) rammer. Once the chalk had been adequately compacted, the formwork was removed, leaving a naturally appearing/aesthetically appealing finished wall. Several columns of reinforced concrete were also erected on the south and east side for the areas of glazing and doors, and with the rammed chalk walls these formed a circular support for the concrete ring beam. To complete the surface, the rammed chalk walls were coated with sodium silicate, which is a liquid glass or sand, to prevent the chalk dust from settling on people as they touch or brush past the walls. The walls are load bearing instantly so there was no drying time required like most earth and conventional construction methods where a shrinkage or setting period occurs before loads can be applied.

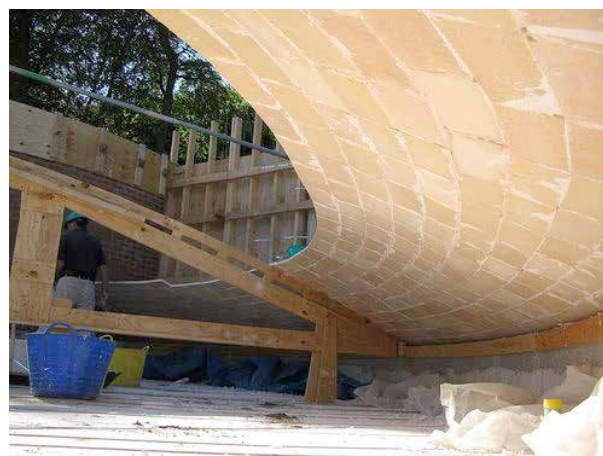
**Fig 2.18** First vaulted roof section (from below)

**August 2005** : The builders started the timber vault ceiling. The inner tiles are lighter and held merely with Gypsum mortar before other tiles are layered over them and held with mortar. The two domes are supported at the perimeter on a reinforced concrete ring beam - see Fig 2.17 and Fig 2.8 in the previous section.

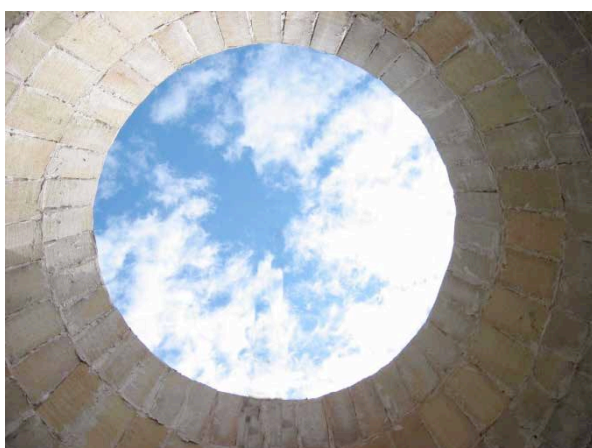
**Fig 2.19** Finished roof Oculi (internal view)

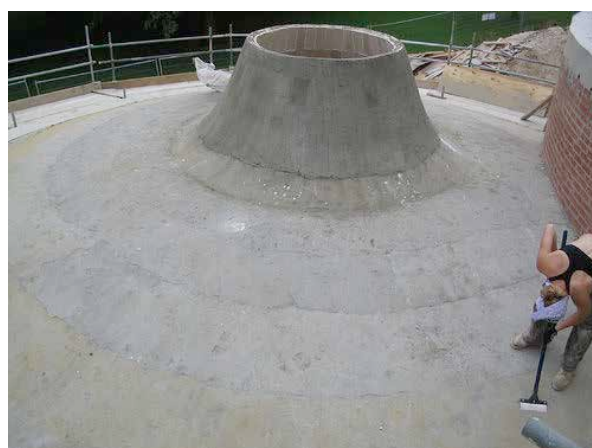
**Figure 2.20** Finished roof with Oculi (external view)

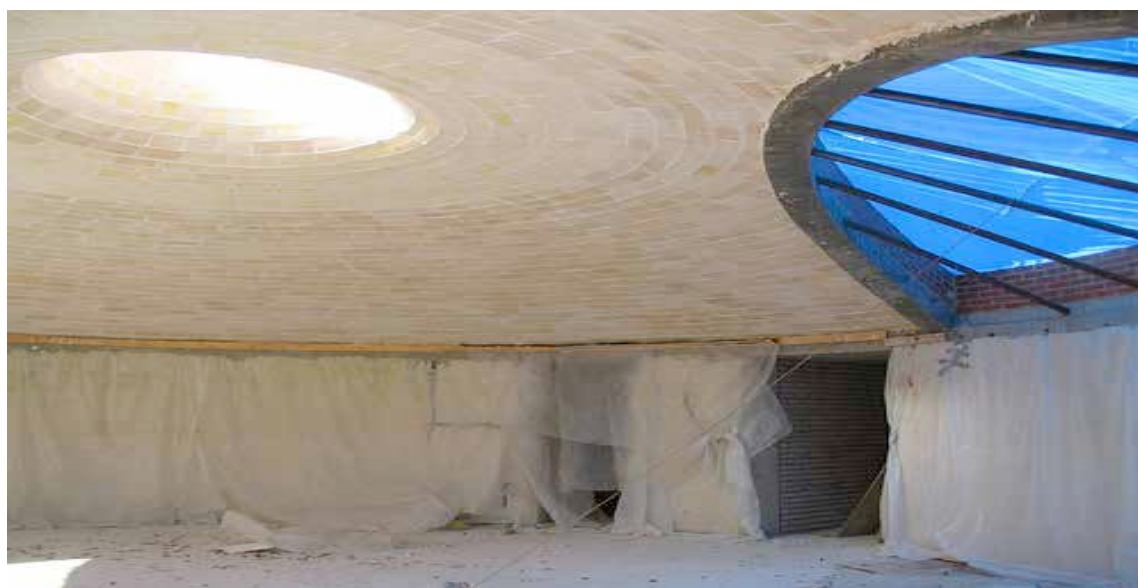
**Figure 2.22** Internal view of upper roundel, prior to fit out – shows a) the structurally engineered design adjustment of the vaulted roof curving up to the Oculi (originally planned to be a right angle); b) the very low curve of the vault that was achieved, thereby reducing materials use and space requiring heating.

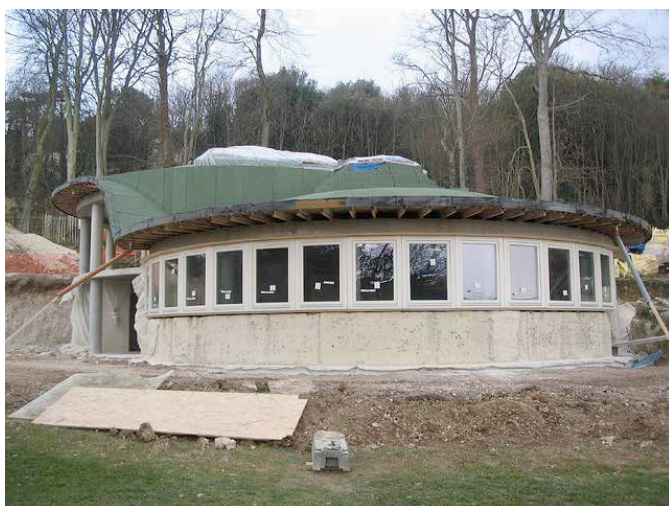
**Figure 2.23** external chalk walls prior to insulation

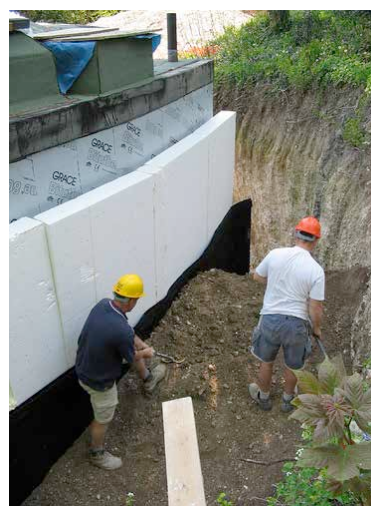
**Figure 2.24** Insulation of earth sheltered walls and render, providing insulated internal thermal mass

**May 2006:** All external works were completed and the building sealed. The process of insulating the chalk walls took place before the landscaping started. Wall waterproofing is Bituthene Liquid Membrane<sup>7</sup>, made from synthetic oils and bitumen. Polystyrene panels line the outer areas, followed by a waterproof membrane to protect the polystyrene once the areas around the building were back-filled with earth and chalk. The insulation of the external walls needs to protect from moisture, thus the use of waterproof EPS (Foamglas being too expensive to insulate the floor and the walls). See Fig 2.24.

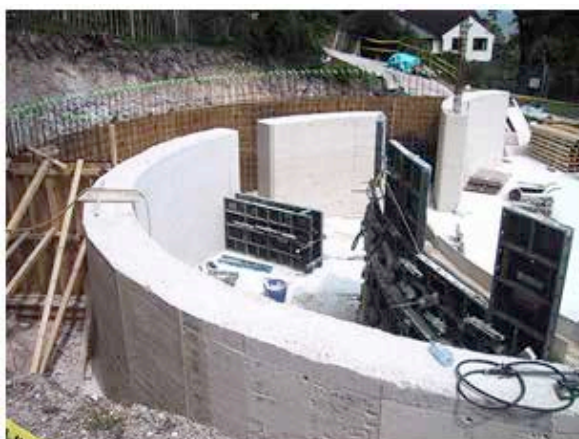
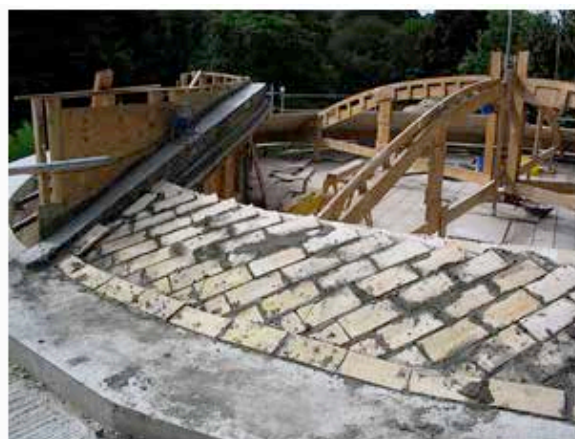
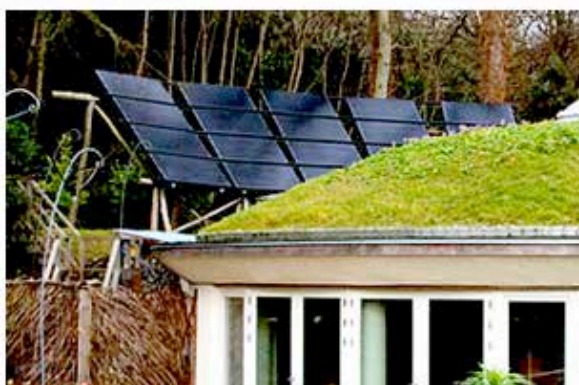
**Figure 5.1:** some of the multiple experimental / innovative components of the Pines Calyx

Building Element	Experimental / Innovative	Advanced	Standard
Design form	Yes		
Walls system + materials	Yes		
Roof system + materials	Yes		
Materials	Yes (many)	Yes (many)	Yes (some)
Energy systems (phase 2)	Yes		
Energy strategies		Yes	
Ventilation systems	Yes		
Lighting systems		Yes	
Lighting controls	Yes
