Rogiet Primary School

Innovate UK project number	40042
Project lead and author	Piers Sadler Consulting (via White Design Associates)
Report date	2014
InnovateUK Evaluator	Roderic Bunn (Contact via www.bpe-specialists.org.uk)

Building sector	Location	Form of contract	Opened
School	Monmouthshire	Design & build	2008
Floor area	Storeys	EPC / DEC (2015)	BREEAM rating
1853 m ² (TFA)*	1	B (32) / C (65)	Excellent

Purpose of evaluation

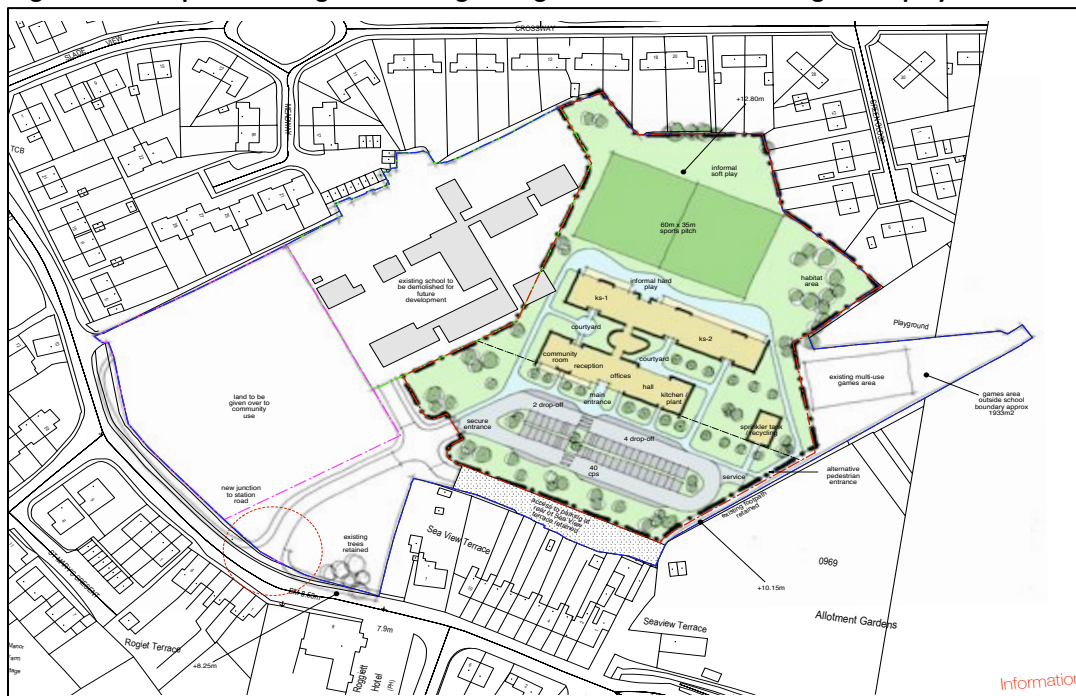
Figure 2.1: Site plan showing north facing arrangement of class-bases to grassed play areas

A secure line across the site, level with the main entrance façade, enables the courtyard spaces between the two wings to be secure educational play spaces. Activities in this area are closely supervised due to the inclusion of a pond and a 15m high wind turbine; hence a further division from the informal hard and soft play spaces beyond.

The landscape design was an important element of the Rogiet school design. The building and landscape were designed together to give aspects such as the productive garden and outdoor performance - a 'centre-stage' within the school, and to provide a range of interactions between the buildings and the diverse external spaces.

The school building is set around a courtyard, allowing the landscape to enter into the heart of the school. Teaching spaces are able to interact with the external spaces and the boundaries between inside and outside learning are broken down. The school uses food growing within an allotment garden, placed at the heart of the school, and an orchard. All these natural and land-based elements are intended to invite interaction with the children either in the form of play or as an educational and creative resource.

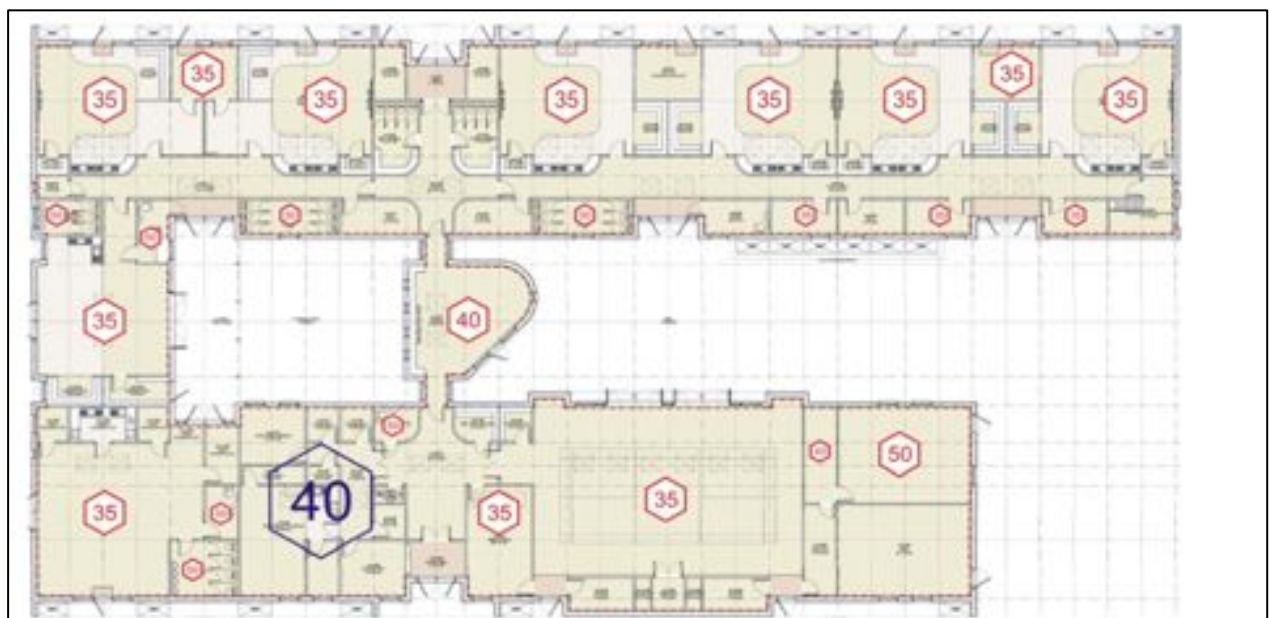
Figure 2.2 : Recommended maximum ambient noise levels(db) in spaces throughout the building.

The adoption of a natural ventilation approach, combined with the acoustic constraints generated by the site context demanded a more involved design process to ensure appropriate internal comfort levels could be met for both ventilation, natural light and prevention of excessive noise ingress. This has led to considerable investigation through the study and more detail can be found in Section 7 technical issues.

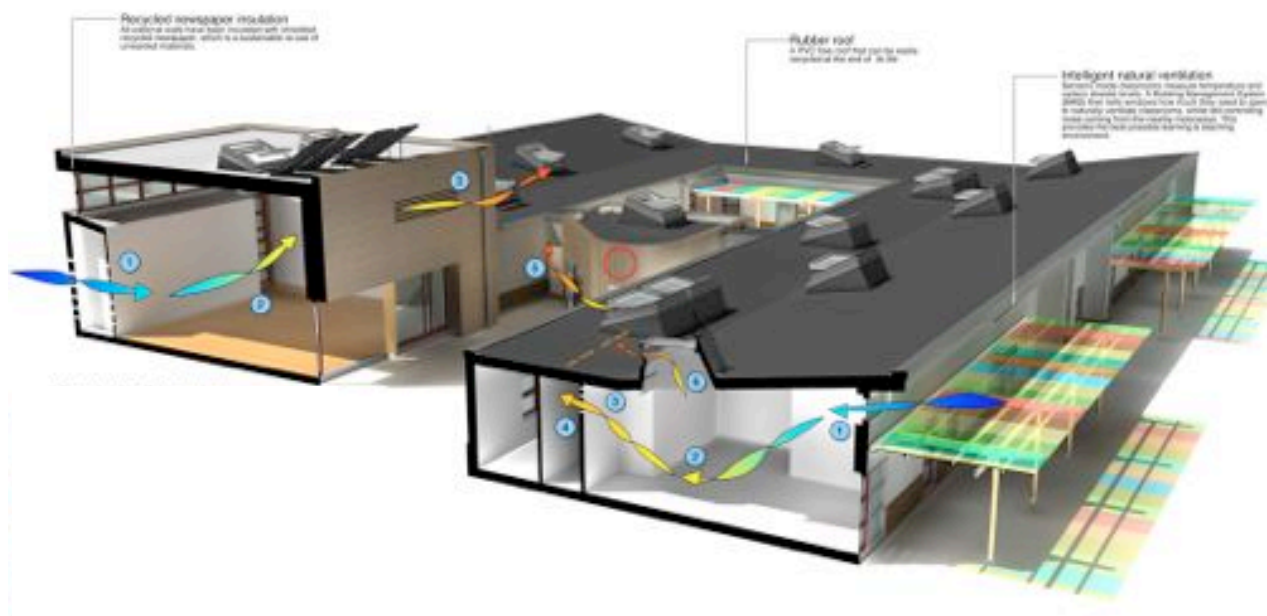
Figure 2.3: Environmental schematic model and diagram prepared by the architects

The natural ventilation design defines the building and has been the subject of many aspects of this study and it is discussed in detail within Section 7 of this report. Issues with its effectiveness were implied through the Building Users Survey, (see Section 4) anecdotal evidence through the interviews with key staff and through the design and construction audit . The focus of the building users guidance and some of the BPE outcomes and recommendation have provided an improved use of this system through assistance from WindowMaster, the system manufacturers. In summary some of these issues and improvements have been,

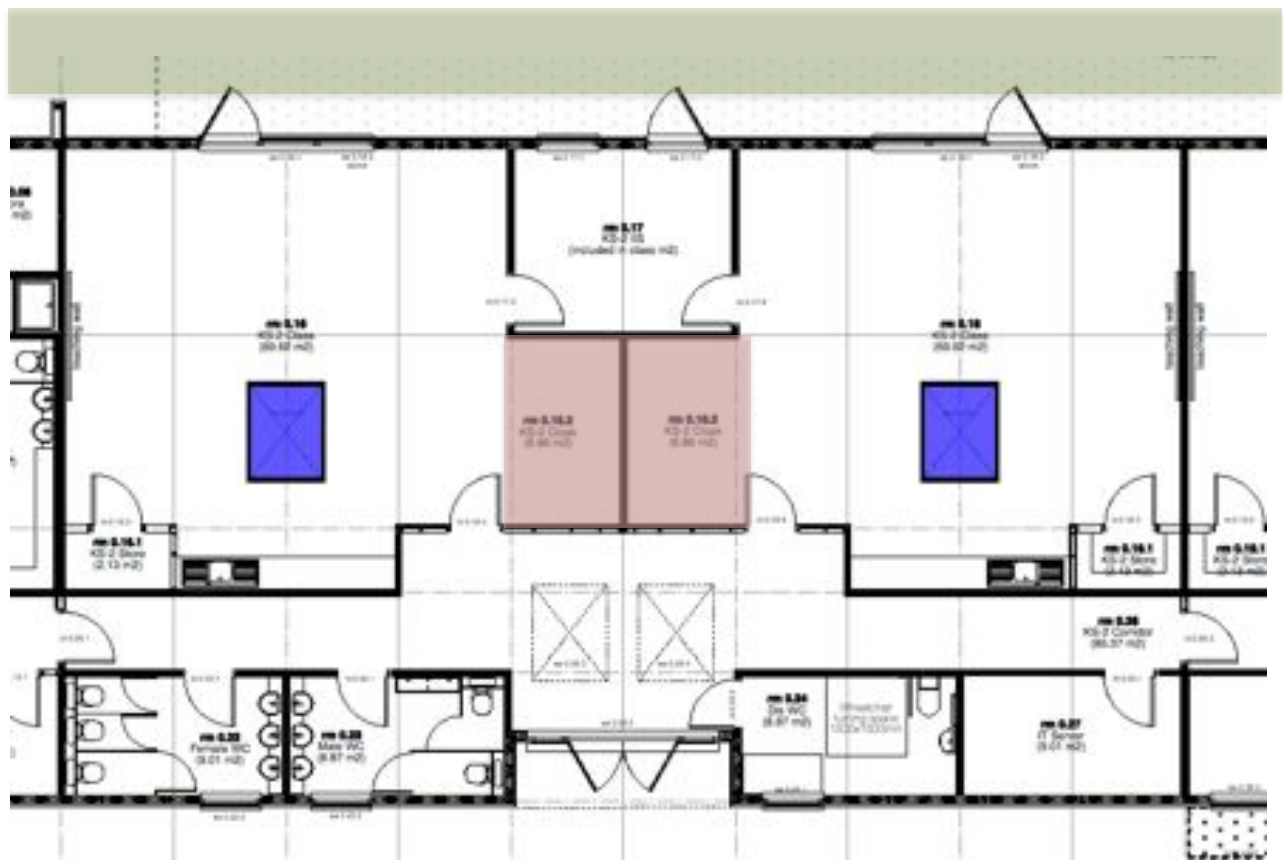
Figure 2.4: Classroom layout: roof light location (blue) and area opened up to the class-bases (pink)

The BUS follow up section in Section 4 and the lighting study carried out in Section 7 reviews some of the anecdotal issues concerning internal lighting levels where there is a noted perception by some that the classrooms are a little gloomy. The study concluded that a number of design decisions and methods of use were combining to produce this perception despite the classrooms still providing lux levels within recommended limits.

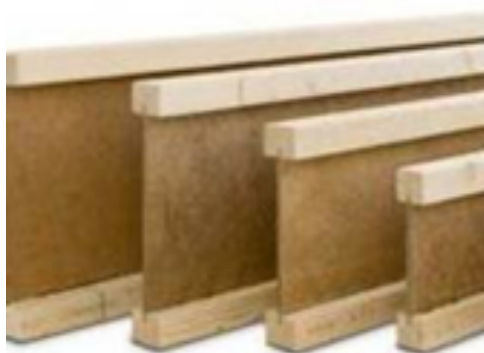
Figure 2.7; Originally proposed solid timber web I beam

These issues are also considered in the construction audit and the following commentary is made here concerning the soffit junction. The prefabricated timber roof construction as part of the Framewise (the timber frame manufacturers) procured system produced a design change to the connection details between wall and roof. The structural proposal designed by architect and engineer used a timber I-beam with a solid and continuous web that cantilevered through the external wall to produce the soffit overhang. Whilst the beam effectively punctures the thermal envelope as it continues outside, the straight edges of the I-beam web enabled a simple to construct and potentially effective airtightness detail. The procurement of Framewise saw their system introduce a timber and steel composite beam with an open web. Whilst concerns were raised at the time over the ability to provide the required airtightness integrity it was concluded that the cost saving provided by the Framewise solution could pay for builders work in connection with addressing the closure of the roof system at the head of the wall. Whilst considerable effort was made in improving the airtightness at this junction, the thermal images show that there is still significant heat loss at this junction.

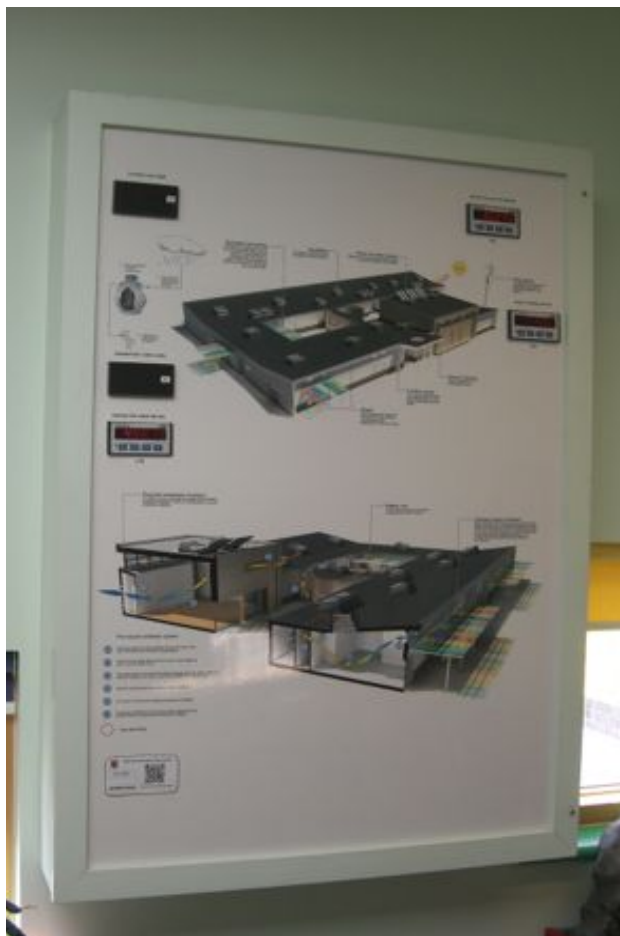
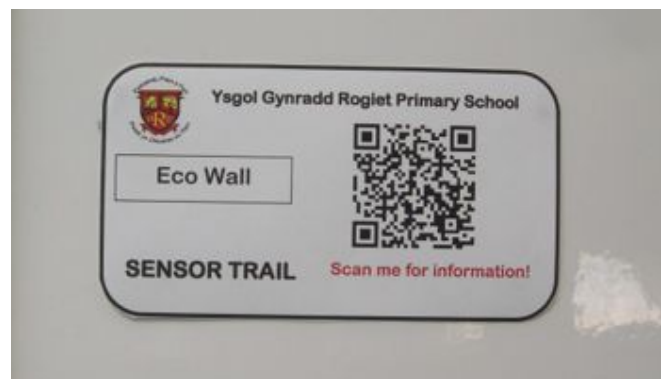
Figures 5.3 Photos of installed QR code information

In the second half of the workshop, the students went on to create Quick Response (QR) codes, linked to a website, which detailed the information about each of the 13 controls/sensors identified to them. Some also created a video to introduce their control. The school now has a newly formed 'Sensor Trail'. This information is designed to not only provide information to the rest of the school and the general public, but also reinforces their abilities in IT, writing and media skills. See Figures 5.3 below.

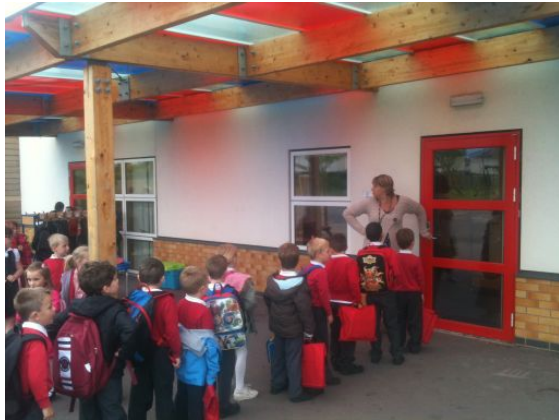
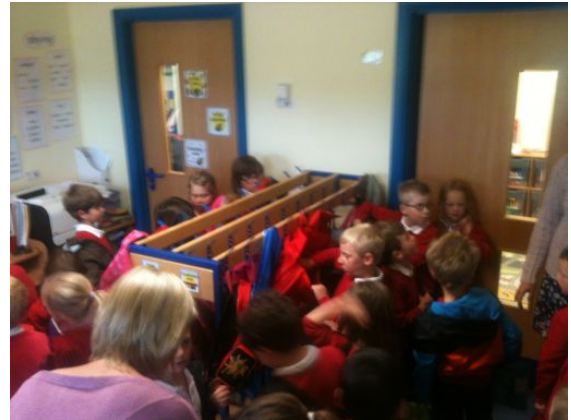
The technical issues considering the design of the Buffer zone spaces is discussed in Chapter 7. Alongside the investigation of this part of the building, an experiment was carried out to determine if the group rooms could be used as lobby spaces as original intended and what would be the effects of this on the use of the space. The experiment involved the teaching staff and students using the lobby space as an airlock to minimise heat lost from the class-base. This was followed by a short presentation to each class. (Years 1 and 2 and Years 5 and 6) regarding the potential effect of heat lost from the classroom by using the direct door to the outside.

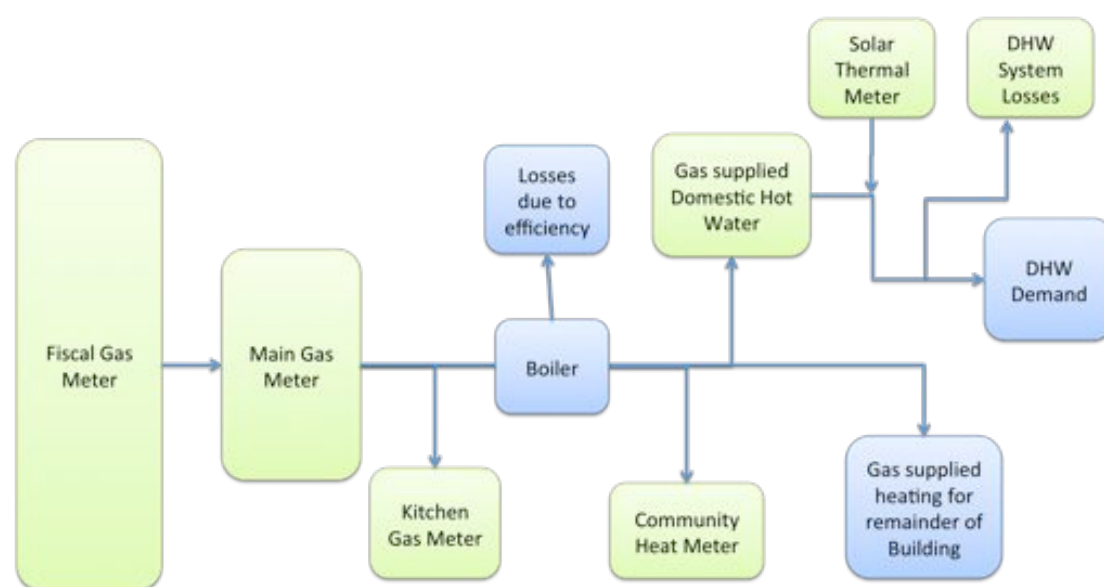
Figure 6.16: Gas and heat metering

Items in green are metered, whilst those in blue have been calculated

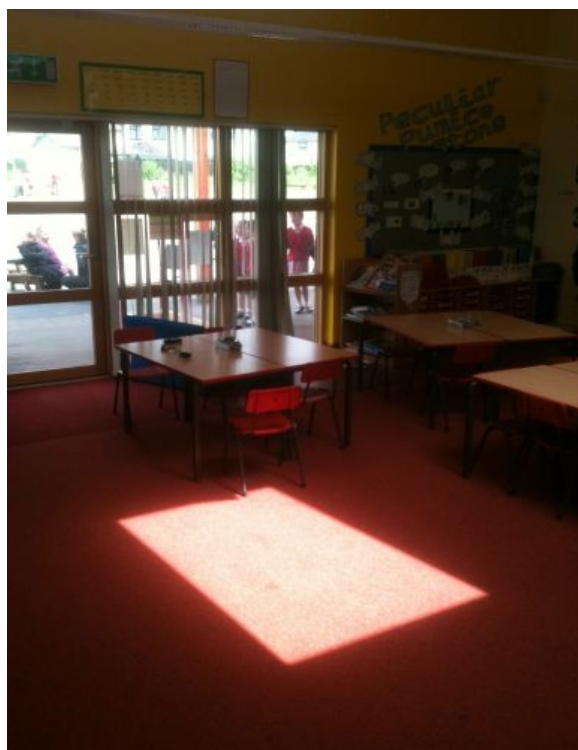
Figure 7.4: Lighting differences with blinds open and closed

- The window control for the blinds is hidden behind the door in the teachers cupboard and the default position of the blinds seems to be closed. (consideration of improving this is provided through the Building Users Guide enhancement)

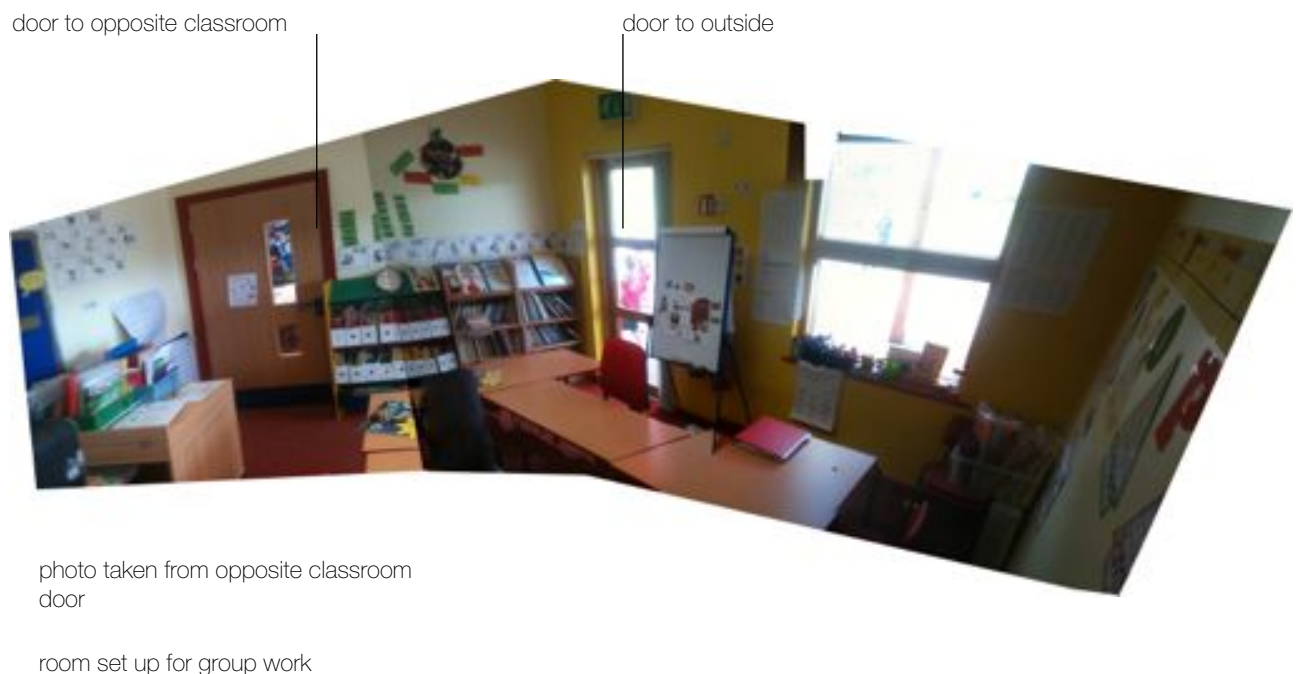
Figure 7.5: The group/lobby space

The photo montage below shows how the group space has become an essential educational space for each key pair of classes. It is loaded with furniture and is not useable as a primary entrance and egress point to the classrooms. The room is used throughout the day for small group activities and one to one activities as well as an independent quiet space.

Conclusions

- Heat loss through the door could be reduced if we assume the door is open for 6 mins in total across the three main entrance times, morning, break, and lunch.

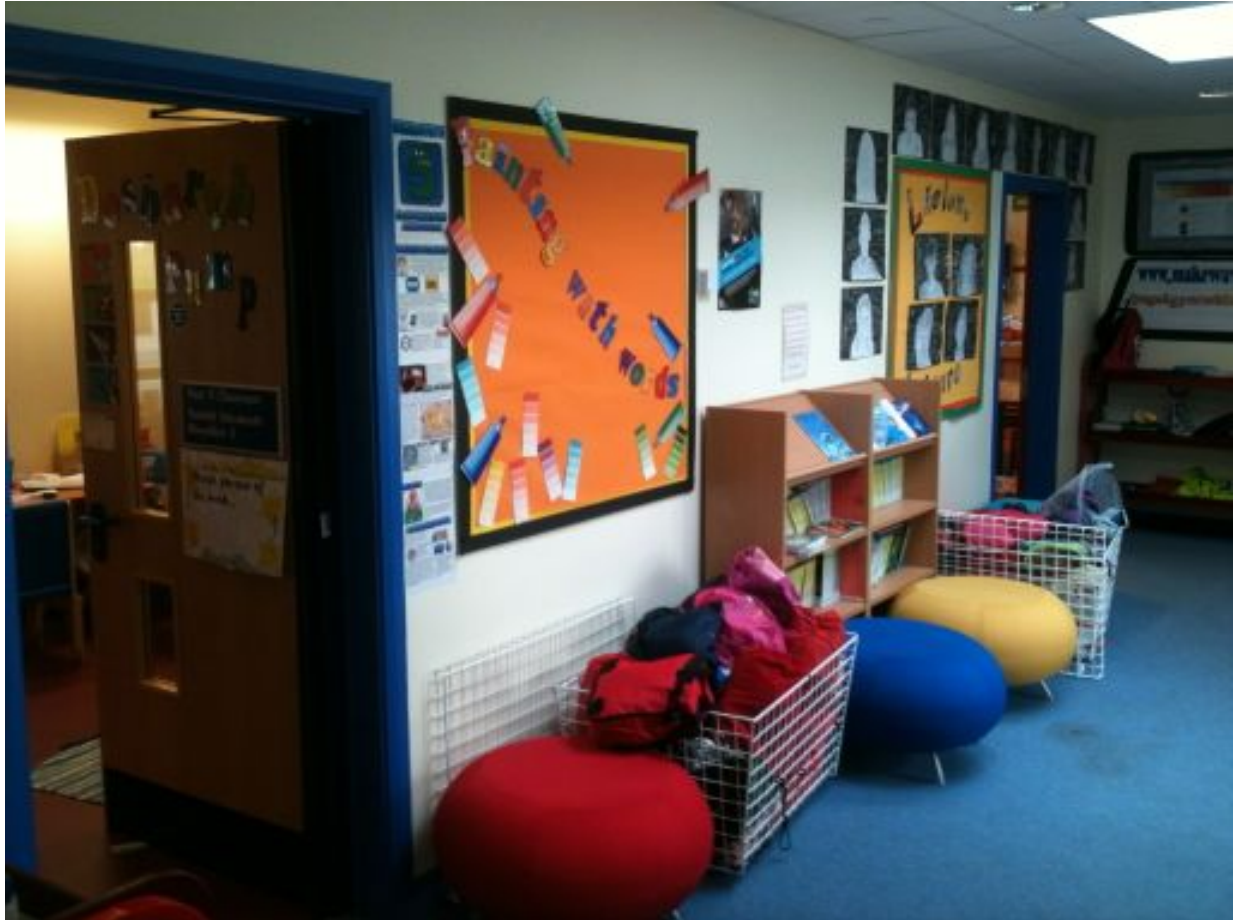
Figure 7.7: Classroom doors always open to the corridor

It does also question the expense made to achieve the acoustic attenuation between corridor and classrooms. This is effectively made redundant with the doors to the classroom open although it is difficult to know how it could have been designed out. One approach may have been to increase the opening windows in the external wall to help achieve the required natural ventilation without the need to cross vent through the corridor wall and the corridor roof-lights.
