# Stevenage Bioscience Catalyst

This document contains a Building Performance Evaluation report from the £8 million Building Performance Evaluation research programme funded by the Department of Business Innovation and Skills between 2010 and 2015. The report was originally published by InnovateUK and made available for public use via the building data exchange website hosted by InnovateUK until 2019. This website is now hosting the BPE reports as a research archive. As such, no support or further information on the reports are available from the host. However, further information may be available from the original project evaluator using the link below.

<b>Innovate UK project number</b>	450046
<b>Project lead and author</b>	AECOM
<b>Report date</b>	2013
<b>InnovateUK Evaluator</b>	Unknown (Contact <a href="http://www.bpe-specialists.org.uk">www.bpe-specialists.org.uk</a> )

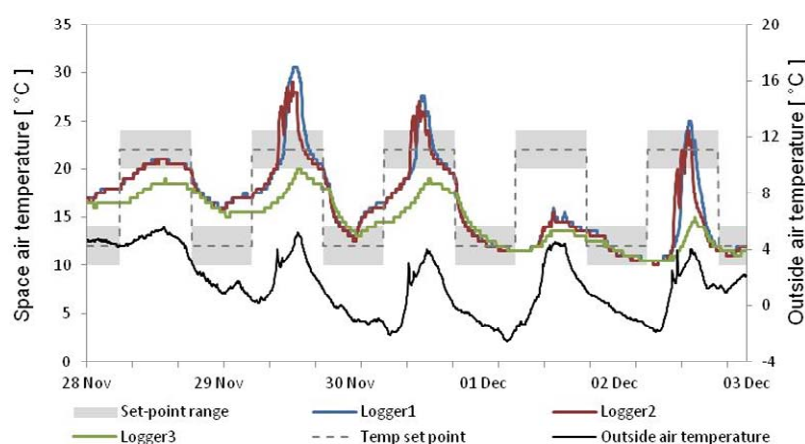
*Example of a graph that could be used to show “operational commissioning” of temperatures in a room (graph shows temperatures at 3 locations in an office over a 5-day period)*

- In addition to standard commissioning, which tests that an installed piece of equipment operates under specific conditions, use commissioning graphs to demonstrate that systems operate as expected over a period of time (e.g a week). This will help ensure that future buildings are commissioned in a more holistic manner.

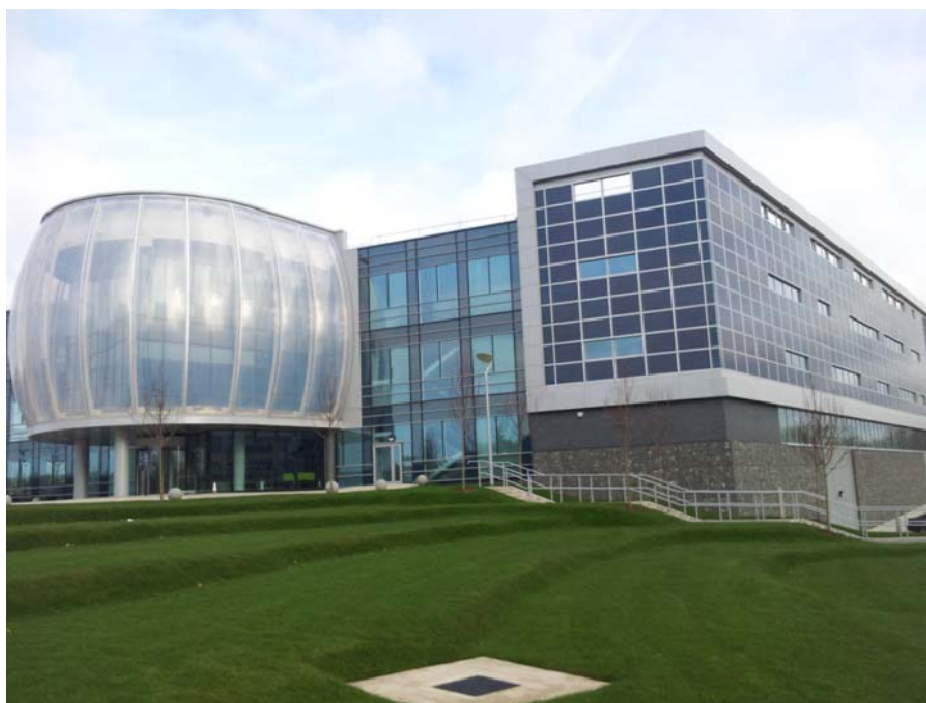
Figure 1 Photograph of the finished Incubator building

The 3-storey building comprises an office wing and a laboratory wing with Containment Level 2 laboratories and attached write-up spaces. A central 'hub' connects the two wings. The total floor area of the Incubator building is approximately 4,750 sqm.

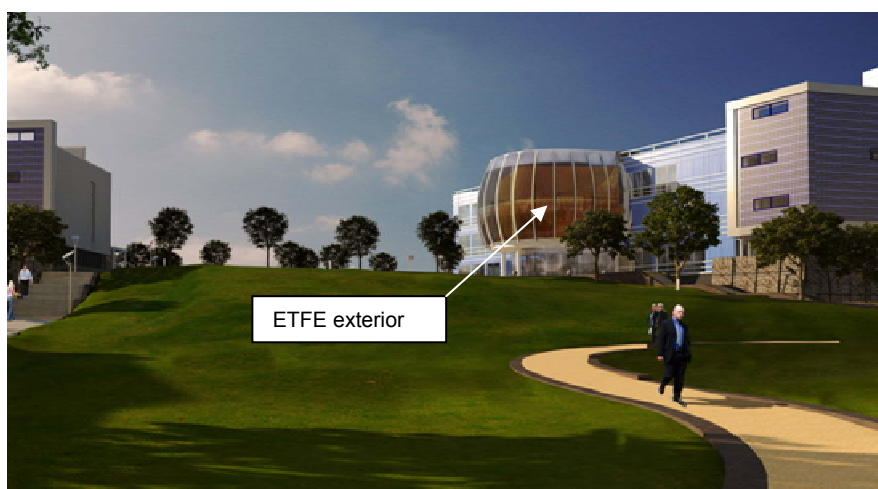
The façades are finished with a mixture of curtain walling and windows, rainscreen metal cladding, integrated PV panels, brickwork and non-structural gabion walls. The hub to the incubator building also includes a feature ETFE air cushion (Ethylene tetrafluoroethylene) exterior.

**Figure 5: Photo render showing ETFE (“the bubble”) exterior around hub of Incubator building**

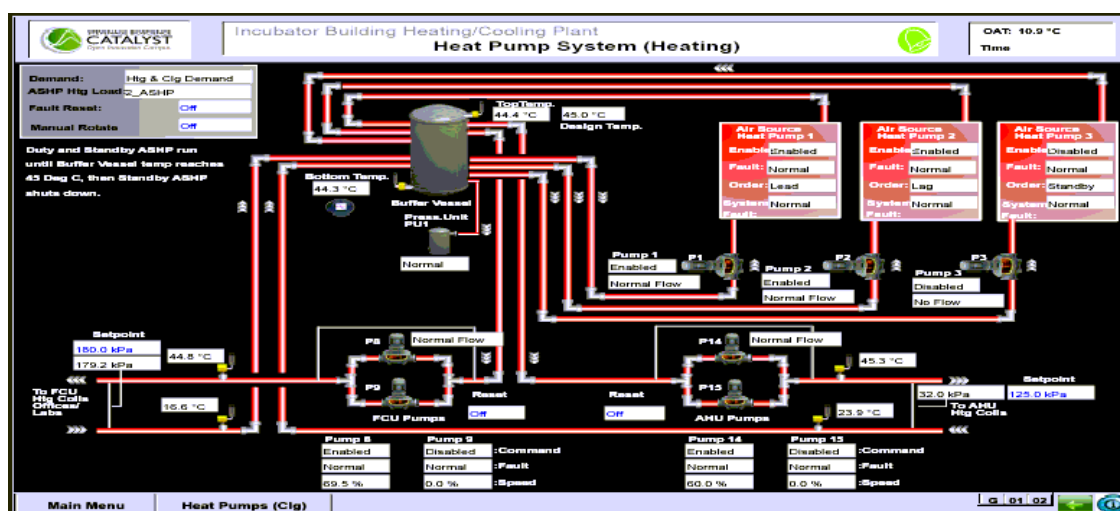
There are three 500 kW air-to water heat pumps located on the roof of the Incubator building which generate either heating or chilled water for the purposes of providing space heating, space cooling and tempering of ventilation air. Heating water is stored in an 5m<sup>3</sup> hot water buffer vessel. Chilled water is stored in a separate 5m<sup>3</sup> chilled water buffer vessel. A CO<sub>2</sub> heat pump, which is used to generated hot water, also supplies some chilled water to the chilled water buffer vessel as a by-product of its hot water generation process. The CO<sub>2</sub> heat pump is discussed further in the section on domestic hot water.

Figure 9: BMS Screenshot showing the building heating system

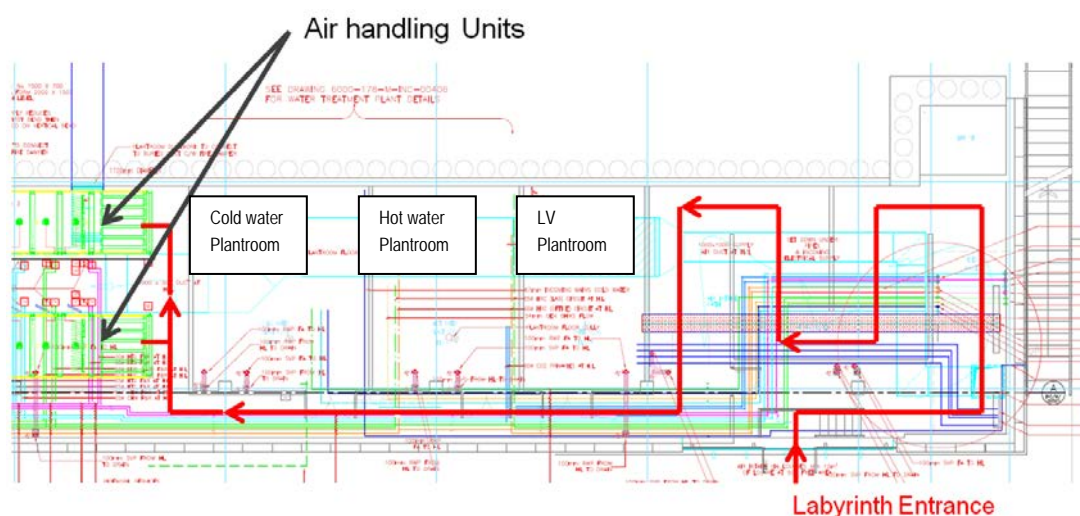
The logic underpinning this idea is that the building structure and surrounding ground would act as a thermal buffer. In the winter it would store heat during the warmest part of the day that it has absorbed from the incoming fresh air and release it during the colder parts of the day back into the incoming fresh air.. The result is that the building energy systems should need to use less heating energy to bring the incoming fresh air up to the required operating temperatures during the morning start-up and any latent heat remaining in the structure should further reduce the building heating energy consumption during the day.

**Figure 12: Diagram showing layout of labyrinth and adjacent plant rooms**

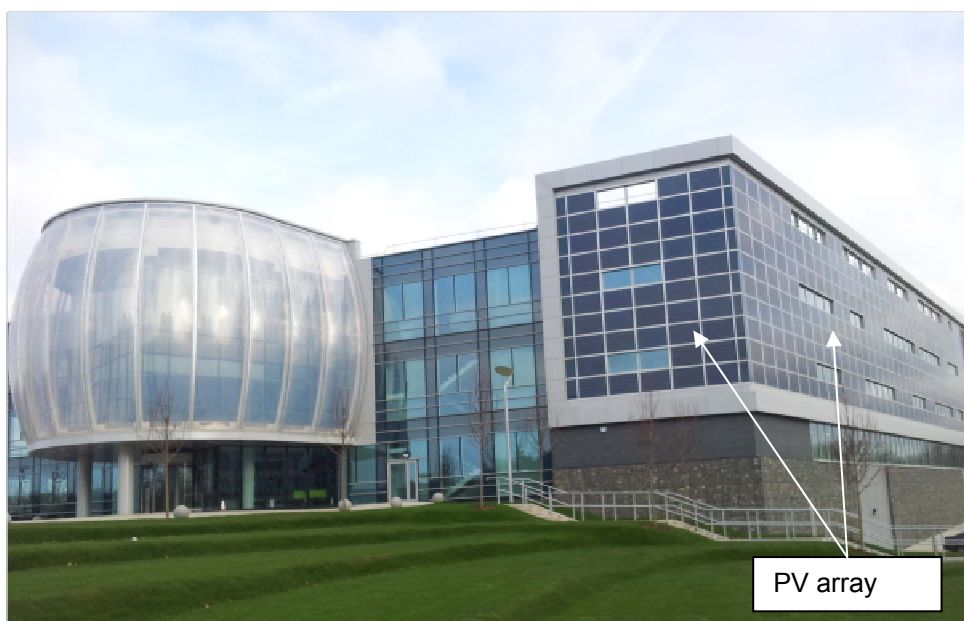
The total amount of PV installed on the Incubator building is 80.8 kWp (approx 67.1 kWp on the south facade, 13.7 kWp on the south west facade). The total area of PV installed is approximately 530 sqm.

**Figure 13: Photo showing PV array on South and South west facade.**

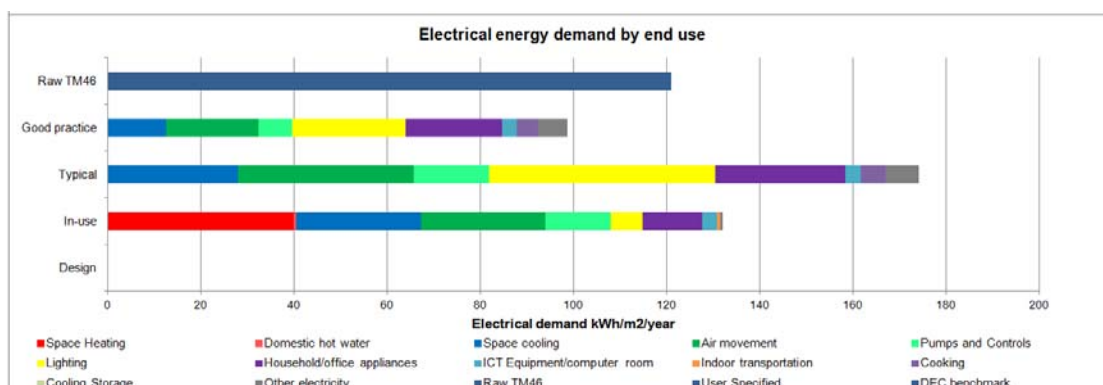
Figure 15 and Figure 16 present the TM22 assessment output showing the comparison of the actual in-use energy consumption against corresponding benchmarks (TM46 and ECON19) based on end-use categories. As the Incubator building is an all-electric building, space heating and DHW generation are also included in Figure 4, resulting in the omission of in-use energy in Figure 16.

Figure 15: Snapshot from TM22 for the electrical energy demand by end use

The Incubator building actual in-use electrical energy consumption is 35% in excess of the ECON19 Good Practice benchmark.

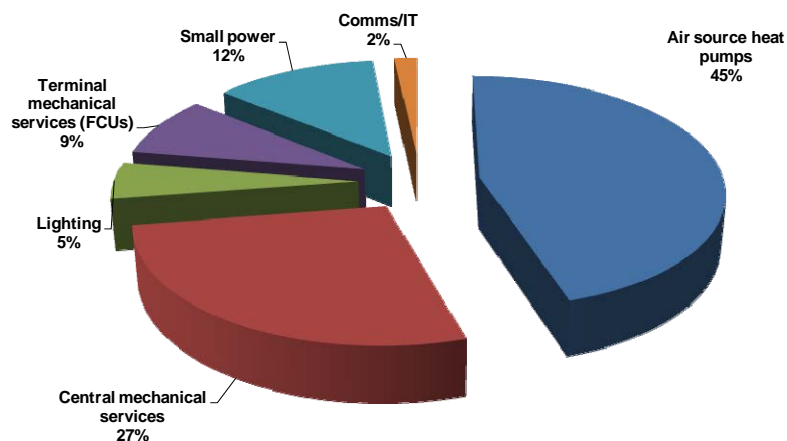
Figure 18 : Pie chart showing a breakdown of electricity use in the Incubator building based on major end use categories.

The building energy use is dominated by heating, and the services to distribute heat and ventilation. Given that the building has laboratory areas, with high potential requirements for air exchange rates, this might be expected. However the low rate of occupancy suggests that this energy use could be reduced substantially for times of low usage.

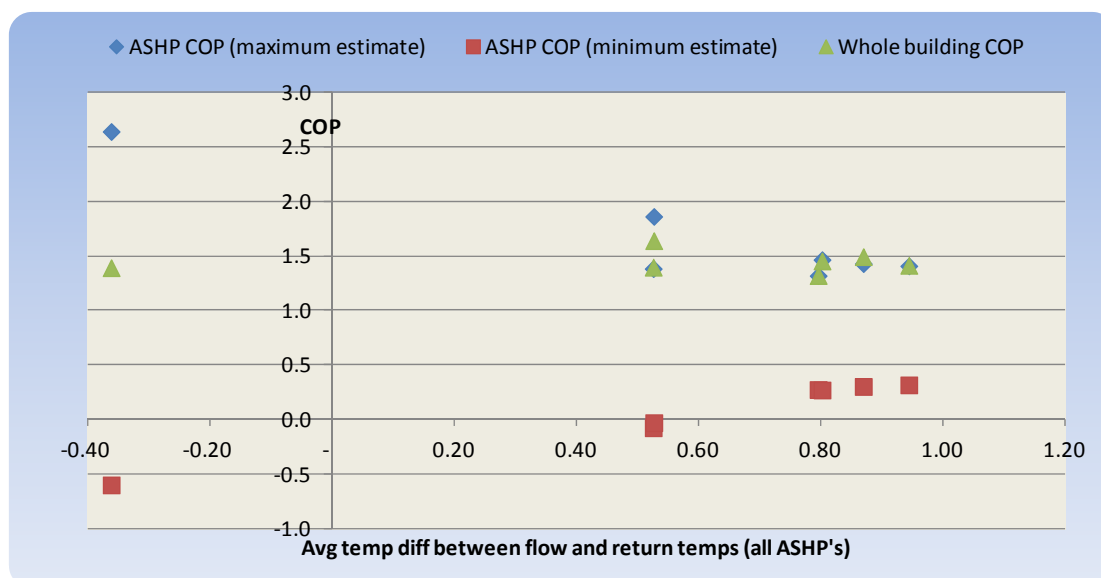
The ASHP COP was estimated from measurements to fall between the range of -0.6 and 1.9, based on measurements of the surface temperature of the flow and return. This uncertainty is so large because the difference between flow and return temperatures is small – and much smaller than the design intent. Because of the losses in the buffer vessel, it would be expected that the ASHP COP would be slightly higher than the whole building COP, if perfect measurements were available.

There is no obvious correlation between the outside air temperatures and the whole building COP on the dates that the analyses have been carried out.

Figure 19: Graph showing calculations of ASHP COP and whole building heating system COP for study periods in January 2013

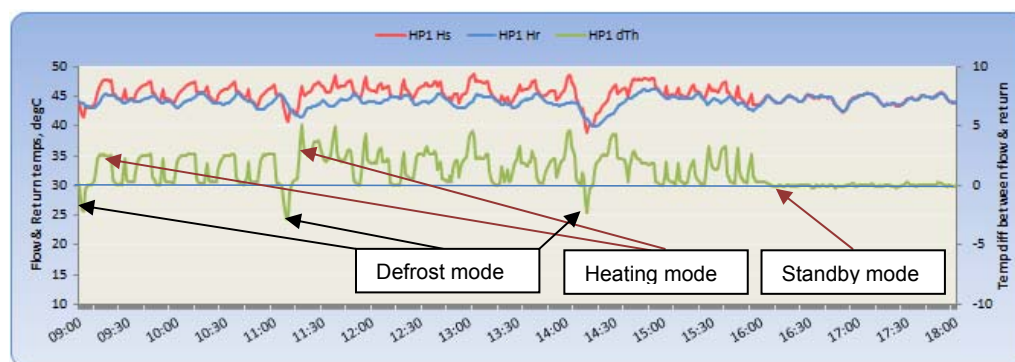
This appears to represent the expected performance of one of the ASHPs (majority of the time in heating mode with periodic defrosting when temperatures are less than +7degC). However it should be noted that the flow and return temperatures measured during all the ASHP assessments (and the difference between them) do not follow a set pattern.

Figure 21 : Stable operation in heating mode with intermittent defrost cycles (ASHP no.1 on 19<sup>th</sup> January 2013). Outside air temperature in Stevenage was between 1 and -1 degC\*.

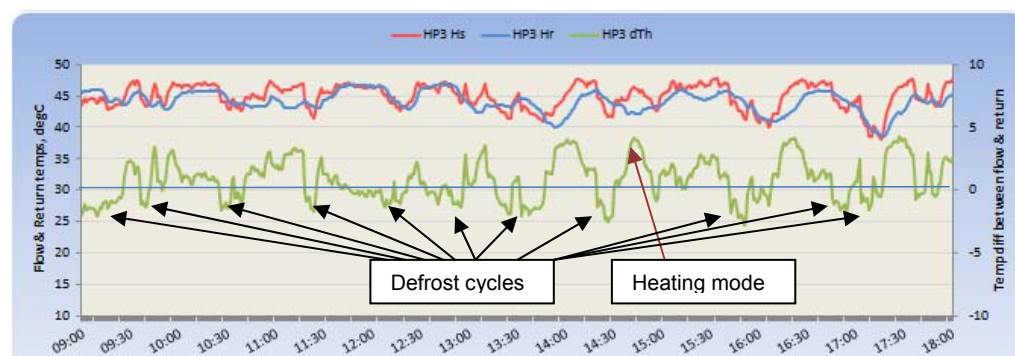
In contrast to Figure 21, Figure 22 shows an ASHP operating with approximately 12 apparent defrost cycles between 9am and 6pm. ASHP3 on the 18<sup>th</sup> January 2013 appears to switch between defrosting and operating in heating mode on a frequent basis. This could represent a problem with the control strategy or a malfunction with the ASHP.

Figure 22: Erratic operation in heating mode with frequent defrost cycles (ASHP no.3 on 18<sup>th</sup> January 2013). Outside air temperature in Stevenage was between 1 and -2 degC\*.
