Sustainable Construction Academy

This document contains a Building Performance Evaluation report from the £8 million Building Performance Evaluation research programme funded by the Department of Business Innovation and Skills between 2010 and 2015. The report was originally published by InnovateUK and made available for public use via the building data exchange website hosted by InnovateUK until 2019. This website is now hosting the BPE reports as a research archive. As such, no support or further information on the reports are available from the host. However, further information may be available from the original project evaluator using the link below.

Innovate UK project number	450062
Project lead and author	Low Carbon Building Group, Oxford Brookes University for the Institute for Sustainability
Report date	2015
InnovateUK Evaluator	Unknown (Contact via www.bpe-specialists.org.uk)

Building sector	Location	Form of contract	Opened
Education	Dartford	Unknown	2011
Floor area (GIA)	Storeys	EPC / DEC	BREEAM rating
2916 m ²	2	A (9) / N/A	Outstanding

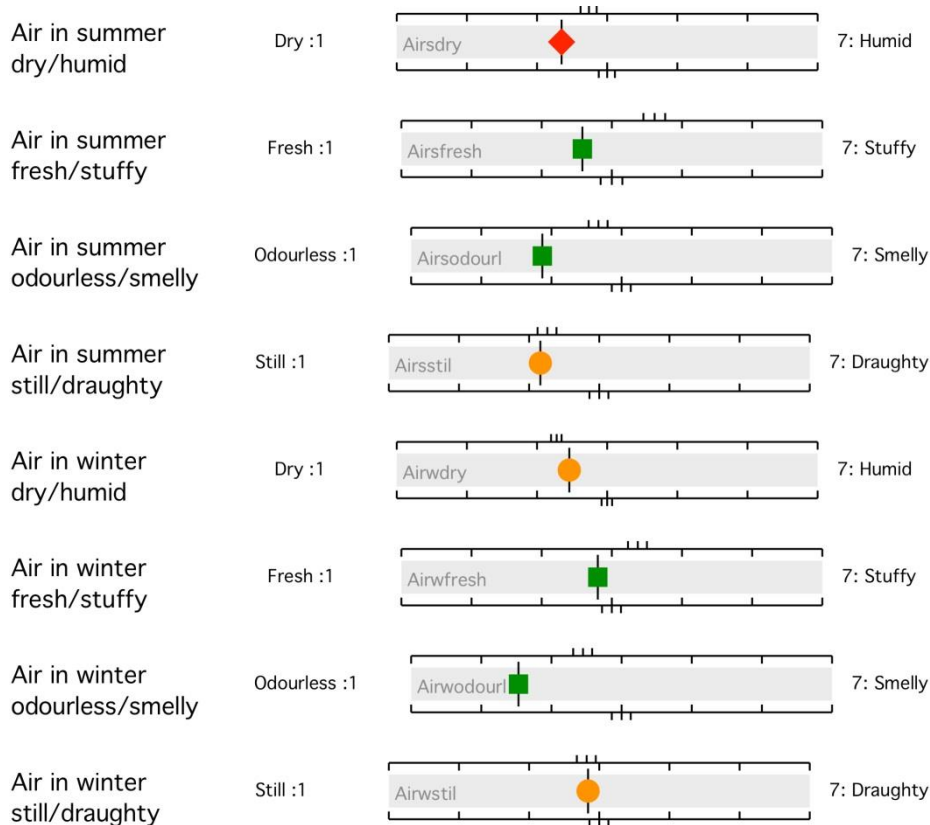
Figure 4.8 BUS responses: air quality in winter and summer

Figure 4.8 illustrates the findings from the BUS questionnaire regarding seasonal air quality.

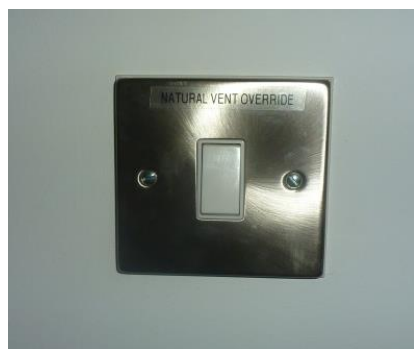
Criteria	Poor				Excellent	
Clarity of purpose						
Intuitive switching						
Usefulness of labelling & annotation						
Ease of use						
Indication of system response						
Degree of fine control						
Accessibility

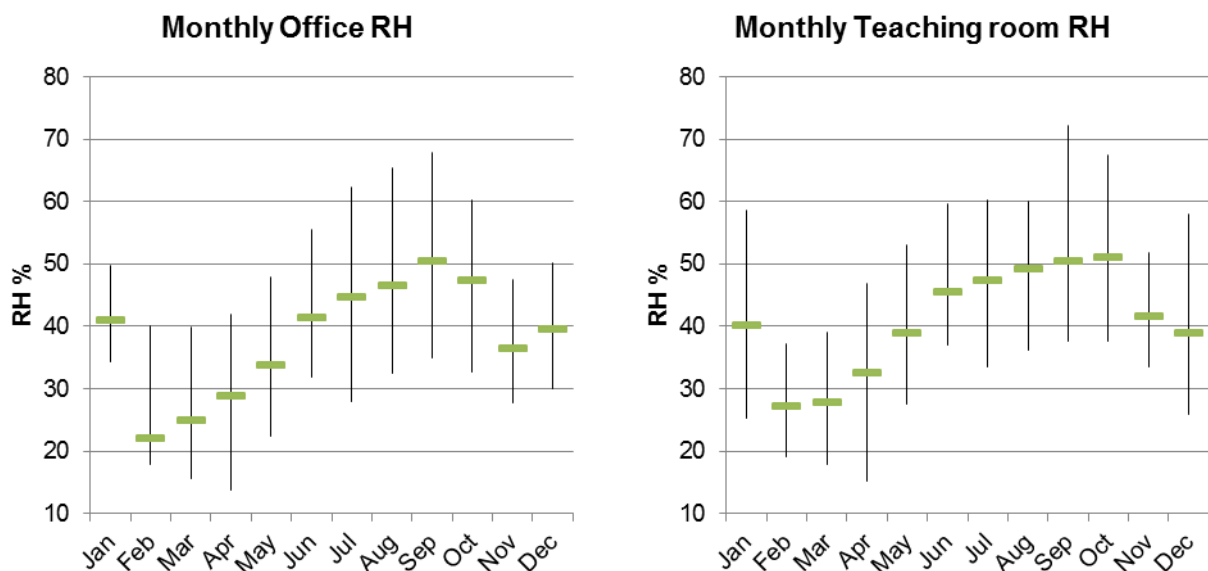
The same can be seen in the monthly maximum, minimum and average RH per month (figure 4.12). The average relative humidity for the office and teaching room are within the recommended range for the months of June – October and potentially unacceptable for a majority of the time in February – April.

Figure 4.12 monthly RH for the office and teaching room. *Note: January and February data are incomplete for a majority of the month.*

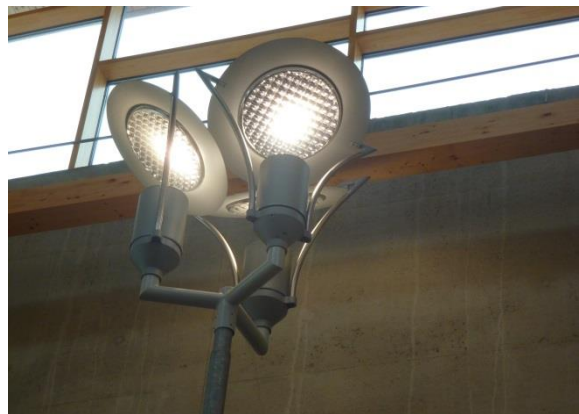
- Reception and circulation corridors benefit from daylight through atrium windows and main and rear entrance areas on the ground floor.
- High daylight factors of above 15% have been identified close to the main entrance area which is not shaded by external louvers.

Figure 4.12 Left: Atrium/reception area | Right: Upright luminaires in the reception area and atrium windows.

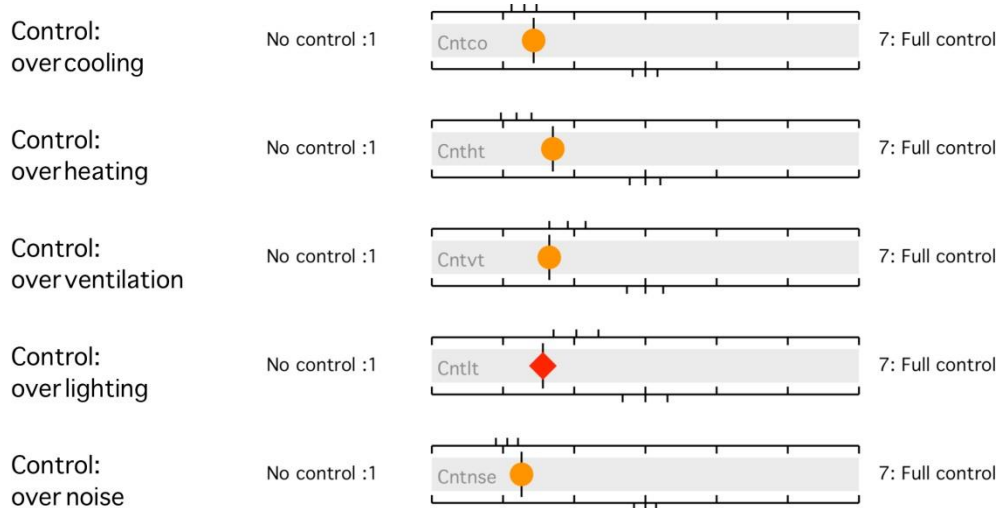
Figure 4.17 BUS responses: control

Figure 4.17 illustrates the findings from the BUS questionnaire regarding perception of control. Overall there is little sense of control for the occupants over the local work environment which is no different from the BUS benchmark apart from control over lighting which is also worse than the BUS benchmark.

- Locally, heating is controlled through the individual radiator valves in all SusCon spaces, apart from the atrium where underfloor heating is installed. Though this would appear to provide sufficient control, interviews indicate otherwise; there are only two radiators on either side of the office; ‘as a result one side is boiling hot and the other is freezing.’ Therefore some occupants use portable heaters, although they are aware that it will increase the energy consumption for the building.

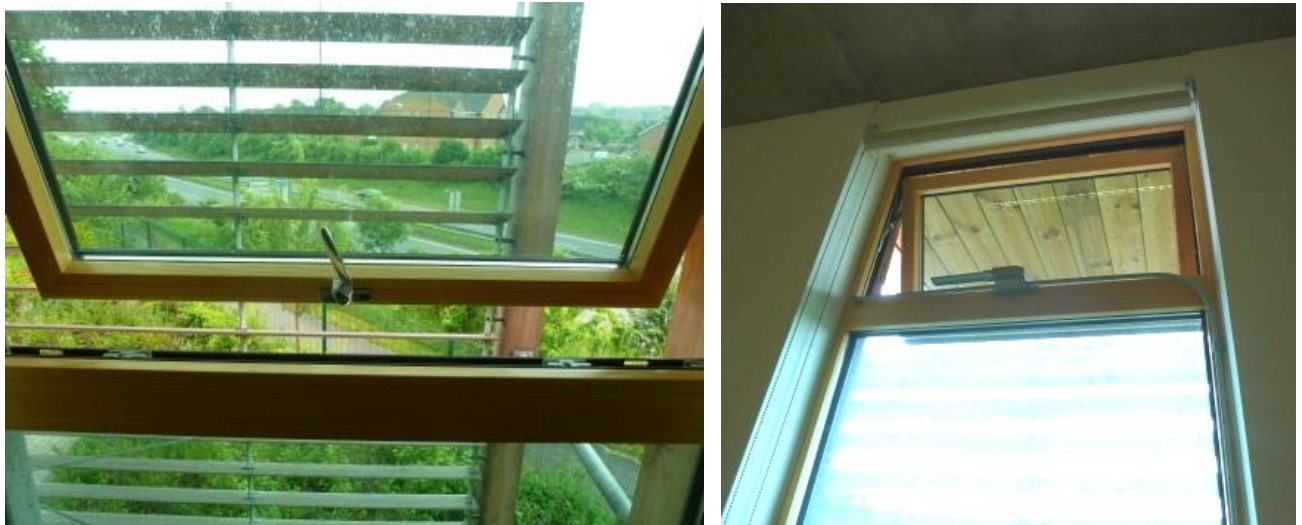
Doors to rooms are often left open for cross flow ventilation. There were no complaints of noise outside rooms (from within the building) which would hinder the use of doors in this way.

Figure 4.18 office windows in open position: left image: lower window, right image: upper window

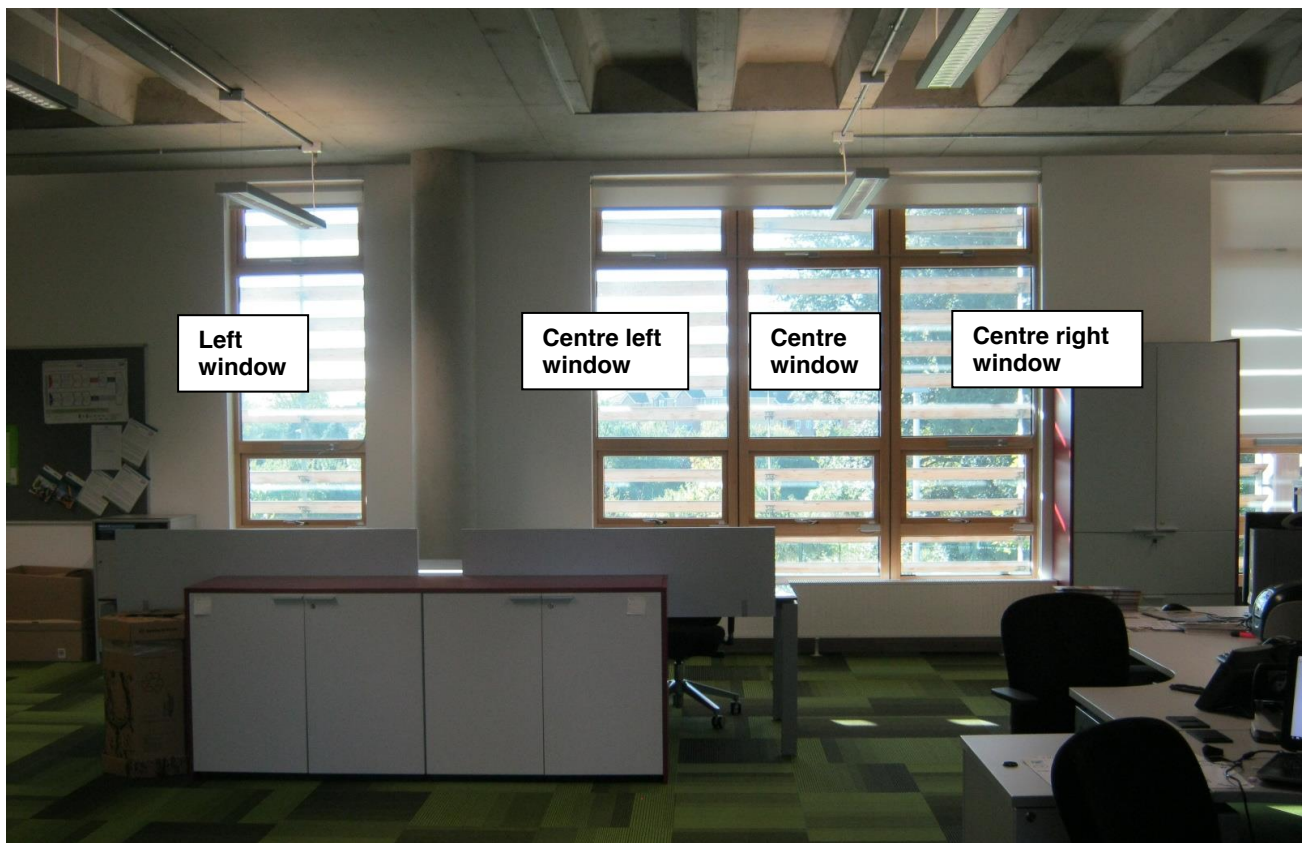
Figure 4.19 Monitored windows in the first floor office

Figure 4.19 shows the location of the monitored windows in the office on the first floor.

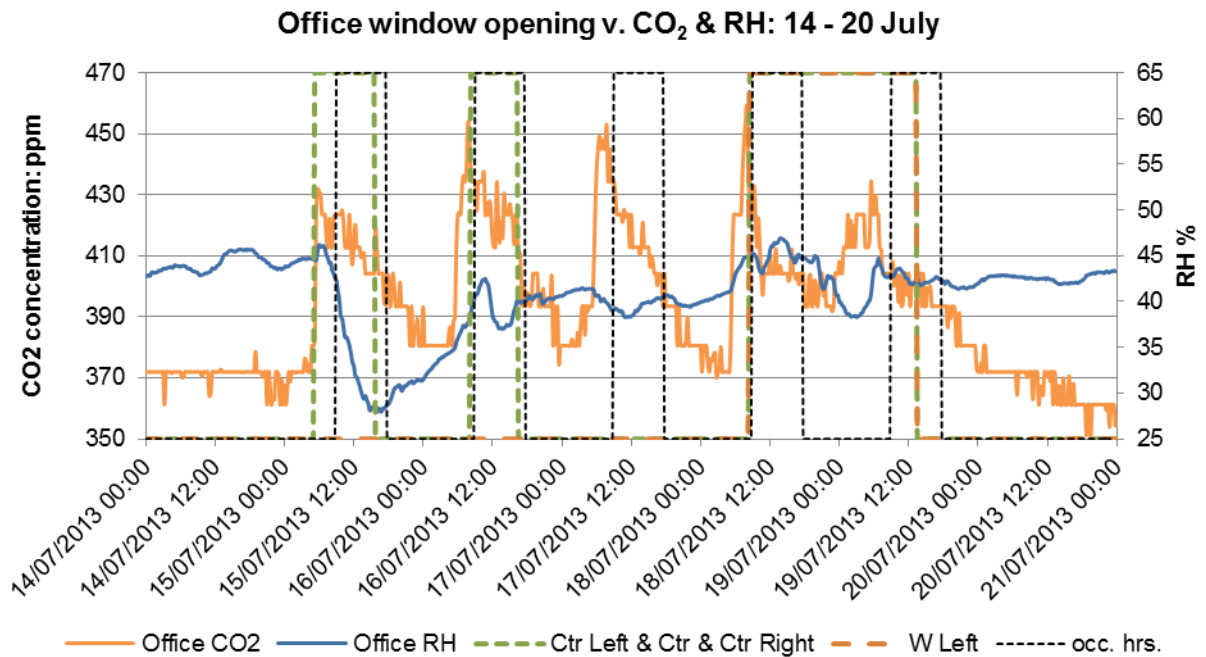
Figure 4.22 Office window, CO₂ and RH 14-20 July 2013

Figure 4.23 Office window, CO₂ and RH 21-27 July 2013

- The building could benefit from night ventilation in the summer months: over the 18th and 19th of July all four windows are left open overnight, this allows the morning of the 19th to begin at a lower temperature and rise slower throughout the day (figure 4.20). More effectively, the three centre windows are left open from the 23rd – morning of the 26th July. This allowed the office temperature to drop to 23°C the night of the 23rd and kept the daily maximum 2°C lower than the typical of 29°C even while the daily maximum external temperature for the 24th peaked above 29°C (figure 4.21).
- Unlike temperature, CO₂ concentration is kept reasonably low during this period even over the days when the windows are closed.
- BUS responses rated spaces as dry in the summer; opening windows appear to help increase RH.

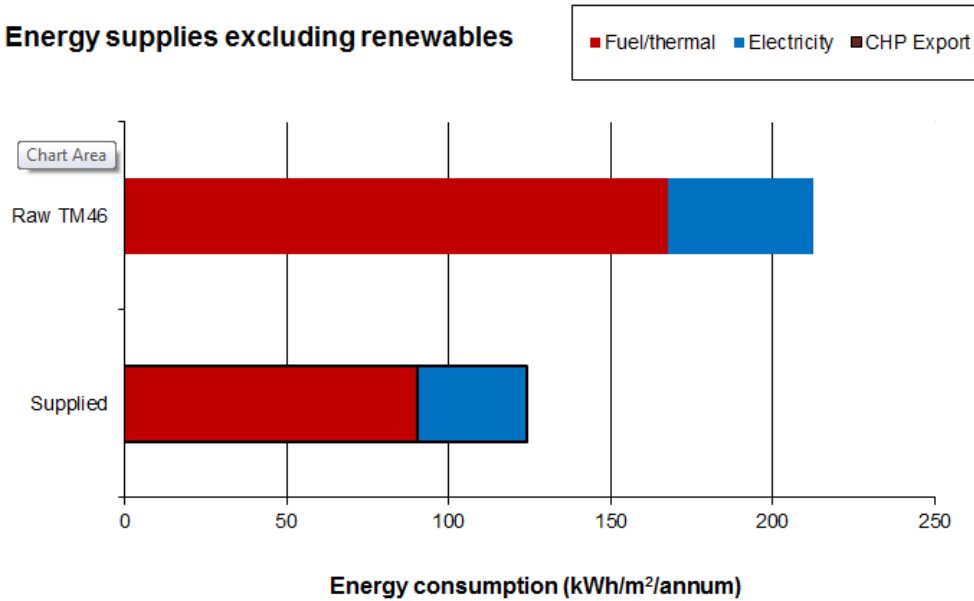
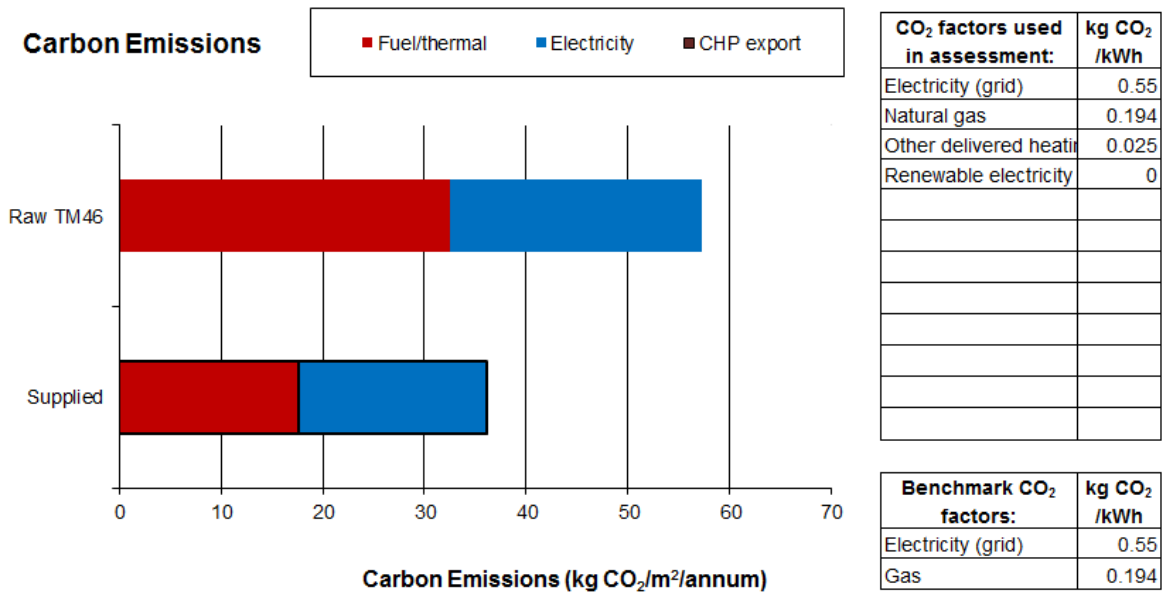
Figure 6.1 Energy supplied excluding renewables (i.e. PV)

Figure 6.2 Carbon emissions

Supplied energy use and resultant CO₂ emissions are lower than the TM46 benchmark. Natural gas supplied is far lower than the benchmark as compared to the difference in electricity supplied; electricity supplied is extremely close but still below the benchmark. Overall the SusCon Academy is supplied energy that equates to 63% of the CO₂ emissions of the TM46 benchmark. SusCon's annual energy consumption and carbon dioxide emissions are shown in table 6.2.

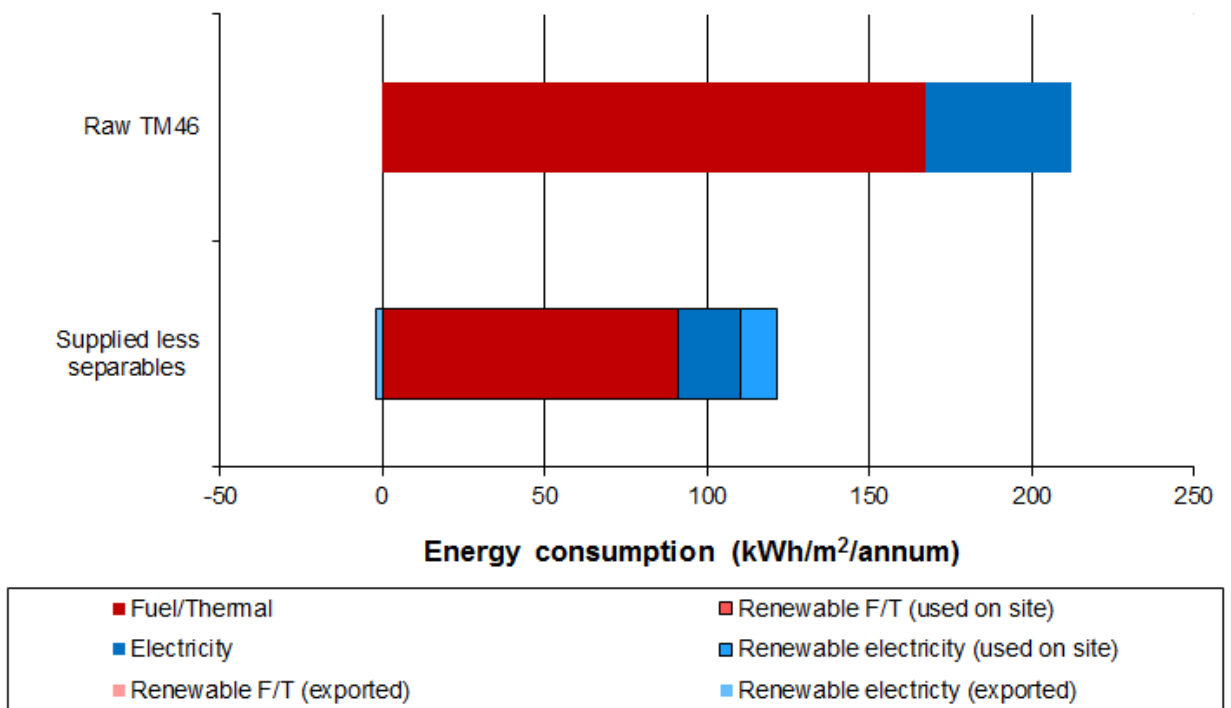
Figure 6.3 Energy supplied excluding renewables

Figure 6.4 Carbon emissions

Predicted regulated emissions from the building were 9.4kgCO₂/m²/year. This represents an annual saving of 55tCO₂ (70%) compared to a Building Regulation Compliant benchmark and 124tCO₂ (84%) compared to an existing building (pre 1995). This aligned the project with the UK Government 2050 target of an 80% reduction in national CO₂ emissions compared with 1990 levels. However, the supplied (actual) CO₂ emissions rate is found to be nearly four times worse (table 6.3) than the building emissions rate (BER) (design aspiration) despite the fact that the building is reported to have been under-used. To be considered:

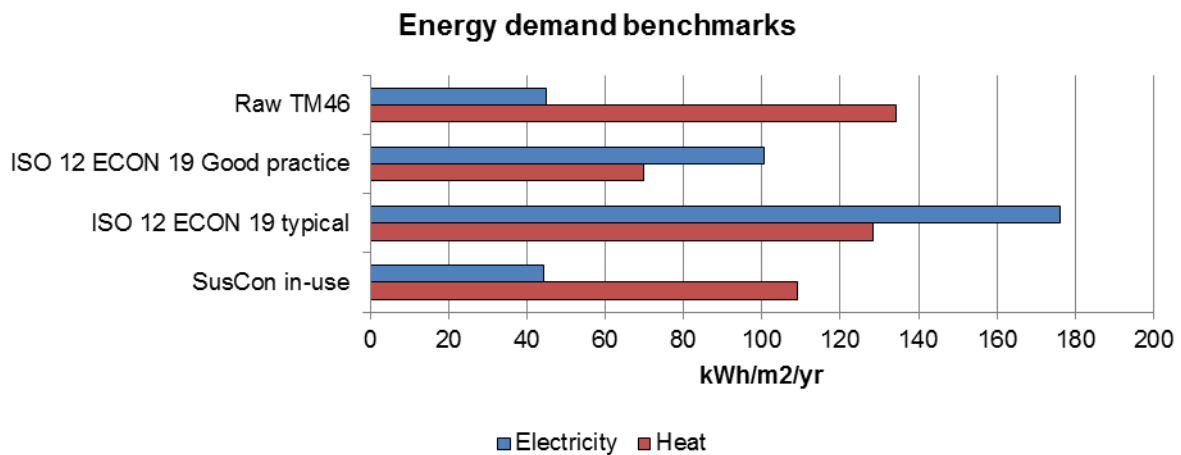
- SusCon heating fuel demand in kWh/m²/yr is above ISO 12 ECON 19 Good Practice.
- Overall whole building CO₂ emissions for SusCon is better than all benchmarks including three Carbonbuzz sampled university buildings.

Figure 6.6 Energy demand benchmarks. *Note: ISO 12 ECON benchmarks are for type 2 office.*

Figure 6.7 Whole building CO₂ emissions benchmarks. *Note: ISO 12 ECON benchmarks are for type 2 office.*

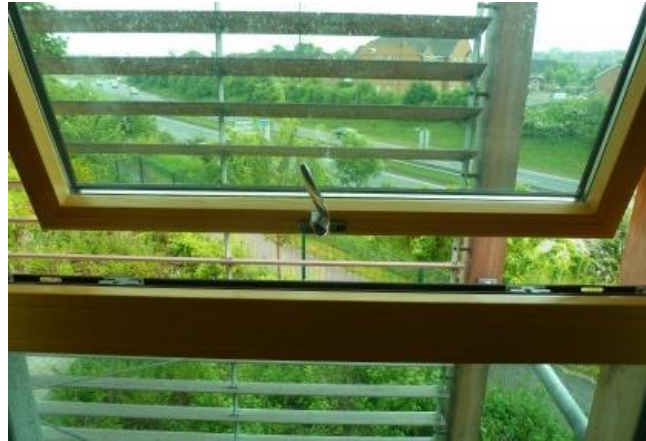
- Manual windows only open to a maximum of 6-8 inches (figure 7.1). There is no degree of fine control and it is doubtful that the windows provide the occupants with an adequate sense of control over ventilation.

Figure 7.1 operable window – limited opening distance

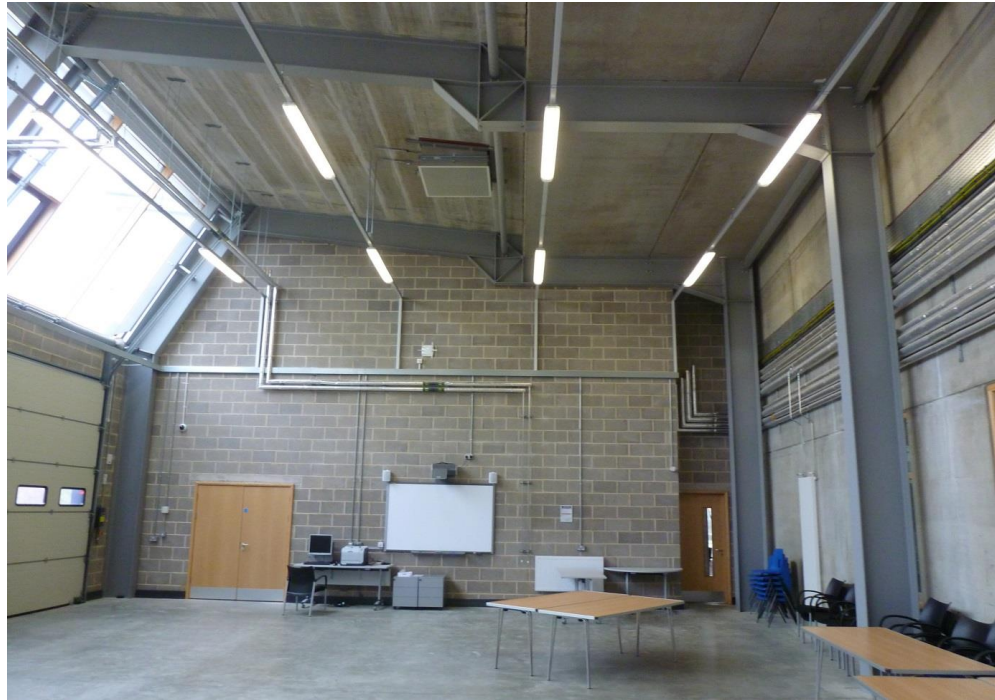
- Suspended ceiling luminaires in workshop areas are switched on and off via remote controls available to the facilities manager and reception staff. The lighting is also on occupancy sensor. The workshops receive a large amount of daylight given the large high windows (figure 7.2). To add to this, when weather permits, the garage doors could be opened to allow more daylight into the space further negating the need for electrical lighting. *Setting lighting in workshop areas on daylight sensors could help reduce the use of electrical lighting in workshops.*

Figure 7.2 ground floor workshop

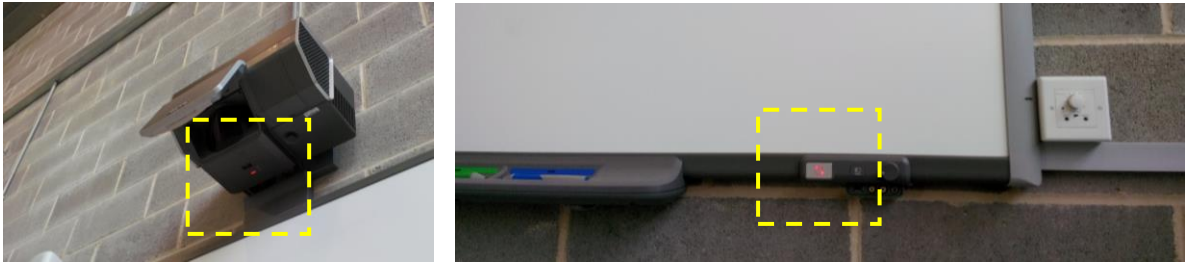
- In most meeting/teaching rooms (including the workshops) equipment was found to be left on, including computers, projection system (one instance) and audio systems. In almost every room all equipment is left on standby (at least); wall switches were in the *on* position. Figure 7.4 shows the projection system is on standby in the workshop though not used the day of the visit.

Figure 7.4 ground floor workshop projection board on standby

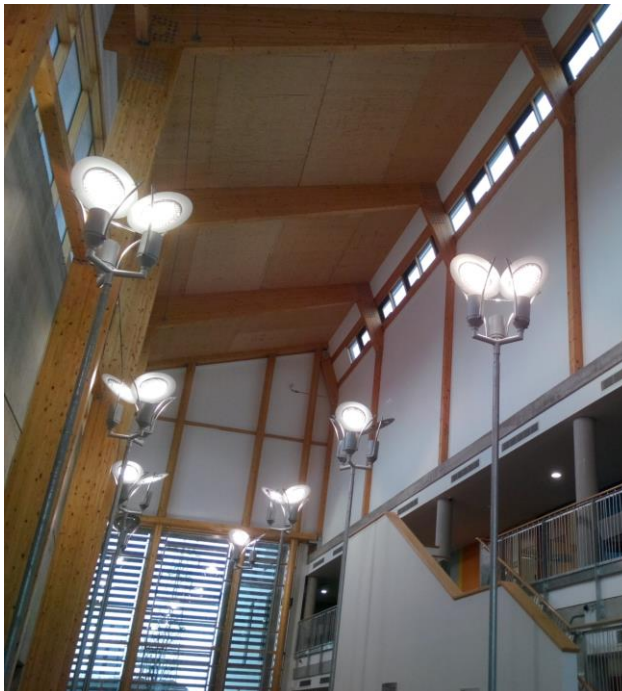
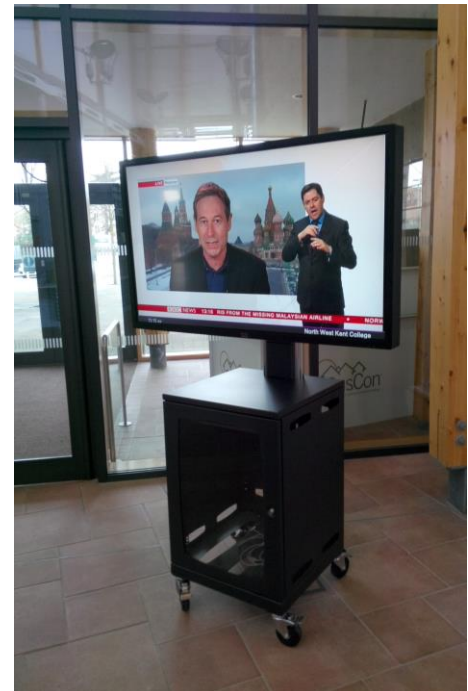
- Atrium lights on when daylight is sufficient for the space (figure 7.5). *500W per post x 10 posts.*
- Television on in atrium – questionable use of energy even if the atrium space was heavily occupied which it is often not (figure 7.6).

Figure 7.5 & 7.6 Atrium lighting and atrium television

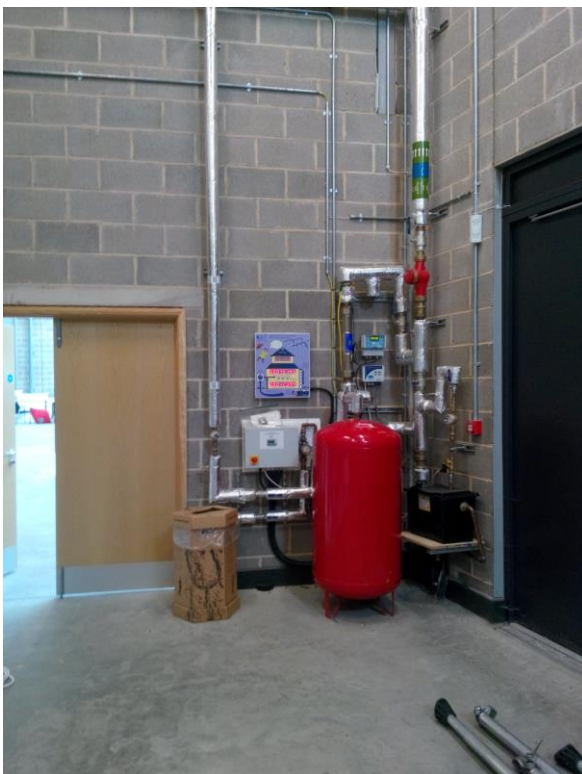
- The rainwater harvesting system is located in the workshop store. The system and controls are located in a relatively open area with easy access. However, the rainwater harvesting display is not in a public space where it is intended. The rainwater harvesting display is located with the rainwater harvesting system in the store between the two workshops on the ground floor (figure 7.7). This is currently out of view for occupants, where the purpose of the display is to educate and raise awareness. Furthermore, for the reason that the display is out of public sight, the display is not updated to indicate the correct values, i.e. the daily use value matches the total all time value (figure 7.8). Because the display is not being used as per its purpose it is wasting energy (however small that may be).

Figure 7.7 & 7.8 rainwater harvesting system and display located in the ground floor workshop store.

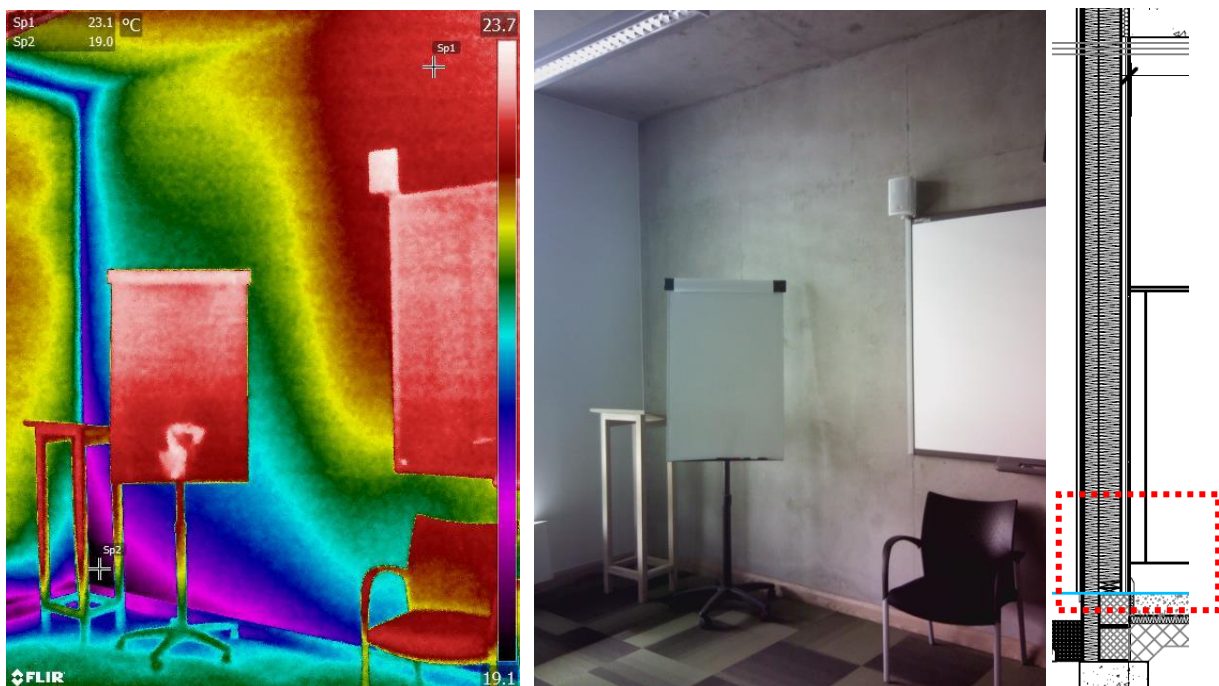
Figure 7.11 Entry façade of SusCon (northwest facing). Signs of potential heat loss under the overhang of the gable and the corner of the building where the atrium space meets the corridor on the second floor; ~3-4°C difference between these hot spots (Sp1) and a point further down the wall (Sp2).

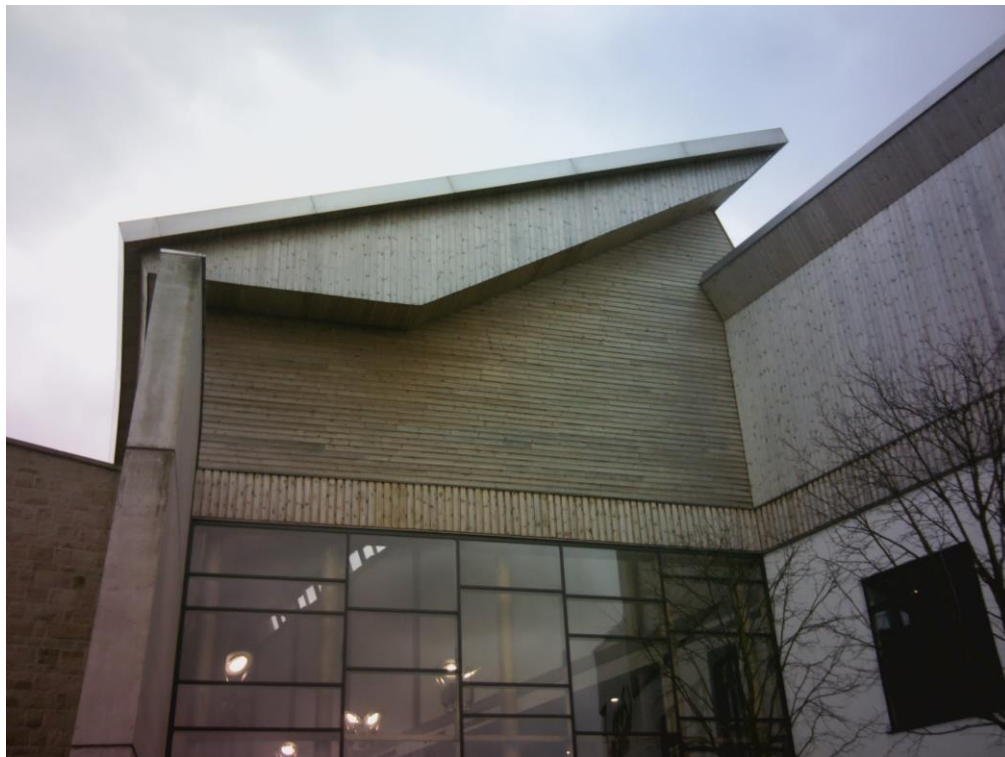
Figure 7.12 West facing corner outside the Linden Room (right of the stairs). Signs of potential heat loss under the overhang of the gable and above the windows; $\sim 2^{\circ}\text{C}$ difference between these hot spots (Sp2 and Sp3) and a point further down the wall (Sp1).
