Thames Valley Houses

Innovate UK project number	450096
Project author	Low Carbon Building Group, Oxford Brookes University, for Thames Valley Housing Association.
Report date	2014
InnovateUK Evaluator	N/A

No of dwellings	Location	Type	Constructed
2 dwellings	Feltham, Middlesex	House 1: 128 m ² 4-bed, mid-terrace House 2: 146 m ² 5-bed, detached	2012
Area	Construction form	Space heating target	Certification level
128 m ² and 146 m ²	Timber frame	N/A (has a SAP analysis)	CSH Level 4

A two-year in-use BPE study of two social housing dwellings. The social housing scheme of 10 council houses was built to *Code for Sustainable Homes* Level 4, with an average 'as designed' dwelling Target Emission Rate (TER) of 9.01 kgCO₂/m² per annum. All dwellings have mechanical ventilation with heat recovery (MVHR) systems with summer bypass mode and thermal sensors. Gas condensing-boilers supply energy for heating and hot water. Electricity is generated by solar PV. The research covered user behaviour in relation to an innovative combination of passive low energy features, the usability and effectiveness of the micro-generation solutions and key control elements and an investigation of the constru

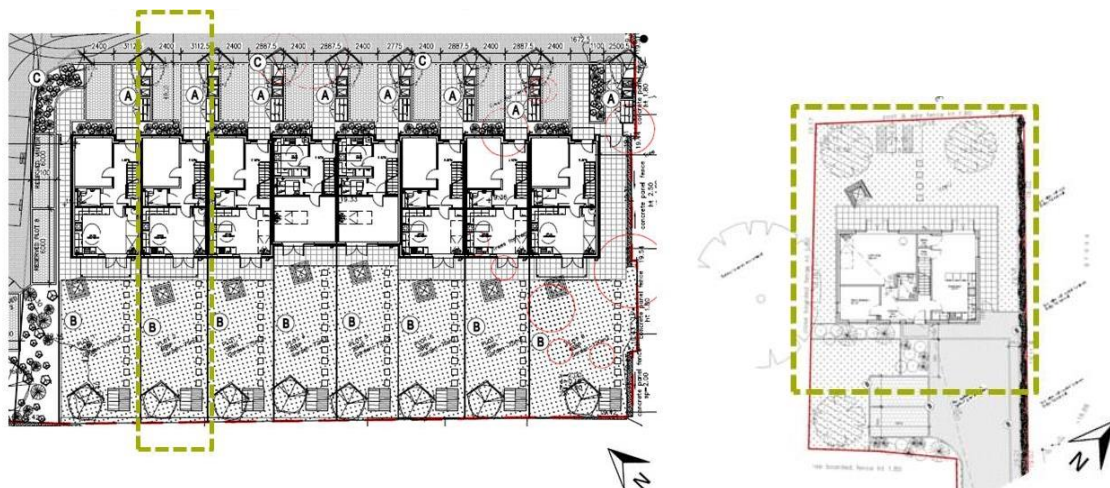
Figure 1 Thames Valley development, plan and elevations. (Left) House 1. (Right) House 2.

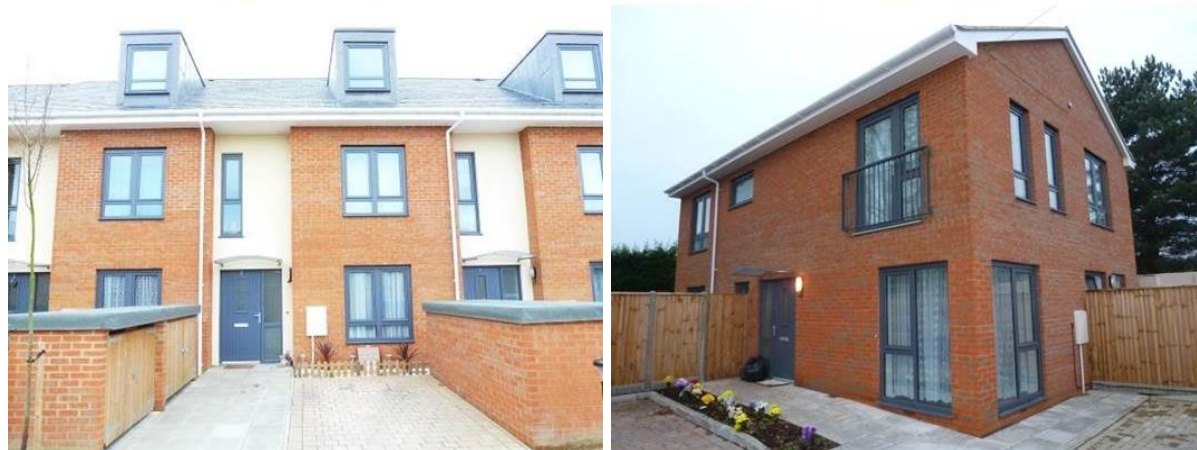
Figure 2 (Left) House 1 front elevation (North East). (Right) House 2 front elevation (South East).

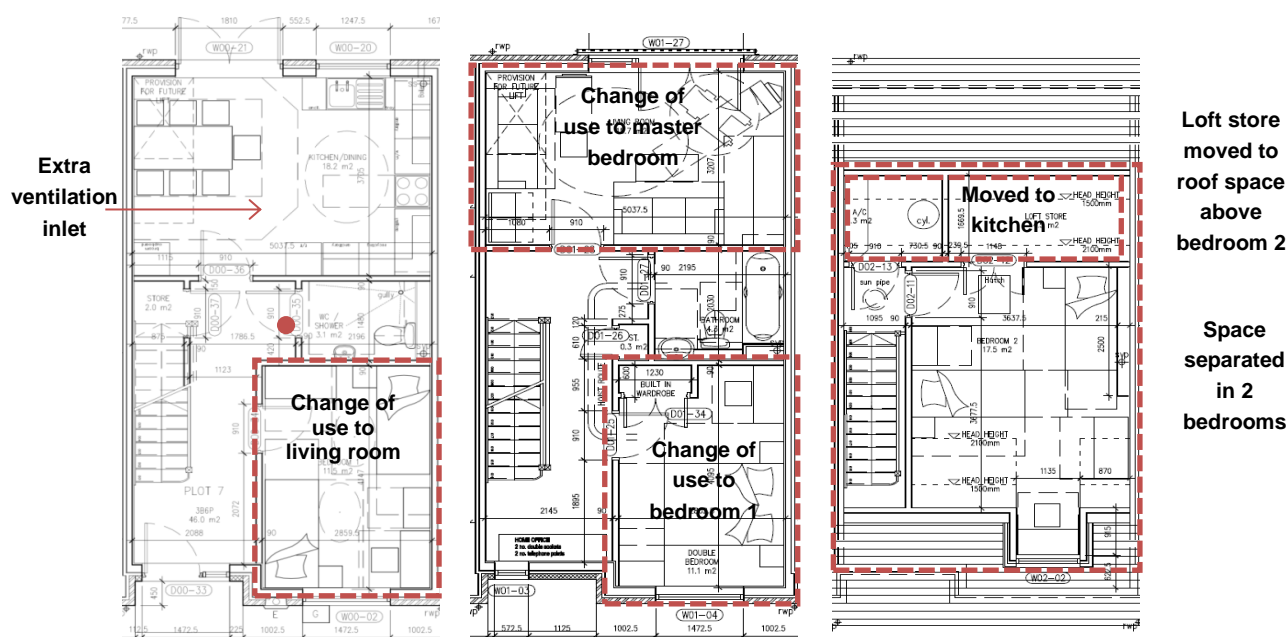
- Several changes of use in ground floor, first floor and second floor spaces were noted (Figure 4) due to family house requirements.
- In particular the living room is located on the ground floor next to the main entrance, whereas the design drawings show it to be on the first floor of the house where the master bedroom is now located.

Figure 4 House 1 ground floor, first floor and second floor plans. Spaces where minor deviations were identified are marked in red frames.

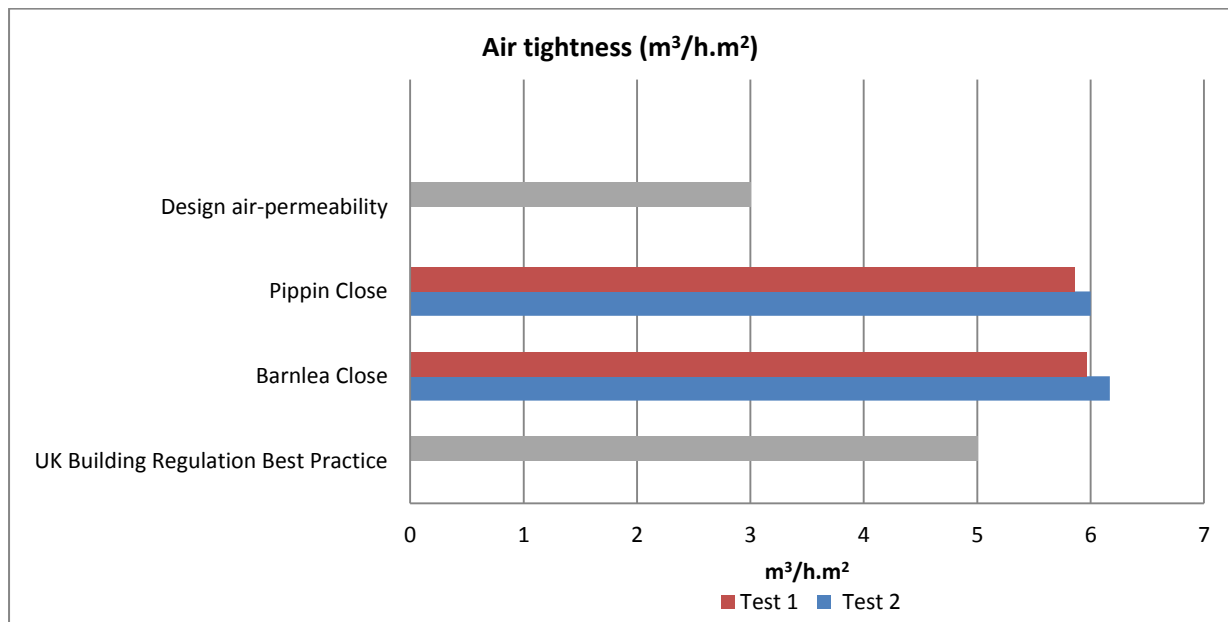
The measured average air-permeability rate of both dwellings when tested using the method contained in ATTMA standard TS1 failed to meet the initial design criteria of $3\text{m}^3/(\text{h.m}^2)$ and was found to be around $6\text{m}^3/\text{h.m}^2$ for both houses. However, they were both significantly less than the national building standard of $10\text{m}^3/(\text{h.m}^2)$ (Table 8)(Figure 6). The gap between designed and actual air tightness in the houses is one of the key parameters leading to the discrepancy between the 'as designed' and 'as built' SAP discussed in the previous chapter.

Figure 6 Comparison of target and measured air permeability rates

Comparison between the two tests reveals that the air-tightness levels of both houses have slightly fallen during the monitoring period. This is likely to be a result of fabric deterioration and appears to be quite a common phenomenon.

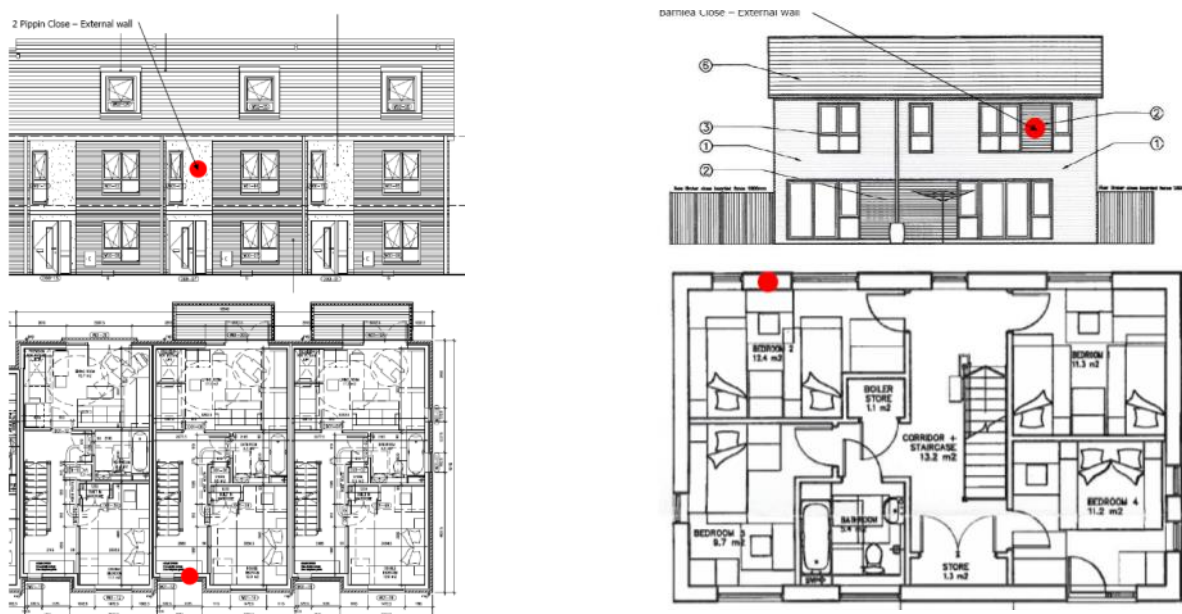
Heat flux measurements were taken at 1 minute logging intervals. The Hukseflux sensors were positioned on the construction elements using custom built sprung clamps that allowed free flow of air around the sensor (Figure 7). A proprietary thermal compound was used to ensure good thermal contact.

Figure 7 Location of heat flux meters in House 1 (Left) and House 2 (Right)

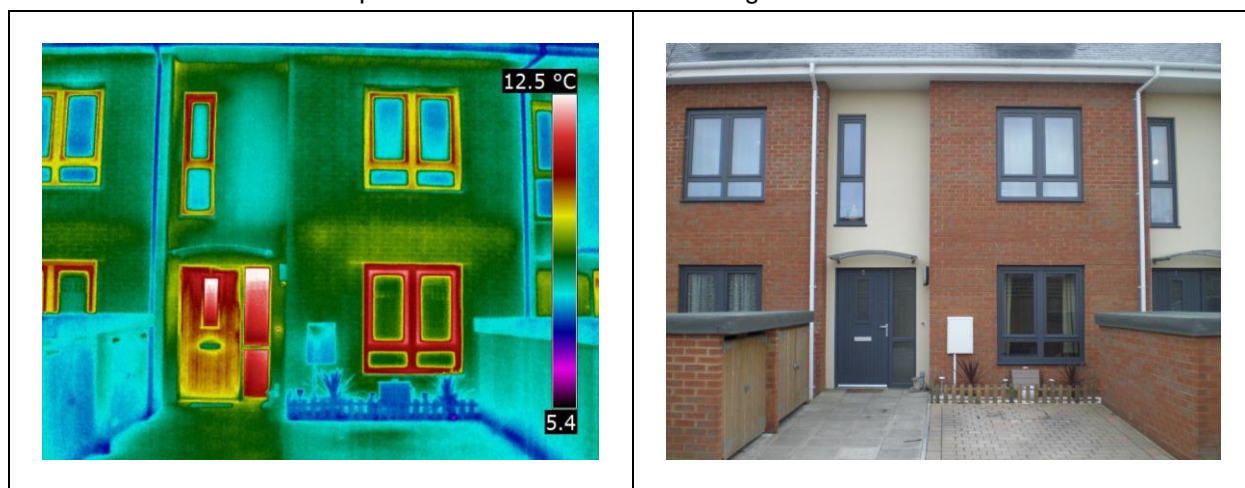
No significant thermal anomalies were observed on the external walls (Figure 8). This is in accordance with the findings of the in situ U-value tests. However, several cold spots and thermal bridges were identified on the top floor ceiling and across thresholds, as a result of floor and ceiling detailing. Lack of drawings specifically showing the light tube detail as well as poorly fitted loft insulation have resulted in the cold spots shown in Figures 10 and 11. The steel beams of the roof construction were not fully insulated, as shown in Figure 12, thus creating the thermal bridge identified in Figure 11 and other areas of the house. The lower temperatures in the bedroom walls, shown in Figure 13, result from air movement in the unheated space behind the wall shown in Figure 14.

Figure 8 (Left) Front elevation thermogram. Note: There are no significant thermal abnormalities evident in the walls due to thermal bridging, but there are signs of a temperature difference above the lower lounge windows which stops at the next floor level. The elevated temperature of the window surrounds and the front door are likely to be due to the change in material and are unlikely to be indicative of heat transfer anomalies. **(Right) Front elevation digital photograph.**

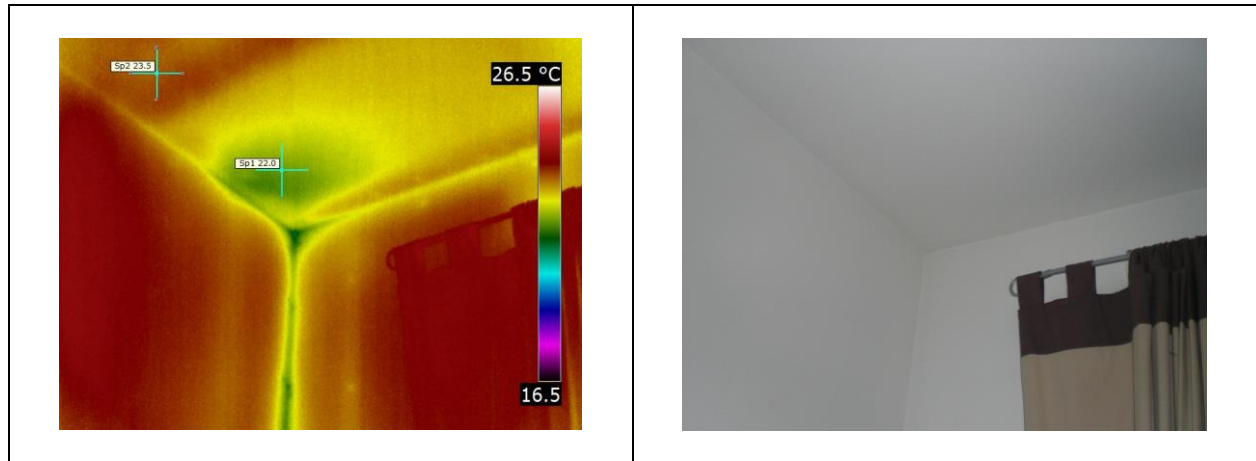
Figure 9 (Left) Living room left window thermogram. Note: Area of reduced temperature on ceiling is likely to be due to external air infiltration into the structure and possibly related to area of temperature difference identified in Figure 8. (Right) Living room left window digital photograph.

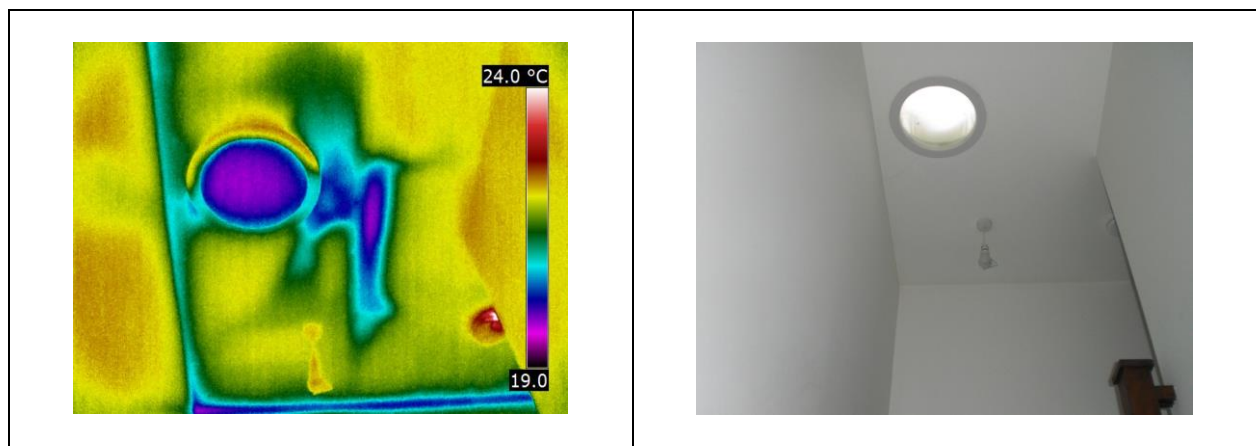
Figure 10 (Left) Top floor landing light tube thermogram. Note: Area of reduced temperature to right of light tube is likely to be due to poor insulation in the roof space. (Right) Top floor landing light tube digital photograph.

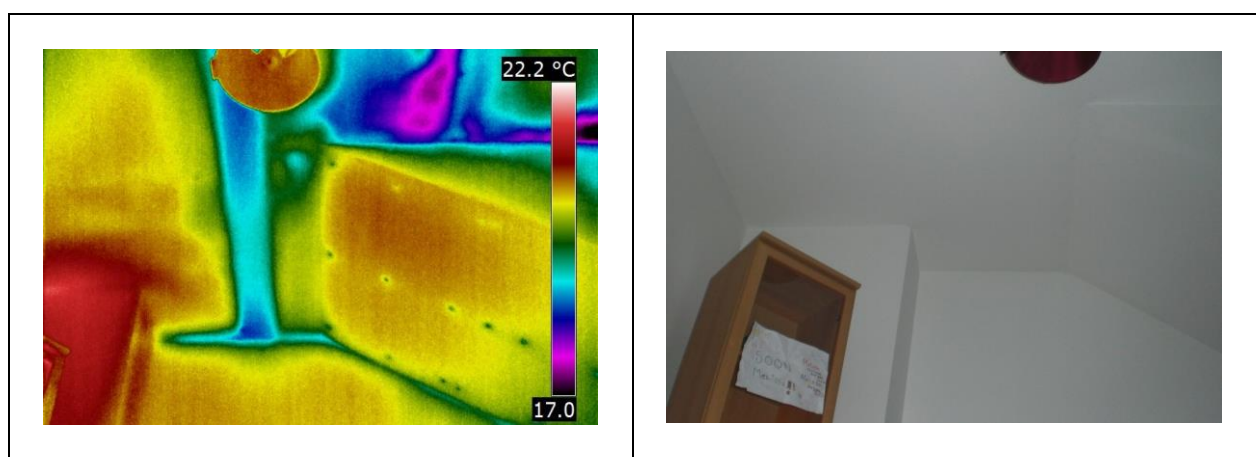
Figure 11 (Left) Top floor front bedroom ceiling thermogram. Note: The vertical area of reduced temperature is typical of a steel beam in the roof structure that has not been insulated. Similar findings also identified in other areas. The area of reduced temperature to right of light fitting is likely to be due to poor insulation in the roof construction. (Right) Top floor front bedroom ceiling digital photograph.

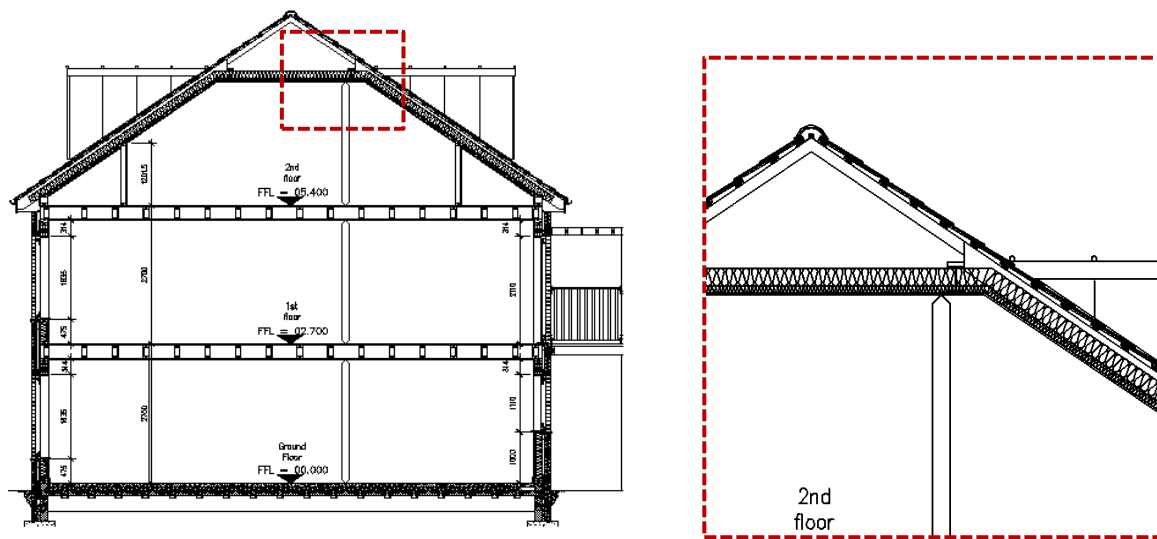
Figure 12 Section and roof detail showing that the top of the steel beam in the roof structure is not insulated creating the thermal bridge shown in Figure 11.

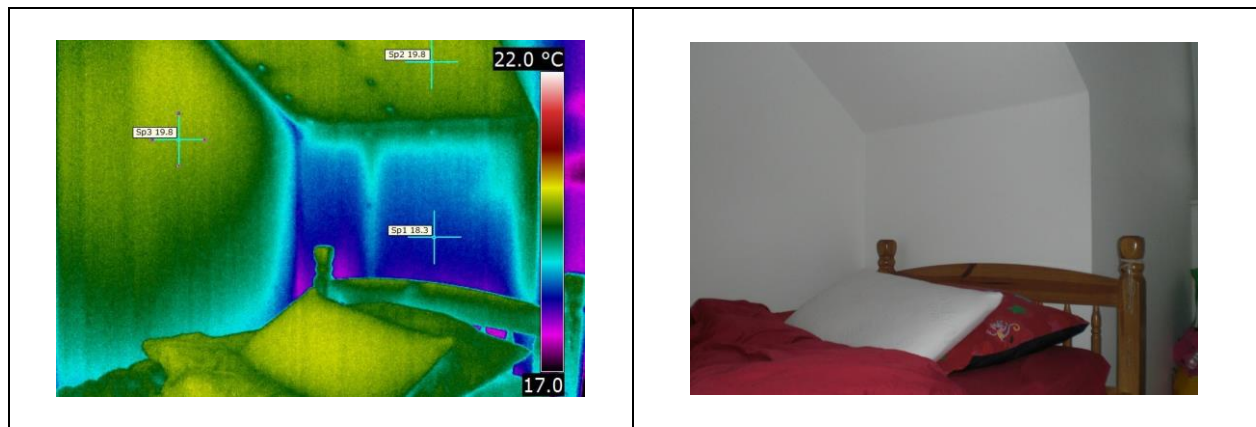
Figure 13 (Left) Top floor front bedroom wall thermogram. Note: Area of reduced temperature behind bed is likely to be due to poor fitting of insulation within the wall / ceiling construction. A similar finding was also identified in other top floor walls. (Right) Top floor front bedroom wall digital photograph.

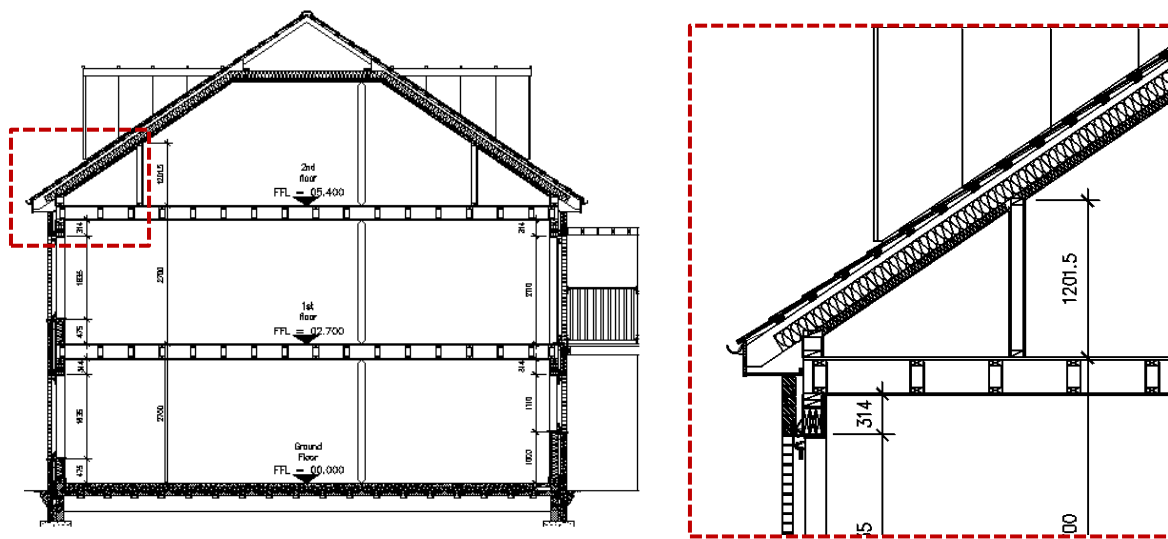
Figure 14 Section and wall detail showing unheated space behind bedroom wall.

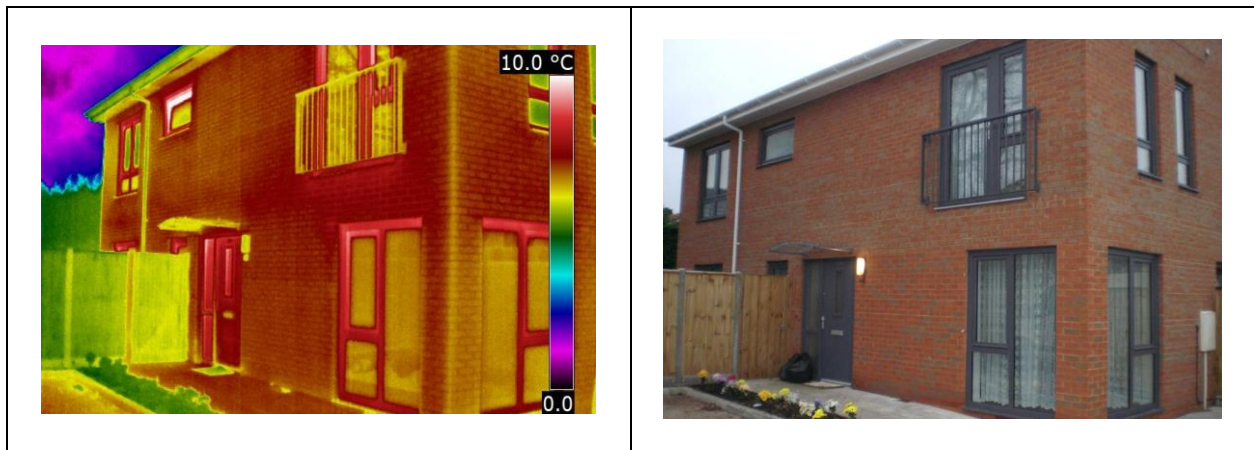
No thermal anomalies were evident on the external walls (Figure 15). However, as in House 1, thermal bridges and cold spots were identified across thresholds and top floor ceilings (Figures 16-19). These issues are mainly related to the design of floor and wall details. As shown in Figure 16, thresholds have not been designed with a thermal barrier thus forming a thermal bridge. Additionally, roof insulation detailing is not considered robust (Figure 19), resulting to the insulation not being well fitted around the edges and creating the cold spots shown in Figure 18.

Figure 15 (Left) Front elevation thermogram. Note: No thermal abnormalities are evident in the walls. The elevated temperatures of the window surrounds and the front door is likely to be due to the change in material, whilst the elevated temperatures in the upper centre bathroom window could either be due to poor fitting or simply that the window has been left open. (Right) Front elevation digital photograph.

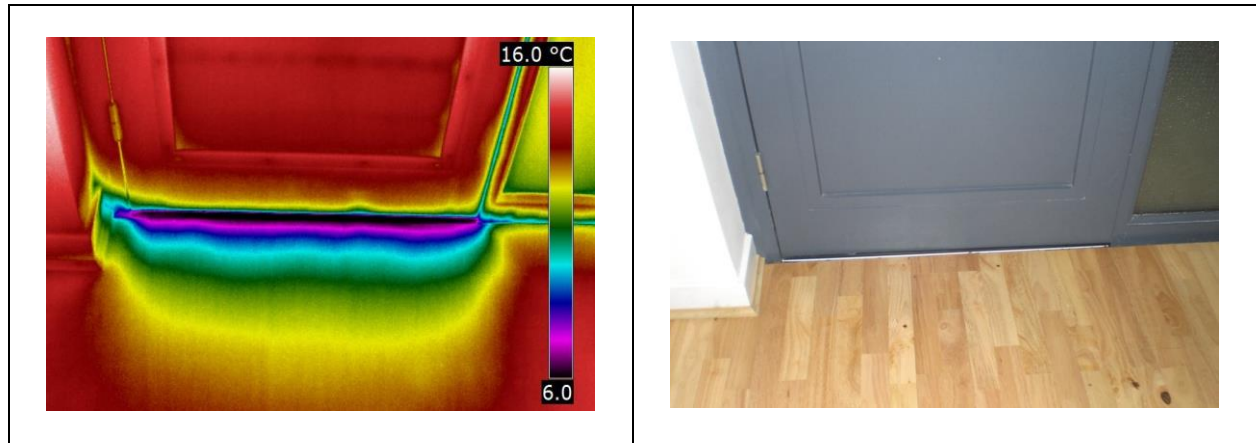
Figure 16 (Left) Front door threshold thermogram. Note: Reduced temperatures due to air ingress beneath door. At the time of the visit all the supply air inlet terminals within the dwelling on the MVHR system were closed, and all the extracts in the kitchen / bathrooms were open. This resulted in the property being depressurized in relation to the external environment and excessive levels of unheated external air entering the property through the opening. (Right) Front door threshold digital photograph.

- Thermal bridges across thresholds and ceiling beams as well as cold spots on ceilings identified in the houses are a result of poor detailing and workmanship. Images showed thermal bridging across the threshold of the front and back doors in both houses. Thermal bridges due to ceiling beams in top floors that have not been insulated were also highlighted. Additionally, areas of reduced temperature on top floor ceilings are likely to be due to poorly fitted insulation within the wall / roof construction. More robust floor and roof detailing is recommended in order to avoid similar issues in future developments.

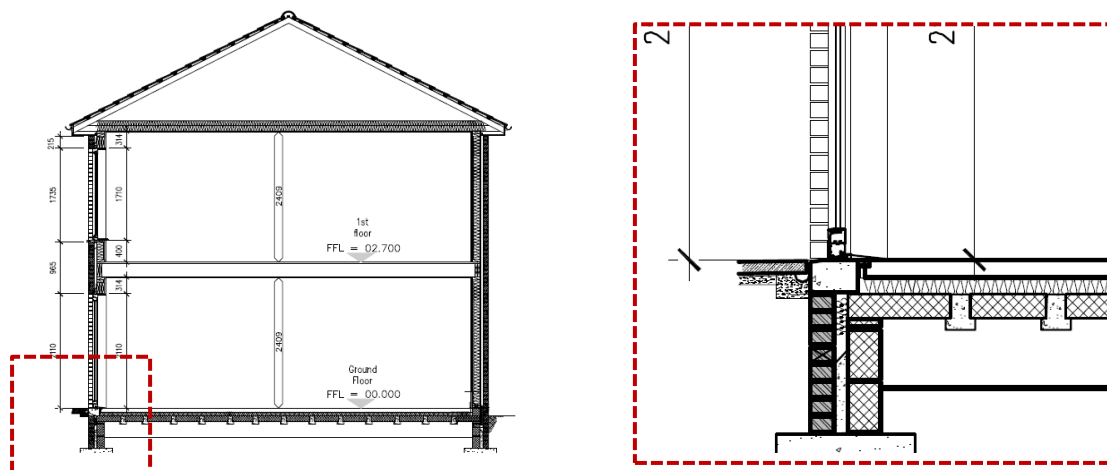
Figure 17 Section and floor detail. Door and window thresholds are not insulated and section shows no thermal barrier resulting in cold bridges as shown in Figure 16. It is recommended that threshold details are reconsidered for future developments.

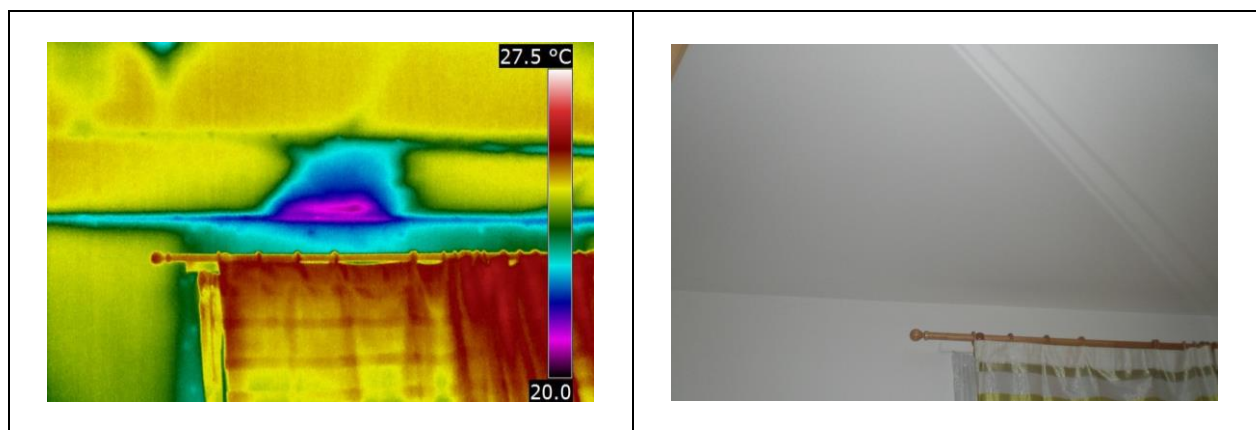
Figure 18 (Right) Bedroom 2 ceiling thermogram. Note: The area of reduced temperature on the ceiling is probably due to poorly fitted or missing loft insulation. Similar findings were also evident in bedrooms 3 and 4 around the external wall perimeter. (Left) No.2 front upper (east) digital photograph.

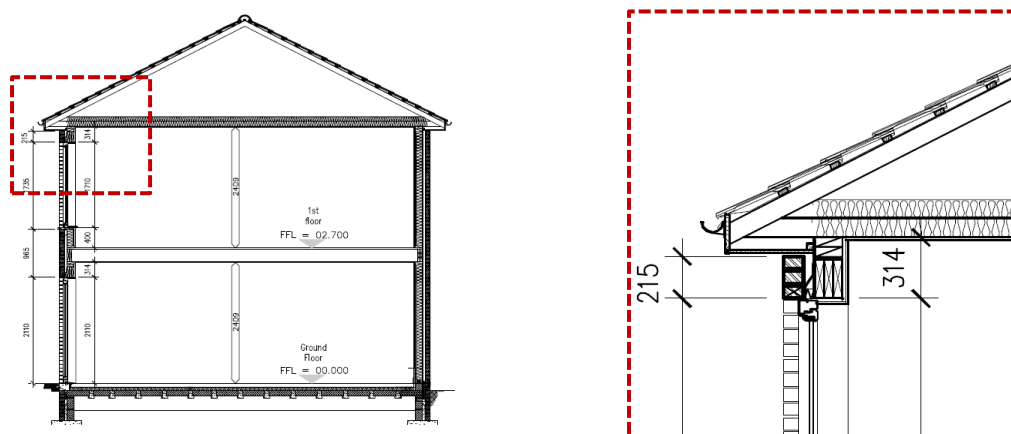
Figure 19 Section and wall-ceiling detail. Poorly fitted insulation at the corner of the roof possibly resulted in the cold spot identified in Figure 15. More robust detailing is recommended for future developments.

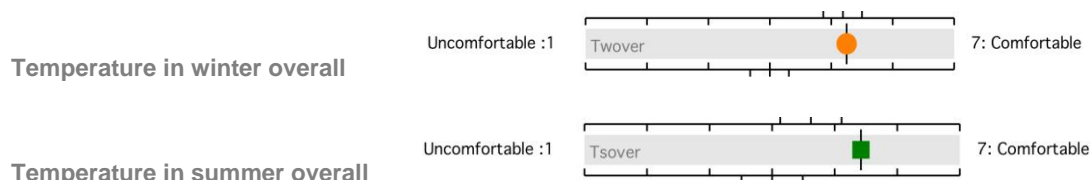
In general, the summer and winter temperature conditions are perceived as comfortable but less so in winter than summer (Figure 22). Overall winter air temperature score sits within the benchmark with 4 of the respondents finding them comfortable. Overall summer air temperatures scored higher than the benchmark with 7 of the respondents finding them quite comfortable. Comments received mention unpleasant draughts and noise from the MVHR system.

Figure 22 Temperatures in winter and summer overall

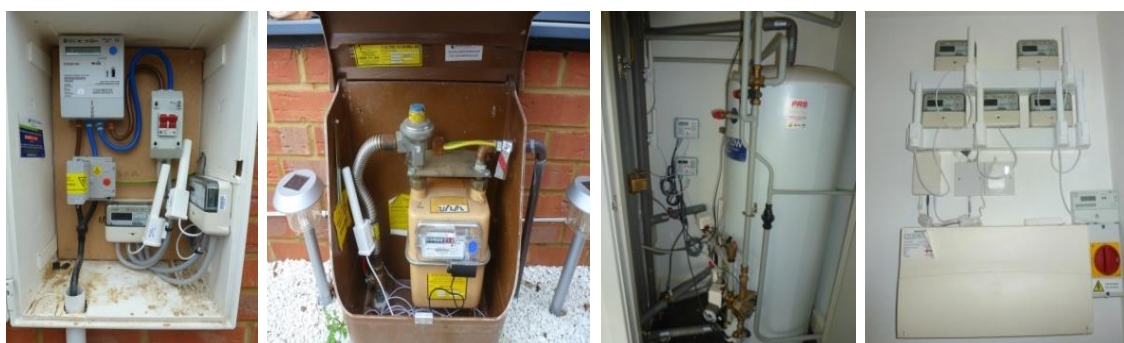
In May 2013 monitoring equipment (Figures 27, 28) was installed in both case study houses. Tables 19 and 18 list the type of monitoring equipment and the variables monitored for each house and the date at which data commenced coming through the Oxford Brookes University (OBU) web-portal without significant interruption, apart from solar radiation sensors which started transmitting to OBU on 28 June 2013.

Figure 27 Examples of energy monitoring equipment installed in properties in Feltham.

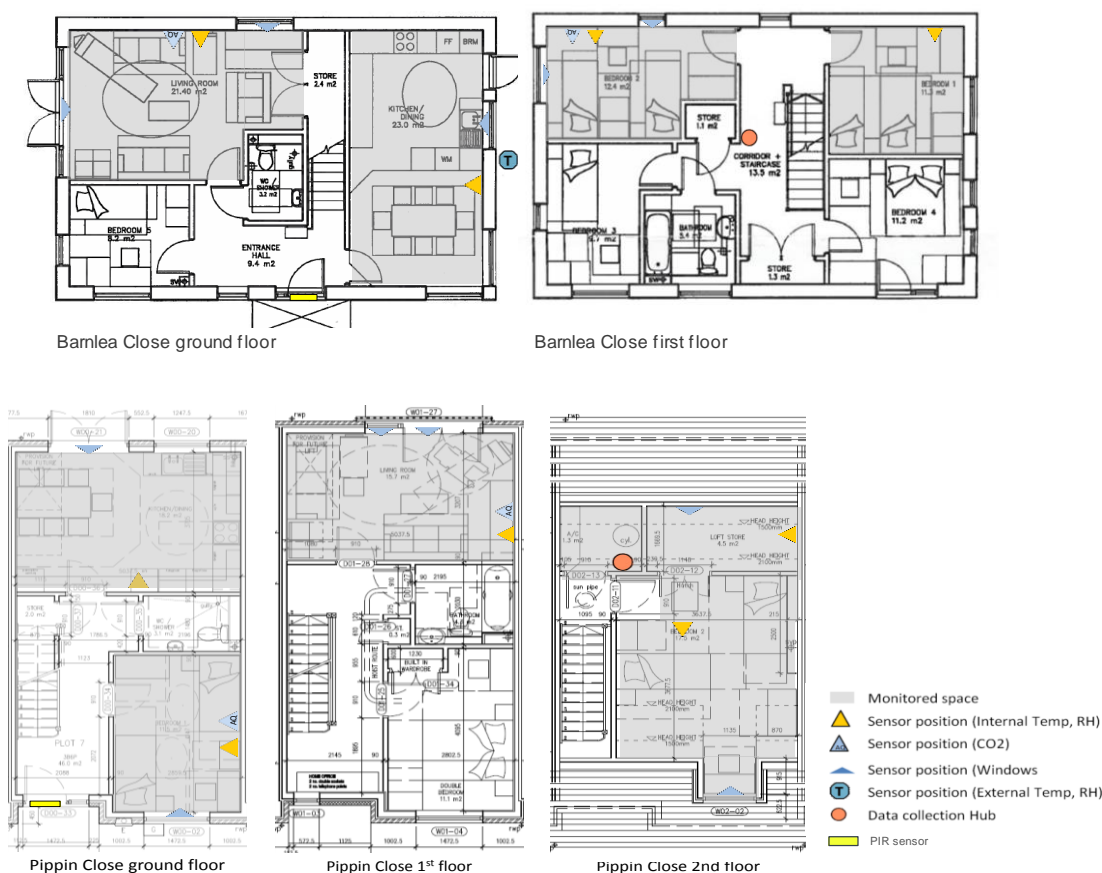
Figure 28 Environmental and occupants' behaviour monitoring: Location of equipment.

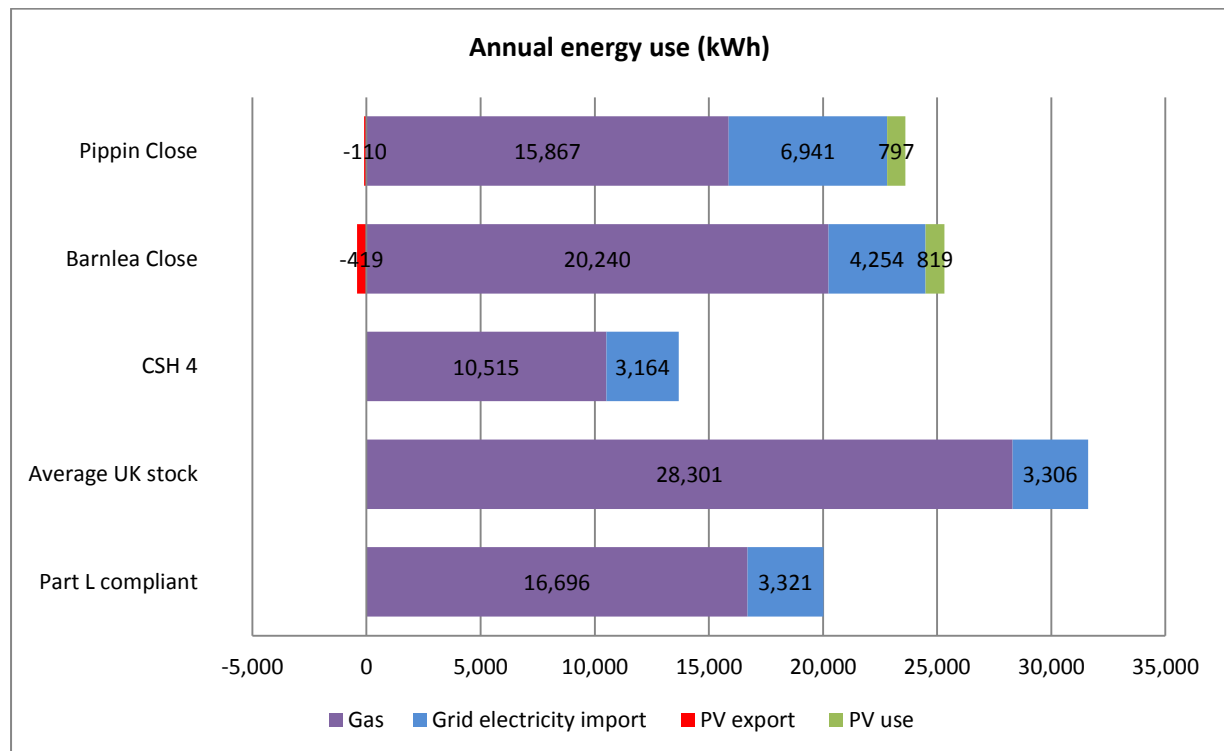
The DomEARM spreadsheet was used to compare the annual energy performance of the case study houses with current benchmarks. Actual grid electricity use in both case study houses is lower than the UK average housing but much higher than the CSH level 4 (CHS level 5 is not available in DomEARM) and Part L compliant benchmarks (Figures 29, 30). Electricity use per m² in House 1 is higher than that in House 2, whereas gas use is lower. This discrepancy between benchmarks and actual energy use is related to occupant heating patterns and appliance's schedule (See Chapter 8.5).

Figure 29 Annual energy use (kWh) from October 2013 to September 2014 and comparison with DomEarm benchmarks.

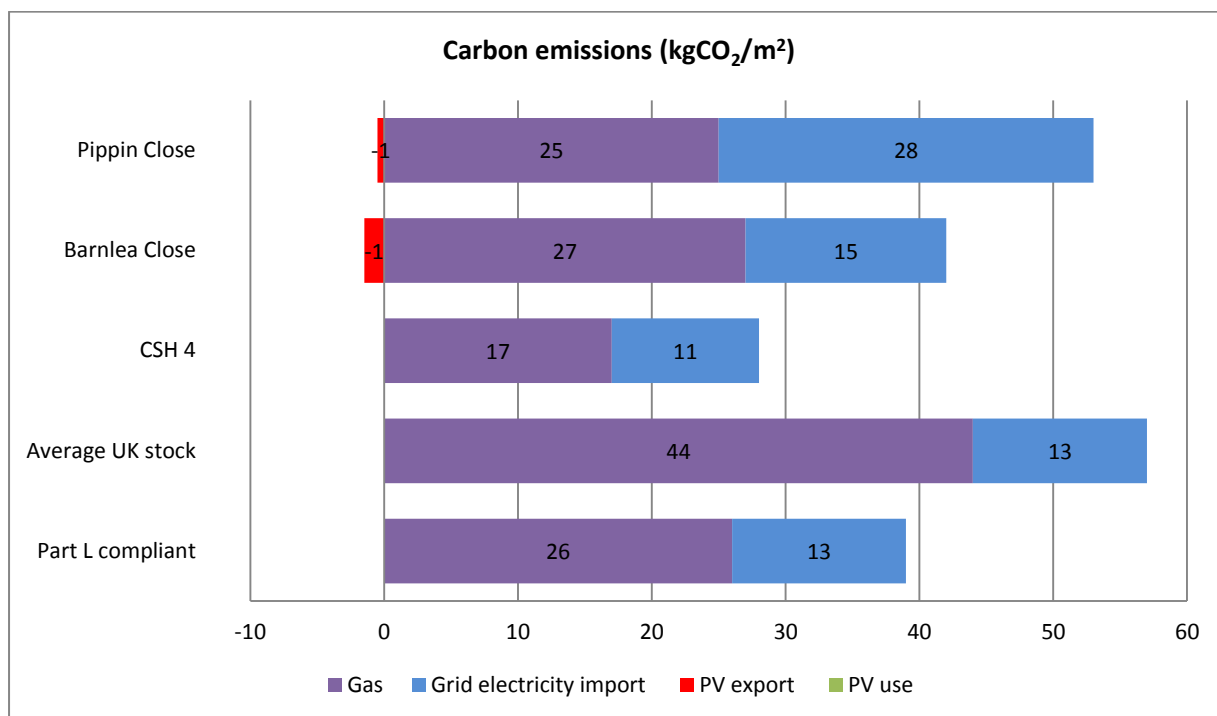
CO₂ emissions from gas use are higher than the CSH Level 4 benchmark and similar to the Part L compliant benchmark. CO₂ emissions from electricity use are higher than the average UK stock in both houses (Figure 31).

Figure 31 Annual carbon emissions from October 2013 to September 2014 and comparison with DomEarm benchmarks. Carbon emissions factors: Electricity 0.517 kgCO₂e, Gas 0.198 kgCO₂e.

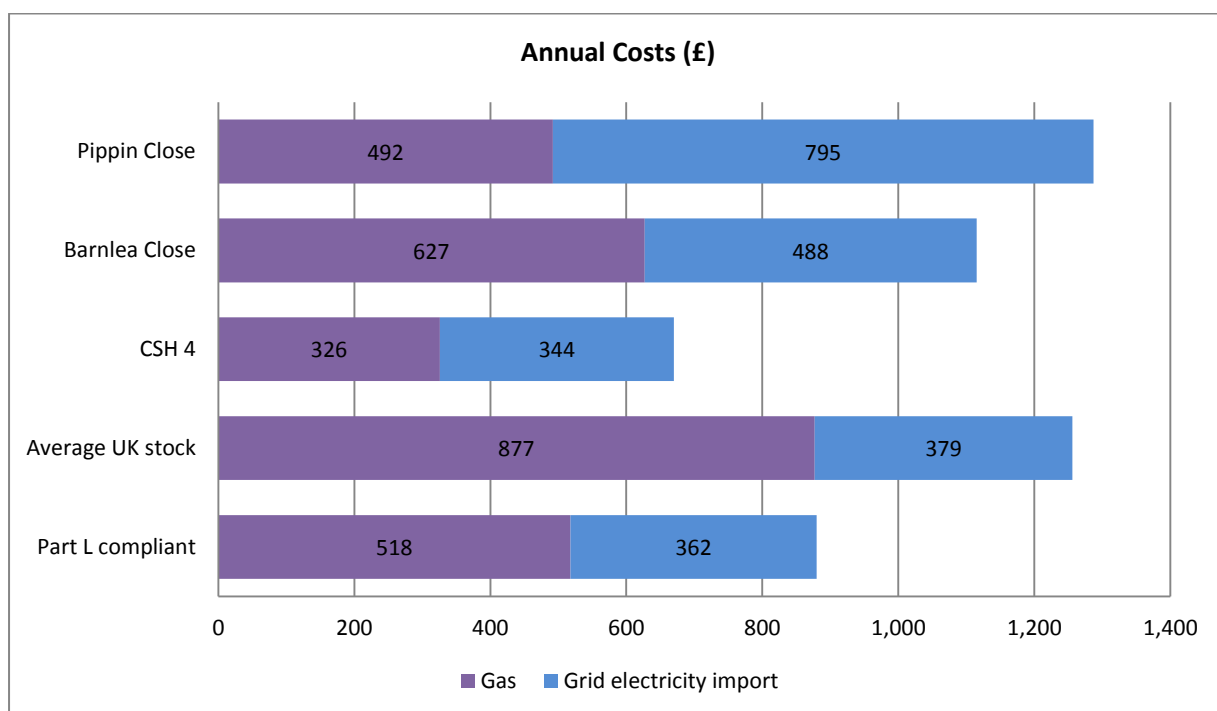
Additionally, energy costs in both houses are high and are comparable to a UK average dwelling (Figure 32). These findings indicate that the houses are not cost efficient despite being designed for CSH Level 4 and support occupant claims of electricity bills being high.

Figure 32 Annual costs from October 2013 to September 2014 and comparison with DomEarm benchmarks. Estimated price 0.11p/kWh.

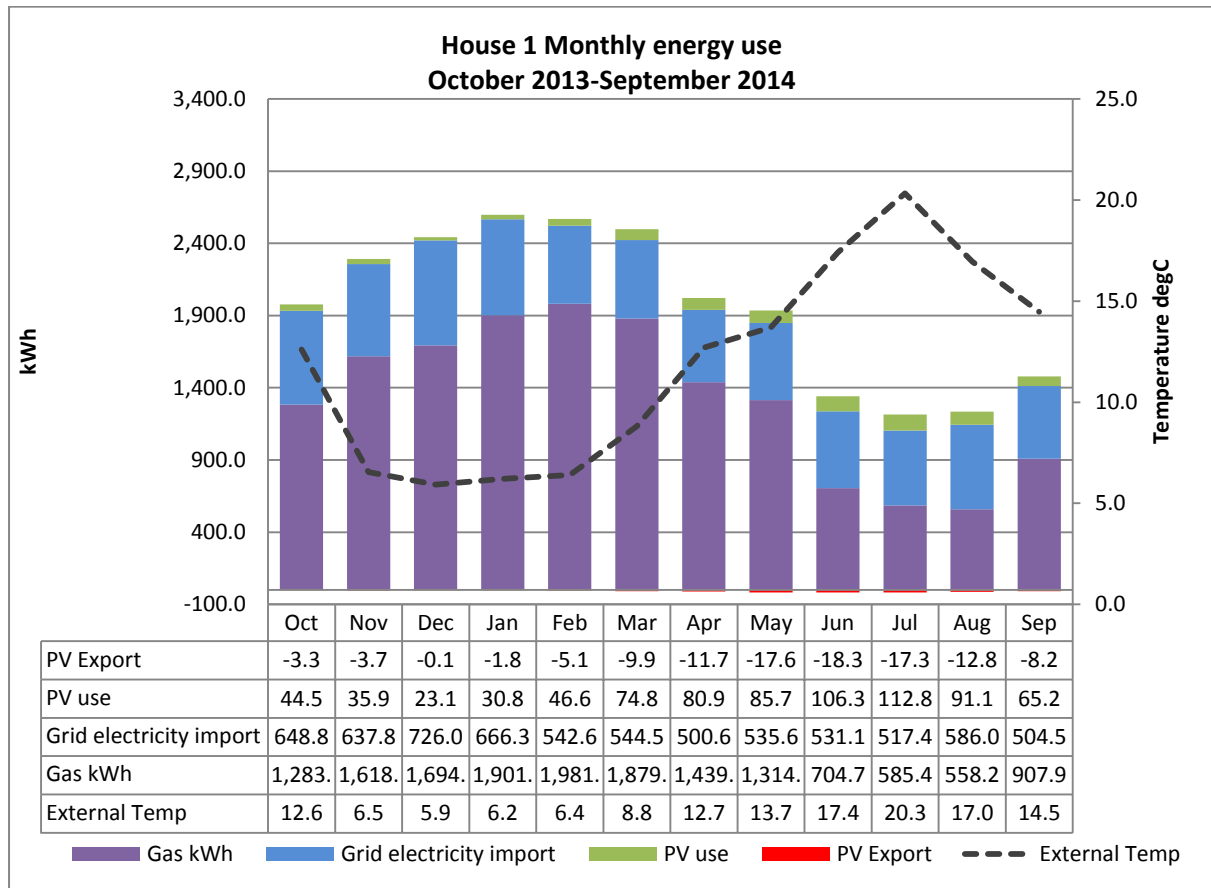
Figure 34 shows the monthly electricity use in House 1 from October 2013 to September 2014. Electricity import in June is close to 400kWh and reaches 700kWh in December. Gas consumption varies from 560kWh in August to 2000kWh in December.

Figure 34 Monthly electricity use in House 1 from October 2013 to September 2014.

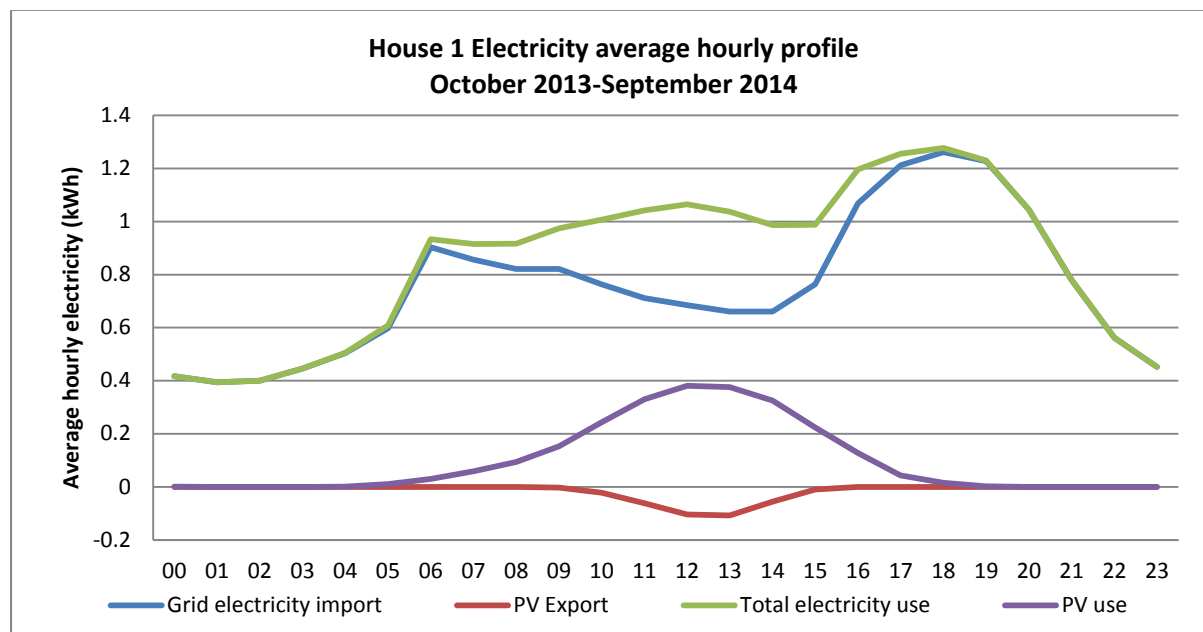
electricity is used instead. Grid electricity import peaks during the afternoon, reaching 1.2kWh at 17:00, when all the family is gathered in the house.

Figure 38 Average hourly electricity profile from October 2013 to September 2014.

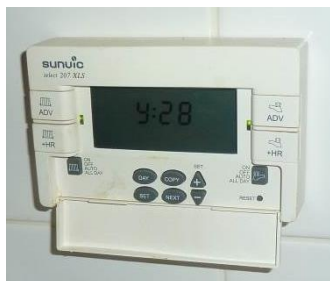
- The control offers independent control of hot water and separate central heating zones and up to three settings per day.
- There is an advance and boost facility and automatic summertime adjustment incorporated in the control.

- An override button allows occupants to manually switch on heating and/or hot water when extra heating and/or hot water is necessary. However, this has caused the heating to run constantly in one of the houses (House 2) where the occupants have set no schedule for heating. Although settings of heating have been defined by technicians that initially commissioned the control, occupants would have to read the control manual in order to change the settings.

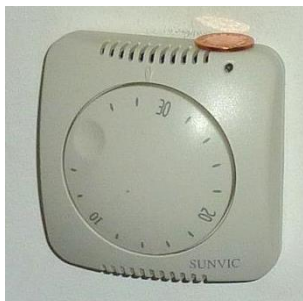
9.1.1.2 Space heating room thermostat

One room thermostat supplied by Sunvic Controls Ltd. has been installed in each property. The room thermostat in House 2 is located in the Ground floor entrance hall, while in House 1 the thermostat has been fixed on the wall next to ground floor bathroom. The commissioning review that took place in March 2013 in House 1 as part of the BPE study has revealed that the thermostat is located very close

to the ground floor bathroom's radiator. This location would cause the heating to switch off once high temperatures occur in the surrounding area and therefore insufficient heating is provided in the rest of the property. The control is satisfactorily intuitive to use, although no significant annotation indicates the purpose of the device. A good level of fine control is provided.

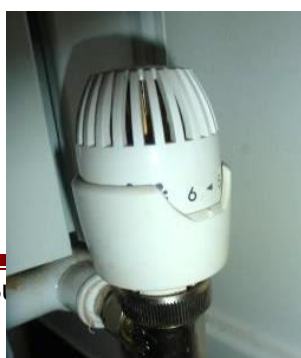
9.1.1.4 Radiator valves

Thermostatic radiator valves supplied by Drayton are fitted on each radiator. Occupants are familiar with this type of heating control. The thermostatic radiator valves provide intuitive switching, ease of use and good degree of fine control (scale 1 to 6). Accessibility is rated as neutral since the radiator valves are located on low level close to floor and are occasionally obstructed by furniture.

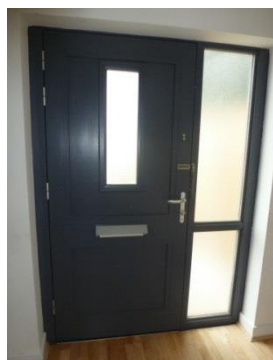
9.1.3.1 Main doors

The main door has a three point multi-way locking system with a split spindle. Overall the door is easy to open.
