This document contains a Building Performance Evaluation report from the £8 million Building Performance Evaluation research programme funded by the Department of Business Innovation and Skills between 2010 and 2015. The report was originally published by InnovateUK and made available for public use via the building data exchange website hosted by InnovateUK until 2019. This website is now hosting the BPE reports as a research archive. Although no support or further information on the reports is available from the host, further information may be available from the original InnovateUK project evaluator using the link below<sup>1</sup>.

<b>InnovateUK project number</b>	450081
<b>Project author</b>	Glasgow School of Art, Mackintosh Environmental Architecture Research Unit (MEARU)
<b>Report date</b>	2015
<b><sup>1</sup>InnovateUK Evaluator</b>	N/A

The Tigh-Na-Cladach (Gaelic meaning 'Houses by the Shore') development is located one mile south of the town of Dunoon in the Scottish county of Argyll and Bute. The BPE project studied one PassivHaus home and two low-energy homes. The Tigh-Na-Cladach dwellings performed significantly better than the UK average and approached best practice

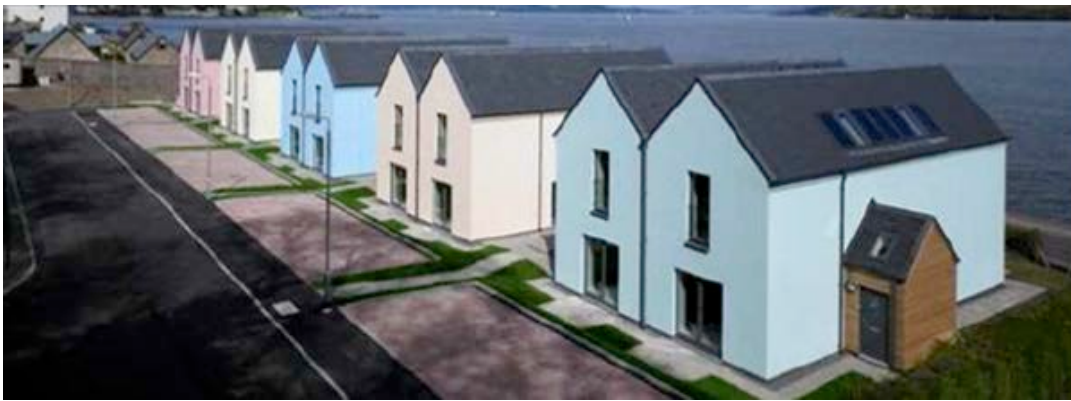
**Figure 1.1:** General eastwards view of the development - car park to the west and sea front to the east.

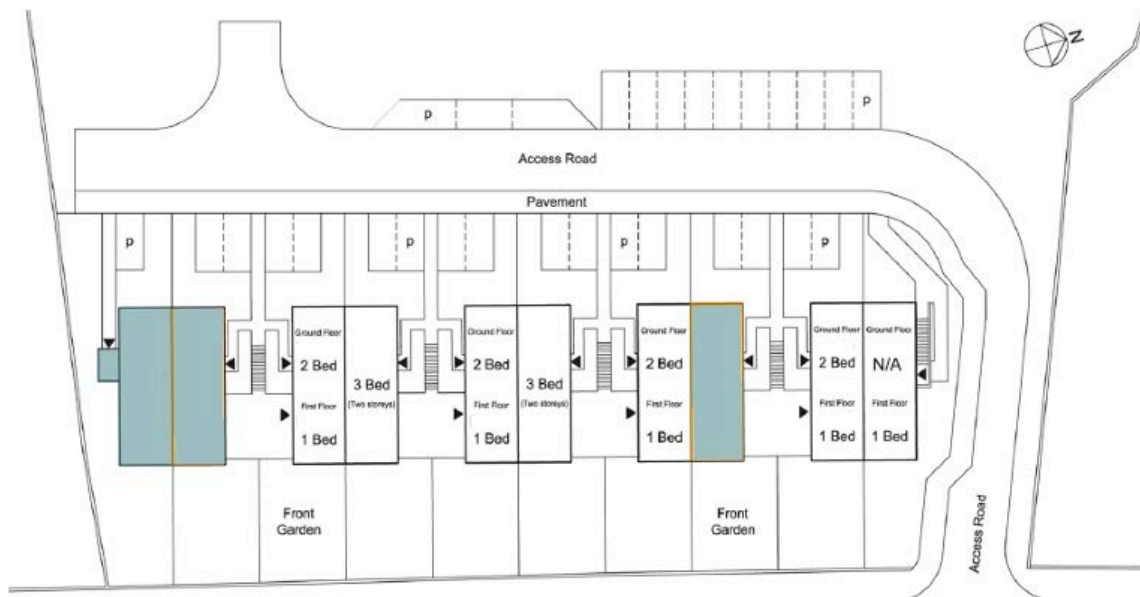
**Figure 1.3:** Site plan: the selected dwellings for the TSB BPE project are shaded.

The long site layout (**Figure 1.3**) was significantly influenced by, and evolved in response to topography and the seafront; and is in harmony with neighbouring housing developments along the sea front. The diversity of dwellings (one, two and three bedroom units) in the development, and their overall sizes do, however, not follow in the tradition of large homes in the neighbourhood, since the development targeted the affordable sector. The orientation of the buildings and internal layout is designed to optimise natural light and energy efficiency (**Figure 1.6**). The design orientation and layout will be discussed further in **Section 2.2** and **section 2.4** under **Design intent**.

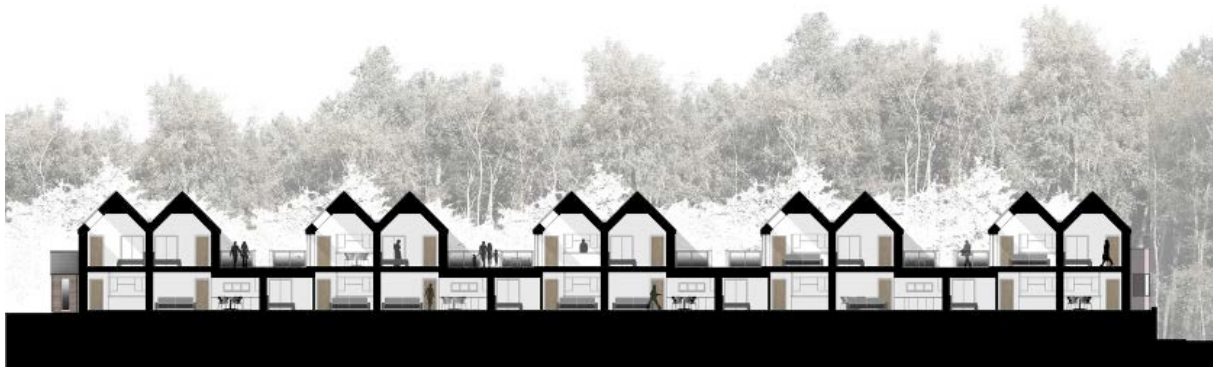
**Figure 1.4:** Section through the entire development.

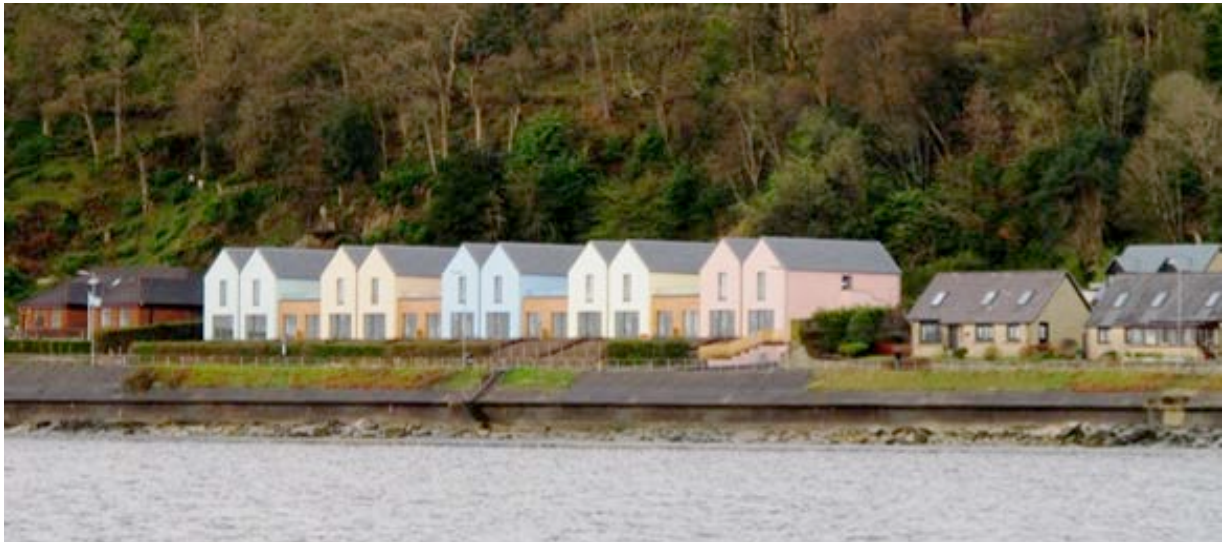
**Figure 1.5:** View towards steep slope to the west of the development. The gable end windows shown are for the Living rooms and kitchens located on the ground floors and bedrooms on the first floors – all facing the sea.

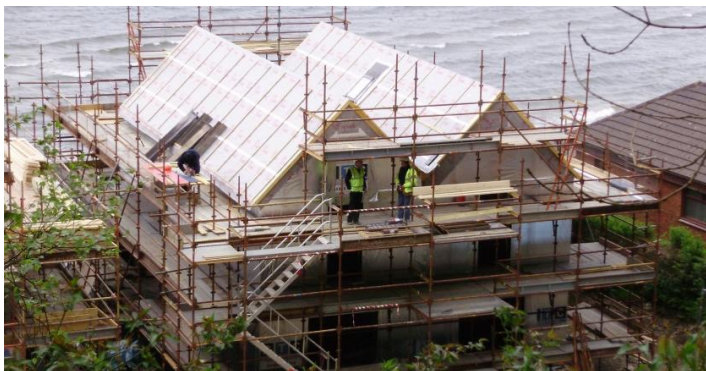
**Figure 2.4:** PassivHaus on the right of image has thicker layer of roof insulation (grey).

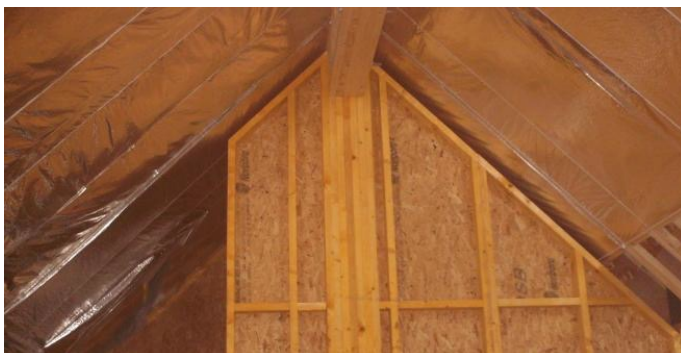
**Figure 2.6:** PassivWall closed panel timber system by RTC Timber Systems.

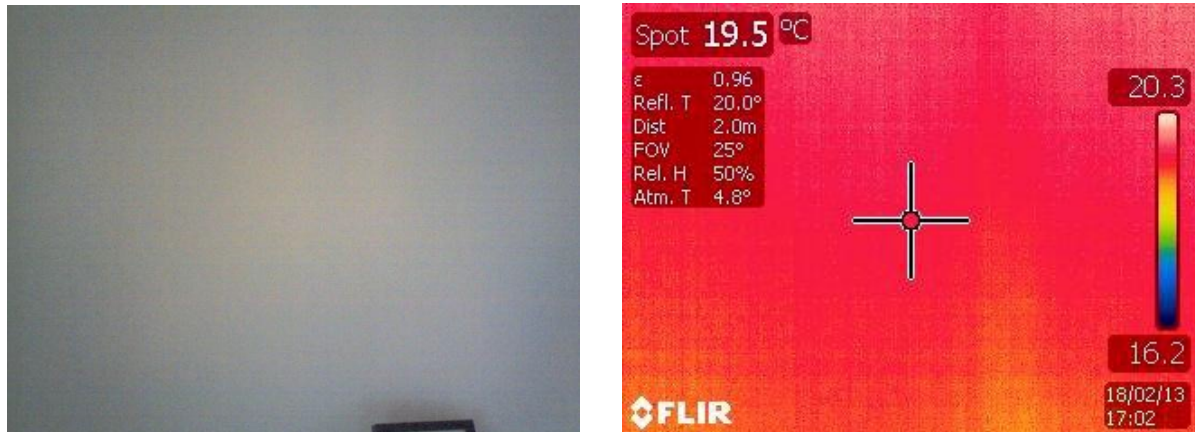
**Figure 3.1:** Thermographic imaging before mounting of heat flux sensors to ensure sensors are mounted on a surface representing even thermo physical properties in dwelling TB1.

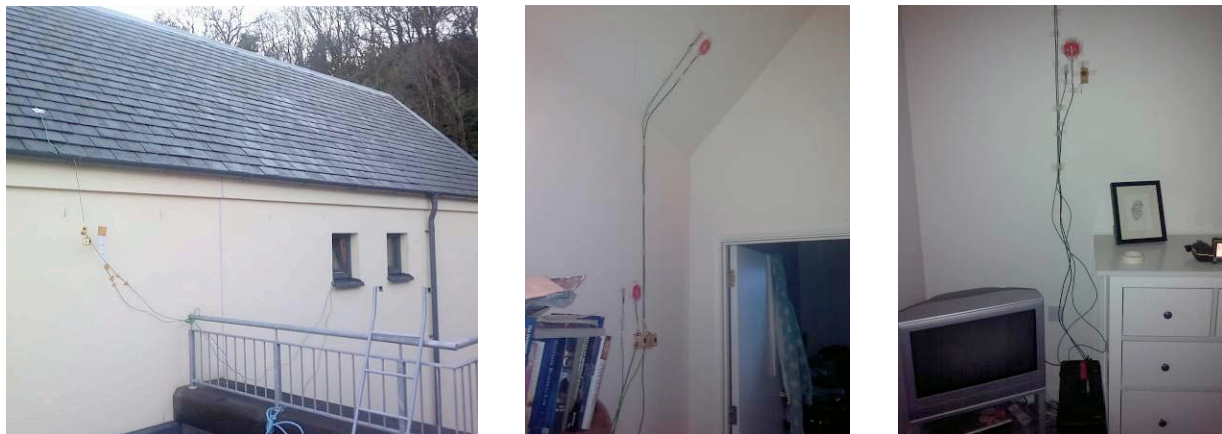
**Figure 3.2:** Air temperature and Heat Flux sensors mounted on internal wall surfaces in dwelling TB1.

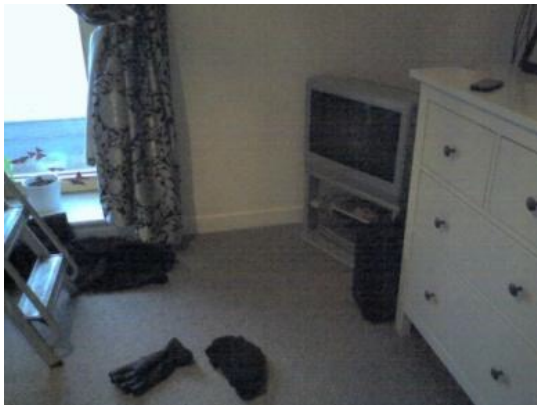
g.

Although the images in **Figure 3. 'h' and 'g'** illustrate uneven green and blue thermal patterns, suggesting that cold air ingress is cooling surfaces at the skirting level, and possible relation to the insulation fitted being ineffective, it is possible that the surrounding furniture and curtain produced this thermal image effect.

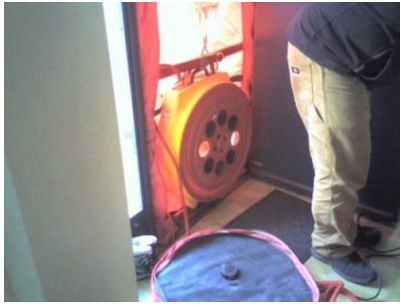
**Figure 3.3:** Air pressure test door fan in Dwellings TA1 and TA2.

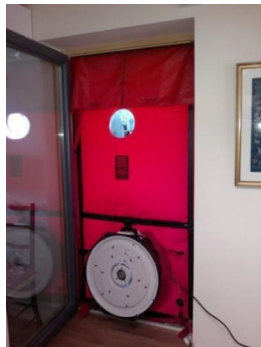
**Figure 3.5:** Air pressure test door fan in TB1.

The testing was carried out in accordance with ATTMA (Air Tightness Testing and Measurement Association) TS1 (Technical Standard for air permeability testing of dwellings) which is broadly based on BS EN 13829:2001. It involves the creation of a pressure differential between inside and outside, by using a portable variable flow fan temporarily installed in a doorway. Air permeability is expressed in air leakage ( $\text{m}^3/\text{hour}$ ) in or out of the building, per square meter of building envelope at a reference pressure of 50 Pascal ( $\text{m}^3/(\text{h} \cdot \text{m}^2)@50\text{Pa}$ ). In order to detect the location of infiltration pathways a smoke pencil is routinely used, together with thermography, these are shown in **Appendix 3.3**. The fan was placed at the main door for TA1 and TA2 (**Figure 3.3**, **Figure 3.4**); and at the door between the glass door after the entrance porch in TB1 (**Figure 3.5**, **Figure 3.6**). The entrance porch was therefore excluded from the pressure test for TB1. Each property was pressurised and depressurised and the mean of the measured values taken as the air permeability. The procedures for the test on each dwelling are presented in **Appendix 3.2**.

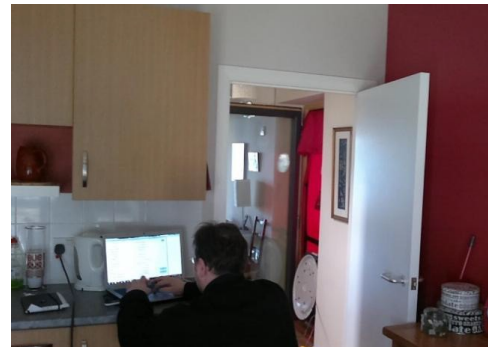
**Figure 3.6:** Air pressure test door laptop link in TB1.

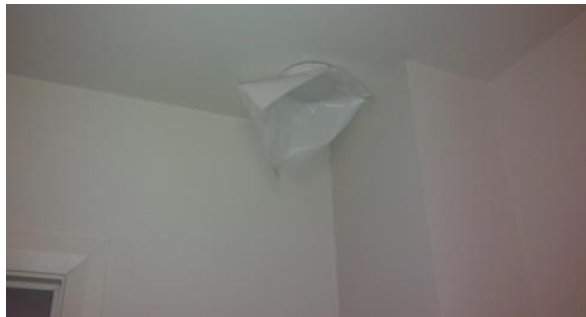
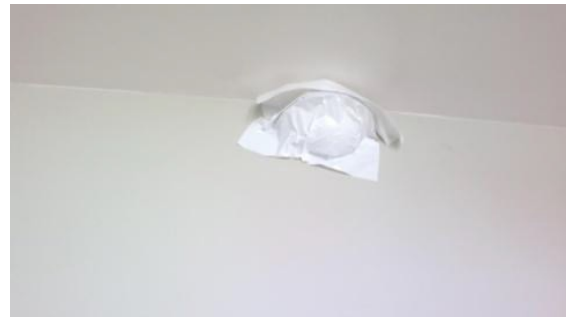
The tests involved the sealing of vents (Fig 3.7) - all kitchen hoods, mechanical vents, trickle vents (TA1 and TA2), and air-to-air source heat pump (TB1). The MVHR air ingress and egress points were also sealed, except two small vents located high at the ceiling of the bedrooms during the tests 1<sup>st</sup> in March 2013.

**Figure 3.7:** Air vents sealed and mechanical vents switched off before air pressure and air leakage tests.

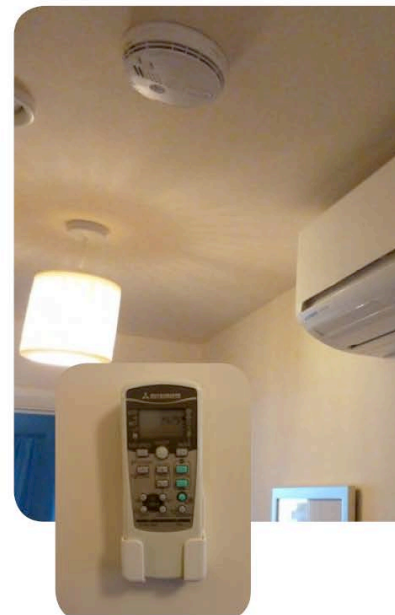
Heat Pump Remote Control

There is a thermostat on the unit which you can set to increase or decrease the amount of heat delivered into the building and the remote control device allows you also to set times for the unit to switch on or off.

**Figure 5.2:** Example pages from a Quickstart Guide given to occupants.

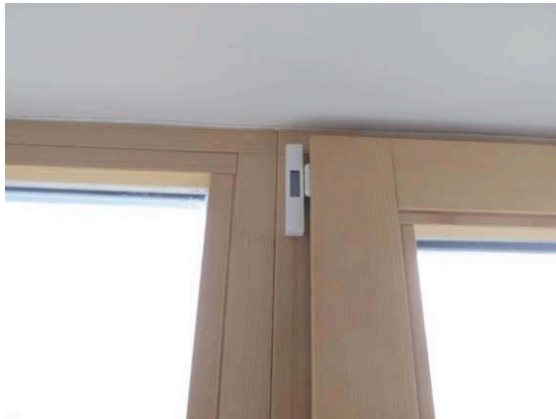
**Figure 7.1:** Window contact sensor: closed.

Combined wireless solar powered sensors for temperature, relative humidity (RH) and CO<sub>2</sub> supplied by t-mac Ltd monitored internal environmental conditions. Solar powered contact sensors monitored window opening patterns - to log the open or closed (Figure 7.1) status of the window. Four rooms per dwelling were fitted with wireless environmental sensors; and each of these rooms was fitted with a contact sensor placed on the most frequently opened windows. The installation and commissioning of these took place on 07/12/12 and 18-19/12/12 respectively. The monitoring equipment and sub-circuits monitors that were installed are summarised in Table 7.1. The site survey report and commissioning report from t-mac are provided in **6 and Appendix 7.2**.

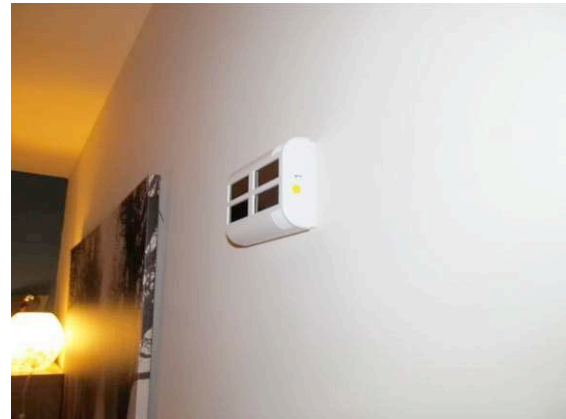
**Figure 7.2:** Living room: installed environmental monitoring (CO<sub>2</sub>, Temperature and RH%) sensor.

The CO<sub>2</sub>, RH and Temperature sensors; window contacts; and sub-meter sensors (Figure 7.2) were all linked wirelessly to the central data logger in each house to log at 5 min intervals in synchrony. The data collected was transmitted wirelessly to a central t-mac unit, which was hard-wired via a fused spur to the meter board, in the utilities cupboard under the staircase of each house. At the distribution board, electrical sub-circuits were monitored via CT clamps (Figure 7.3) which were connected to the t-mac unit. A wireless WiST repeater unit was plugged into a wall socket in each dwelling to boost signals and ensure robust communication from the sensors to the wireless gateway.
