TSB FILE REFERENCE 450107 Building performance evaluation follow-on project

FINAL REPORT

Woodland Trust Concrete Radiator Performance Analysis

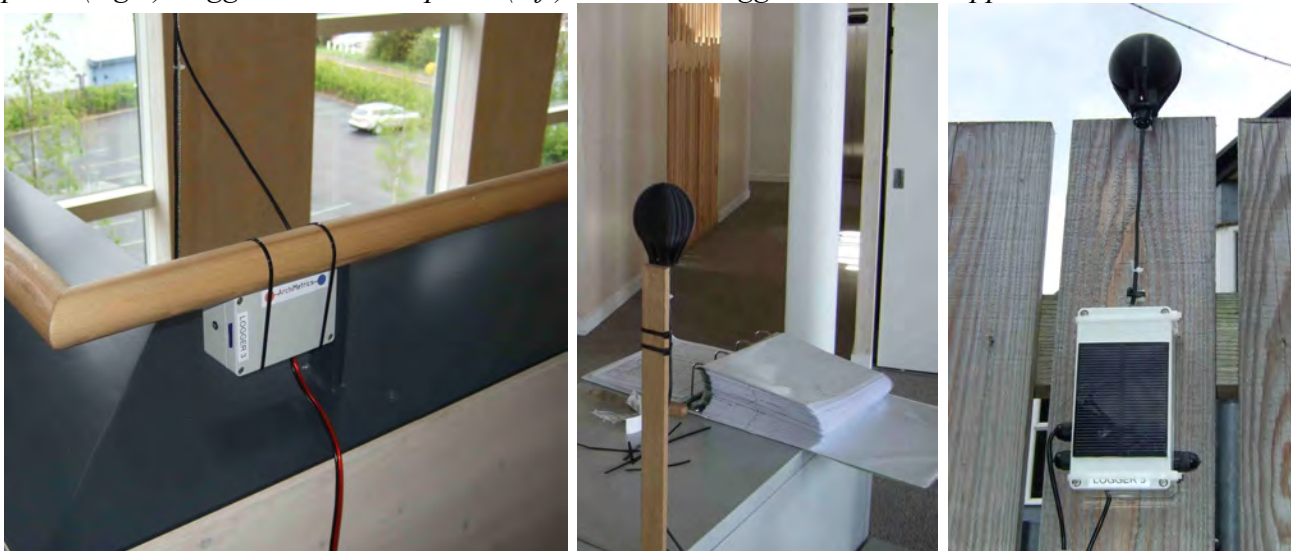
LEFT: Logger 3, with cable to the vertical array of sensors above. Low voltage power cable below. CENTRE: Globe temperature sensor for Logger 4. RIGHT: Outdoor Logger 5 with globe sensor above.

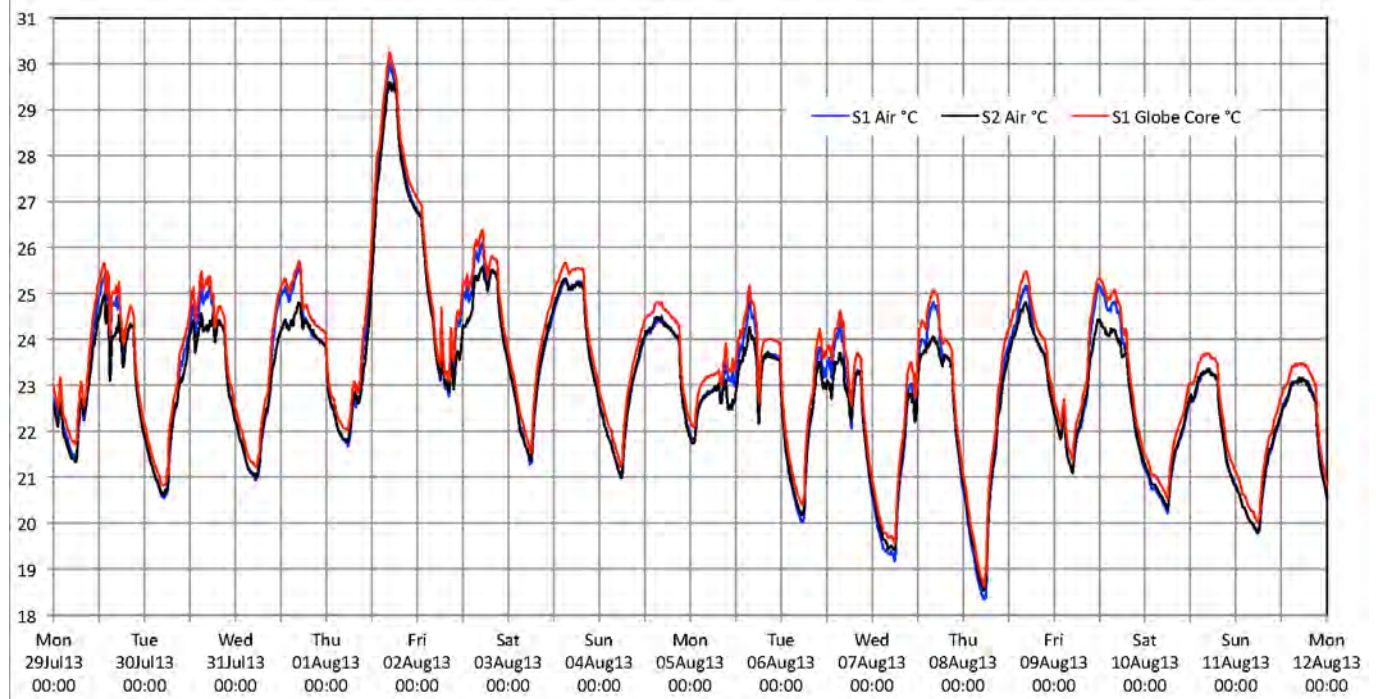
FIGURE 6.1: Air and globe temperatures at workstation level on the first floor north

- 6.2 Figure 6.1 above shows an extract of the data for the period 29 July to 11 August, a typical warm summer period, apart from the exceptionally hot 1 August. This indicates:

- Generally higher air temperatures at the workstation position (S1 air, blue) during working days than at the filing cabinet (S2 air, black), owing to heat from local occupancy and equipment.

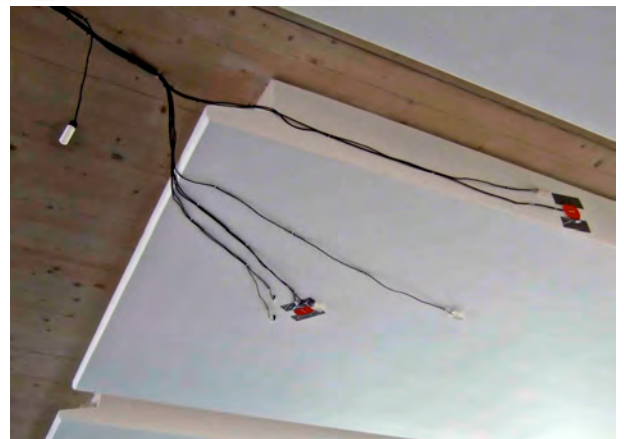
The photo to the right shows the sensors attached to the second concrete radiator towards the south on entry to the first floor offices from the main (west) stair. These were monitored by Logger 1. The projecting rim at the left (northern) edge of the concrete conceals a fluorescent tube that provides ambient lighting to the central corridor of the first floor offices as necessary. The concrete radiators on the north side do not have the lamp and lip.

- The white suspended cylinder to the top left is an open-ended tube that contained the local air temperature sensor.
- The red discs are Hukseflux heat flux sensors.

- The first (HF1, centre left) was attached to the bottom of the concrete radiator, in the centre of the lowest 80 mm thick cell of the structure.
 - The second (HF2, top right) was attached to the side, to help identify the contribution of this surface to stabilising indoor temperatures.

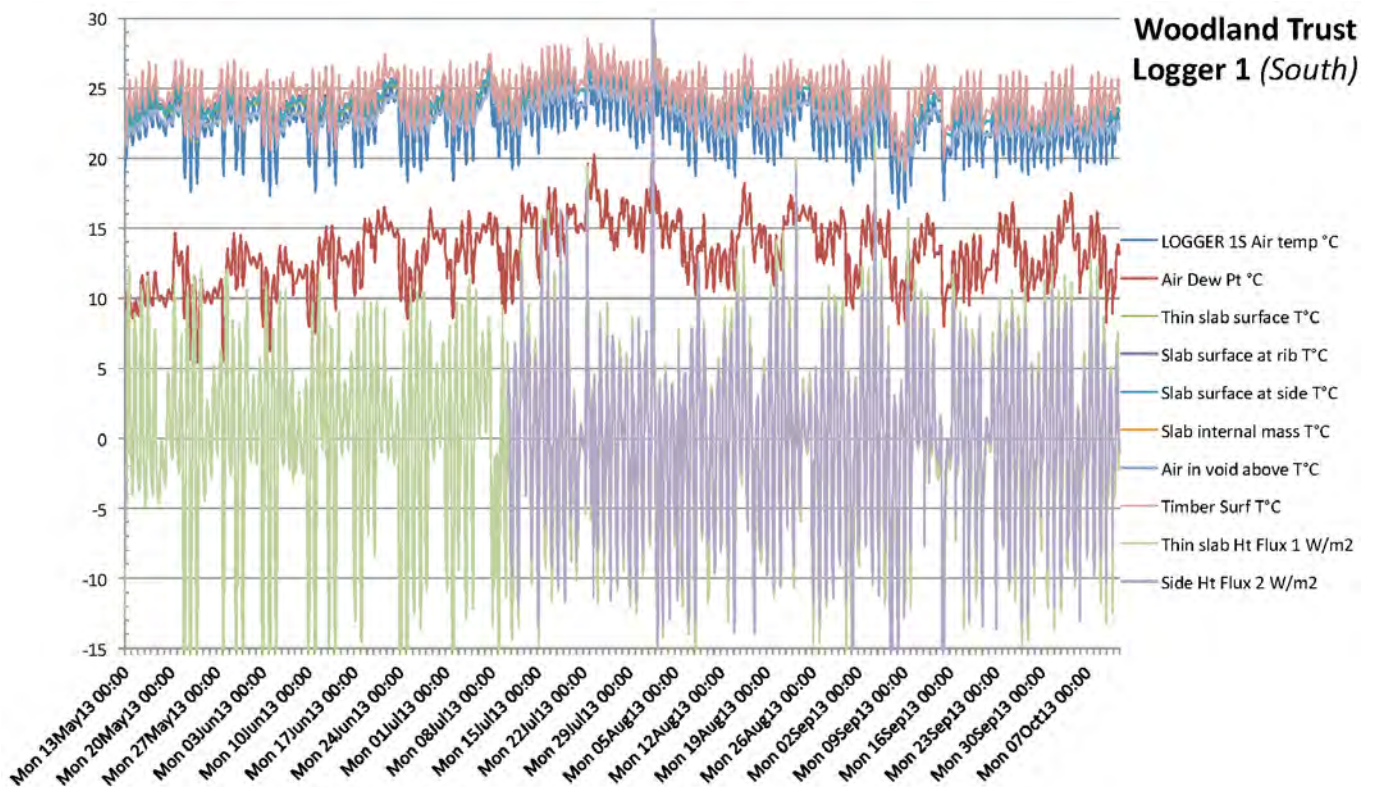
FIGURE 7.2: Concrete Radiator temperature and heat flux monitoring – first floor south

Figure 7.2 above summarises the Logger 1 data for the entire period. The traces at the top show:

- 2 Heat from the ambient lighting, which was programmed ON from 7 to 9 AM and from 4 to 6.30 PM on working days. The effect was most noticeable during the afternoon ON period, when it caused spikes of typically 1.5°C. Heat from the lights was also retained in the southern edge of the concrete radiator for up to 12 hours, as revealed by infra-red photos.

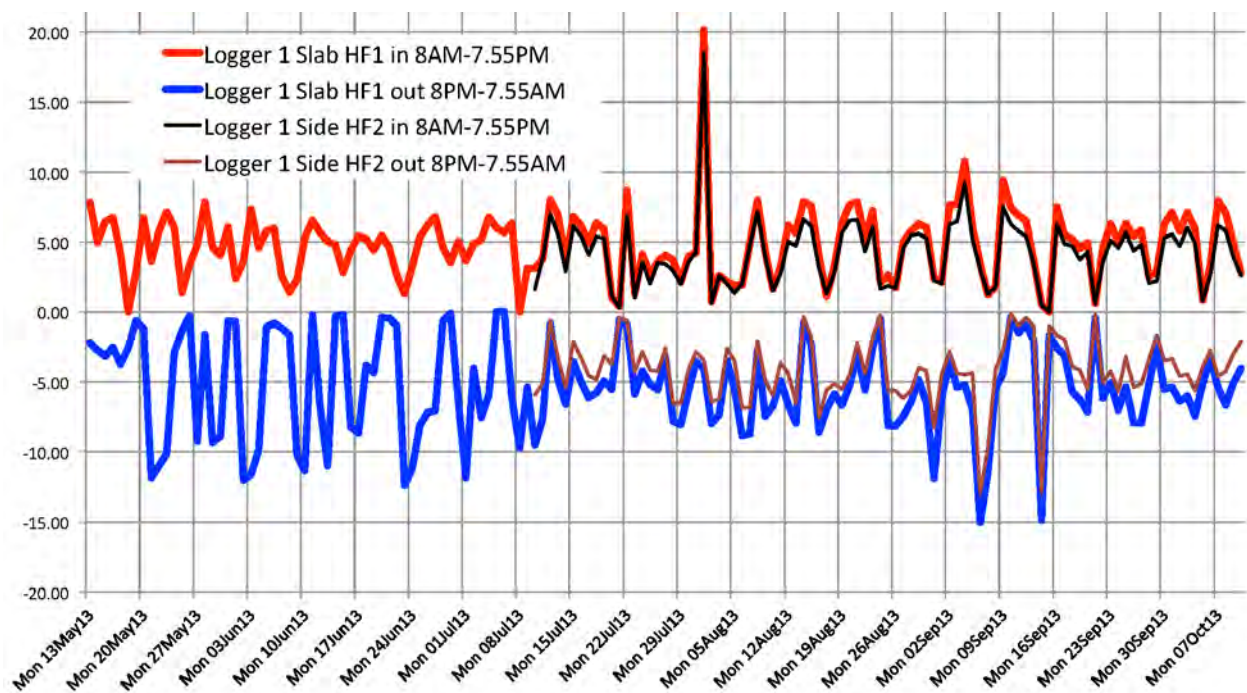
FIGURE 7.4: Logger 1: South panel daily 12-hour heat absorption and night removal (W/m^2)

- In both charts, heat passing into the thin (100 mm) soffits of the concrete radiators during the day is shown in red, while the heat passing out at night in the same locations is shown in blue.
- In Figure 7.4, the thin black and lilac traces show heat flux through the side of the radiator.
- In Figure 7.5, the same coloured traces show heat flux into the timber panel.
- The missing traces before 10 July indicate when sensors lost good thermal contact.

Figures 7.4 and 7.5 confirm that heat transfer through the bottom of the concrete radiators was much the same in both locations. The pattern of heat flux through the side was similar, but typically 20% less in magnitude. Heat flow through the timber was also similar, but with 28% of the amplitude. Some key figures are summarised in Table 7.1 below.

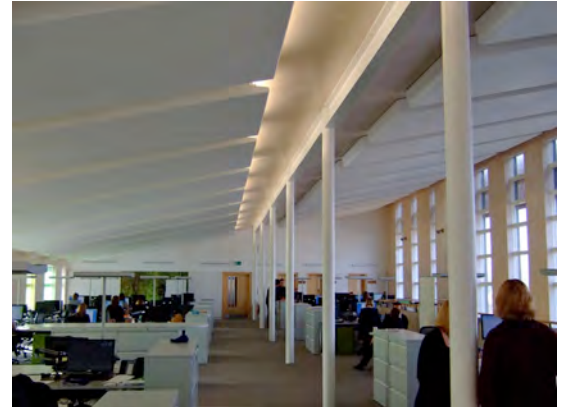
The external walls, upper floors and roof at the Woodland Trust's naturally-ventilated offices are made of cross-laminated timber. To add thermal capacity and structural stiffness, "concrete radiators" are bolted to the undersides of the roof and ceilings, as shown in **Figure 1.1** to the right. The BMS is programmed to open motorised windows on all floors to remove any excess heat overnight, providing cooler air and radiant temperatures for the following day.

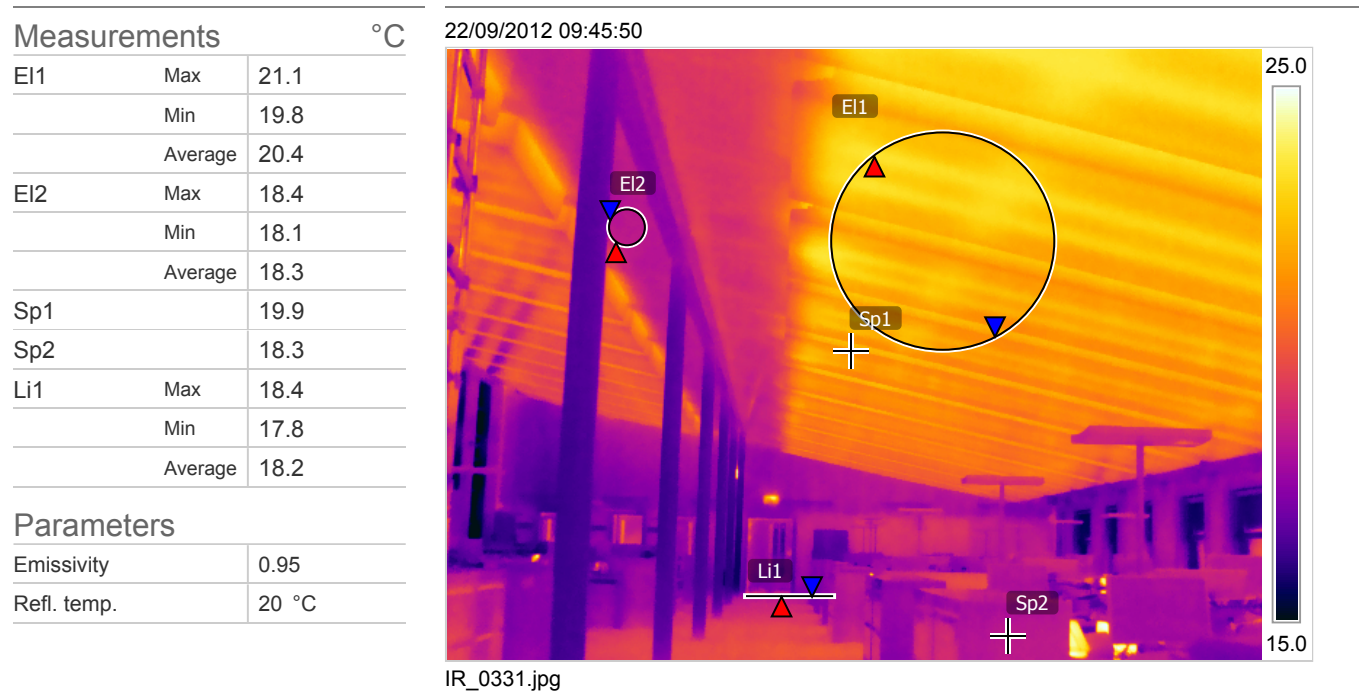
FIGURE 3.3: THE SATURDAY MORNING, 15 MINUTES AFTER WINDOWS CLOSED

Figure 3.3 shows how much the surface temperatures have risen, in as little as fifteen minutes after the windows were closed. The average surface temperature of the concrete radiators (EI1) is up by 0.4 C, the ceiling surface by 0.5 C, and the floor and furniture by 0.7 C.
