Charities Aid Foundation

THE PROBE PROJECT

The headquarters of the Charities Aid Foundation was the subject of a PROBE investigation in 1998. Ten years on, **Roderic Bunn** reports on the building's first major refurbishment

BSRIA PROJECT REVISIT

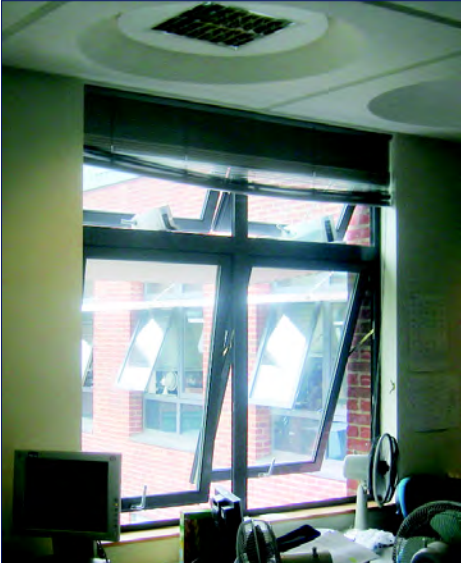
Above: Books were used to prop open fanlights that were never fitted with friction hinges.

JPA found that the fanlights were unusable. Although generously sized, the top-hung windows were too high for most people to operate them, and even if they could be reached, the windows had no stays to hold them open unless they were jammed open with books or cardboard. As they were not motorised, the fanlights couldn't be used for night cooling.

All casement windows have been fitted with new friction mechanisms to ensure that they remain open when needed, while the high-level windows have been equipped with automatic actuators, under the control of an improved Trend controls system. Each set of windows also has a local override switch for each window.

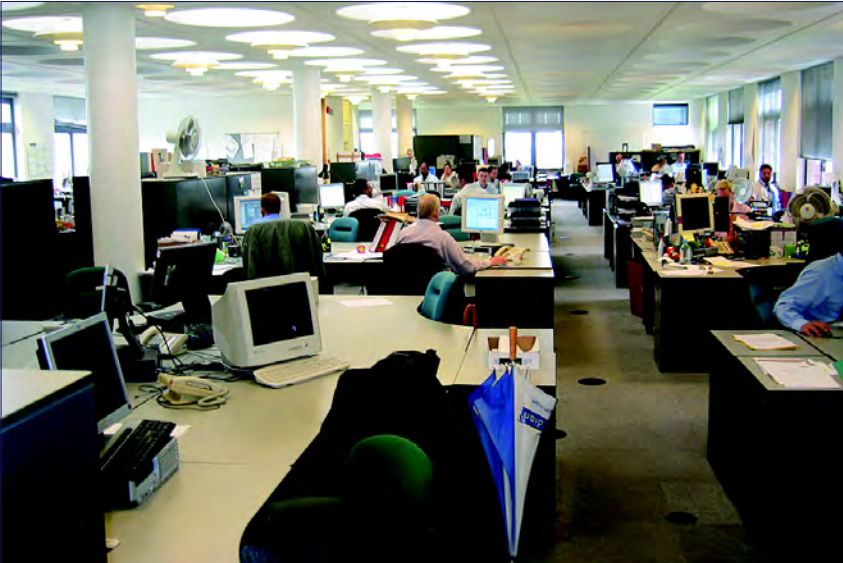
Above: The offices in 2006. Count the desk fans in this and the adjacent photograph – always a clue that conditions aren't quite right.

Packer Associates (JPA) led to the consultant being asked to solve what had become an intolerably hot and poorly ventilated building. JPA carried out an environmental survey in summer 2006, the results of which showed that the initial shortcomings had led to severe summertime overheating and poor occupant comfort. Seemingly every desk had a electric fan.

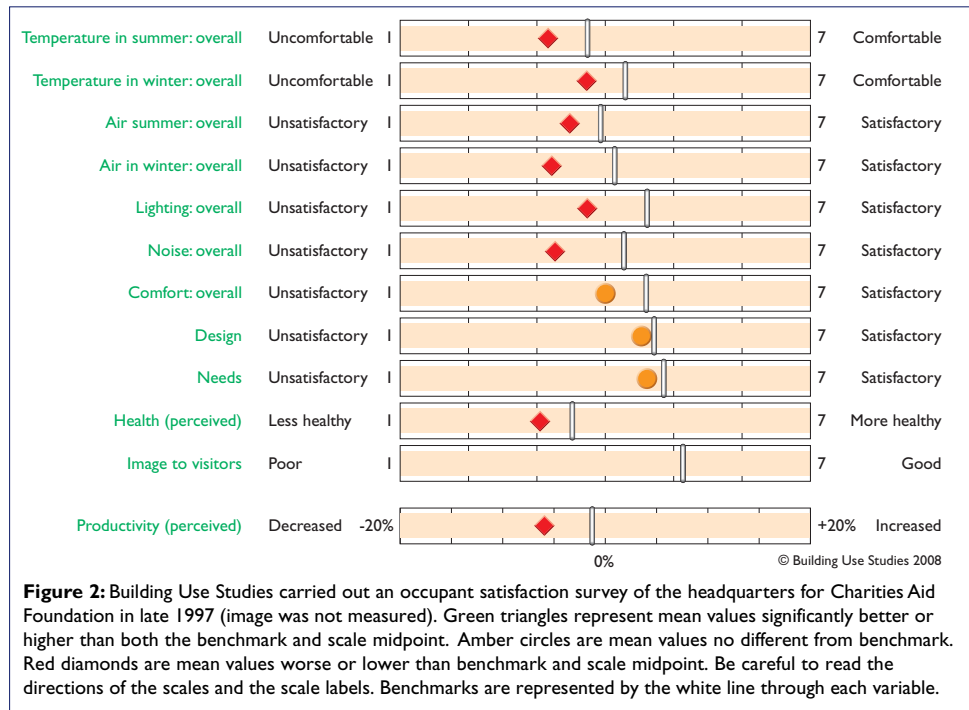
Figure 2: Building Use Studies carried out an occupant satisfaction survey of the headquarters for Charities Aid Foundation in late 1997 (image was not measured). Green triangles represent mean values significantly better or higher than both the benchmark and scale midpoint. Amber circles are mean values no different from benchmark. Red diamonds are mean values worse or lower than benchmark and scale midpoint. Be careful to read the directions of the scales and the scale labels. Benchmarks are represented by the white line through each variable.

The 1997 occupant survey showed the building to be similar to national benchmarks, but slightly on the cool to draughty side. It was also perceived to be more stuffy than benchmarks. Summertime temperatures overall were much hotter, less comfortable and more variable than benchmarks. The second floor was hotter owing to the planar glazing and rooflights.

Figures 2 and 3 show the occupancy survey data for 1997 and 2008 respectively.

The results for 1997 were surprisingly poor, given the building's specification, but the seeds of discontent over summertime overheating were already beginning to show two years after completion.

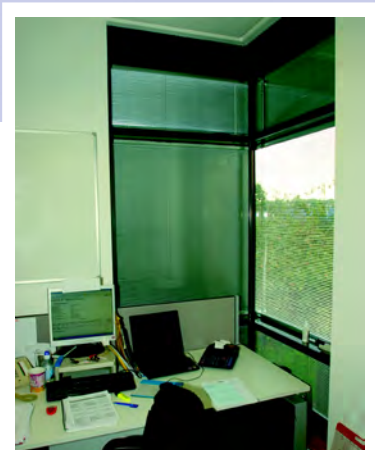
Windows and blinds are difficult to match. Here, corner windows have mid-pane blinds that do not compromise the natural ventilation. However, the occupant has to keep the nearest blinds fully closed to prevent her eyes seeing lines on the screen. A roller blind may be better.

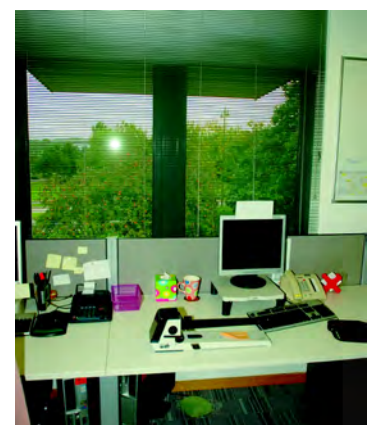
Here, the (original) venetian blind is mounted internally, which not only compromises air flow from the open fanlight, but may also direct air down behind the partition causing cold draughts around the legs. Mid-pane blinds may have been a more robust solution for all likely desk combinations.

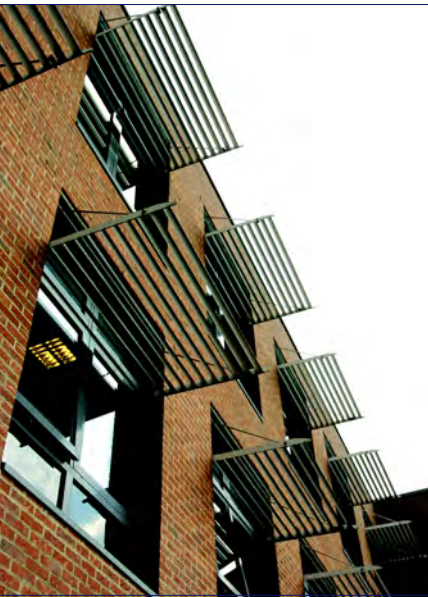
Left: Each window on the eastern courtyard facade of the building is provided with horizontal brise-soleil between the main window and the fanlight. "We considered tilting or pivoting them so they don't face true south and deliver a bit more shading, but it wasn't cost-effective," said JPA's Jack Hatfield.
