Technology Strategy Board
Non-domestic Building Performance Evaluation Workshop
Coventry, 29 January 2013

Can you trust the fabric?

Bill Bordass
WILLIAM BORDASS ASSOCIATES
&

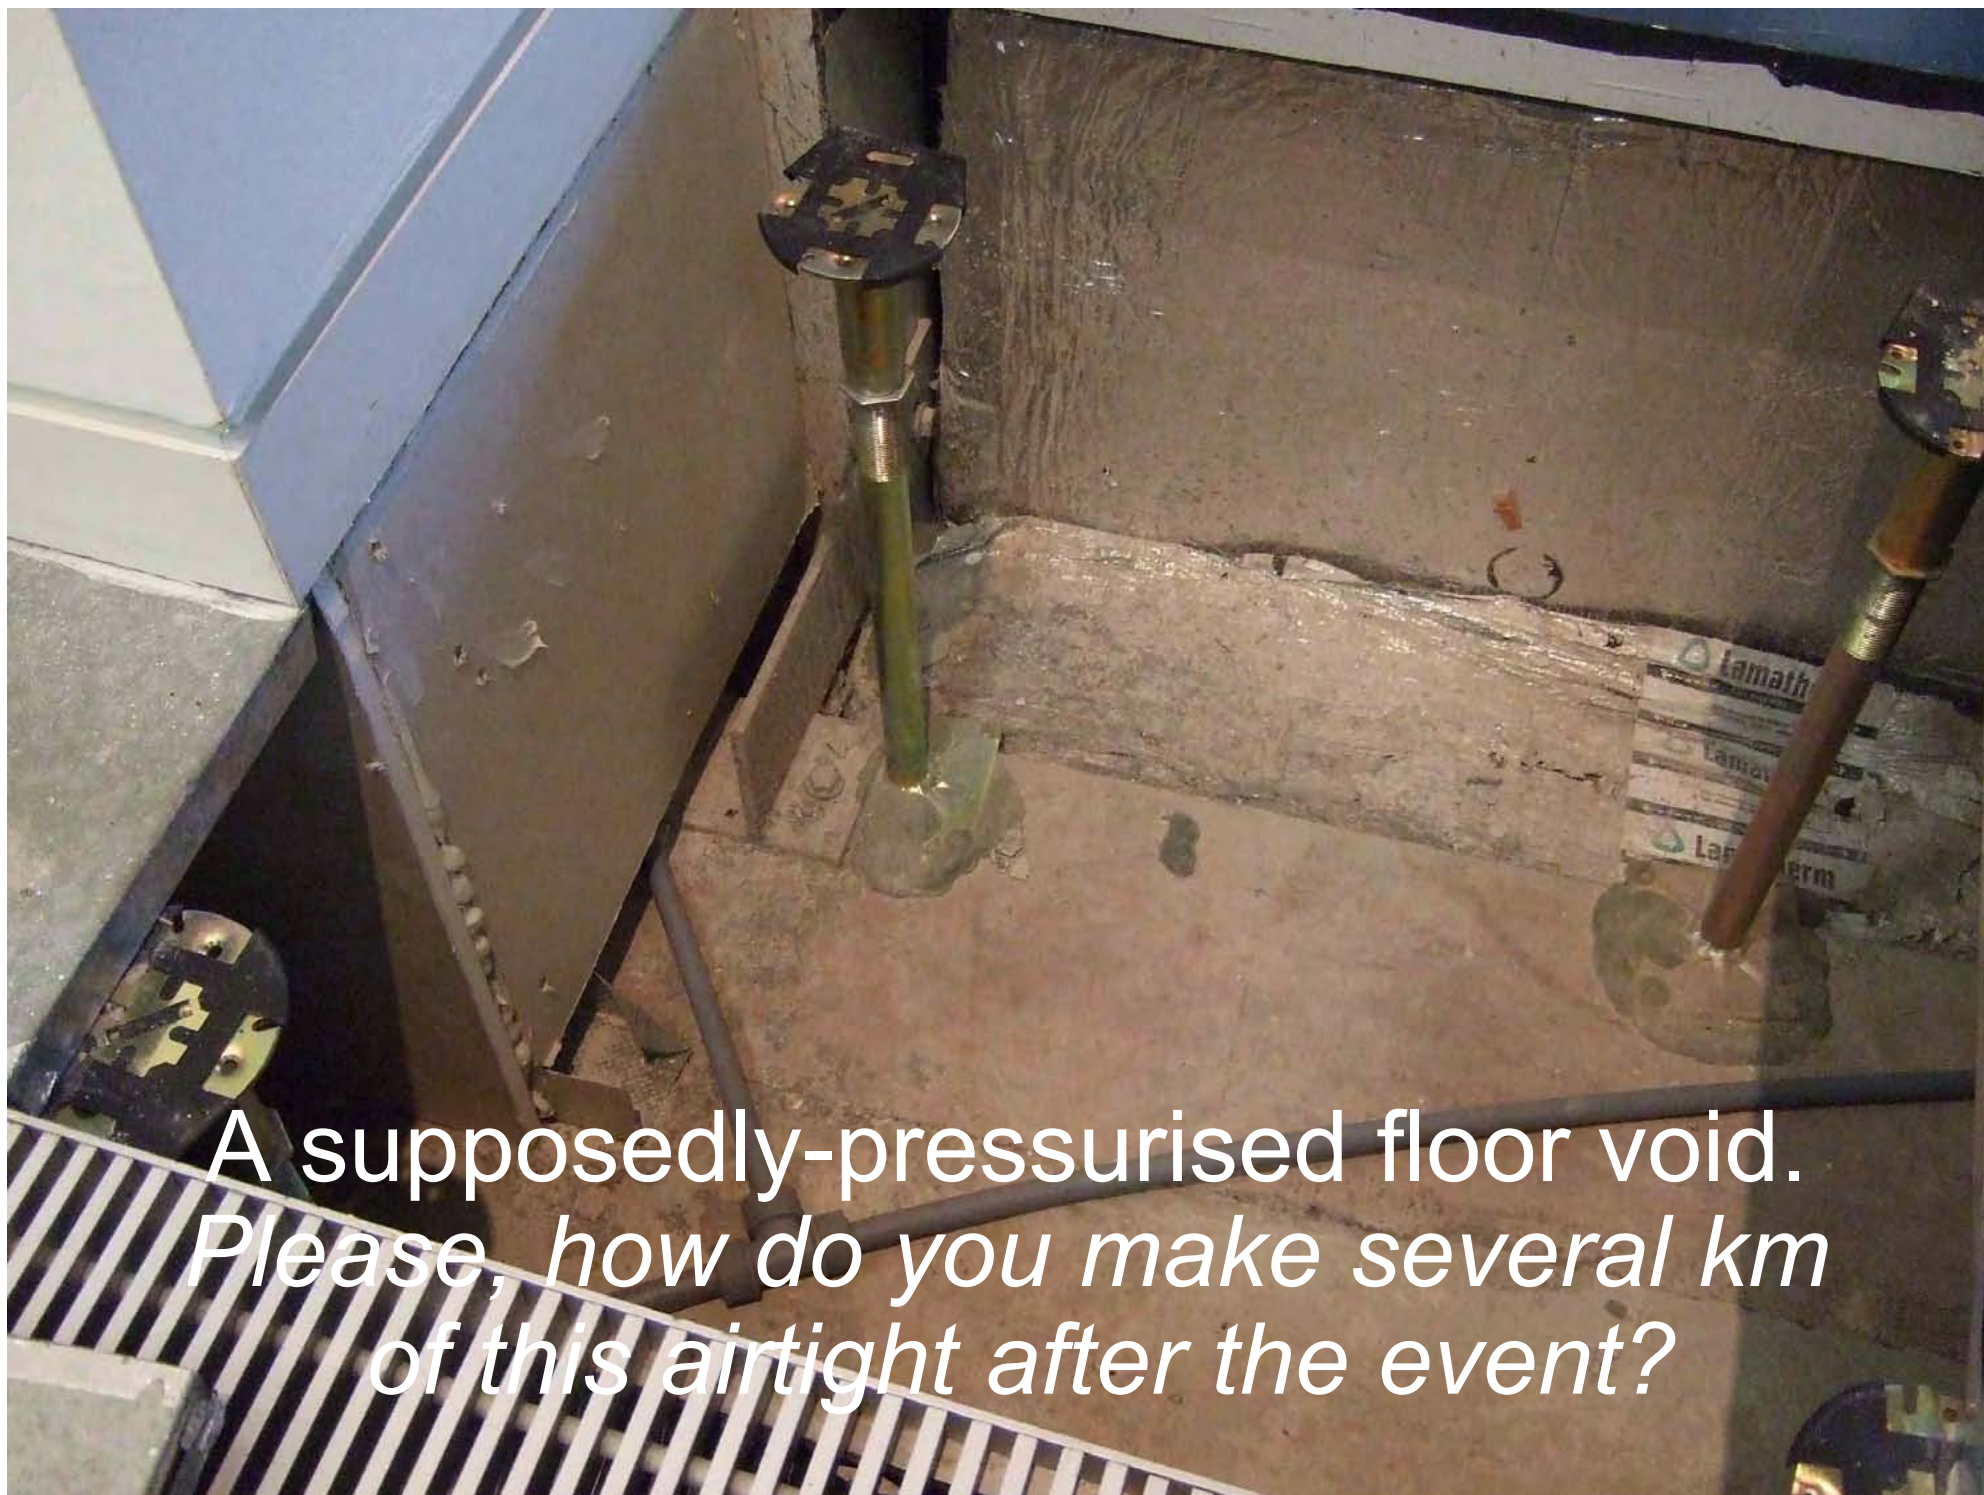
Spot 14.5 °C

Local infiltration can be a problem
even where overall standards are good
WOODLAND TRUST TRENCH HEATER OPEN ENDS

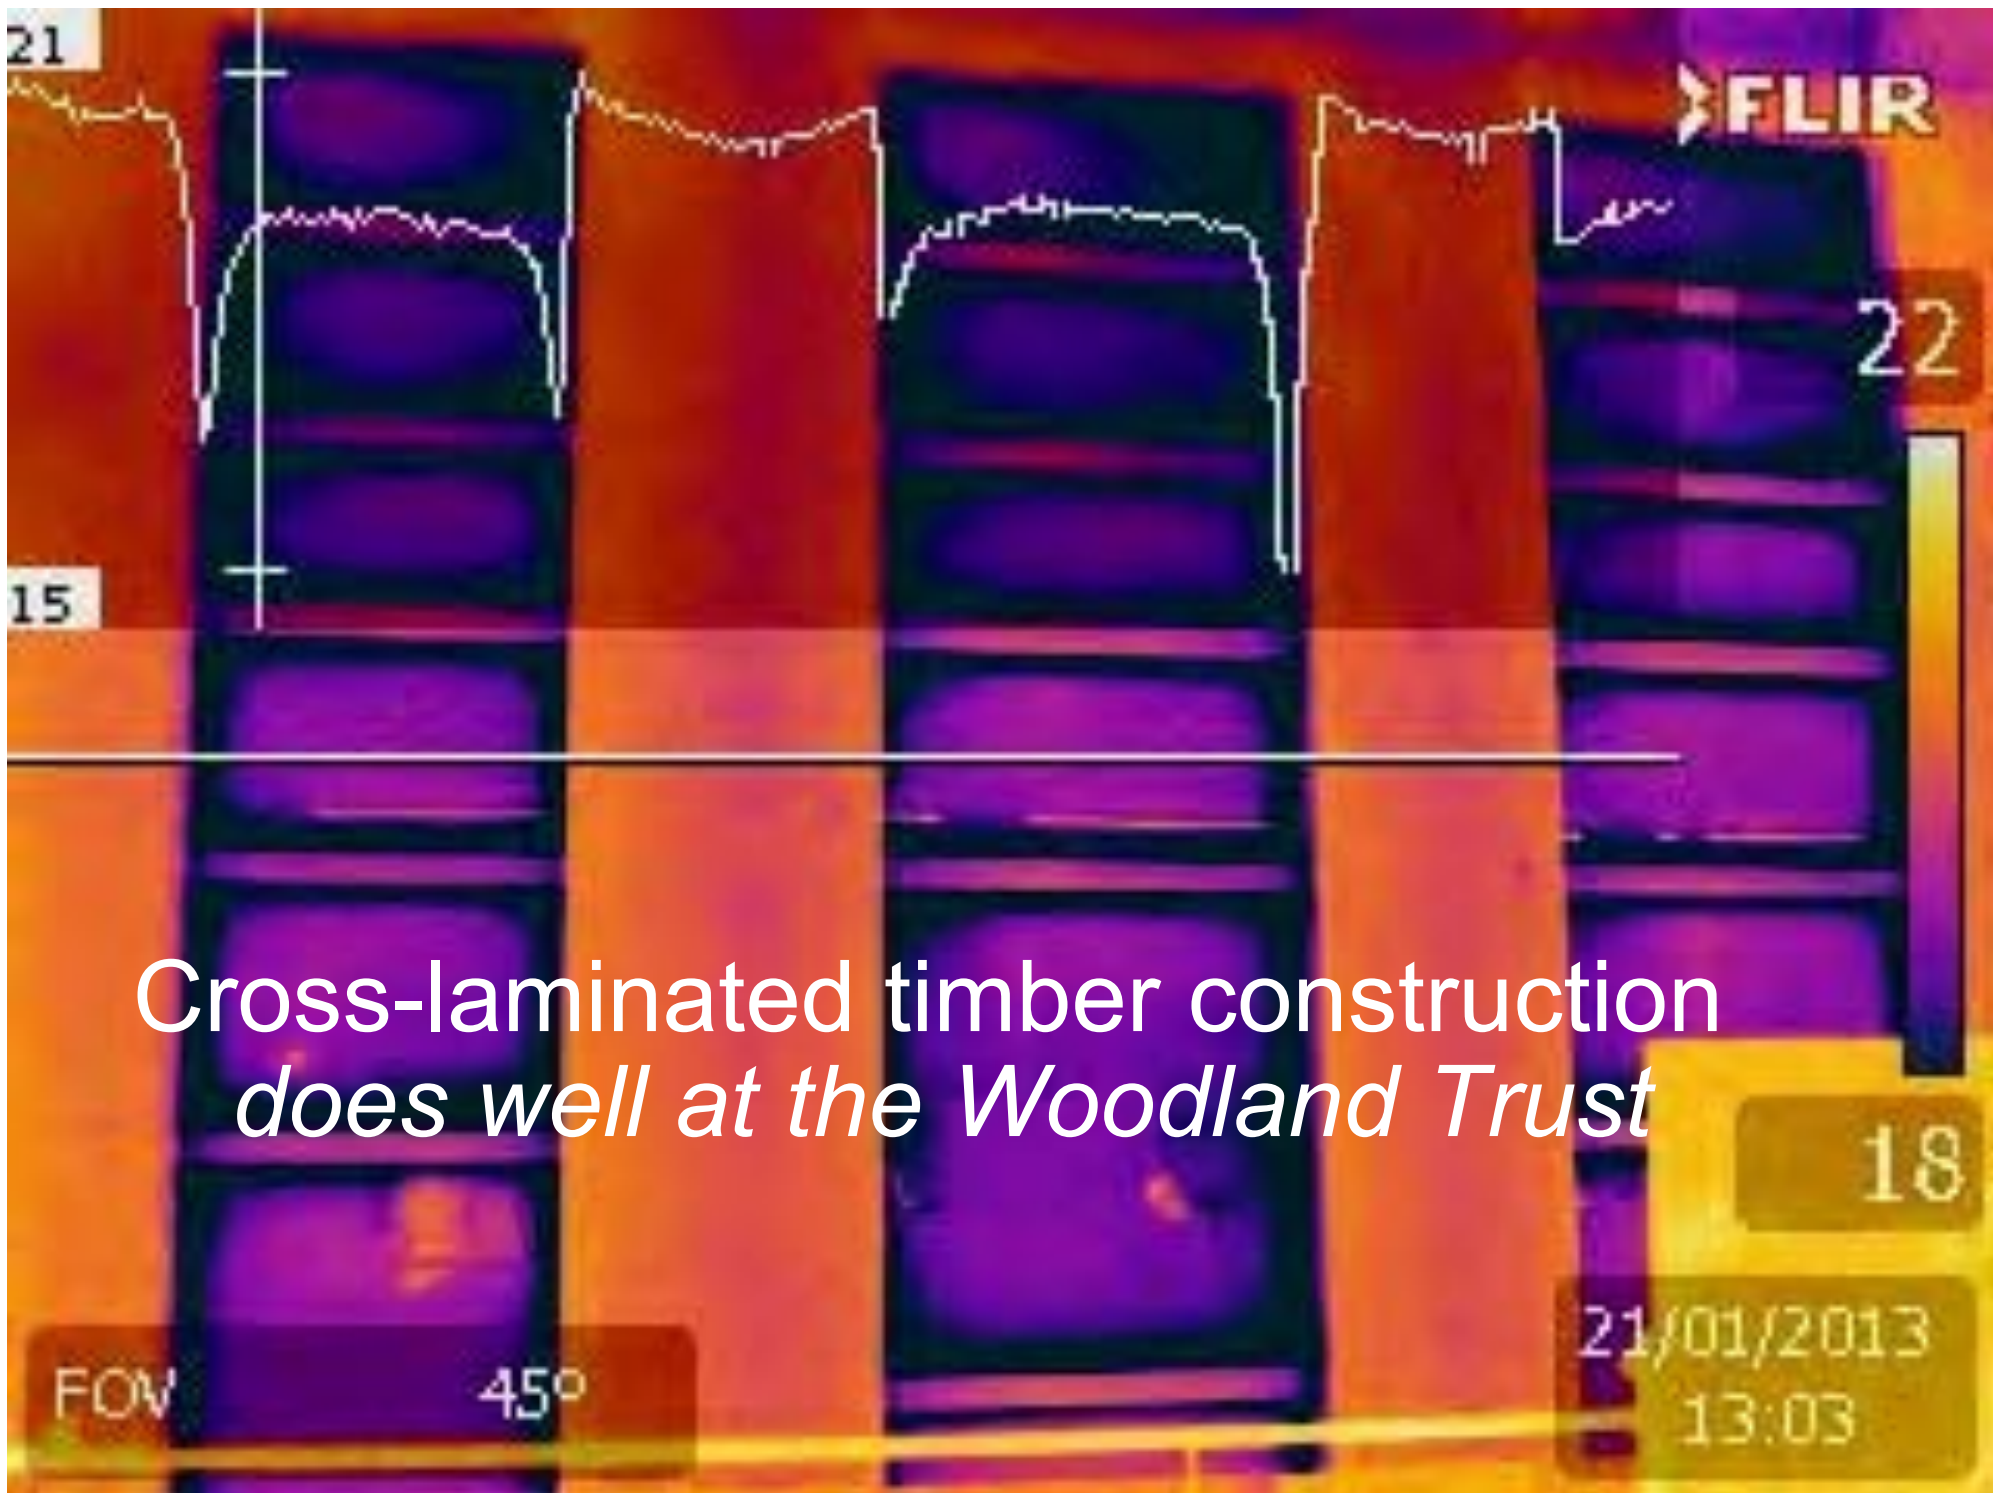
Spot 12.2 °C

And where geometry gets complex
Floor:ceiling junction in a meeting room

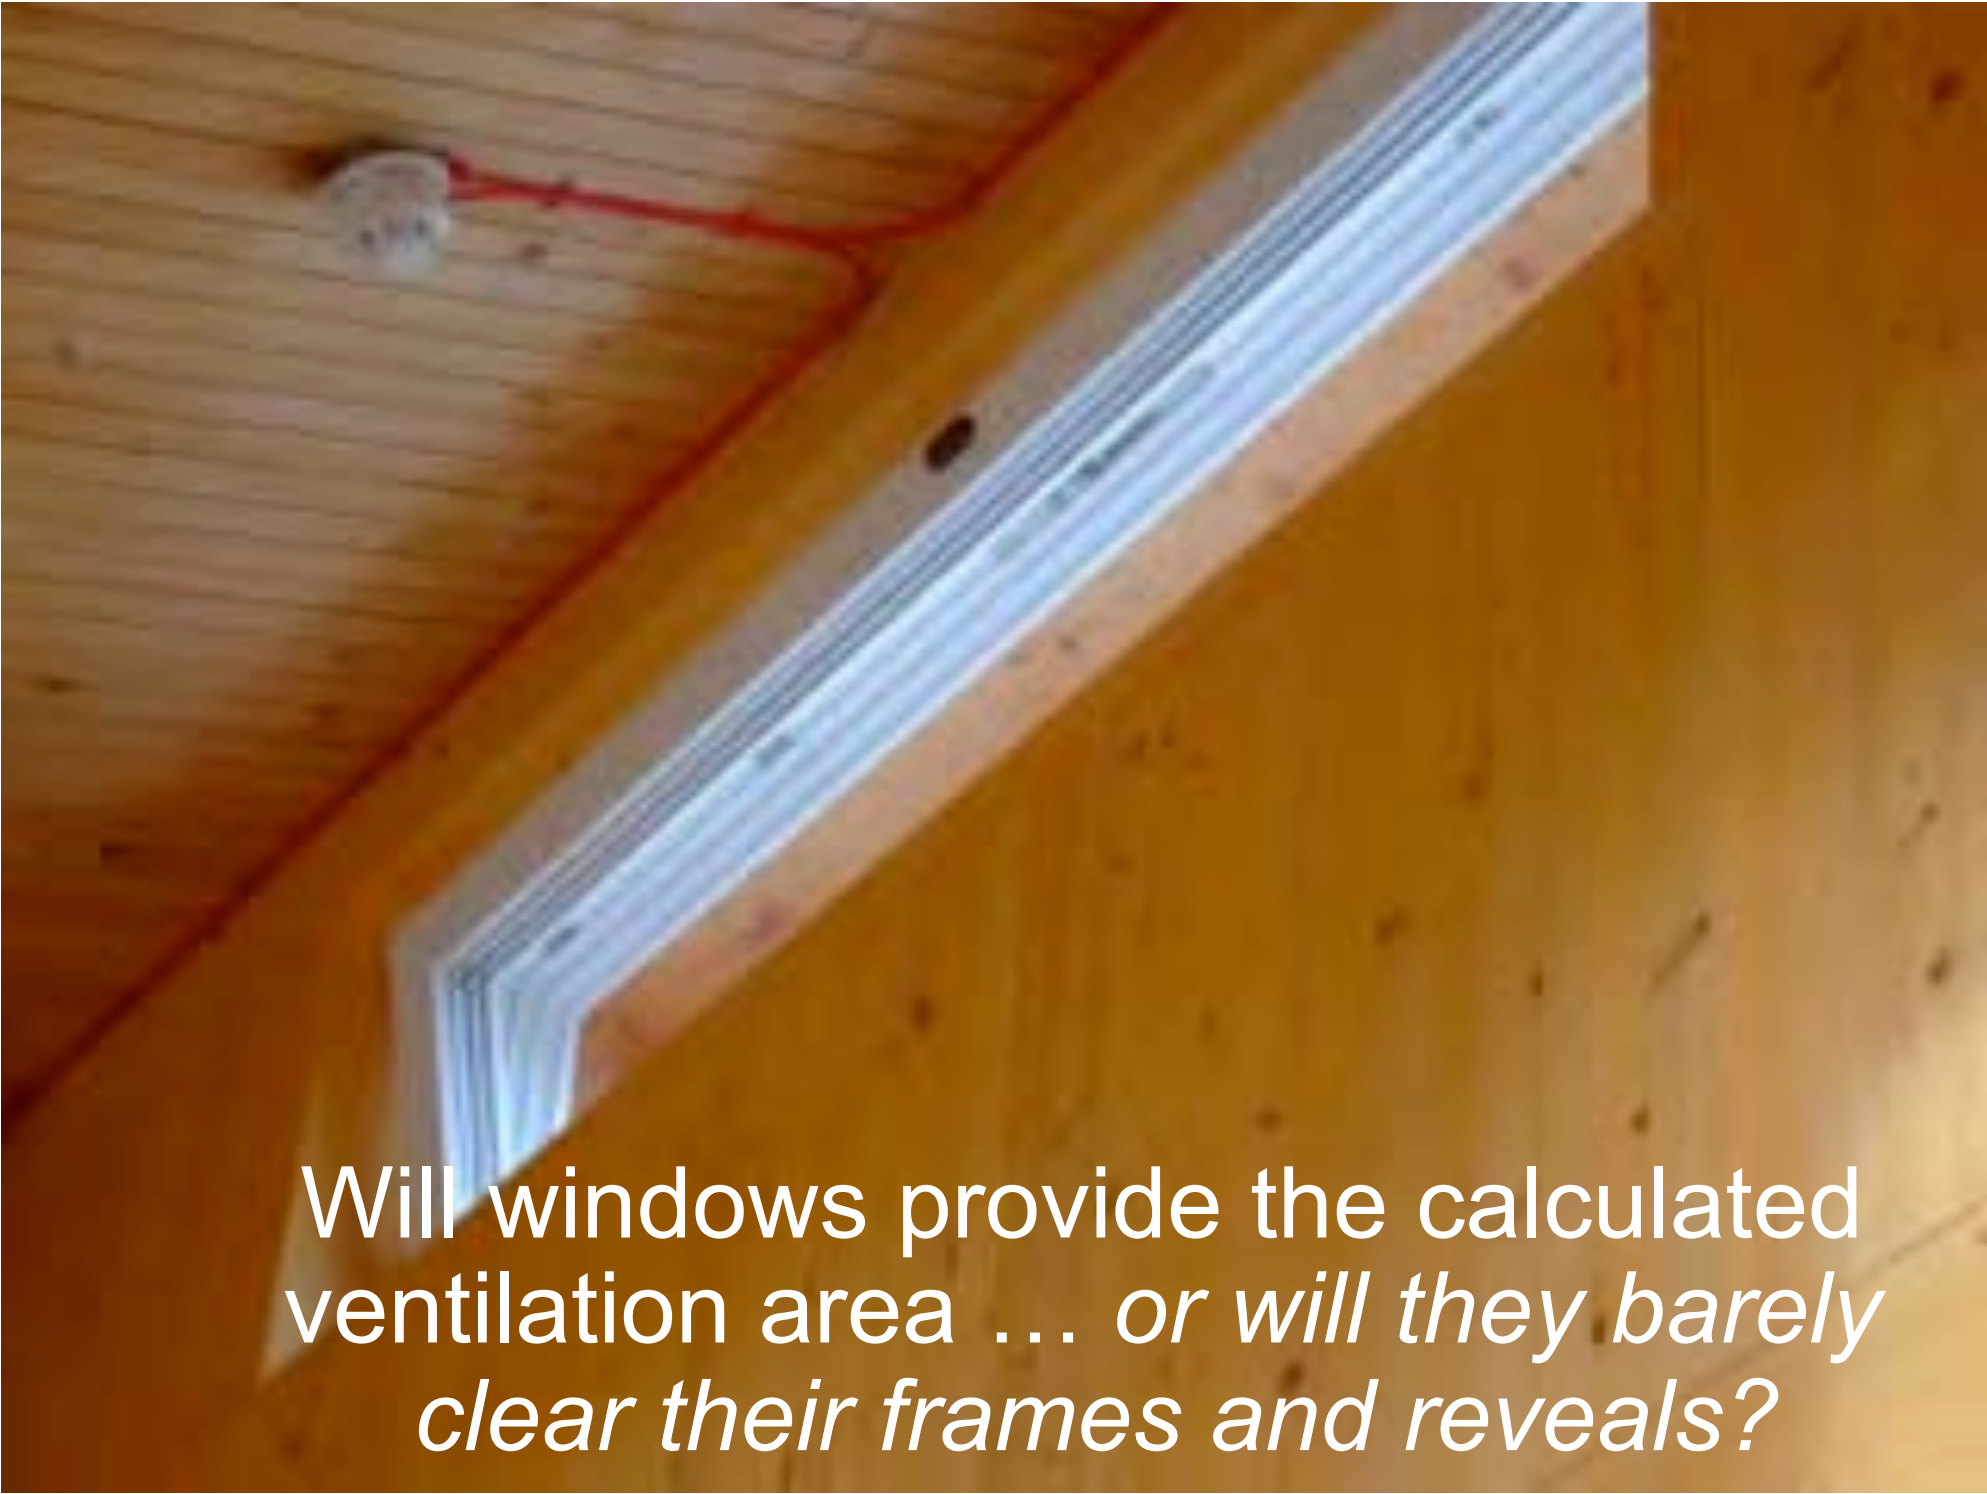
Will windows provide the calculated ventilation area ... *or will they barely clear their frames and reveals?*

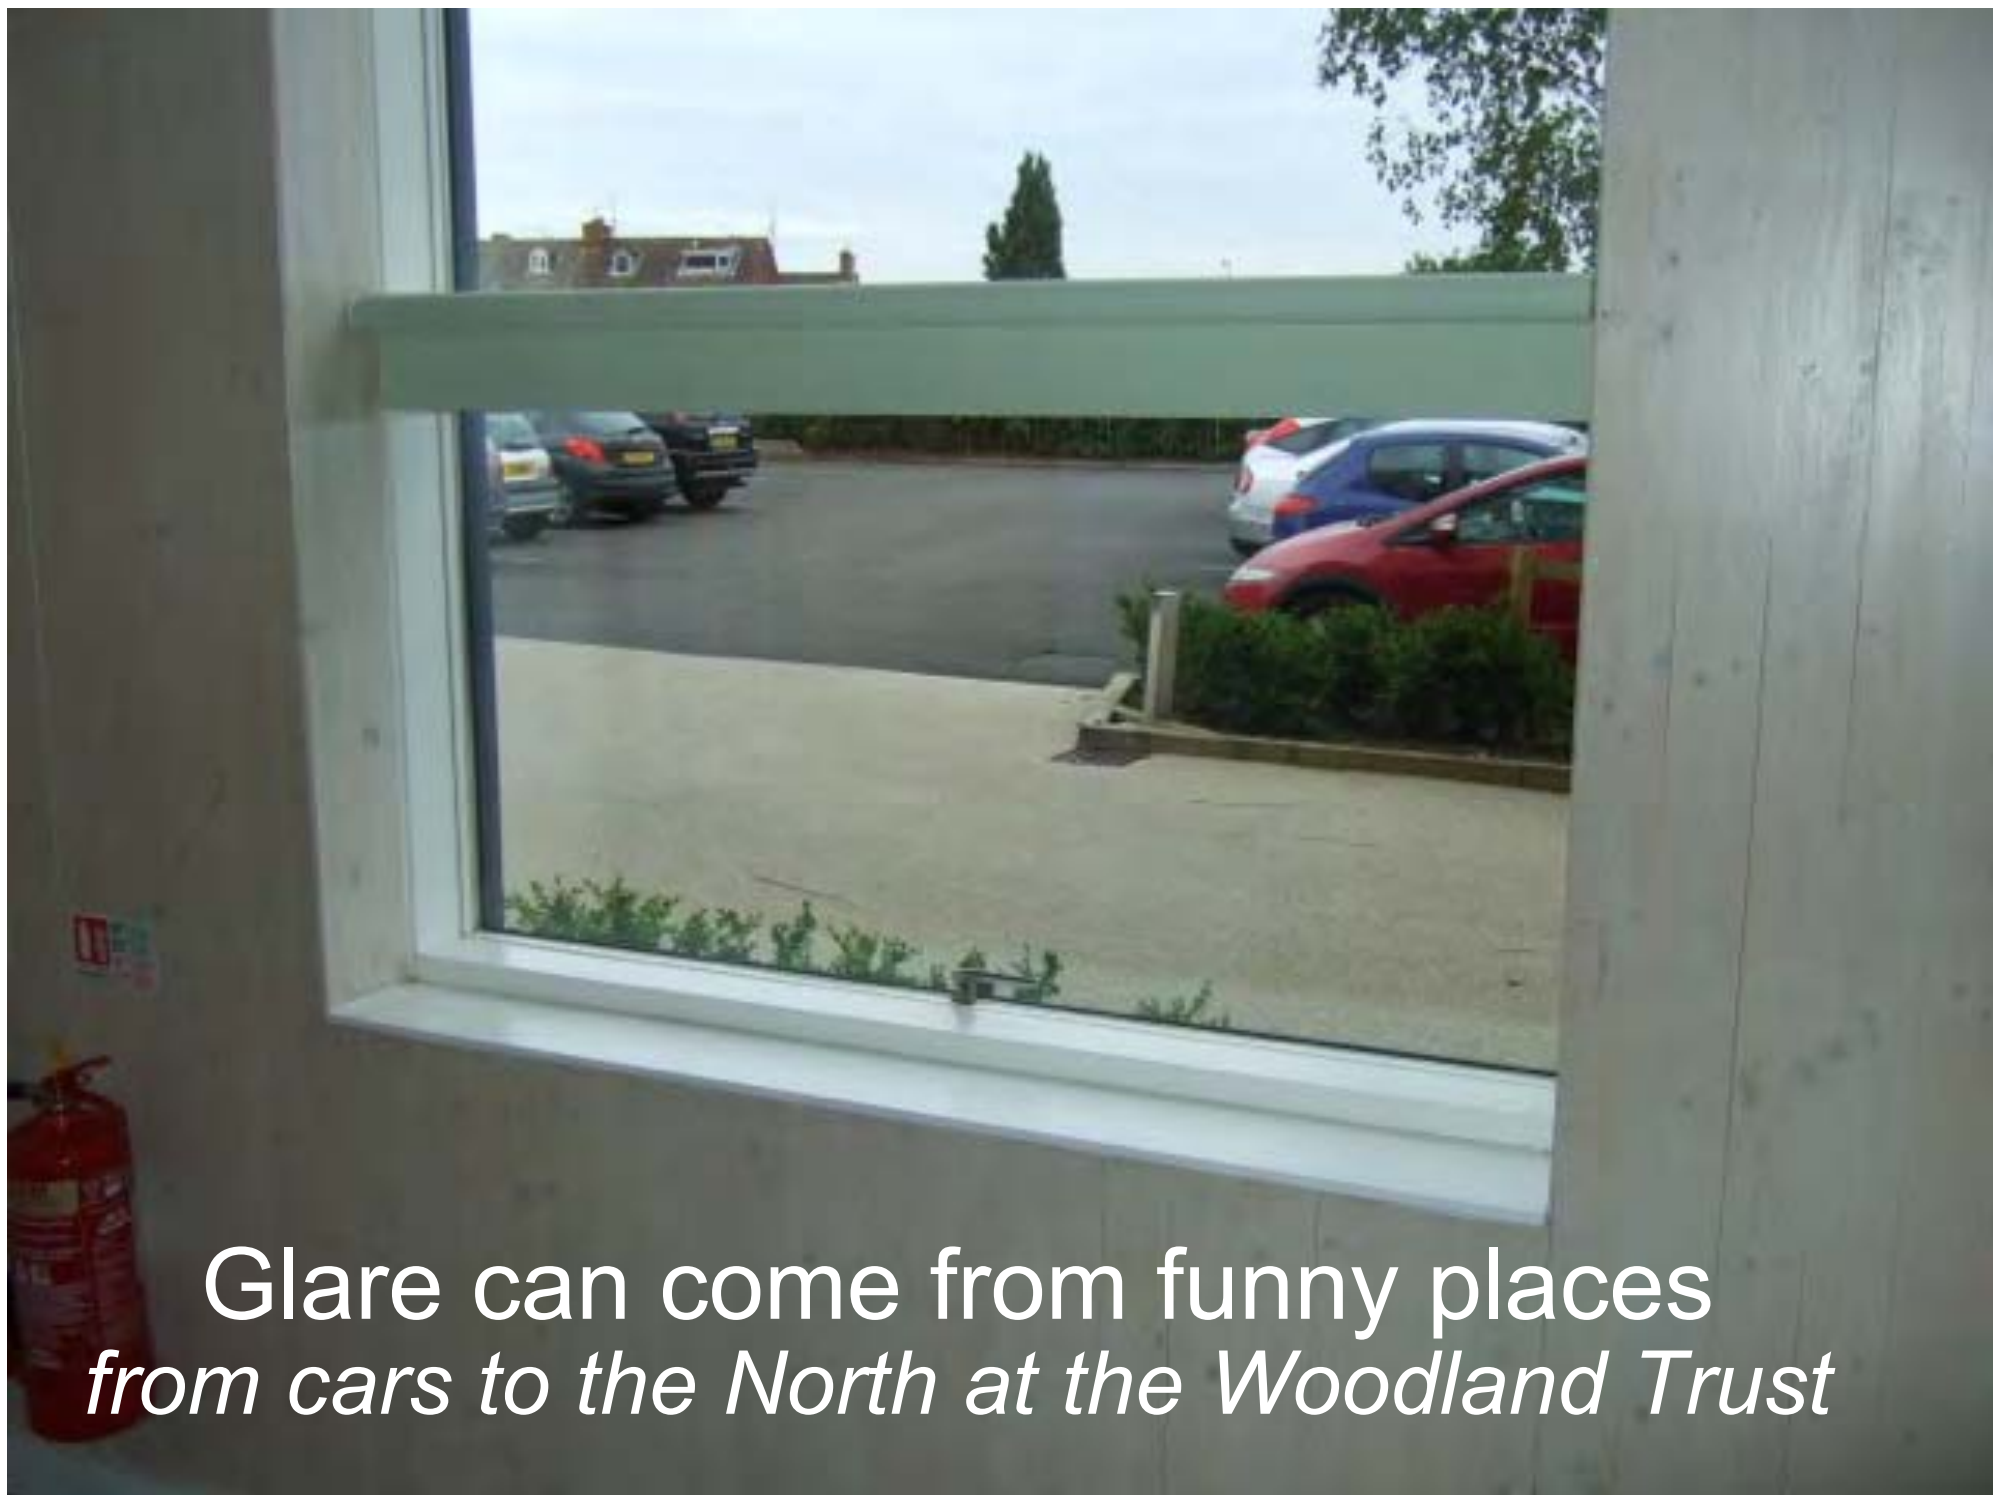
Glare can come from funny places
from cars to the North at the Woodland Trust

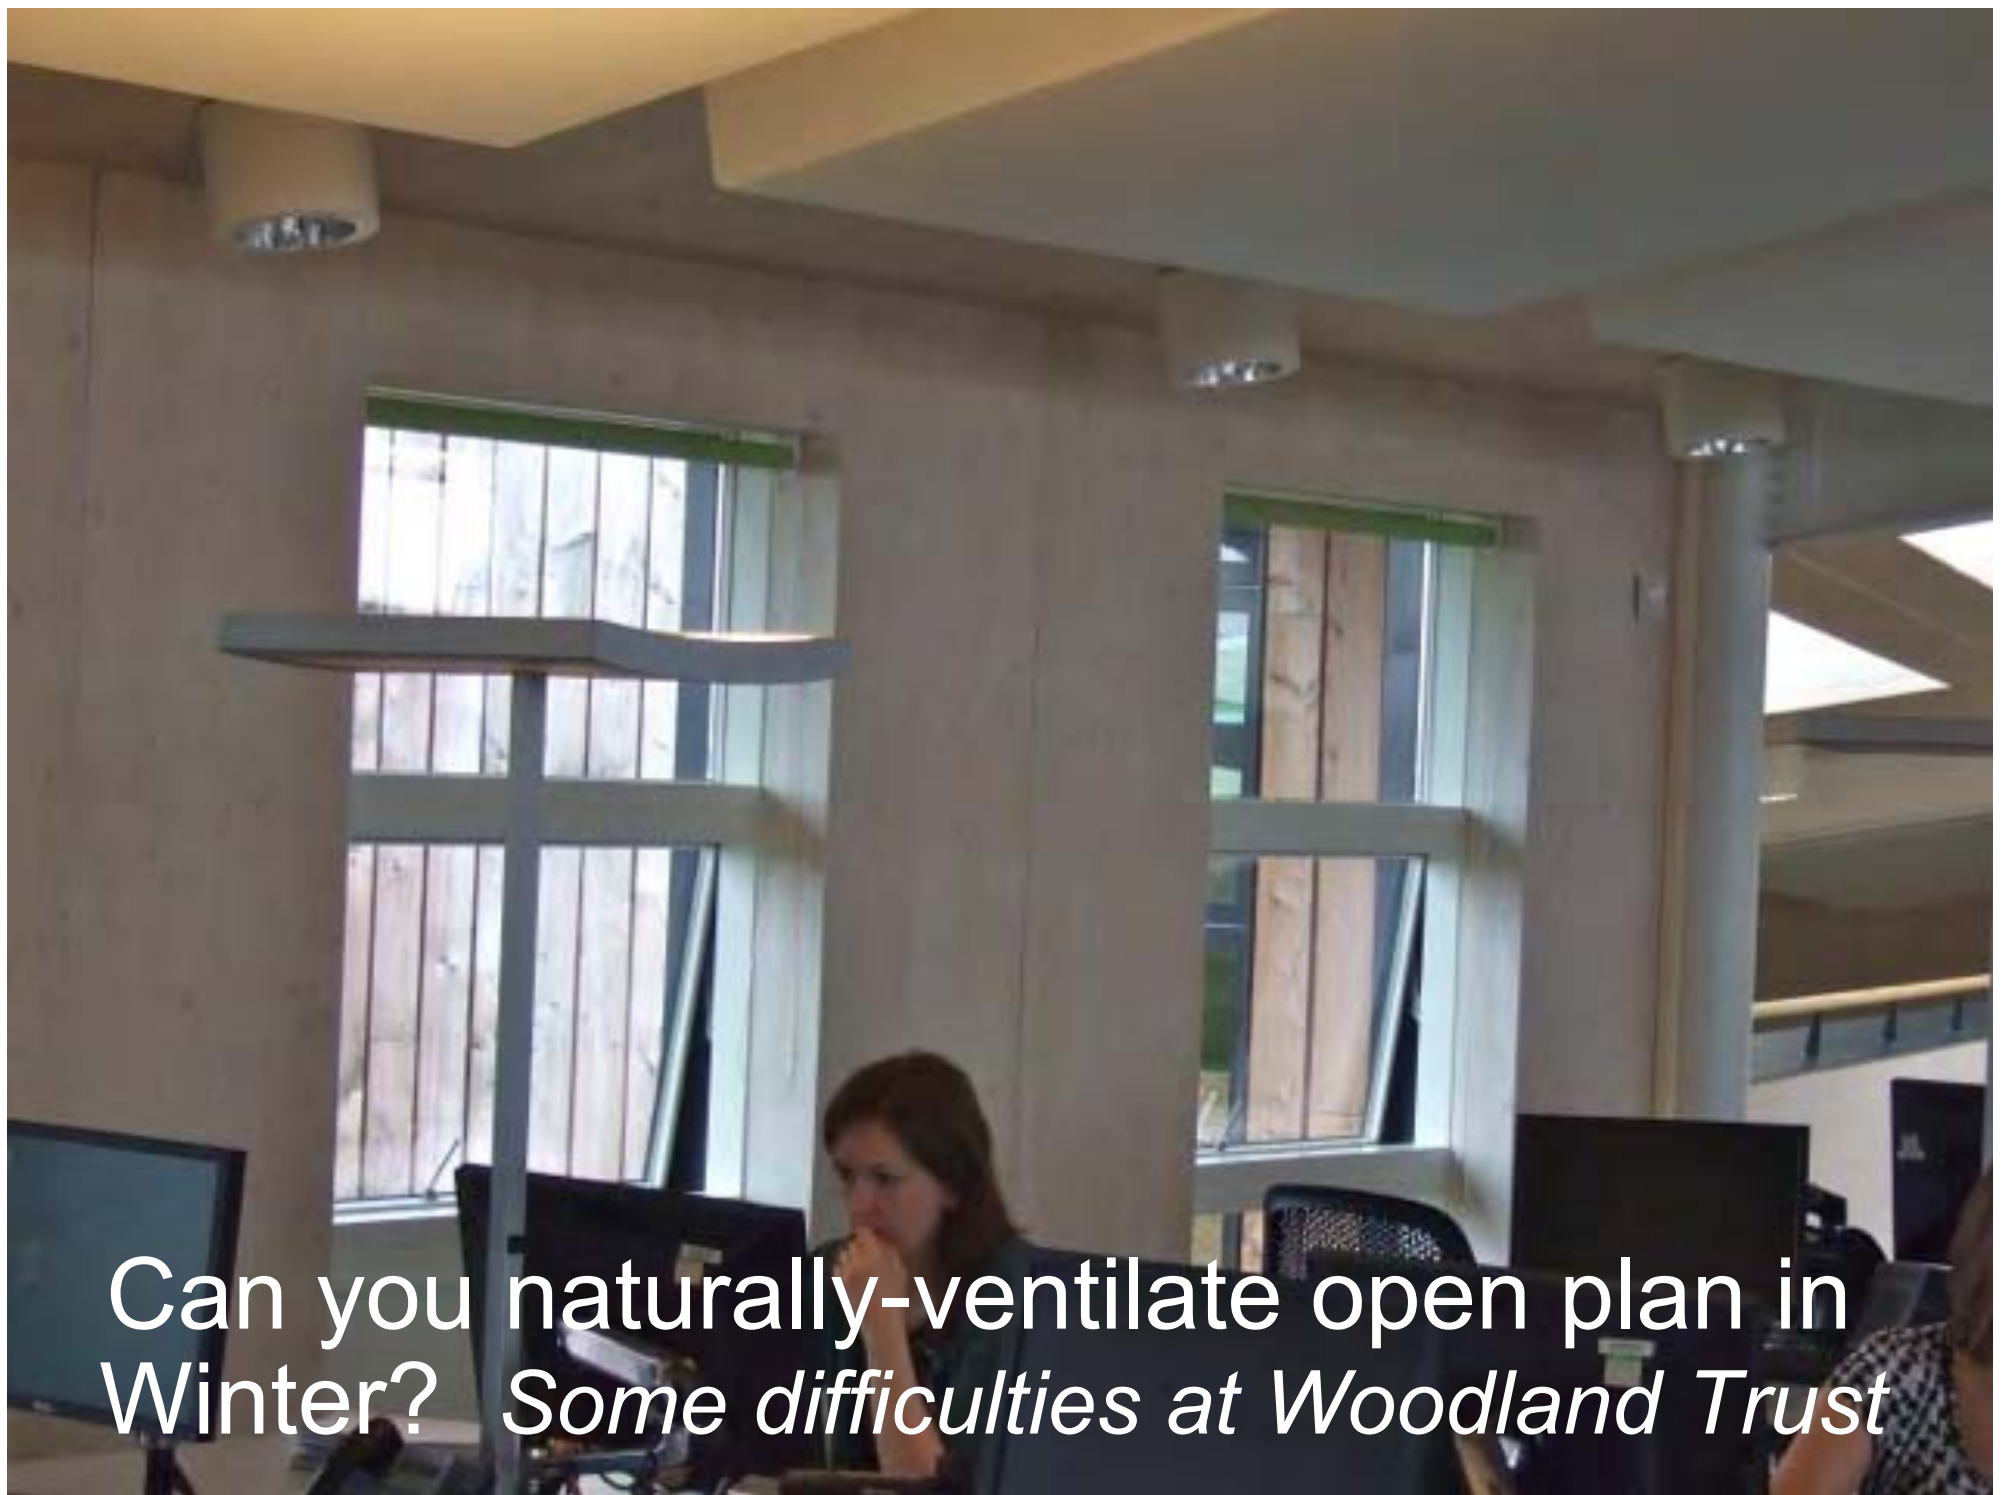
Can you naturally-ventilate open plan in Winter? *Some difficulties at Woodland Trust*
