Queens Building

De Montfort University

Roderic Bunn revisits De Montfort University's Queens Building, an award-winning project considered a trailblazer of passive solar design. How is it performing a decade on?

BSRIA PROJECT REVISIT

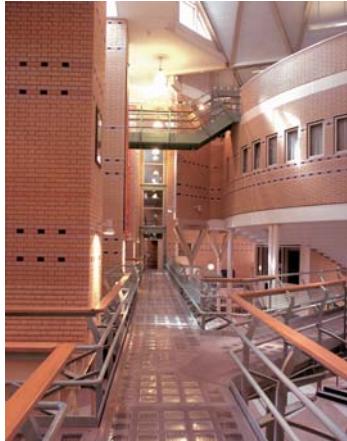
Above: The first floor walkway through the central concourse showing the rear of auditorium 1.12. Feature lighting is on almost permanently in this well daylit space.

While the increase in electrical use may be a combination of high concentration of computers and the changes of use of the engineering wing, the relatively inefficient electric feature lighting in the main concourse has defaulted to on, despite very good daylighting. Lighting controls in many open plan areas and laboratories seem either non-existent or nonsensical in operation. In one lab, the fluorescent lights were on in the daylit perimeter, but off in the central area. A notable exception is the offices for the IESD where a daylight-linked dimming system has been installed.

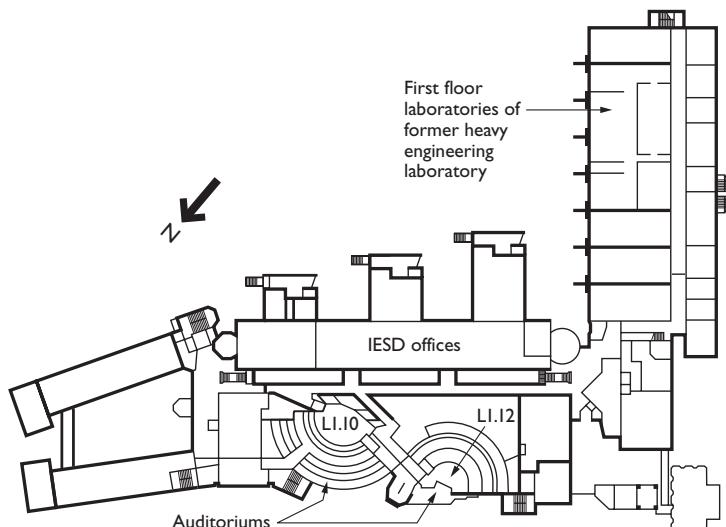
The Institute of Energy and Sustainable Development occupies the former m& lab. Improved electric lighting, glare control and replacement of the rooflight motors (now under the direct control of occupants) has improved comfort conditions.

The IESD has replaced the motors for the rooflights. The original motors burned out shortly after they were first installed.

"The Queens Building was one of the first of the new generation of naturally ventilated buildings, and engineers weren't sure how powerful the motors had to be, or how far they should drive open the windows," explained the IESD's Dr Malcolm Cook. "As a result the motors were under too much strain."

A decade might seem an inordinately long time for failed motors to be replaced, but the engineering staff weren't bothered by the leaky rooflights, being able to both move around, and be warmed by large, heat-generating machinery. Today, the IESD staff can open and close the rooflight vents via wall-mounted switches.

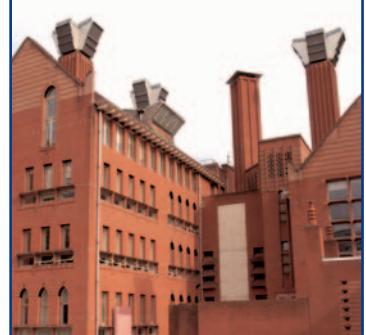
The former drawing office on the third floor of the main building suffers from overheating. Motors serving the ridge ventilators may be those that burned out soon after occupation. In any case they are switched off. Direct solar gain on the lightweight roof, coupled to high heat gains from computers, make this area very hot in summer. The electric lighting tends to remain on in this well daylit space.

The third floor of the Queens building was originally designed as an open-plan drawing studio, with copious amounts of daylight from glazed ventilators in the roof gables and large, triangular windows on the east-facing elevation.

Drawing boards went out of fashion very early on, and the space was subsequently used by other departments. Today, it is home to banks of computers for student use. As in the machine shop, the motors serving the ridge ventilators burned out. Previous occupants of the space found ways to wedge open the ventilators, but at the time of writing the vents were found to be closed and the motors switched off.

There seems little effective ventilation in the space. With a lack of thermal mass in the roof, heat from the computers and hot air rising up from low levels, the former drawing studio is a hot space in summer.

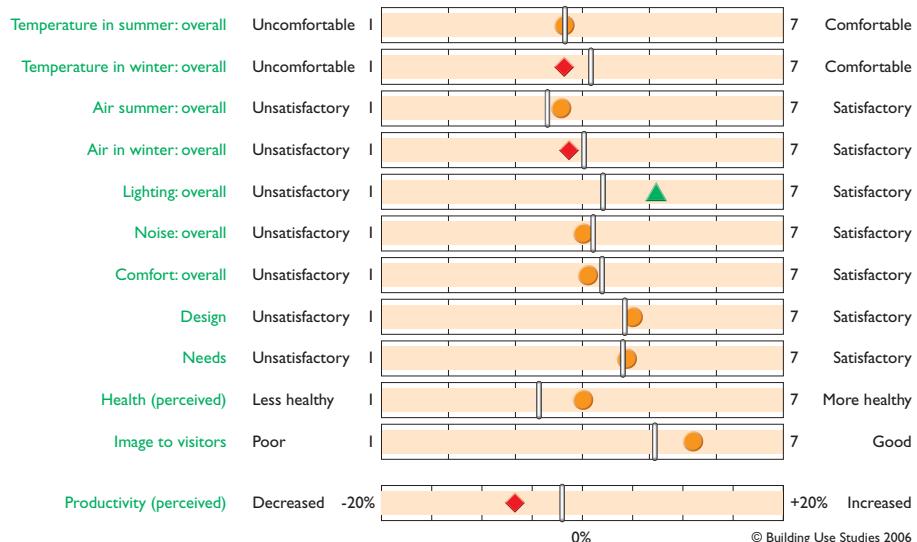
Building Use Studies carried out a new occupant satisfaction survey on the Queens Building using the PROBE methodology. Green triangles represent mean values significantly better or higher than both the benchmark and scale midpoint. Amber circles are mean values no different from benchmark. Red diamonds are mean values worse or lower than benchmark and scale midpoint. Be careful to read the directions of the scales and the scale labels. Benchmarks are represented by the white line through each variable.

In general terms, satisfaction with temperature in both summer and winter is the same, although occupants perceive the air in winter to be better. Productivity has improved by around four percent, but the building still suffers a minus score as it did in 1996. Lighting and noise scores are better.

Levels of occupant satisfaction are very dependent on location. For example, the relatively high occupant satisfaction in the refurbished IESD offices is not matched by those occupying the new laboratories.

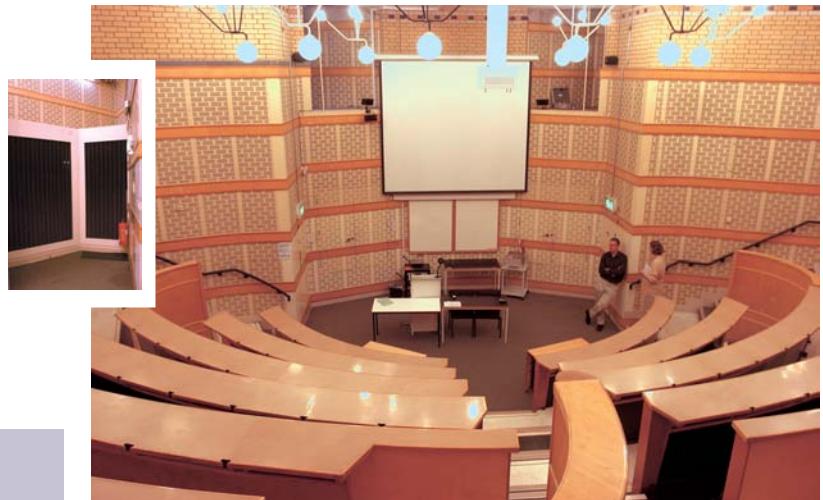
Auditorium 1.10 is the building's flagship space. The natural ventilation works well, with heat accumulating at high level and exhausting through two chimney stacks behind the screen. For auditorium 1.12, the heating coils set in the external wall (*inset*) are unable to raise the temperature of incoming air winter.

The hemispherical auditoriums sit side-by-side along the north-west elevation, with the second auditorium rotated through 180°, ostensibly as a space-saving manoeuvre. Both rely on buoyancy-driven ventilation, with incoming air tempered by traversing a concrete plenum beneath the seating and

extracted through tall, insulated chimneys. The strategy has worked well for the auditorium that is orientated with its raked seating backing onto the road, but has arguably failed for the other auditorium.

Some incoming air for the second auditorium does traverse a convoluted route to reach the seating plenum, but the greater proportion takes the line of least resistance, entering the space directly past heating coils set into the perimeter wall. The incoming air is simply not in contact with the heating coils long enough to raise its temperature, and a lack of turbulent flow creates serious stratification problems. The result can lead to an 8°C difference between the upper and lower seating areas.

Malcom Cook postulates that blanking off a proportion of the supply grille may encourage better mixing.
