# West Suffolk House

First published October 2011

by Roderic Bunn

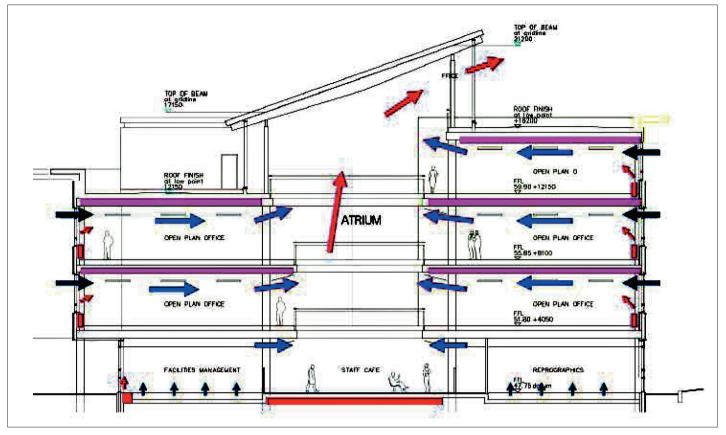
The building's natural ventilation strategy.

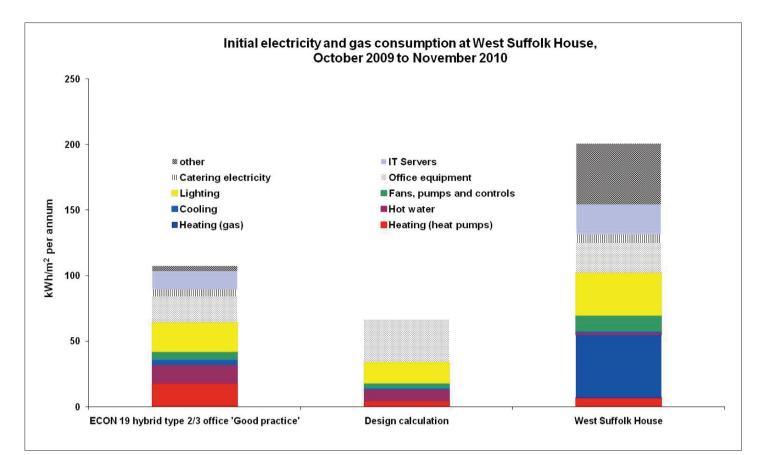
Total energy use at West Suffolk (including electricity for office equipment, IT servers and catering) is 201 kWh/m<sup>2</sup> per annum. This compares with the design prediction of 66.2 kWh/m<sup>2</sup> per annum (including 31.9 kWh/m<sup>2</sup> per annum for unregulated loads), and the good practice hybrid benchmark in *ECON 19* of 103 kWh/m<sup>2</sup> per annum. The *CIBSE TM46*

Figure 1: The initial energy performance of West Suffolk House against the desgin estimation and relevant benchmarks from *Energy Consumption Guide 19 (ECON 19)*.

median benchmark is 215 kWh/m<sup>2</sup> per annum.

Despite a design calculation for gas consumption being 13.9 kWh/m<sup>2</sup> per annum, gas was used extensively in winter when the heat pumps were meant to be the main source of heat. Given that gas consumption was 48.3 kWh/m<sup>2</sup> per annum, the boilers must be picking up at least 50 per cent of the load. To put this into a broader context, the *ECON 19* good practice benchmark is 81 kWh/m<sup>2</sup>.

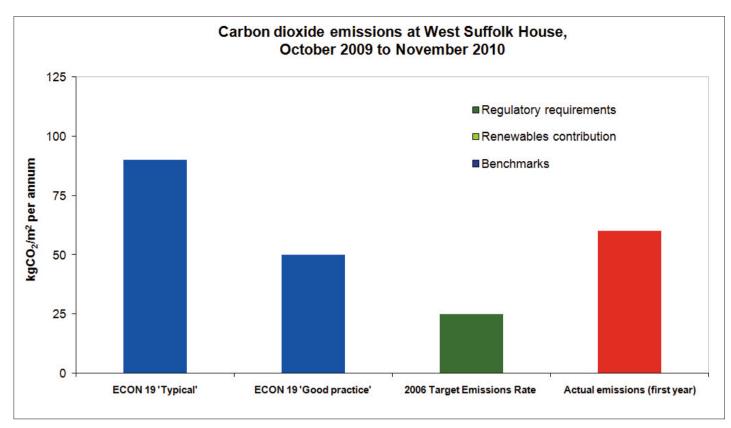
**Figure 2:** The initial carbon dioxide emissions for West Suffolk House against the Energy Performance Certificate and relevant benchmarks from *Energy Consumption Guide 19 (ECON 19*). The carbon factors used to calculate emissions were 0.198 for fossil fuel (gas) and 0.423 for electricity.

The energy data extrapolates to the building's carbon dioxide emissions (Figure 2). The energy consumption of West Suffolk House equates to actual carbon dioxide emissions of 88.4 kgCO<sub>2</sub>/m<sup>2</sup> per annum, nearly three times the design estimate of 31.4 kgCO<sub>2</sub>/m<sup>2</sup> per annum (Figure 2). The *ECON 19* good practice (hybrid) benchmark is 51.8 kgCO<sub>2</sub>/m<sup>2</sup> per annum. The median value in CIBSE *TM46* is 75.1 kgCO<sub>2</sub>/m<sup>2</sup> per annum.

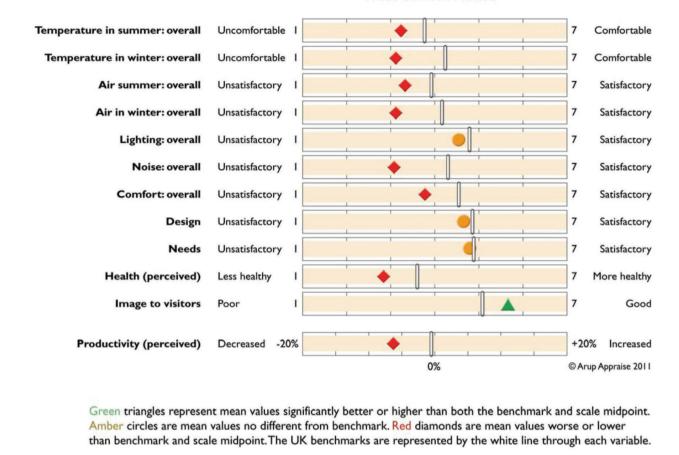
Be careful to read the directions of the scales and the scale labels.

Figure 3: The results of the Building Use Studies occupant satisfaction survey.

Figure 3 shows the building's performance against the 12 BUS summary comfort variables. In terms of overall satisfaction, West Suffolk House has scored poorly. Internal temperature, air quality, noise, health and overall comfort all received low scores compared with the rolling BUS benchmark dataset of 80 comparable buildings. Satisfaction with lighting, the degree to which needs were met, and the design of the building were all close to the benchmark average.
