A DISAPPOINTING PERFORMANCE

Laban dance centre swept the critics off their feet when its gleaming facades were first unveiled. But for the school, poorly functioning services mean it's just a pretty face, says Andy Pearson

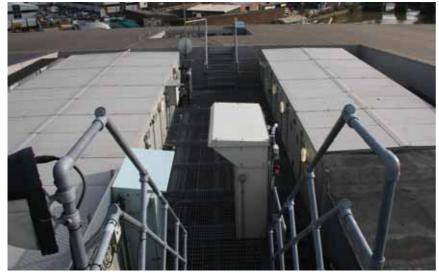
RIGHT: The ahus are squeezed into a pit on the building's roof. ABOVE LEFT: A baffle was added to prevent air short circuiting between the unit's intake and exhaust louvres. ABOVE RIGHT: Since completion a curved scoop has been added to throw the exhaust air clear of the roof pit

Squeezing the large double-deck air handling unit serving the dance studios into the tiny plant-well, so that its adjacent supply and exhaust louvres are about 1m from the wall, has caused short circuiting problems. As a result of the wall's proximity air from the units exhaust was found to be short-circuiting into the adjacent intake louvre. According to Fitch this resulted in a 2°C increase in air temperature at the intake. It may also have reduced the amount of fresh air supplied to the building, which might go some way to explaining the "breathlessness" reported by some of the dancers. To overcome this problem, Fitch designed and fitted a vertical baffle plate, which he had fabricated locally, to separate the intake from the exhaust (see photographs, opposite).

A similar problem existed on the double deck air-handling unit serving the general areas. Here a curved cowl has had to be installed to direct hot exhaust air out of the pit and away from the intake below. Both problems would appear to have arisen as a result of the squeezing these large air handling units into such a small space. The consultants admit that this was a poor solution under the circumstances: "It is not an excuse, we should have dealt with that better," acknowledges Keelin.

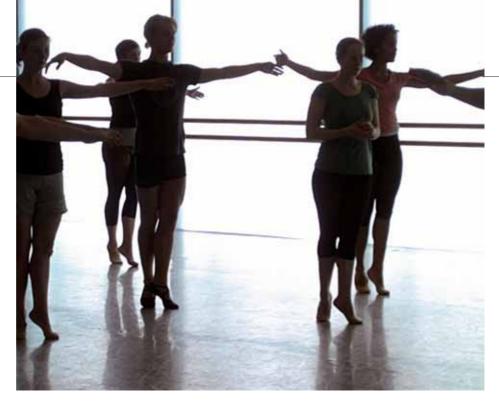
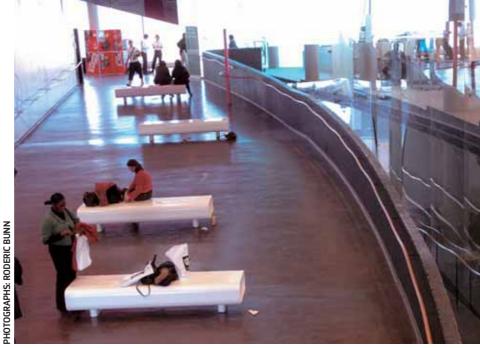
However daylight introduced issues such as glare. Before construction started, Arup Lighting spent a year working out the colour intensities and levels of light for the dance studios; the consultant even built a half-scale mock-up to test the various solutions. The mock-up also helped to conclude that white diffuse laminated double-glazing was the best glass treatment to soften and diffuse the light coming into the building through the facade to the studios. The solution appears to work well. However, the intensity of these luminous walls

does make the students appear as silhouettes against the luminous walls making it difficult to see their facial expressions.
