APU Learning Resource Centre

Robert Cohen, Adrian Leaman, Darren Robinson and Mark Standeven report on how the Queens Building at Anglia Polytechnic University, the final building in our post-occupancy review series, has performed since completion. To understand the building's detailed design readers must refer to the original article "Making light work", which appeared in the November 1994 issue of *Building Services Journal*.

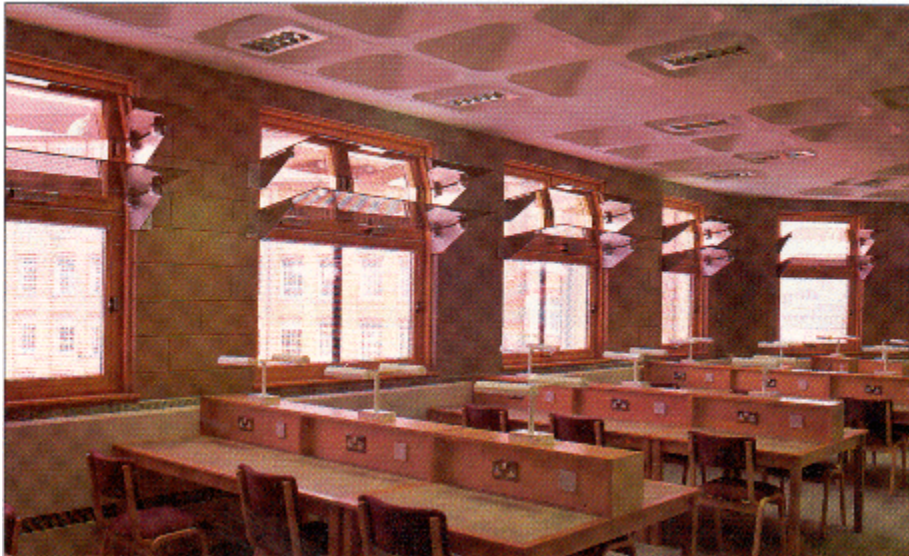
The library desks. A study carried out by a building physics researcher revealed a rapid reduction in daylight levels away from the perimeter. Hence plans to fit coffer infill panels at the facade and atrium boundaries.

Daylighting The twin mirrored-glass lightshelves are cumbersome and ineffective in enhancing light levels deep into the space. Once it was known that the flat ceiling slab was going to be replaced by a waffle slab, the use of such expensive light shelves might have been reconsidered. Single opaque versions of the same dimensions might have provided sufficient protection against glare and direct solar radiation in perimeter areas.

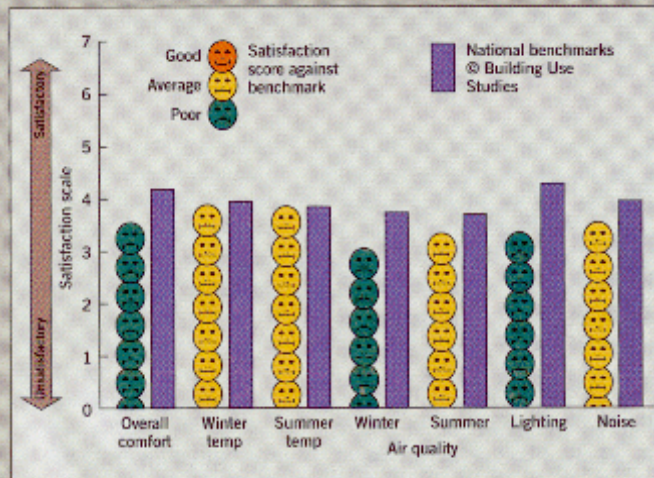
FIGURE 2: Overall satisfaction scores compared with national benchmarks.

Against national benchmarks, overall comfort of staff at APU was significantly lower than the mean (figure 2). Perceived temperatures in winter/summer and air quality in summer were no different to the benchmarks, although winter air quality was less satisfactory.

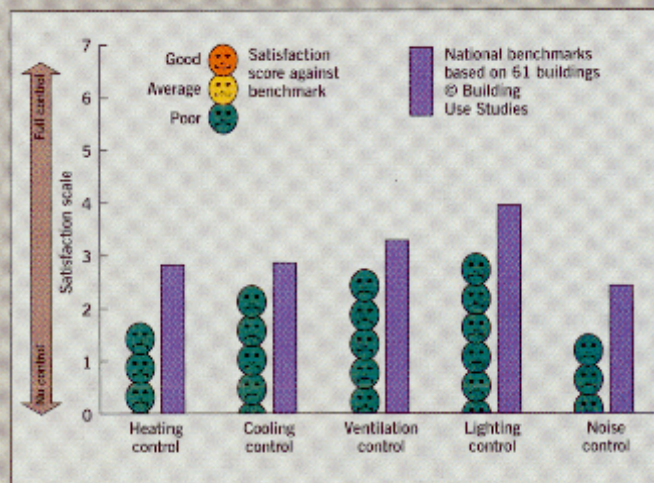
FIGURE 3: Occupancy satisfaction with control strategies.

The LRC is worse than the norms for control of all environmental characteristics (figure 3). However, there is no difference in the quickness of response of all characteristics except noise, which is less quick and reflects the fact that there is little one can do to reduce noise travelling between atrium floors, or that coming through an automatically opened window for which there is no local override.

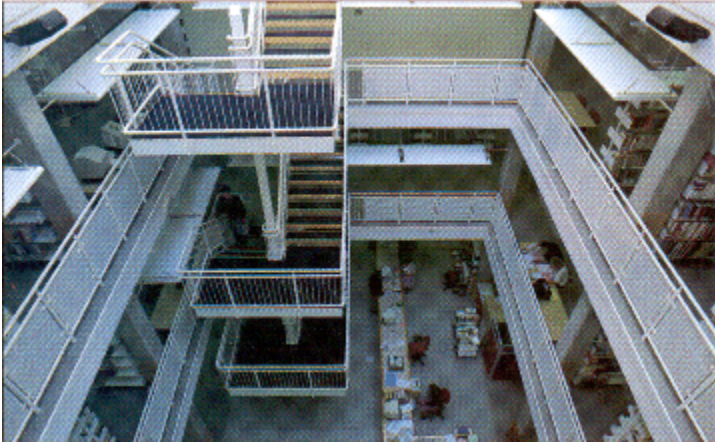
Top floor atrium light levels of 45 000 lux were measured on the main stairs when the atrium lights were on.

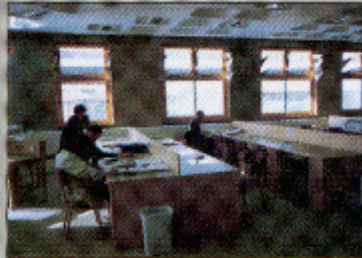
Daylight levels from the perimeter drop quickly, probably due to the waffle slab.

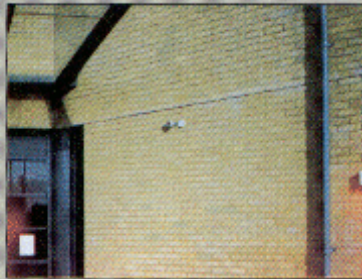
The external air temperature sensor exposed to the sun.

Students began using the building in September 1994. During the first winter the north of the building experienced underheating problems. Under the terms of the warranty, the contractor increased the primary flow temperature set-point. This helped to reduce the underheating problem, but caused overheating in the southern parts of the building. The underheating could be exacerbated by the external temperature sensor being located on a west-facing wall, which is in full sun from about 15.00 h onwards. Sensor readings are used for flow temperature compensation.

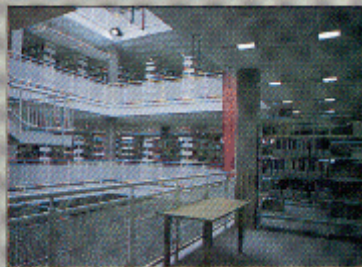
The second floor, showing the circulation lighting on despite good daylighting from the north atrium.

The o&m manuals state that, if any luminaires identified for corridor lighting or any main lighting are manually switched on, all corridor lighting is switched on until 30 minutes after the last main lighting has been switched off. Discussions with security staff seem to confirm this operation as they manually switch on the atrium projector lamps hourly during the night, which causes all corridor and circulation lights to switch on.

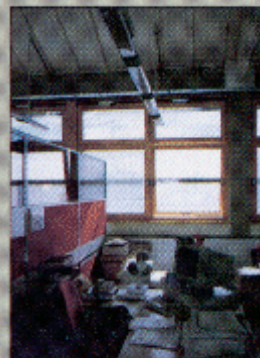
Between June 1995 and July 1996, zones on the third floor experienced 300 h above 27°C.

During the year July 1995 to June 1996 considerable overheating was experienced, the worst in some zones on the third floor of the library, which experienced over 300 h above 27°C . However, the summer of 1995 was one of the hottest in recent years.
