# PROBE

## 11: John Cabot City Technology College

Mark Standeven, Robert Cohen, Bill Bordass and Adrian Leaman revisit the first building in our new series of post-occupancy articles: John Cabot City Technology College. To understand the building's detailed design, readers must refer to the original article "A lesson in school building" (*Building Services Journal*, May 1994).

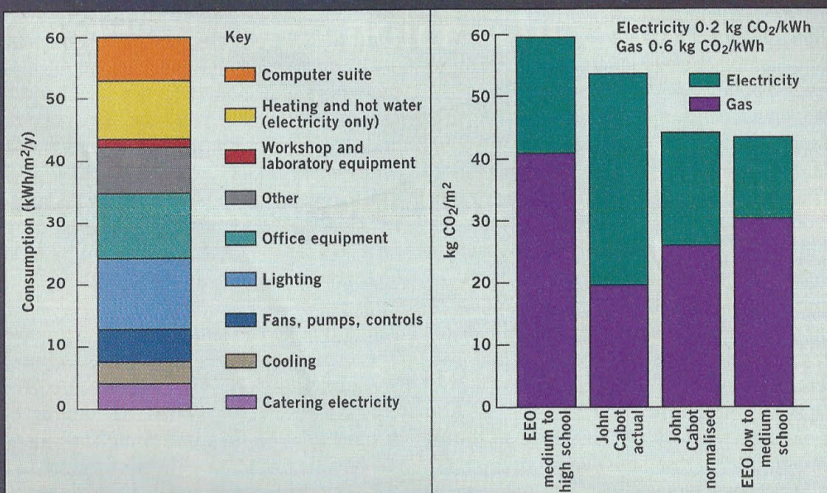
FIGURE 1: Breakdown of carbon dioxide emissions and annual electricity consumption at John Cabot CTC.

Based on the treated floor area of 8800 m<sup>2</sup>, actual gas and electricity consumption equate to 98 kWh/m<sup>2</sup> and 57 kWh/m<sup>2</sup> respectively, while weather-corrected gas consumption is estimated to be 130 kWh/m<sup>2</sup> (figure 1).

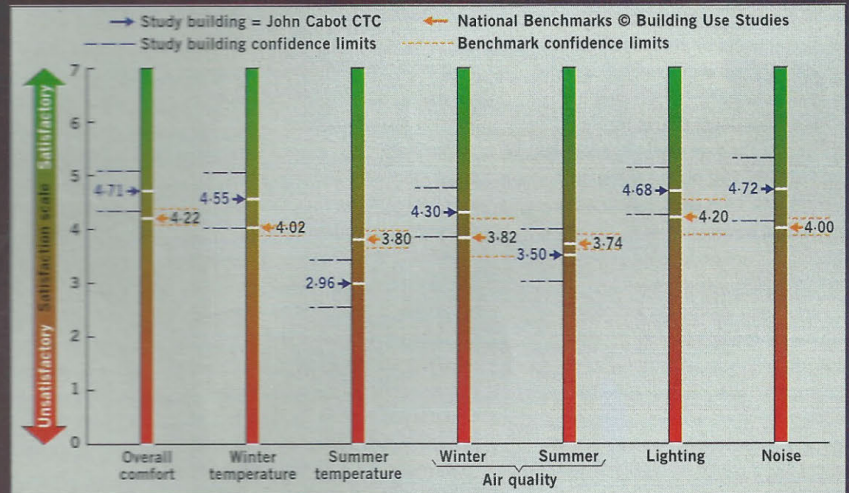
FIGURE 2: Overall satisfaction with John Cabot CTC's comfort conditions compared to BUS benchmarks.

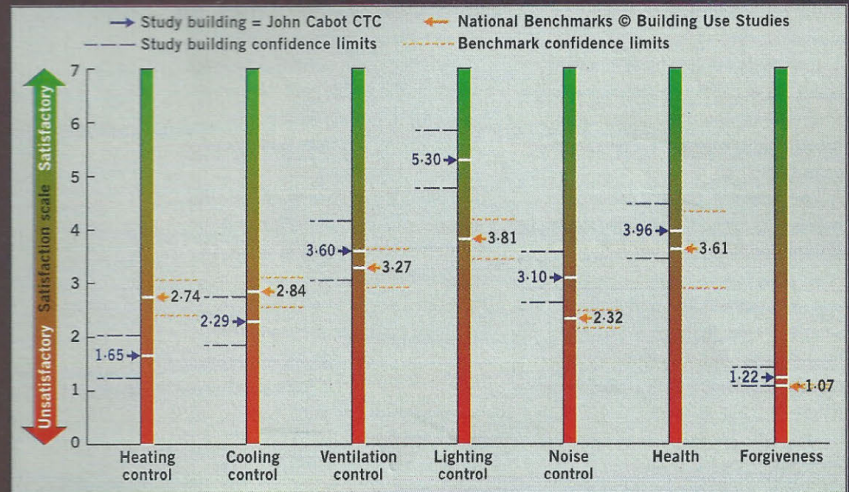
FIGURE 3: Occupant satisfaction with the building's health, management and control strategies.

Perceived productivity is good with a gain of 6% attributable to the building (within the top 10% of the BUS dataset). On matters of control (figure 3), staff reported little perceived control over heating, cooling and lighting. There is also little perceived control over noise, although this is still better than benchmarks.

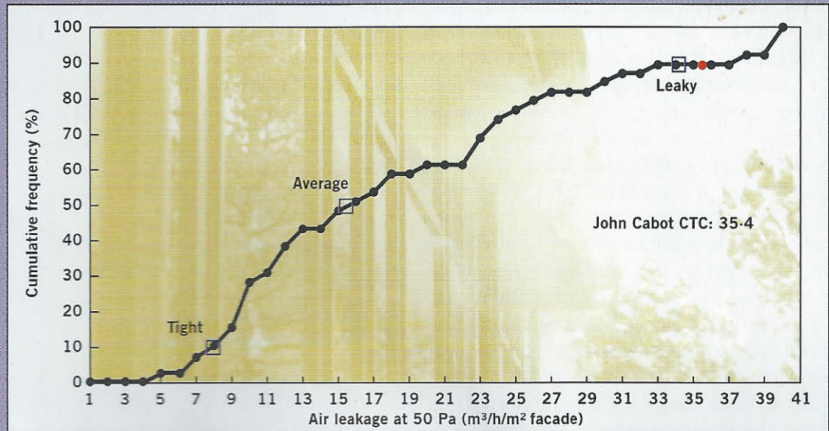
FIGURE 4: The air leakage rate of John Cabot CTC plotted on the BRE/BSRIA database.

With the non-blanked off ridge vents closed the air leakiness was measured at 23.9 m<sup>3</sup>/h/m<sup>2</sup> of envelope at 25 Pa. With the non-blanked off vents open, the corresponding leakiness was 27.6 m<sup>3</sup>/h/m<sup>2</sup> and with the vents open (but all the extracts sealed) the leakiness was 25.2 m<sup>3</sup>/h/m<sup>2</sup>.

The infiltration rate for the non-blanked off ridge vents in the closed position, corrected to a flow equivalent of 50 Pa, comes out at 35.4 m<sup>3</sup>/h/m<sup>2</sup>. This has been plotted on the recently compiled building infiltration database (figure 4). At 25 Pa test pressure, a tight building would have a leakiness of less than 5 m<sup>3</sup>/h/m<sup>2</sup> and a

leaky one more than 20 m<sup>3</sup>/h/m<sup>2</sup>. From this it can be concluded that Wing B of John Cabot is leaky, and there is no reason to think that other parts of the building would be markedly different.

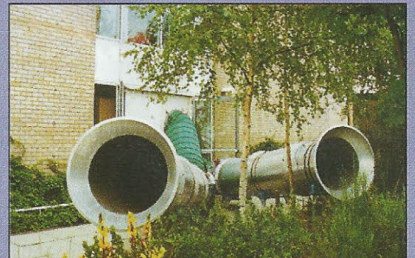
The BREFAN unit was also operated in reverse to de-pressurise the building and enable smoke tubes to identify the paths of air leakage.

By reversing fan flow, smoke pencils showed the main leakage path to be through the high-level ventilation dampers, particularly between the louvres and their housing, and around the blanking panels covering the dampers.

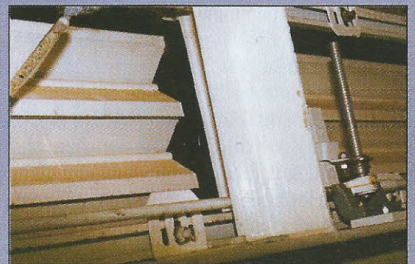
The roof-level ventilation dampers were found to be very leaky along the top and bottom blades.

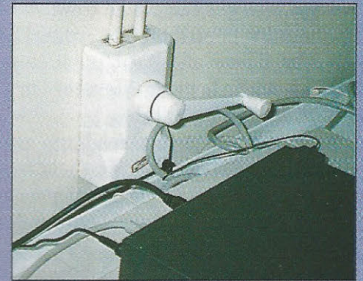
Space planning defeats technology: obstructed louvre controls in the music room.

**Ridge dampers** The summertime ventilation in the first floor corridors has been sacrificed due to the poor winter performance of the ridge-mounted ventilation louvres, which have been blanked off. This demonstrates the potential problems encountered when using mechanical services dampers as opposed to opening window technology for the control of natural ventilation.

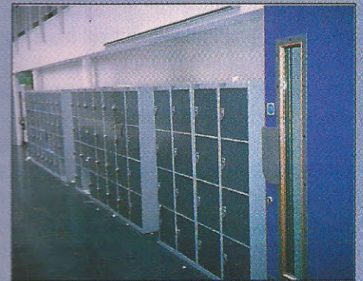
Student lockers in the circulation corridors, added after handover, are causing increasing congestion.

**Space** The brief did not allow space for lockers as it was assumed that pupils would carry all they needed. Lockers have now been placed along the walls of the main street as a lesser evil than cutting into teaching space, but the additional congestion in the main street is noticeable, a problem which may worsen with more students.

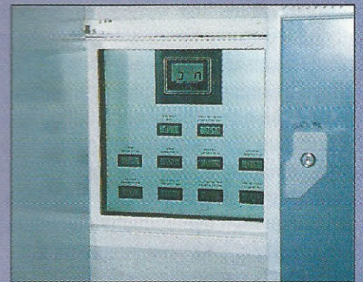
ABOVE: The bems summary display panel, intended to provide pupils with an insight into the building's performance, is not operating reliably.

**BEMS** Shortcomings in commissioning and handover have produced a lost opportunity for good control and monitoring of the building services. At John Cabot CTC, the controls have never worked properly, probably due to shortcomings in the specification, commissioning handover acceptance and lack of 'sea trials'. The users have no confidence in the systems, and the poor usability of the bems interface is also a strong deterrent to its effective use.

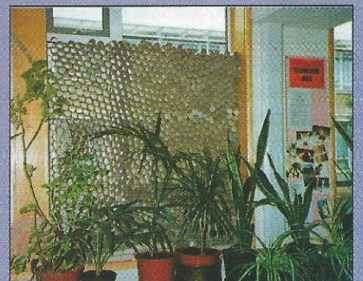
Do-it-yourself transparent insulation – stacked toilet rolls do the honours in the art studio. A patent beckons, surely...
