# The Old Apple Store, Stawell

# The Old Applestore, Stawell

Technology Strategy Board Building Performance Evaluation Programme: Initial Occupancy Study

## **Final Report**

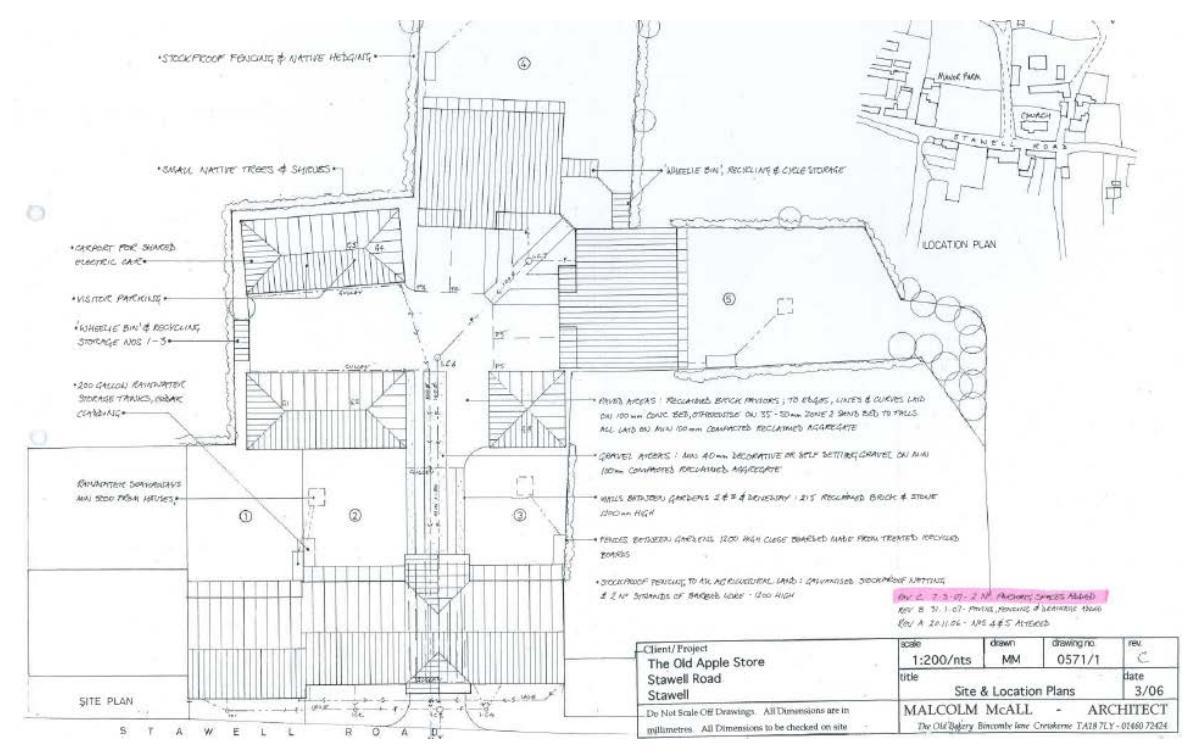
Figure 1 Site plan, March 2006, 0571/1

- 3.40. Very few changes have taken place in the intentions of the site layout since the original drawing in March 2006 (fig 1).

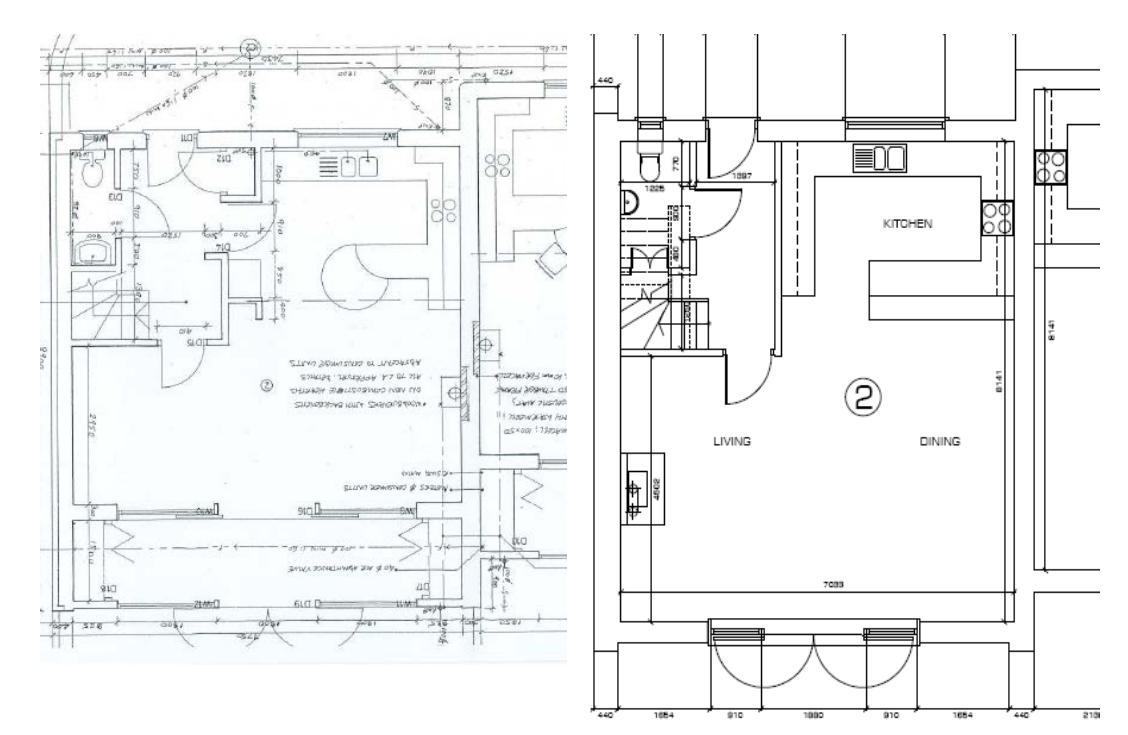
Figure 2 October 2006 ground floor plan, 0571/8

- 3.41. A number of changes have taken place to the house type number 2 since the original layouts by the design architect in October 2006.
- 3.42. Increased liveable space was achieved by including the sunspace area within the main living room and providing it with an insulated roof. (fig 2 and 3) The main driver for the reduction in glazing was a concern with overheating.

- 3.43. The arrangement of the front hall is simplified (fig 3); the provision of a bigger meter store would have been better as **the current inverter store overheats considerably and will need substantial ventilation openings** (fig 4).
- 3.44. The living room is more spacious room and the boiler changes from the kitchen side to the stair side of the building (fig 2 and 3). This has a knock on effect on the upstairs-the water services and the flue (fig 7).

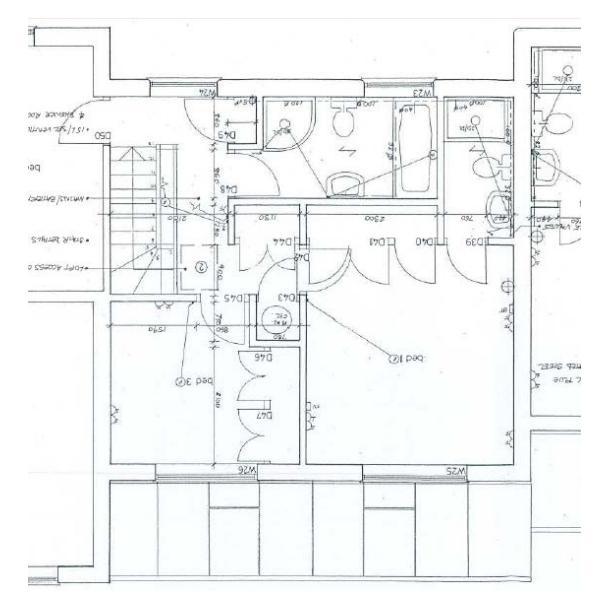
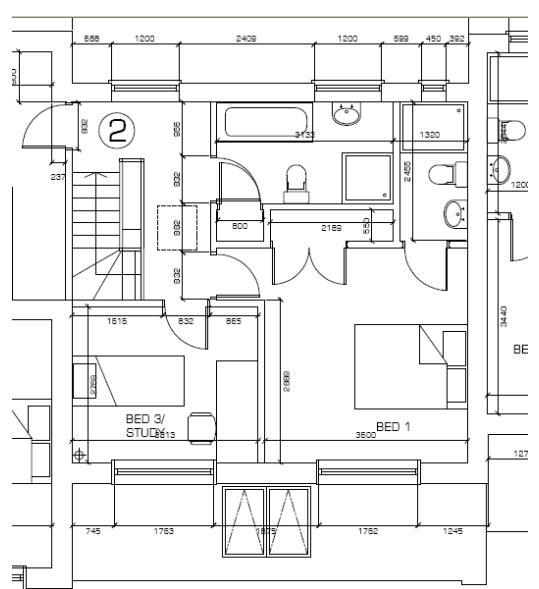
Figure 5 first floor plan October 2006,0571/10

Figure 6 first floor plan July 2007 203(10)21G

- 3.45. It is apparent from the drawings (fig 5 and 6 above) that the first floor plan has changed considerably. The cylinder store and cupboards are omitted from bedroom 3, and the cupboards rearranged around the main bathroom which is itself substantially rearranged. The flue has much more impact than the flue pipe drawing might indicate (fig 6 and 7). A small window is now included in the ensuite bathroom (fig 6) where a passive stack vent was planned.
- 3.46. The south facing elevations have changed considerably from October 2006 to July 2007 (fig 8 and 9). The conservatory (fig 10) being replaced by a single storey offshoot to the living room, smaller windows to the first floor bedrooms and a smaller window to the bedroom over the alleyway. The additional inclusion of the two roof

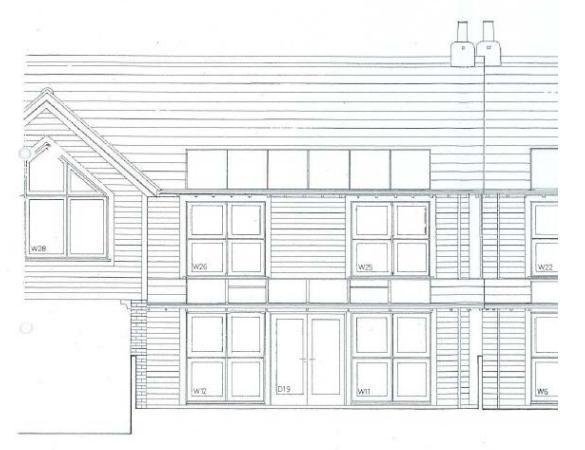
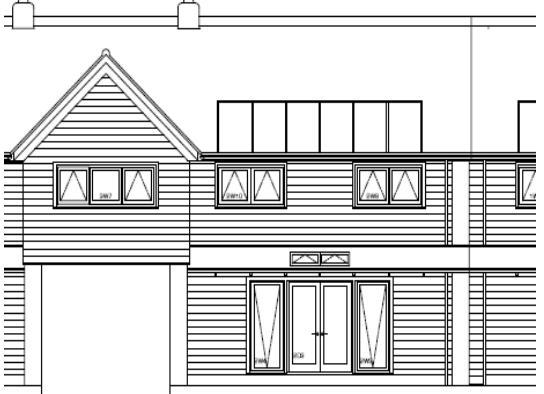
Figure 8 South elevation October 2006, 0571/14

Figure 9 South elevation, July 2007, 203(10)28

- 3.47. Moving the wood pellet stoves has the result of also changing the chimney position, the pitch of the roof over the alley way changes and the PVs appear to be a different size.
- 3.48. The North elevation first floor window has a raised cill level (fig 12) compared to the original drawing (fig 11). This is to accommodate a splash back from the sink area.

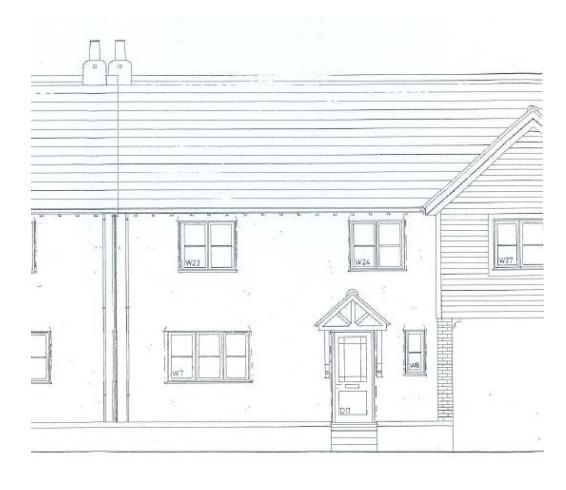
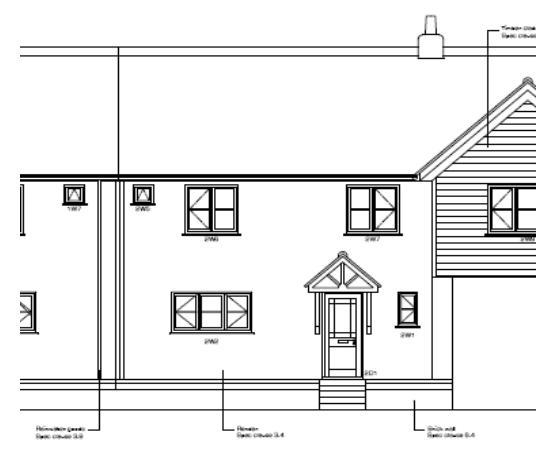
Figure 11 North elevation, October 2006, 0571/12

Figure 12 North elevation, O2i design 2007

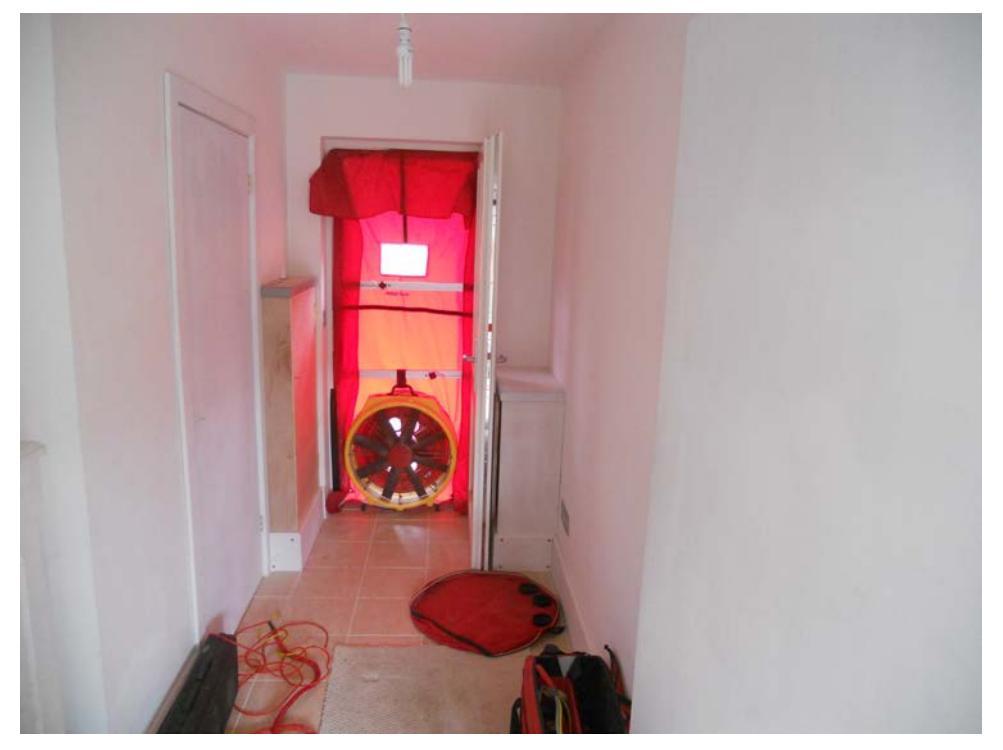
Figure 23: Air pressure testing – blower door in front door

- 4.14. Air permeability results were obtained from two tests by BAT Limited, before and after the co-heating test. The averaged results of 6.10 m³/h/m² were higher than the predicted SAP values of 5 m³/h/m².
- 4.15. It should be noted that the second test was undertaken in very windy conditions and therefore did not meet Air Tightness Testing and Measurement Association (ATTMA) criteria.
- 4.16. The house was not in a fully finished state, and it was thought that there was scope for some additional air sealing in the roof space.

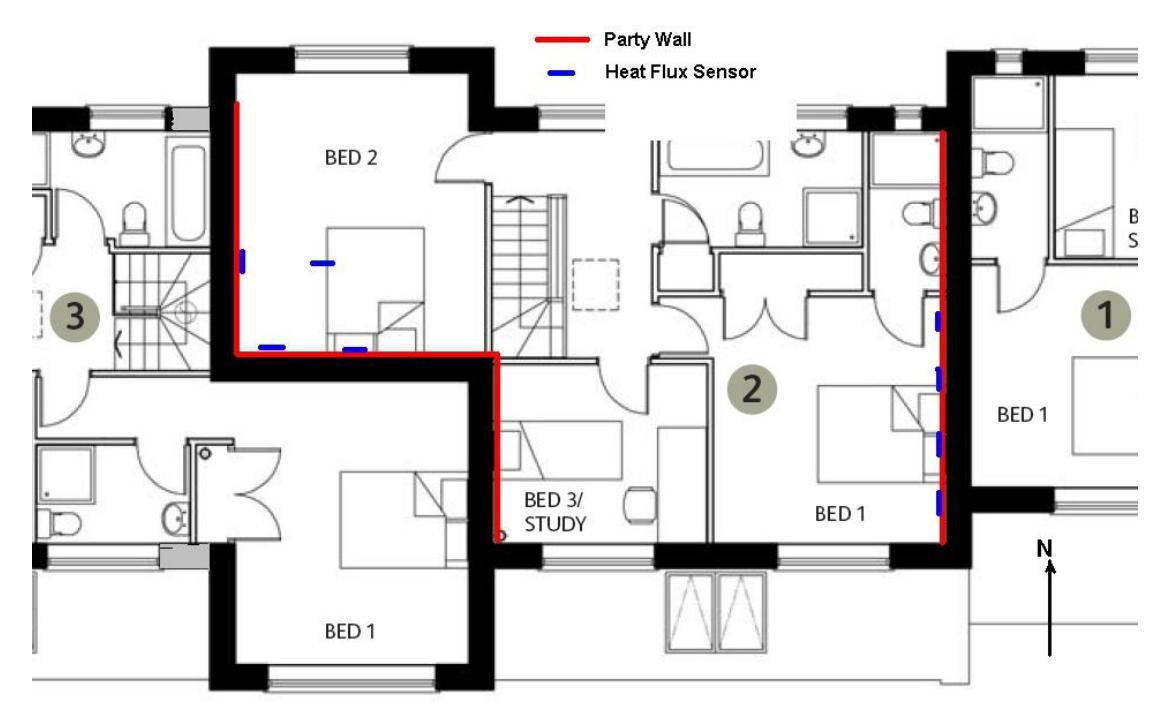
Figure 31: 1<sup>st</sup> floor plan of No.2 showing position of heat flux sensors and identified party walls.

4.26. The property tested is a terrace, sharing one party wall with No 3 (occupied) and one with No 1 (empty and heated to 25°C) as shown in the diagram below:

- 4.33. The measured rate of average heat loss of 48.26W is much bigger than expected and was found to be approximately 2.65% of the total heat loss from the building.

- 4.34. There is some party wall thermal bypass, most probably due to the party wall to foundation construction as shown below, which shows an unfilled cavity in the wall allowing air currents and thermal bridging to occur at the base of the Celcon blocks abutting the foundations:

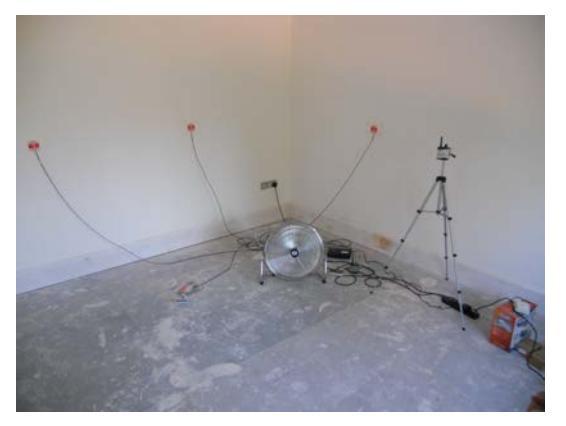
Figure 32: Heat flux sensors on Bedroom 2 party wall and floor

4.27. An array of three heat flux sensors (HFS) was installed initially on the Bedroom 2 party wall adjoining No 3 to record heat flux every ten minutes throughout the co-heating test. Two sensors were fixed to the south wall and one to the west wall. In addition ones sensor was fixed to the floor of Bedroom 2 because exposed floors were known to be problematic.

Total party wall area to Plot 3				
HFS (17 <sup>th</sup> Feb – 8 <sup>th</sup> March)	West	Average		
Average flux W/m <sup>2</sup>	1.25	1.13	1.27	1.22
Average flux W	30.16	27.27	30.72	29.35
Average ΔT (°C)				Not known

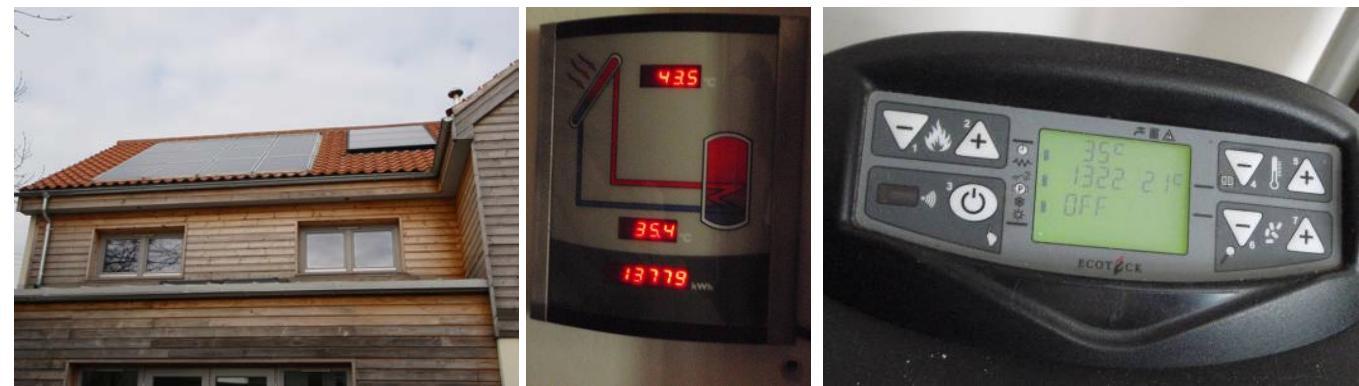
- 8.4. They are very **pleased with the renewable energy systems** (solar hot water and photovoltaic panels fig 34). The earnings they get from the PV array almost match the cost of the electricity they use. This is, however, about to go down as they missed out on the new Feed In Tariff. This is because their system was in use three months before the government's retroactive deadline.

- 8.5. The occupants do not seem to use the boiler from mid May to October relying mostly on the solar hot water panel to provide all the hot water in the summer months. They have found their own way of integrating the use of the three potential sources of hot water and they feel a better display of the hot water temperature and the effect of each source would help them. The current temperature display (fig 35) for the hot water gives readings for the solar panel input and the immersion heater but it does not give feedback on the effect of the wood pellet boiler, which they find confusing.

- 8.6. There is **no easy way of controlling** the flow or temperature of the **hot water towel rails** in bathrooms and airing cupboard which seems wasteful in terms of energy use.

Figure 34 (left) PVs and solar hot water panel in roof, Figure 35 (middle) Hot water temperature display in airing cupboard, Figure 36 (right) Control panel for wood pellet boiler.
