BRE Scotland Innovation Park Visitor Centre

Innovate UK project number	450086
Project lead and author	BRE Scotland
Report date	2014
InnovateUK Evaluator	Unknown (Contact www.bpe-specialists.org.uk)

Building sector	Location	Form of contract	Opened
Visitor centre	Glasgow	Unknown	2012
Floor area	Storeys	EPC / DEC	BREEAM rating
110 m ²	Single	A / N/A	Outstanding

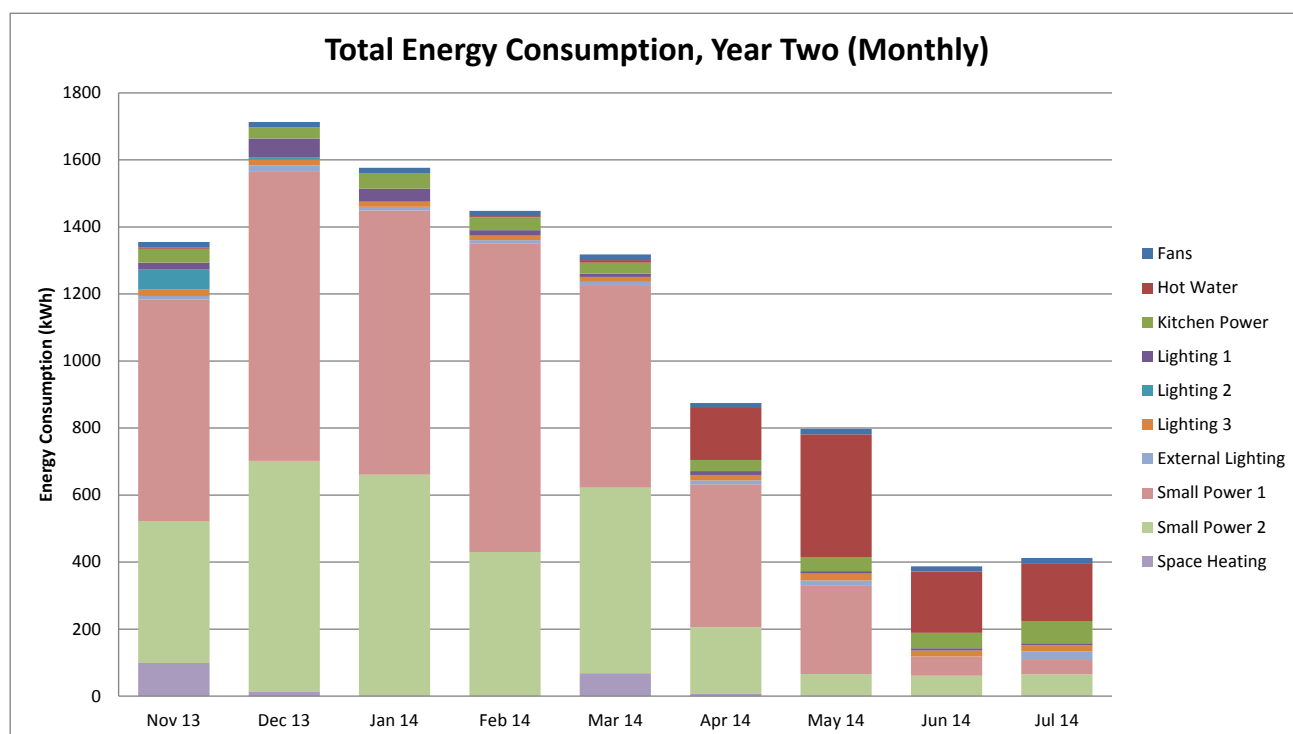
Figure 28: Energy Consumption (Monthly, by end use) Year 2

Energy consumption data has continued to be collected into year two of the BPE project. The energy consumption from November 2013 – July 2014 can be seen in Figure 28. The profile of energy use is dramatically different to that seen in the first year (in Figure 26) with the dominant energy use now on the small power circuits. This is due to a fault with the heating system which occurred at the beginning of October 2013.

This switch from use of the space heating circuit to electric heaters plugged into the small power 1 and small power 2 circuits can be seen from the change in graphs in Figure 26 and Figure 28. A direct comparison can be viewed in Appendix section 10.9, particularly in Figure 147. In addition, energy profiles for all ten circuits for year one and year two can also be seen in section 10.9.

In addition to the fault with the space heating, a fault was discovered on the Lighting Zone 2 circuit. As such, following investigation work, although the lights continue to operate (though are still felt to be too bright by the occupants), the meter for this circuit ceased to take individual readings for the circuit from around the 12th December 2013. Unfortunately, this fault has not been resolved.

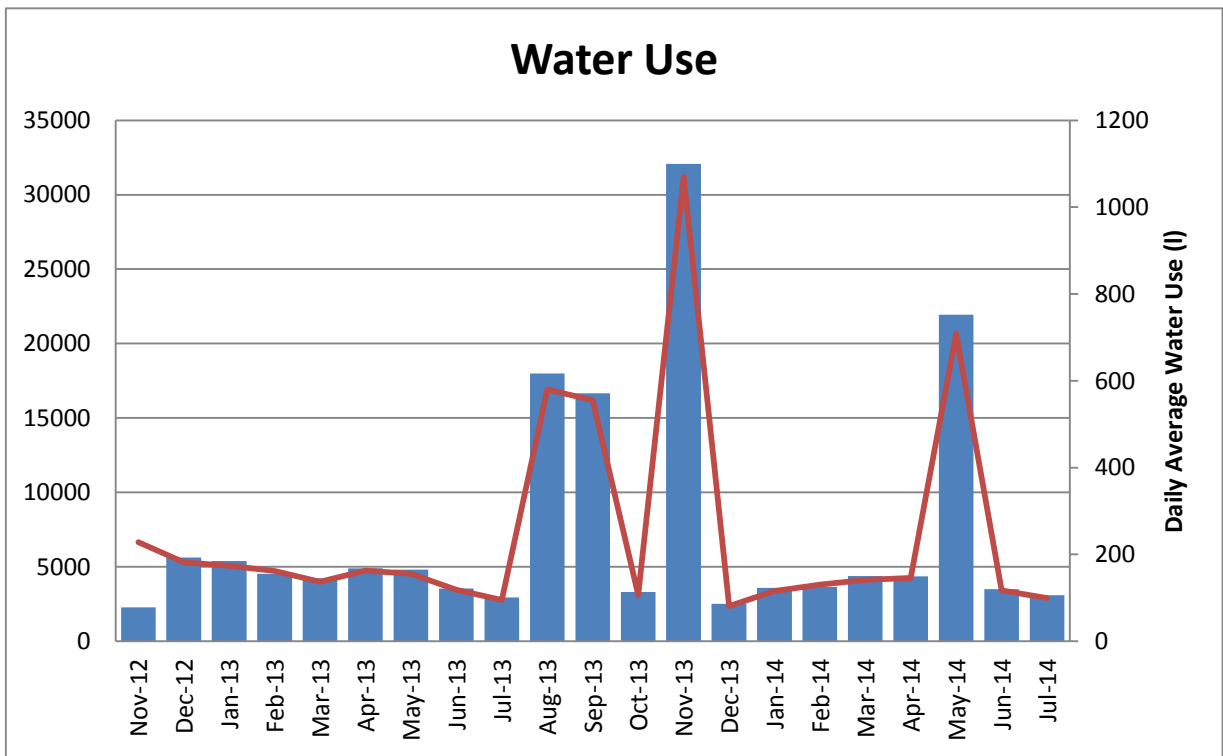
Figure 29: Monthly Water Use

As can be seen in Figure 29, water consumption in August, September, November 2013 and May 2014 was extremely high in comparison to other months. The bar shows the total water use, and the red line, the average water use per day.

These issues contributed to increase the overall water consumption to be 251 litres per day, or 2.28 litres per day/m². Not including these months outlined above, the average water consumption for the other monitored months was 138 litres per day, or 1.26 litres per day/m². As there is no standard occupancy of the Visitor Centre, water consumption 'per occupant' is unable to be calculated.

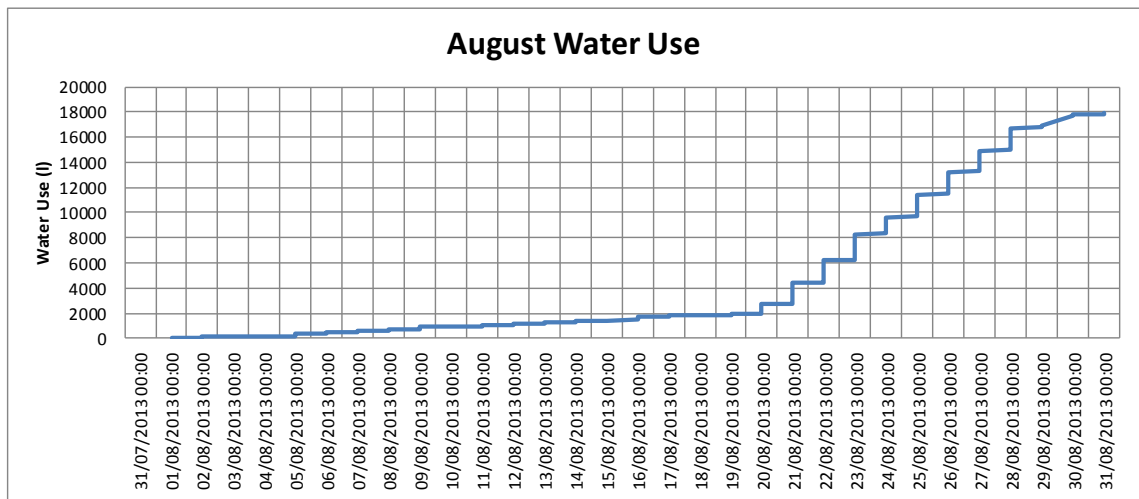
Figure 30: Cumulative August Water Use

Figure 30 shows a profile of water use throughout August. It can be seen from the graph that water use began to increase at a greater rate from around the 20th to the 28th. This increase in water consumption can be attributed to a tap in the gent's bathroom which was broken by a visitor on Tuesday 20th August. Whilst the tap was broken it was running constantly and it was not possible to isolate and switch off the supply. A plumber was not able to be arranged until the following week. As can be seen on the graph, water consumption reduced again following the repair on the 28th. Figure 31 shows the consumption in September which shows a jump in consumption on the 27th and 28th of the month. No particular fault has been attributed to this increase in water use, but consumption levels returned to normal and remained so throughout October. Further jumps in water consumption were seen in November (Figure 32) and May 2014 (Figure 33), due respectively, to draining and refilling of the heating system during investigative works and a request from Scottish Water to run taps on a few days to drain the system, as potential contamination was found in a neighbouring site.

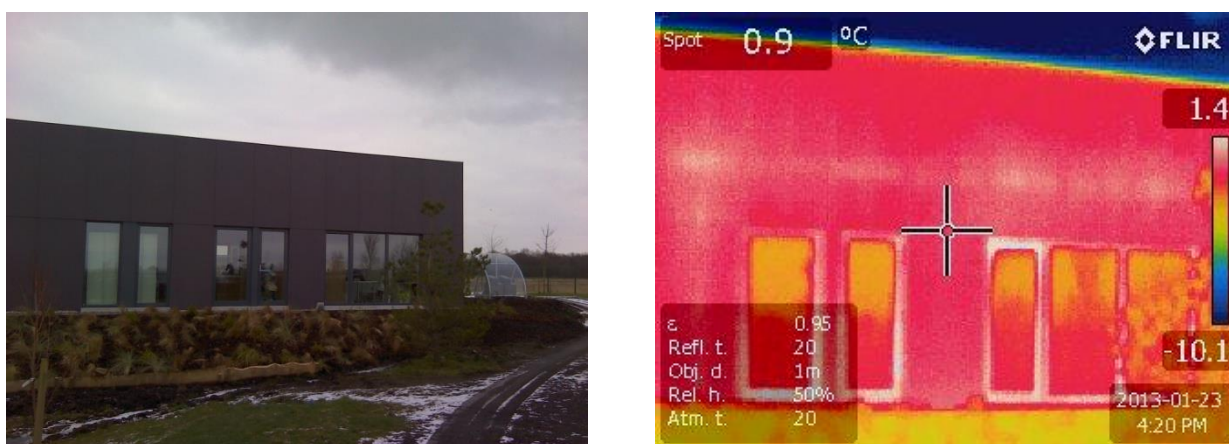
Figure 50: External Thermal Image 3

The above images (Figure 48, Figure 49, Figure 50 and Figure 51) demonstrate acceptable continuity of insulation, with uniform temperatures across all external surfaces. The highest temperatures recorded on the external surfaces were through the window and door frames, as is to be expected.

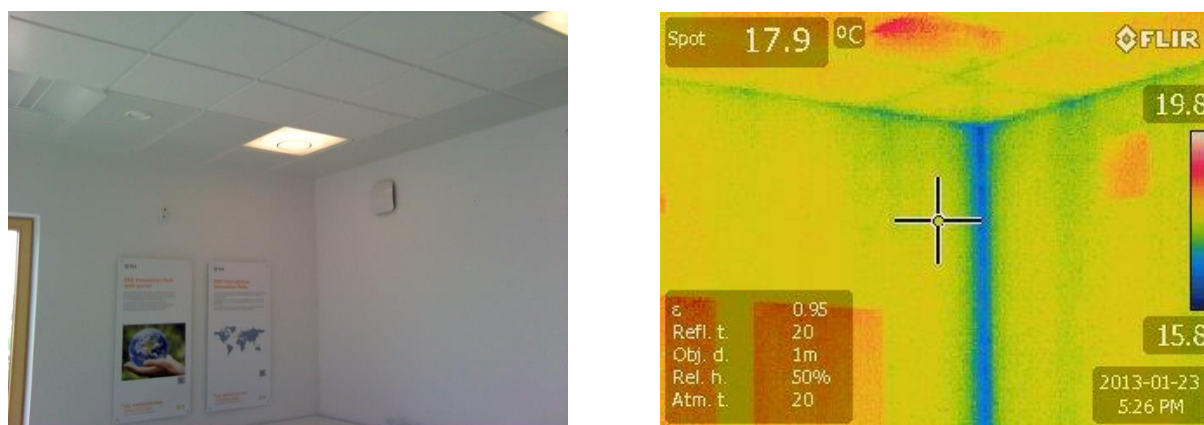
Figure 53: Internal Thermal Image 2

A number of areas were identified as having lower surface temperatures throughout the inside of the building, primarily at junctions where some cracks have appeared. This is particularly clear in Figure 52 and Figure 53. The significance of these cracks, when compared with the as designed performance, will be determined through the air tightness testing results, but recorded temperatures are considered lower than would be expected.

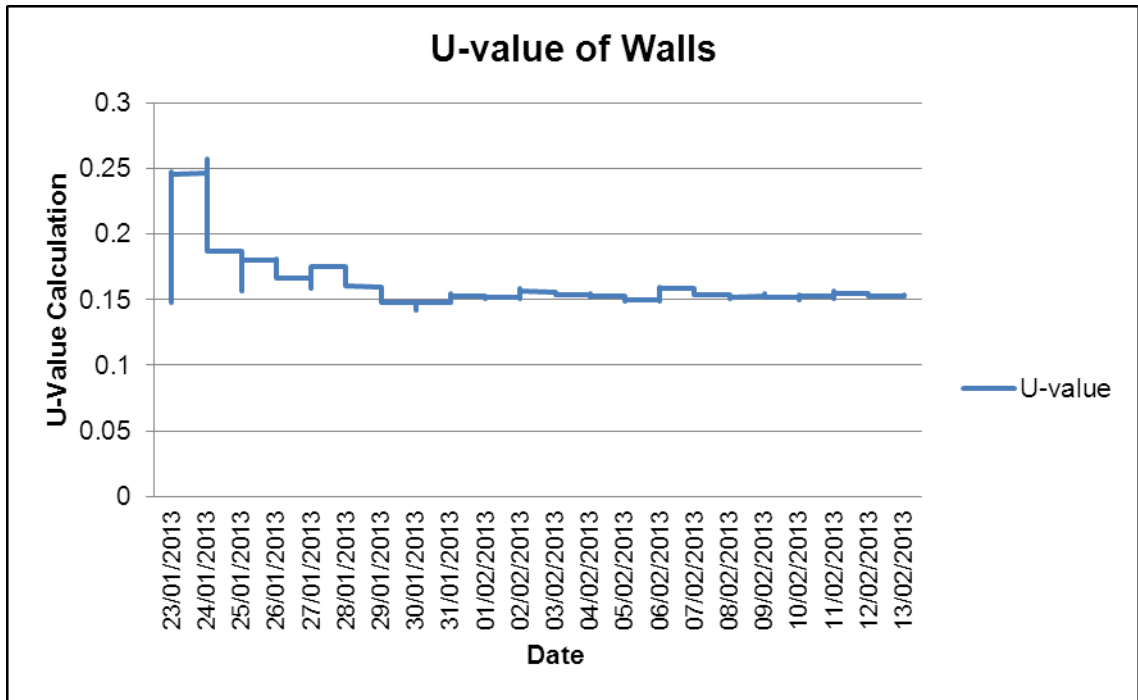
Figure 59: Wall U-Value Calculation

Figure 59 and Figure 60 present results from the measurements, derived using the techniques described in ISO 9869. A direct comparison between the measured U-values and the U-values calculated using the methodology in BS EN ISO 6946 is then possible.

Within Figure 59 and Figure 60, the heat flow appears to fluctuate following the initial installation of the equipment. After a few days, the U-value measurement appears to reduce to the designed U-value specification. The fluctuation may be due to the effects of thermal mass.

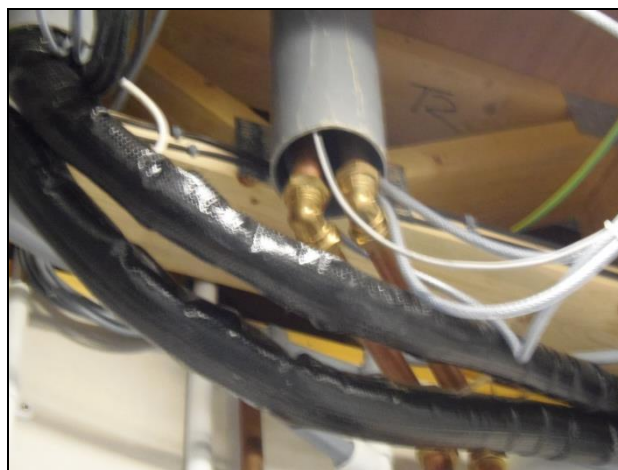
Figure 68: Pipe through Roof

In addition to the possible gaps within the air barrier, there are also a number of penetrations that could be negatively affecting the air tightness performance of the building. While the majority of the building has a fairly clean finish, the plant room has a number of penetrations in the floor, roof and walls. It should be noted that some work in the plant room has been undertaken retrospectively, for various projects and purposes, following handover and therefore the building may have been handed over to BRE with a better level of air tightness than has been measured at this stage in the project. A number of the building fabric penetrations have been documented; see Figure 67, Figure 68, Figure 69 and Figure 70.

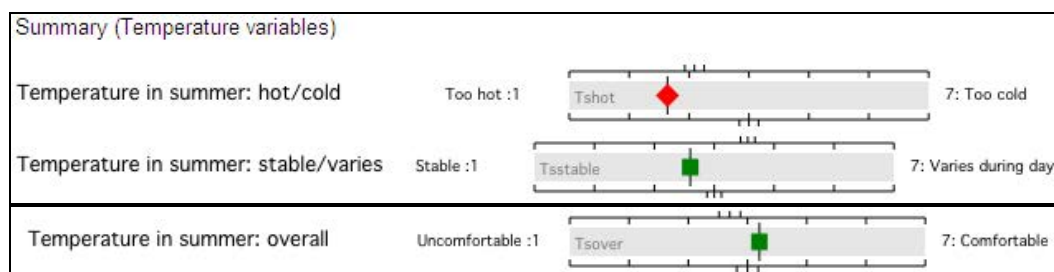
Figure 73: BUS Survey - summer temperature results

The graphs in Figure 73 show a summary of results regarding temperature. Mostly the temperature was found to be good in terms of comfort and stability.

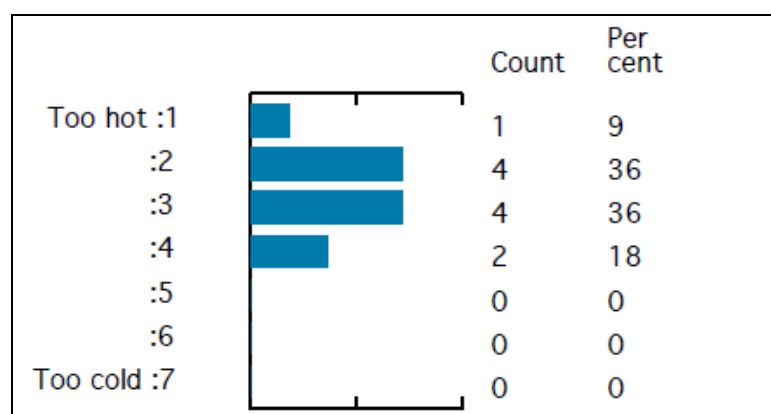
Figure 74: BUS Survey - Temperature in summer (too hot/too cold)

The temperature in the summer was toward the ‘too hot’ end of the scale. As can be seen in Figure 74, all respondents scored the summer temperature as average (4) to ‘too hot’ (1), with 45% of respondents scoring 1 or 2 and 36% scoring 3.

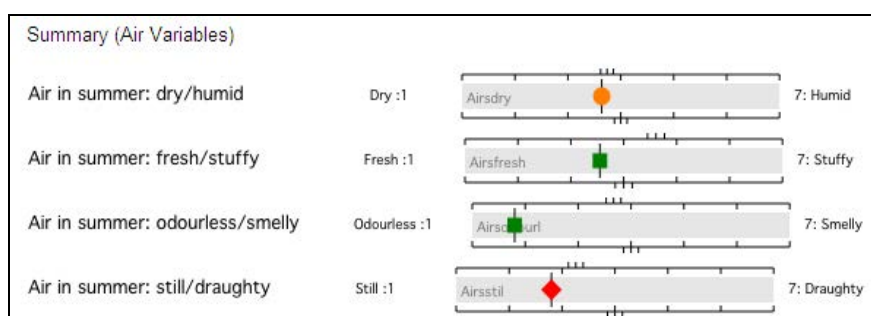
Figure 76: BUS Survey - Summary of Air Results

In Figure 76 above, the air in summer is shown to be average in terms of humidity, but not ideal, though 64% of the respondents found it to be good (gave it a mark of 4, see Figure 77). The air was found to be towards fresh, with 45% of respondents giving a score of 2, however 18% thought it was average, and 36% voted towards the 'stuffy' end of the scale. The air was found to be considerably fresher compared to the benchmark data.

While 60% of the respondents thought the air was neither still nor draughty (a score of 3-5), 40% found the air to be still. This gave an overall score of 2.8, lower than the benchmark average.

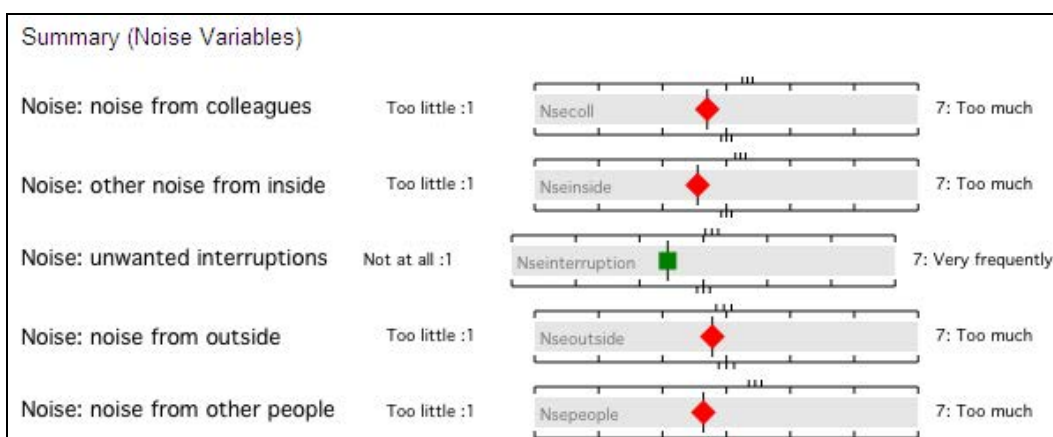
Figure 79: BUS Survey - Summary of Noise Results

With regards to noise, the summary responses can be seen in Figure 79. Four of five of the questions relating to noise (those regarding noise from colleagues, other internal factors, external factors and from other people) have 'poor' responses (i.e. they are 'red diamonds'), however, for these questions the ideal score would be 4 and the feeling of respondents was that the noise levels from these factors was only slightly too little.

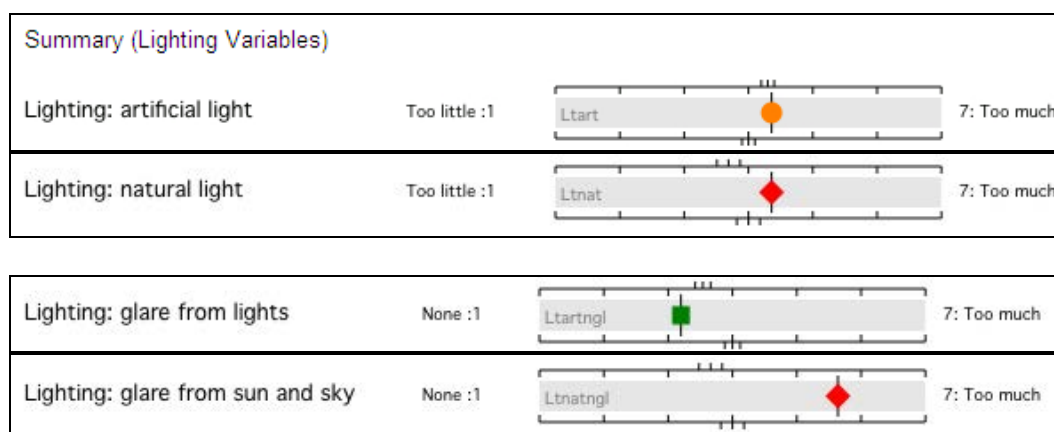
Figure 81: BUS Survey - Summary of Lighting Results

The graphs shown in Figure 81 relate to the lighting within the Visitor Centre. The ideal score for the lighting questions would be 4, and for those which relate to glare, the ideal score would be 1. In terms of artificial light, the respondents found there to be acceptable levels (orange circle) with a score of 4.36 and 64% giving a score of 4 (ideal). For natural light, the average score was also 4.36, with 55% feeling the levels were ideal. When comparing to the benchmark data (for all non-domestic buildings surveyed by Arup), the levels of

artificial light were found to be comparable, but the average score for natural light was higher, meaning that there was felt to be too much natural light in the Visitor Centre, compared to other non-domestic buildings (hence the red diamond for this score).

In contrast, glare from the sun and sky was found to be an issue. This question scored an average of 5.64, with all respondents scoring 4 or higher and 36% scoring 7, saying there was too much glare from the sun/sky; this was considerably higher than for the comparable benchmark data. Comments related to lighting mentioned this issue of glare:

However, one comment noted that there was good natural light and two comments pointed out that the glare issues could be solved by using blinds in the affected areas.

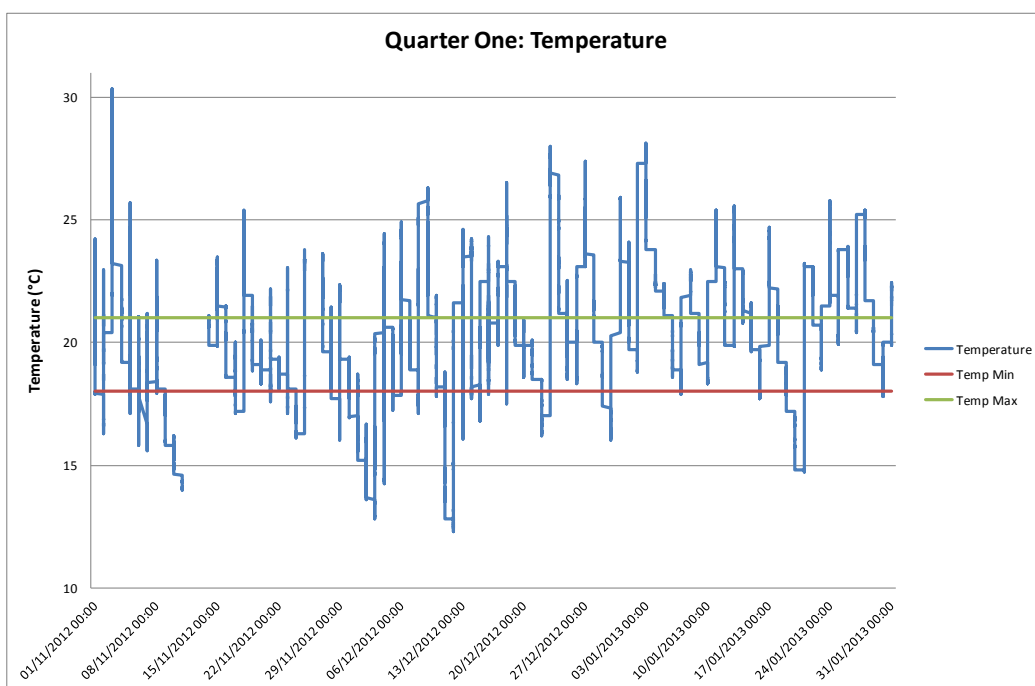
Figure 95: Quarter One Temperature (Internal)

Temperatures within the Visitor Centre during quarter one, which covers the winter months from the beginning of November to the end of January, varied widely from a peak of 30.3°C on the 1st November to a low of 12.3°C on the 12th November. For almost 40% of the time, the temperature was above the suggested maximum, and for almost 18% of the time it was below the suggested minimum. The average temperature over quarter one was 20.34°C.

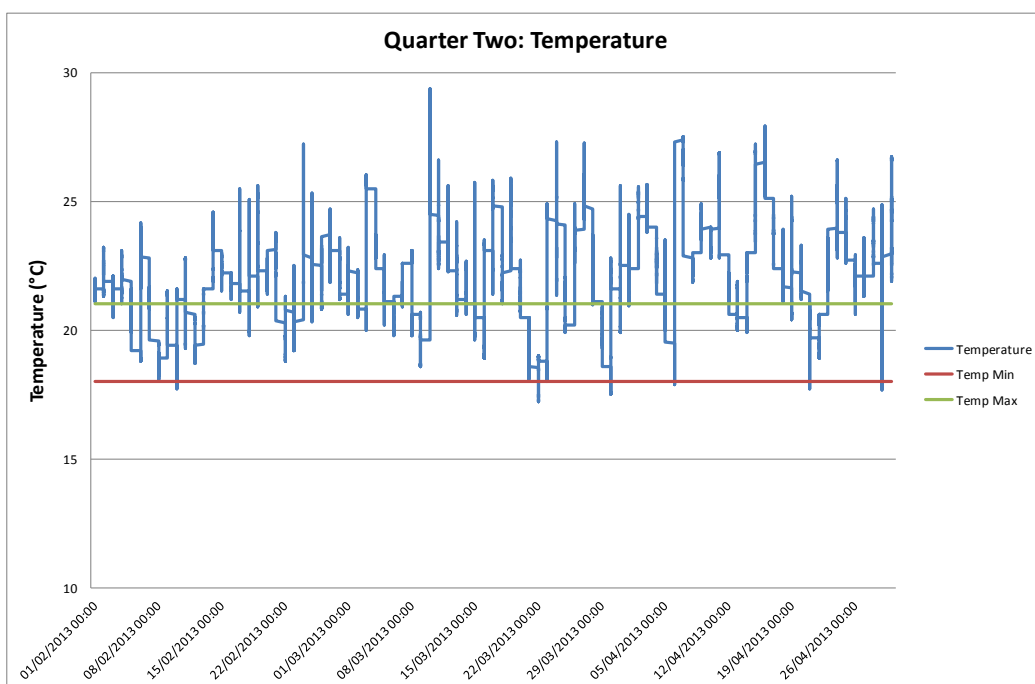
Figure 97: Quarter Two Temperature (Internal)

For more than 70% of the time, the temperature in the Visitor Centre in quarter two (February to April) was greater than the recommended maximum. The external temperatures (as seen in Figure 98) don't correlate with the internal temperatures in the same way that they did in quarter one. A maximum external air temperature of 11.6°C was noted at Salsburgh, but temperatures frequently dropped below 0°C and the Visitor Centre was able to maintain an average temperature of 22.1°C.

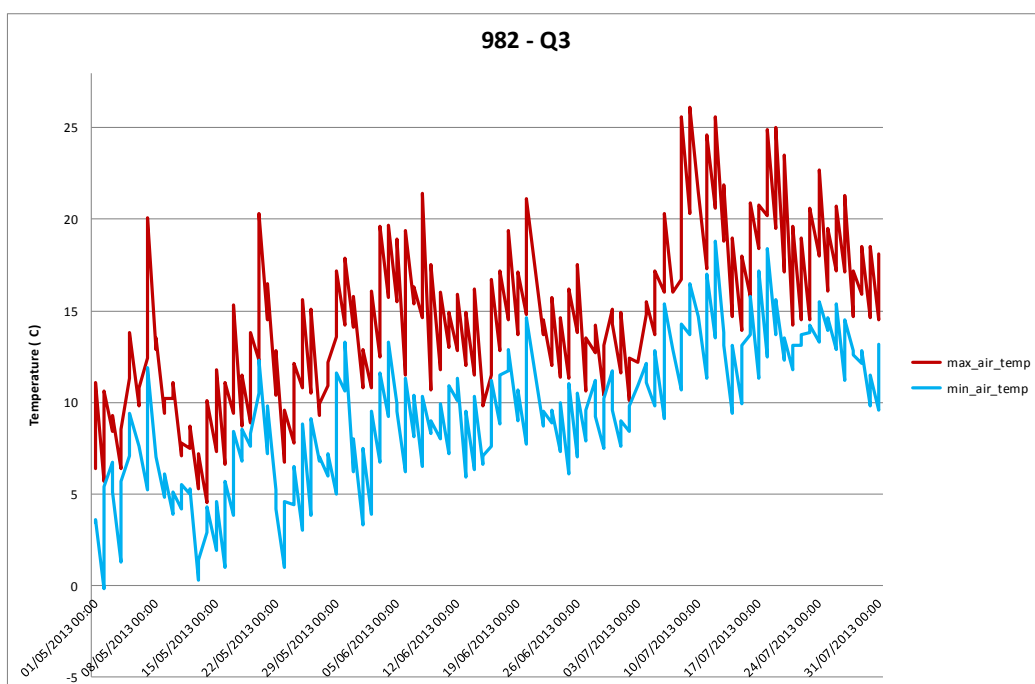
Figure 100: Quarter Three Temperature (External)

In quarter three, for almost 95% of the time, the temperature was above the recommended maximum of 21°C. The temperature is recorded every five minutes and 101 recordings (0.39%) were above 30°C. A maximum temperature of 30.88°C was recorded. The average temperature was 24.39°C.

In June and July, the temperature profiles from the Visitor Centre (internal) and the weather station (external) follow a similar pattern with a slight dip at the end of June and then a rise in early July. The maximum external temperature recorded during this quarter was 26.1°C. This peak temperature occurred the day before the peak temperature recorded in the Visitor Centre.

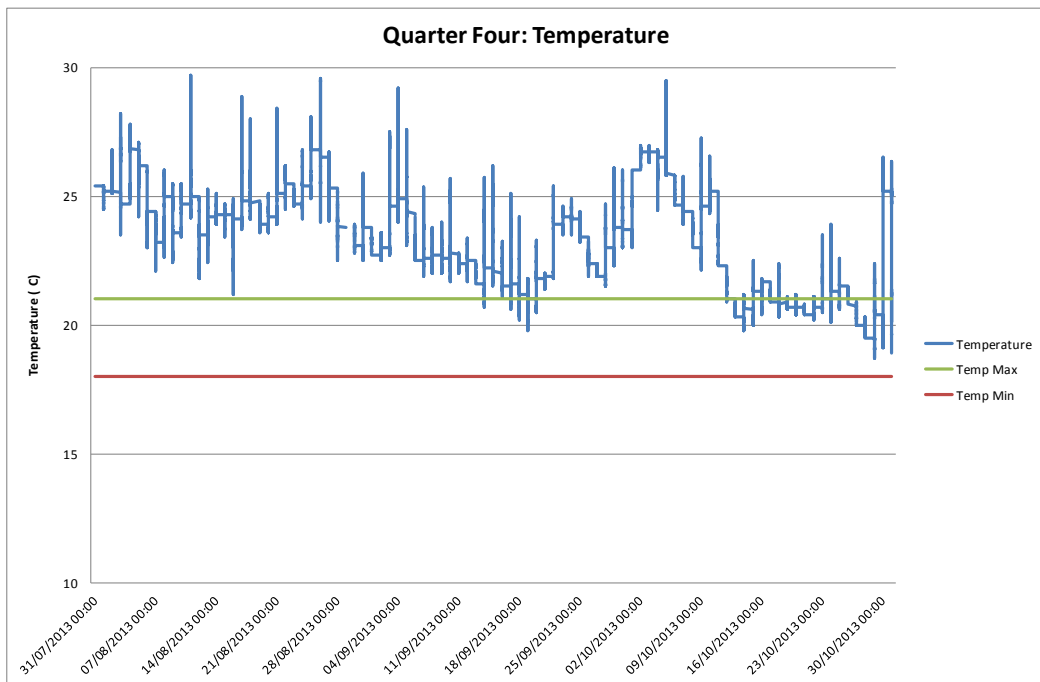
Figure 101: Quarter Four Temperature (Internal)

In quarter four, which covered the months from August to October, the average temperature was 23.33°C; almost 85% of readings were above the recommended maximum of 21°C, with a maximum temperature recorded of 29.71°C.

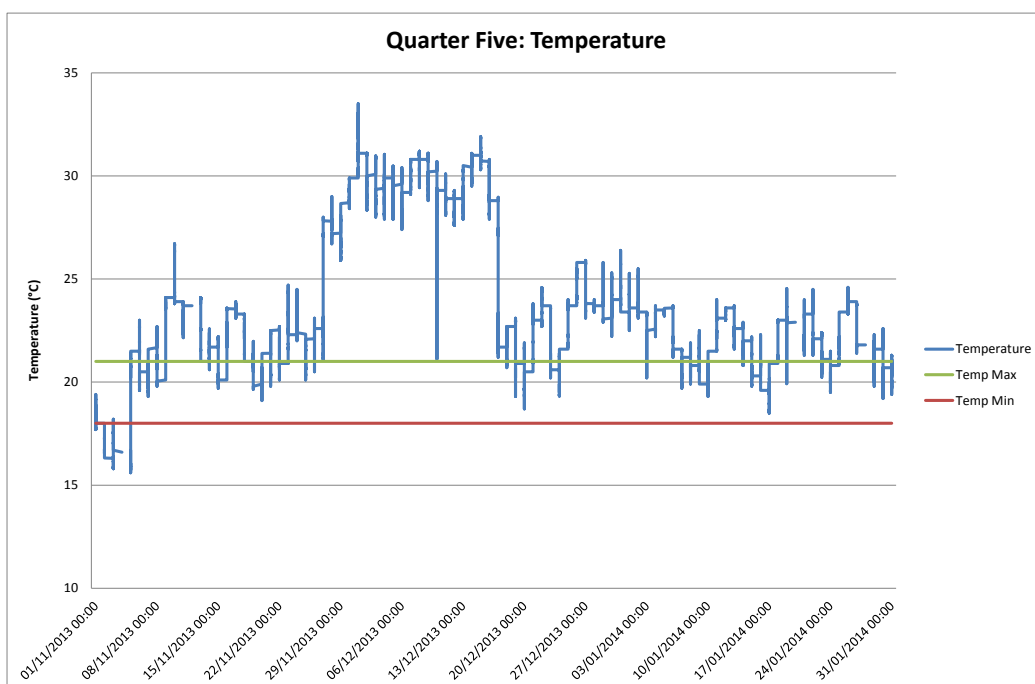
Figure 103: Quarter Five Temperature (Internal)

The temperature profile in quarter five is quite different to the other quarters with a defined period of increased temperatures from the 27th November, when the Visitor Centre heated up rapidly in the evening, to the 17th December, when it cooled quickly in the morning. Given that the energy consumption on the power circuits (used during this time to power electric bar heaters) totalled over 800kWh, it can be assumed that the heaters were used profusely during this time. As the average external temperature in quarter five was 3.94°C, some heating would be necessary, but there was no control over the use of the electric heaters.

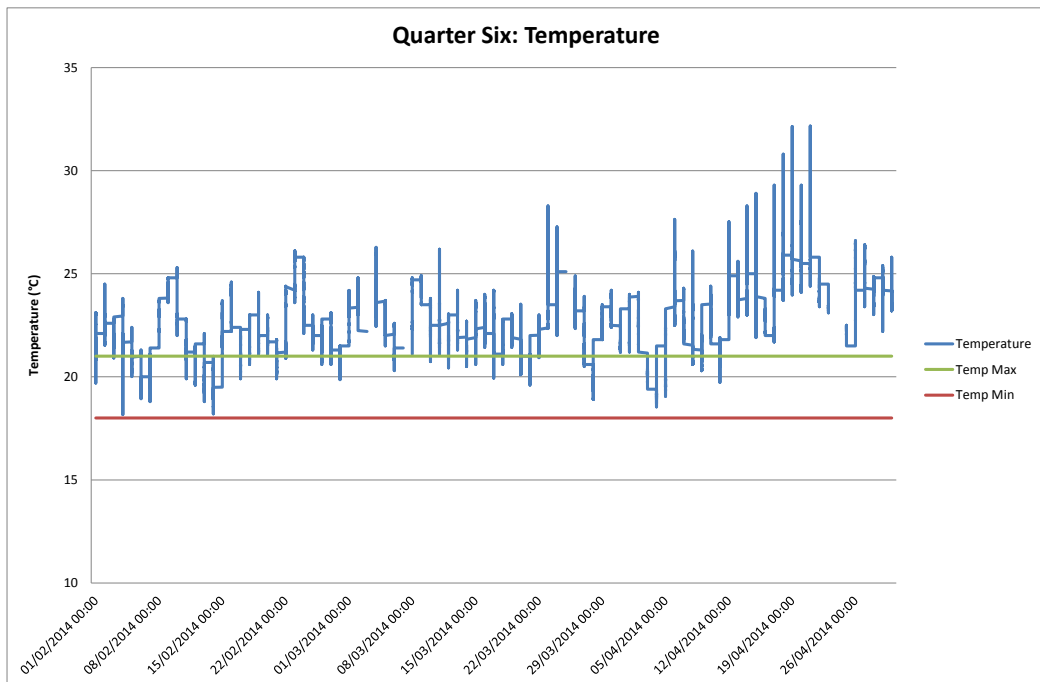
Figure 105: Quarter Six Temperature (Internal)

The internal temperature during quarter six, were much more stable than the previous quarter. Temperatures were still high, with more than 80% of readings above 21°C, but they more closely followed the external profile, increasing towards the end of the quarter, at the end of April.

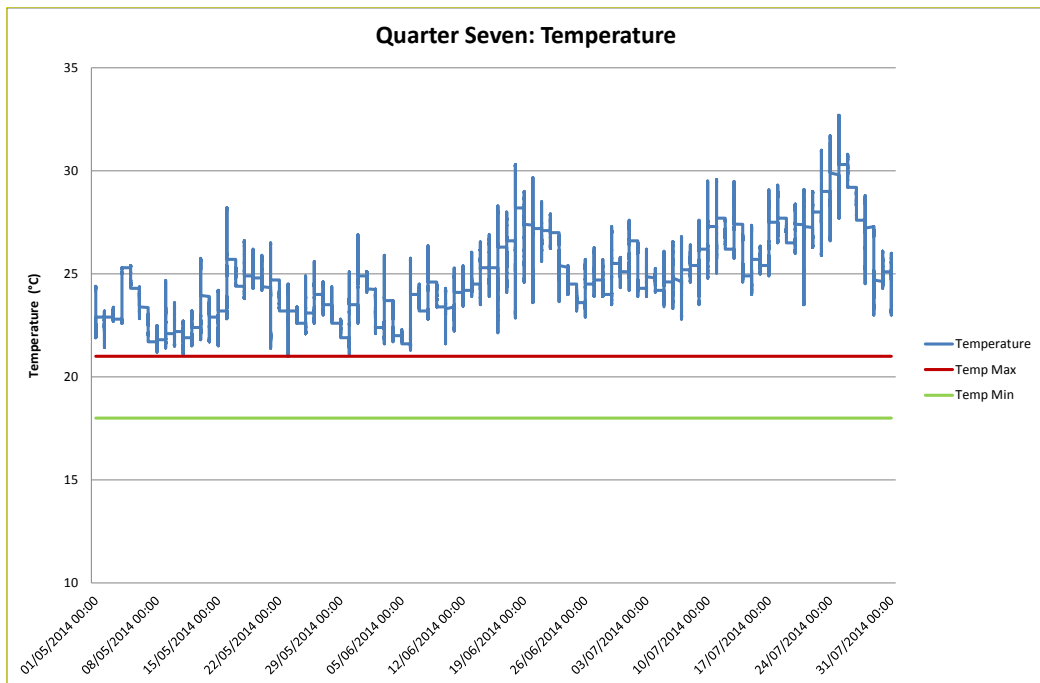
Figure 107: Quarter Seven Temperature (Internal)

All of the internal temperature readings for quarter seven were above the recommended maximum of 21°C. Although the Met Office data is only available until 18th July, the general trend of external temperatures to this point, match the internal temperatures in the Visitor Centre.

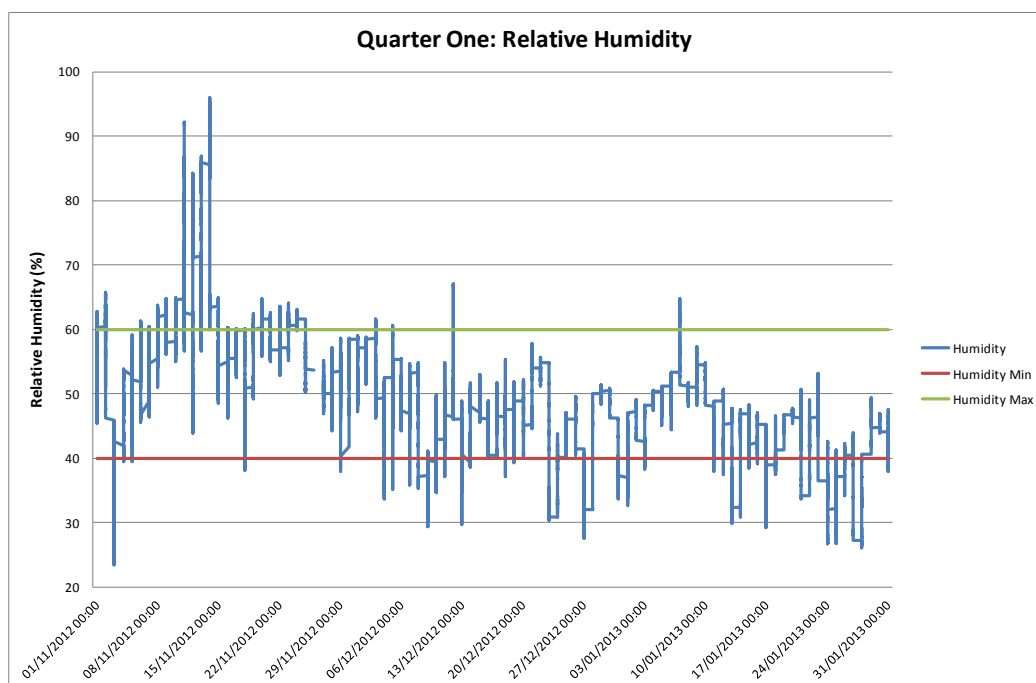
Figure 110: Quarter One Humidity

Relative Humidity in quarter one, was for the most part between the suggested minimum and maximum limits of 40% and 60%. A peak of high humidity levels were recorded between 6th November and 17th November, a smaller peak between 19th and 25th November and two other notable dates when the humidity was high; 12th December 2012 and 7th January 2013.

There were periods of generally low humidity in late December, early January 2013, and also during mid- to late January. The maximum recorded reading for relative humidity in quarter one was 95.97% on 14th November at 2.25pm (which is likely due to a fault with the sensor) and the minimum relative humidity reading for the first quarter was 23.36% on the 3rd November at 2.35pm. Average relative humidity in quarter one was 49.39%.

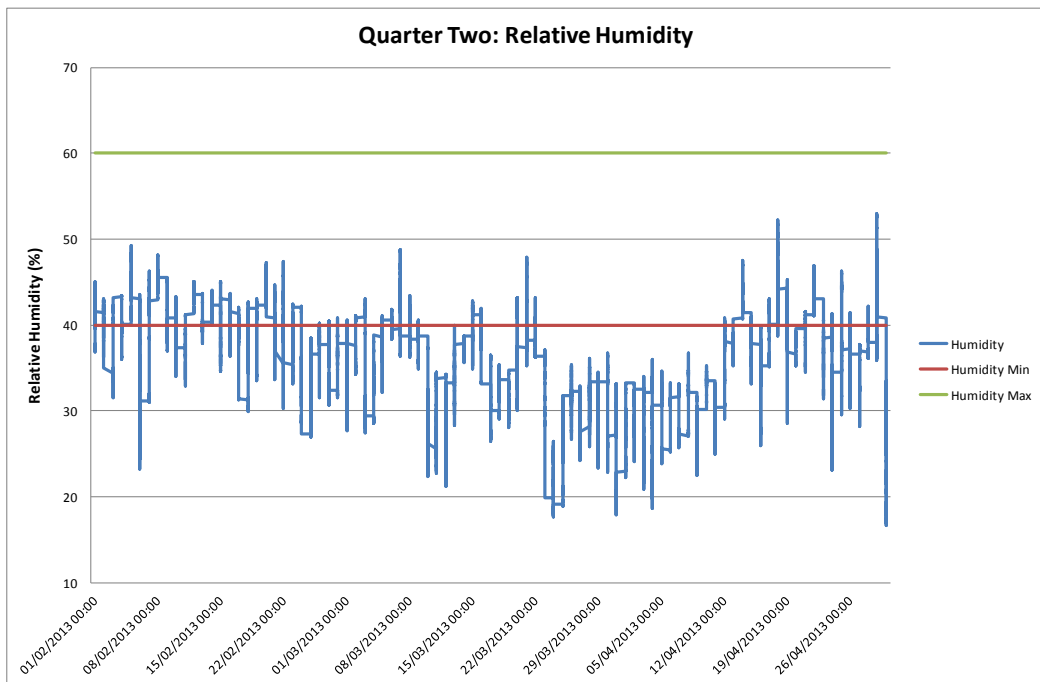
Figure 111: Quarter Two Humidity

Overall, the relative humidity for quarter two showed that conditions were drier than recommended; 70% of the readings (taken every five minutes) showed a relative humidity of below 40%. The lowest recorded relative humidity reading was 16.7% on the 30th April at 4.10pm. The highest relative humidity reading for quarter two was 52.99%, on the 29th April (1.45pm) and the average over the three months was 36.22%.

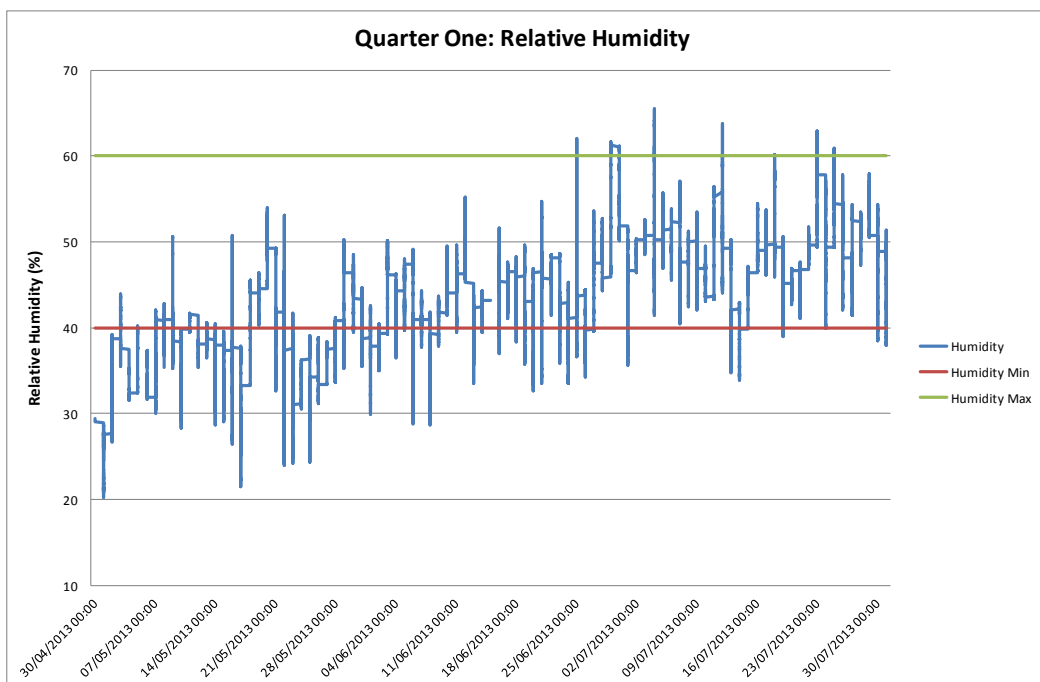
Figure 112: Quarter Three Humidity

In quarter three, the relative humidity reading started quite low, but the general trend was that they increased towards the end of July. In June and July the majority of readings were between the recommended minimum and maximum values. Overall, 32.14% of readings were below 40%. The average relative humidity was 43.32%.

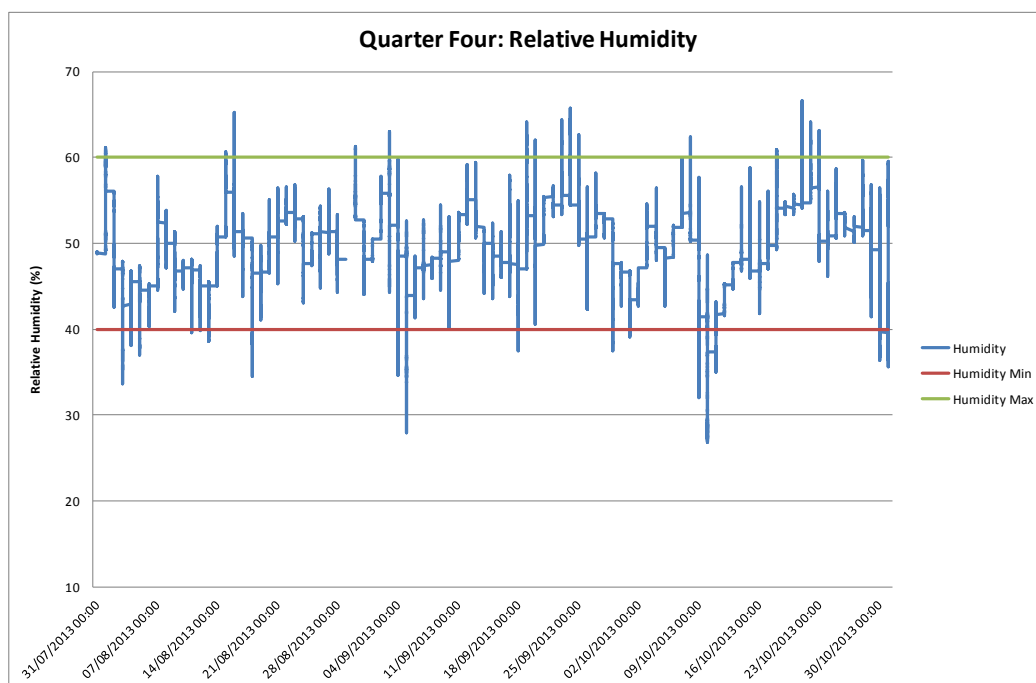
Figure 113: Quarter Four Relative Humidity

For the majority of the time during quarter four, the relative humidity readings were between the recommended minimum of 40% and the recommended maximum of 60%. Only 0.85% of readings were above 60% and only 3.37% of readings were below 40%.

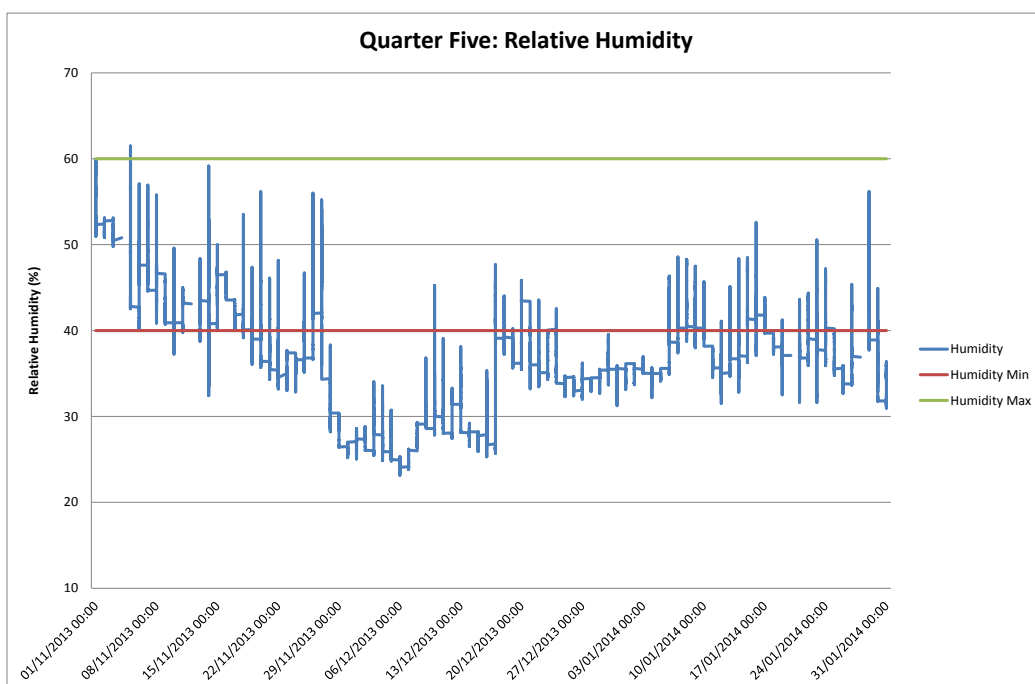
Figure 114: Quarter Five Relative Humidity

As in Quarter Two, relative humidity within the Visitor Centre in quarter five was quite low, with 70.58% of readings below the recommended minimum of 40%. The majority of these lower readings are from the beginning of December to mid-January. Anecdotal evidence from building occupants is that they generally find the Visitor Centre to be ‘very dry’.

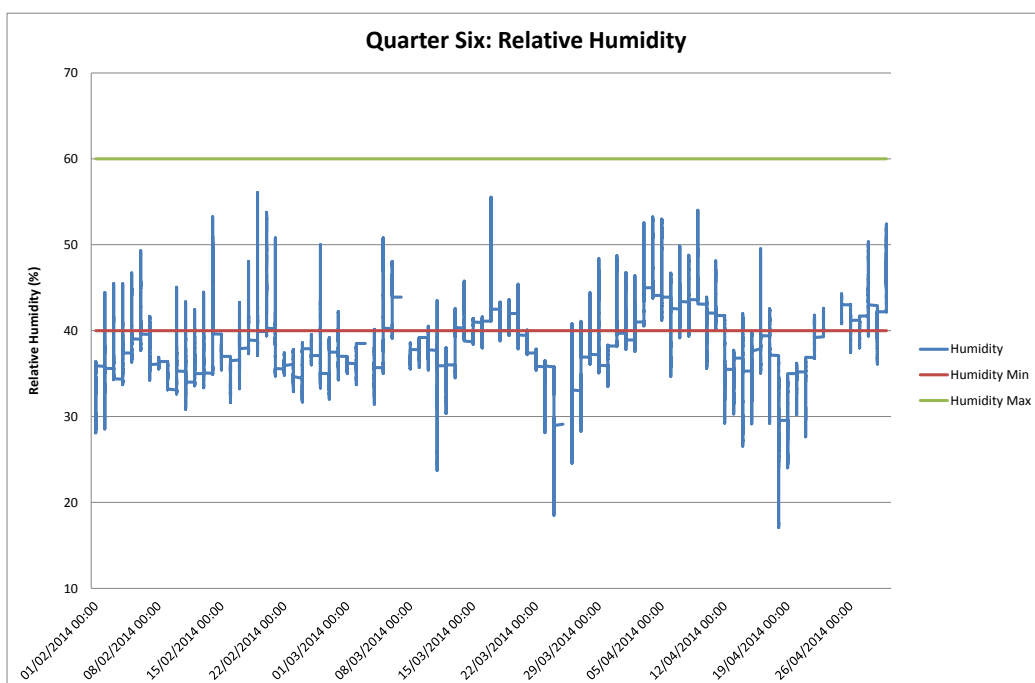
Figure 115: Quarter Six Relative Humidity

Again in quarter six, the relative humidity readings were generally lower than recommended; 65.88% of readings were below 40% RH. The percentage of low readings in quarter five and six are similar to quarter 2.

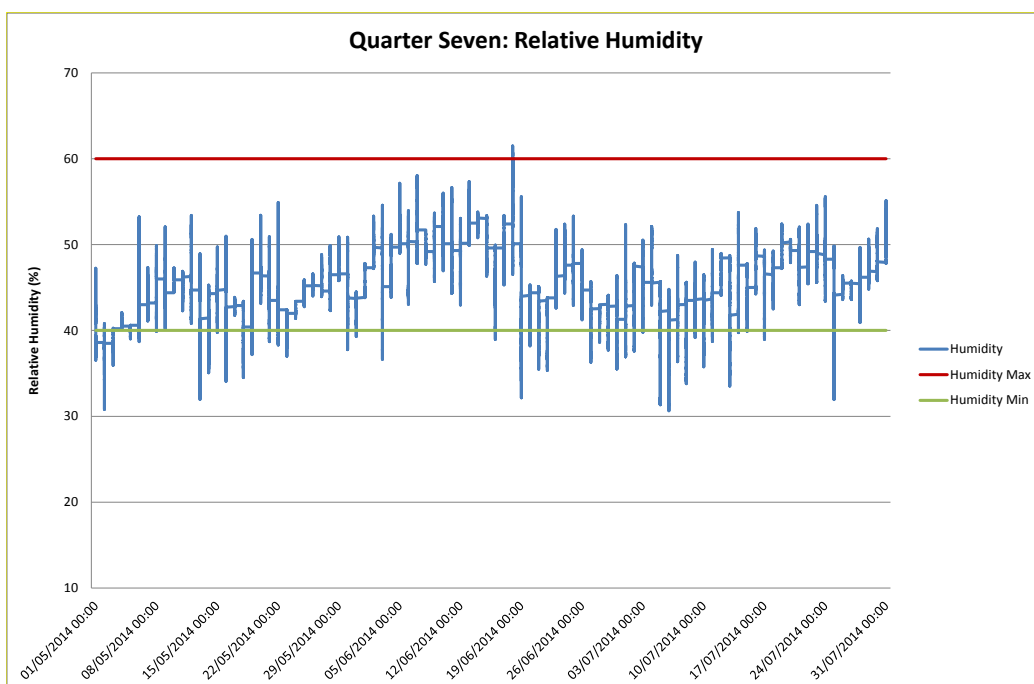
Figure 116: Quarter Seven Relative Humidity

In general, the relative humidity readings for quarter seven were between the recommended levels of 40% and 60%. For only 11.35% of the time were the readings out with these limits – and only on one occasion was the relative humidity higher than 60%.

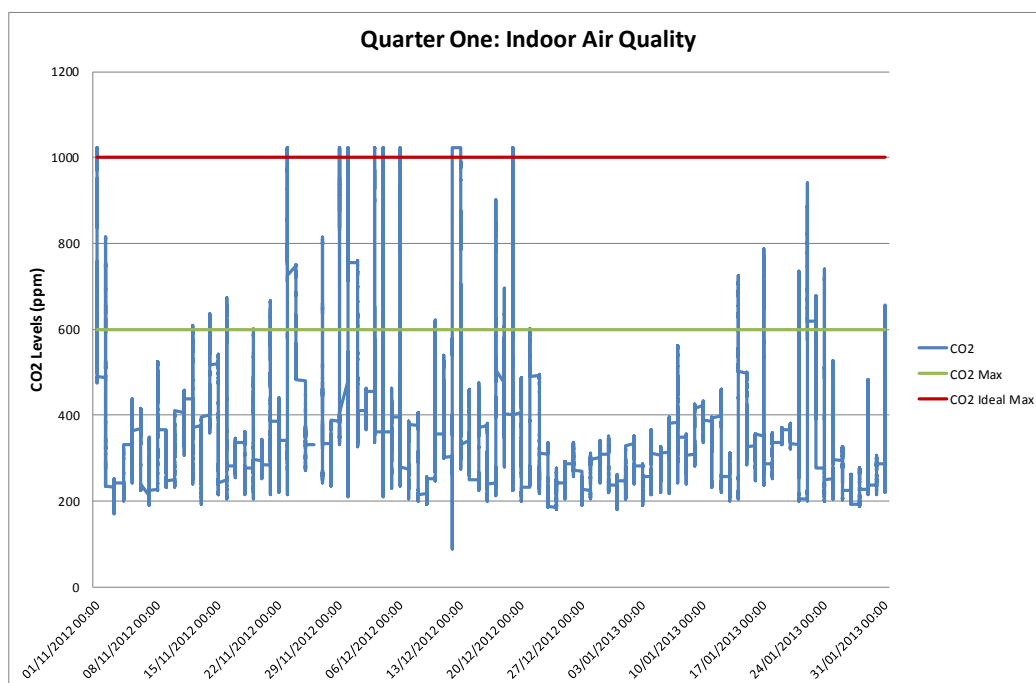
Figure 118: Quarter One Air Quality

Generally during quarter one, the CO₂ levels were below the ideal maximum of 600ppm, with an average reading of 362.74ppm. On occasion the CO₂ levels have increased but for the majority of time, they are still below the recommended maximum CO₂ level of 1000ppm. On nine occasions shown on the graph, the CO₂ levels increased above this maximum. Most of these occasions occurred in the winter months, when perhaps the windows were not open to ventilate the building due to cold external temperatures.

These also fall during a busy time for events within the Visitor Centre. Each of the spikes in CO₂ levels above 1000ppm are investigated below in Figure 119 with increased occupancy generally the reason for increased CO₂ levels. It must also be noted that the ventilation system was not operational during this quarter.

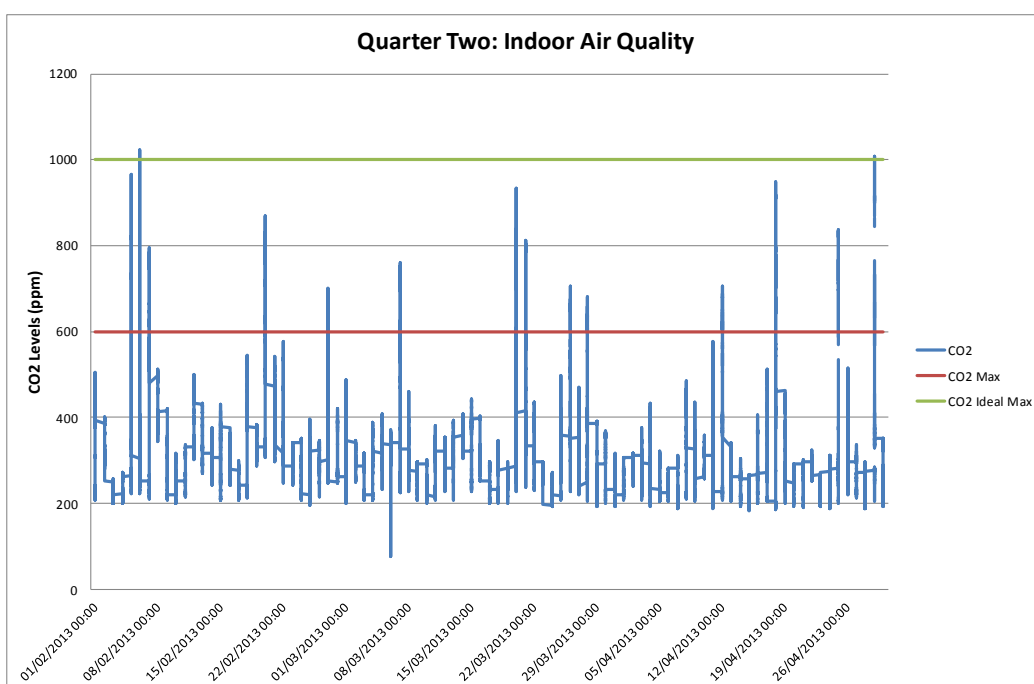
Figure 120: Quarter Two Air Quality

For the majority of the second quarter, the CO₂ levels within the Visitor Centre were between 200ppm and 400ppm, with an average level of 306.98ppm. On around 14 occasions, the CO₂ levels increased above the recommended ideal maximum of 600ppm. On two occasions, the 6th February and 29th April 2013, the CO₂ levels increased above the maximum recommended level of 1000ppm. On the 6th February, an event was held in the afternoon with around 40 delegates attending; on the 29th April, a meeting was held all day in the Visitor Centre. The ventilation system was still not operational during this quarter but as the weather grew warmer outside, the Visitor Centre staff will have had windows open more frequently.
