BRE Scotland Innovation Park Visitor Centre

Innovate UK project number	450086
Project lead and author	BRE Scotland
Report date	2014
InnovateUK Evaluator	Unknown (Contact www.bpe-specialists.org.uk)

Building sector	Location	Form of contract	Opened
Visitor centre	Glasgow	Unknown	2012
Floor area	Storeys	EPC / DEC	BREEAM rating
110 m ²	Single	A / N/A	Outstanding

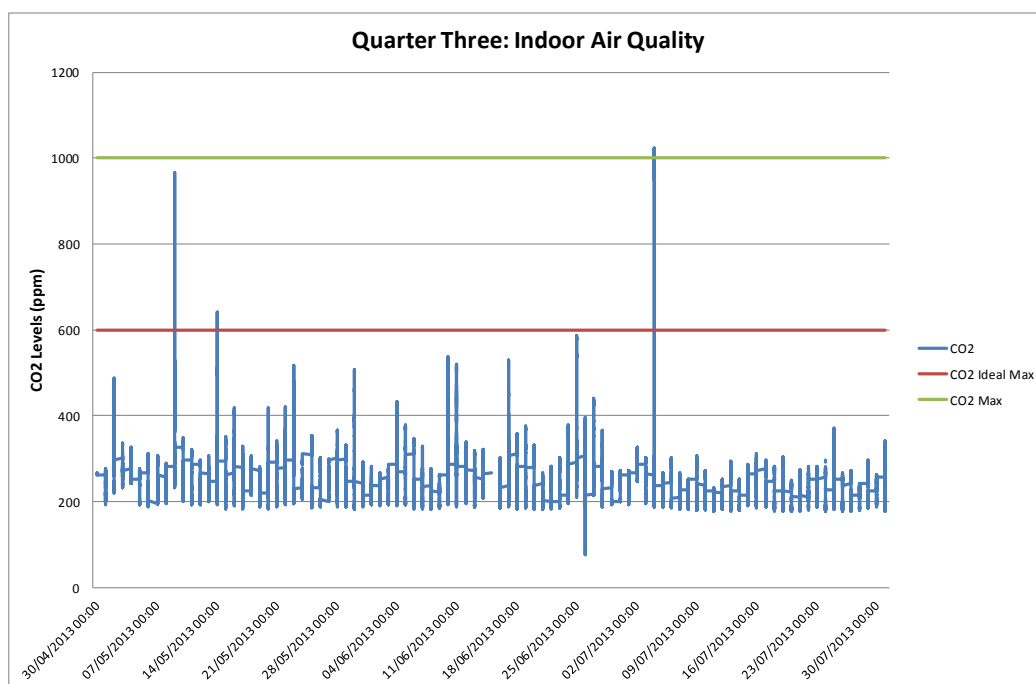
Figure 121: Quarter Three Air Quality

In the third quarter, which covers the months of May, June and July, the CO₂ levels were in the majority below the ideal maximum of 600ppm. Most of the readings fall between around 200ppm and 350ppm with an average reading recorded of 246.57ppm. On two occasions the CO₂ levels were above the ideal maximum of 600ppm and on one occasion, 4th July 2013, the CO₂ levels reached above the 1000ppm recommended maximum. There were no meetings or events held on the 4th July, and there was not a greater volume of people within the Visitor Centre than normal so it is difficult to understand why this spike in readings occurred.

The ventilation system was correctly operating by June 2013, which may be the cause of the fewer fluctuations in the graph (excluding the 4th July) from the end of June onwards. However, the Visitor Centre staff also generally had windows and doors open for much of the working day as the building warmed due to solar gain and external temperatures.

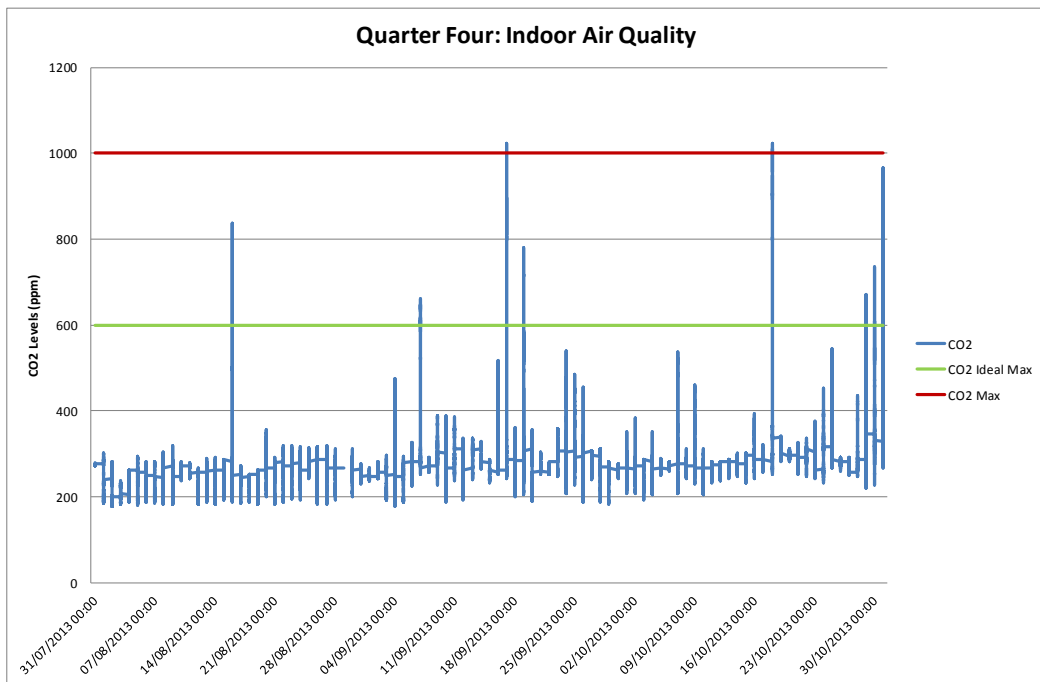
Figure 122: Quarter Four Indoor Air Quality

The CO₂ levels within the Visitor Centre during quarter four (August, September and October) were generally steady between approximately 200ppm and 300ppm. The average reading for this quarter was 276.13ppm.

On 17th September and 18th October, the CO₂ levels rose above 1000ppm; a large meeting (around 15 delegates) was held and a large event was being set up on these respective dates. On six further dates, the CO₂ levels were above the ideal maximum of 600ppm but were still below 1000ppm.

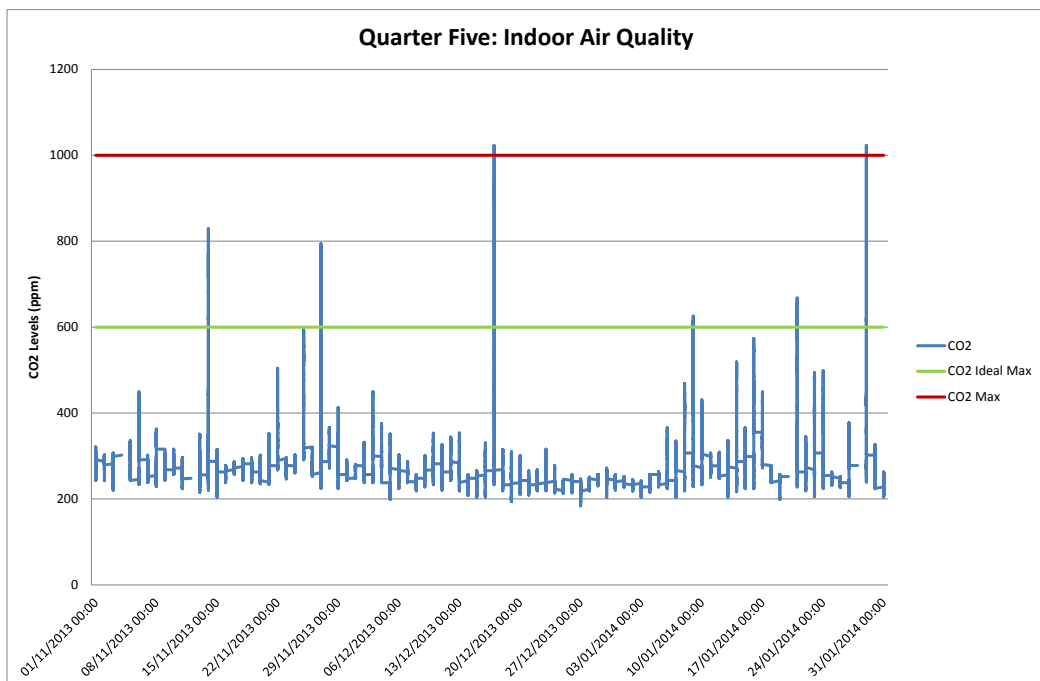
Figure 123: Quarter Five Indoor Air Quality

Indoor air quality in quarter five was generally well within the recommended maximum level of 600 ppm. On only two occasions did the CO₂ levels increase beyond the absolute maximum of 1000 ppm; between 12.05pm and 12.40pm on 17th December and from 10am to 14.50pm on 29th January 2014. Following each of these peaks, the CO₂ levels returned back to normal acceptable levels.

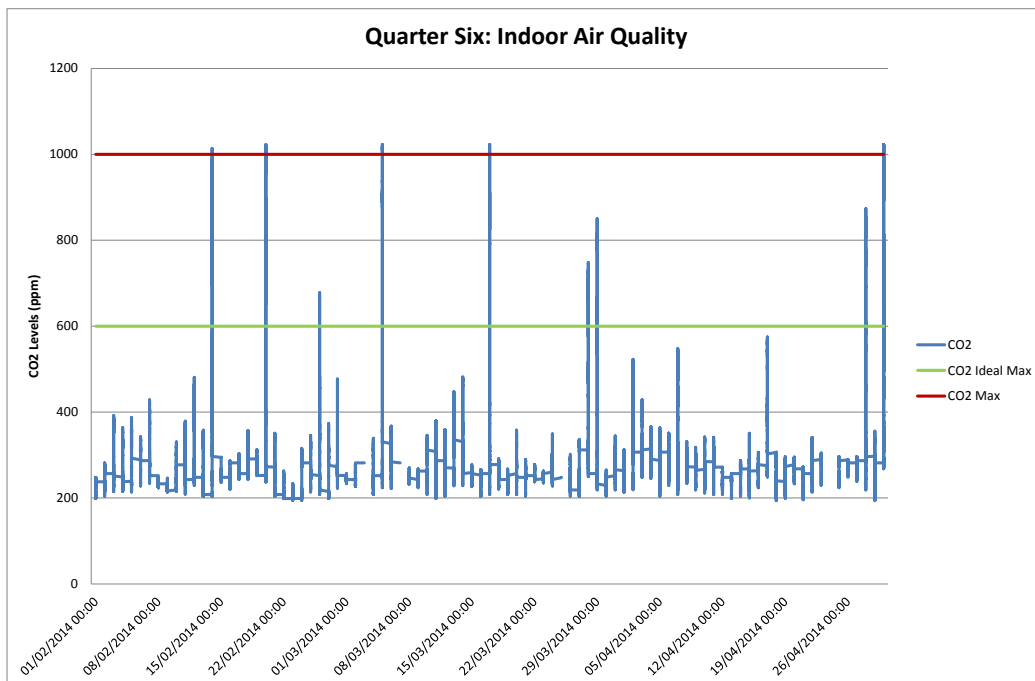
Figure 124: Quarter Six Indoor Air Quality

Again, in quarter six the CO₂ levels were generally between 200 and 400 ppm. On five separate dates, the CO₂ levels increased briefly above 1000 ppm but the levels then returned back to acceptable levels.

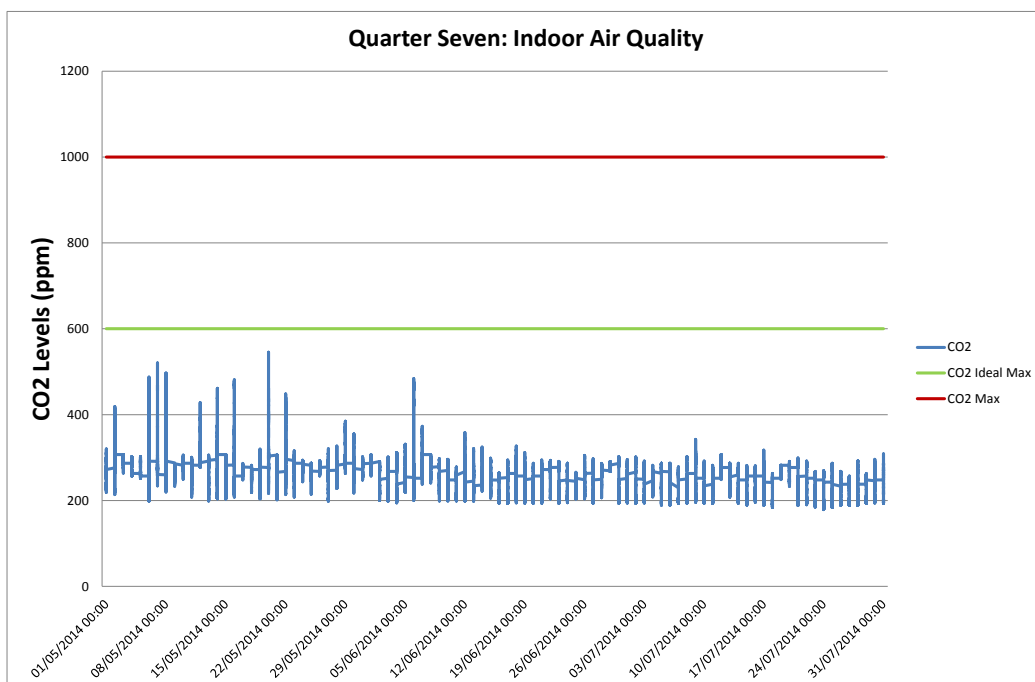
Figure 125: Quarter Seven Indoor Air Quality

In quarter seven, the average CO₂ levels were 255.01ppm, and on no occasions did the readings exceed the recommended ideal maximum of 600ppm. As this quarter covers the summer months, May, June and July, it is likely that staff working in the Visitor Centre will have had windows and doors open to cool the building, and as such there would be no expected issues with indoor air quality.

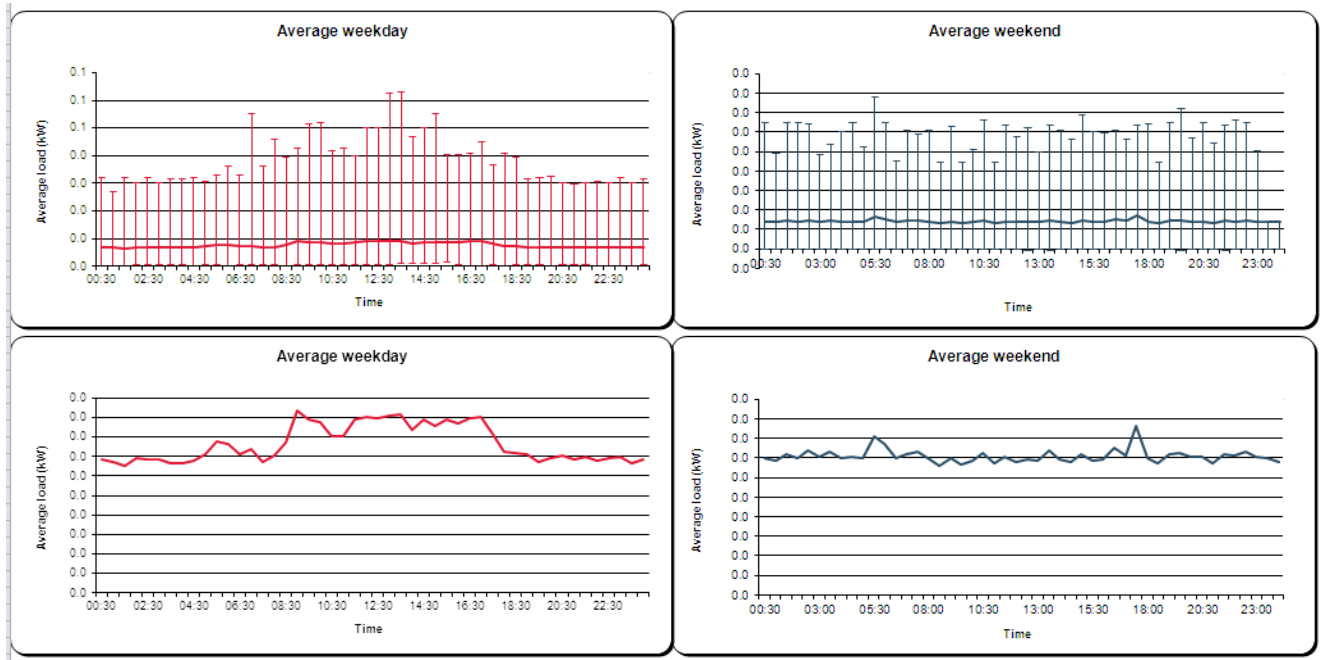
Figure 133: Circuit 1 – Fans (Year 1 – with and without error bars)

The fans circuit was not switched on until May 2013, but since then it has followed a steady consumption rate, peaking during office hours on weekdays.

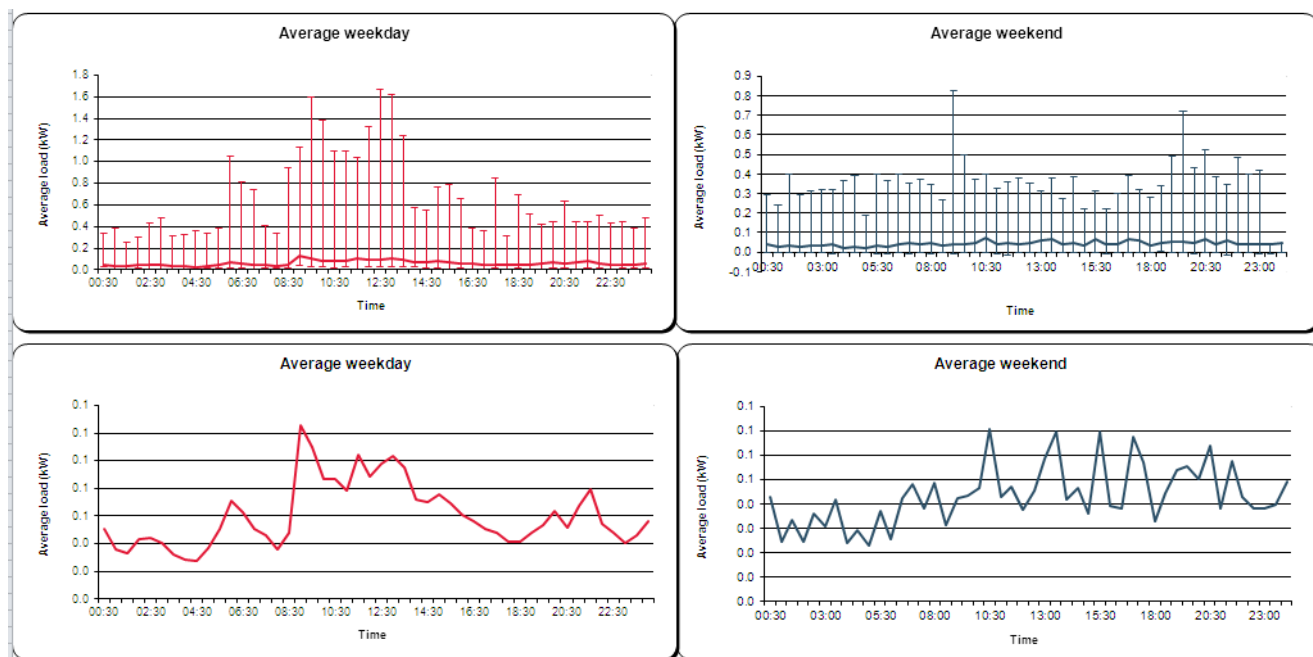
Figure 135: Circuit 3 - Kitchen Power (Year 1 – with and without error bars)

The kitchen power circuit recognises a base level of consumption, with sporadic peaks. These peaks result from use of the kettle, toaster and microwave in the kitchen.

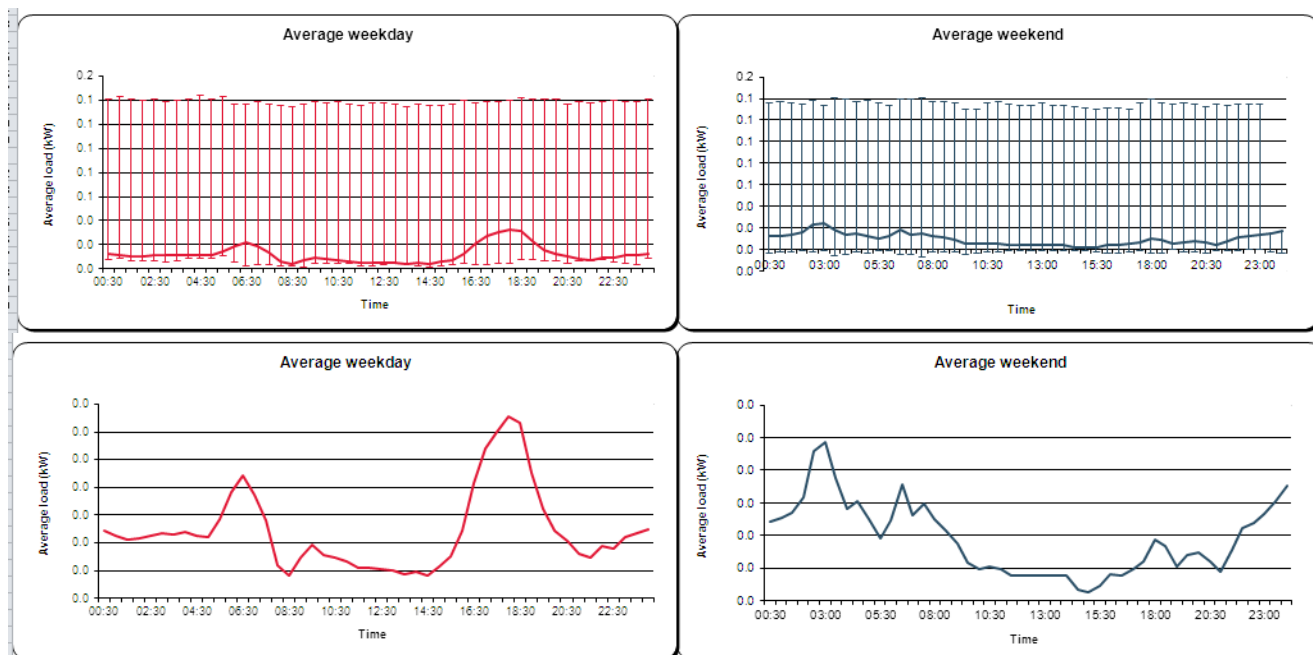
Figure 136: Circuit 4 - Lighting Zone 1 (Year 1 – with and without error bars)

As expected, lighting consumption is limited during the day, however, it is not clear why it would peak in the evening and morning and decrease again overnight, as the Visitor Centre is occupied by security staff from 6pm to 6am.

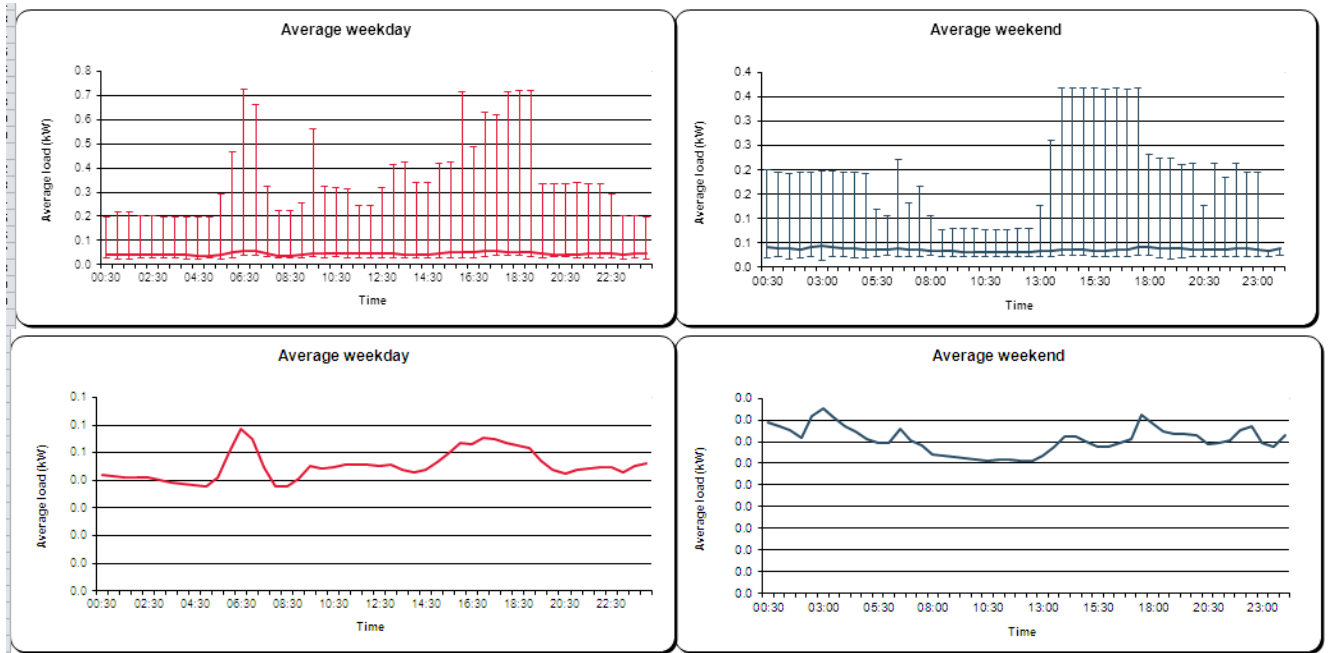
Figure 137: Circuit 5 - Lighting Zone 2 (Year 1 – with and without error bars)

Defined peaks are shown in the lighting zone 2 circuit, particularly in the early morning weekdays.

- Sub-meter 5, Lighting Zone 2: this circuit covers the lighting in the staff area. The actual metered consumption is much lower than the estimated in use figure. BRE staff members using the Visitor Centre have noted that in general the levels of daylight are sufficient that artificial lighting is not required. In addition, they have commented that even when natural light levels fall, they are reluctant to switch on the lights as they find them to be too bright.

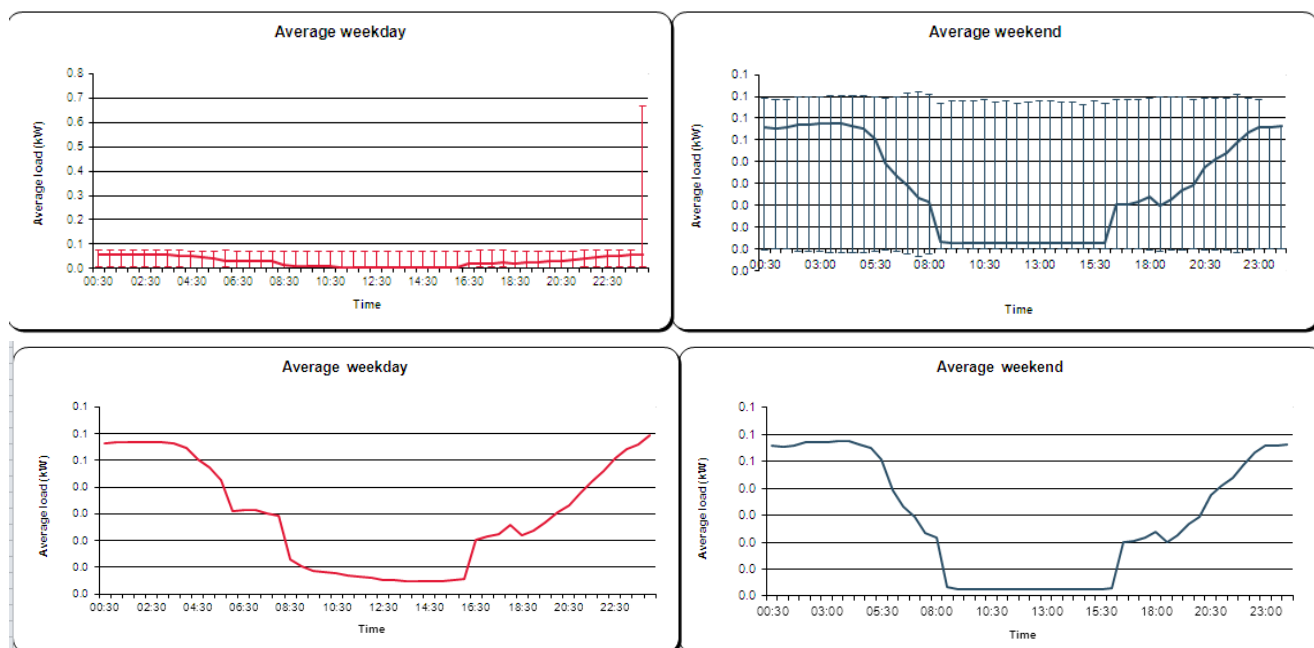
Figure 139: Circuit 7 - External Lighting (Year 1 – with and without error bars)

External lighting is controlled by a timer and as such, the profiles are quite distinct, with little or no electricity consumed during the day. The electricity consumption shown during the day results from a few isolated days when the timer has not correctly switched off the lights.

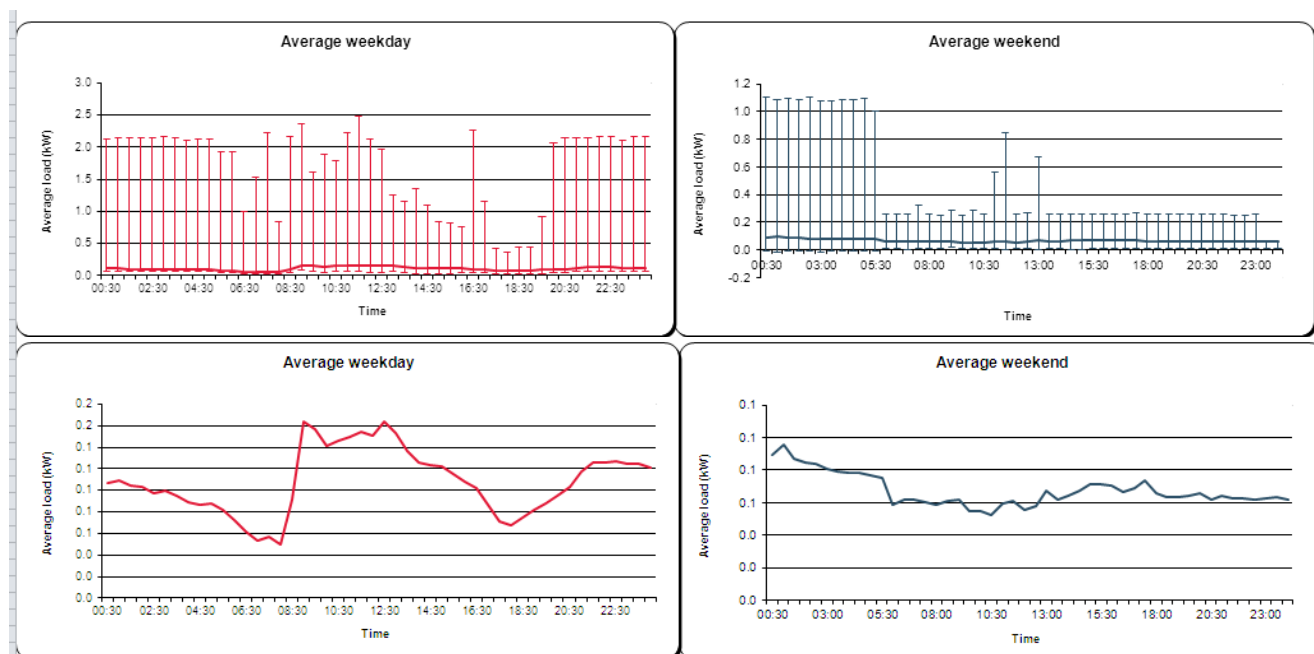
Figure 140: Circuit 8 - Small Power Zone 1 (Year 1 – with and without error bars)

The consumption profiles for year one shows more energy consumed during the day in year one for both small power zones (Figure 140 and Figure 141)

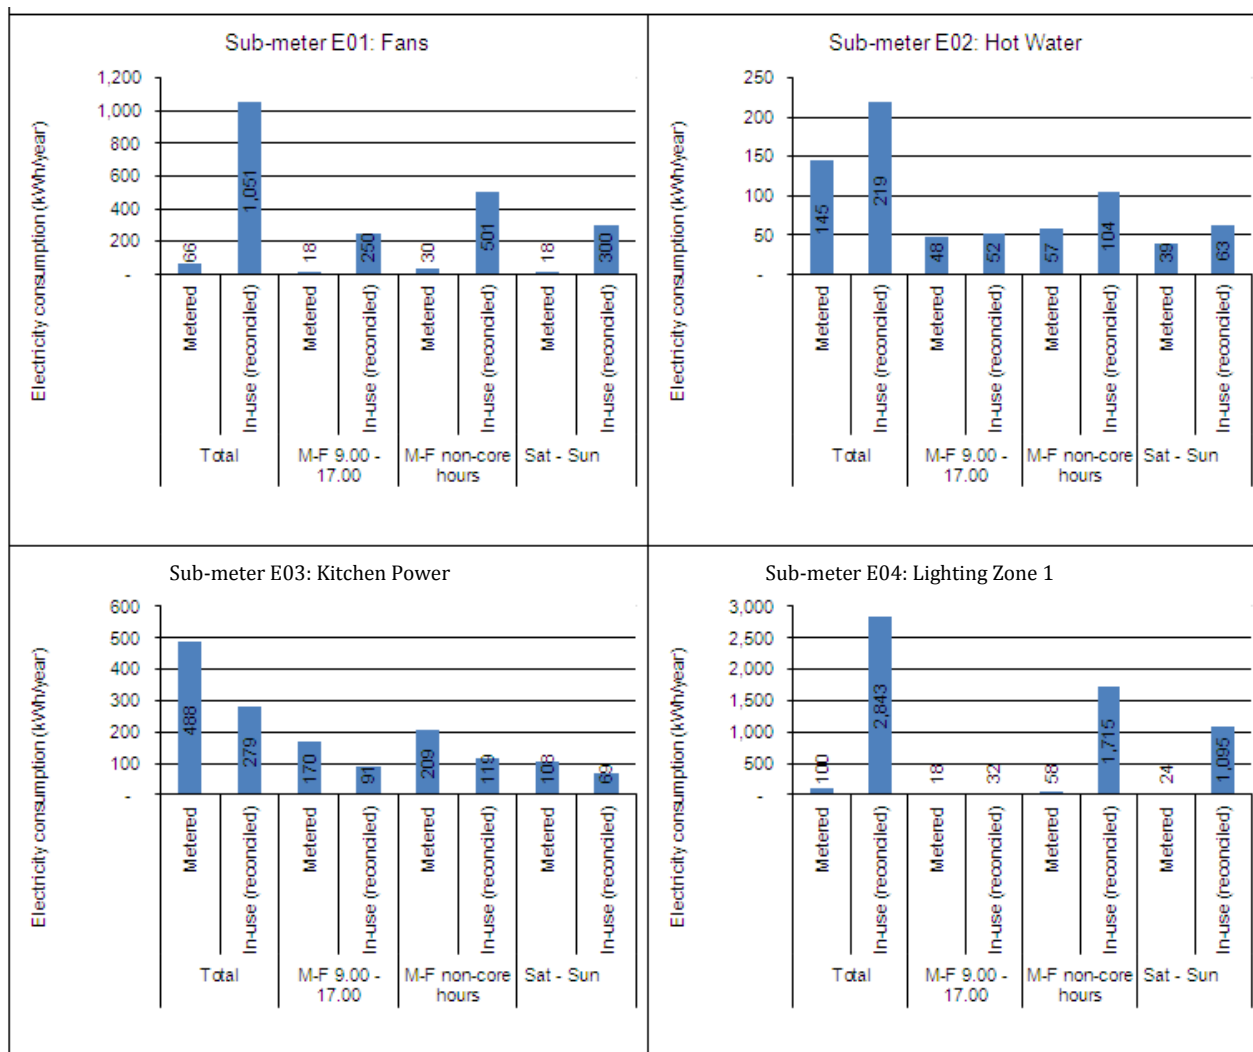
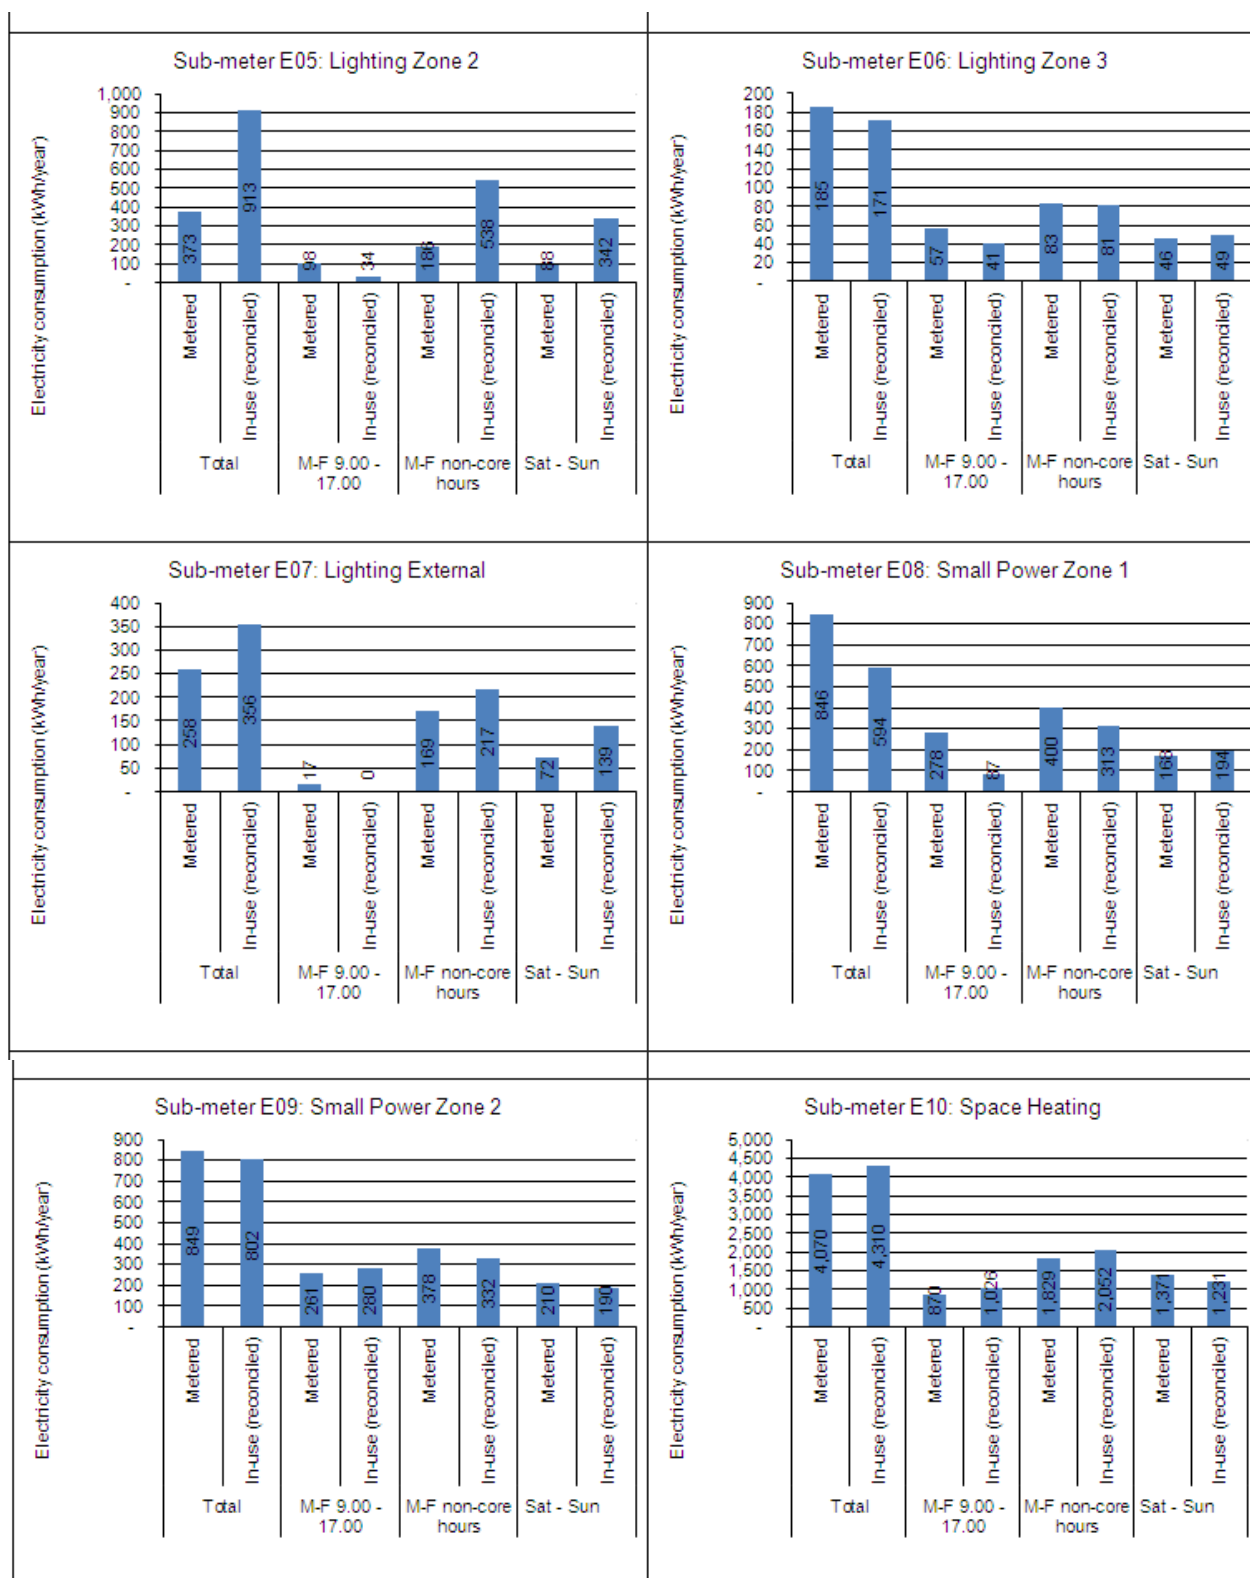
Figure 143: Electricity Consumption (Sub-meters)

The discrepancies between the ‘metered’ value and the ‘in-use’ value as shown in Figure 143, can be explained as follows.

- Sub-meter 4, Lighting Zone 1: this circuit covers the lighting in the main event space in the Visitor Centre. The discrepancy between metered and in-use data for this circuit is because of the use of electricity generated by the PV array to power these lights.

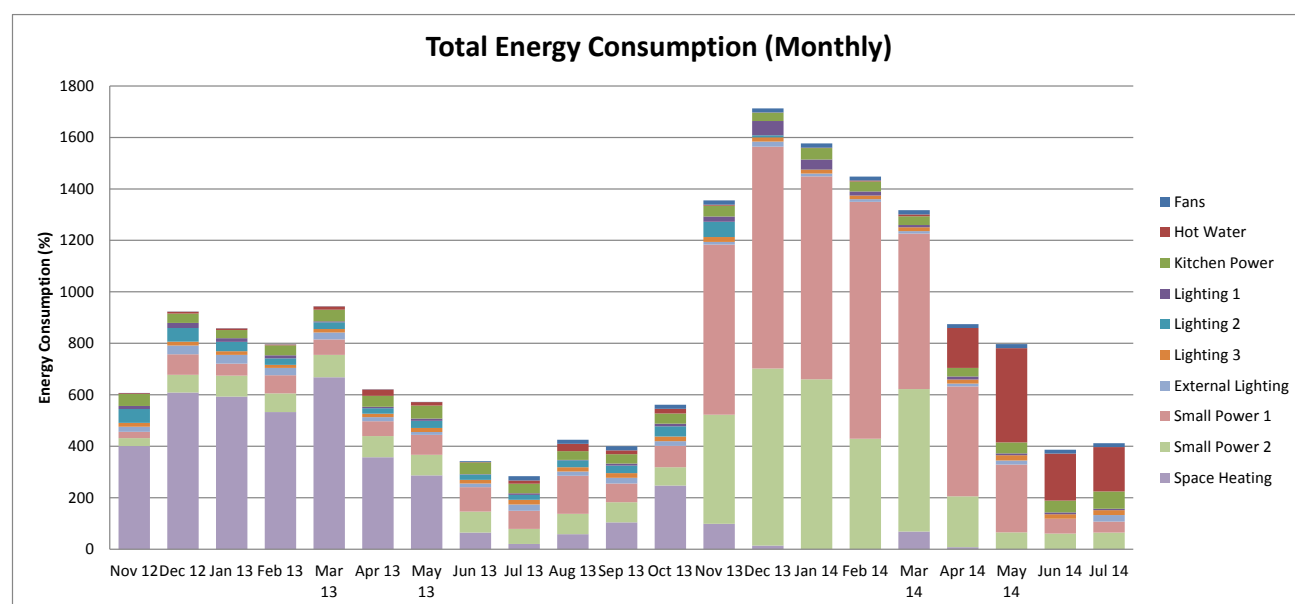
Figure 146: Total Energy Consumption (kWh)

These patterns in energy use can be clearly seen in Figure 146 and Figure 147.

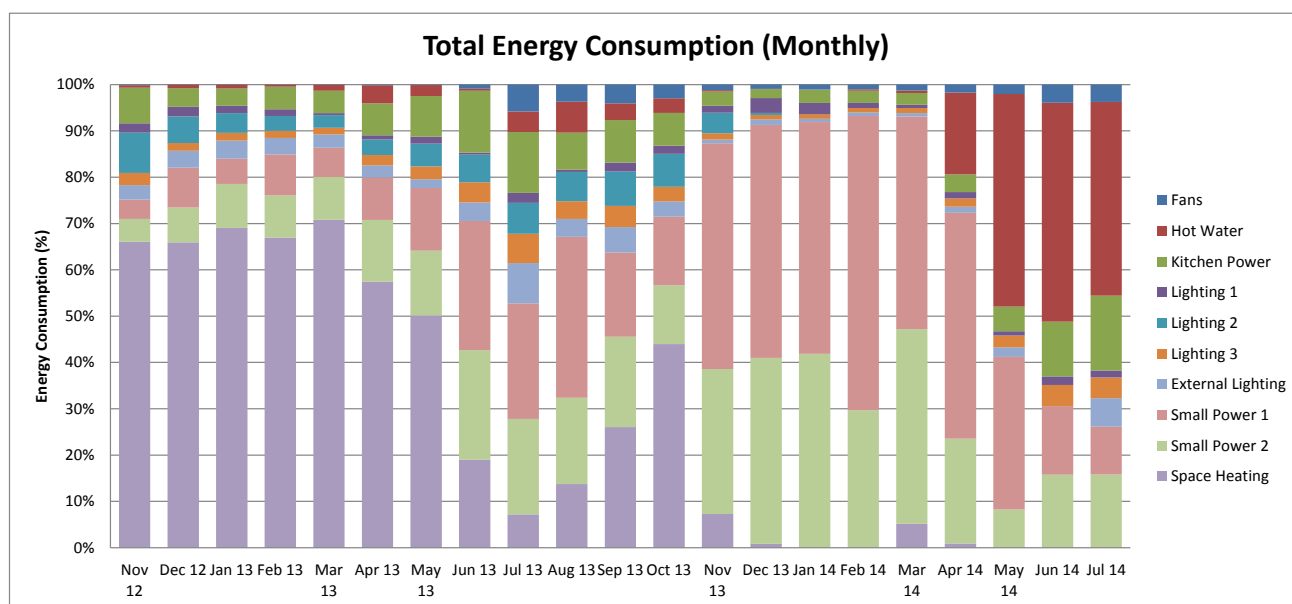
Figure 147: Total Energy Consumption (%)

This switch from use of the space heating circuit to electric heaters plugged into the small power 1 and small power 2 circuits can be seen from the change in graphs in Figure 26 and Figure 28. A direct comparison can be viewed in Appendix section 10.9, particularly in Figure 147. In addition, energy profiles for all ten circuits for year one and year two can also be seen in section 10.9.

The graph in Figure 147 clearly shows the change from the use of the ASHP for heating, to the use of electric heaters which are plugged into the small power circuits. Use of the small power 1 circuit increased from an average monthly consumption of 78kWh to an average 710kWh per month and likewise the consumption on the small power 2 circuit increased from 76kWh to 492kWh.

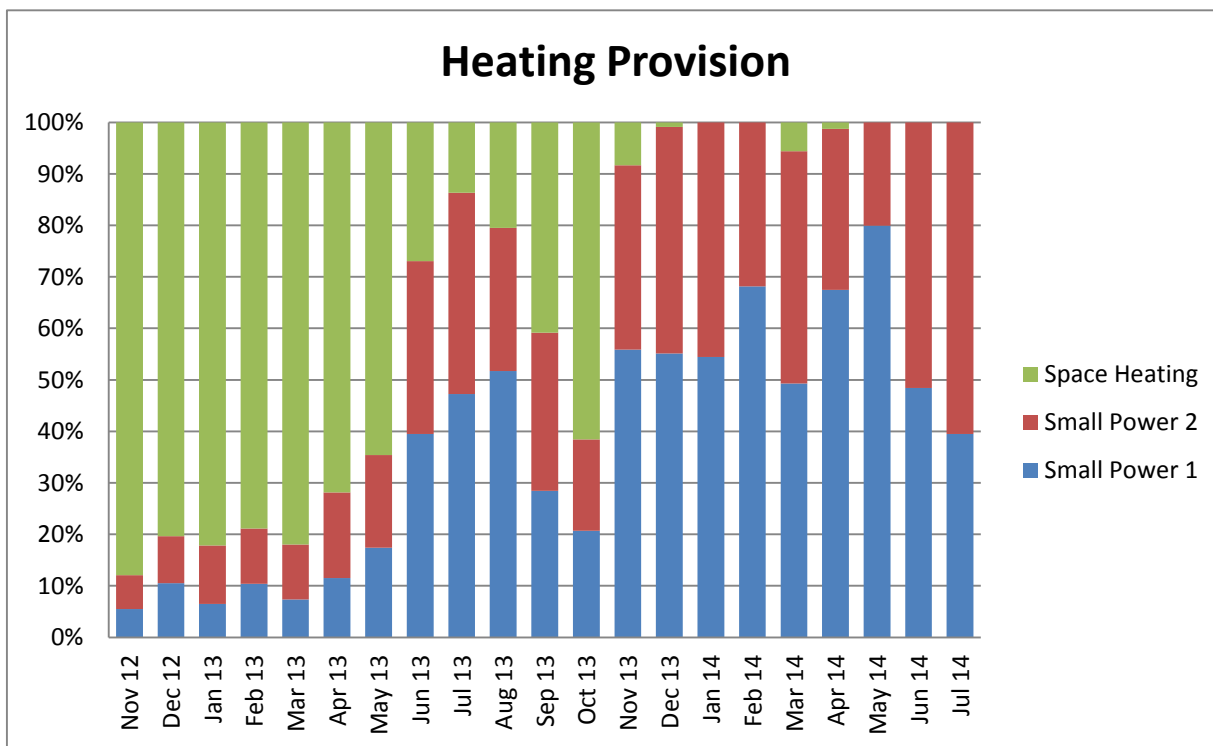
Figure 148: Heating Provision

This change in heating provision can also be seen in Figure 148 below. This graph shows the increase in use of the space heating circuit from July/August to September and October, before the electric bar heaters were utilised from November onwards. The heating circuit was switched back on for testing in March, hence the energy used at that point. No heating was used from May 2014 onwards, so the consumption on the small power circuits reverts back to normal small power use.
