This document contains a Building Performance Evaluation report from the £8 million Building Performance Evaluation research programme funded by the Department of Business Innovation and Skills between 2010 and 2015. The report was originally published by InnovateUK and made available for public use via the building data exchange website hosted by InnovateUK until 2019. This website is now hosting the BPE reports as a research archive. Although no support or further information on the reports is available from the host, further information may be available from the original InnovateUK project evaluator using the link below¹.

InnovateUK project number	450054
Project author	ECD Architects for Hanover (Scotland) Housing Association Ltd
Report date	2014
¹InnovateUK Evaluator	N/A

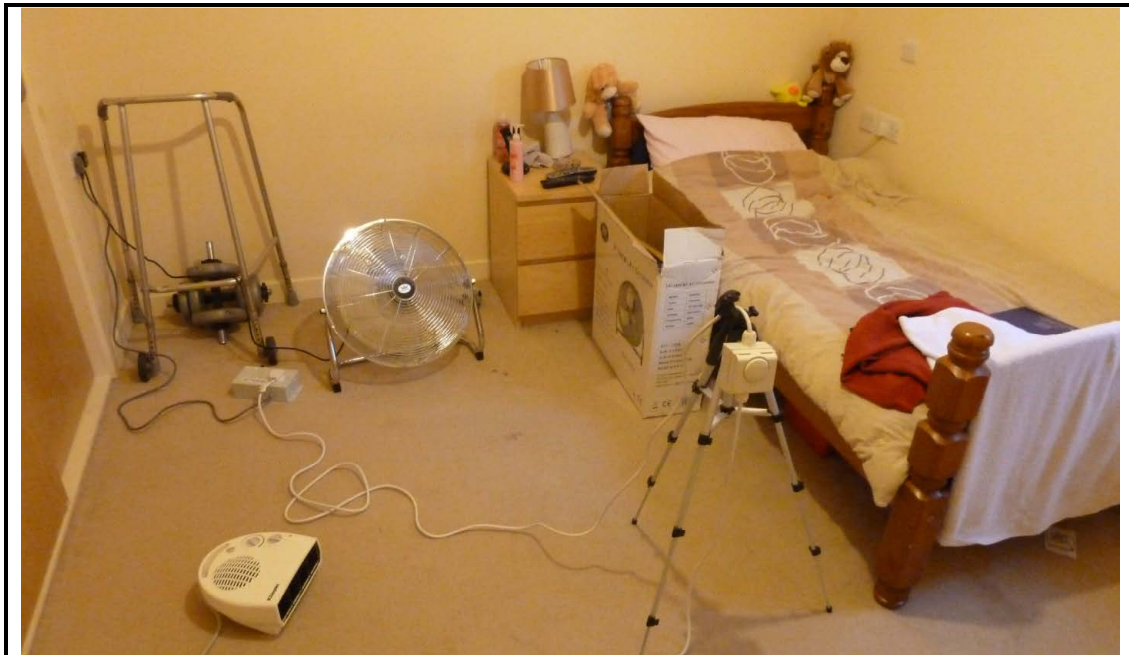
Co-heating kit disposition in one of the test bedrooms

Two issues were identified from the test procedure which could impact on the results. Hukseflux flux plates were installed on the party wall to monitor energy movement through this element of construction and quantify losses. Unfortunately, as with the U-value testing, the tape holding these plates in place failed at some time during the test period as a result of the high temperatures and low RH drying out the adhesive. The point at which these plates came off the wall could not be identified thus none of the data could be used. Temperature data from the adjacent dwelling has been used in the calculation process but this does not account for energy which is lost by convection in the cavity between the two dwellings. A small degree of error is likely to result from this.

The thermostats used were placed at an altitude of 850mm above finished floor level as specified in the protocol but in the case of the living room, kitchen and bedroom 3 the associated temperature monitor was located at a different level. This was a result of using the t-mac sensors which were already installed as part of the BPE monitoring but which are at a level of 2000mm in each room. This meant that conditions might indeed have been the same between rooms, although leaves the possibility that these rooms appear to be hotter

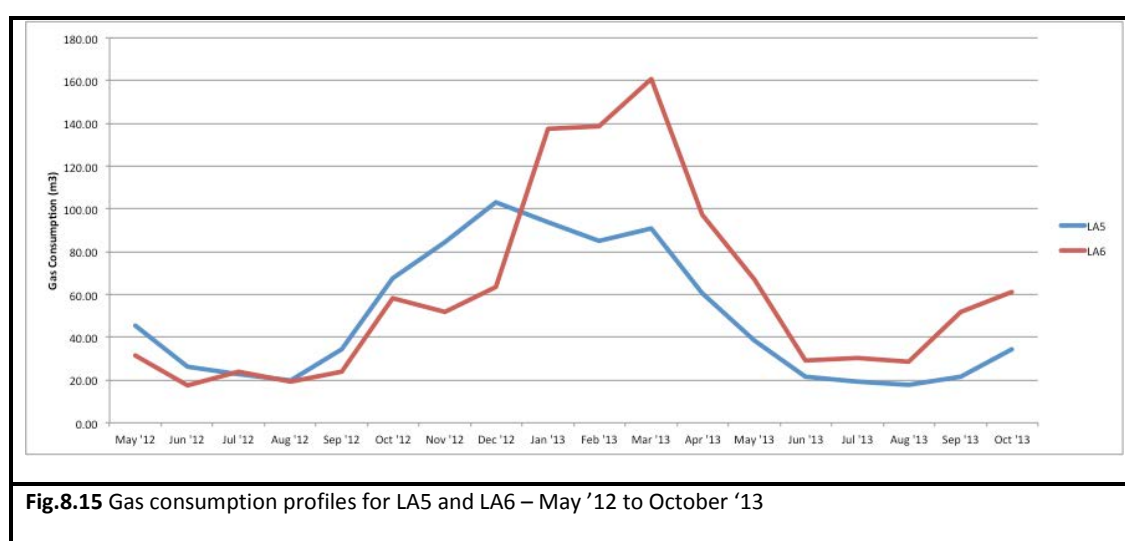
In December, LA6 was unoccupied for a period, easily seen in the above graph and evident in the 'dip' in the red line in the graph below, before new occupants moved in (18th December 2012). From this point onwards it is clear to see that gas consumption in LA6 immediately and steeply rises and remains the higher of the two throughout the remainder of the monitoring period, although both properties still show a seasonal reduction in gas consumption through the warmer months.

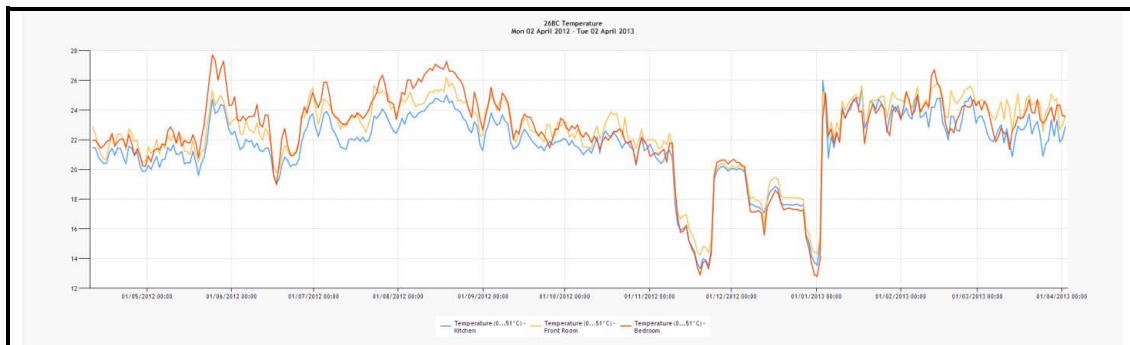
Fig.8.20 LA6 annual temperature profile, kitchen (blue), living room (yellow) and bedroom (red). Note there is greater variation here and the vertical scale starts at 12°C, with the peak at 28°C. Starting around 22°C in May and June the temperatures rise over the rest of the summer, remaining fairly constant around 22°C again in October and November before dropping in December and January while the property was unoccupied. In January, the high temperatures resume, averaging around 24°C for the remainder of the monitored period.

As mentioned in the section on energy, internal temperatures remain consistently high throughout the year. The effect of LA6 being empty over the Christmas period is apparent, as is the period of heating only. This period is actually very significant as it represents an unoccupied but heated period where temperatures vary between approximately 18°C and 20°C. What this suggests is that the difference in temperatures become due to incidental gains from people and electrical use. There appears to have been some interventions on or around the 23rd November – this may perhaps have been a visit by the housing association who turned the heating on to protect against frost damage, and further interventions were made at 3 points over the Christmas period, again appearing to be adjustments to the thermostat of the heating system, including the system being turned off again prior to occupation.

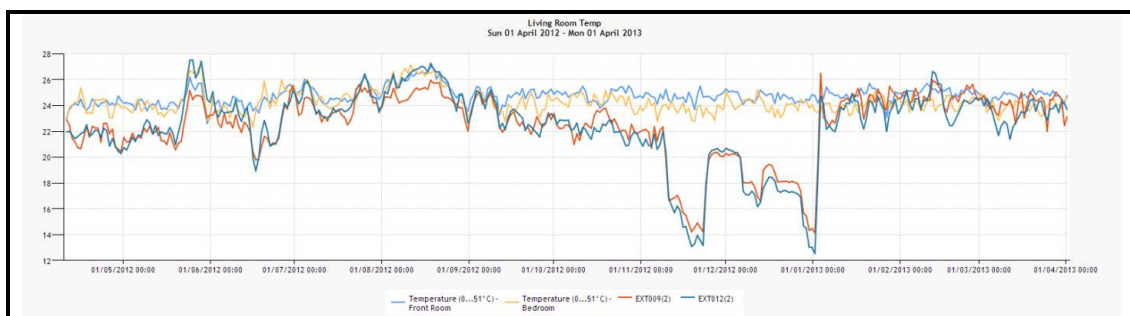
Fig.8.21 Comparison of annual temperature profile LA5 and LA6, living rooms and bedrooms only.

It is clearer to see above the relative temperatures of the two properties. While it gets a little messier during the later summer, during both the early summer and autumn, LA5 retains a higher and noticeably more consistent temperature, whilst the two properties are indistinguishable once the new residents are settled in, in early 2013.

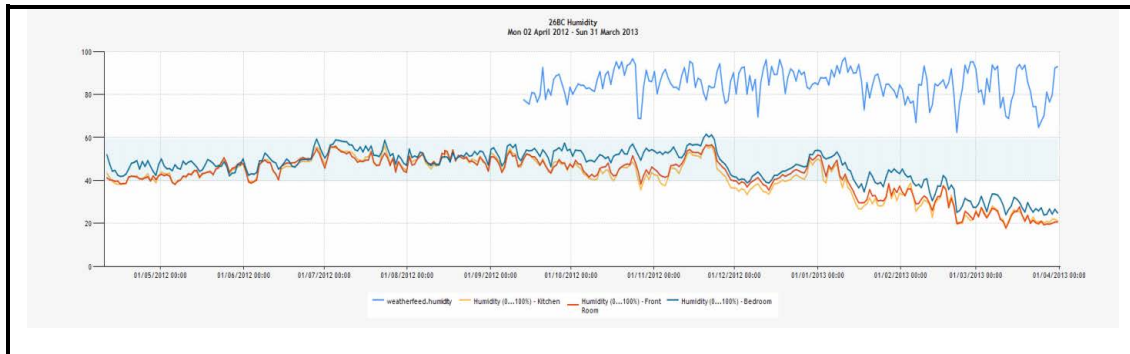
Fig.8.22 LA6 Annual relative humidity profile. The pale blue horizontal band represents the desirable range of 40-60% RH, while the light blue line above represents external RH.

Observations of this data are that RH levels generally remain within acceptable limits, but that low levels of RH are experienced in the spring periods. This is a commonly observed phenomenon whereby winter heating regimes and ventilation habits are maintained well into warmer drier weather periods, resulting in high internal temperatures and consequently low internal RH levels. These levels of RH are a cause for concern because low levels of RH can lead to health problems, particularly associated with skin, eyes and respiratory systems in occupants.

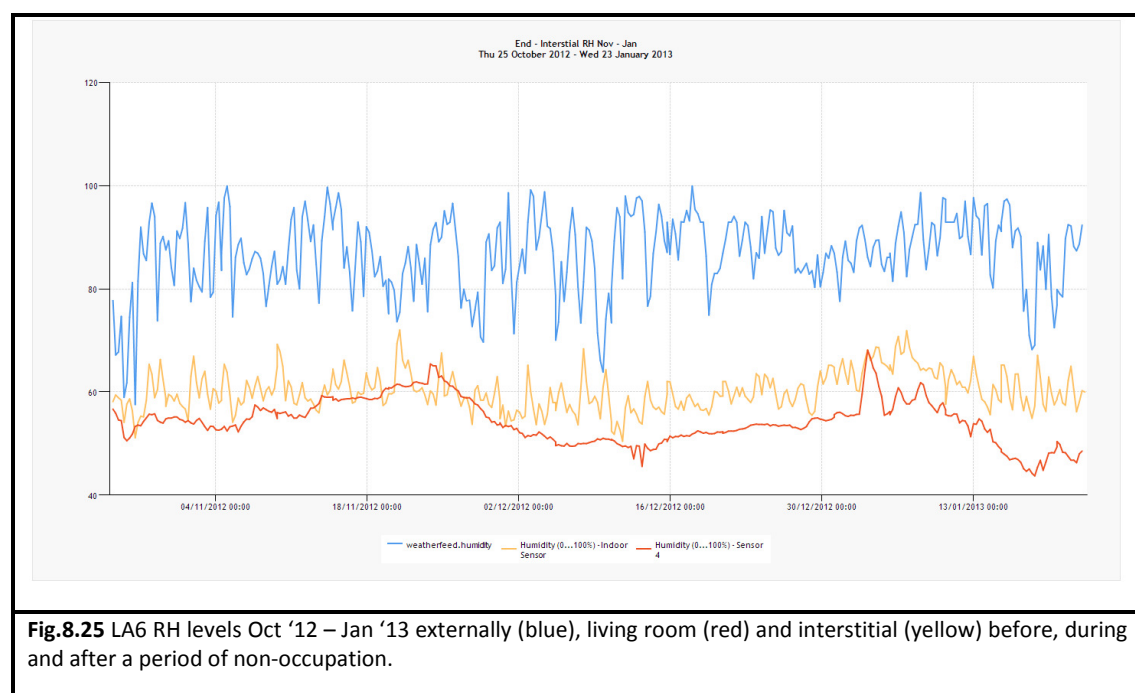
Observation of the same period in the occupied house showed that the relationship is more derived from the internal conditions (Fig. 8.26). External RH levels were high during this period.

There is no obvious indication of sustained high humidity levels in the monitored rooms. Issues with dampness in the bathrooms identified in the BUS survey would therefore appear to be localised and due the ventilation performance of those spaces.

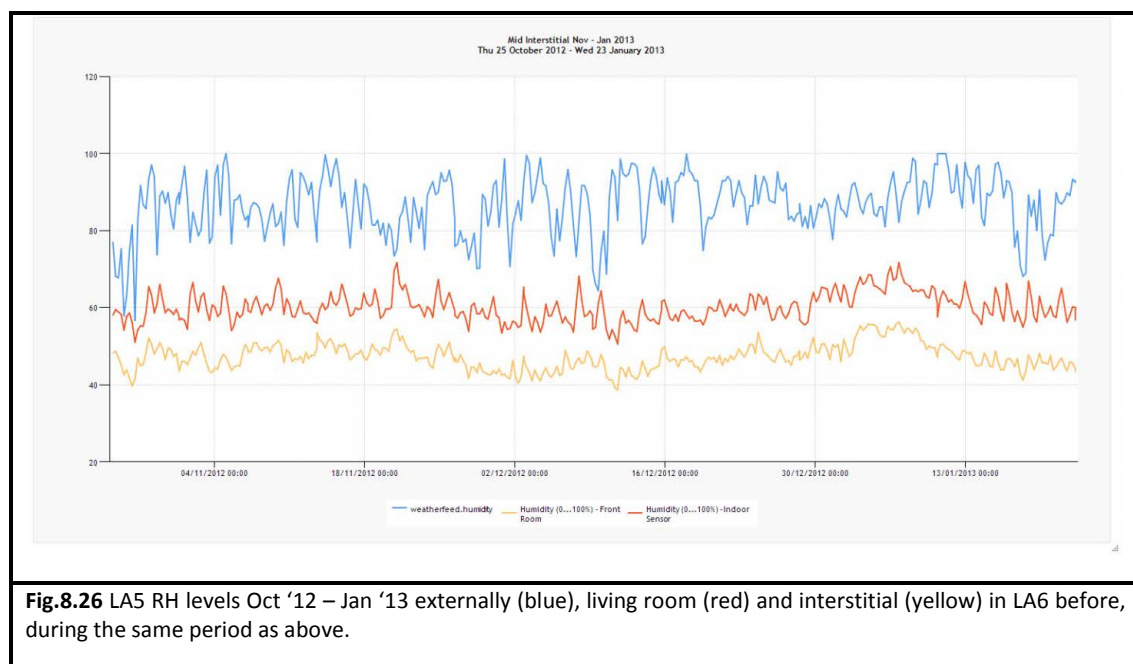
The effects of the lack of occupancy can be observed at the end of the period, when LA6 is empty. RH levels increase slightly after the house is first empty, but then drop, to lower levels. This is explained by the house being heated whilst it was empty. Without occupants there is no moisture being produced and the heating then reduces RH levels.

What this does suggest is that very low levels of heating are required during unoccupied periods to protect against frost, but to also avoid potentially damaging low levels of RH that could result in drying out of materials from excessive heating.

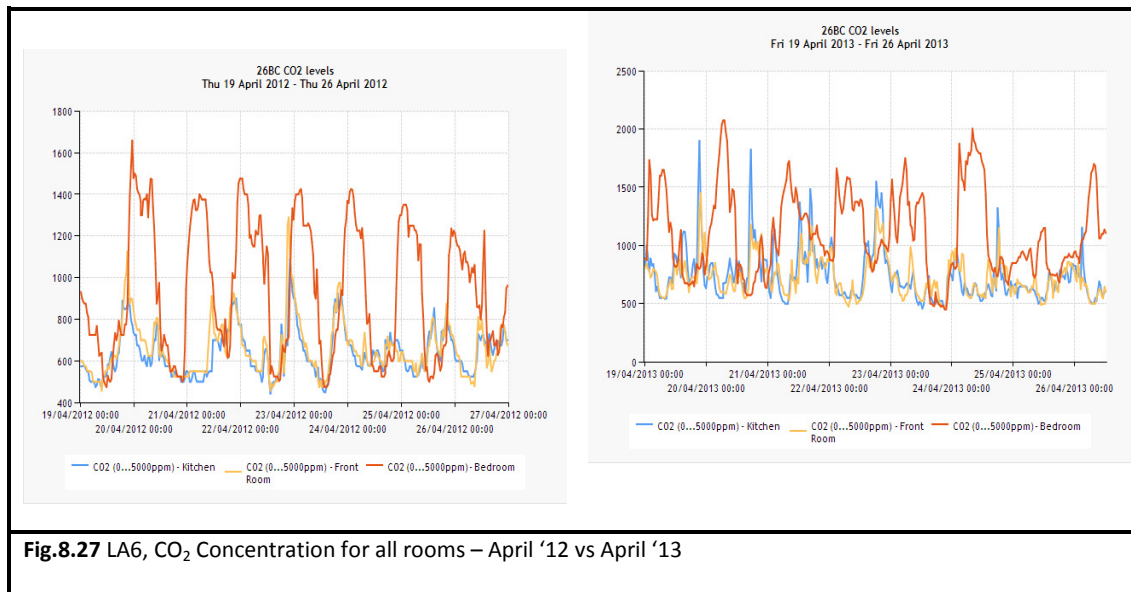
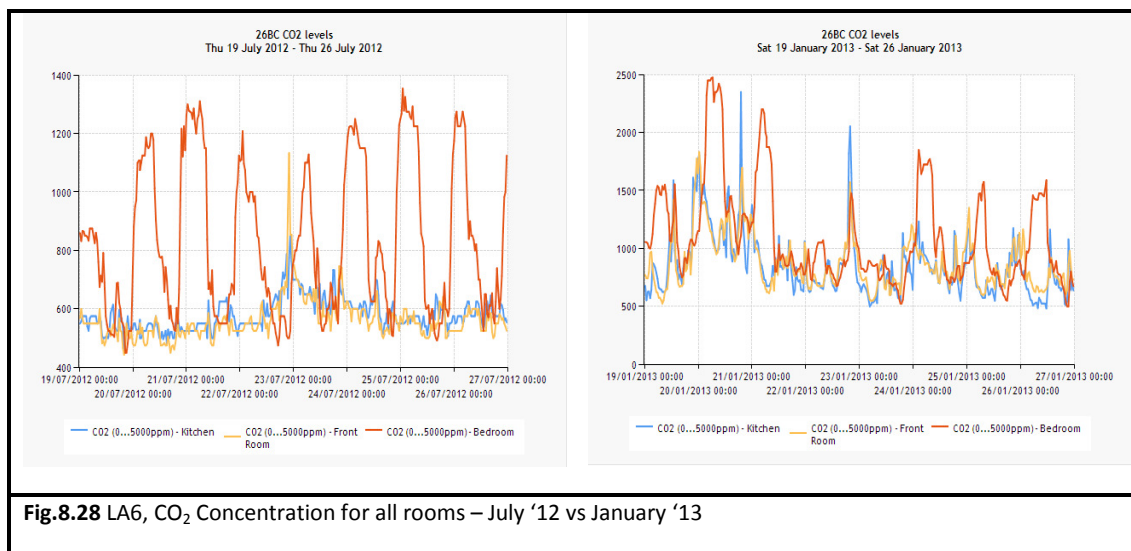
The diurnal pattern remains consistent throughout the year, with CO₂ levels rising during occupancy. It is clear from the graphs below that CO₂ levels in bedrooms reach higher levels and for longer periods than the Living Rooms and Kitchens which peak occasionally but tend to remain below 1000ppm. Ventilation levels in the bedrooms are a cause for concern, with extended periods over the accepted limit of 1000ppm in both properties.

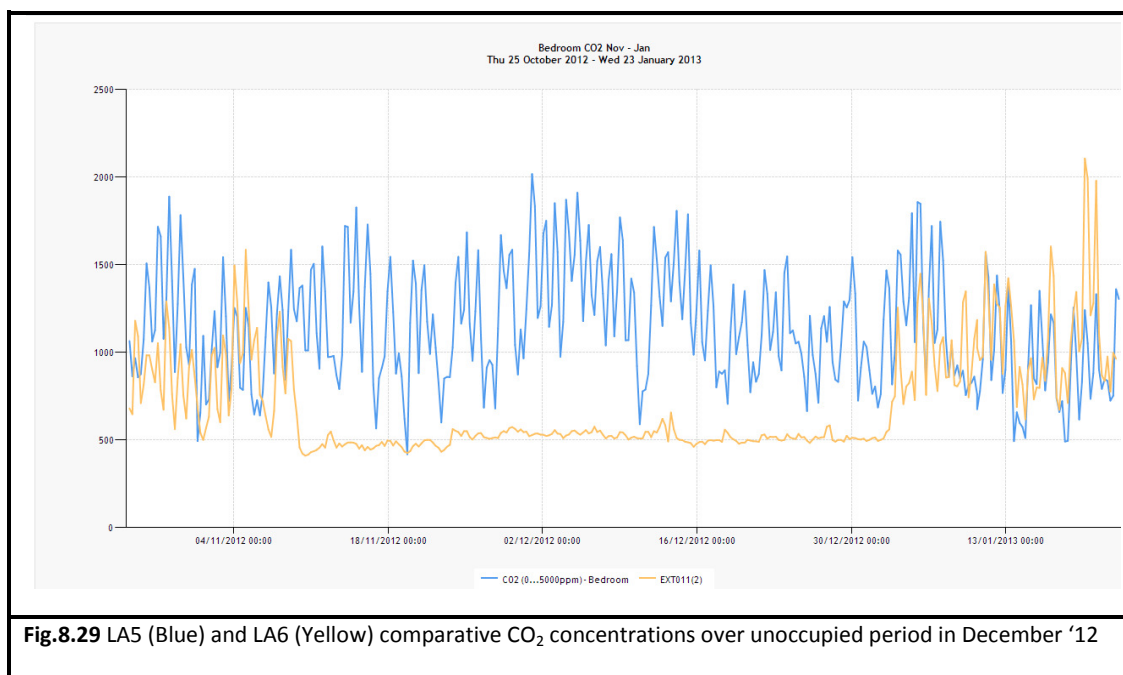
The unoccupied period in LA5 can clearly be seen below (Fig. 8.29). What this does indicate is the value of CO₂ as a measure of occupancy. On re-occupation, high levels of CO₂ are again observed. The findings from previous quarterly reporting analysis highlighted that these issues are primarily due to room occupancy, volume and ventilation strategy.

It is recommended that interventions be made in the houses to test these observations. This would include gathering data on bedroom ventilation habits, more detailed information on bedroom area, volume, net volume, and background ventilation provision. However, some intervention could also be made with occupants to test particular behaviours; for example asking them to open trickle vents, and/or keep windows open at night, to observe whether these significantly affect CO₂ levels.

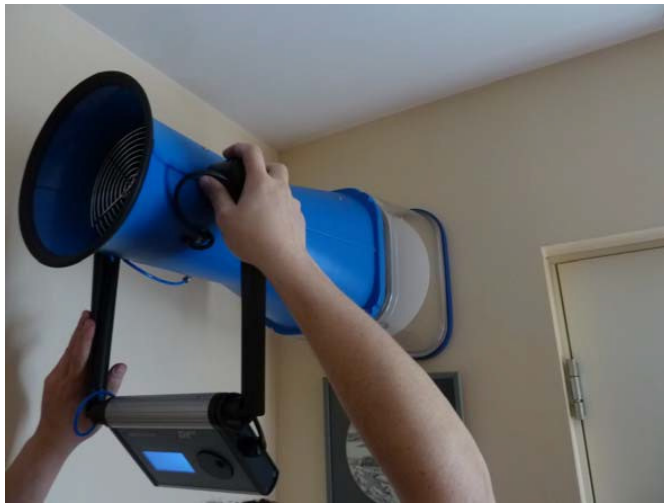
Fig 9.1: Powered flow hood in operation showing volume flow rate of kitchen fan

The equipment was operated as per the manufacturer's instructions. Fans were switched to operate and three volume flow measurements were taken at each fan inlet (in litres per second), once the air flow had stabilised. The exception from this was one kitchen extract fan, due to arrangement of appliances it was not possible to take measurements on the fan inlet, therefore for this fan air flow measurements were taken on the air outlet. The final result of the testing for each fan was an average of the three measurements taken.
