# **Bryan House**

InnovateUK project number	450100
Project author	Low Carbon Building Group, Oxford Brookes University for Sanctuary Green Technologies
Report date	2014
<sup>1</sup> InnovateUK Evaluator	N/A

Low Carbon Building Group (LCBG) of Oxford Institute for Sustainable Development (OISD) at Oxford Brookes University was commissioned to monitor and evaluate the social housing project during its *Post construction and initial occupancy* phase and provide key comments and recommendations.

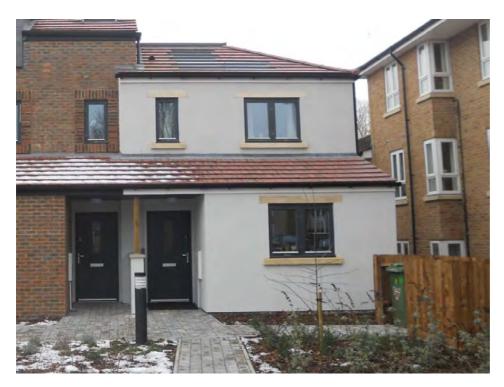
Figure 23 No. 1 front (east) digital photograph.

Figure 22 No.1 front (east) elevation thermogram. Note: No thermal abnormalities are evident in the walls. The elevated temperature in the front door is typical for design, and the elevated temperatures in the upper centre of the windows is likely to be due to poor fitting.

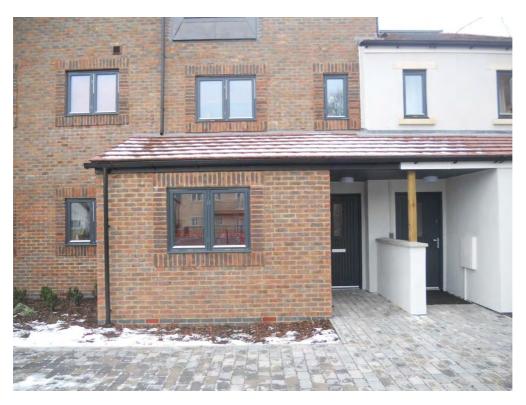
Figure 27 No. 2 front lower (east) digital photograph.

Figure 26 No.2 front lower (east) elevation thermogram. Note: No thermal abnormalities are evident in the walls.

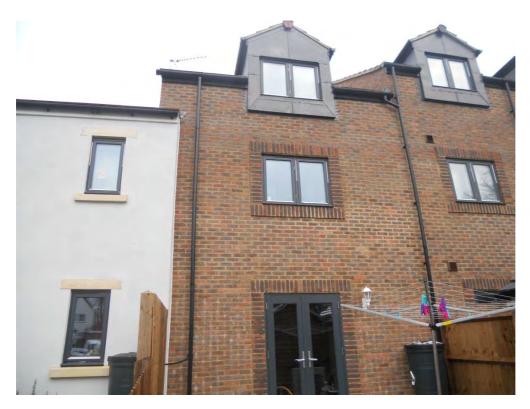
Figure 31 No. 2 rear upper (west) digital photograph.

Figure 30 No. 2 rear upper (west) elevation thermogram. Note: Elevated temperatures were observed on the north walls between properties 1 & 2 as well as 2 & 3. Area temperature boxes are shown on the image for comparative purposes.

- No thermal anomalies are evident in the walls with the exception of the party walls between the properties of different height where some heat loss was observed.
- Elevated temperatures around the window frames are likely to be due to poor fitting.
- Front door heat loss is due to low insulation and design of door.

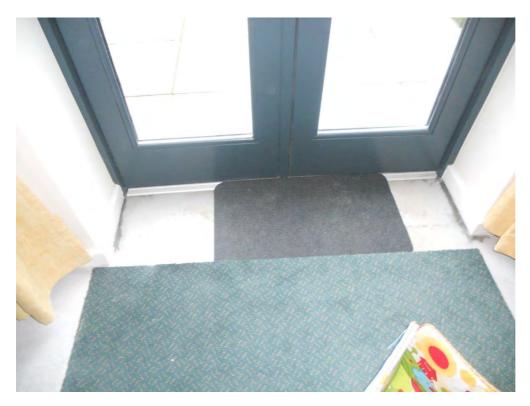
Figure 33 No. 2 rear patio doors lower (internal) digital photograph.

Figure 32 No. 2 rear patio doors lower (internal) thermogram. Note: Thermal bridging across threshold and different temperature scale used from image 17. Similar characteristics also observed in property No. 1.

- Thermal bridging across threshold was observed in both properties.
- A cold bridge from a beam in the ceiling of the kitchen was identified in both houses. This is due to the detailing of the kitchen roof. It should be noted that part of the kitchen ceiling is exposed as the kitchen extends beyond the floor above it. The steel beam was not insulated resulting in a cold bridge.

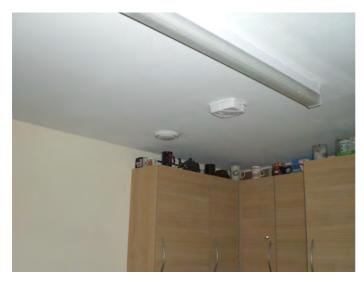
Figure 35 No. 2 kitchen ceiling digital photograph

Figure 34 No. 2 kitchen ceiling thermograph (south view). Note: Image shows cold bridging from structural beam in ceiling. The same was observed in House 1 kitchen ceiling

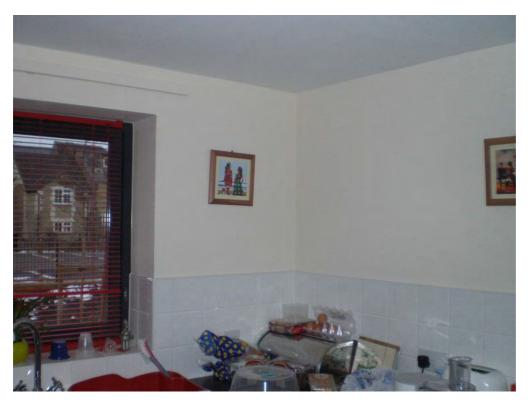
Figure 38 No. 2 kitchen wall digital photograph (south view).

Figure 37 No. 2 kitchen wall thermograph (south view). Note: Cold spot identified on wall is an irregular shape probably due to air movement within the structure

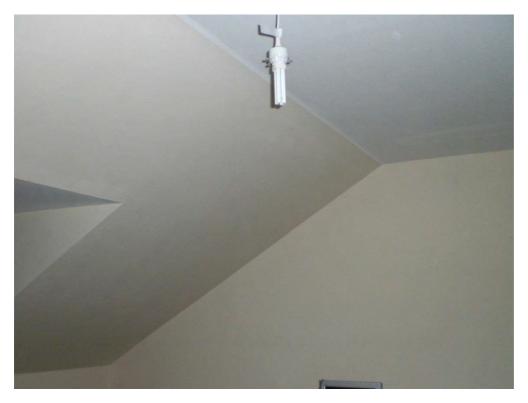
Figure 40 No. 3 bedroom ceiling (north) digital image.

Figure 39 No. 3 bedroom ceiling (north) thermograph. Note: Image shows cold bridging from beam above ceiling. Similar image also is viewed (south) towards other end of room and similar characteristics were observed in bedroom 4.

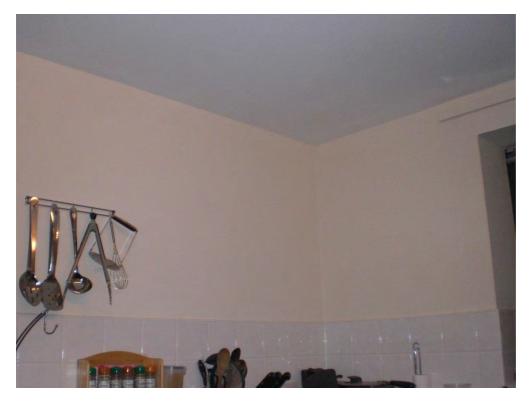
Figure 42 No. 1 Kitchen wall digital photograph (north view).

Figure 41 No. 1 Kitchen wall thermograph (north view). Note: Cold area identified on wall in an area similar to property No. 2.

- Square solid area in House 1 kitchen wall indicates that an insulation panel is missing. This is possibly due to a mistake during construction.
- Cold spots identified on House 1 ceilings indicate that roof insulation is missing. This was
  further investigated during the commissioning review and a visit in the loft revealed that the loft
  insulation has been misplaced, possibly be the occupants, to make room for storage. It could
  also be that the insulation was never distributed in the roof space properly.

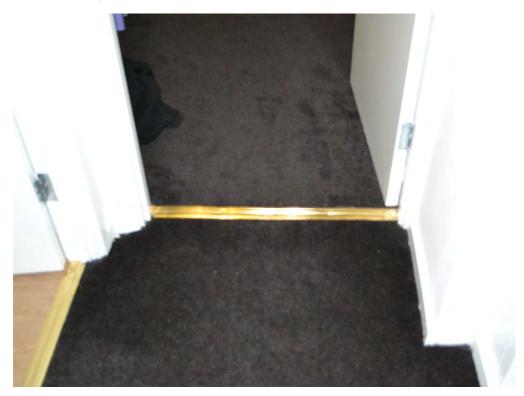
Figure 44 No. 1 landing to bedroom 1 floor interface digital image.

Figure 43 No. 1 landing to bedroom 1 floor interface thermogram. Note: Resident of property 1 commented during survey that bedroom 1 was always cold compared to remainder of house. The thermogram confirmed that this phenomena despite the controller within the space calling for heat. Further investigation of this fault is therefore recommended.

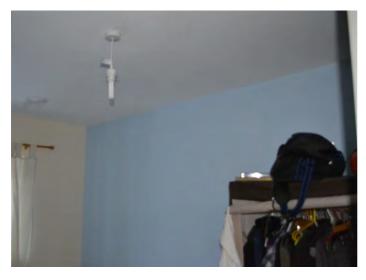
Figure 46 No. 1 bedroom 2 ceiling (centre north) digital photograph.

Figure 45 No. 1 bedroom 2 ceiling (centre north) thermogram. Note: Cold area possibly due to missing roof insulation or insulation not located correctly between roof joists. No digital image available of area.

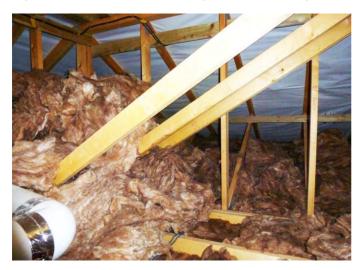
Figure 47 Roof insulation is not distributed well resulting in insulation gaps.

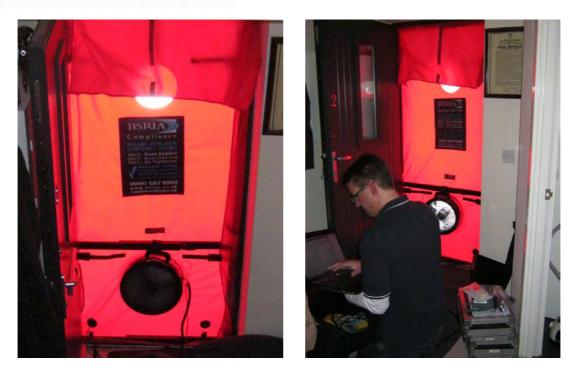
Figure 52 Air permeability testing kit

The measured average air-permeability rate of both dwellings when tested using the method contained in ATTMA standard TS1 failed to meet the initial design criteria of  $3m^3/(h.m^2)$ . However, they were both significantly less than the national building standard of 10 m<sup>3</sup>/(h.m<sup>2</sup>) (Table 7).

- Both houses failed to meet the design air permeability of 3 m<sup>3</sup>/hm<sup>2</sup> and were measured to have between 5.27-5.91 m<sup>3</sup>/hm<sup>2</sup>.
- However, they were both significantly less than the national building standard of 10 m<sup>3</sup>/hm<sup>2</sup>.
- High air permeability might indicate that there is no need for the use of the MVHR system.
- The smoke pencil test revealed several air leakage paths through skirting boards, electrical outlets, plasterboards, light fittings loft hatch.

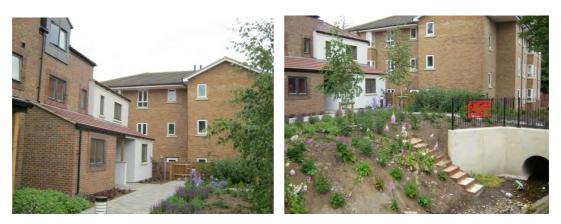
Occupants are satisfied with the appearance of the house and the door and entrance area. However, they dislike having the open stream in front of the house (Figure 86) as they consider it dangerous for young children. Railings could be added to prevent children from falling in the stream.

Figure 86 Front space. Right hand image shows the open stream in front of the houses.

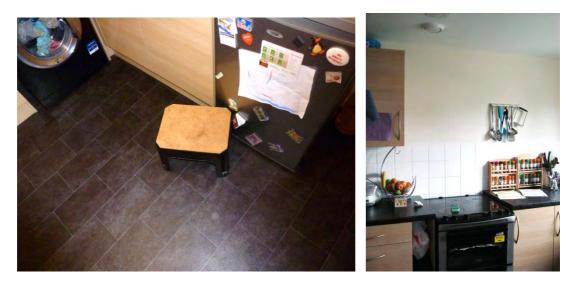
Figure 89 Kitchen

Occupants are satisfied with the size and layout of the kitchen and feel that the amount of storage is the best aspect of this space. They also feel that the space has good daylight levels and the floor is easy to clean. Occupants reported that the fire alarm gets set off really easily and that the MVHR is not as effective as a cooker hood and they would like to have a hood above the hob. The occupants use the MVHR boost while cooking but feel that the system disperses cooking smells to other rooms in the house (Figure 89).

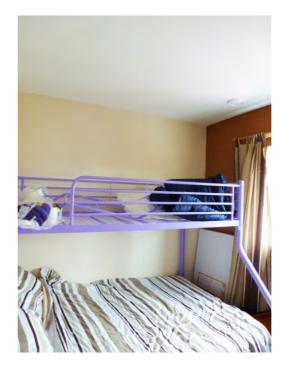
Occupants find this room unnecessarily big and would have preferred a better space distribution among the rooms. Good daylight levels are considered to be the best aspect of this space. The worst aspect of the space is considered to be the MVHR system (Figure 92). The MVHR vent is located directly above the bed leading to annoying draughts. As a result the occupants have shut the vent closed.

Figure 92 Front bedroom. The MVHR vent is located directly above the bed.

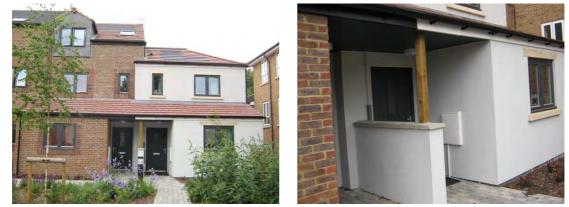
Figure 93 Front space.

Occupants are satisfied with the appearance of the house but do not like having an open stream in front of their entrances as they consider it to be dangerous for young children (Figure 93). They would also have preferred to have their own separate bins instead of having to use the communal bin shelter.

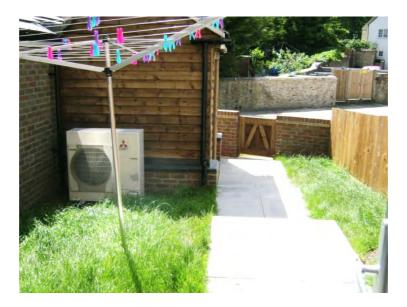
Figure 94 Back garden.

The occupants are not satisfied with the size and design of the back garden. Also, they do not like having the ASHP unit in within reach of children (Figure 94).

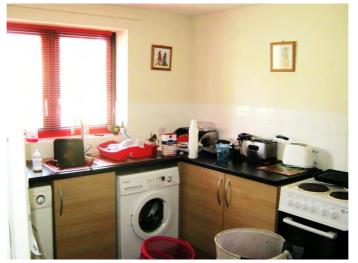
Figure 95 Kitchen

Occupants find the kitchen easy to clean and maintain and are satisfied with the size, storage space, daylight, ventilation and temperatures in the space (Figure 95). There are enough cupboards for storage. They find the smoke alarm to be the worst aspect of the space as it goes off very easily and they do not have a hood above the hob.

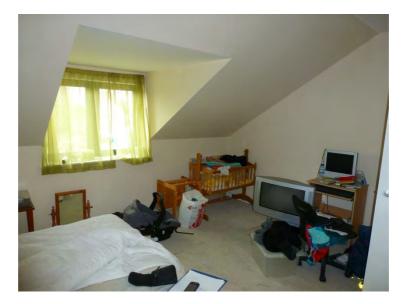
Figure 97 Double bedroom.

The temperatures in this room are high as the heating system is not working properly and the room is south-facing (Figure 97). The air quality is not good because the MVHR system is not working and occupants open the windows to ventilate and get rid of excess heat.

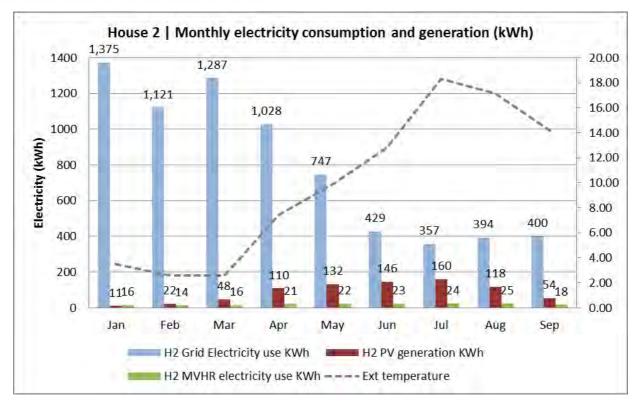
- Monthly grid electricity consumption ranges between 350-1370 kWh.
- Monthly PV generation ranges from 11-146 kWh.
- MVHR electricity consumption ranges between 14-23 kWh. It should be noted that the MVHR unit has been out of order from the past 4 months, however, the system seems to be consuming electricity.

Figure 110 House 2 monthly grid electricity consumption and PV generation (January-September 2013).

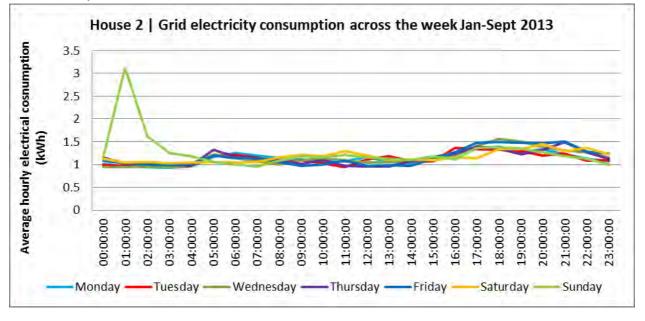
- Average hourly electricity remains constant throughout the week and during the day. A peak on Sunday at 01:00 is linked to the Immersion heater and the safety settings to prevent legionella. This does not appear in House 1 as the occupants had de-programmed the legionella timer in order to reduce their electricity consumption.
- During sunshine hours electricity consumption is slightly lower as the house is using PV generated electricity.

Figure 111 House 2 Average hourly grid electricity consumption across the week (January-September 2013).

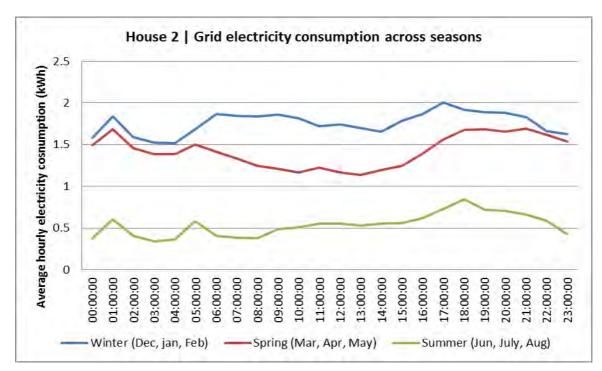
Figure 112 House 2 average hourly grid electricity consumption across seasons (December 2012-August 2013).

Figure 112 shows the average hourly grid electricity consumption across seasons. The higher electricity consumption is recorded during winter (December-February) and is kept quite steady throughout the day ranging between 1.5-2 kWh per hour. During summer (June- August), grid electricity consumption ranges between 0.4-0.8 during the day, indicating that the residual amount in winter months (1-1.6 kWh) is used for heating. Winter and spring daily profiles are quite similar as heating was on during most spring months.

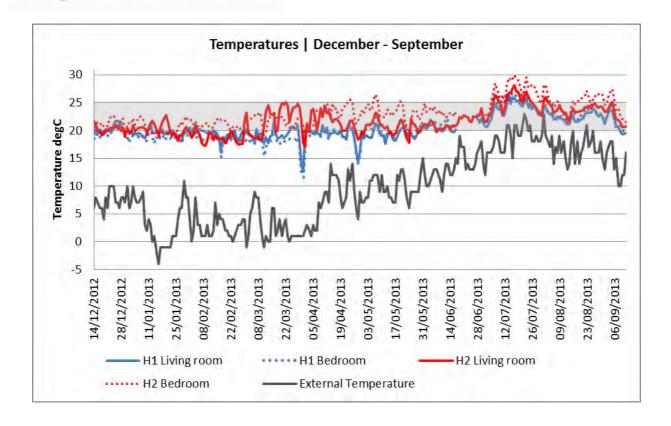
Figure 113 Average daily internal temperature in Houses 1 and 2 from December 2012 to September 2013.

Figure 113 shows the average daily indoor temperatures in Houses 1 and 2 from December 2012 to September 2013.

- House 1: temperatures range between 18°C-25°C. Bedroom 1-2°C cooler than living room during winter and 1-2°C warmer in summer.
- House 2: living room temperatures range between 19°C-26°C. Bedroom 1-2°C hotter than living room during winter and 2-3°C hotter during summer.

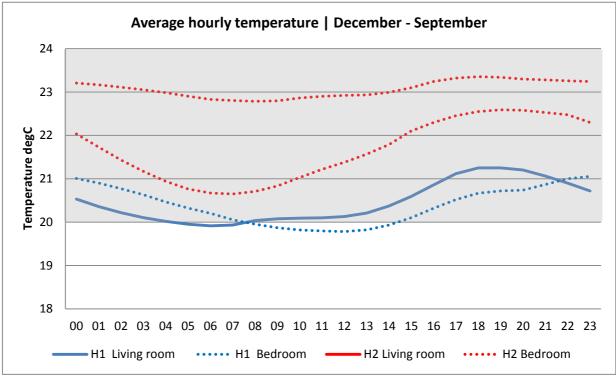
Figure 114 Average hourly temperatures in Houses 1 and 2 (December 2012-September 2013)

Figure 114 shows the average hourly temperatures in House 1 and 2 living rooms and bedrooms throughout the day.

- House 1: Living room temperatures range between 19°C-21.5°C. Bedroom temperatures range between 19°C-21°C, decreasing during the day. It should be noted that occupants kept the heating off during the day to save electricity. As a result temperatures in the living room and bedroom fall below the comfort band during winter.
- House 2: Living room temperatures range between 20.5°C-22.5°C. Bedroom temperatures range between 23-24.5°C. Occupants complain that the bedroom is always very hot and that they could not turn off the heating. As discussed in Section 7 investigation revealed that the thermostats were not connected to the heating system which was constantly on in the bedroom. Occupants in House 2 are not satisfied with the room temperatures and complained that it is always very hot in their house as a result of not being able to control the heating through the thermostats.

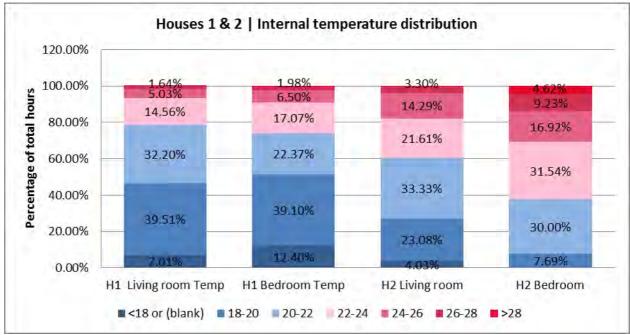
Figure 115 Internal temperature distribution (December 2012-September 2013).

Figure 115 shows the internal temperature distribution in Houses 1 and 2.

- House 1 temperatures remain above 28°C for 1.6-1.8% of the time.
- House 2 temperatures remain above 28°C for 3.3% of the time in the Living room and 4.6% of the time in the bedroom, indicating overheating. It should be noted that the heating was on even when the rooms where above 26°C, because the thermostats were not connected to the heating system.

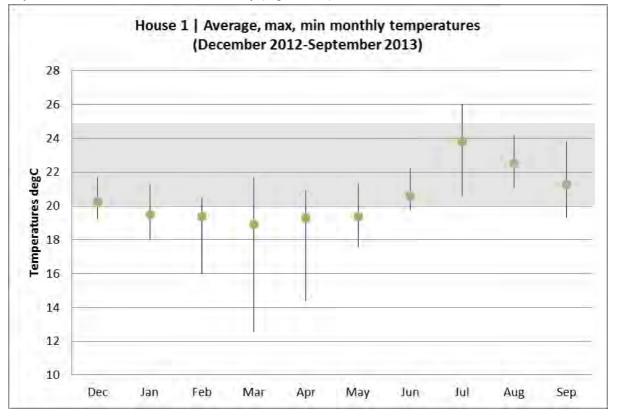
Figure 116 House 1 average, minimum and maximum monthly temperatures from December 2012 to September 2013.

In House 1 average monthly temperatures are below the comfort band from January to May falling as low as 13°C in March due to the fact that the occupants switched off the heating systems during the day in winter in order to save on electricity (Figure 116).

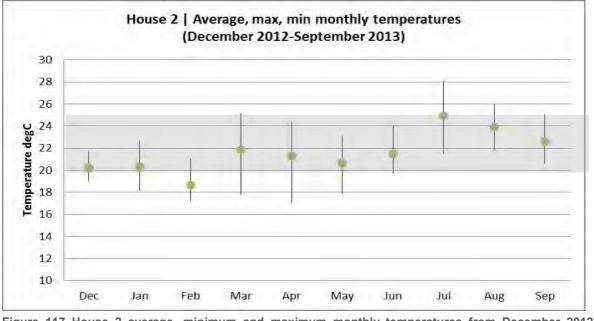
Figure 117 House 2 average, minimum and maximum monthly temperatures from December 2012 to September 2013.

Average monthly temperatures in House 2 living room are well within the comfort band with the exception of January (19°C). Temperatures in July went high above the comfort band reaching 28°C (Figure 117).

- Overheating was observed in House 2. This might be related to the fact that the MVHR system is not working and also to the fact that the occupants could not turn off the heating through the thermostats.

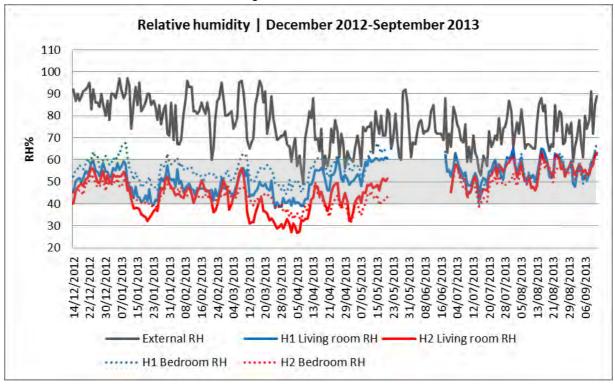
Figure 118 External and internal relative humidity in Houses 1 and 2 (December 2012 -September 2013). (Gap in monitoring data from 20/5/13 to 16/06/13).

Figure 118 shows the external and internal relative humidity in Houses 1 and 2 living rooms and bedrooms from December 2012 to September 2013. Relative humidity levels range between 40-65% in House 1 living room and 30-60% in House 2 living room, remaining within CIBSE recommended levels of 40-70% for most of the monitoring period. During winter the highest RH levels are recorded in House 1 bedroom and the lowest in House 2 living room.

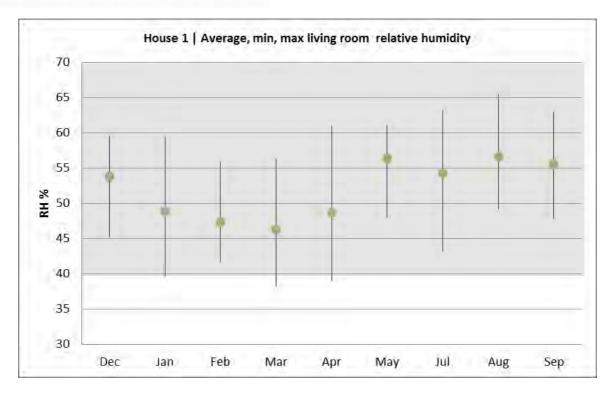
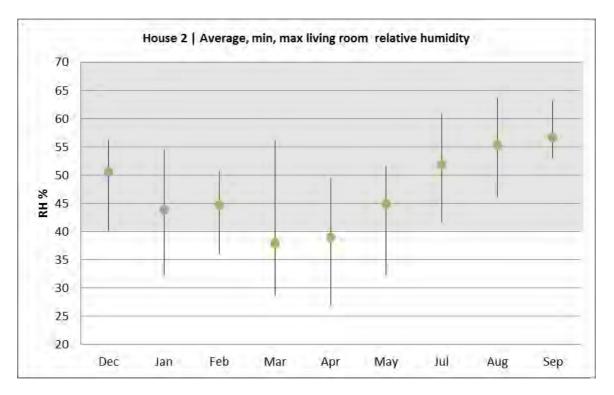
Figures 119 and 120 shows the average, minimum and maximum monthly relative humidity in House 1 and House 2 living room. Relative humidity levels in House 1 living room remain well within the CIBSE recommended levels throughout the whole monitoring period. Relative humidity levels in House 1 living room fall below the CIBSE recommended levels during winter months, possibly due to the low air change rates in the house as a result of the MVHR breakdown and the high temperatures recorded in the spaces.

Figure 119 House 1 living room average, minimum and maximum monthly relative humidity. <mark>(June has been omitted due to lack of monitoring data).</mark>

Figure 120 House 2 living room average, minimum and maximum monthly relative humidity. <mark>(June has been omitted due to lack of monitoring data).</mark>

- Relative humidity levels in House 1 living room fall below the CIBSE recommended levels during winter months, possibly due to the low air change rates in the house as a result of the MVHR breakdown and the high temperatures recorded in the spaces.

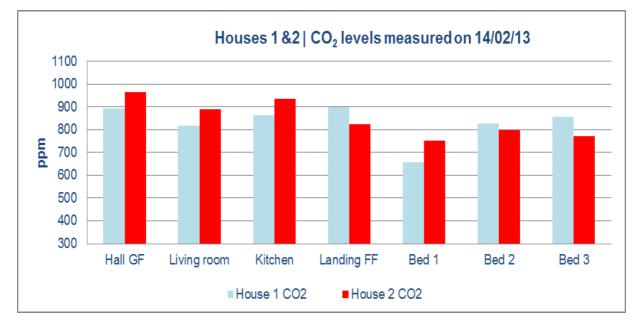
Figure 121 CO<sub>2</sub> levels in Houses 1 and 2. Spot measurements taken on 14<sup>th</sup> February 2013.

Spot measurements were taken on 14<sup>th</sup> February 2013 (Figure 121).

- VOCs were zero in both properties.
- CO<sub>2</sub> levels in both houses do not exceed ASHRAE benchmark (400-1000 ppm)
- The highest value (950 ppm) was recorded in the hallway of House 2.
- CO<sub>2</sub> levels in House 2 were generally higher than those in House 1 possibly due to the fact that the MVHR system in the house was not working.

These results, coupled with the fact that the measured air permeability of the houses (6 m3/m2.h) is double than the design target (3 m3/m2.h), and taking into account that the MVHR system in House 2 was not working, indicate that the MVHR system might not be necessary. However, safe conclusions cannot be drawn unless the air quality in the spaces is monitored for a long period of time with the use of dataloggers.
