# Castle Hill Primary School

<b>Innovate UK project number</b>	450035
<b>Project lead and author</b>	ECD Architects
<b>Report date</b>	2014
<b>InnovateUK Evaluator</b>	Robert Cohen (Contact via <a href="http://www.bpe-specialists.org.uk">www.bpe-specialists.org.uk</a> )

## Purpose of evaluation

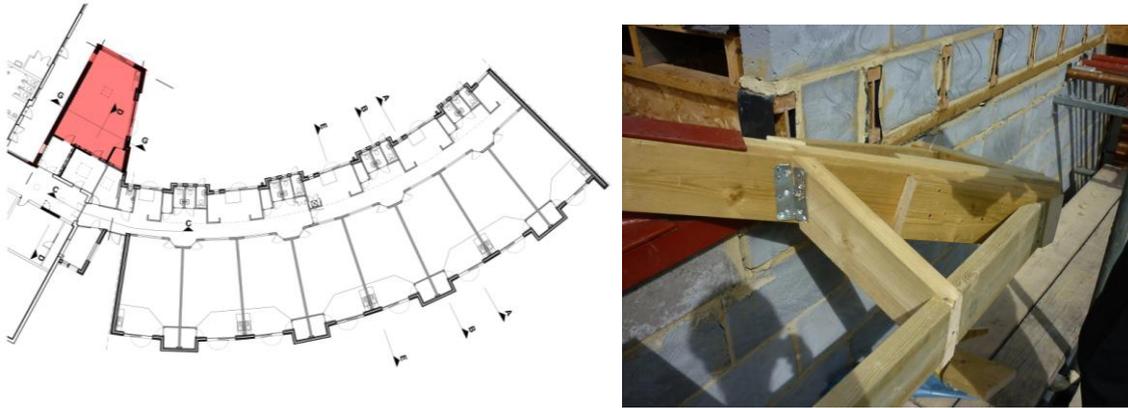
**Figure 2.3: Additional 56m<sup>2</sup> Classroom highlighted in red. This addition created difficult junctions with the classroom roof, as illustrated in the Figure to the right, as well as an increase in floor area, heat and electrical demands.**

- Architects spotted missing insulation whilst on site, but air tightness was not always considered. See separate Thermography Report and Air Permeability tests for further details.
- The curved roof and faceted walls resulted in difficulties in build-ability, which led to a less airtight building. These details should be reviewed in future projects.

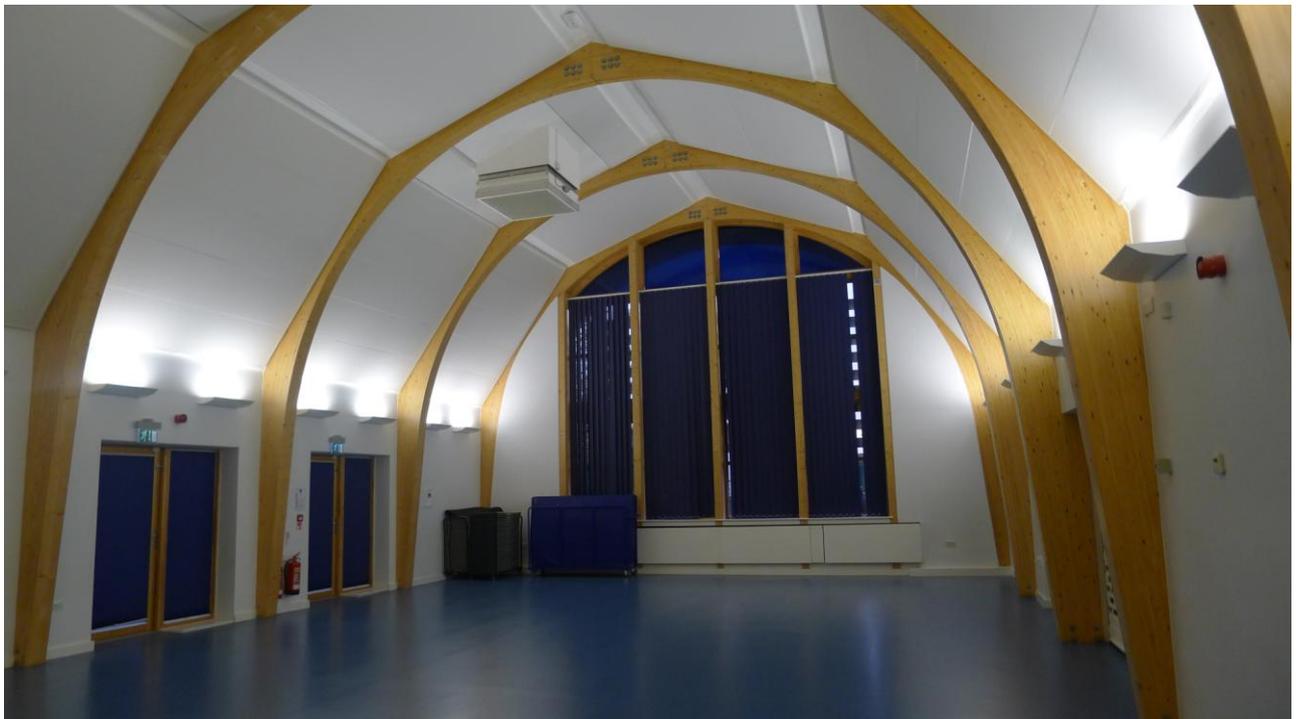
Figure 2.6: Photograph of the main Dining space, looking South toward the picture window.

- The Dining Hall has been carefully detailed and the on-site finish is generally of high standard. The 'Dutch Barn' Glulam arches with matching window frames give the building a soft, uplifting appearance, which complements its use as a space for primary school children.

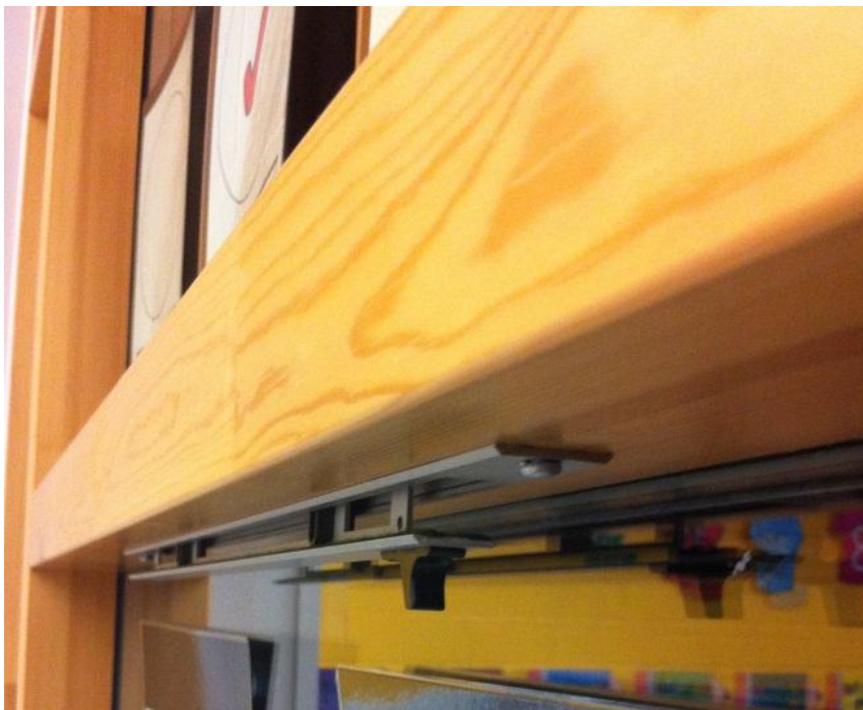
Figure 3.1: Trickle vents in the Junior Block classrooms

The IAQ study by UCL noted that teachers kept the doors closed during most part of the occupied period to avoid noise disruptions from the corridor and the playground. The design of the windows incorporates trickle vents [Figure 3.1] for minimum fresh air supply; however researchers noted that the occupants were unaware of the use.

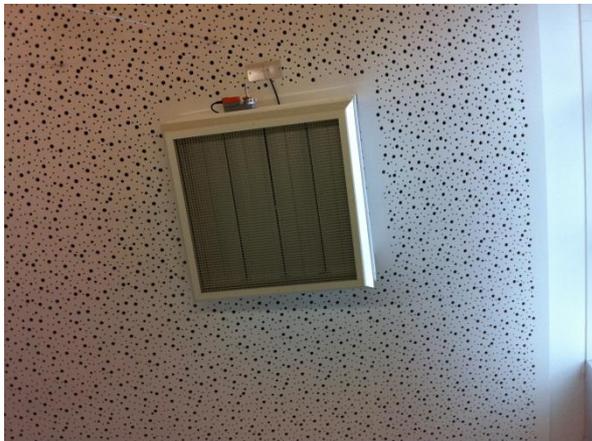
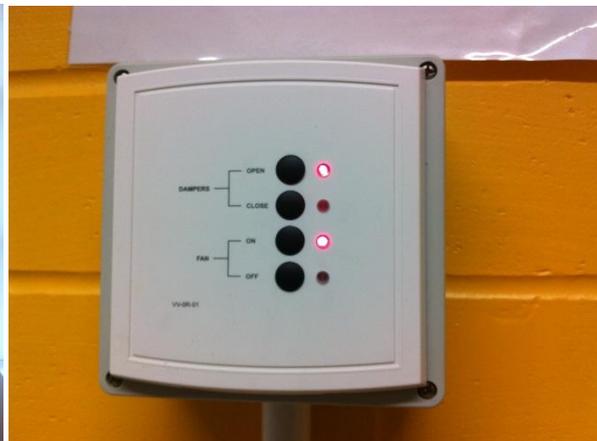
Figure 3.3: Mechanical exhaust with manual override in the Junior Block Extension

Teachers were not aware of the use of the mechanical exhaust due to inadequate briefing. Moreover, the controls were located away from the teacher’s desk possibly discouraging the use.

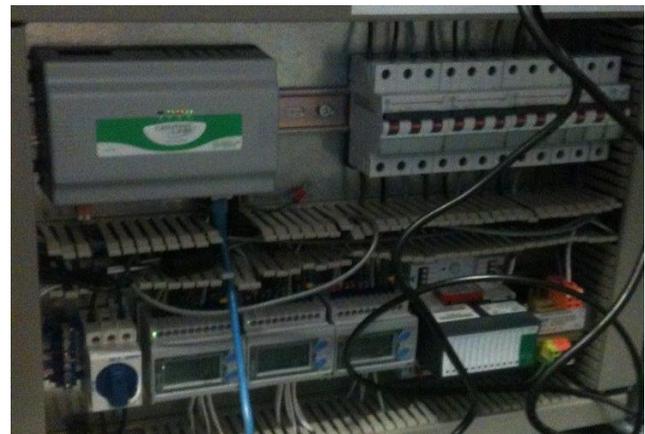
Figure 3.4: Pulsed type meters in the plant room provide a record of energy consumption, although labelling appeared incomplete during the building walkthrough.

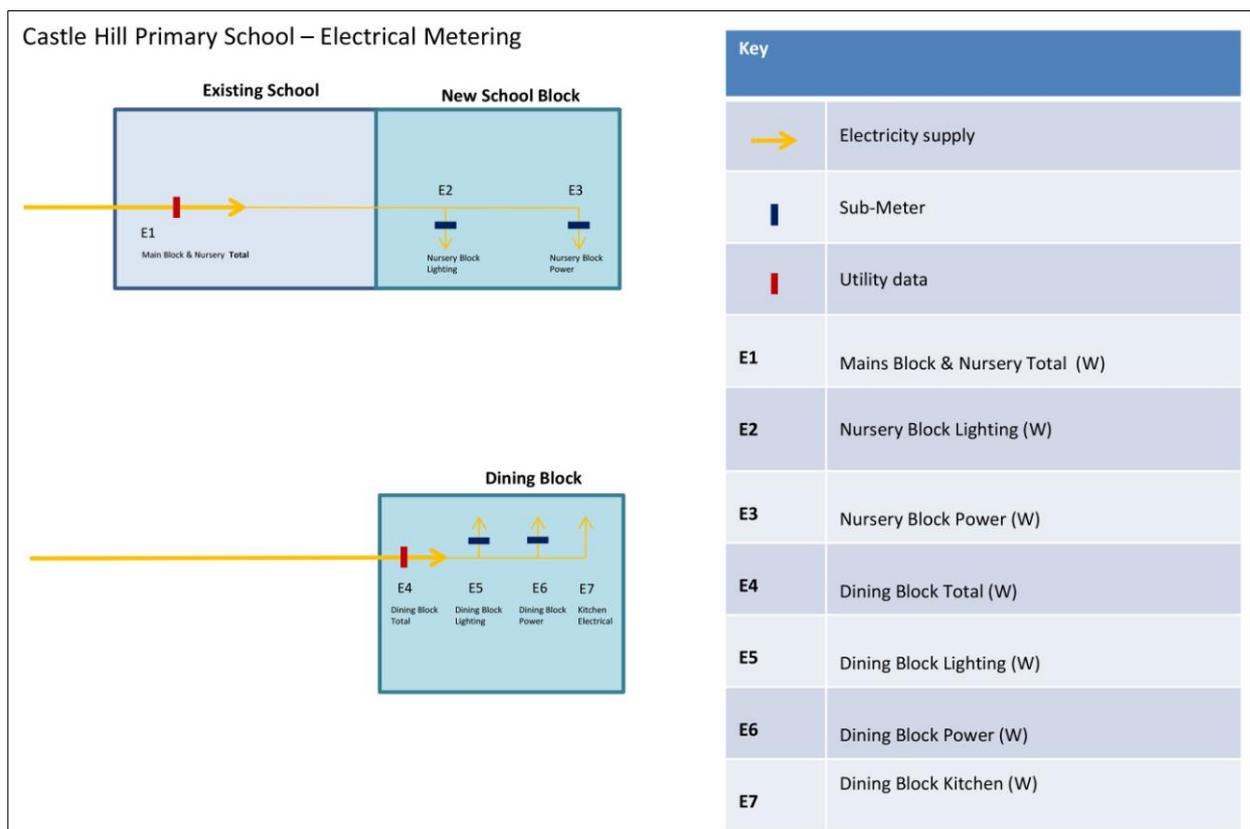
Figure 3.6: Sub meter tree diagram for the electricity supplies at Castle hill

One notable weakness in the sub metering strategy across the various supplies is the reliance on manual calculation to determine residual 'unregulated' loads. An example of this can be seen in the Dining Hall, where neither the kitchen electrical, nor kitchen gas supplies have a dedicated sub meter. In theory, this does not cause a problem; consumption is the residual amount left after subtracting the consumption of other sub metered loads from the utility supply meter. In practice, if there is a problem with either the utility meter or any of the sub meters, it is not possible to cross reference one with another to check for correlation. There is always, in effect, a hypothetical 'missing meter' which prevents this cross check from happening.

The missing meter conundrum has the effect of reducing the level of confidence that any client or energy assessor can place on their energy metering equipment. They become reliant on claims on manufacturer/installer claims that metering is installed correctly.

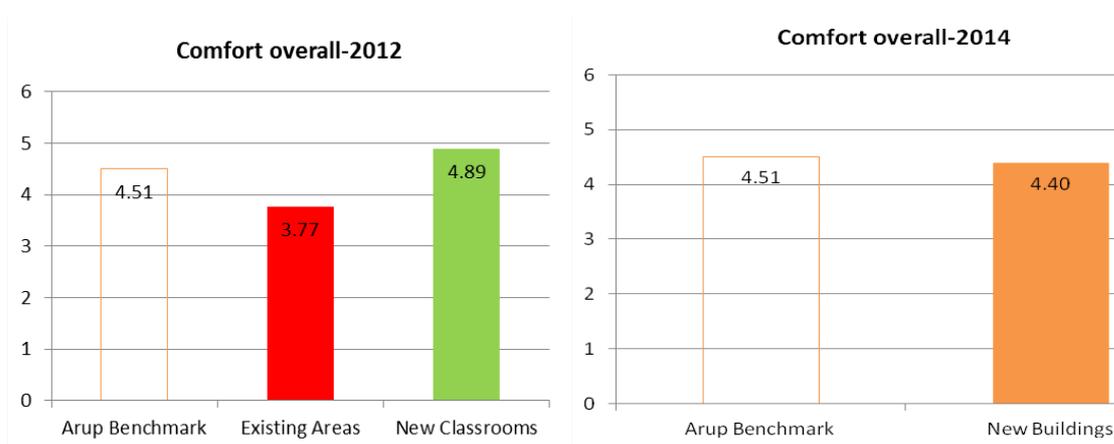
Figure 4.7: Comparison of Perceived Comfort levels during summer and winter,

During both summer and winter, the users of the existing building are moderately comfortable compared to the Arup benchmark. The new Classrooms are less comfortable during the winter. This has been seen in naturally ventilated schools, (Fitzgerald; 2012) with overheating and inadequate ventilation in winter.

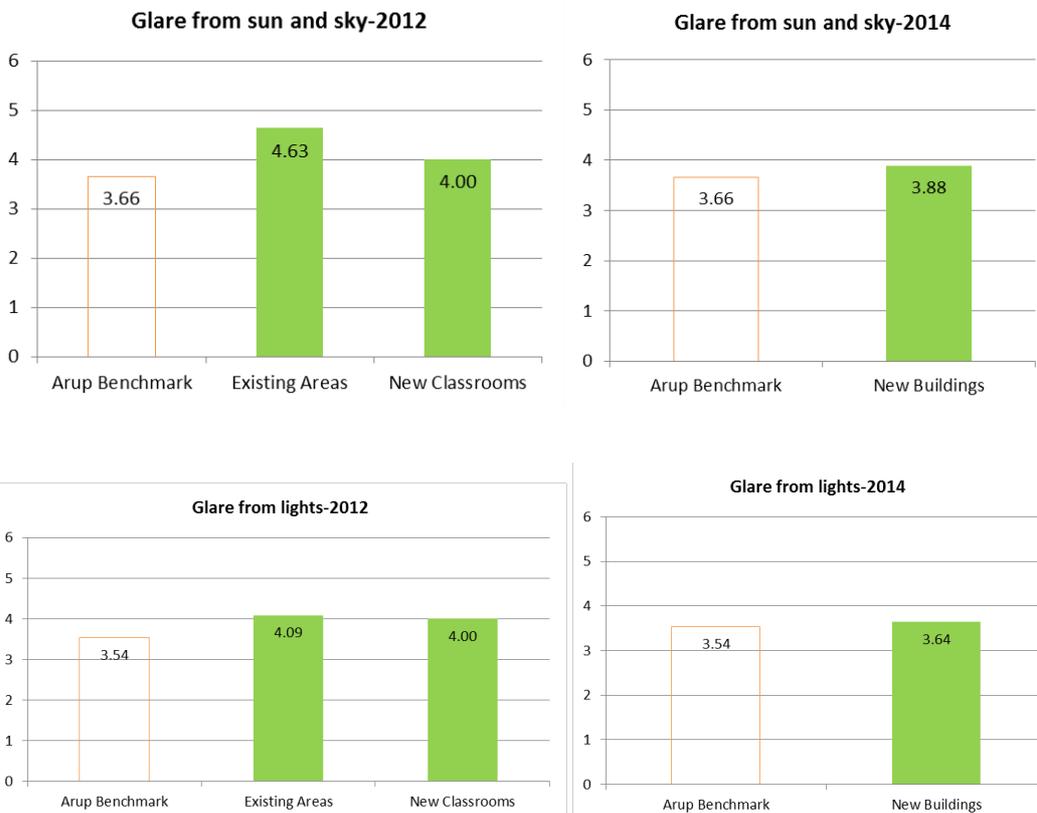
Figure 4.9: Glare from Sun and Sky, and artificial light

On both surveys the overall lighting was received well with a slight rise in 2014 as see from **Figure 4.9**. In both the 2012 and 2014 surveys glare from the sun and sky were commented on as negative aspects of the building, but, despite these comments, the users described the lighting as satisfactory overall. It should be noted that the lighting score for the new classrooms was better in 2014 than in 2012 and both scores were better than the existing buildings and the Arup benchmark. It is possible that the improvement between 2012 - 14 is a result of additional understanding of lighting controls on the part of the users. The caretaker noted during the building walkthrough that the lighting controls had not been fully understood when the building was first occupied, but that through informal training, the users became better informed. Whilst the improving score for 2014 is therefore a positive indicator that staff are happy with the lighting, it is also likely that statistical variations in sampling also played a factor.

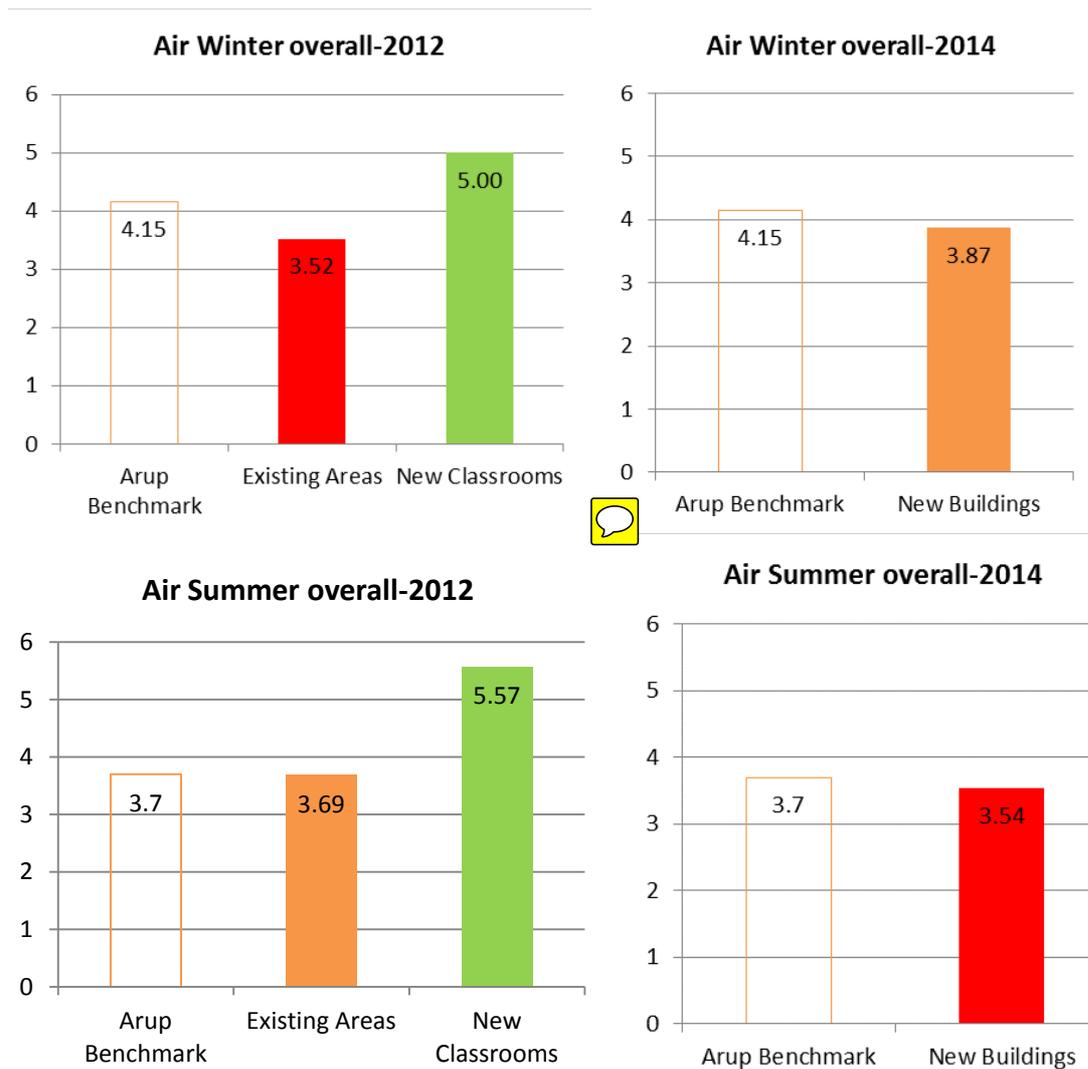
Figure 4.10: Perception of Air Quality overall during summer and winter

In 2014, overall, the occupants deemed the air quality closer to the 'unsatisfactory' mark, than the 'satisfactory'. In winter similar results were obtained for air quality, though the overall satisfaction was slightly better. It is possible that the poor air quality results are related to problems with drainage, which - as has been noted elsewhere in the report - often result in smells from some of the classroom sinks.

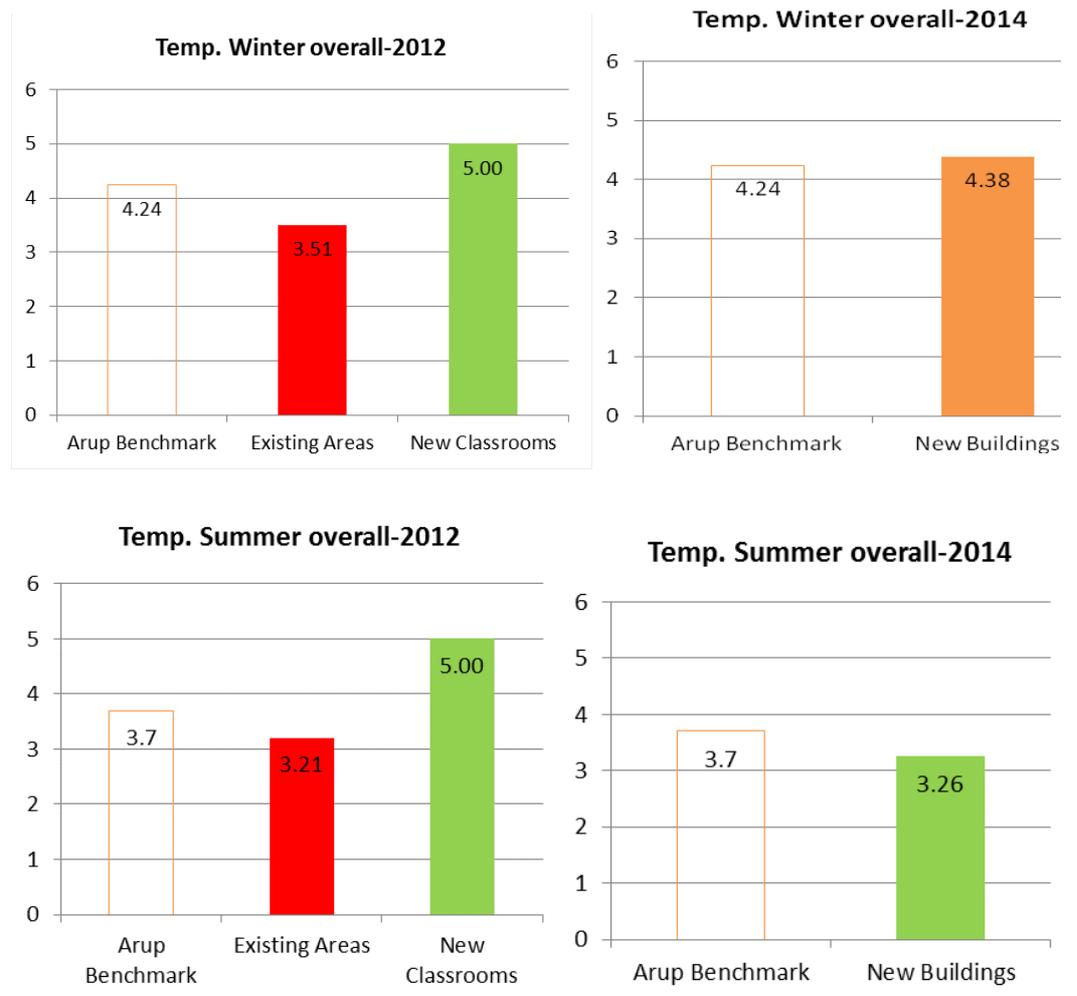
**Figure 4.11: Figures showing separated data demonstrating temperature satisfaction levels in both summer and winter.**

The temperature satisfaction levels appear to have dropped significantly between the 2012 and 2014 surveys. The 2012 results for the new classrooms were substantially better than the existing areas in the school and the Arup benchmark in both winter and summer overall temperatures. By 2014, the new classroom temperatures in the winter were still perceived as better than the existing areas, and the Arup benchmark, but now only by a small margin. It is unclear what may have caused the differences here, although it is possible that the problem is linked to the cold down-draughts from vents in the classrooms [discussed further in

**Section 7].** Despite these concerns, it is encouraging that the new buildings are still considered more comfortable than either of the comparisons.

The temperature in the summer results on the other hand, demonstrate a much more significant drop in perceived comfort between 2012 and 2014. Whilst the 2012 result for the new classrooms was better than either the Arup benchmark or the existing school, by 2014 its result was the poorest. It is possible that the results were influenced by the especially hot summer of 2012, one of the ten hottest UK summers on record. Changes of staff or sampling differences may have also been a factor in the change of opinion. The wide degree of variation between the two data samples indicate changing opinions of the comfort in the building and suggest that further BUS studies in subsequent years may be appropriate.

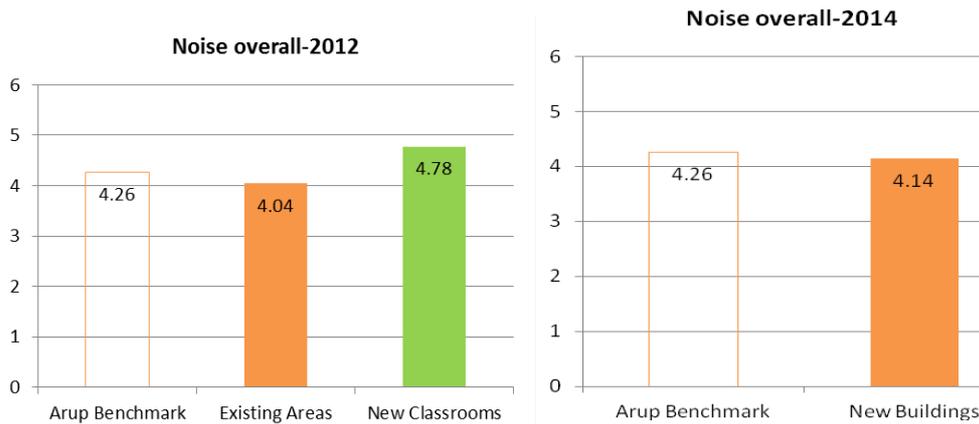
Figure 4.12: Noise satisfaction responses level.

The noise satisfaction level seems to have fallen from the 2012 survey to the 2014 survey to the point where it is almost not possible to differentiate between the new and existing areas of the school. It is difficult to see what differences could have occurred in the building fabric between 2012 and 2014 that could have caused such a significant change in attitude. It is more probable in this instance that the changes are a result of a difference in the usage or management of the space.

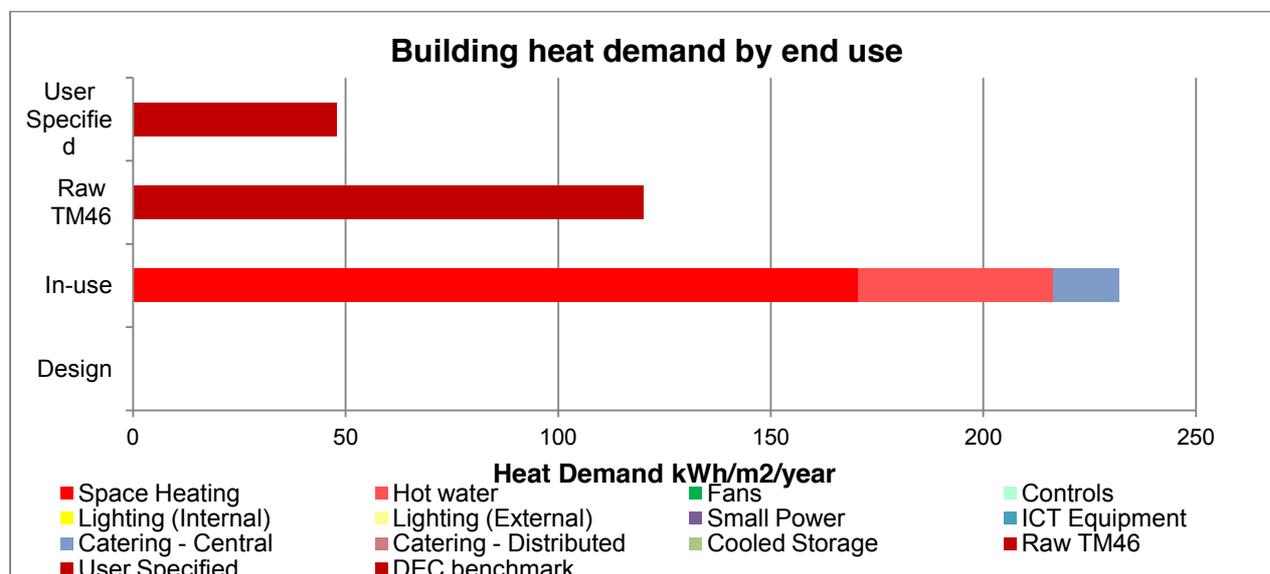
Figure 6.3: Building heat demand by end use

At first glance [Table 6.2] the biggest contrast can be seen in the predicted vs. Actual gas consumption, a difference of almost double the TM46 benchmark and 4.5 times greater than the amount predicted at design stage. This benchmark data should nonetheless be considered with slight caution, noting that the TM46 energy benchmark refers to “Schools and seasonal public buildings” in general where only the Dining Hall of the building is reviewed here. As a result, Figure 6.3 from the TM22 could be potentially misleading.

The biggest consumption of gas relates to space heating, with 170.6 kWh/m<sup>2</sup> [Table 6.3] and there are possibly two main justifications for this. The first one relates to the fact that the Dining Hall is a double height space and it is not possibly represented accurately by the GIA of 302m<sup>2</sup>; it would take longer to warm up in comparison to a building with similar GIA but lower ceiling height. The second is possibly contributed to by the heat losses from the piping connection since, as can be seen from the meter tree [Figure 6.1], the heating in the Dining Hall is supplied from a boiler in the Existing Block. One notable factor affecting the energy performance of the building is its intermittent occupancy. Large number of people use the space for short periods of time, but in the intermediate periods the space is empty, and therefore it has a lower internal heat gain than other parts of the building. As the occupancy is transient this also affects the amount of time that doors are kept open, which impacts further on the space heating demand. Other contributory factors could be the kitchen feedback loop as noted in Section 7, the large proportion of external doors, or its poor air-permeability score.

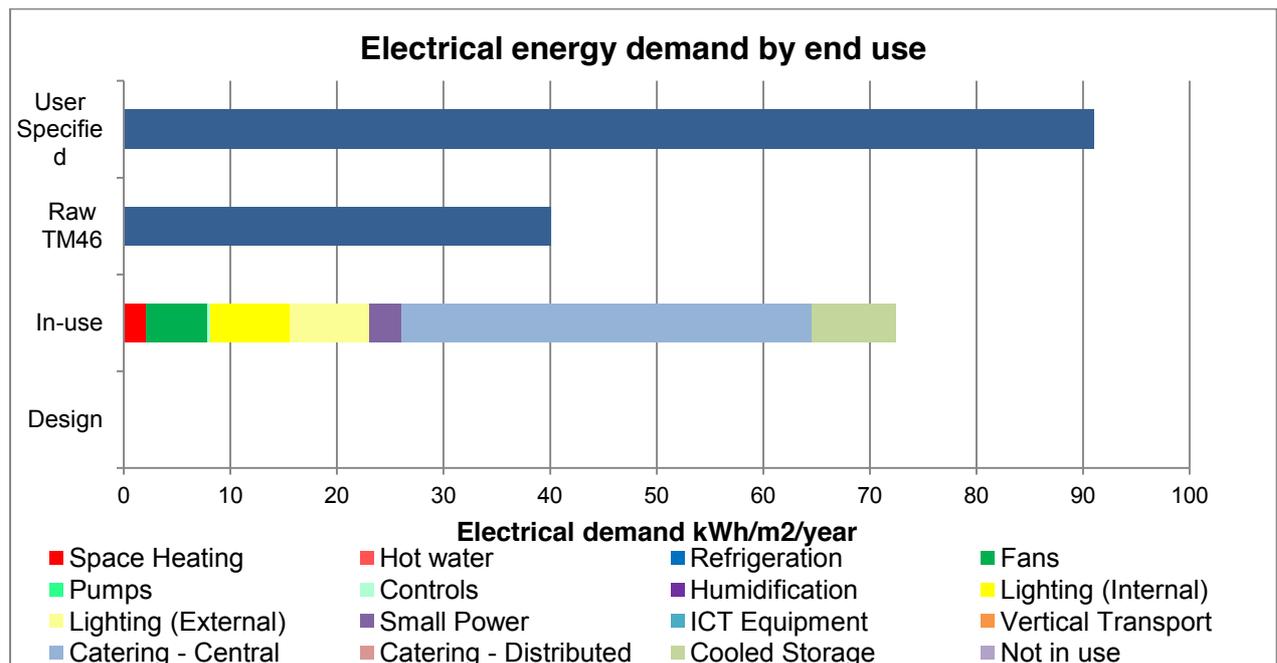
Figure 6.4: Electrical energy demand by end use

At first glance [Table 6.2] it can be seen that the total actual electricity consumption 73.8kWh/m<sup>2</sup> was lower than the predicted 91kWh/m<sup>2</sup>. Nevertheless, it is still higher than the TM46 benchmark of 40kWh/m<sup>2</sup>. Once more it should be noted that the TM46 energy benchmark, refers to “Schools and seasonal public buildings” in general, where here only the Dining Hall of the building is reviewed. So the Figure 6.4 from the TM22 could be misleading.

The electrical loads in the Dining Hall comprise artificial lighting fixtures, external and internal, extract fans and MVHR, and finally kitchen equipment for food preparation, display and cleaning. There are minimal loads for small power. As can be seen from **Table 6.2** and **Figure 6.4**, and as might be expected, the highest consumption comes from the kitchen equipment, which is responsible for the 68% of the total.

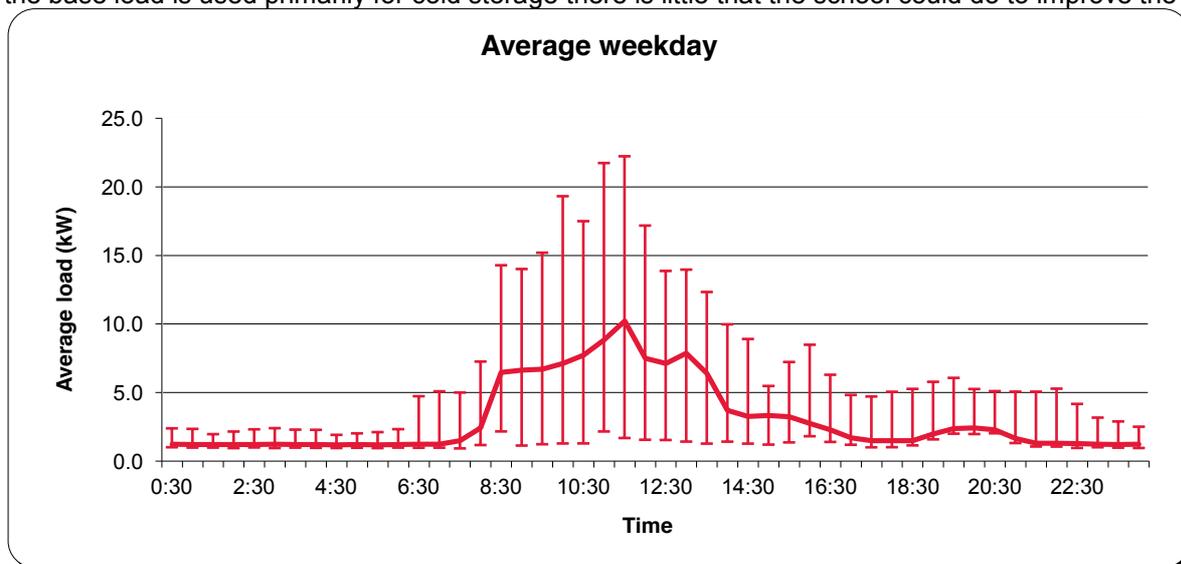
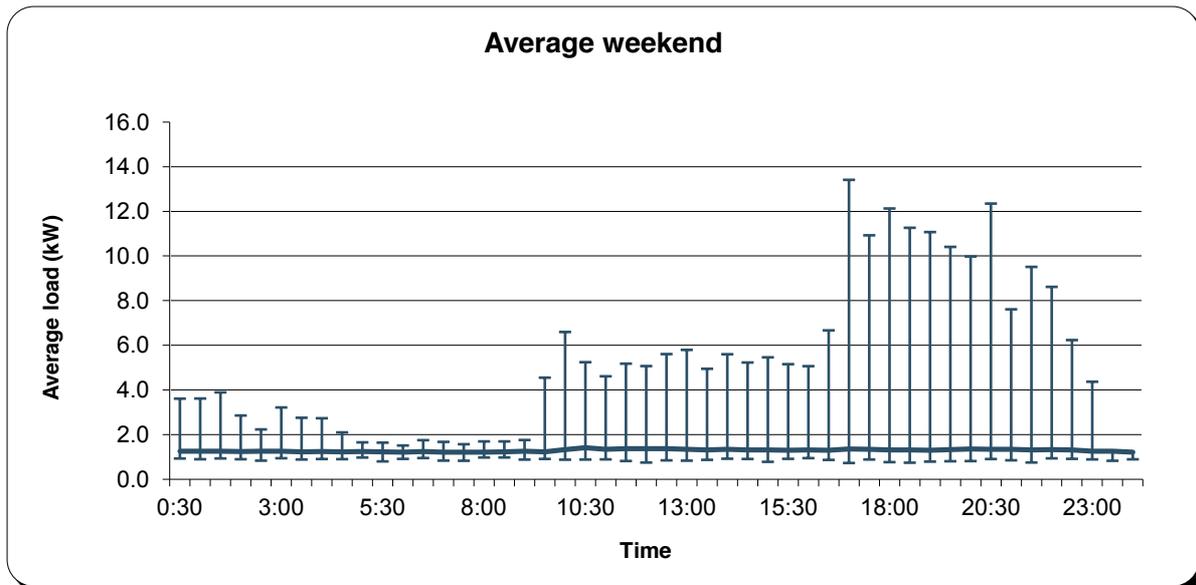
A small but significant amount of energy, approximately 1200W or 12% of the average peak load [**Table 6.4**, **Figure 6.5-6**] is used when the building is not in use, with a significant 46% of the Dining Hall total (Non-core hours and weekends). As noted in the TM22 Guidelines, it is reasonable to expect such a high figure with non-domestic buildings that are mostly occupied of around 10 hours in weekdays (50 a week) and especially with schools where longer holidays apply. There is some evidence as well from the half hourly data [**Figure 6.5-6**] that a significant amount of energy is used between 18:30 to 20:00, outside the normal operational hours. This can be attributed to the fact that the Dining Hall space is occasionally used for evening events. As the base load is used primarily for cold storage there is little that the school could do to improve the result.

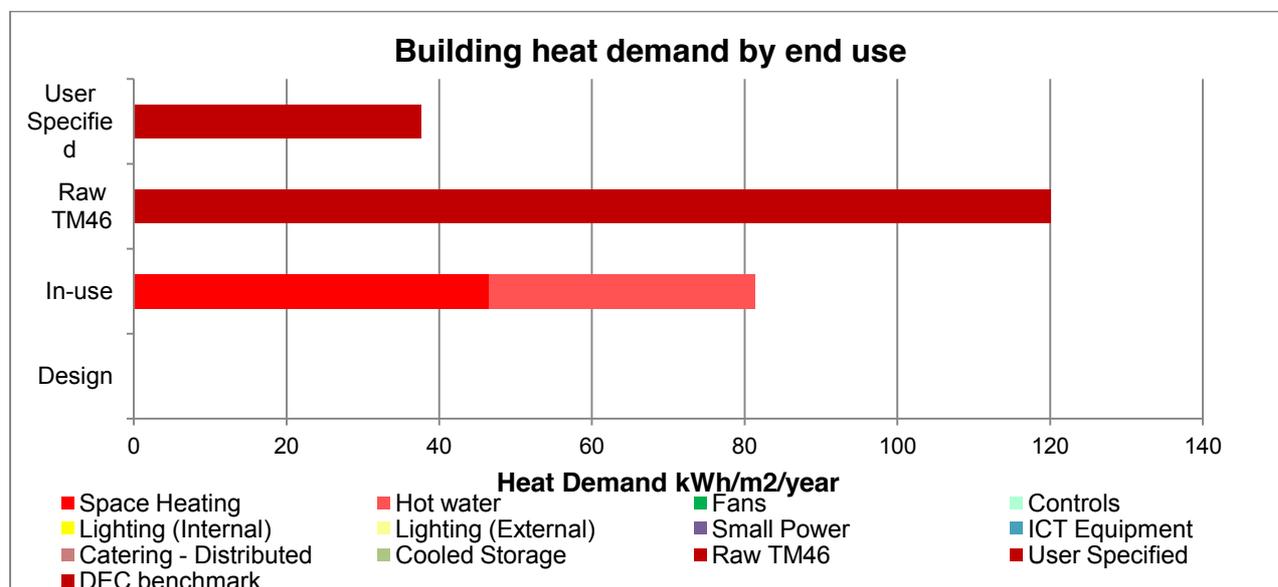
Figure 6.12: Building heat demand by end use

The overall gas consumption was 50% greater than predicted at design stage, as can be seen in Table 6.7 and Figure 6.12. Nevertheless, it is still ~30 % lower than the TM46 Benchmark.

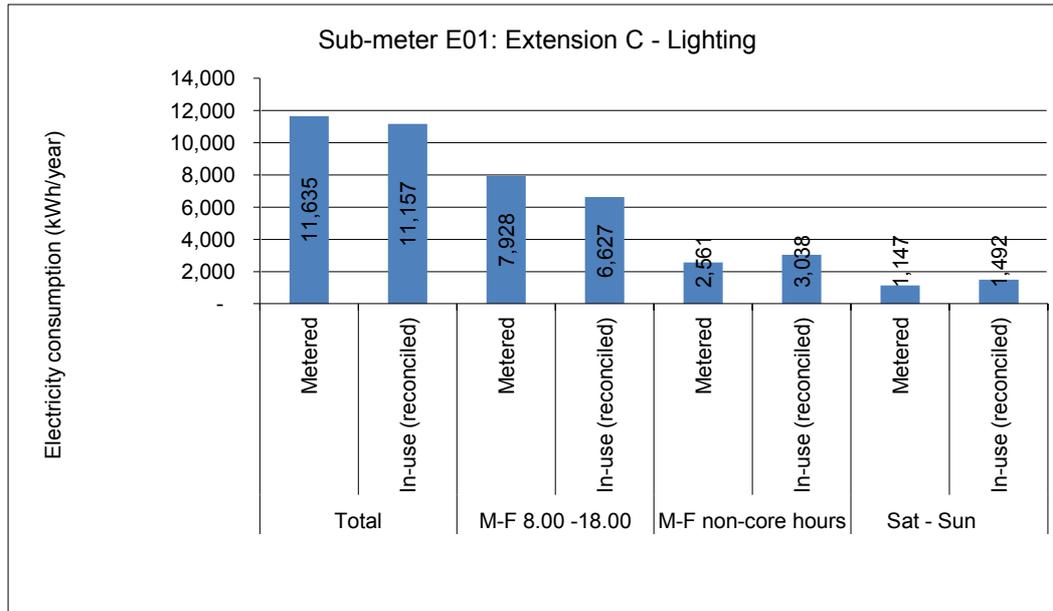
Figure 6.18: Sub meter E01 Extension C Lighting

The lighting consumption was also comparable in relation to in use against metered. A greater difference can be observed during the core hours of internal lights where the metered energy is greater than the in use entries [Figure 6.18]. This can be possibly explained by the fact that some light fixings are more energy intensive than stated or their use profile is slightly different from that as surveyed.

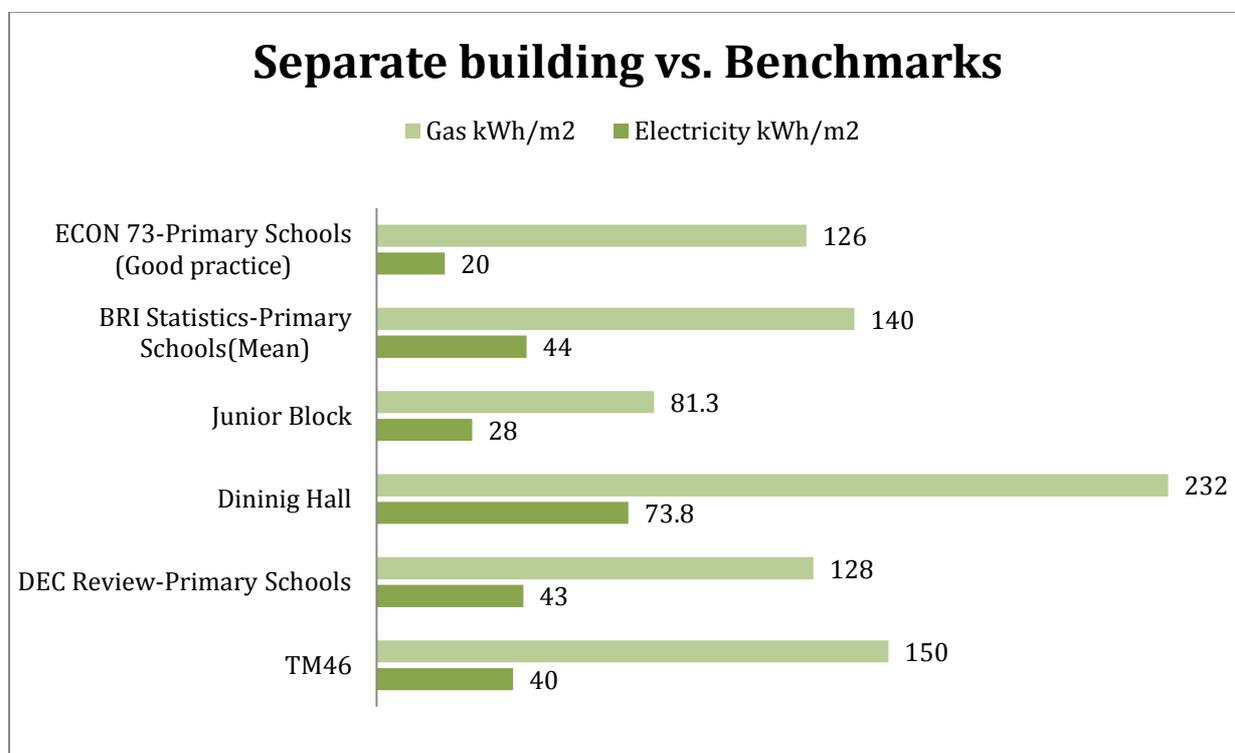
Figure 6.20 Junior Block and Dining Hall Block compared separately with a series of other benchmarks

If both of the buildings were to be reviewed as a total project, even with the “over consumption” of gas the total energy consumption falls very close to the available benchmarks/statistics<sup>1</sup> as seen from Figure 6.21. Furthermore, the Dining Hall due to its seasonal use falls into the category of TM46’s “seasonal buildings”, so its final energy consumption should perhaps not be compared with school/primary school benchmarks as a separate building but rather as part of it.

If the Junior Block is assessed on its own as seen in **Figure 6.20**, then the results presented are quite encouraging, as it shows to be much less energy intensive than other benchmarks/statistics presented.

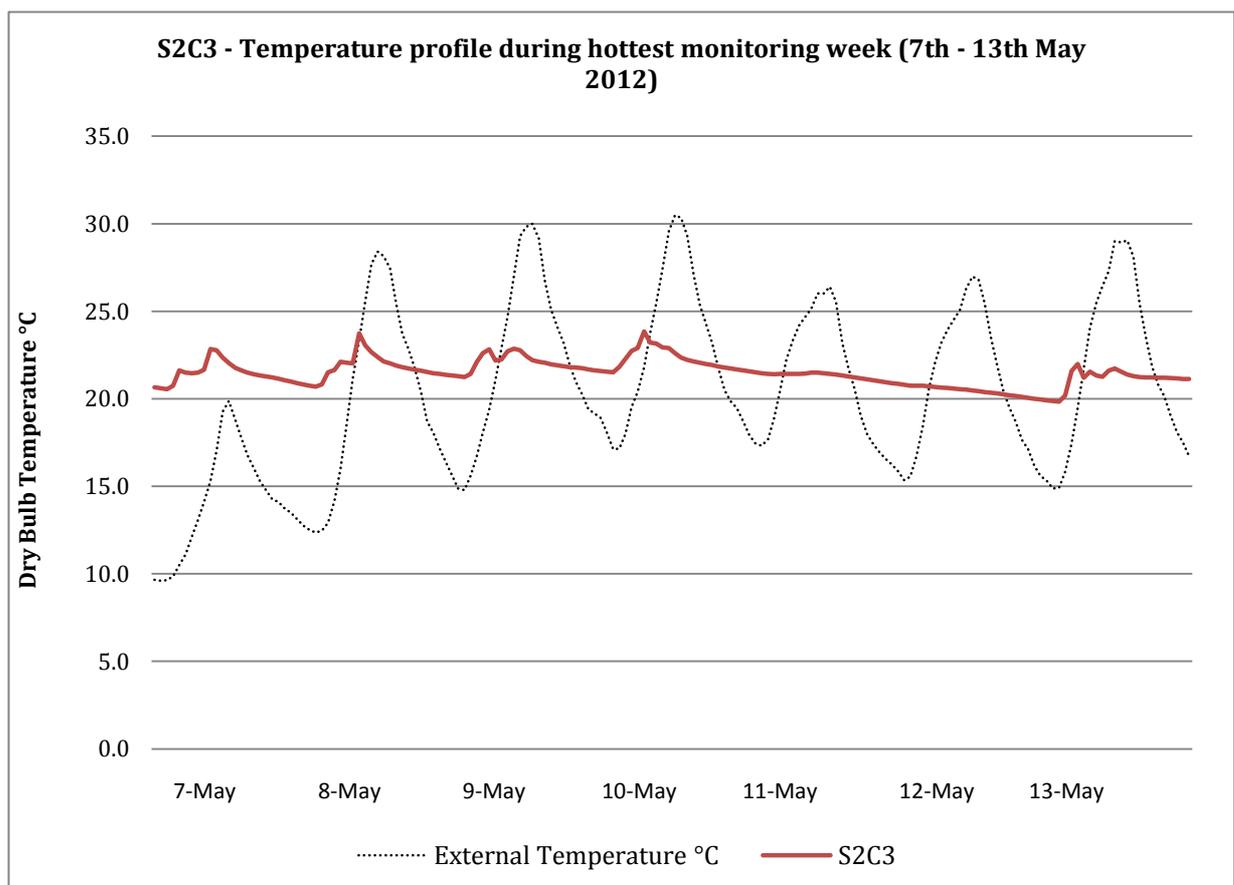
Figure 7.4: Temperature profile of classroom S2C3 for one monitoring week (7<sup>th</sup> to 13<sup>th</sup> May 2012)

The temperature profiles illustrate relatively stable space temperatures with minor peaks in temperature. The internal temperatures are unaffected by the sharp rise in the external temperatures, indicating that the space is not likely to be vulnerable to incidences of overheating.

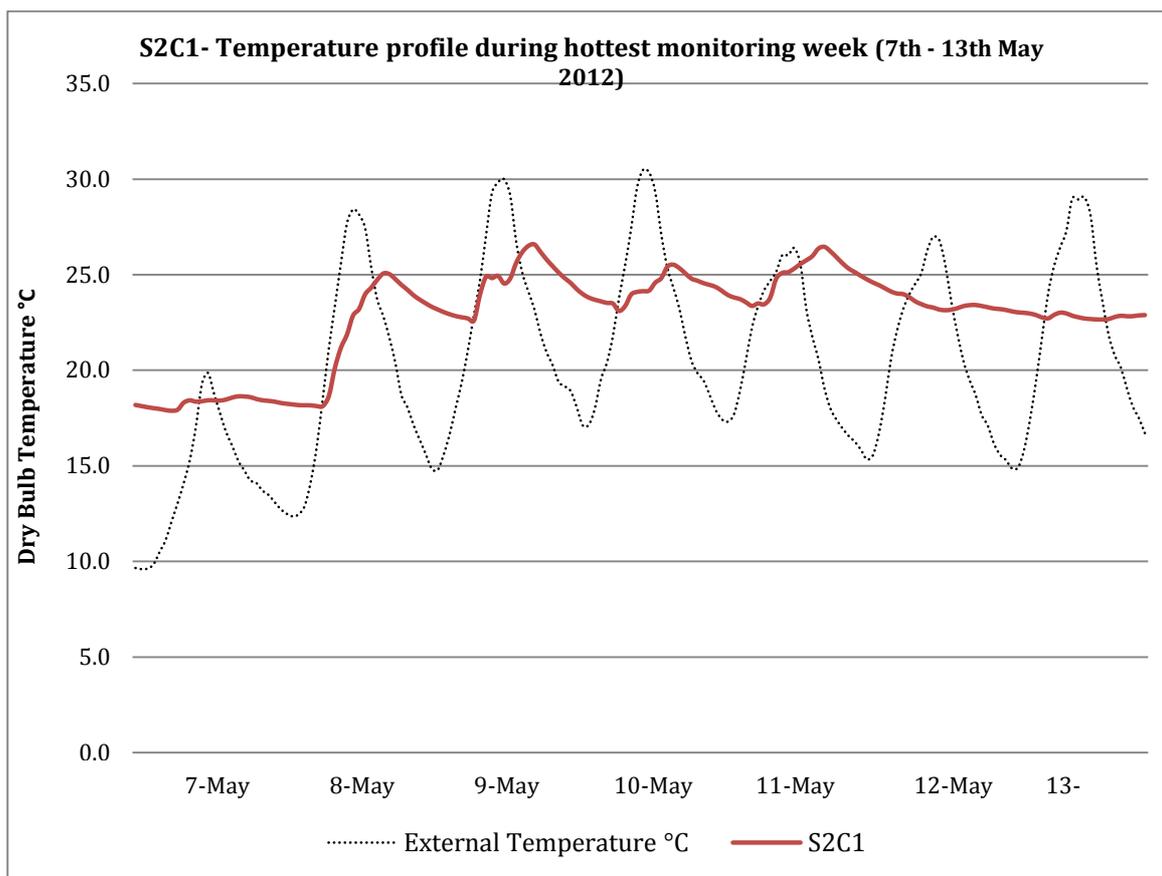
Figure 7.5 Temperature profile of classroom S2C1 for one monitoring week (7<sup>th</sup> to 13<sup>th</sup> May 2012)

The highest peaks in temperature were exhibited in Classroom S2C1. The internal temperature profile illustrates sharp peaks followed by decay in temperature. The peaks are presumably associated with instant occupation of the classroom in the morning. The decay in temperature is deemed to be representative of the effectiveness of the ventilation in dissipating the peaks in internal temperature. During the hottest days, despite that the internal temperature does follow the trend of the external temperature, it does not reach the highest peak of the outdoor temperature. However since the internal temperature responds to a certain extent to the external temperature, this might indicate that the space is vulnerable to overheat in future incidences of elevated temperature.

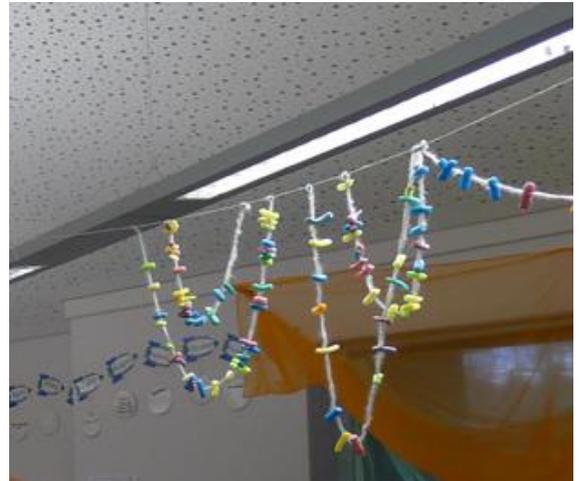
Figure 7.6: Lighting in the bulge classroom, (with additional improvements from the children)

- Lighting is regarded as one of the most positive aspects of the building, both the provision of natural light and the provision of adequate artificial lighting [Figure 7.6]. The bursar explained that staff do not generally comment when services are performing well, as they seem to assume it should just be working, and so the fact that complaints are rarely received about the lighting is a good indication. These findings are corroborated by the **BUS survey**, where lighting scores highly in comparison to the ARUP benchmark.

- One suggestion from the caretaker was that the staff would have benefitted from additional training on using the lighting during early occupation. Although the daylight-linked dimmable low energy lighting and PIR sensors appear to operate correctly, the staff were unaware that if they wanted more light once the lights were dimmed, they could simply 'press and hold' the switch until the required brightness was achieved. The caretaker reported that once he had established this capability when using the controls, he subsequently informed the other staff.

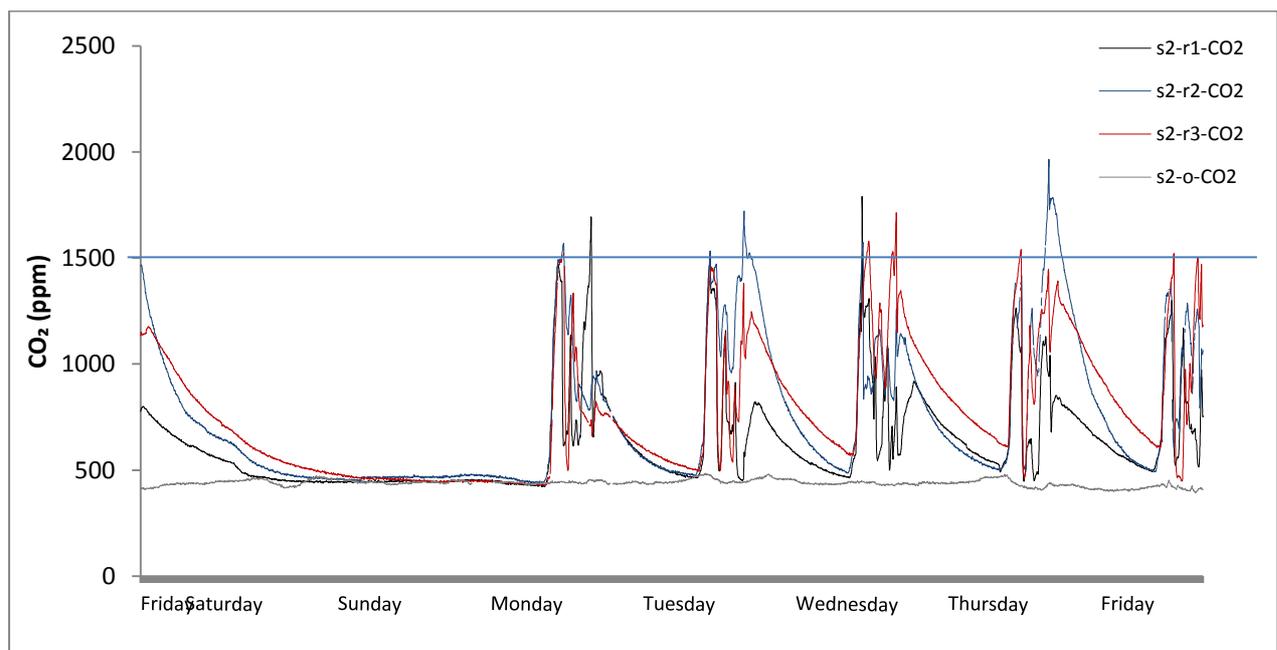
Figure 7.9 : CO<sub>2</sub> concentrations during the winter season in 3 investigated classrooms and the outdoor site

A significant increase of indoor CO<sub>2</sub> concentrations was noticed in the non-heating season [Figure 7.10]. In [Figure 7.9] it can be noticed that indoor levels did not exceed 1500 ppm due to CO<sub>2</sub> controlled sensors of the mechanical exhaust. However, during the non-heating season, indoor concentrations of CO<sub>2</sub> exceeded 1500 ppm 50% of the occupied period [Figure 7.10]. While there is not a clear explanation of the observed differences, it was speculated that an unsuitable setting of the mechanical exhaust was applied during the non-heating season.

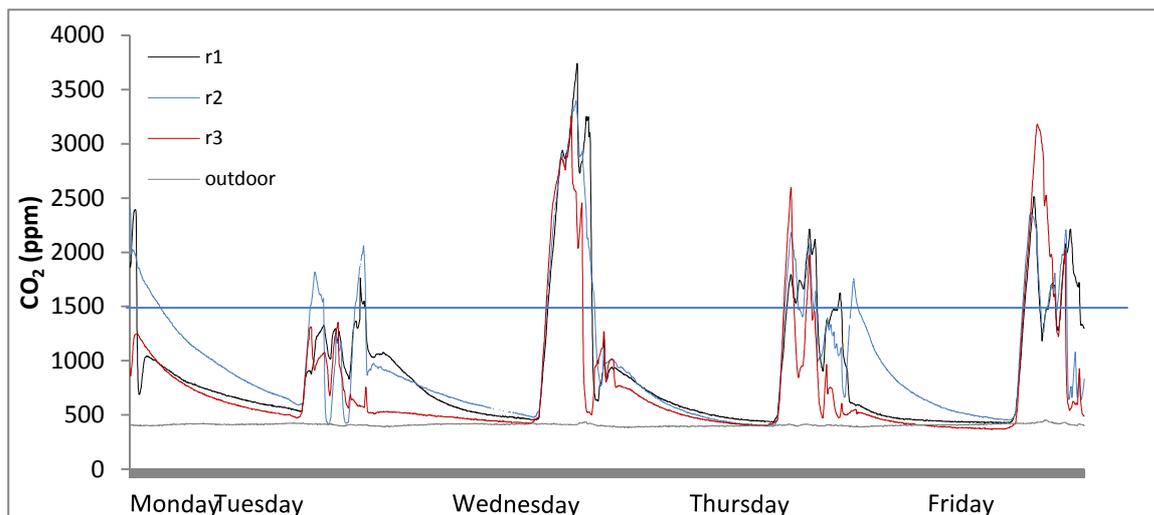
Figure 7.10: CO<sub>2</sub> concentrations during the spring season in 3 investigated classrooms and the outdoor site

The research concluded that the ventilation strategies were capable of providing a satisfactory environment according to BB101 guidelines in both seasons. However, it also found daily average concentrations of CO<sub>2</sub> above 1000 ppm in the spring season and cited increasing evidence in studies of other school classrooms that the high concentrations might be related to increased prevalence of SBS symptoms and reduced academic performance.

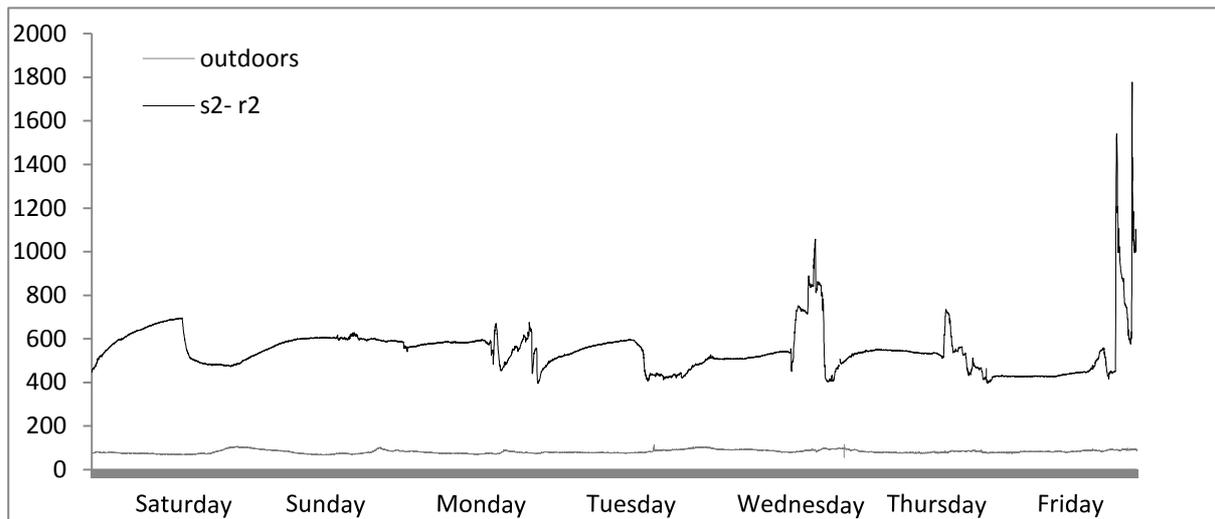
**Figure 7.11 Indoor and outdoor concentrations of TVOCs in the non-heating season**

While there are no thresholds on TVOCs exposure developed in the UK, most countries' thresholds are in the magnitude of 90 to 260 ppb. Daily average values in the school exceeded the values because of cleaning products used in the school. The high pinene and limonene concentrations indicated the use of inappropriate cleaning products introduced in the classrooms.

Although obtaining emission factors from materials is still under development, the continuous TVOC profile and high formaldehyde concentrations indicated the presence of high emitting furniture and construction materials. It is therefore crucial that school management should use low emitting cleaning products and designers should consider emission factors of materials used in educational buildings and other buildings with vulnerable occupants.
