# Castle Hill Primary School

<b>Innovate UK project number</b>	450035
<b>Project lead and author</b>	ECD Architects
<b>Report date</b>	2014
<b>InnovateUK Evaluator</b>	Robert Cohen (Contact via <a href="http://www.bpe-specialists.org.uk">www.bpe-specialists.org.uk</a> )

## Purpose of evaluation

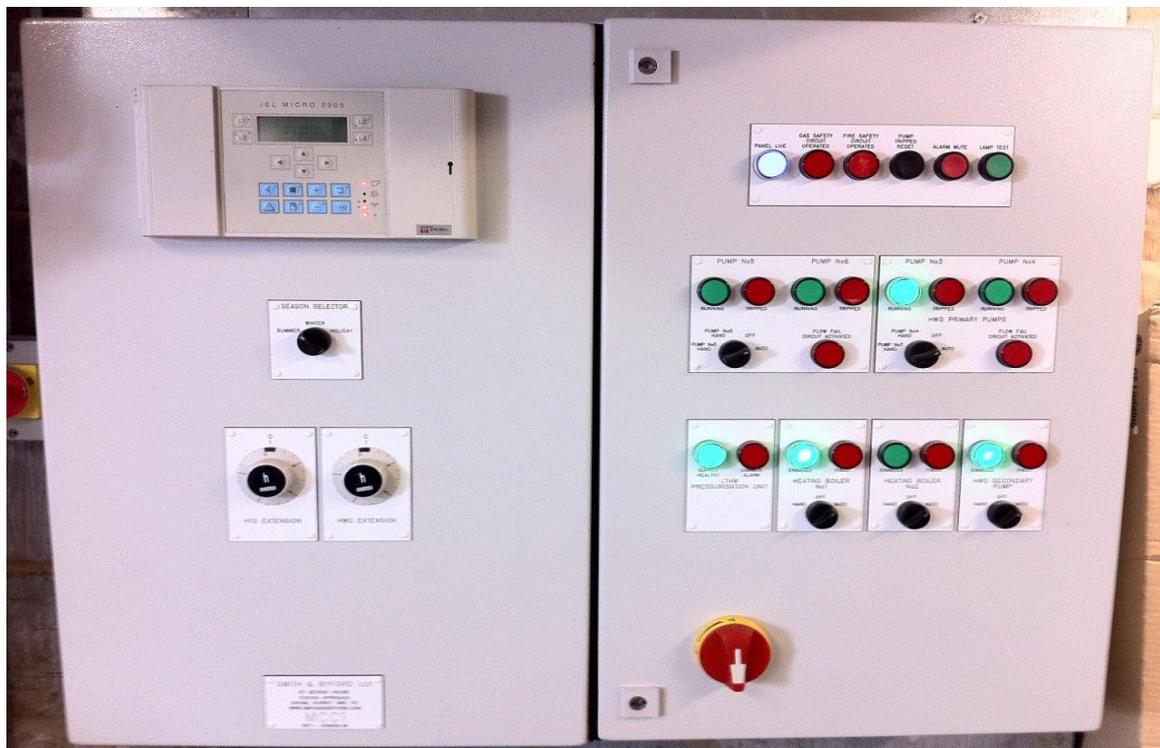
Figure 7.13: One of the Smith and Byford BMS control panels, which link the existing Jel Micro 2000 controls (as top left)

- One of the JEL systems in the main boiler house has to be left on 'manual' in order for it to function. If it is put on automatic mode then it shuts off the other systems. Engineers from Smith and Byford were called in to check and the last engineer who visited acknowledged that certain elements of the wiring in the panel were incorrect. He wrote a report explaining the problem, which the company are now aware of, although the matter has not yet been resolved. The bursar noted that as a result of the fault they were paying unnecessarily for heating the school at the weekend. It was confirmed that this particular issue did not concern the heating or DHW in the Dining or Junior Block extensions, even though the BMS also controls these areas.

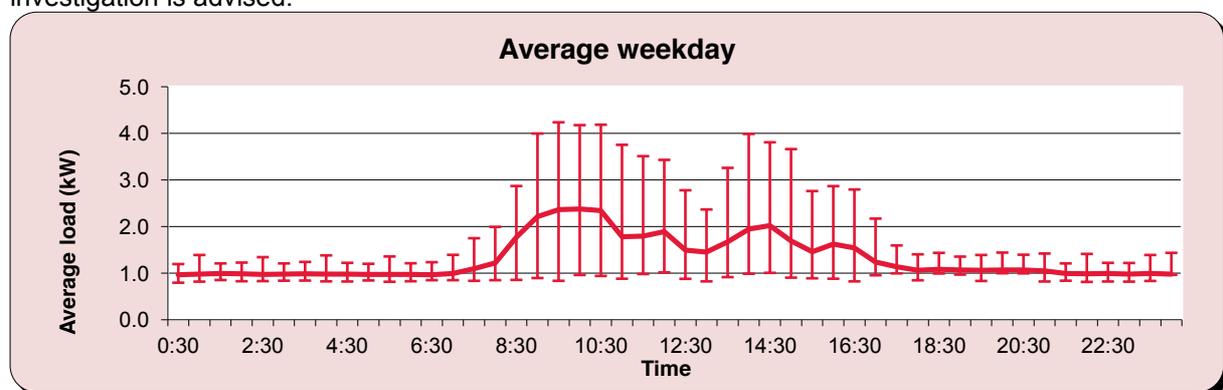
Figure 9.1 Junior Block, Average weekday power consumption profile , 3 months data

The TM22 assessment of the new buildings found that a number of services are being left switched on overnight amounting to an average load of approximately 1-1.5kW in each building **[Figures 9.1-3]**. Further investigation is advised.

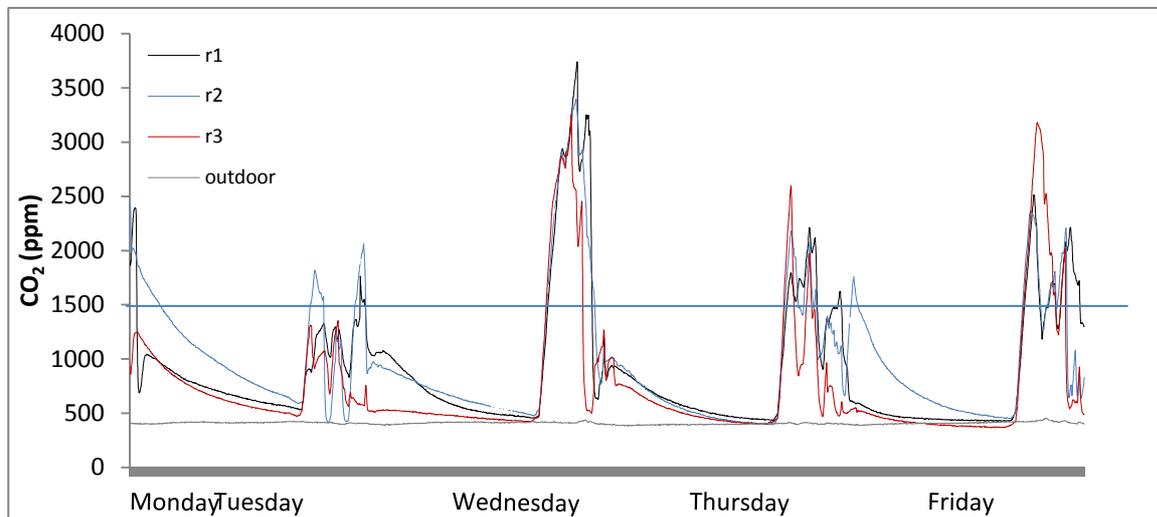
**Figure 9.4: CO<sub>2</sub> concentrations during the spring season in 3 investigated classrooms and the outdoor site**

There is strong evidence to suggest that the ventilation systems are not functioning correctly outside of the heating season, with CO<sub>2</sub> levels over the 1500ppm threshold **[Figure 9.4]**, and it is recommended that a visit is booked in with the manufacturer Midtherm to resolve these issues.

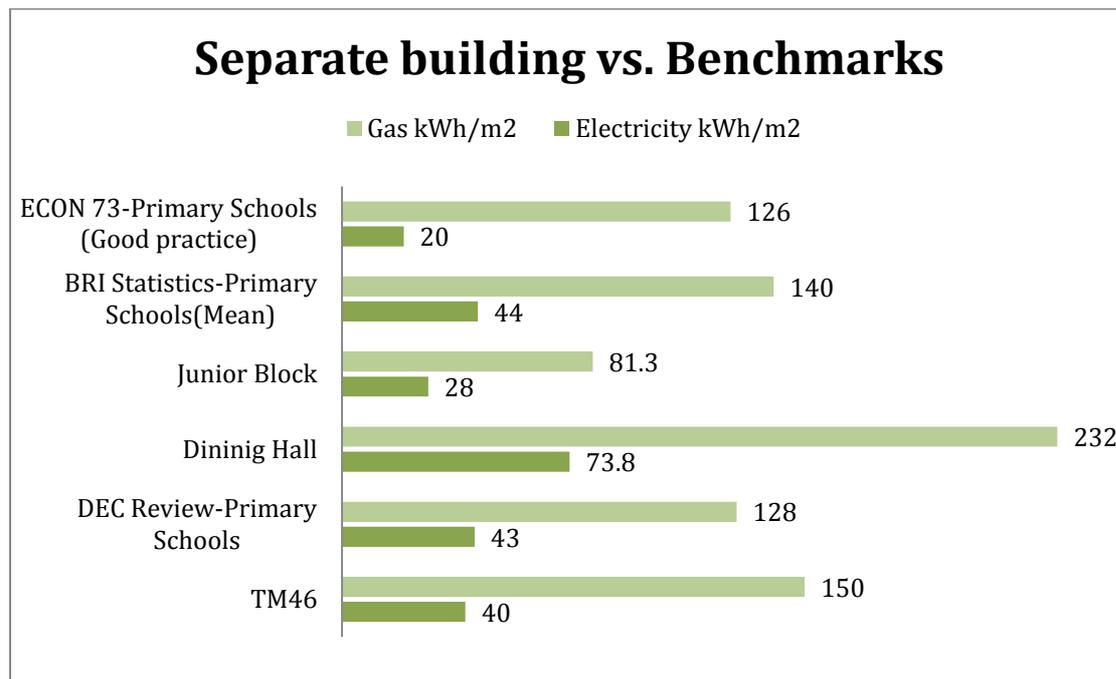
Figure 9.5 Junior Block and Dining Hall Block compared separately with a series of other benchmarks

When compared with other benchmark buildings shown in **Figure 9.5**, both electricity and gas usage for the Junior block can be seen to be comparatively low. The Dining Hall on the other hand has a comparatively poor result, most notably for the gas usage. Taken as an average, the buildings are comparable in performance with a number of the other Benchmarks **[Figure 9.6]**
