Community In A Cube

InnovateUK project number	450052
Project author	Leeds Beckett University for the Good Homes Alliance
Report date	2013
¹InnovateUK Evaluator	N/A

No of dwellings	Location	Type	Constructed
Single apartment	Middlesbrough	Flat	2011
Area (TFA measured)	Construction form	Space heating target	Certification level
42.9 m ²	Concrete frame	N/A	Building Regulations

Background to evaluation

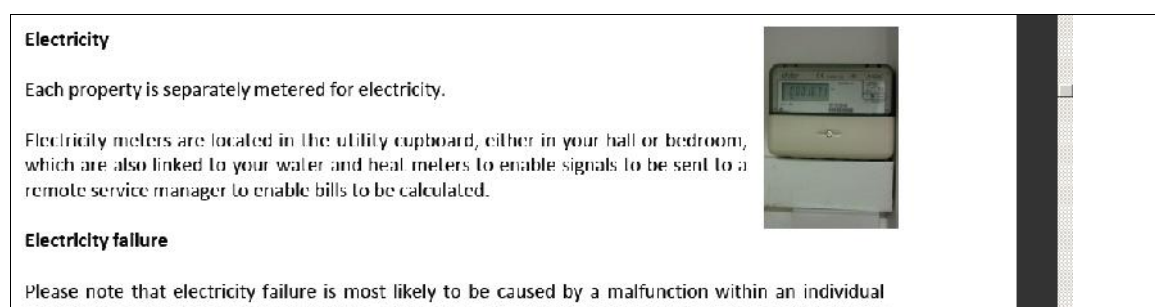
Image: Example of image quality in Homeowner Manual

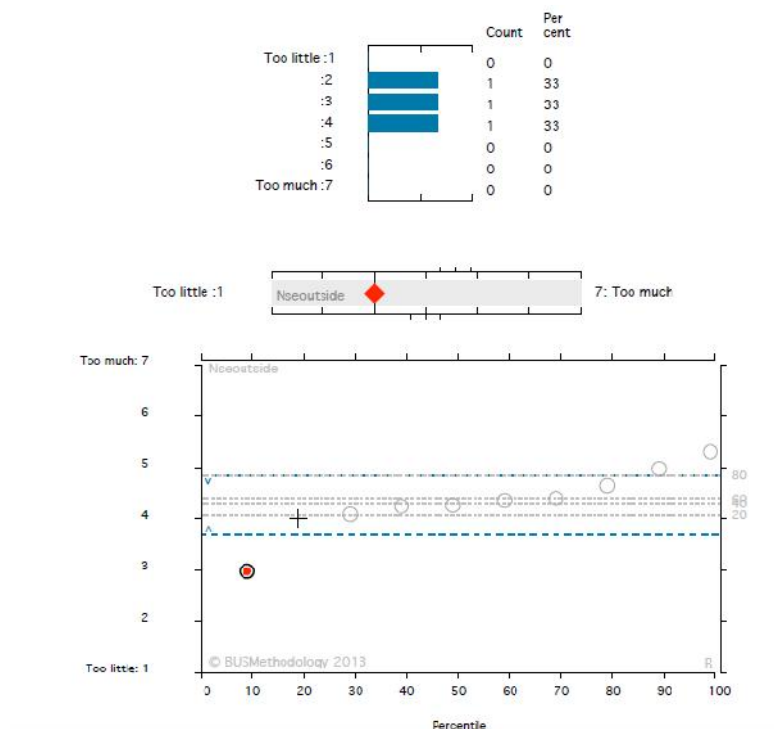
- Noise levels** – Feedback indicated that many residents found noise levels to be too quiet. It is assumed that this is a direct result of the dwelling being away from roads and made of materials with superior soundproofing to the occupant's previous property. It should also be noted that this is not a negative aspect of the dwellings – feedback indicated that residents liked this feature of their homes.

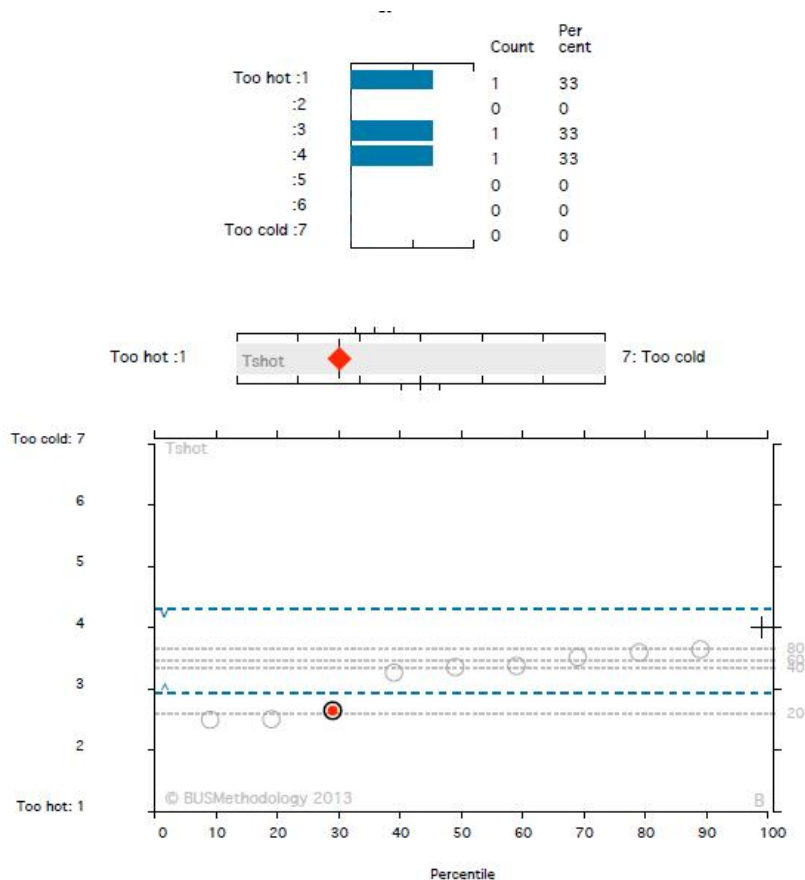
- Temperature** – Residents have reported that they find the temperature in the dwelling too hot.. This may be due to a combination of several factors which are discussed in previous sections

of this report. In particular, it is thought that the cause of this overheating is a combination of poorly insulated piping and an underperforming MVHR system. These issues are certainly something to be aware of and address in future projects of a similar nature.

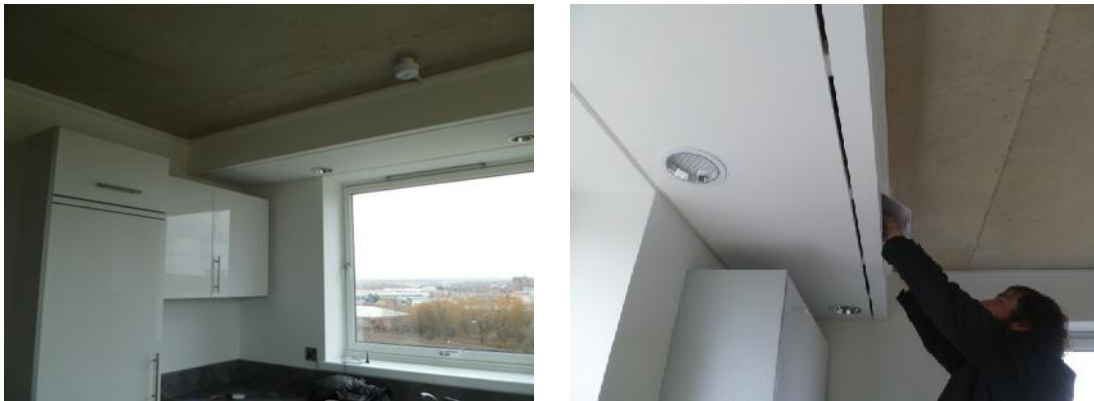
Figure 7 Extract slot above the external window in the bathroom and above the cupboards in the kitchen.

Extract from the bathroom and open plan living/kitchen area is provided via a channel located in the plasterboard ceiling. This channel is positioned above the window in the bathroom and above the cupboards in the kitchen. Air extracted through the channel is fed into an air plenum behind the plasterboard ceiling. This air then enters the MVHR extract ductwork via an extract air valve. The extract air valve comprises a metal slot grille (the same as that fitted on the supply air valve) that has been crudely taped onto the end of the rectangular extract ductwork (see Figure 12). In order to gain access to the extract air valve, a small access hatch is provided in the plasterboard ceiling in the bathroom and the plasterboard in the living/kitchen area (see Figure 13). However, due to the location of the extract valves in relation to the access hatch, access to the valve is limited, making it difficult to make any fine adjustments to the metal slot grille attached to the end of the extract ductwork. As with the supply air valves, it does not appear to be easily possible to make individual adjustments to the extract air valve to the bathroom or kitchen area to meet particular room requirements.

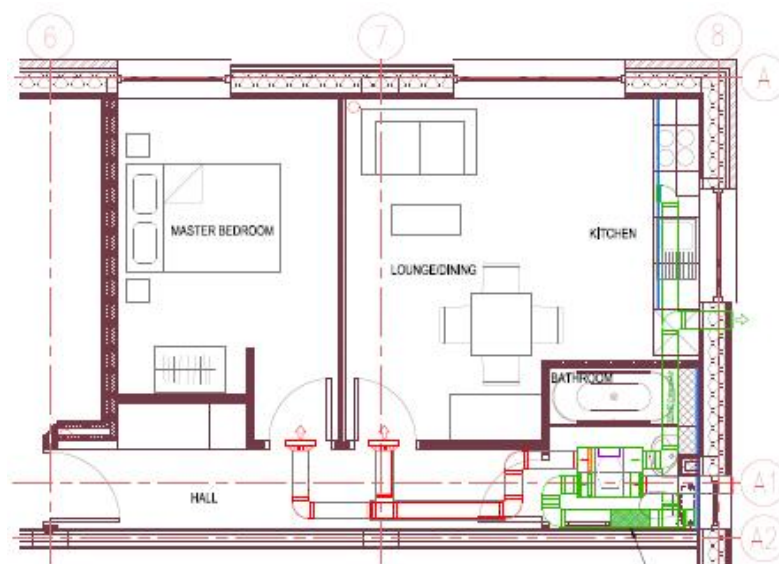
Figure 8 MVHR layout in apartment (handed version).

In terms of the MVHR system, observations revealed that the MVHR unit had been installed in the intended location (in the ceiling void in the bathroom) within the apartment and all of the rectangular plastic ductwork visible in the ceiling void appears to have been installed correctly and to the appropriate standard. The extract and supply valves have also been installed in the intended locations, as indicated on the drawings (see Figure 8). The supply valves used in the bedroom and living/kitchen

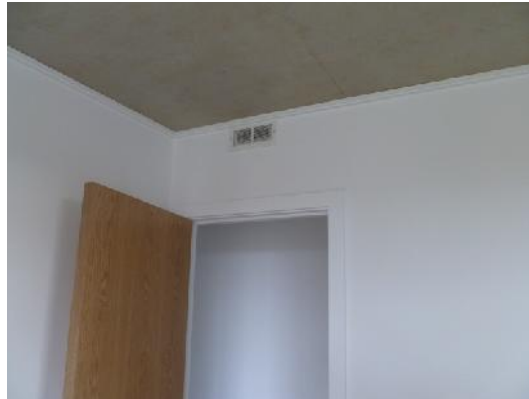
Figure 9 Supply air valve located above the door in the living room/kitchen.

area are located directly above the doors (see Figure 9) and are adjustable (see Figure 10), although they can only be adjusted once the grille has been unscrewed from the wall. Given the type of air valve used, it is difficult to see how adjustments could be made during commissioning to achieve a particular flow rate, as the main grille would have to be continually removed from the wall to make any fine adjustments. The supply air valves also incorporate a thin filter medium (see Figure 11), which can only be accessed by unscrewing the supply air valve from the wall. The exact purpose of this filter is not known, as the main unit also incorporates a supply and extract filter. The position of the supply air valves within the apartment also means that there is a risk, particularly in the bedroom, that a significant proportion of this room will be inadequately ventilated as the type of supply air valve used is not capable of supplying air deep into the room. Instead, it is likely that the supply air will be drawn directly into the corridor towards the extract valves located in the bathroom and/or open plan living room/kitchen area. The use of a directional throw valve designed to exploit the 'coanda effect' would have been more appropriate. Alternatively, the air supply valve should have ideally been located diagonally opposite the doors to each room to maximise cross flow. However, this would have meant that the exposed soffit feature would have to have been compromised. Initial feedback from the occupants has revealed that they perceive there to be stale regions of air within the apartment, suggesting that the current design and configuration of the MVHR system is not providing adequate ventilation to all areas of the apartment.
