# Crawley Library

<b>Innovate UK project number</b>	450003
<b>Project lead and author</b>	Low Carbon Building Group, Oxford Brookes University for West Sussex County Council
<b>Report date</b>	2014
<b>InnovateUK Evaluator</b>	Peter Tse (Contact via <a href="http://www.bpe-specialists.org.uk">www.bpe-specialists.org.uk</a> )

<b>Building sector</b>	<b>Location</b>	<b>Form of contract</b>	<b>Opened</b>
Public library	Crawley Library	Design and build	2008
<b>Floor area (GIA)</b>	<b>Storeys</b>	<b>EPC / DEC 2010</b>	<b>BREEAM rating</b>
4,468 m <sup>2</sup>	4	A (25) / D (90)	Very good

Phase 2 of the Technology Strategy Board (TSB) funded Building Performance Evaluation (BPE) project is designed to evaluate the in-use condition of Crawley Library.

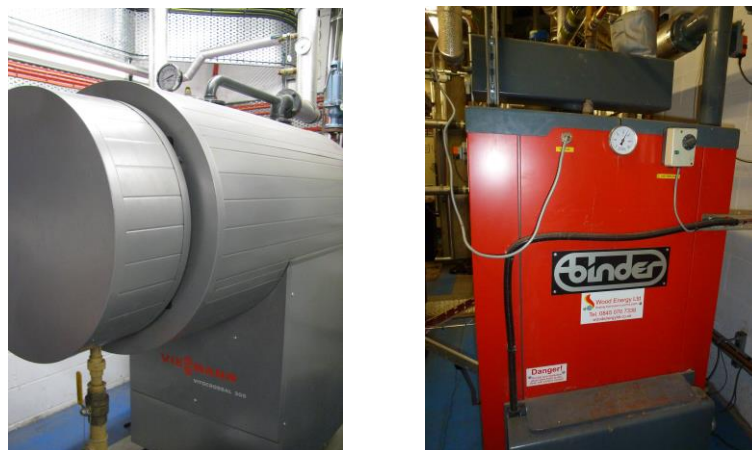
- There has only been very limited use of the biomass boiler prior to the end of the defects period due to H&S concerns related to service access. It was not commissioned properly and there were cables placed over a hatch preventing its proper use/access. By the time this was fixed by the contractors six months had passed and it needed another service at a total cost of £1,600 which WSCC could not afford so there was a need to search for another cheaper service company. Therefore, the biomass boiler had been out of order from April 2009 until December 2011.

Figure 9 (Left) Gas boiler located in Ground Floor plant room. (Right) Biomass boiler located in Ground Floor plant room.

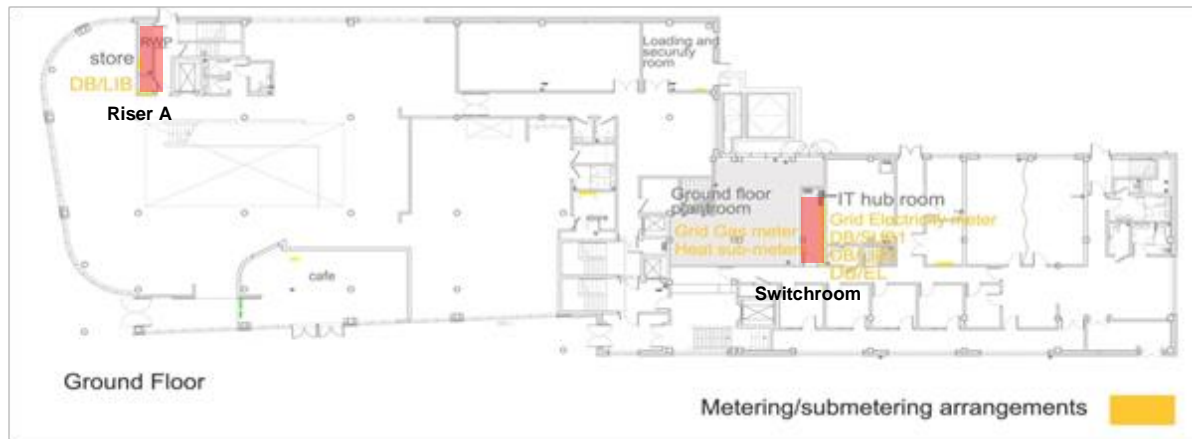
**Sub-meters** were difficult to locate since the drawings with the metering and sub-metering arrangements were missing from the BAM electrical and mechanical specification documents. The electrical distribution schematic which was made available by Gifford provided some information on the metering location (GF Library Riser A, Switchroom) and strategy but could not be verified by a final document. The FM manager did not have any plan available of the metering and sub-metering arrangements either and their position was identified during a walkthrough within the building in the Ground Floor Switchroom and a shaft cupboard (GF Library Riser A) (Figures 15 and 16).

Figure 15 Metering and sub-metering arrangements in the ground floor plan.

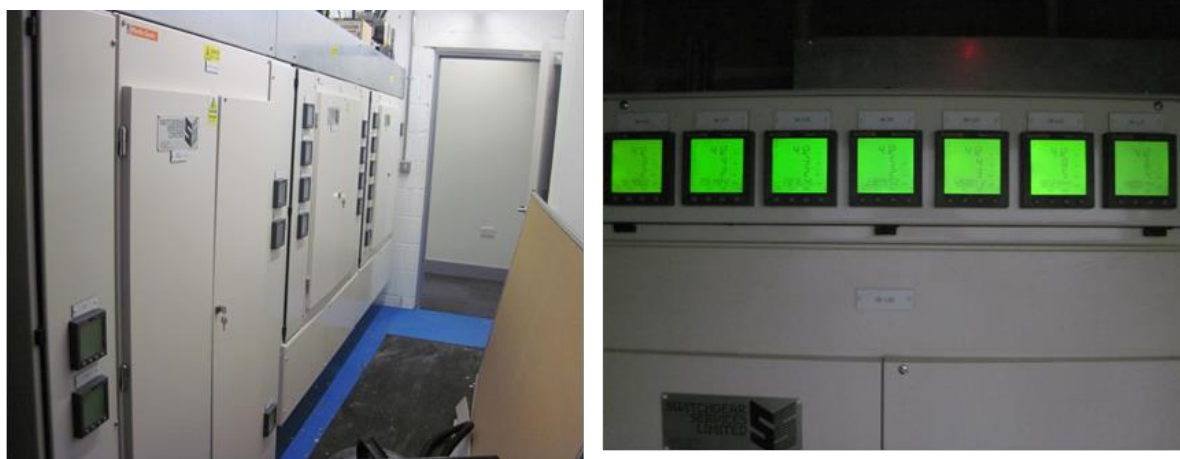
Figure 16 Left: The sub-metering arrangement in Switchroom. Right: DB/LIB1 sub-metering in Ground Floor Riser A.

The main end-use of each sub-meter was not clear in the building Logbook, BMS or any other provided documentation and the information shown in Table 4 are drawn from the pre-visit questionnaire. Most of the sub-meters were logging during the initial walkthrough visit with the exception of DB-EL (Figure 17, left) which had a zero screen indication. The half-hourly profiles of the sub-meters that were connected to the BMS system were not available according to the FM manager. The Asset Planning Officer of WSCC who is responsible for the maintenance of the system explained that due to the limited memory capacity of the BMS only a few weeks (2-3) of half-hourly profiles are available. However, further inspection showed that the data from the BMS system were not been saved in a front-end computer. In addition to that, it was discovered that the eight sub-meters of DB/LIB1, located in Riser A, were not connected to the BMS system.

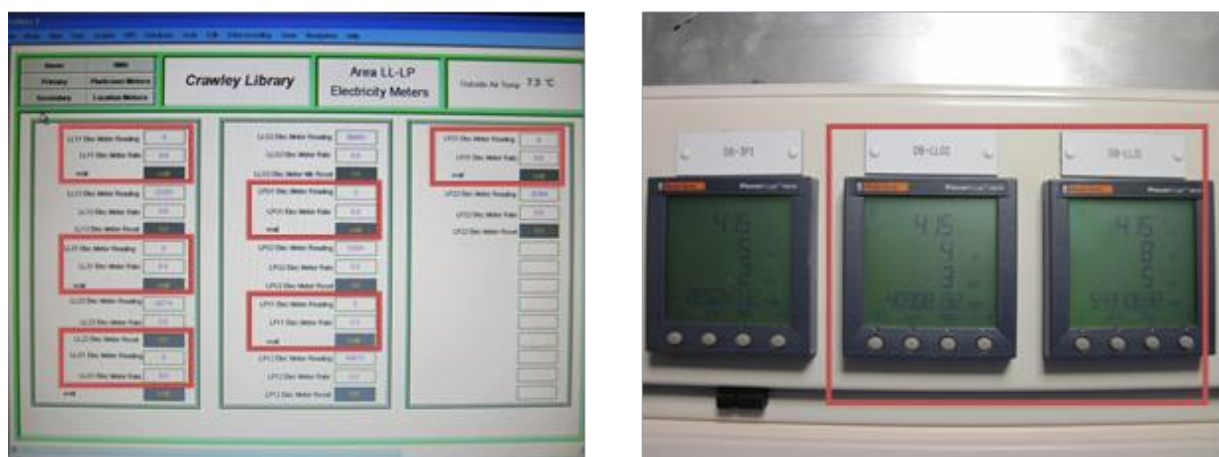
- DB-LL21, DB-LLG1, DB-LPG1, DB-LP11, DB-LP21, DB-3L1, DB-3P1, DB-FL are logging in reality but were not connected to the BMS where they appeared to have a zero indication (Figure 18).
- DB-LP11 is missing from the Logbook monitoring schedule but exists in the BMS and is located in DB/LIB1 meters (Figure 19).
- DB-SEC exists in the PVQ but not in Log Book and BMS and was not found during the walkthrough.
- DB-FL exists in BMS but not in the Log Book and PVQ. It was not found in the walkthrough.
- DB-EL exists in the Log Book but not in BMS and PVQ, it was found during the walkthrough. Potentially, the above are the same meter but with different names in each case. The Log Book and BID document do not give any information on what DB-EL was supposed to be monitoring. However, there is a sub-meter in the PVQ that was supposed to measure external

Figure 18 Sub-meters are logging in reality but appear to have a zero indication in the BMS.

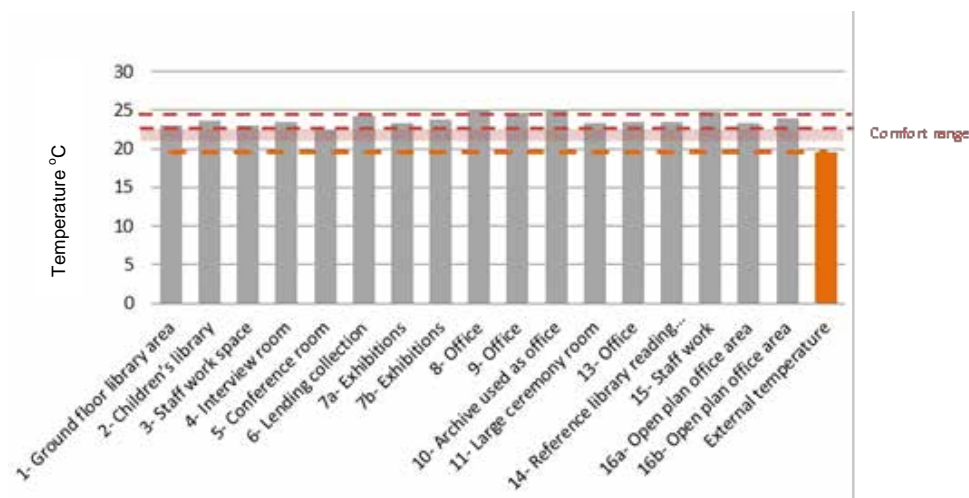
Figure 24 Temperature values in various spaces of the library during the summer spot check visit.

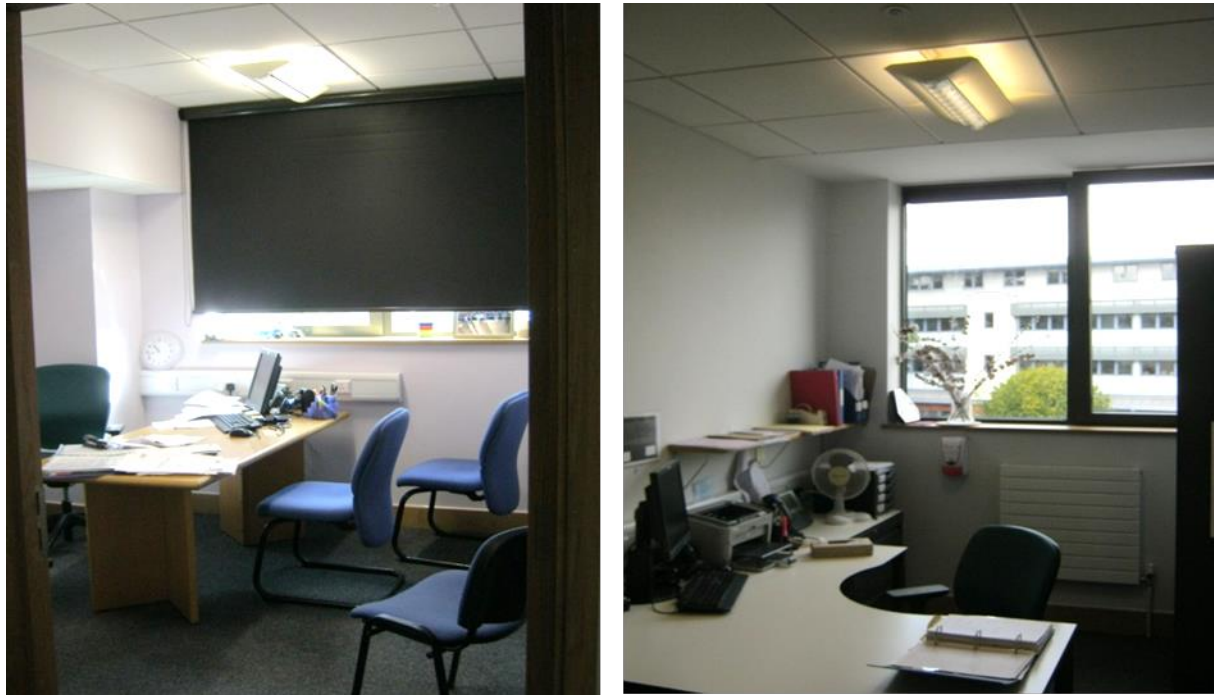
However, during the semi-structured interview the Registration Service manager mentioned there is a lack of natural light in key working spaces of the building such as offices. He mentioned that daylight in most of the offices is blocked by dark blinds and electric lights are on in order to avoid sunlight reflections on the computer screens. This was verified during the walkthrough (Figure 30, left). Additionally, even though lights in the Registration offices are automatically turned on by a PIR control, in several offices lights were still on although the rooms were unoccupied for more than 30 minutes (Figure 30, right).

Figure 30 (Left) Blinds drawn in the register offices and lights are turned on. (Right) Lights are on in registration offices even when the rooms are unoccupied.

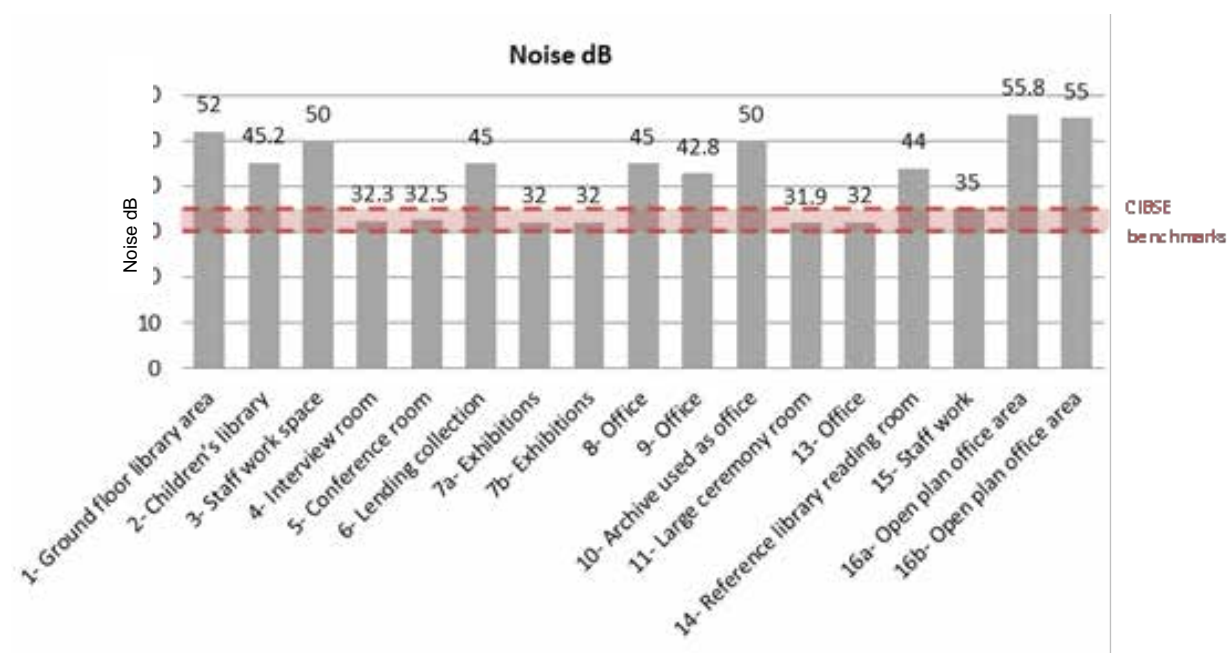
This effect was verified during the summer spot measurements visit (8<sup>th</sup> August 2011) when windows were open. The highest dB levels recorded in the open plan office area highly exceeded the recommended limits (Figure 32). The noise levels were slightly high in general throughout most of the building spaces. It was noticed that the windows were open in most of the spaces and external traffic noise contributed to the higher dB levels.

Figure 32 Noise level values in various spaces of the library during the spot check visit (08.08.2011)

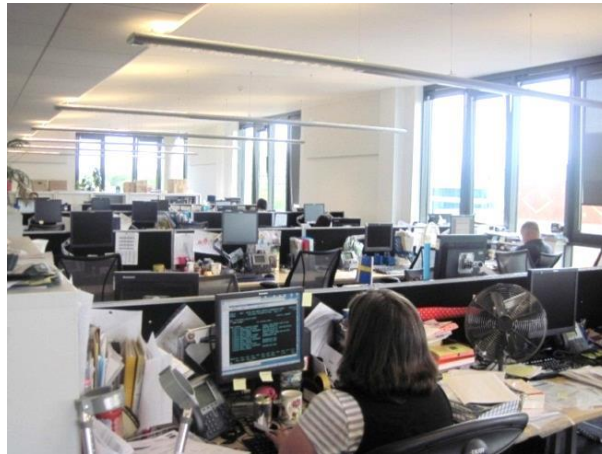
During the semi-structured interview the Registration Service Manager mentioned that issues of excessive noise levels, overheating during summer and cold draughts during winter, coupled with lack of adequate office space and equipment to cover staff's needs, have been reported by occupants working in the office space on the 3rd floor of Crawley library building (Figure 33).

Figure 33 The open plan office on the top floor of the library.

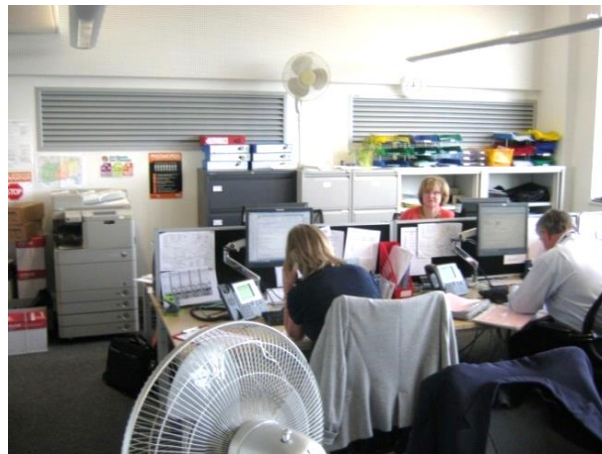
Occupants reported that photocopying equipment in the open plan offices area is placed very close to their working areas and produces excessive noise levels which often disrupts staff's working schedule (Figure 34).

Figure 34 The photocopier is placed too close to the desks rising complaints over noise issues.

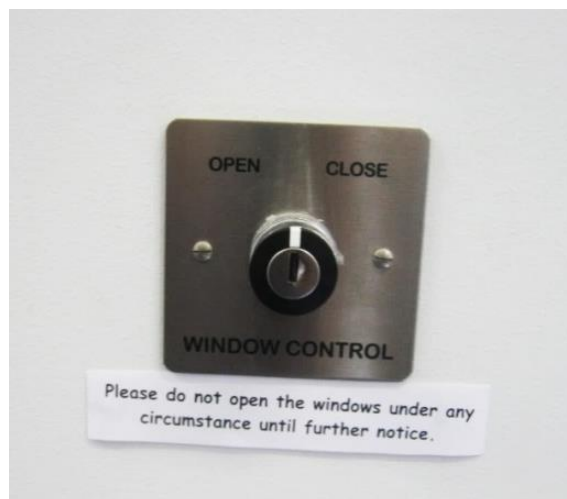
During the semi-structured interviews occupants mentioned that window controls do not function properly, window control keys are difficult to use and are not provided to building occupants. Only security staff has access to keys for window controls (Figure 35). As a result, windows may remain closed which has a detrimental impact on the perceived indoor air quality by occupants. In addition, window control keys have been removed from the general staff and are used only by security for health and safety reasons. There is no occupancy control when the building is overheated.

Figure 35 The window control keys have been removed from the general staff to be used only from the security for health and safety issues.

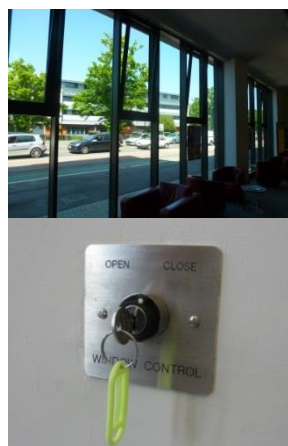
Figure 36 Review of control interface for mechanically controlled windows

Criteria	Poor	Excellent
Clarity of purpose		
Intuitive switching		
Usefulness of labelling & annotation		
Ease of use		
Indication of system response		
Degree of fine control		
Accessibility		
<b>Comments</b> Mechanically opened windows are located in the main office areas and in the Library areas. They are not easy to use and not very intuitive. Users reported that the controls break down quite often and that they struggle to use the key. No good level of fine control as one control is used for many windows or entire areas limiting the choice of users.

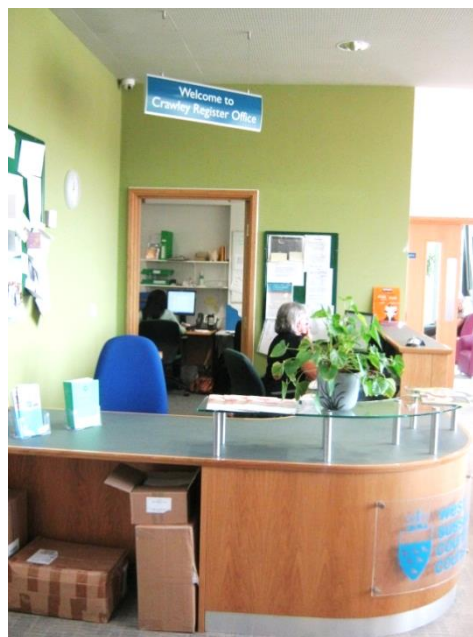
The reception area of Registration Services is currently underused; it is a very large space which is only used as transient reception space and is not easily adoptable to future needs and changes (Figure 38). There is no flexibility for office expansion which has led to unintended solutions such as the conversion of the archive space into a working area and the moving of the ceremonies hub into third floor office space, breaking the Registration Services into two separate building parts. During the semi-structured interview the Registration Service manager mentioned that several design options for the division of the big ceremony room (Figure 39) into two different spaces, the potential of the unused space next to the staircase and the partition of the reception space were discussed between office members of the Registration Services but the architects have not been consulted.

Figure 38 Register service reception and archive space on the back currently used as a hot desk office.

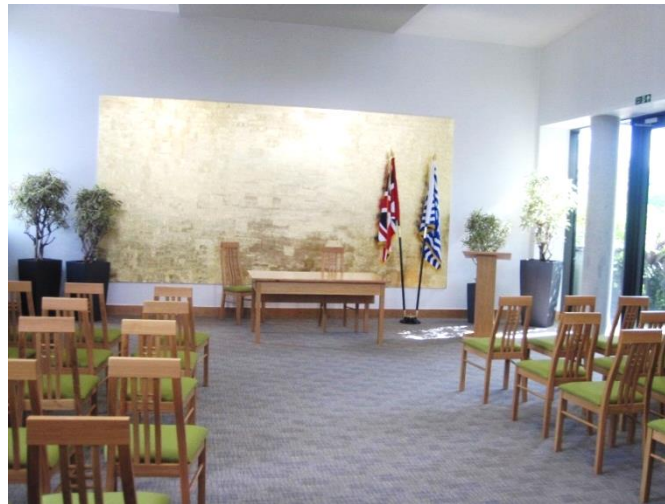
Figure 39 The possibility of dividing the underused big ceremony room was ruled out because of the spot lights placed on a plasterboard in the ceiling. Architects were never consulted on any renovation plans.

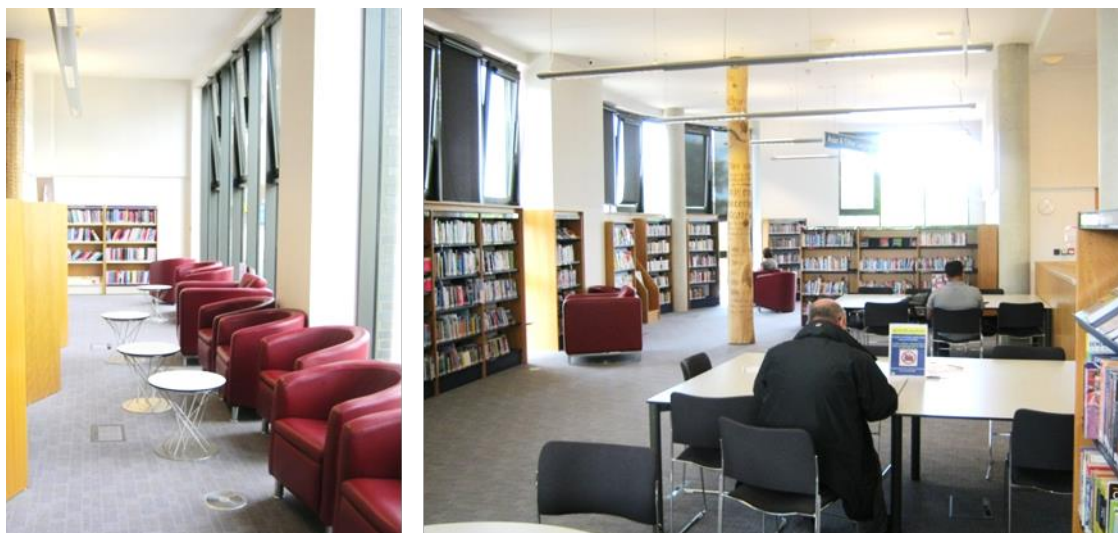
In turn, the Library officer pointed out that there are several issues with the layout and usability of furniture within the library but there is no rigid plan for improvement. During the walkthrough it was discovered that there is little flexibility in moving and rearranging furniture in the library space (Figure 40).

Figure 40 it is not easy to move and rearrange furniture in the library. Study desks in the library cannot be split up into smaller parts.

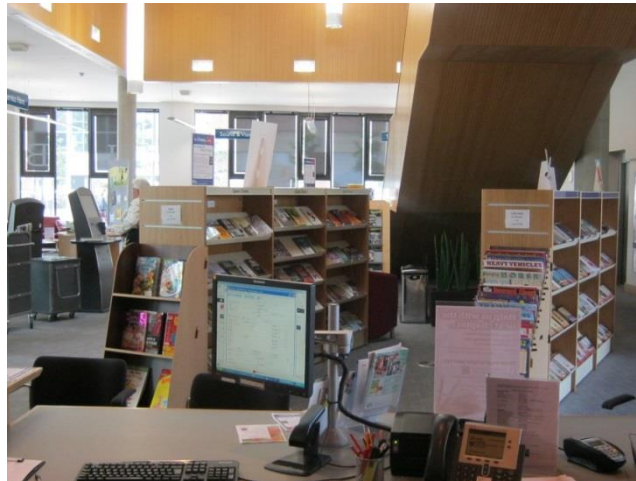
During the semi-structured interview, the Library officer also pointed out that lots of theft issues have been reported on the ground and first floors due to lack of proper supervision of these spaces. The walkthrough revealed that the eye-line from the reception towards the other end of the library ground and first floor is obstructed by the staircase preventing control and surveillance to hub areas located on that side of the floor (Figure 41). The design intent was for the main staircase material to be transparent but for security purposes it has been changed to wood. Additionally it was observed that operable windows in the library are placed in low height and open inwards creating issues with health and safety, usability and theft.

Figure 41 The eye-line from the reception towards the other end of the library ground and first floor is obstructed by the staircase preventing view to hub areas located on that side of the floor.

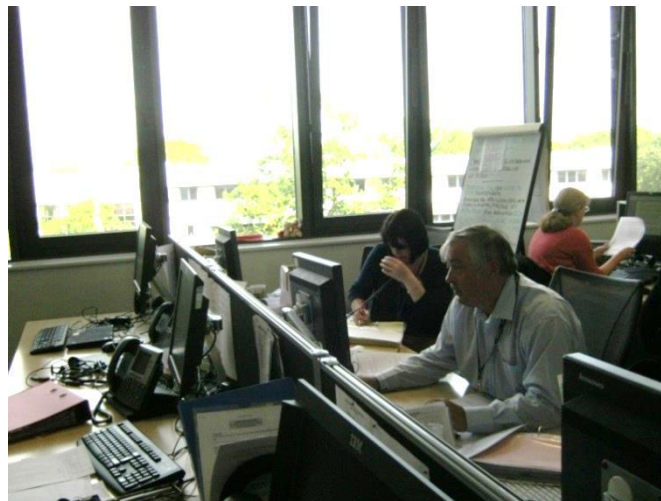
In the third floor open plan office area staff members complained about lack of adequate individual office space, notice boards and equipment to cover their needs (Figure 42). In particular, the registration manager mentioned that corporate office standards set by WSCC limit any options for enlarging individual office spaces.

Figure 42 A noticeboard was provided to the 'registration hub' after complaints on the lack of adequate space for notices.

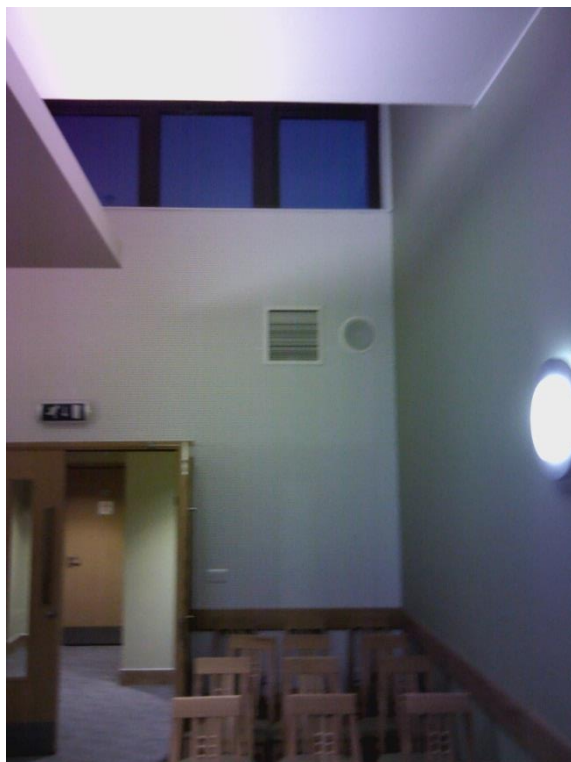
Figure 44 Large ceremony room thermogram. An irregular cold air fringe is dropping from the top windows indicating a cold bridge due to the geometrical elements or lack of insulation on that place. Cooling is on in as in the first ceremony without the rooms being occupied.

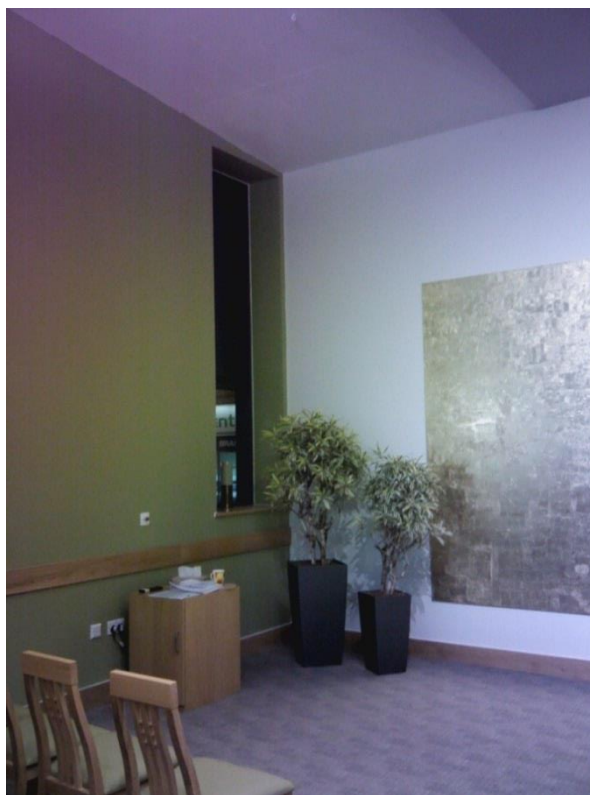
Figure 45 Large ceremony room thermogram. A cold bridge probably due to geometry of building elements can be identified in the room corner.

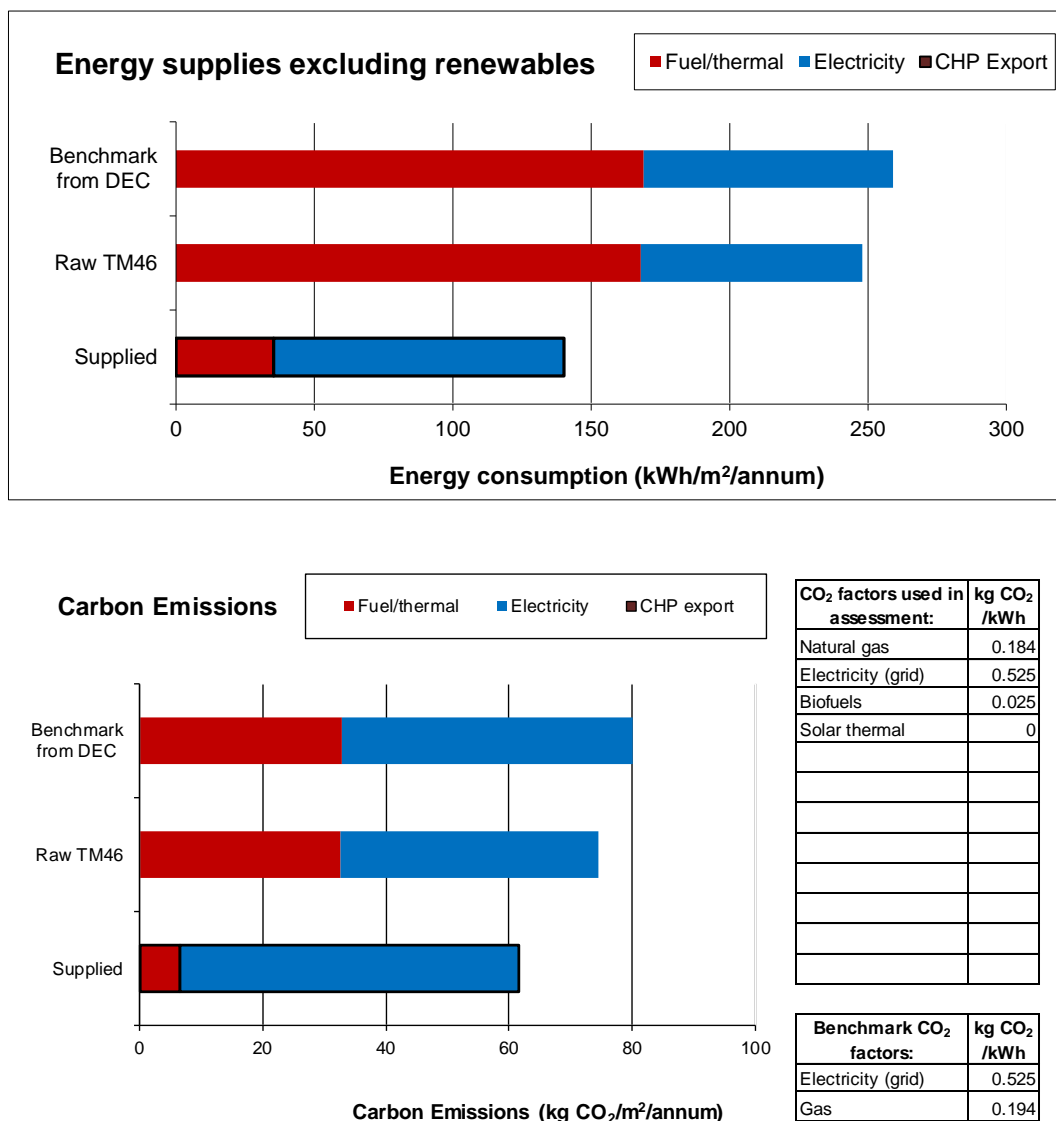
Figure 46 CIBSE TM22:2011 simple assessment tables (January – December 2012).

Based on the total energy supplied to the building, the associated carbon emissions figure of 61.6kgCO<sub>2</sub>/m<sup>2</sup> is lower than the raw CIBSE TM46 benchmark and 25% lower than the DEC benchmark (Figure 46).

In terms of gas consumption the building performs 80% better (lower) than the raw CIBSE TM46 and DEC benchmarks. However in terms of electricity consumption, the building performs 23% worse (higher) than the raw CIBSE TM46 benchmark and 14% worse than the DEC benchmark (Figure 46).

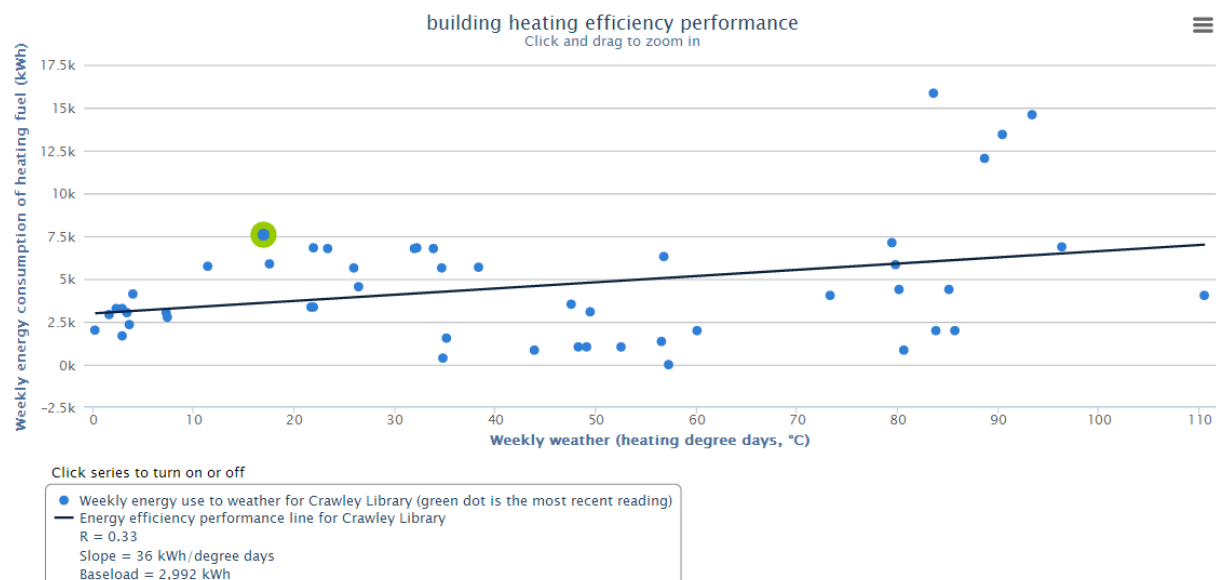
In addition, the correlation between weekly weather and weekly energy consumption for heating is poor ( $R=0.33$ ) (Figure 50). This indicates that the heating system and the controls do not follow closely the changes in external temperature and that the efficiency of the heating system is poor.

Figure 51 Heating efficiency performance. The correlation between weekly weather and weekly energy consumption for heating is poor ( $R=0.33$ ). This indicates that the heating system and the controls do not follow closely the changes in external temperature.

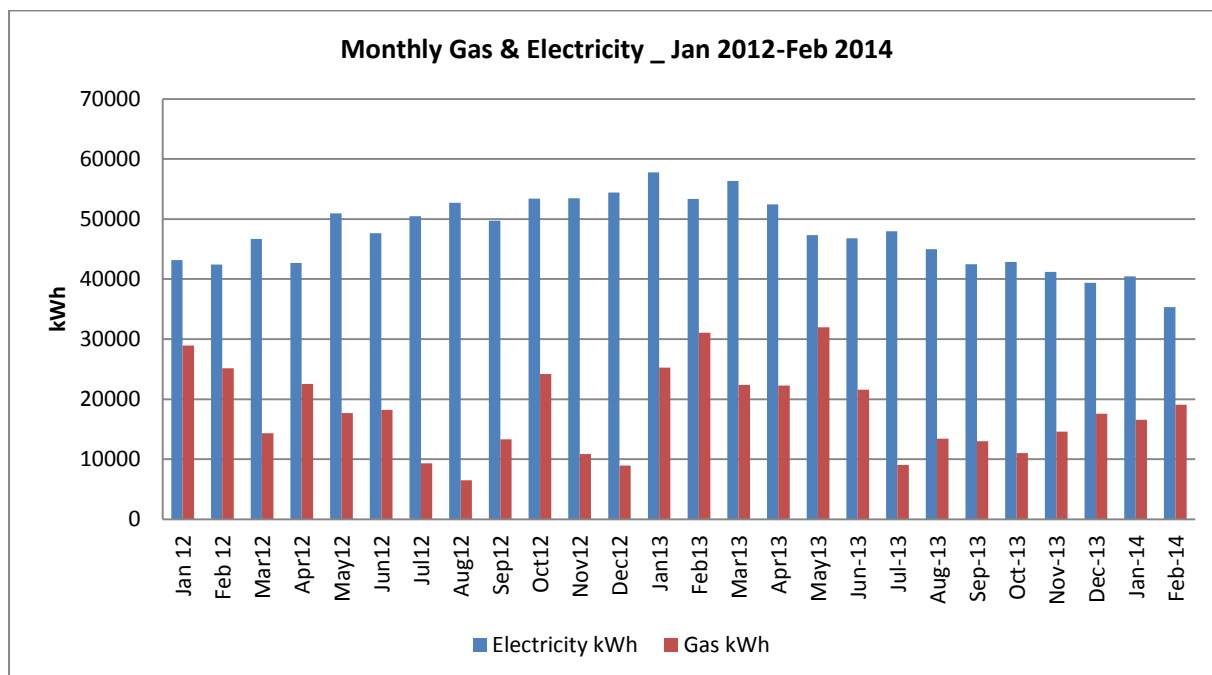
Figure 52 shows the monthly electricity and gas consumption from January 2012 to February 2014. Gas consumption presents great variation from one year to another, likely to be related to the intermittent use of the biomass boiler (due to frequent breakdowns). Electricity use, on the other hand seems to be steadily reducing since June 2013 following the first calibration of the BMS system. Since October 2013, following the calibration of the heating settings on the BMS system electricity use during winter was further reduced.

Figure 52 Comparison of monthly gas and electricity consumption from January 2012 to February 2014.

The monthly gas consumption of both winter periods is quite similar (Jan 2012: 28,900kWh, Jan 2013 25,000kWh). Electricity consumption during that period ranges between 35,000-58,000 kWh/month. Monthly gas consumption ranges from 6,500kWh in August 2012 to 32,000kWh in May 2013 related to the frequent breakdowns of the biomass boiler. During the winter months, gas consumption ranges between 15,000-27,000 kWh in 2012 and between 22,000 and 32,000kWh in 2013. Interestingly from December 2013 to February 2014, gas consumption ranges between 16,500-19,000 kWh (lower than previous years) as the BMS system is working (since October 2013) and used actively by the building management team.

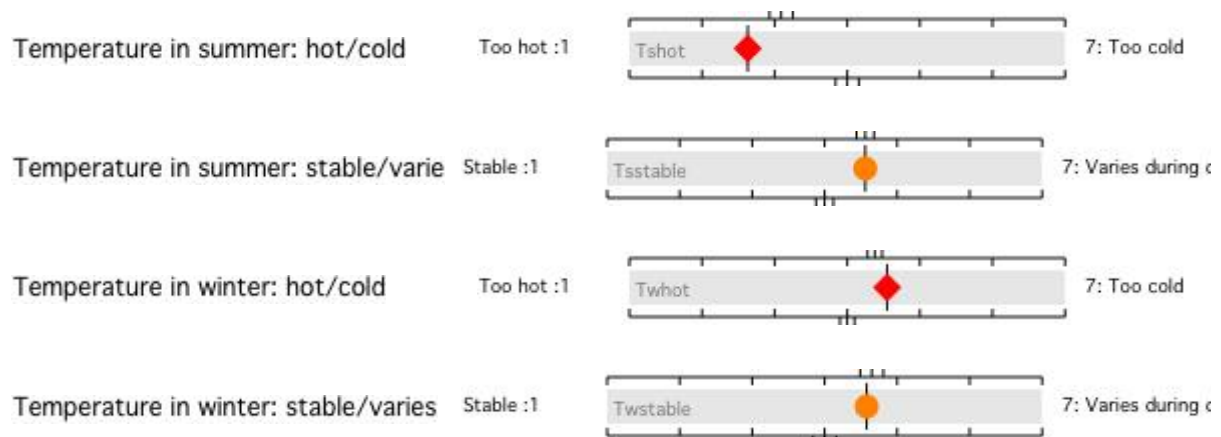
Figure 76. Air temperature in summer and winter.

Comments about uncomfortably hot spaces over summer were made by 68% of the respondents implying problems with the cooling system (*“lack of air-conditioning”*) and control over the opening and closing of windows (*“cannot open individual windows instead of a whole row at once”*) (Figure 76, Figure 77). Indoor temperature readings on the day of the survey were surprisingly high for some of the spaces such as the children’s library and the first floor office reaching a peak of 25.4°C during the midday, with an external temperature of 20.4°C. This could account for a significant amount of staff experiencing air as hot and stuffy.

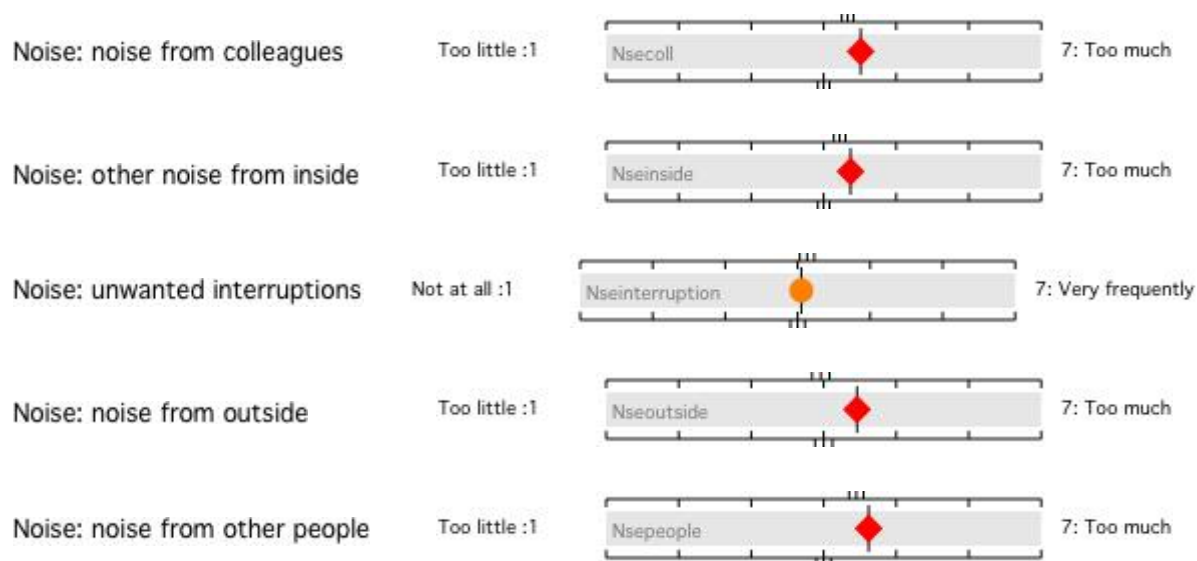
Figure 79. Noise

Noise was clearly an issue for the staff members mainly because of the open plan spaces within the library and the external noise coming from the adjacent road when the windows are open (Figure 79). The staircase design and the open plan office on the third floor were considered to help noise travel

through the different levels of the building while the lack of control over individual windows enhanced the traffic noise due to the necessity of opening at least six windows at a time.

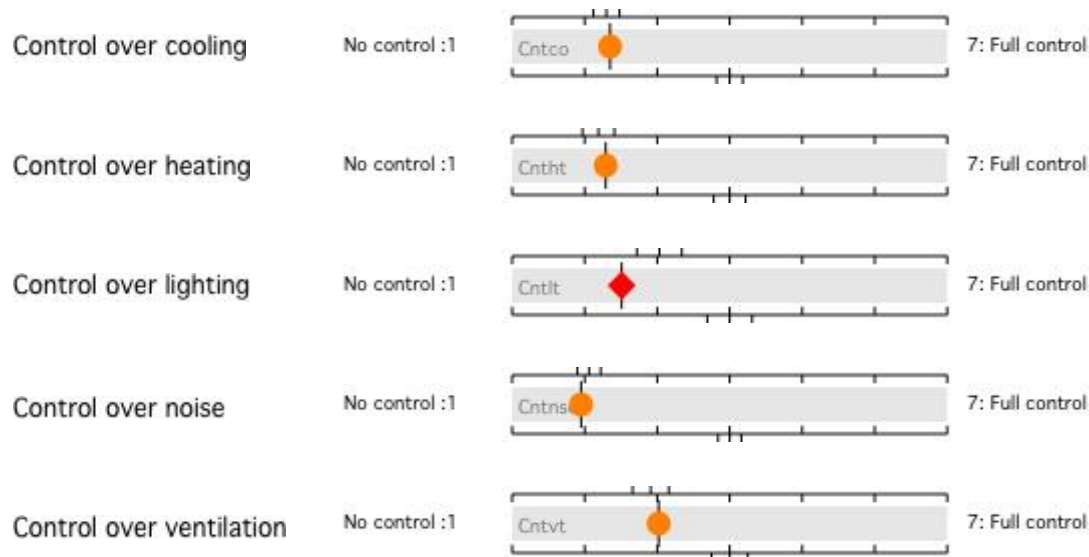
Figure 80. Personal control.

In terms of control over heating, cooling, lighting, noise and ventilation the majority stated to have no control at all over their comfort conditions with the exception of ventilation over which, a third of the staff felt they had some degree of control (Figure 80). One of the most problematic spaces was found to be the exhibition room since it is either too hot or too cold, due to having no windows for adequate ventilation.

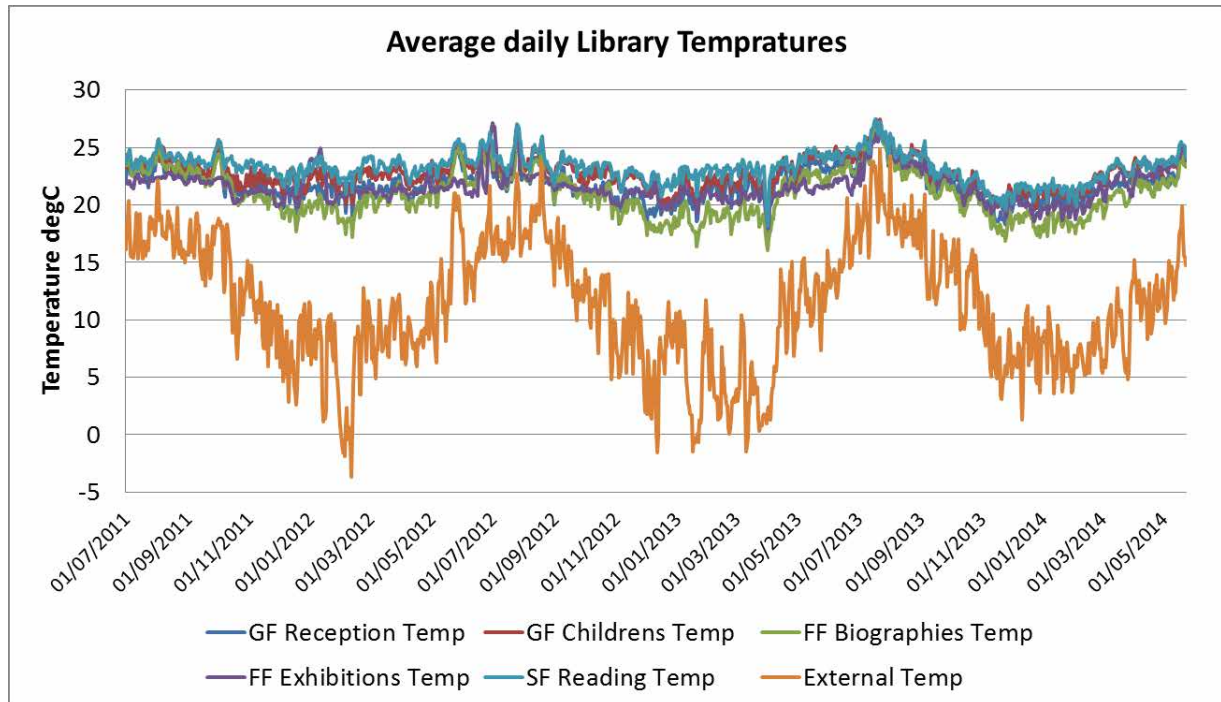
Figure 89 Temperatures in the Library area during the monitoring period (July 2011-May 2014).

- Internal temperatures fluctuate between 20 and 25 °C while external lies between -2.4 and 22°C. The internal temperatures in most of the spaces remain between the comfort levels (21-23°C) (Figure 89).

- The first floor exhibitions room and the first floor Library area present the lowest temperature during the whole period falling slightly below the comfort zone during the coldest periods (Jan-Feb).

- During the summer period the temperature rises slightly above the comfort zone indicating that measures might need to be taken to prevent the building from overheating (shading, cooling).

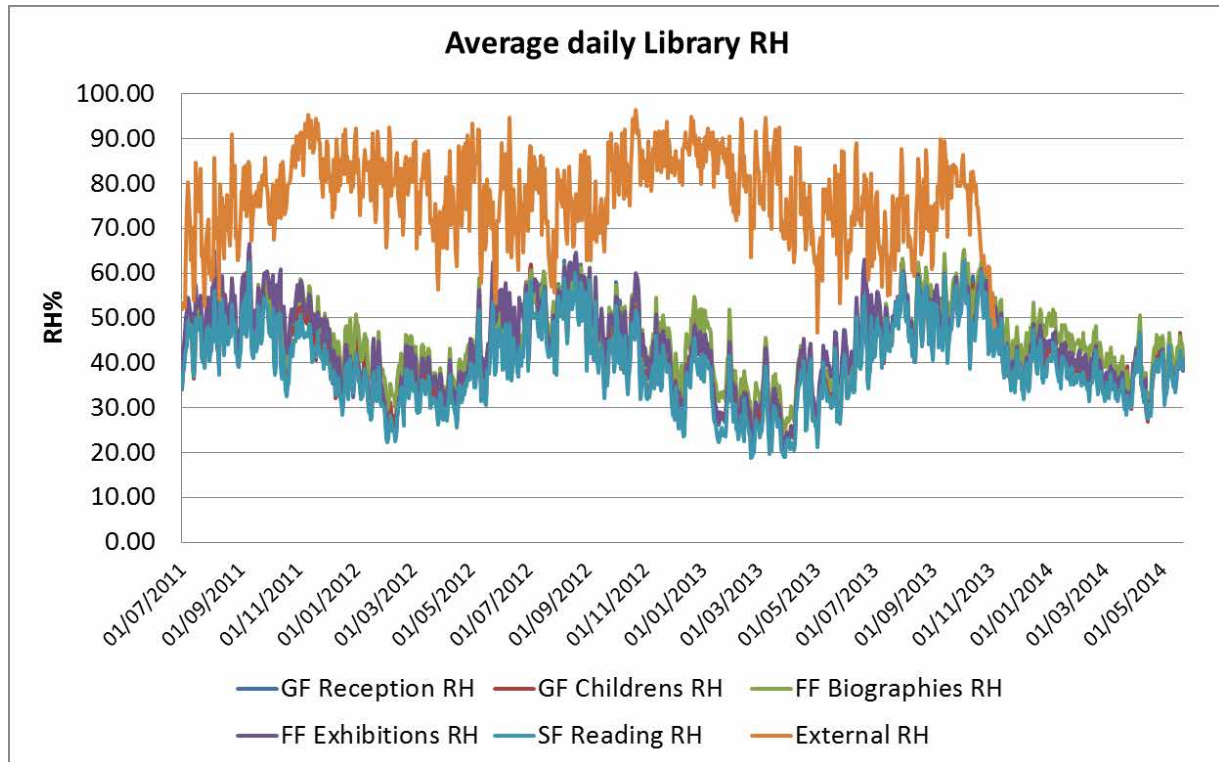
Figure 90 Relative humidity in the Library area during the monitoring period (July 2011-May 2014).

- Relative humidity (RH) generally stays between 25 – 60%, where 40% is most common (Figure 90). Humidity in the range of 40-70% is generally acceptable (CIBSE Guide A) but in case of sustained cold weather values under 40% are also considered up to standard. Humidity of 30% or lower may be acceptable but precautions should be taken to limit the generation of airborne irritants and dust and prevent static discharge from occupants (CIBSE Guide A).
- The lowest values in RH are noticed in the second floor of the Library where higher temperatures were recorded. This is probably due to solar gains and heat rising up through the open atrium of the stairwell area.

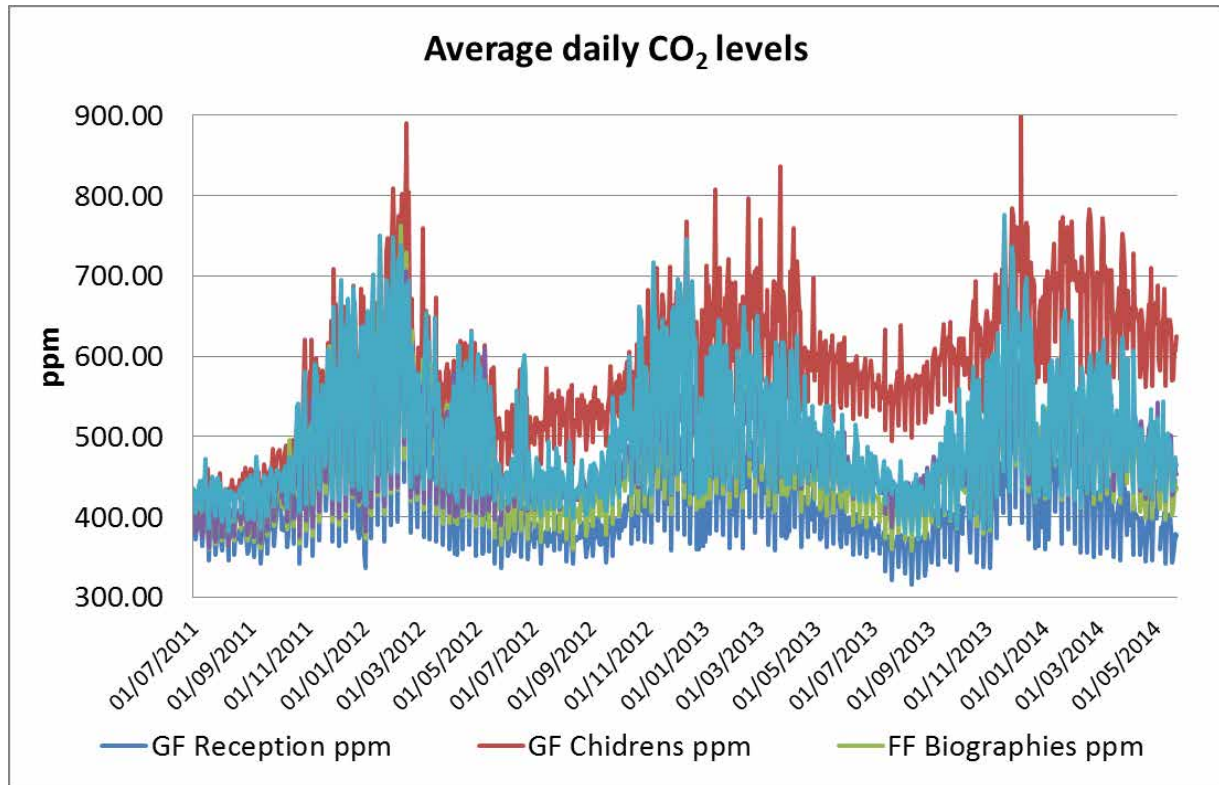
Figure 91 CO<sub>2</sub> levels in the Library area during the monitoring period (July 2011-May 2014).

- The CO<sub>2</sub> levels in the children's library are the highest and are typically between 500ppm and 800ppm (Figure 91). CO<sub>2</sub> readings between 1000ppm and 2000ppm are generally related to perceptions of poor air quality or stuffiness and suggest inadequate ventilation but in this case the values, such levels are not found anywhere, and when CO<sub>2</sub> levels rise, they quickly degrade again to acceptable levels. The CO<sub>2</sub> daily variation is more obvious in the third floor open plan office due to the large concentration of people during office hours.
- CO<sub>2</sub> levels are generally higher during the winter period when the building is mechanically ventilated suggesting that more ventilation might be needed in more densely occupied spaces.

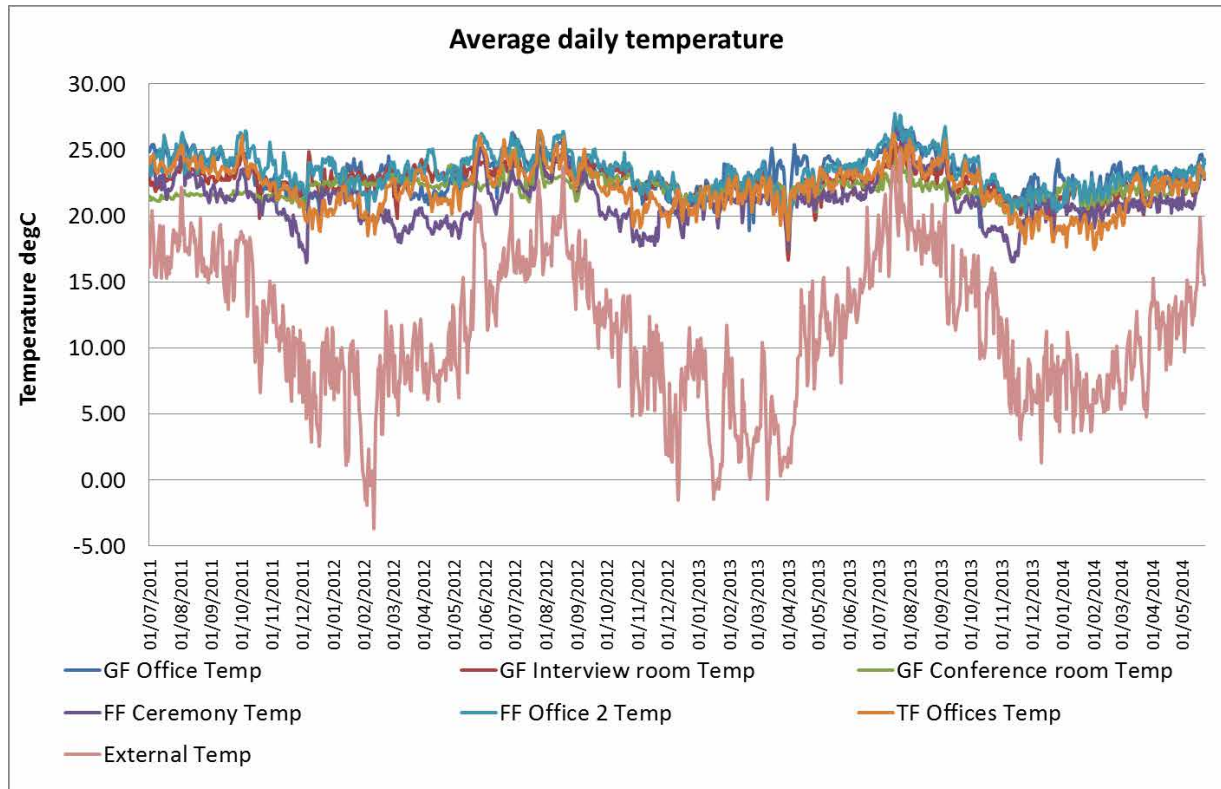
Figure 92 Temperatures in the Registry service and Office areas during the monitoring period (July 2011-May 2014).

- Internal temperatures fluctuate between 20 and 25°C while external lies between -2.4 and 22°C. The internal temperatures in most of the spaces remain between the comfort levels (21-23°C) (Figure 92).

- The first floor ceremony room presents the lowest temperature during the whole period falling slightly below the comfort zone during the coldest periods (Jan-Feb) possibly due to the fact that it remains unoccupied most of the time.

- During the summer period the temperature slightly rises above the comfort zone indicating that measures might need to be taken to prevent the building from overheating (shading, cooling).

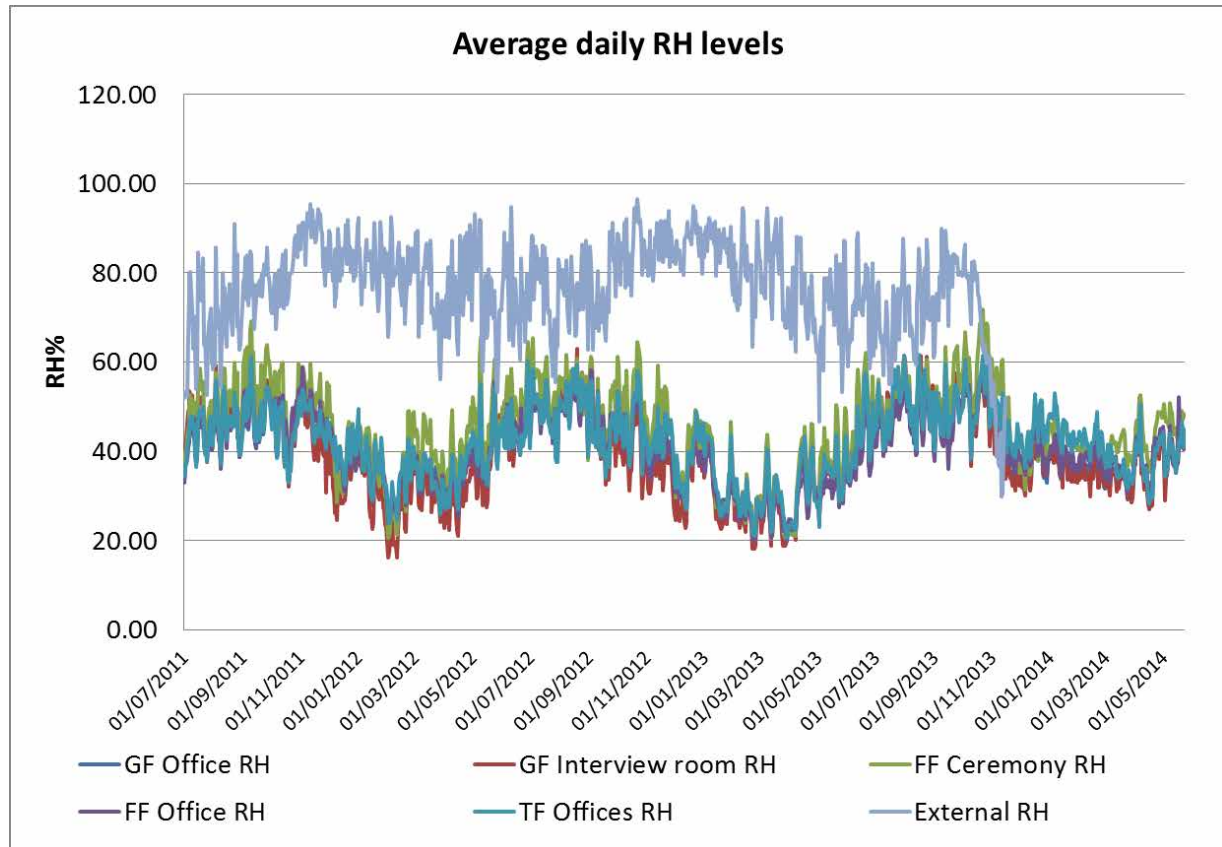
Figure 93 Relative humidity in the Registry service and Office areas during the monitoring period (July 2011-May 2014).

- Relative humidity generally stays between 20 – 60%, where 40% is most common (Figure 93). Humidity in the range of 40-70% is generally acceptable (CIBSE Guide A) but in cases of sustained cold weather values under 40% are also considered adequate. Humidity levels of 30% or lower may be acceptable but precautions should be taken to limit the generation of airborne irritants and dust and prevent static discharge from occupants (CIBSE Guide A).

- The lowest values are noticed in the third floor offices where higher temperatures were also recorded. This is probably due to high internal gains from people and office equipment.

- RH levels inside the building do not directly follow the fluctuations of the external RH but tend to drop during the heating season and rise during the summer period. This shows that RH levels are significantly impacted on by the heating and ventilation strategy of the building, particularly during the winter.
