# Crawley Library

<b>Innovate UK project number</b>	450003
<b>Project lead and author</b>	Low Carbon Building Group, Oxford Brookes University for West Sussex County Council
<b>Report date</b>	2014
<b>InnovateUK Evaluator</b>	Peter Tse (Contact via <a href="http://www.bpe-specialists.org.uk">www.bpe-specialists.org.uk</a> )

<b>Building sector</b>	<b>Location</b>	<b>Form of contract</b>	<b>Opened</b>
Public library	Crawley Library	Design and build	2008
<b>Floor area (GIA)</b>	<b>Storeys</b>	<b>EPC / DEC 2010</b>	<b>BREEAM rating</b>
4,468 m <sup>2</sup>	4	A (25) / D (90)	Very good

Phase 2 of the Technology Strategy Board (TSB) funded Building Performance Evaluation (BPE) project is designed to evaluate the in-use condition of Crawley Library.

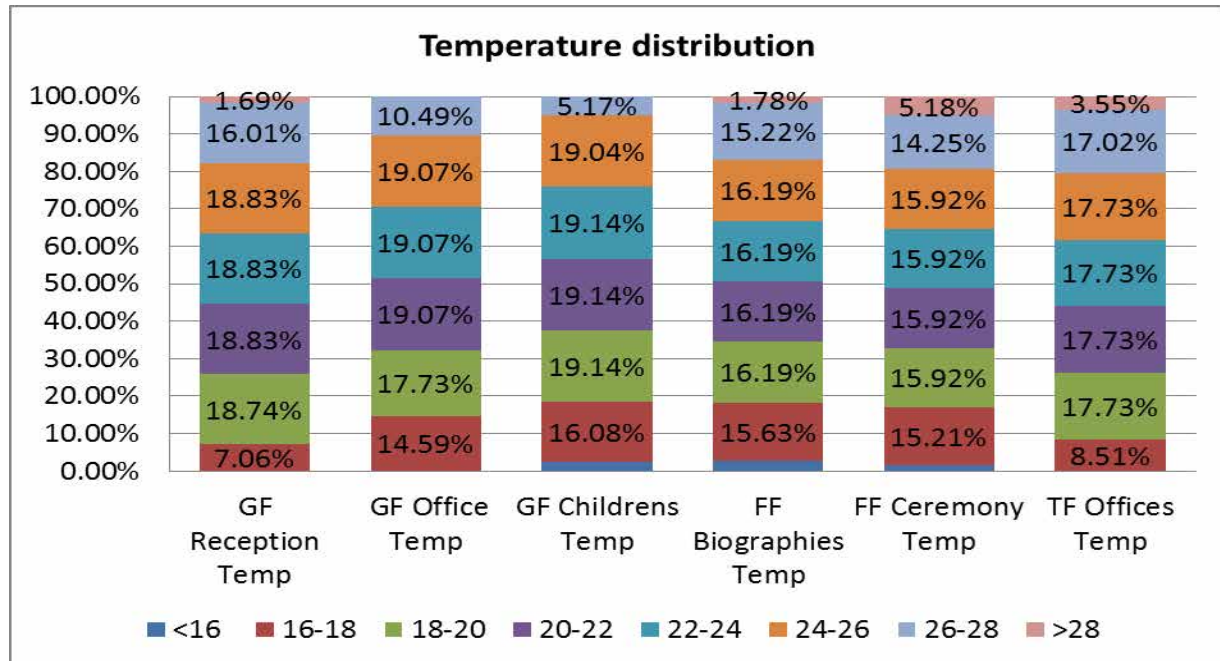
Figure 94 Temperature distribution (July 2011 – May 2014) .(Comfort zone ranging between 20-25°C)

- Temperatures remain within the comfort zone.
- Spaces remain above 26°C between 15-20% of the time
- Similar temperature distribution across all spaces

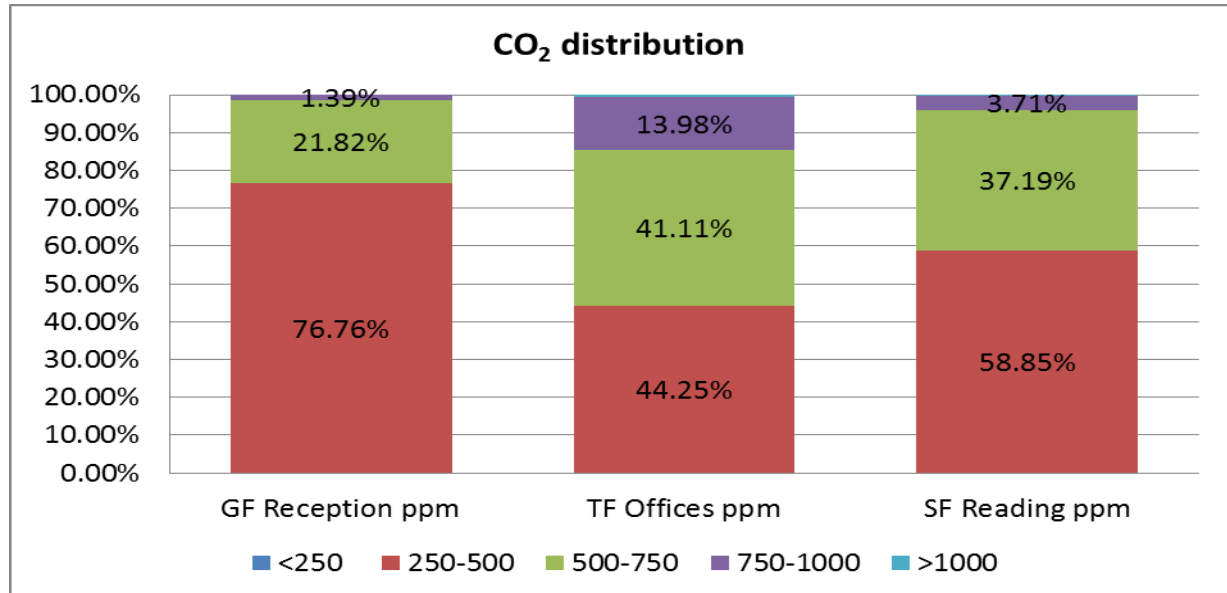
Figure 95 CO<sub>2</sub> distribution (July 2011 – May 2014). (ASHRAE recommended limit is 1000ppm)

CO<sub>2</sub> levels remain well below the recommended levels in all spaces.

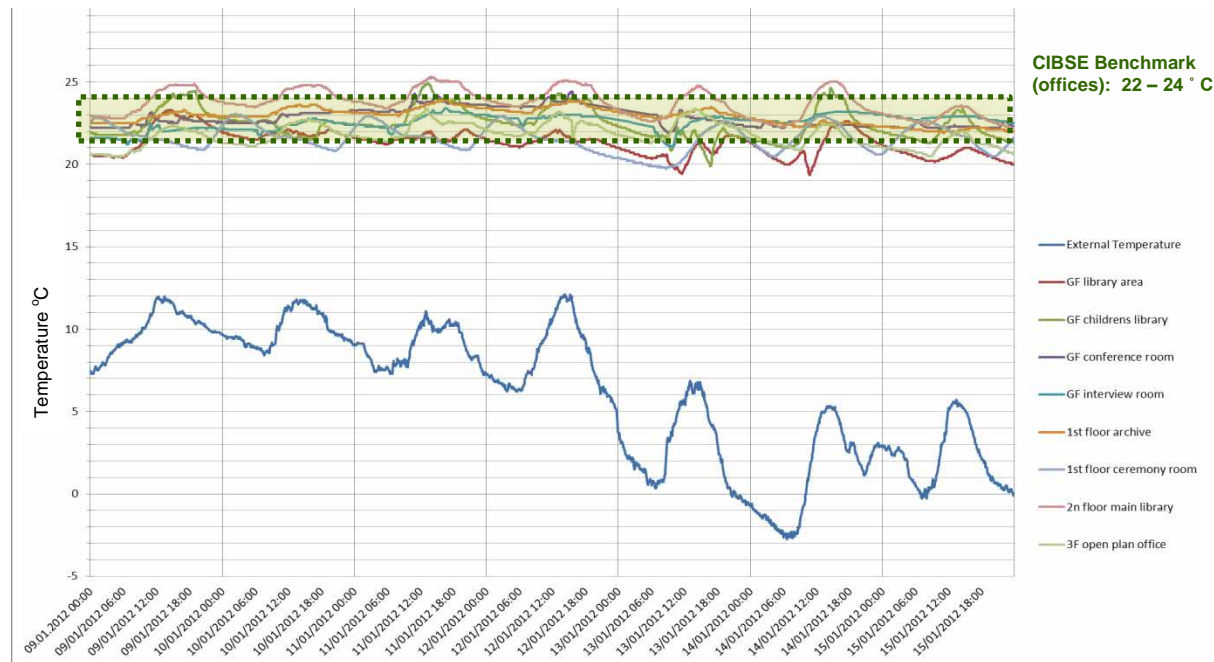
Figure 96 Temperature graph of a typical winter week (09/01/2012-15/01/2012)

- Internal temperature fluctuates between 20 and 25°C while external lies between -2.4 and 12.8°C. The internal temperatures in most of the spaces remain between the comfort levels (21-23°C) (Figure 96).

- During the coldest day (14/01/2012), the lowest temperature value is 19.8°C in the ground floor library. This could possibly be caused by the automatic entrance doors bringing cold air draughts directly into the library space.

- The first floor ceremony room revealed an interesting heating pattern during this week, where the temperature peaked at 1.00am, at 23°C, and gradually fell throughout the day to 21°C during the evening, before rising again. This pattern changes towards the weekend where the temperature peak moves around midday. This is potentially related to the activities that take place in this space during weekdays and the BMS settings that control the temperature and ventilation in the space. The room is occupied Monday-Thursday from 14:00-16:00 and Friday – Sunday 12:00-16:00 and the mechanical ventilation settings in this are set to maintain a cooler temperature due to potential intensive activities that may take place in here. This may account for the continuous drop in temperature during the day, but also points at the heating being on unnecessarily, when the room is unoccupied. Unfortunately, there are no details of the BMS settings at this time known to the researchers, and contradictory information has been given regarding the settings of both the

heating and mechanical ventilation so the reasons for the unusual peak time cannot be fully validated. Despite this, a further investigation to ensure that the heating and ventilation strategies are combined would be advised.

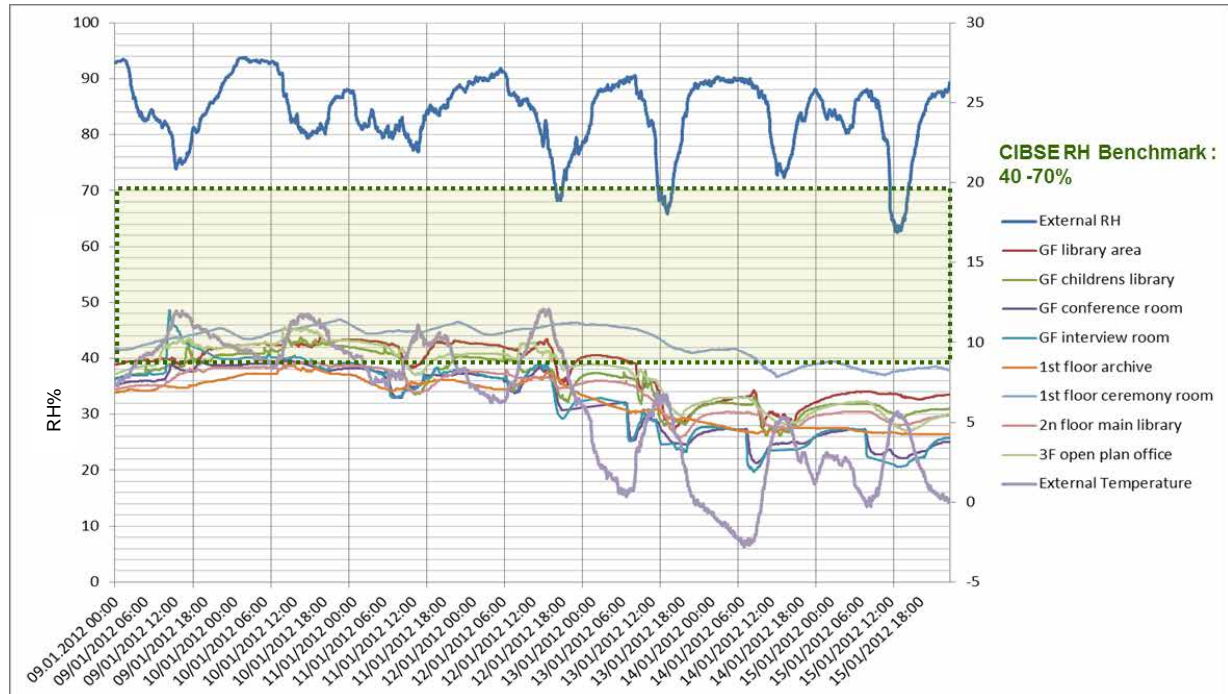
Figure 97 Relative Humidity levels during a typical winter week (09/01/2012-15/01/2012).

- Relative humidity generally stays between 25 – 45%, where +/-35% is most common. Humidity in the range of 40-70% is generally acceptable (CIBSE Guide A) but in case of sustained cold weather values under 40% are also considered tolerable. The lowest values are noticed in the conference and interview room reaching 21% in the early morning of 14<sup>th</sup> January 2012 while the external RH was 89%. The space temperature during that time was 22.5 °C in both spaces while external temperature was below zero reaching -2.5 °C (Figure 97).
- The ceremony room has the most stable RH levels lying between 40-45%, most likely due to the use of mechanical ventilation for that space.

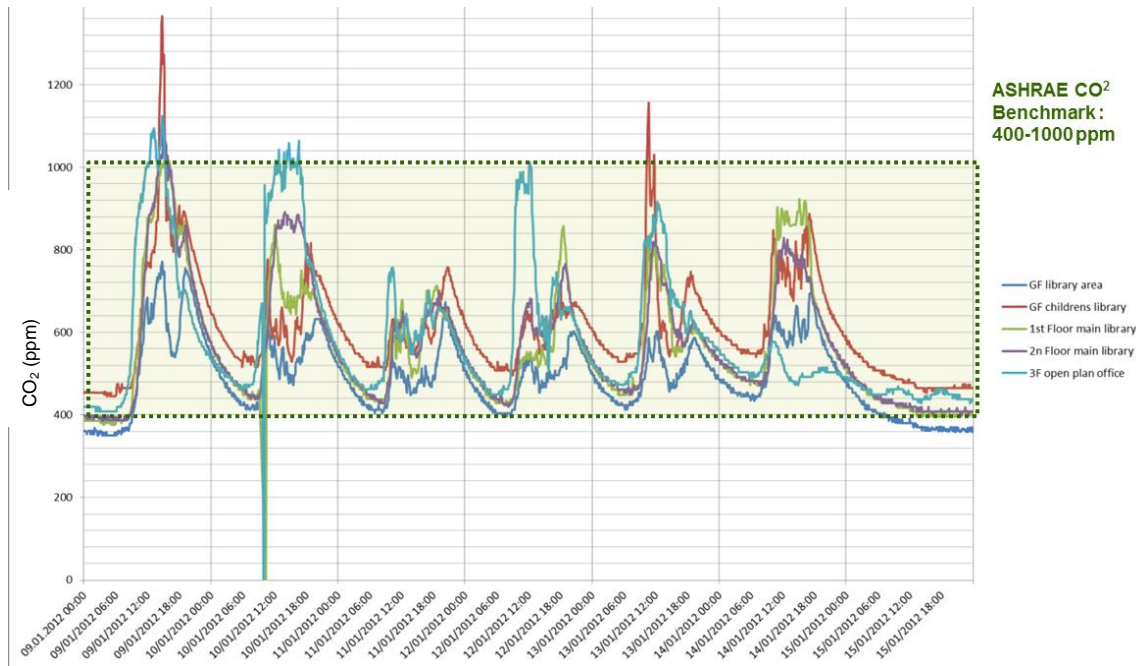
Figure 98 CO2 levels during a typical winter week (09/01/2012-15/01/2012).(Drop indicates error in data).

- The CO<sub>2</sub> in the children's library is typically between 500ppm and 800ppm with two high peaks of 1,370ppm (9th January 2012, 14:45) and 1,150ppm (13th January 2012, 10:40) during gathering activities in the monitored space, highlighting the impact of occupancy on CO<sub>2</sub> levels. Despite this, the levels quickly drop again to more acceptable levels and are never constantly high. The CO<sub>2</sub> daily variation is more obvious in the third floor open plan office fluctuating between 450ppm and 1,050ppm during the peak office hours (12:00 – 15:00) (Figure 98).

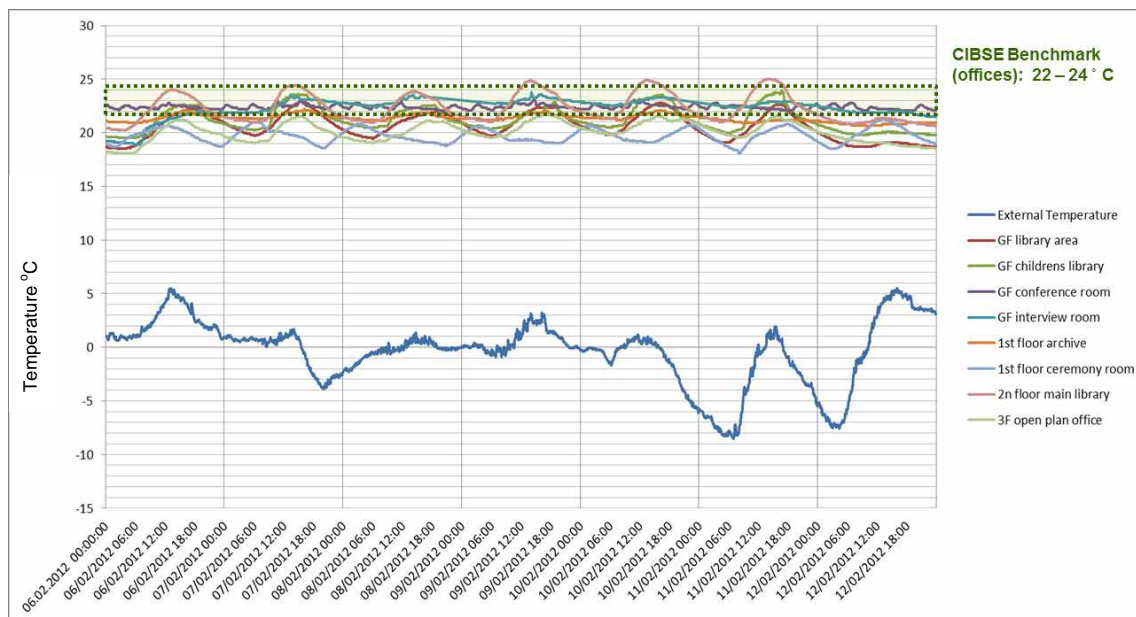
Figure 99 Internal and external temperature levels during a typical winter week (06/02/2012-12/02/2012).

- The external temperature ranges between -8.2 and 5.5°C while internal temperatures lie between 18 and 25°C (Figure 99).
- The ceremony room presents a stable variation pattern between 18 and 21°C. It is noticeable that the mechanical ventilation continues to work during weekends due to ceremonies taking place at that time.
- In the third floor open plan office, the heating is on during Saturday indicating either that some activity is taking place, and the space is occupied, or the heating has been left on.

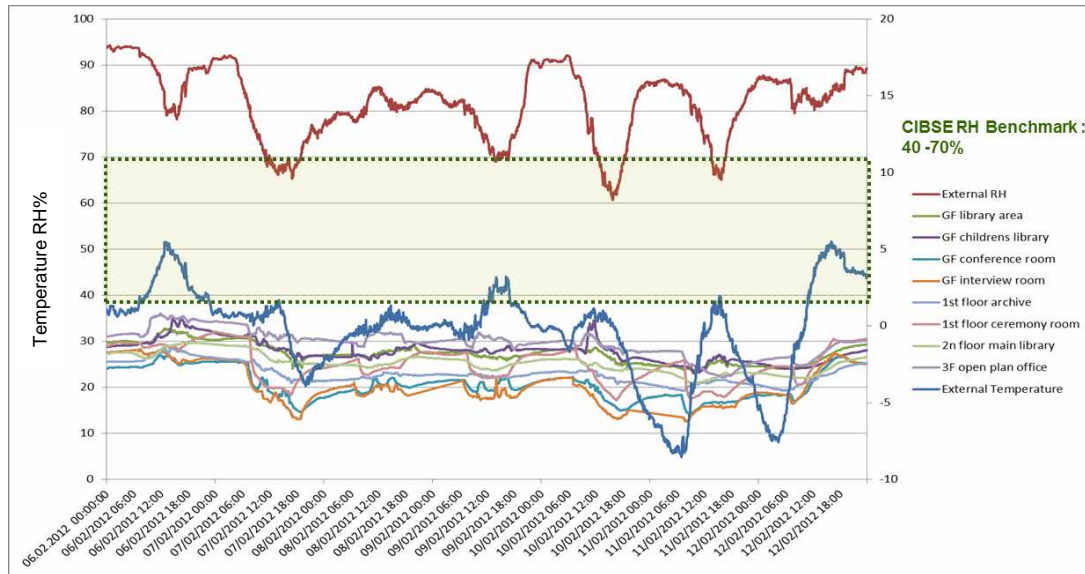
Figure 100 Relative Humidity levels during a typical winter week (06/02/2012-12/02/2012).

- Relative humidity stays mainly under 30%. This can be explained by the very low outdoor temperatures and lack of mechanical ventilation in most of the spaces (Figure 100).
- The conference room, interview room and first floor archive present the lowest values. In this case it has to be noticed that the last two spaces do not have windows so natural ventilation is not possible.

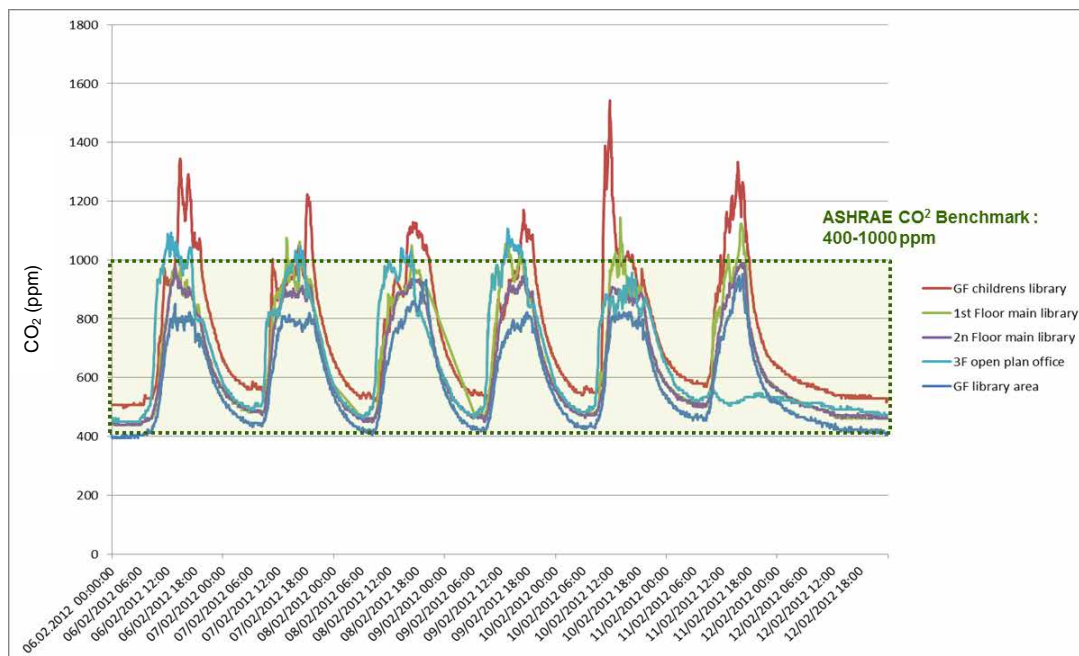
Figure 101 CO<sub>2</sub> levels during a typical winter week (06/02/2012-12/02/2012).

- CO<sub>2</sub> values during the day range between 600ppm and 1,100ppm in most areas (Figure 101).
- In the children's library, the levels are higher, with peaks between 1,300 and 1,500ppm on Monday, Friday and Saturday, which is when the space concurrently has peak occupancy.

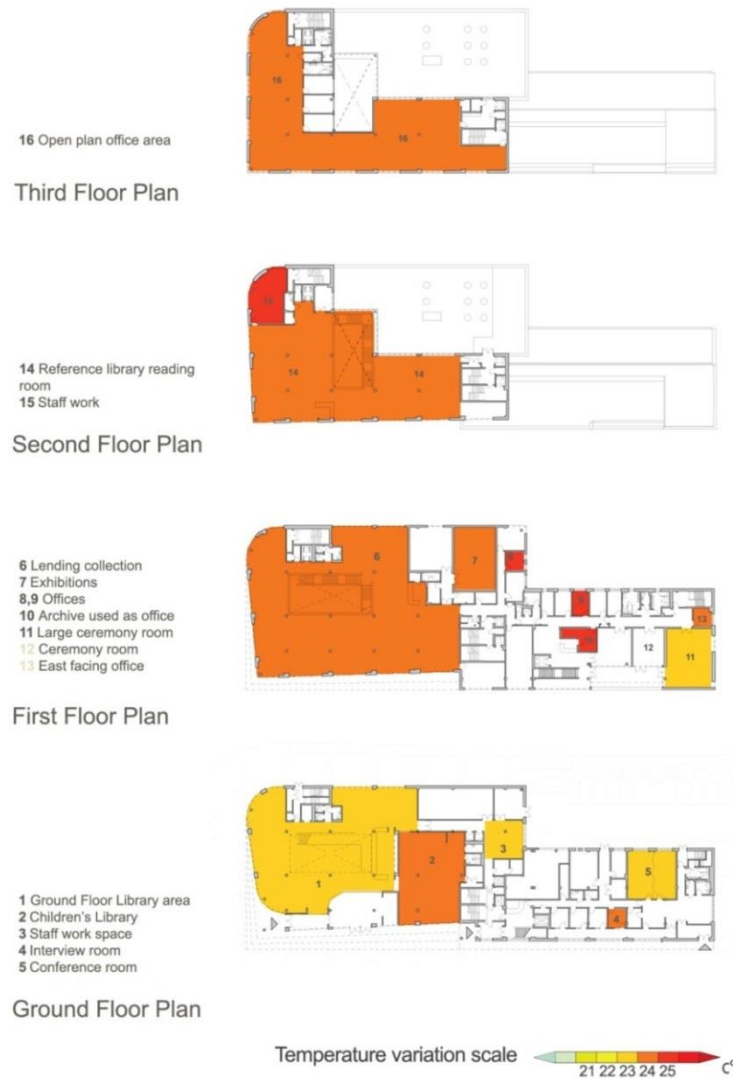
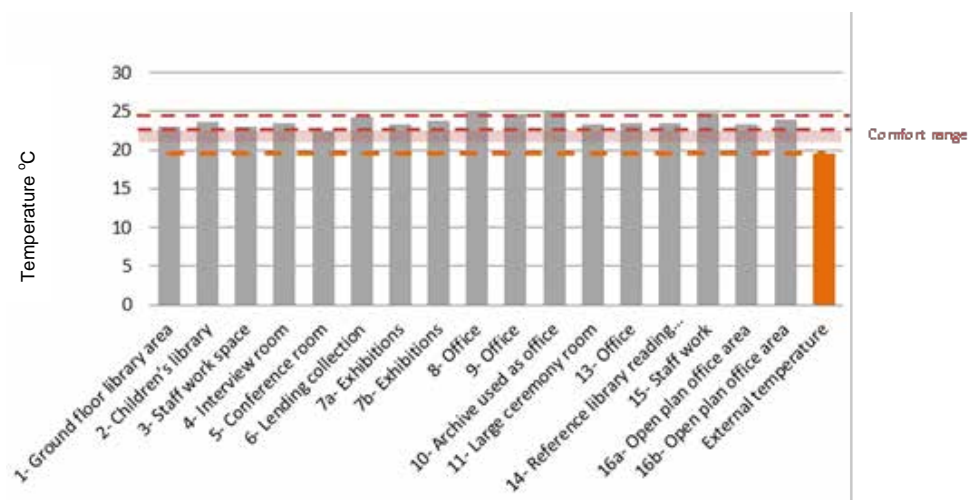
Figure 103 Temperature values in various spaces of the library during the spot check visit.

- The majority of the library spaces were found to have a temperature within the comfort range of 22-24 °C while the external temperature was 19.9 degrees.
- It was noticed that in the first and second floor office spaces the temperature slightly exceeded the 25°C having a temperature difference of 5°C with the external temperature.
- The archive space in the first floor which has been converted into an office, had a temperature of 25.2 °C which combined with a very low humidity of 43% and illuminance levels of 280 lux indicates the unsuitability of the space for its current use.
- A temperature difference of about 2°C was noticed between the ground floor and the upper floors; indicating a slight overheating of the top floors during summer.

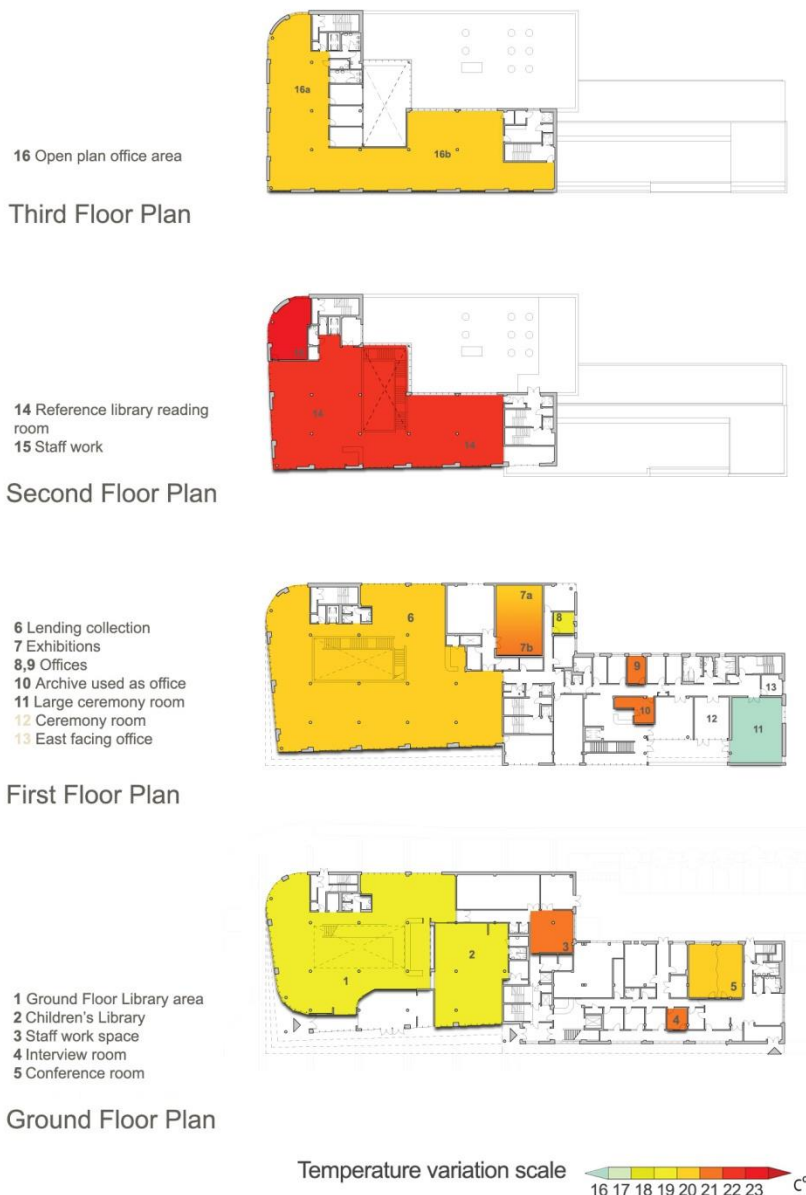
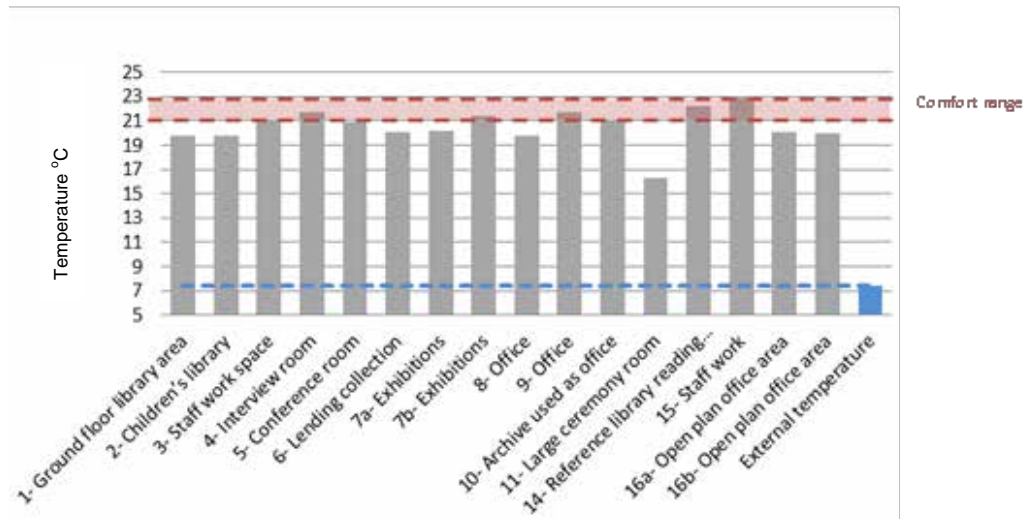
Figure 105 Temperature values in various spaces of the library during the spot check visit.

- The majority of the library spaces were found to have a temperature slightly below the comfort range of 21-23 °C with the library reading space on the second floor being the warmest space with 23°C (Figure 105). All the office spaces presented homogenous temperatures with the exception of the small east facing office on the second floor where the temperature was slightly over 19 °C.

- The coldest room within the building was found to be the large ceremony room where the temperature was below 17 °C. This is explained by the fact that mechanical ventilation is on even during the winter to avoid the room being too warm during the various ceremonies.

- A temperature difference of 1°C between two corners of the exhibition space has been noted explaining the staff remarks of the space being draughty and colder on the one side. This difference is also supported by the infrared photographs of the room revealing a cold bridge on the ceiling on northern side of the room.

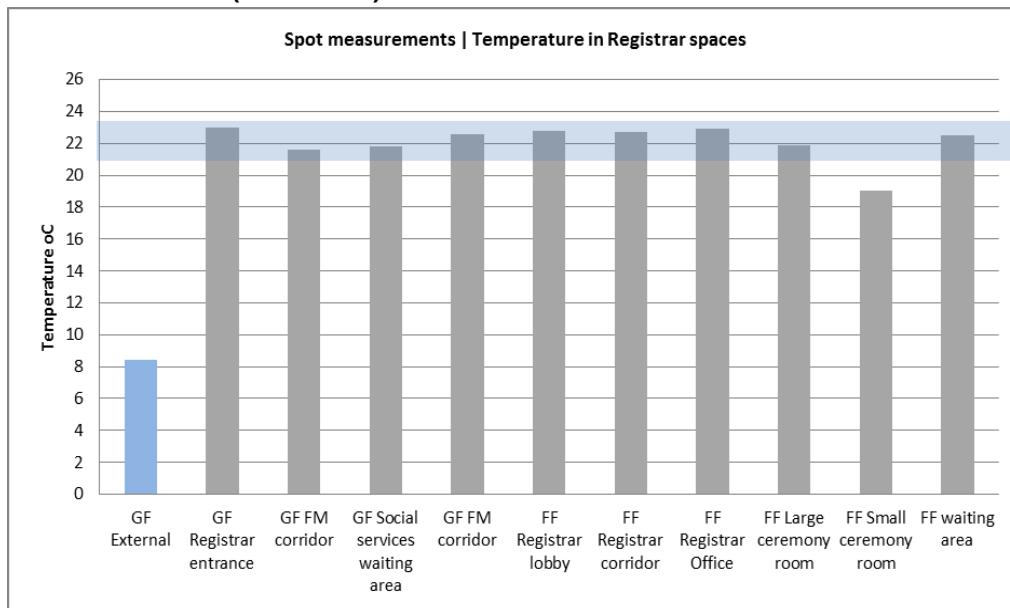
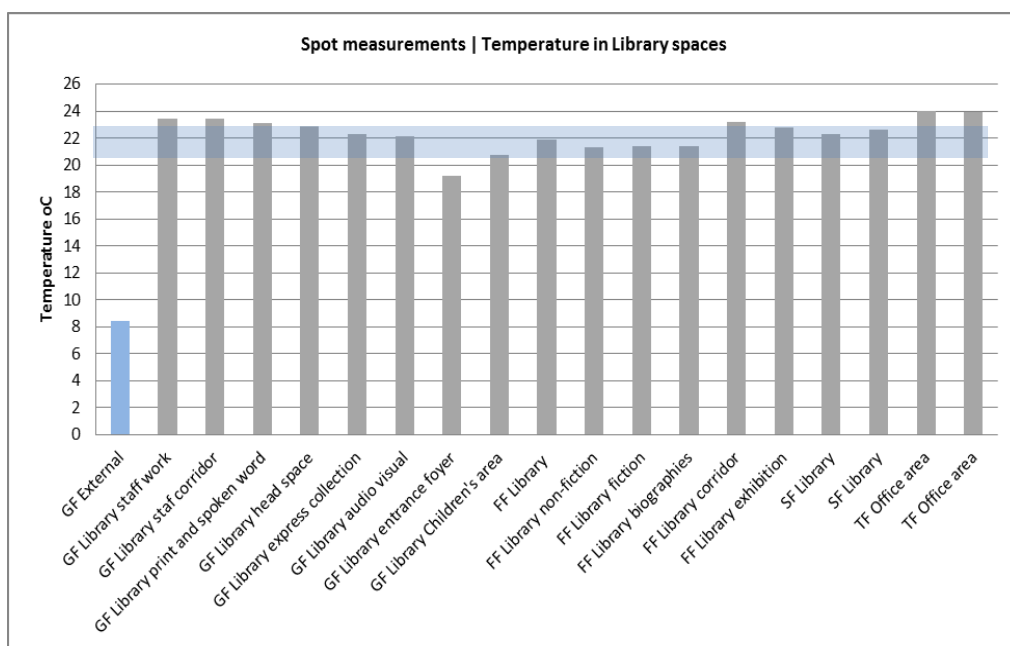
Figure 106 Temperature values in various spaces of the registrar building during the 2<sup>nd</sup> winter spot check visit (11.02.13)

Figure 107 Temperature values in various spaces of the library during the 2<sup>nd</sup> winter spot check visit (11.02.13)

- The majority of the library spaces were found to have a temperature within the comfort range of 21-23 °C with the office space on the third floor being the warmest space with 24 °C. All the office spaces presented homogenous temperatures.
- The coldest room within the building was found to be the first floor large ceremony room where the temperature was below 19 °C. This is explained by the fact that cooling is on even during the winter to avoid the room being too warm during the various ceremonies. However, cooling remains on all the time irrespective of the event schedule and the use of the room because there is not individual switch in the room to adjust or turn it off but is set on as a default.

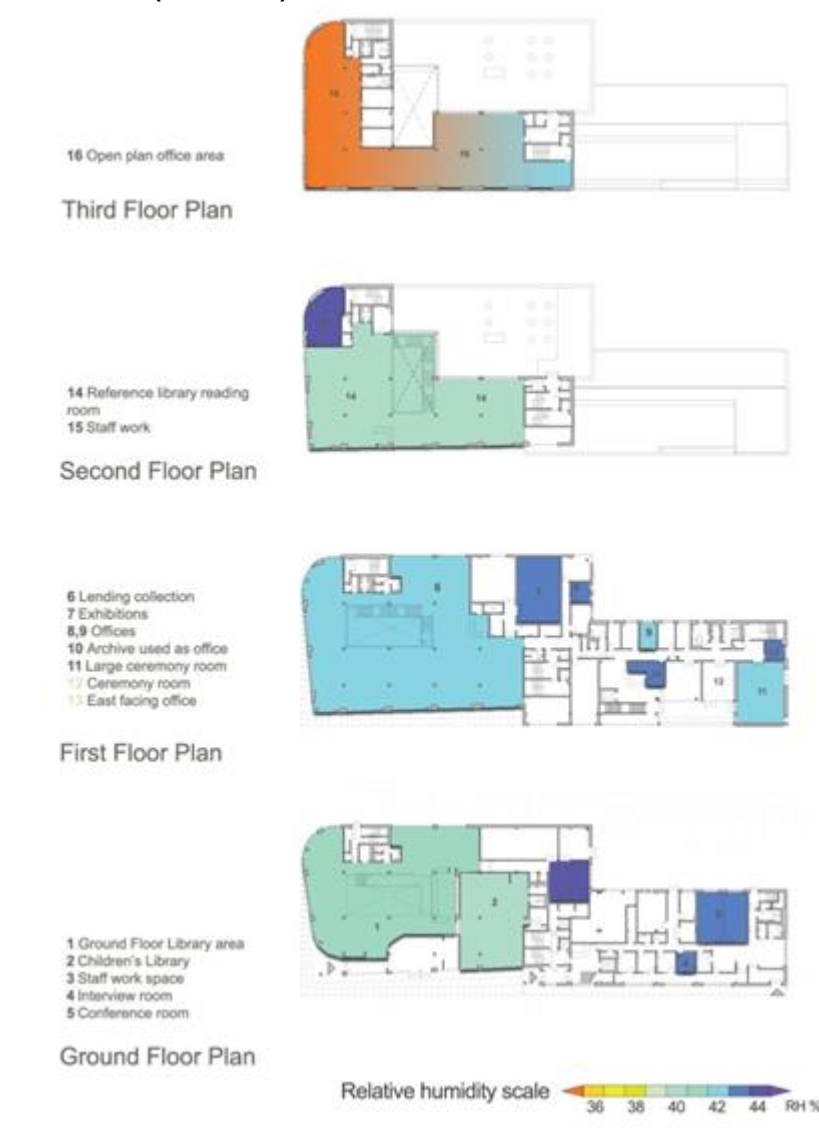
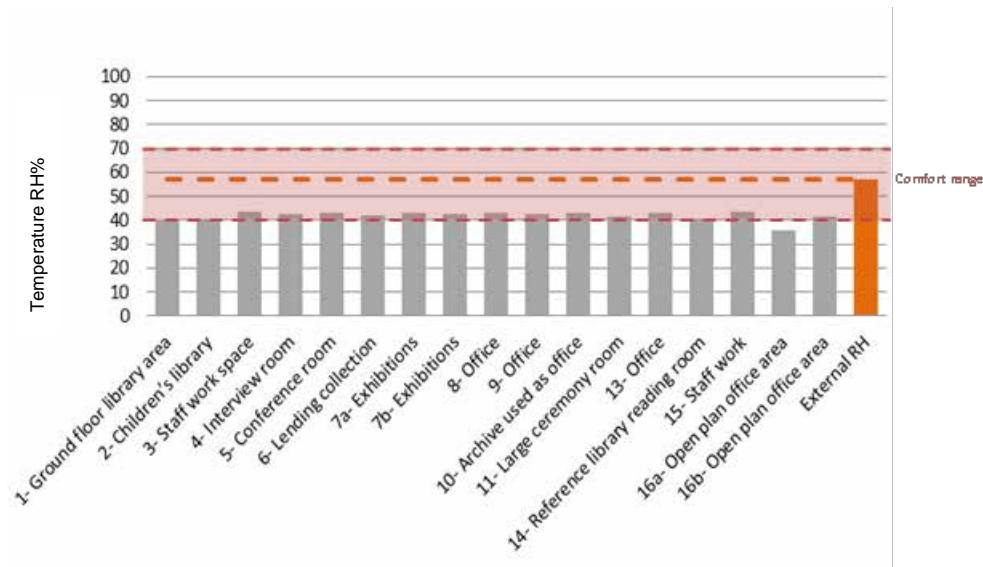
Figure 108 Floor plan with relative humidity coloured levels during the summer spot check visit.

Figure 109 Relative humidity values in various spaces of the library during the summer spot check visit.

- Humidity levels for most of the spaces were fluctuating between 35.8% and 43.8% slightly below the external rate that was 57%. The range is considered as normal for a typical summer day of 20°C.
- The lowest value was detected on the east side of the open plan office area on the third floor where it was 35.8% in comparison with the 41.7% on the north side, possibly due to more windows being open in this area at the time, bringing in moist external air and less direct sunlight available.

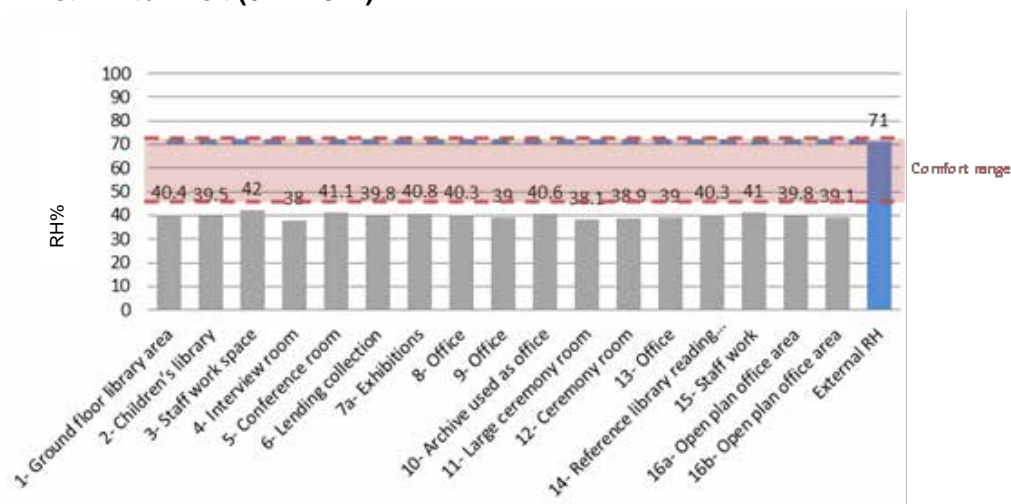
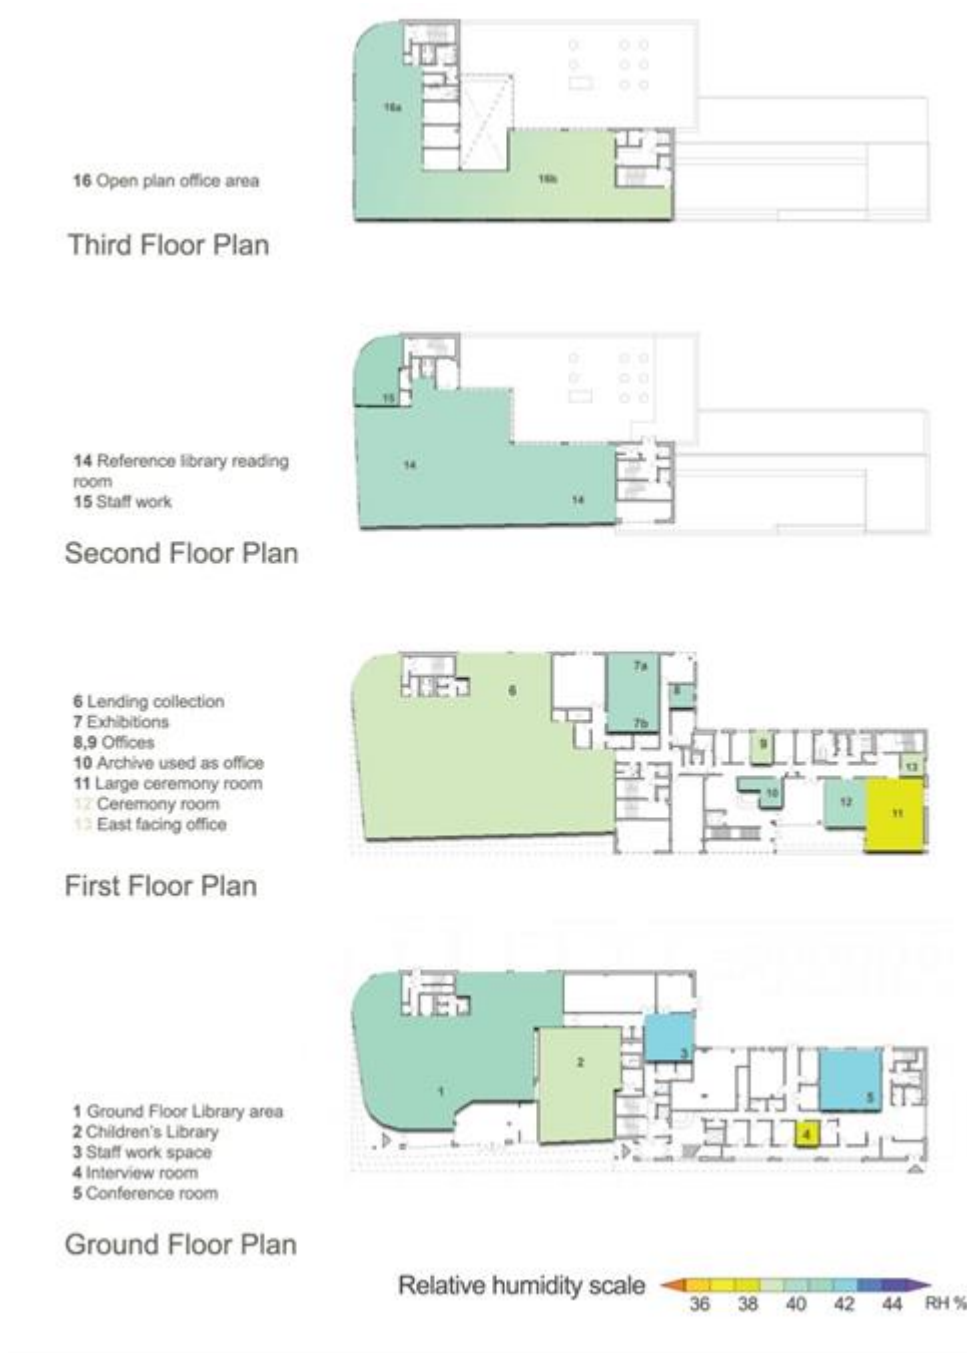
Figure 110 Relative humidity values in various spaces of the library during the spot check visit.

Figure 111 Floor plan with relative humidity coloured levels during the winter spot check visit.

- The building seemed to have normal humidity levels during the winter visit, with %RH ranging between 38% and 42%; significantly lower than the external RH measurement of 71%. This can be explained by the use of heating inside the building and the windows being closed almost all of the time.
- The lowest value was detected in the interview room on the ground floor and the ceremony spaces on the first floor. Although the difference with the rest of the spaces is minor, in the case of the interview room this can be explained by the fact that the space has no windows so fresh air can come only through the corridors. The low humidity levels in the large ceremony room are most likely due to the increased air movement caused by the mechanical ventilation. The mechanical ventilation was designed to prevent overheating in the summer by providing fresh air when the

occupancy increases during a ceremony. However, it is still in operation in the winter, even when the space is unoccupied. This is the most likely cause of the measured low temperatures and low humidity levels. There are no controls for this mechanical ventilation within the room.

- There is an indirect correlation between humidity and internal temperature. It was found that although the second floor recorded the maximum temperatures, the humidity levels at 40.3% are comfortable and higher than other less hot spaces. This could be due to windows being opened occasionally allowing fresh moist external air to enter. It may also demonstrate that the heating system optimally operates without drying out the air.

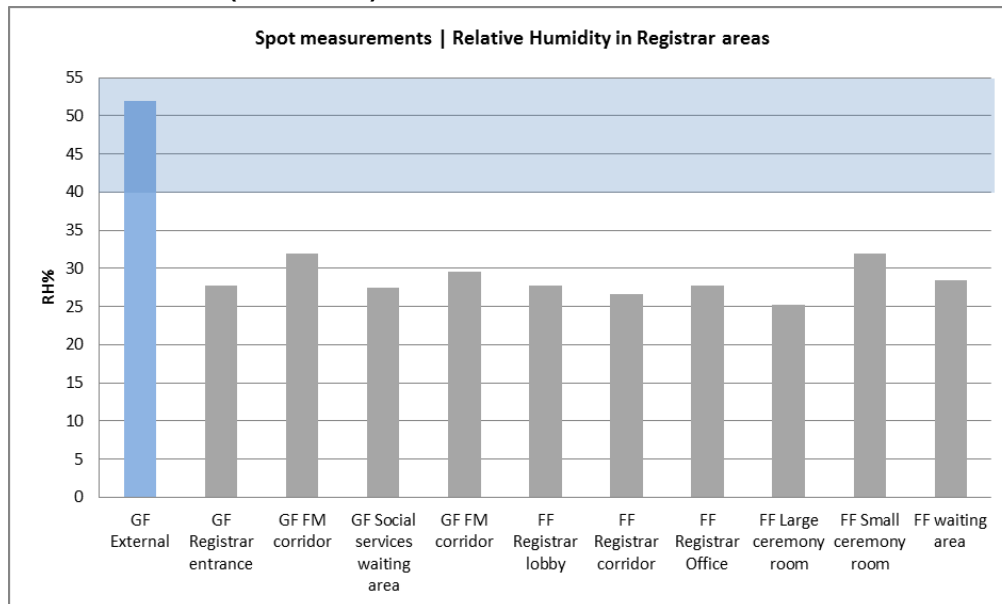
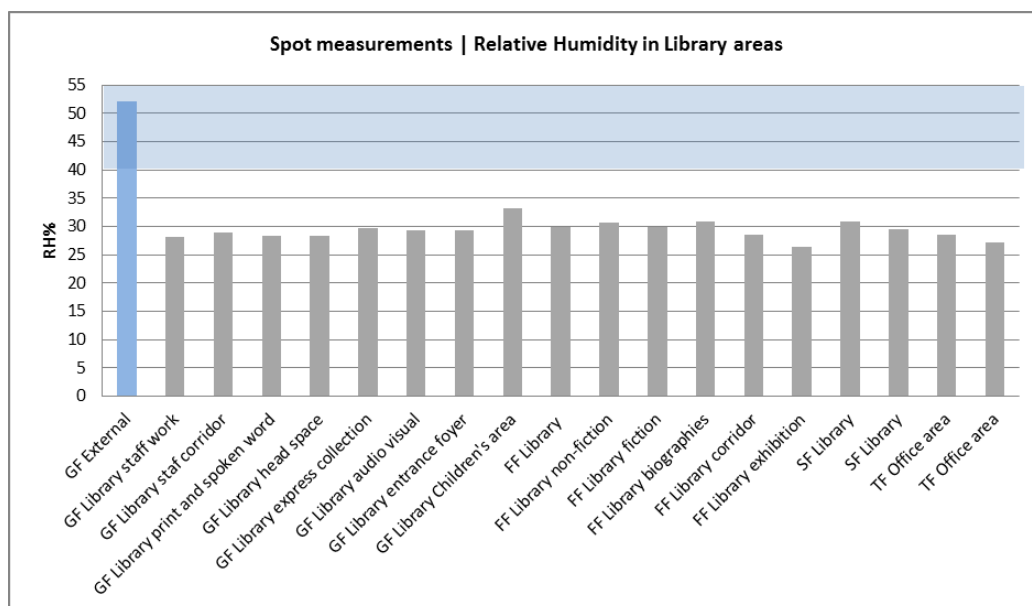
Figure 112 Relative humidity values in various spaces of the Registrar building during the 2<sup>nd</sup> winter spot check visit (11.02.13)

Figure 113 Relative humidity values in various spaces of the library during the 2<sup>nd</sup> winter spot check visit (11.02.13)

- The building seemed to have low humidity levels during the second winter visit, with values ranging between 27%RH and 31%RH; significantly lower than the external 52%RH. This can be explained by the use of heating inside the building and the windows being closed almost all the time.

- As in the first winter visit the lowest value was detected in the ceremony spaces on the first floor. The low humidity levels in the large ceremony room are most likely due to the increased air movement caused by the mechanical ventilation. The mechanical ventilation was designed to prevent overheating in the summer by providing fresh air when the occupancy increases during a ceremony. However, it is still in operation in the winter, even when the space is unoccupied. This is the most likely cause of the measured low temperatures and low humidity levels. There are no controls for this mechanical ventilation within the room.

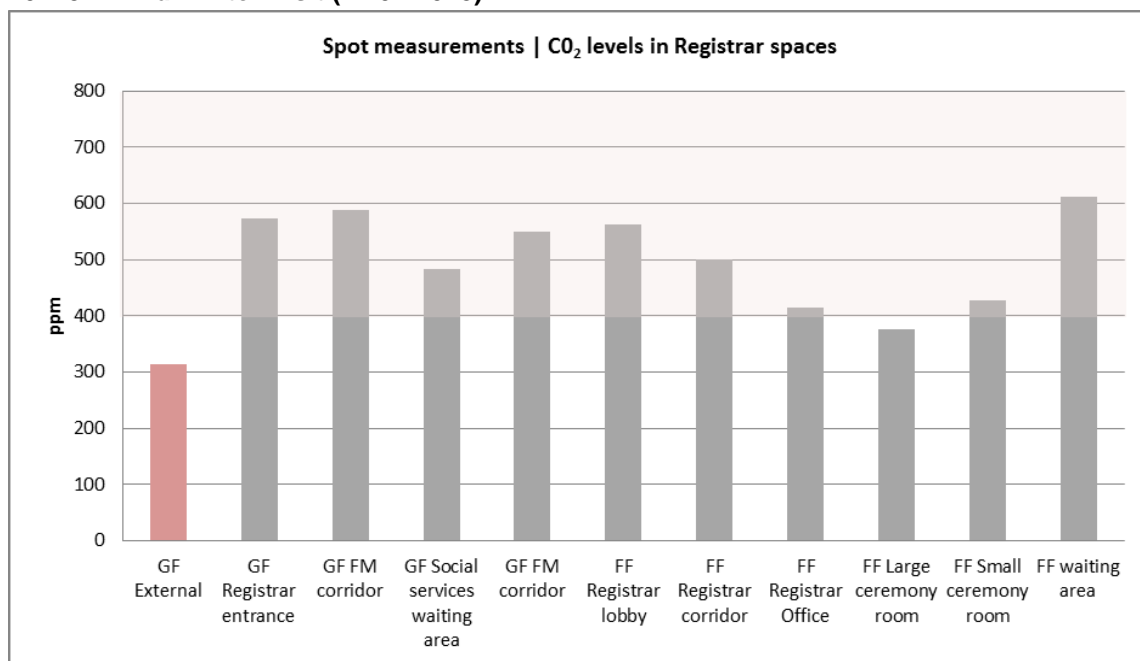
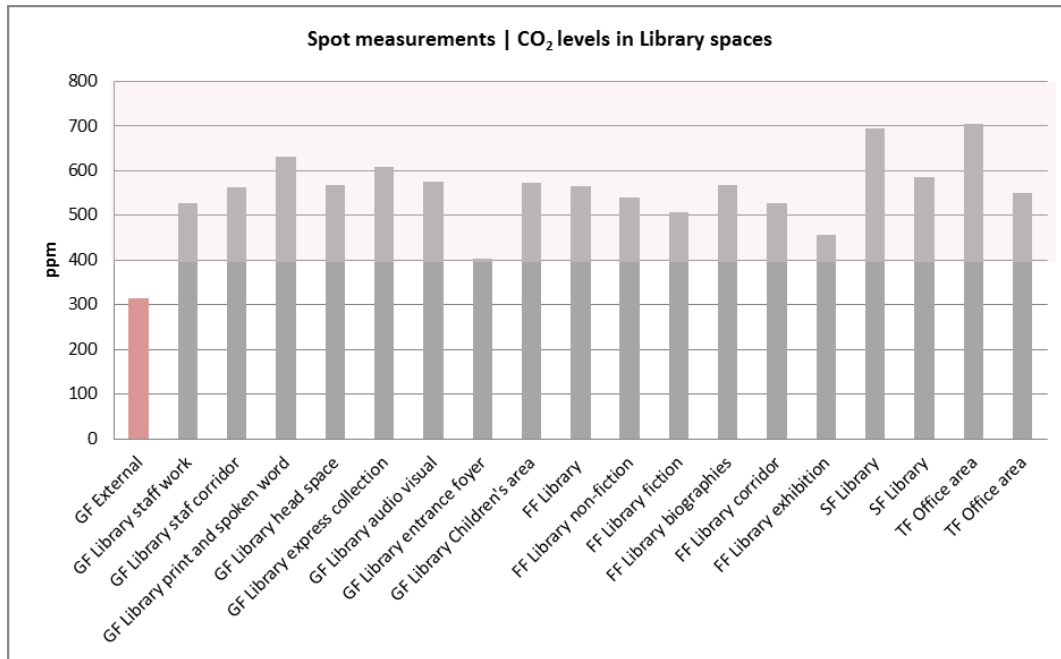
Figure 114 CO<sub>2</sub> values in various spaces of the Registrar building during the 2<sup>nd</sup> winter spot check visit (11.02.13)

Figure 115 CO<sub>2</sub> values in various spaces of the library during the 2<sup>nd</sup> winter spot check visit (11.02.13)

- The CO<sub>2</sub> levels in most spaces range between 400 to 600ppm. Higher values were only measured in the second floor of the Library and in the third floor offices.
- The lowest values were recorded in the Register Services areas and the ceremony rooms, which were empty during the measurements.
- During the measurement the spaces were occupied but not many visitors were in the Library. The office areas were half occupied that day. Windows were closed in all spaces.

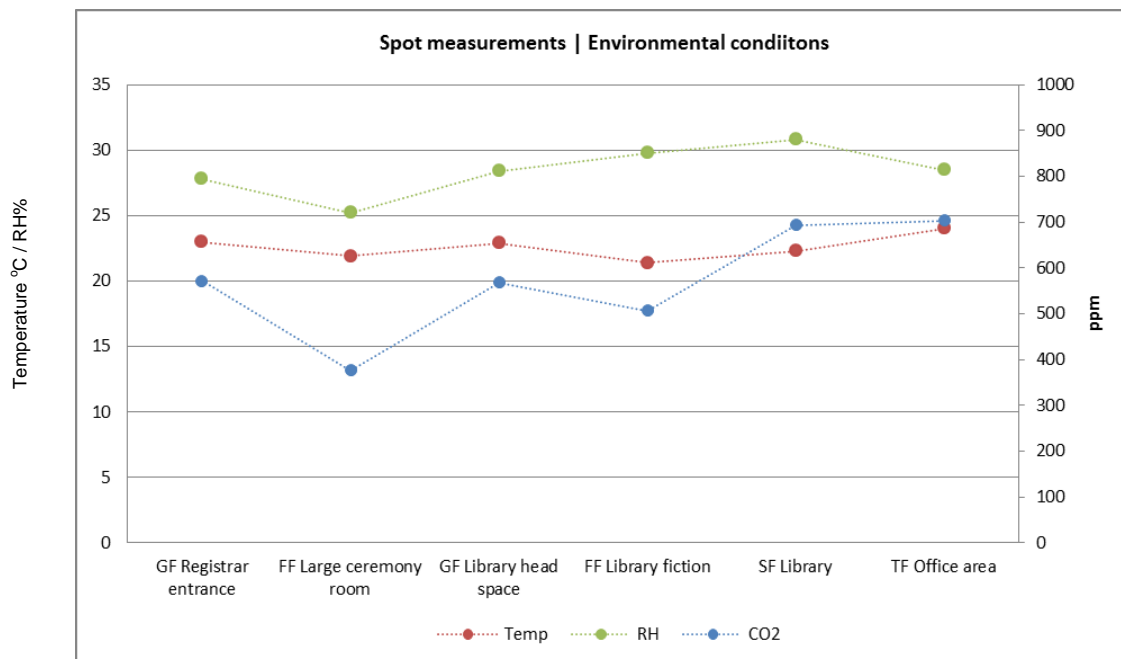
Figure 116 Temperature, Relative Humidity and CO<sub>2</sub> levels in various spaces of the building during the 2<sup>nd</sup> winter spot check visit (11.02.13)

Most spaces present similar environmental conditions. Figure 116 shows a comparison of key spaces of the library. Temperatures are quite homogeneous throughout the Library but RH and CO<sub>2</sub> levels vary. The Lowest RH levels were measured in the large Ceremony room possibly due to the mechanical ventilation. The highest temperatures were recorded in the 2<sup>nd</sup> floor of the Library as a result of the warm air rising up through the atrium. The highest CO<sub>2</sub> levels were recorded in the 3<sup>rd</sup> floor office area which is highly occupied.

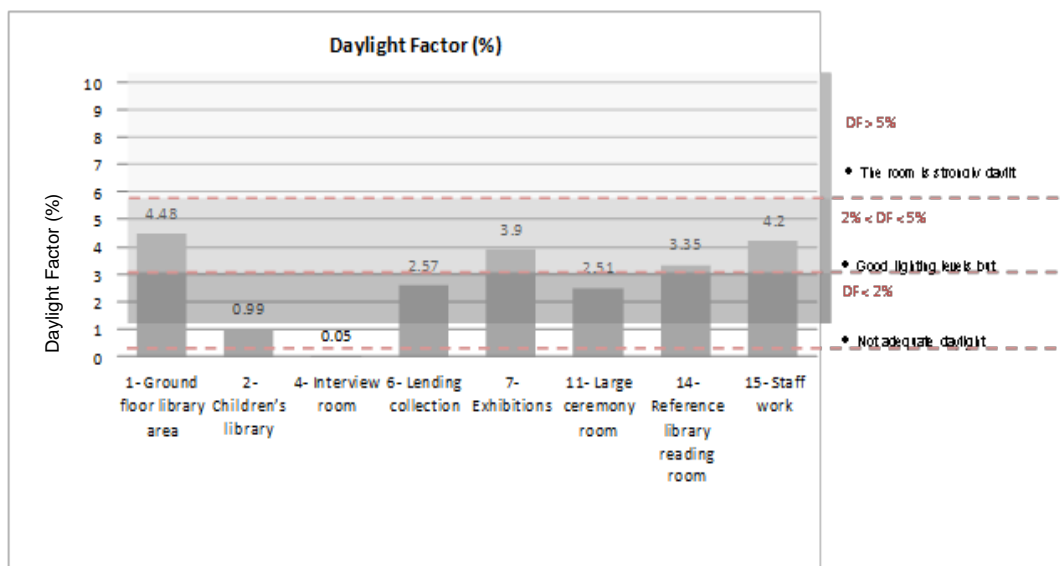
In the building, wide variations in light levels (up to 750 lux) between the areas closest to windows and the interior areas in the same room were observed (Figure 117).

Figure 117 Illuminance level values in various spaces of the library during the spot check visit

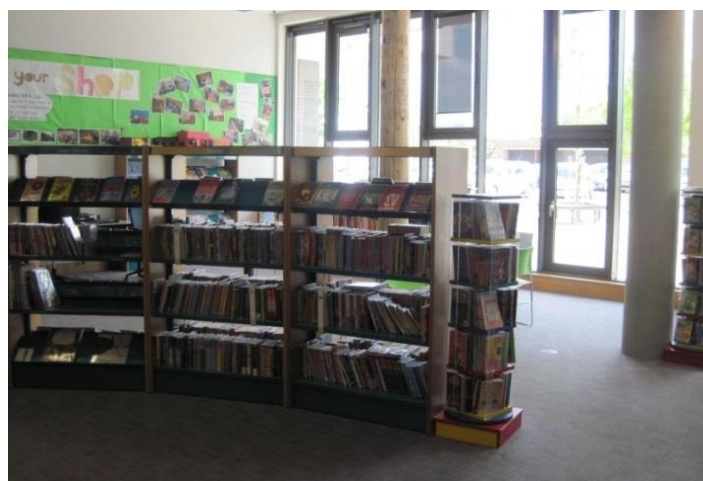
Figure 118 Children's library space. Blinds are up but light levels decrease behind the book stalls.

- The ground floor reception area and children's library were found to have significantly low lux levels and required artificial lighting despite an exterior lux level of 5,200 lux. Daylight factors in the children's library are as low as 0.1 and the current furniture arrangement further decreases the amount of light reaching interior spaces.
