# Crawley Library

<b>Innovate UK project number</b>	450003
<b>Project lead and author</b>	Low Carbon Building Group, Oxford Brookes University for West Sussex County Council
<b>Report date</b>	2014
<b>InnovateUK Evaluator</b>	Peter Tse (Contact via <a href="http://www.bpe-specialists.org.uk">www.bpe-specialists.org.uk</a> )

<b>Building sector</b>	<b>Location</b>	<b>Form of contract</b>	<b>Opened</b>
Public library	Crawley Library	Design and build	2008
<b>Floor area (GIA)</b>	<b>Storeys</b>	<b>EPC / DEC 2010</b>	<b>BREEAM rating</b>
4,468 m <sup>2</sup>	4	A (25) / D (90)	Very good

Phase 2 of the Technology Strategy Board (TSB) funded Building Performance Evaluation (BPE) project is designed to evaluate the in-use condition of Crawley Library.

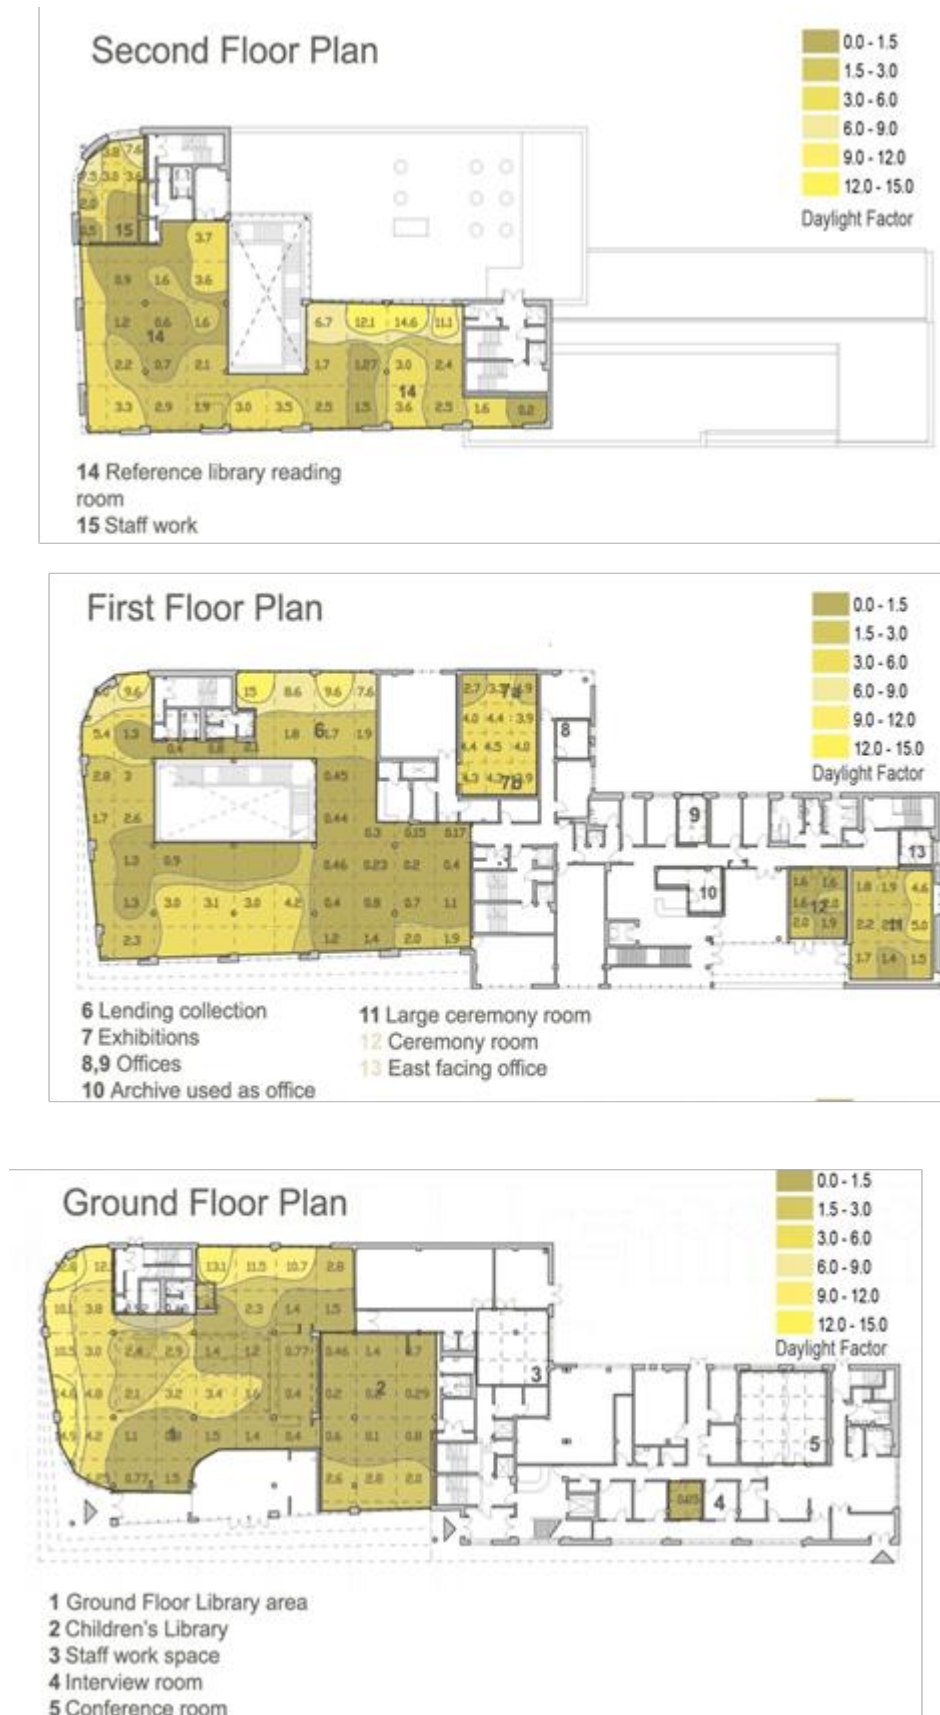
Figure 119 Floor plans with daylight factor levels during the spot check visit.

- The ground floor reception area and children's library were found to have significantly low lux levels and required artificial lighting despite an exterior lux level of 5,200 lux. Daylight factors in the children's library are as low as 0.1 and the current furniture arrangement further decreases the amount of light reaching interior spaces.

- The interview room on the ground floor received almost no natural light in cloudy overcast conditions with a DF of 0.5%.
- Furniture arrangement around the GF lending collection reception area reduced the daylighting levels to 0.4-0.7%.

- Daylighting levels in the first floor exhibition space were uniform and bright due to the skylights on the ceiling. The average electric lighting level was 583 lux. The offices were found to have slightly low lighting levels but it was noted that the blinds were down and the electric lighting on.

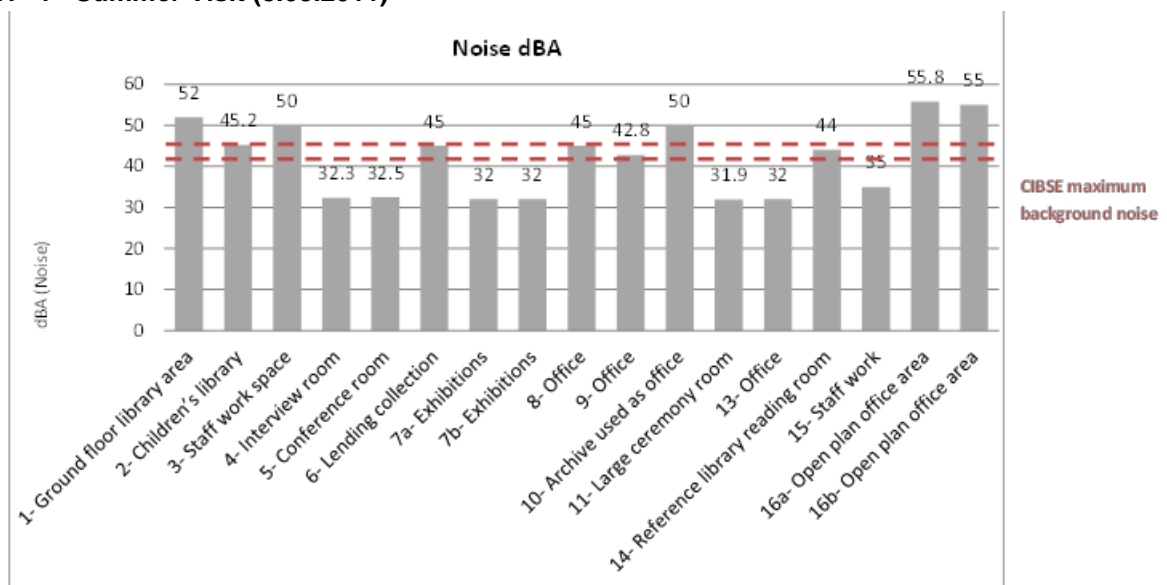
Figure 121 Noise level values in various spaces of the library during the spot check visit

- The noise levels were slightly high in general throughout the most of the building spaces. It was noticed that the windows were open in most of the spaces and traffic noise contributed to the higher dBA levels.
- The highest dBA levels were recorded in the open plan office area. It should be noted that the offices were occupied when the measurements were taken.

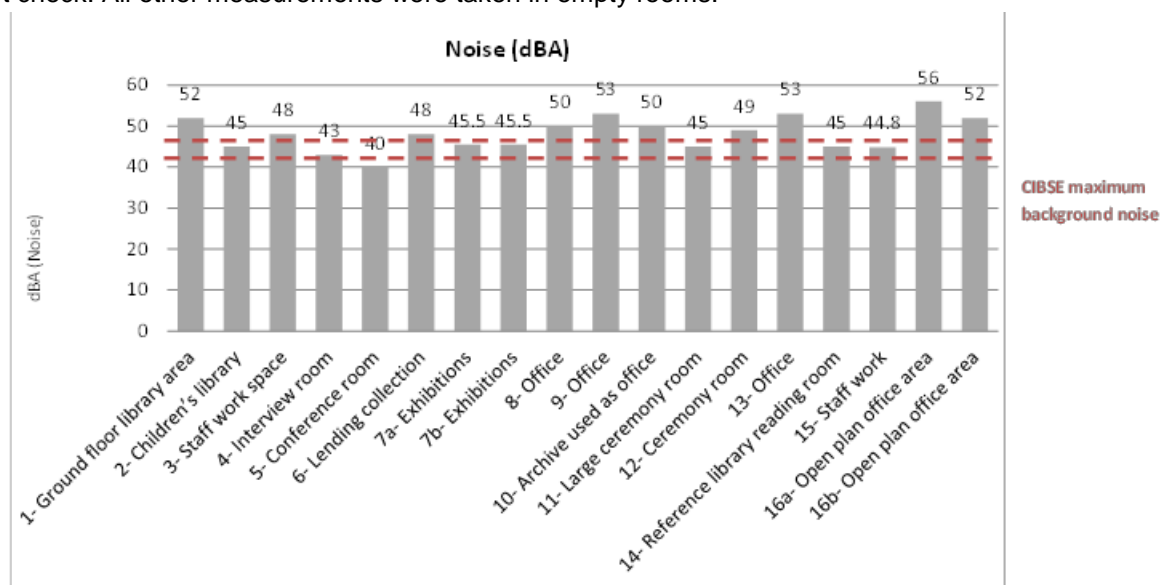
Figure 123 Noise level values in various spaces of the library during the spot check visit.

The high sound levels in the ground floor library, first floor offices and ceremony room, second floor reference room, third floor office could be attributed to the fact that the spaces were occupied during the spot check. All other measurements were taken in empty rooms.

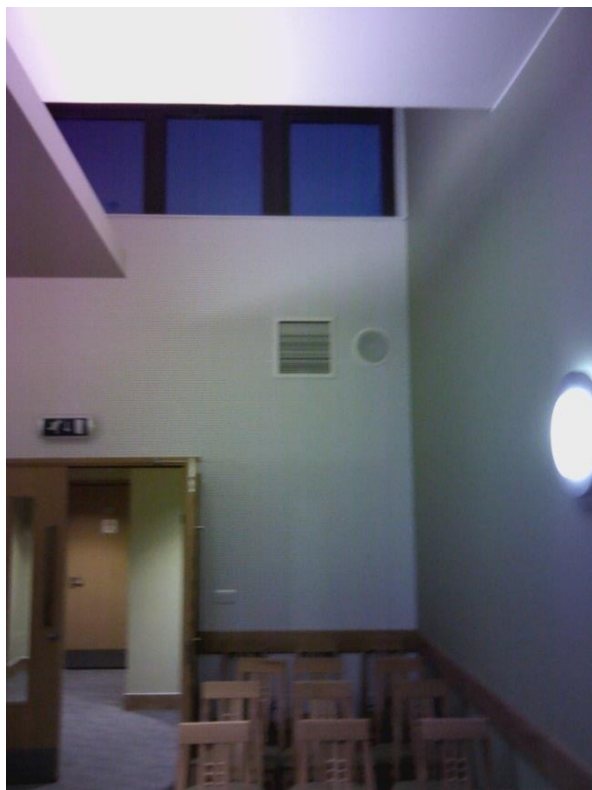
Figure 129 Large ceremony room thermogram. An irregular cold air fringe is dropping from the top windows indicating a cold bridge due to the geometrical elements or lack of insulation on that place. Cooling is on in as in the first ceremony without the rooms being occupied.

- Thermograms revealed heating and cooling being on in unoccupied spaces (e.g. interview spaces, ceremony room). This shows poor control of heating and cooling system leading to unintended energy losses.
- Clerestory windows in the atrium, windows of both ceremony rooms and conference room appear to not be properly sealed, which can lead to cold air draughts entering the building.
- The exhibition space, conference room and ceremony room were found to have cold bridges possibly due to discontinuous insulation/material.

- Thermal bridging due to geometry or insulation/material inconsistencies needs to be discussed with the project architects to further indicate the causes and identify the actions that may need to be taken in order to minimise this effect.
- Facilities management need to have better control of heating and cooling over unoccupied spaces especially the two ceremony rooms. Staff should also be incentivised to turn off the heating when they plan to leave a room.

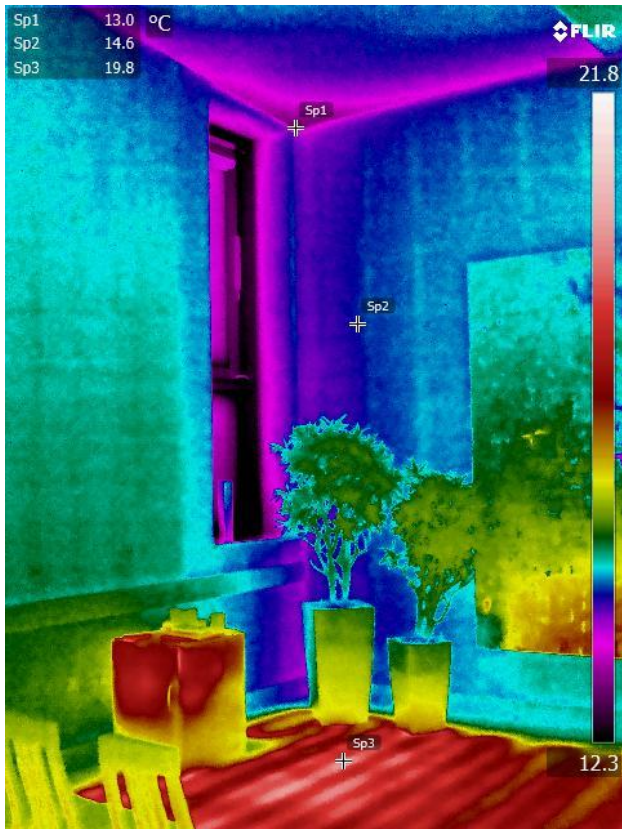
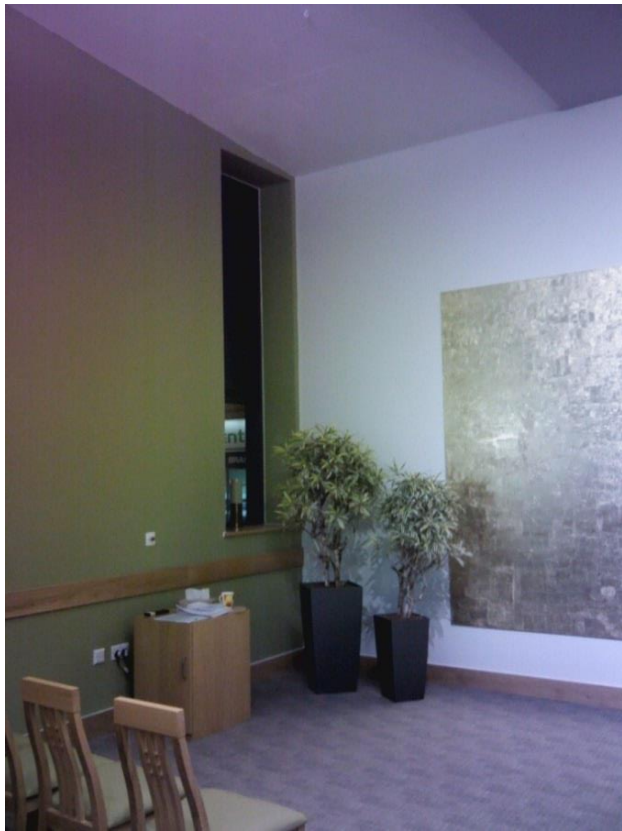
Measurements	°C
Sp1	13.0
Sp2	14.6
Sp3	19.8
Parameters	
Emissivity:	0.95
Refl. Apparent temp:	20 °C
Room temperature:	17.5 °C

Figure 130 Large ceremony room thermogram. A cold bridge probably due to geometry of building elements can be identified in the room corner.

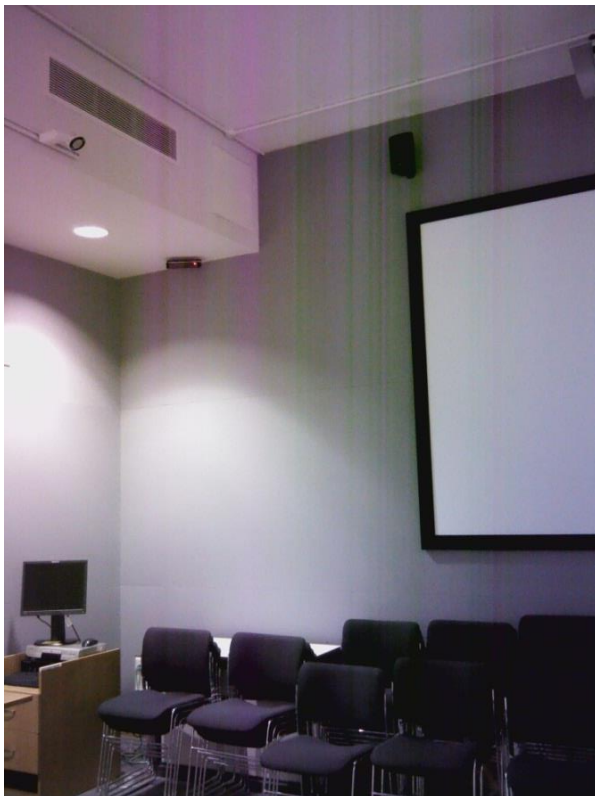
Measurements	°C
Sp1	20.8
Sp2	17.3
Sp3	19.6
Parameters	
Emissivity:	0.86
Refl. Apparent temp:	20 °C
Room temperature:	20.7 °C

Figure 133 Exhibition room thermogram. The cold bridge on the junction of wall and ceiling is obvious indicating material inconsistency on that part of the roof. Cooling is also on in the room with cold air blowing through the ventilation grilles.

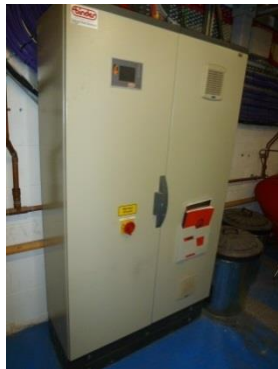
#### Biomass boiler control panel

The biomass boiler control panel is located in the externally accessible plant room. The purpose of the panel is not immediately obvious as there is no clear labelling of what it is. User manual can be found on the lid of the panel. The control is quite complex and only to be programmed and operated by experts. The facilities manager of the building is not very familiar with the control panel. Faults appear quite often as the biomass boiler needs frequent maintenance. The biomass boiler is also connected to the BMS system.

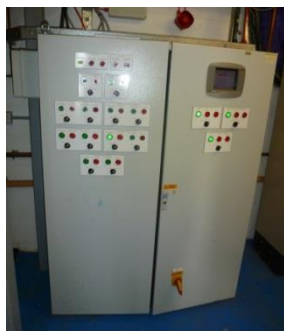
#### BMS control panel

Although the purpose of the trend logging facility is clear, occupants are not familiar with it and do not know how to use it. It appears that the BMS system is not properly connected to the sub-meters. The facilities manager is not qualified to operate the logging facility and has not received training. It should be noted that the BMS system is working though it has not been properly commissioned. The computers that have access to the BMS logging facility are located in the facilities manager office and are easily accessible.

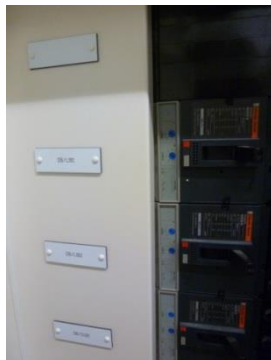
### Electrical sub-meters \_ Switches

Their purpose is clear but it is not clear what each sub-meter is connected to. Existing labelling is not good enough as it uses codes to indicate what each sub-meter is measuring without providing information what these codes actually stand for. Sub-meters are easily accessible in the ground floor of the registrar area next to the facilities manager office.

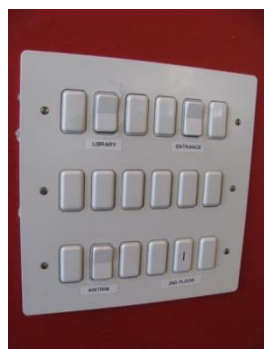
### Lights in Library area

Criteria	Poor	Excellent
Clarity of purpose		
Intuitive switching		
Usefulness of labelling & annotation		
Ease of use		
Indication of system response		
Degree of fine control		
Accessibility		
<b>Comments</b>		
Three switches located in the receptionist area control the Library, Entrance and Atrium lights respectively. These are switched on by members of staff in the morning and are switched off after the Library closes in the afternoon. They are easily accessible, easy and intuitive to use.

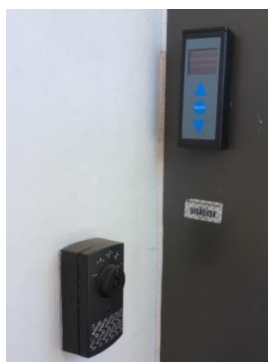
#### Main entrance automatic doors

These controls are located next to each of the main entrance automatic doors (three in total). Their purpose is not clear at all and user needs to be experienced in order to use them. They are poorly labelled and not very easy to use. User needs to be shown how to operate them. Additional instructions would be useful. They offer several modes to operate the automatic doors providing a good level of fine control.
