# Cross Lane Development

<b>Innovate UK project number</b>	450021
<b>Project author</b>	Sheffield Hallam University
<b>Report date</b>	2012
<b>InnovateUK Evaluator</b>	Fionn Stevenson (Contact via <a href="http://www.bpe-specialists.org.uk">www.bpe-specialists.org.uk</a> )

<b>No of dwellings</b> 22 properties: 18 tenanted, 4 in shared ownership*	<b>Location</b> Royston, Barnsley	<b>Type</b> 2 detached, 20 semi-detached*	<b>Constructed</b> 2011
<b>Area</b> 82 - 120 m <sup>2</sup>	<b>Construction form</b> Timber frame	<b>Space heating target</b> N/A	<b>Certification level</b> CSH Level 4

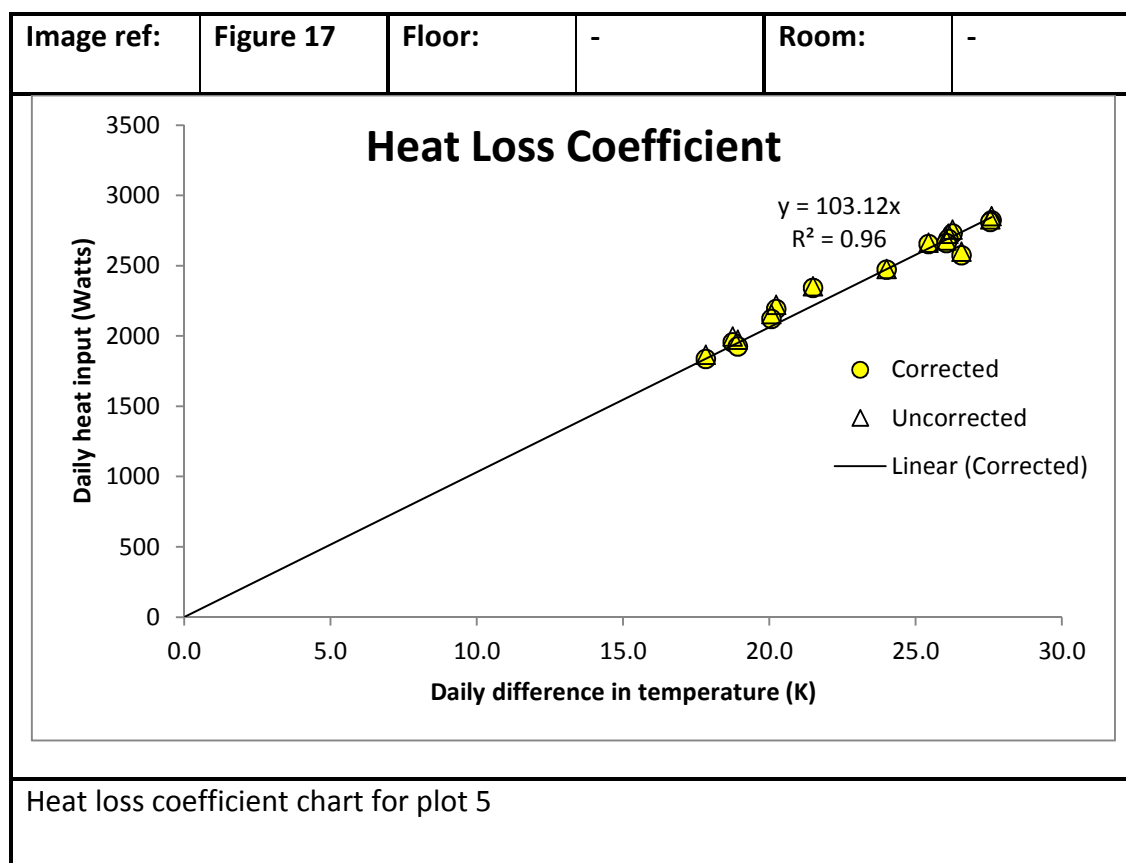
The heat loss coefficient, which is a plot of the daily heat input (in Watts) to the dwelling against the daily difference in temperature between the inside and outside, is given in Figure 17. This was obtained from the co-heating test (Section 3.1) and the coefficient is attributable to heat loss through the building fabric and background ventilation. The slope of the plot gives the heat loss coefficient in W/K, in this case, 103.12 W/K and is corrected for wind speed and solar gain. However, it is clear to see from the plot that these environmental conditions have a negligible effect on the heat loss coefficient, the average

daily wind speed throughout the test period was only 0.94 m/s, the daily solar flux averaged 91 W/m<sup>2</sup> (building is a timber frame with a low thermal mass so these results are unsurprising).

The as-designed SAP gives a heat loss coefficient of 107.41 W/K but when reviewed using in-situ data, the heat loss coefficient only slightly increases to 108.58 W/K, a negligible difference between the two. The difference was mainly due to a slightly higher post-test air pressure tests - see Section 3.5. However, due to the strong correlation of the co-heating data presented in Figure 17 (see also Section 3.5), if it is assumed that the as-built heat loss coefficient of 103.12 W/K is the correct value then by a trial and error process, a  $\gamma$  value of 0.05 in addition to using the in-situ  $u$  values would yield a SAP heat loss coefficient close to the measured value. However, the SAP rating would stay at 93.

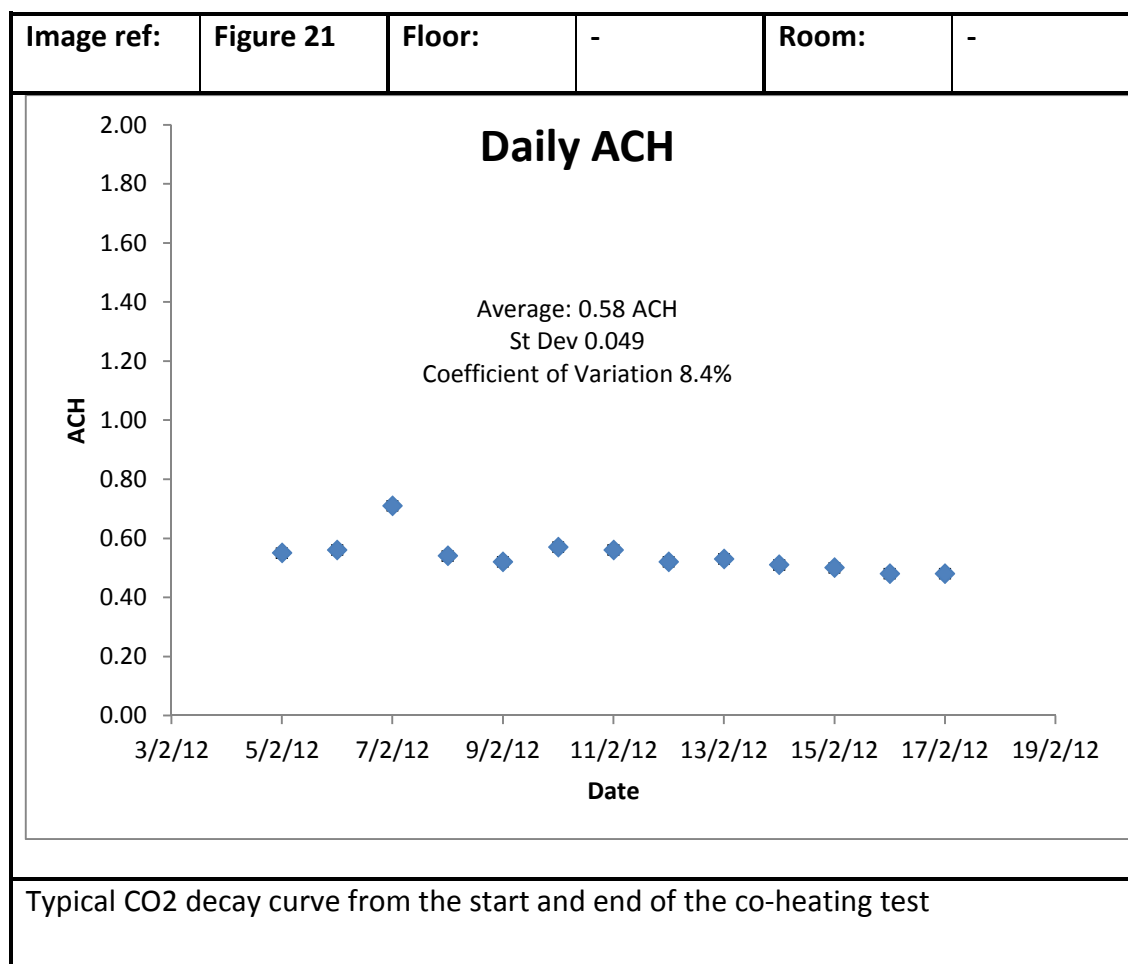
Using the recommendations given by Roulet and Foradini<sup>2</sup>, the number of air changes per hour (ACH) is estimated from the tracer gas decay curves (as shown in Figure 20. Note: the normalised concentration equation given in p41 of the paper<sup>2</sup> is incorrect, it should read  $C_N = (C(t) - C_o) / (C(0) - C_o)$ , confirmed with the author, June 2012). The daily ACH values are plotted in date order as shown in Figure 21 and show that the average ACH is 0.58 with a standard deviation of 0.049 (coefficient of variation 8.4% which is within research parameters). It is unclear why the ACH for 7/2/12 is higher than the rest of the data (0.71), the heat loss coefficient for this day is actually lower than on other days tested although  $\Delta T$  was at its highest (as will be shown in Figure 22). The base CO<sub>2</sub> was also higher throughout the night (462ppm) when the average was 426ppm. Further research is required, it may simply be due to equipment or transmission of data. If this value was omitted from the analysis, the ACH would drop marginally to 0.57. Apart from the rogue reading on 7/2/12, the statistical analysis suggests quite a high level of confidence can be placed on the results of the co-heating test (Figure 17) as there appears to be no significant changes/defects arising to the building during the rest of the testing period.

The effective air change rate given in the SAP analysis is 0.64 for February so the air change rates are slightly lower in practice compared to as-designed. It is possible that even greater accuracy could be gained by increasing the amount of CO<sub>2</sub> tracer gas to cover a 24 hour period as opposed to a period covering 'office hours' as described above, but this would have the disadvantage of not having measured base CO<sub>2</sub> levels for use in the calculations and would also require entry to the sealed property if a 10l gas cylinder was used.

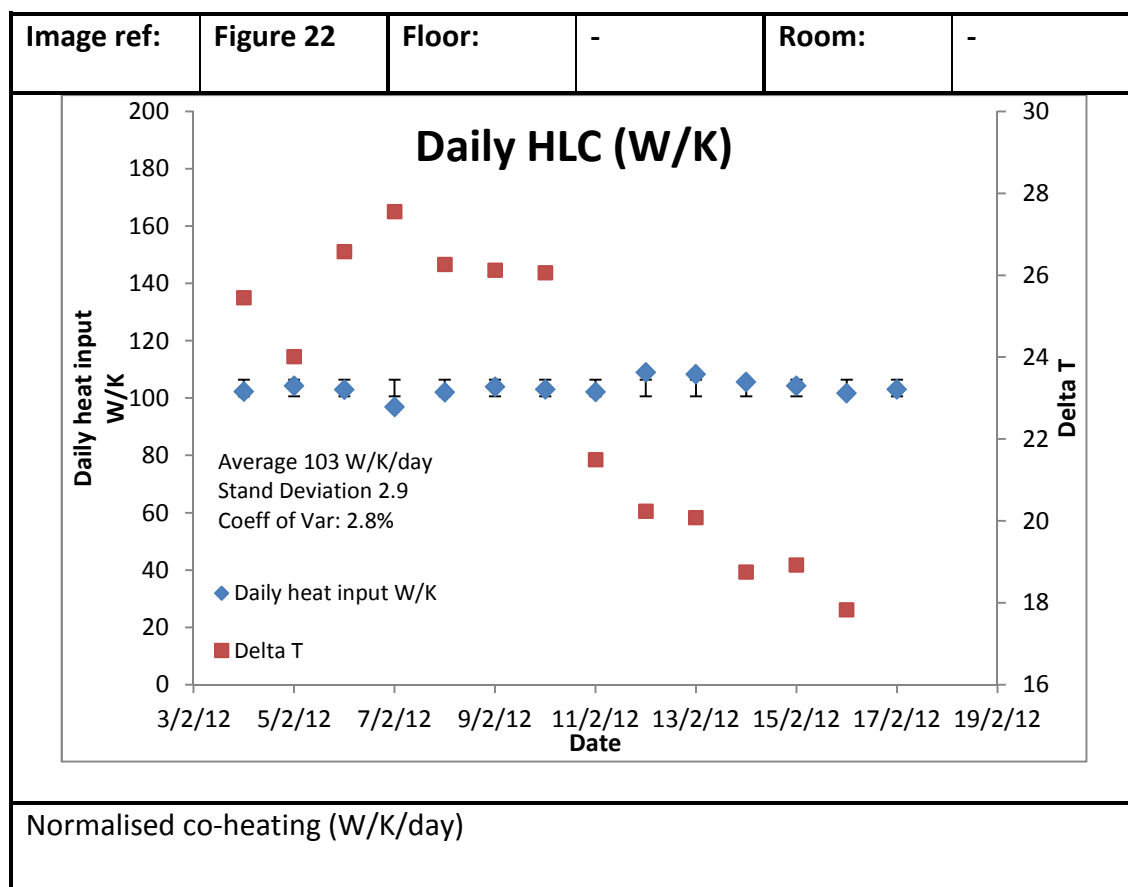
The second piece of information to validate the co-heating test is based on normalising the co-heating data to determine if significant changes have taken place in the building during the course of the co-heating test. This is presented in Figure 22, where the corrected daily heat input/K is plotted in chronological order (standard deviation error bars also included). The difference between internal and external temperature ( $\Delta T$ ) during this period is also given and range from 27.6°C to 17.8°C. The lowest value (97 W/K) is recorded on 7/2/12 but this coincided with the largest  $\Delta T$  as was discussed in the previous paragraph so it is unclear why this occurred.

The resulting plot is, nevertheless, quite linear meaning that the building is consuming a similar amount of energy on a daily basis across the two week test period, 103 W/K (standard deviation 2.9 which corresponds to a coefficient of variation of 2.8%). This value naturally corresponds to the heat loss coefficient as shown in Figure 17. This plot and statistical analysis again indicates that the building has not suffered any significant changes or defects during the co-heating tests and despite the lateness in conducting the second air pressure test, the heat loss coefficient (Figure 17) can be relied upon.

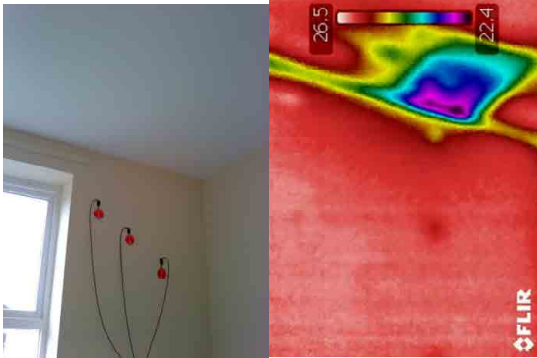
Image ref:	Figure 25	Floor:	First	Room:	1

<p>The figure consists of two side-by-side images. On the left is a standard color photograph of a bedroom wall. A window is visible on the left side of the frame. Three red electrical outlets are mounted on the wall. On the right is a corresponding thermal image from a FLIR camera. It shows the same wall area with a color scale indicating temperature. The scale ranges from 20.2 (red) to 26.5 (blue). A significant cold spot (blue/purple) is visible near the top of the wall, corresponding to the window area. The FLIR logo is in the bottom right corner of the thermal image.</p>					
Photo and thermal image of bedroom 1 east wall

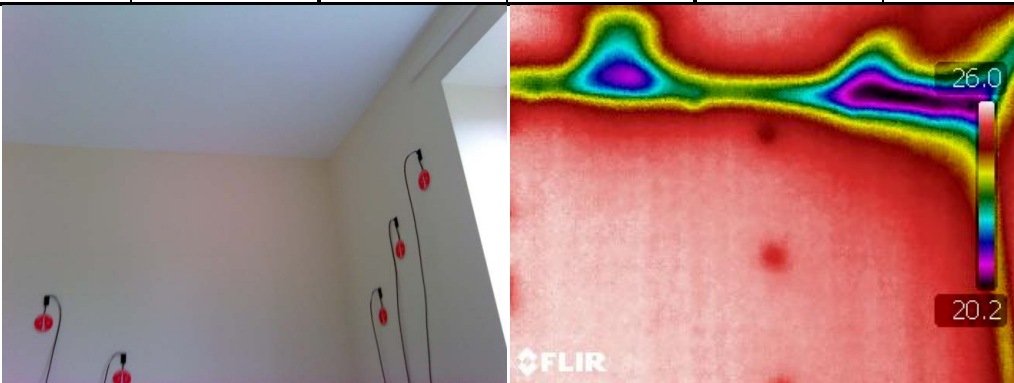
Image ref:	Figure 26	Floor:	First	Room:	3

Figure 28, it is clear from the internal thermal images that the roof detail has a bearing on heat loss. The pitch of the roof is such that it is impossible to get 400mm of insulation at eaves level - see Figure 31. This was also highlighted by the developer in the walkthrough survey and is something they want to rectify in future developments. Construction details at the eaves/valley junction are given in Figure 32 and Figure 33. The ground floor/wall junctions were also monitored using the thermal camera but no heat loss was evident (images were not recorded).

<p>The figure consists of two side-by-side images. On the left is a standard color photograph of a bedroom wall. Three red electrical outlets are mounted on the wall. On the right is a corresponding thermal image from a FLIR camera. It shows the same wall area with a color scale indicating temperature. The scale ranges from 20.2 (red) to 26.0 (blue). A cold spot (blue/purple) is visible near the top of the wall. The FLIR logo is in the bottom left corner of the thermal image.</p>					
Photo and thermal image of bedroom 3 south/east wall

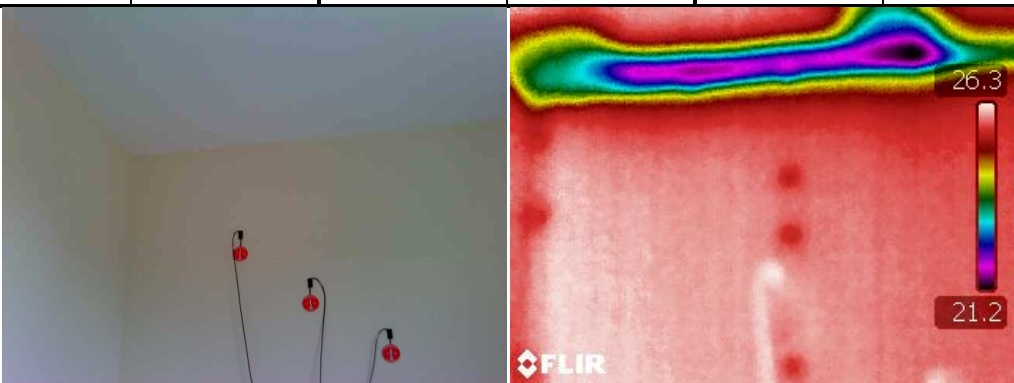
Image ref:	Figure 27	Floor:	First	Room:	3

<p>The figure consists of two side-by-side images. On the left is a standard color photograph of a bedroom wall. Three red electrical outlets are mounted on the wall. On the right is a corresponding thermal image from a FLIR camera. It shows the same wall area with a color scale indicating temperature. The scale ranges from 21.2 (red) to 26.3 (blue). A cold spot (blue/purple) is visible near the top of the wall. The FLIR logo is in the bottom left corner of the thermal image.</p>					
Photo and thermal image of bedroom 3 west wall

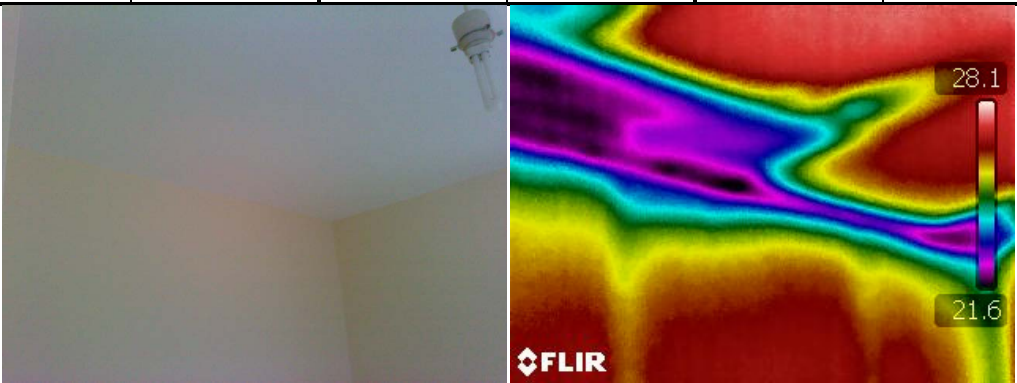
Image ref:	Figure 28	Floor:	First	Room:	Landing

Photo and thermal image of landing south wall

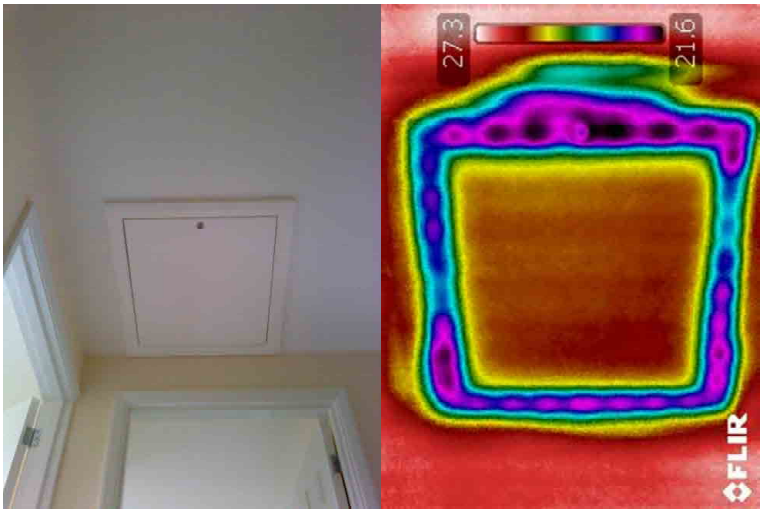
Image ref:	Figure 29	Floor:	First	Room:	Landing

Photo and thermal image of roof space hatch

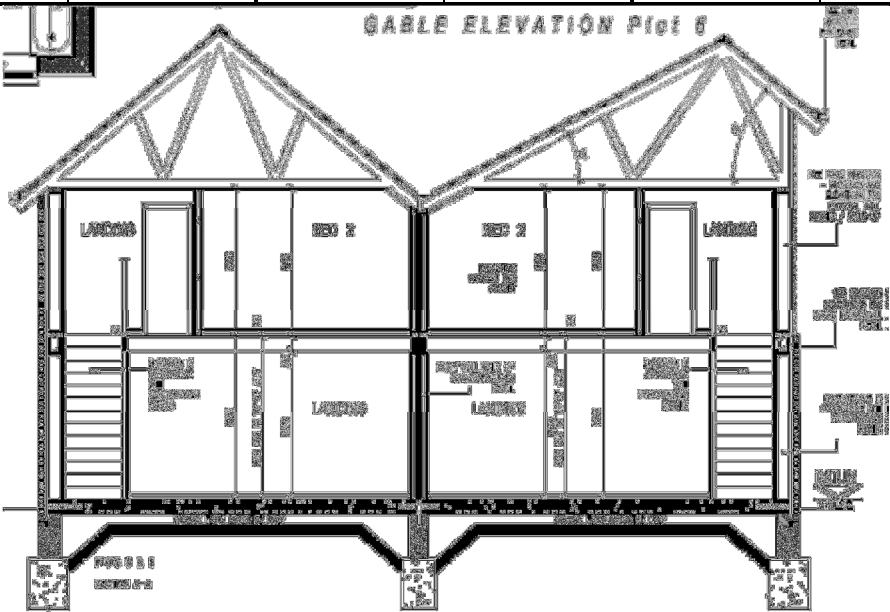
Image ref:	Figure 31	Floor:	-	Room:	-

<p>The diagram is a cross-section of a two-story building, labeled 'GABLE ELEVATION PLOT 6' at the top. It shows the internal structure, including rooms labeled 'BED 2', 'LIVING', and 'KITCHEN'. The drawing includes structural details like roof trusses, walls, and stairs. The section is shown for two adjacent plots, 5 and 6.</p>					
Section through plots 5 (left) and 6 (right)

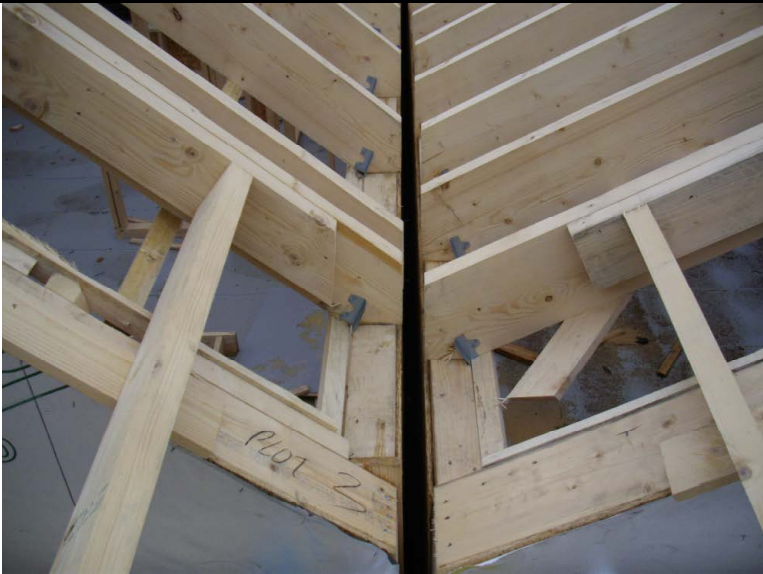
Image ref:	Figure 32	Floor:	-	Room:	-

<p>A photograph showing the internal wooden framework of a roof at a valley. The structure consists of numerous light-colored wooden beams and joists. A diagonal brace is visible on the left side, and a horizontal beam is labeled 'Plot 2' in handwritten text. The roof is supported by a concrete base.</p>					
Roof construction detail at valley

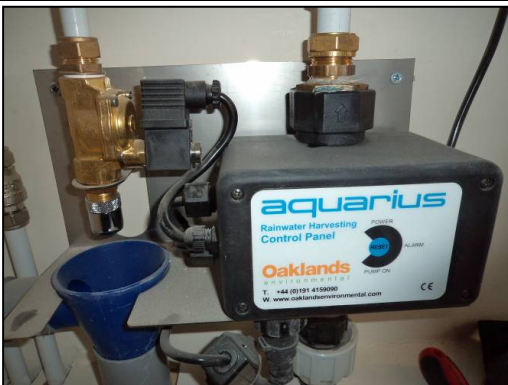
<b>Image ref:</b>	<b>Figure 46</b>	<b>Floor:</b>	-	<b>Room:</b>	-

- It is recommended that SYHA continue to use approved contractors in all future RWH system installations.
- The standard of installation was very high. For example, Figure 46 shows a close up of the mains back-up. Note that the outlet from the mains back-up finishes above the tundish. This is helped by the good design of the support bracket that keeps the solenoid and the tundish apart. However it would still be possible to install the mains back-up so it does

not conform to the Water Regulations. Using Oakland's own plumbers to install the system ensured that the Water Regulations were not contravened.

Close up of the mains back-up

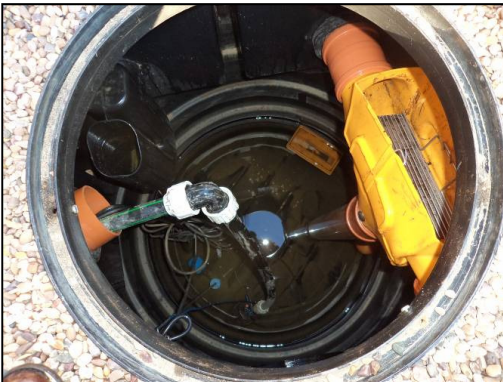
<b>Image ref:</b>	<b>Figure 47</b>	<b>Floor:</b>	-	<b>Room:</b>	-

- A comprehensive overview of the rainwater harvesting system was conducted at one property which was working very well at the time of the site visit. Figure 47 shows the insides of the rainwater storage tank.

- The 110mm ducting (carrying black hose with green marking to denote non potable/recycled water supply and electrical connections) can be clearly seen.
- Cables are neat and tidy and are not unduly stressed

View inside rainwater storage tank

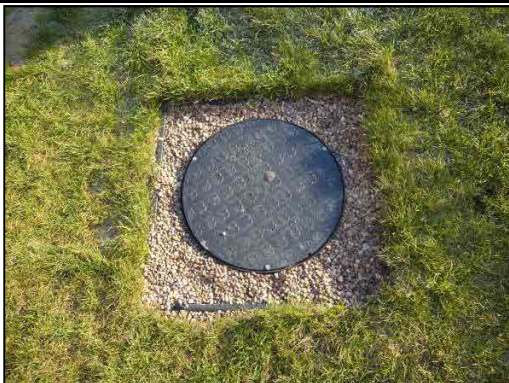
<b>Image ref:</b>	<b>Figure 48</b>	<b>Floor:</b>	-	<b>Room:</b>	-

- The pump is upright and the floating filter is securely attached.
- The tank access cover is housed in a tray which is filled with pea shingle. (Figure 48) This is a good design detail as it means that when accessing the tank only pea shingle (as opposed to earth) is likely to be kicked into the tank, ensuring that the quality of the stored rainwater is not impaired. It also makes it less likely that run-off from the surrounding ground seeps into the rainwater storage tank.
- There was no evidence of air in the pump (a common fault with poorly installed or poorly commissioned RWH systems.)

Tank cover

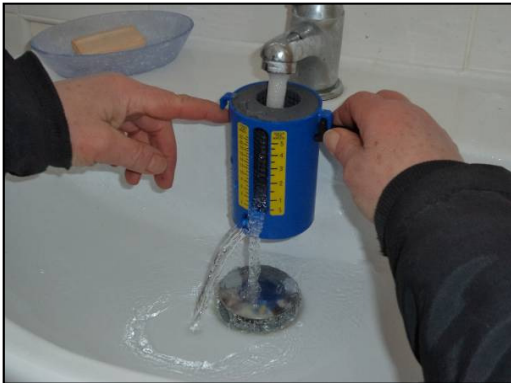
Image ref:	Figure 50	Floor:	Ground	Room:	Bathroom

- The flow rate at the basin tap in the bathroom was 5.5 litres/min for the cold and 4.5 litres/min for the hot, averaging a 100% greater flow rate than specified (Figure 50).
- It was not possible to access the kitchen sink to check flow rates there, but from discussion with the tenants they, too, are greater than specified.
- The shower is a Mira Sport electric shower. Subsequent research showed this was rated at 9.8 kW, and that the flow rate from the shower at 35°C is 4.5 litres/min (as opposed to 4.03 as specified).

Checking flow rate at wash basin

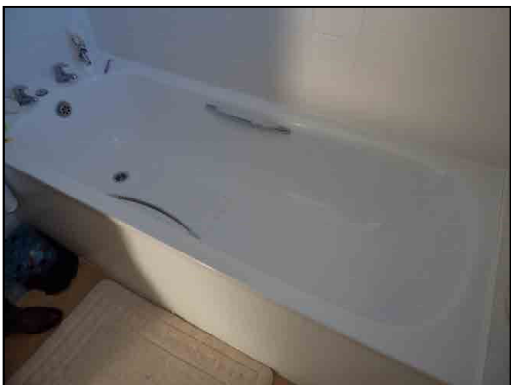
Image ref:	Figure 51	Floor:	Ground	Room:	Bathroom

- The tenants report that the water from the bath tap is only warm. This is due to legislation in Part G of the Building Regulations that all hot bath taps require a thermostatic mixing valve set to 48 degrees C to prevent scalding.
- It was not confirmed whether the bath volume was 140 litres as stated in the original design specification. However, from the appearance of the bath, 140 litres is a likely volume (Figure 51).

bath in one of the properties

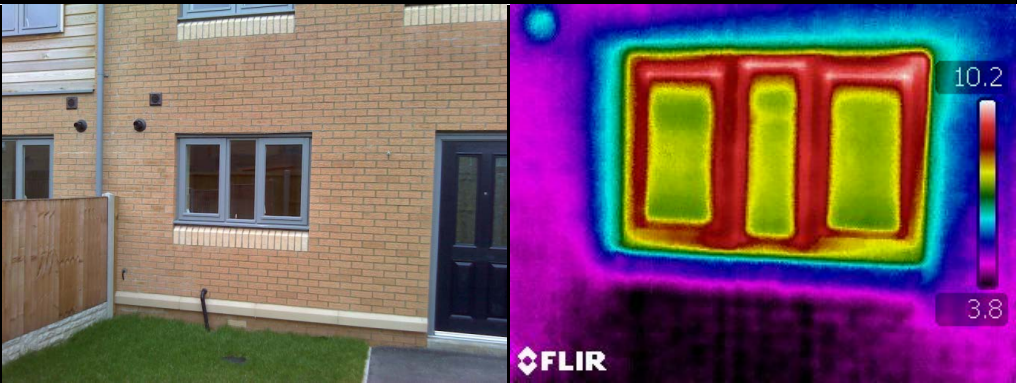
Image ref:	Figure 62	Floor:	Ground	Room:	Kitchen

<p>The figure consists of two side-by-side images. On the left is a photograph of a brick building's exterior showing a window and a door. On the right is a thermal image of the same window area, showing a bright yellow/orange rectangular shape indicating high heat loss, surrounded by cooler blue/purple areas. A color scale on the right of the thermal image ranges from 3.8 to 10.2. The FLIR logo is visible at the bottom of the thermal image.</p>					
Photo and thermal image of kitchen window (west)

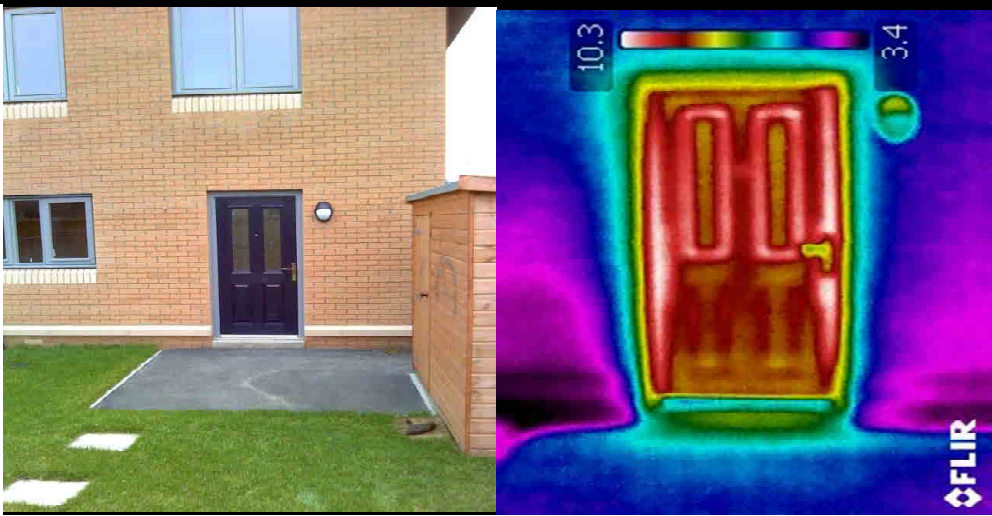
Image ref:	Figure 63	Floor:	Ground	Room:	Dining

<p>The figure consists of two side-by-side images. On the left is a photograph of a brick building's exterior showing a door and a window. On the right is a thermal image of the same door area, showing a bright yellow/orange rectangular shape indicating high heat loss, surrounded by cooler blue/purple areas. A color scale at the top of the thermal image ranges from 3.4 to 10.3. The FLIR logo is visible at the bottom of the thermal image.</p>					
Photo and thermal image of dining room (external back)door

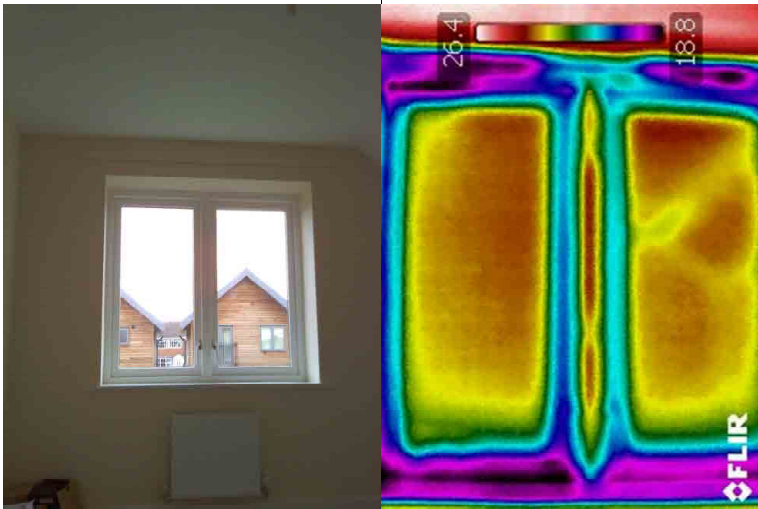
Image ref:	Figure 77	Floor:	First	Room:	Bed 2

Photo and thermal image of bedroom 2 window (west)

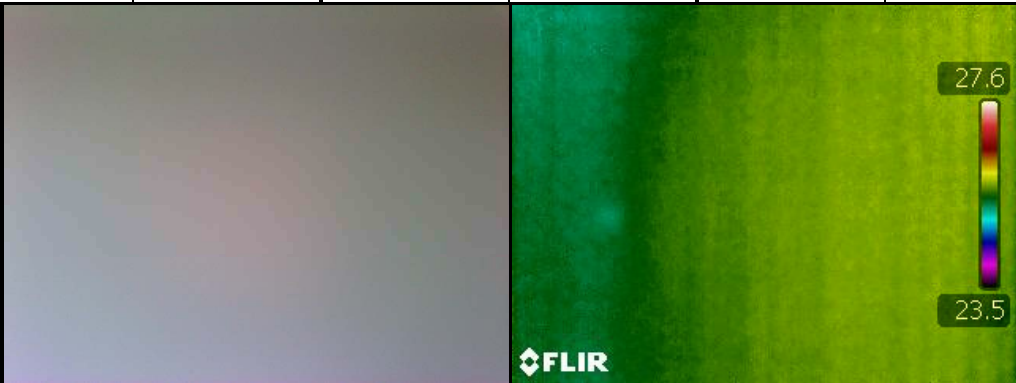
Image ref:	Figure 78	Floor:	First	Room:	Bed 2

Photo and thermal image of bedroom 2 party wall (north)
