This document contains a Building Performance Evaluation report from the £8 million Building Performance Evaluation research programme funded by the Department of Business Innovation and Skills between 2010 and 2015. The report was originally published by InnovateUK and made available for public use via the building data exchange website hosted by InnovateUK until 2019. This website is now hosting the BPE reports as a research archive. Although no support or further information on the reports is available from the host, further information may be available from the original InnovateUK project evaluator using the link below¹.

| InnovateUK project number | 450040 Related study: 450013 (Phase 1) ² |
| Project author | Leeds Beckett University for Joseph Rowntree Housing Trust |

This report outlines the findings obtained from an in-use performance and post occupancy evaluation study undertaken on a small mixed-tenure development of six dwellings. The development comprised two 4-bed detached bungalows for supported living, and four 4-bed terraced family dwellings for rent or shared ownership. Due to monitoring issues, data is incomplete in many areas, limiting the ability of the resea

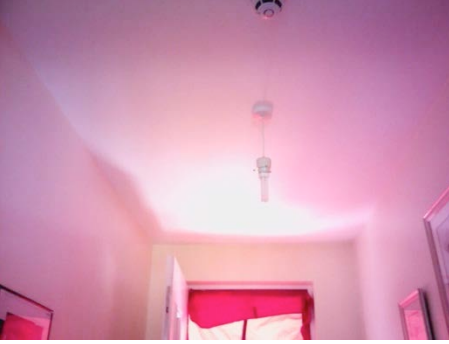
| | | <p>IR_1939 and DC_1940</p> <p>24th March 2014 10:36</p> <p>Internal Temp – 21.3 °C</p> <p>External Temp – 4.5 °C</p> <p>Internal RH – 44.5%</p> <p>External RH – 70.7%</p> |

| <p>Front door</p> <p>A number of cold spots can be clearly seen on the ceiling of the entrance hall, particularly at the junction with the partition wall. This suggests discontinuities in the insulation layer in the loft space.</p> | | |

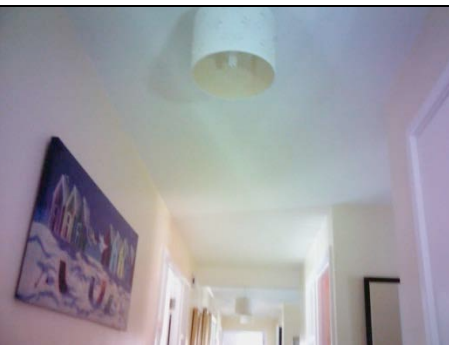
| | | <p>IR_1993 and DC_1994</p> <p>24th March 2014 10:44</p> <p>Internal Temp – 21.3 °C</p> <p>External Temp – 4.5 °C</p> <p>Internal RH – 44.5%</p> <p>External RH – 70.7%</p> |

| <p>Main hallway</p> <p>Looking down the corridor from the consumer unit cupboard towards the laundry room, a number of cold spots on the ceiling are evident, illustrating various discontinuities in the loft insulation layer (IR_1993). An area of unregulated heat gain is also apparent in the middle of the ceiling, which is over 1 metre in length and is approximately 2°C warmer than the surrounding area. It is thought that this heat gain area is a result of heat loss from a poorly insulated or uninsulated domestic hot water supply pipe. Unfortunately, due to Health & Safety reasons (the lack of any form of artificial light or access platform in this section of the loft), it was not possible to investigate this source of unregulated heat gain.</p> <p>The underfloor heating system can be clearly seen in Image IR_1997.</p> <p>Discontinuities in the loft insulation layer can also be observed in the hallway ceiling just outside the doorway to the laundry room (IR_2025).</p> | | |

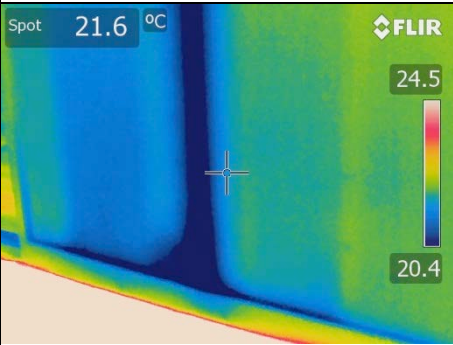
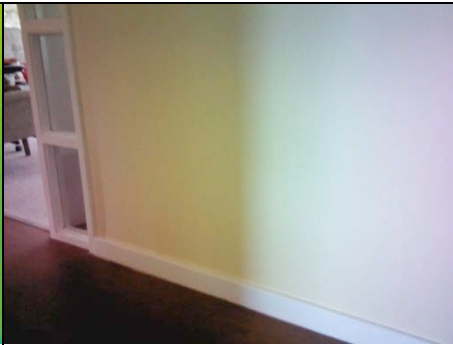
| | | <p>IR_1957 and DC_1958</p> <p>24th March 2014 10:39</p> <p>Internal Temp – 21.3 °C</p> <p>External Temp – 4.5 °C</p> <p>Internal RH – 44.5%</p> <p>External RH – 70.7%</p> |

In the main hallway, the cavity of the potential party wall clearly shows up as a cold strip that runs up the wall (IR_1957), across the corridor (IR_1961 and 1963), and then back down the other side of the wall (IR_1963). This cold strip suggest that there is an unplanned heat loss mechanism operating at the potential party wall, which is bypassing the thermal insulation layer.

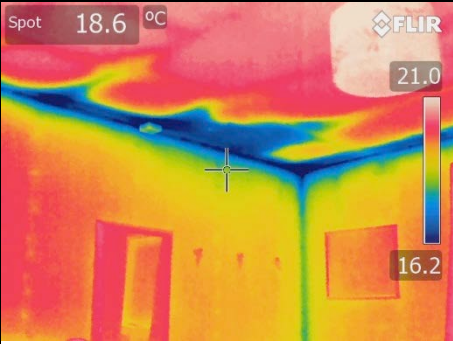
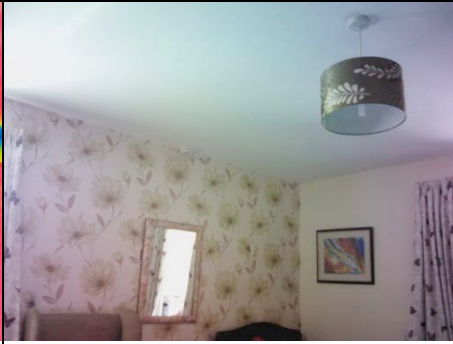
| | | <p>IR_1975 and DC_1976</p> <p>24th March 2014 10:42</p> <p>Internal Temp – 21.3 °C</p> <p>External Temp – 4.5 °C</p> <p>Internal RH – 44.5%</p> <p>External RH – 70.7%</p> |

| <p>Discontinuities in the loft insulation at the eaves are clearly illustrated on both the gable wall (IR_1975) and the rear elevation (IR_1977).</p> | | |

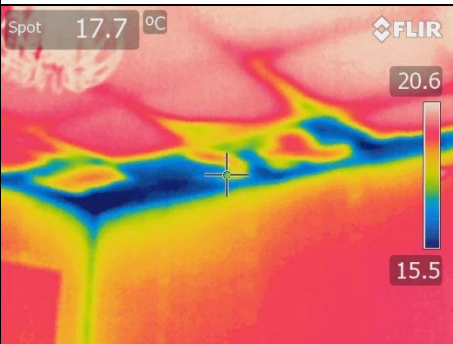
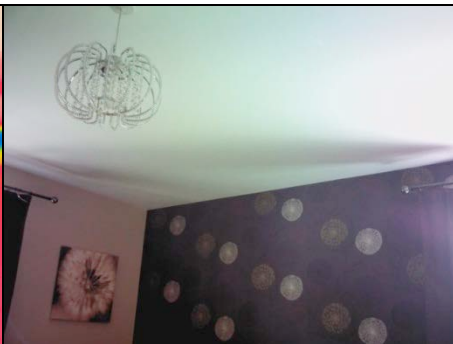
| | | <p>IR_1981 and DC_1982</p> <p>24th March 2014 10:42</p> <p>Internal Temp – 21.3 °C</p> <p>External Temp – 4.5 °C</p> <p>Internal RH – 44.5%</p> <p>External RH – 70.7%</p> |

| <p>Bedroom 2</p> <p>Discontinuities in the loft insulation at the eaves are clearly apparent on both the gable wall (IR_1981 and IR_1983) and the front elevation (IR_1985). The lack of insulation below the loft access platform is also clearly illustrated in IR_1985.</p> | | |

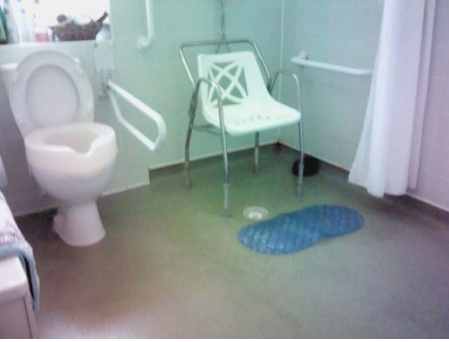
| | | <p>IR_1999 and DC_2000</p> <p>24th March 2014 10:45</p> <p>Internal Temp – 21.3 °C</p> <p>External Temp – 4.5 °C</p> <p>Internal RH – 44.5%</p> <p>External RH – 70.7%</p> |

| <p>Bathroom 1</p> <p>No underfloor heating and the lack of insulation below the sunken shower tray is evident in IR_1999. Some discontinuities in the loft insulation at the eaves and the lack of insulation below the loft access platform are also apparent in IR_2001.</p> | | |

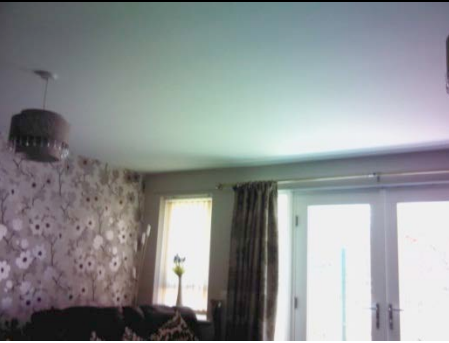
| | | <p>IR_2005 and DC_2006</p> <p>24th March 2014 10:46</p> <p>Internal Temp – 21.3 °C</p> <p>External Temp – 4.5 °C</p> <p>Internal RH – 44.5%</p> <p>External RH – 70.7%</p> |

| <p>Living area</p> <p>Discontinuities in the loft insulation are apparent at the eaves (IR_2005 and IR_2007) and at the potential party wall/ceiling junction (IR_2011 and IR_2013). There is also a discontinuity on the loft insulation layer on the ceiling close to the entrance to the living area from the corridor (IR_2009).</p> | | |

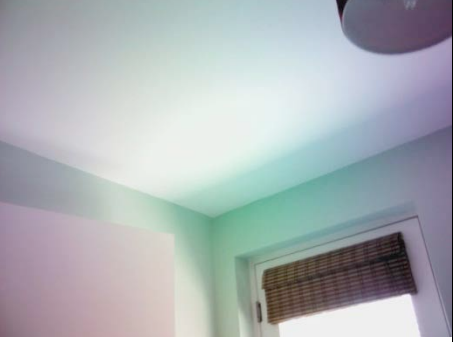
| | | <p>IR_2019 and DC_2020</p> <p>24th March 2014 10:47</p> <p>Internal Temp – 21.3 °C</p> <p>External Temp – 4.5 °C</p> <p>Internal RH – 44.5%</p> <p>External RH – 70.7%</p> |

| <p>Kitchen area</p> <p>Discontinuities in the loft insulation are apparent at the eaves (IR_2019 and IR_2021) and to a lesser extent at the potential party wall/ceiling junction (IR_2015). There is also some unregulated heat gain from around the frame of the central heating manifold cupboard and through the partition wall at the top of the cupboard (IR_2023).</p> | | |

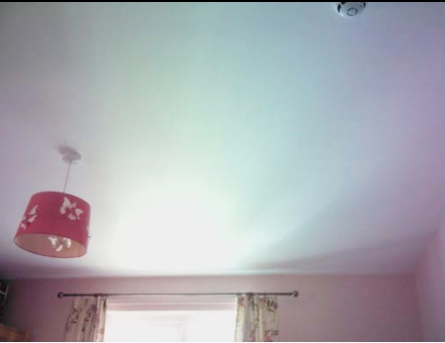
| | | <p>IR_2031 and DC_2032</p> <p>24th March 2014 10:49</p> <p>Internal Temp – 21.3 °C</p> <p>External Temp – 4.5 °C</p> <p>Internal RH – 44.5%</p> <p>External RH – 70.7%</p> |

| <p>Bedroom 3</p> <p>Discontinuities in the loft insulation were observed at the eaves (IR_2034). In addition, discontinuities were also observed around the MVHR supply vent and smoke sensor (IR_2034) and at a section of the ceiling close to the gable wall (IR_2035).</p> | | |

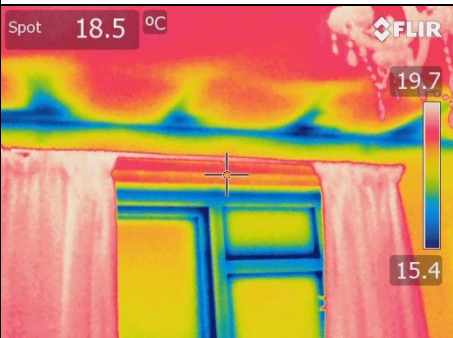
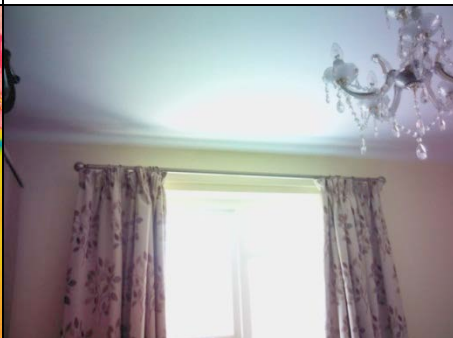
| | | <p>IR_2047 and DC_2048</p> <p>24th March 2014 10:50</p> <p>Internal Temp – 21.3 °C</p> <p>External Temp – 4.5 °C</p> <p>Internal RH – 44.5%</p> <p>External RH – 70.7%</p> |

Colder areas are obvious around the opening portion of the loft hatch (IR_2043). There is also a discontinuity in the insulation layer around the loft hatch. Discontinuities in the loft insulation layer are also evident at the eaves (IR_2045 and IR_2047).

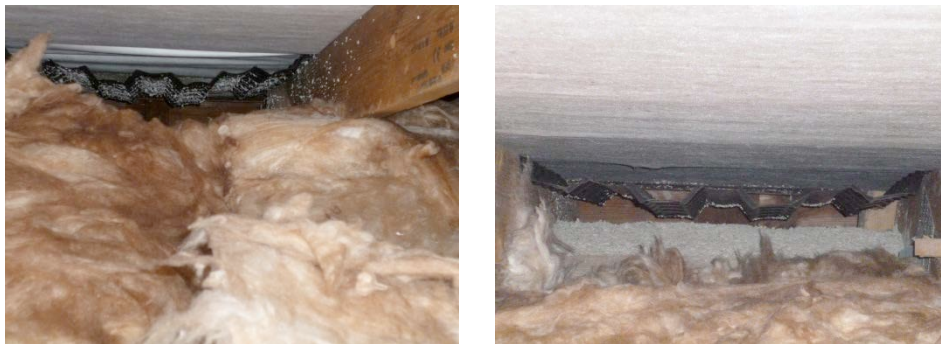
Figure 4 Proprietary eaves ventilator.

- **Eaves detail** – The proprietary eaves ventilator that has been installed is too short, so does not extend far enough up the inside face of the pitched roof (see Figure 4). As a consequence, the insulation at ceiling level has been stopped short in order to ensure that there is still a

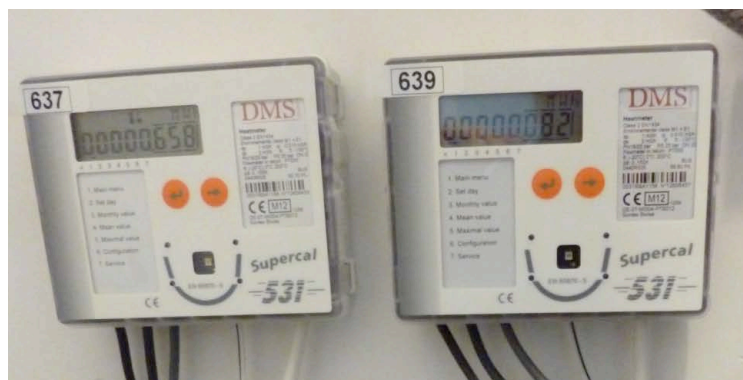
Figure 13 Installed Heat meters in MWh resolution

Heat meters and the associated pulsed head units were installed in both extensively monitored properties so that energy use for domestic hot water and central heating could be recorded. These meters and head units were passed on directly to the team at JRHT, and following installation it was discovered that the head units were configured for one pulse per kWh, despite being ordered with a pulse resolution of 1 pulse per Wh (Figure 13). Unfortunately, it is not possible to check the pulse resolution of the heat meter head unit until the device is powered and each head unit is calibrated to a particular heat meter, so it is not possible to simply replace the head unit. The pulse resolution that was supplied with the heat meters does not give a good indication of energy use in a domestic setting as energy use is too low. As a result, the heat meters and the associated head units had to be removed and sent back to the supplier for reconfiguration.

During this process, two of the heat meters and head units were misplaced and had to be replaced which led to further delays. Once the heat meters and head units were returned, there were further delays due to access issues to the properties to allow reinstallation. The heat meter head units are equipped with a pulse output that is connected to an Eltek GC62 pulse transmitter which sends data to the external logger. When the heat meters and head units were reinstalled, they were not reconnected to the Eltek transmitter, resulting in data only being recorded on the heat meter unit and making interpretation impossible. There were then further delays whilst the correct transmitters were located and reconnected. The result was that no usable data was collected by the heat meters in either property.

The issue with pulse resolution was unavoidable from the perspective of the research team, as the correct equipment was originally ordered and the fault was with the supplier. A system which allows pulse resolution to be checked prior to installation may have avoided the issue. Delays due to misplaced equipment and access were also out of the control of the research team.

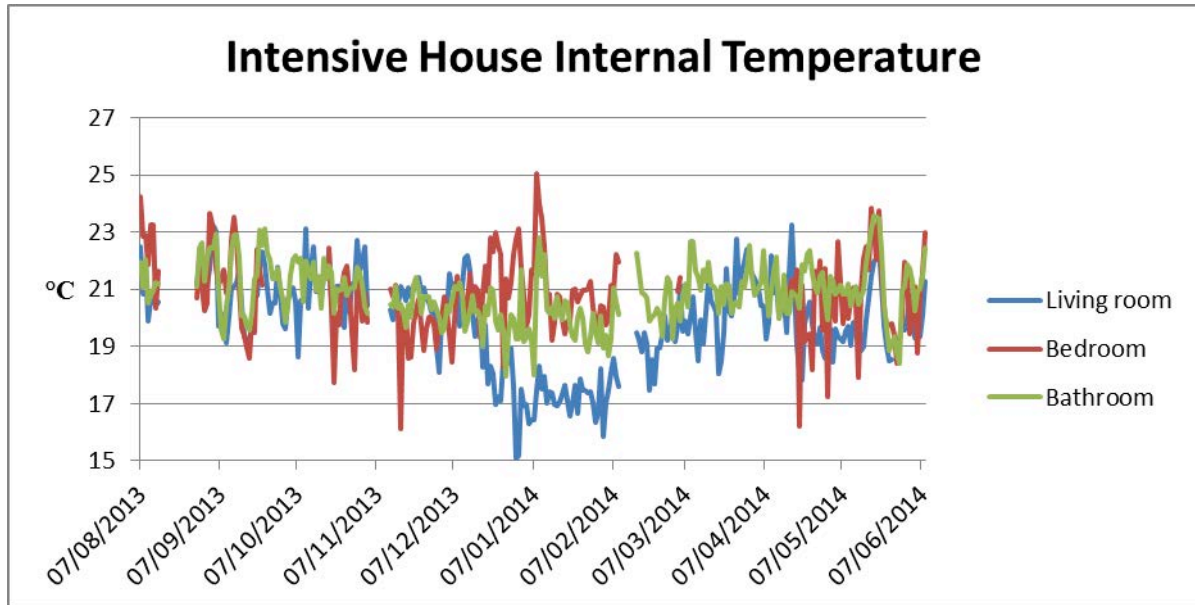
Figure 18 Intensive house (Dwelling 4) internal temperature.

Internal temperature data for the intensive house (Dwelling 4) is displayed in Figure 18. Internal temperature appears quite erratic on a daily basis, although consistently within a range of 19-23°C across the full monitoring period. The exception to this is during winter, when the living room temperature appears to drop significantly. This may suggest that the dwelling heating system is unable to heat this space effectively. It has already been determined through occupant questioning that the MVHR system in the home is not in operation, having been turned off due to noise complaints, and this may provide an explanation for the lower temperature in the living room. Despite the various peaks and troughs, the intensive house does display the ability to maintain an internal temperature. The data shows comfortable living conditions, with only brief overheating periods (over 23°C in bedrooms, over 26°C living room) which appear to be the result of short term factors, such as increased occupancy.

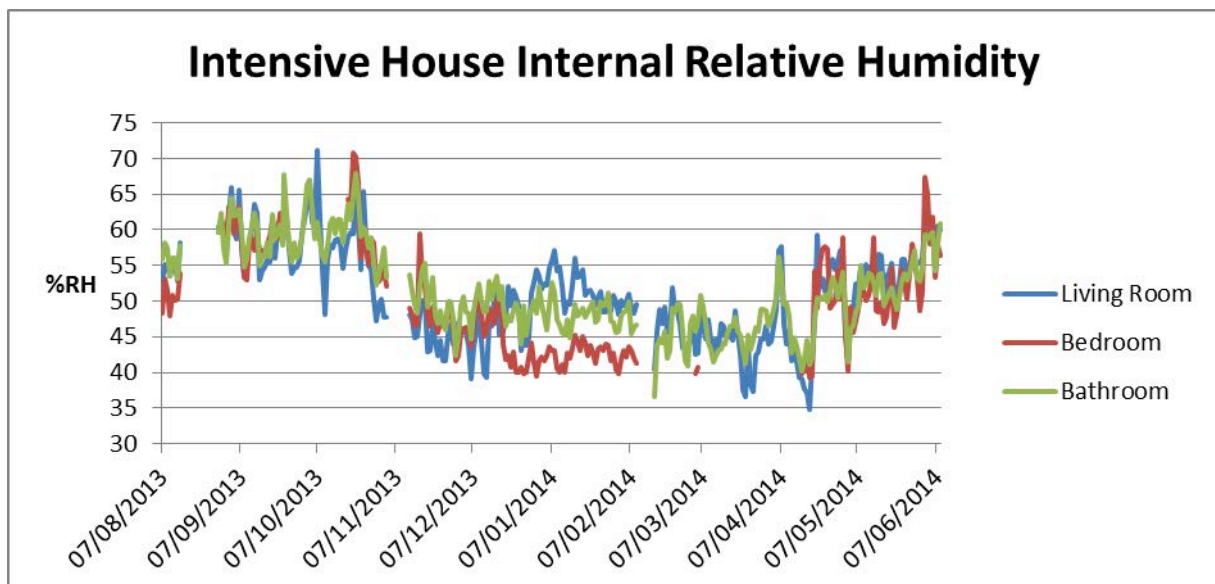
Figure 19 Intensive house (Dwelling 4) internal relative humidity.

Internal relative humidity displayed in Figure 19 fluctuates between 40-65% for the majority of the testing period, with only short periods of time outside this range. It is interesting to observe the reduction in internal humidity during winter months, which may be the result of reduced window opening during colder weather and a consequent decrease in the introduction of moist external air to the dwelling.

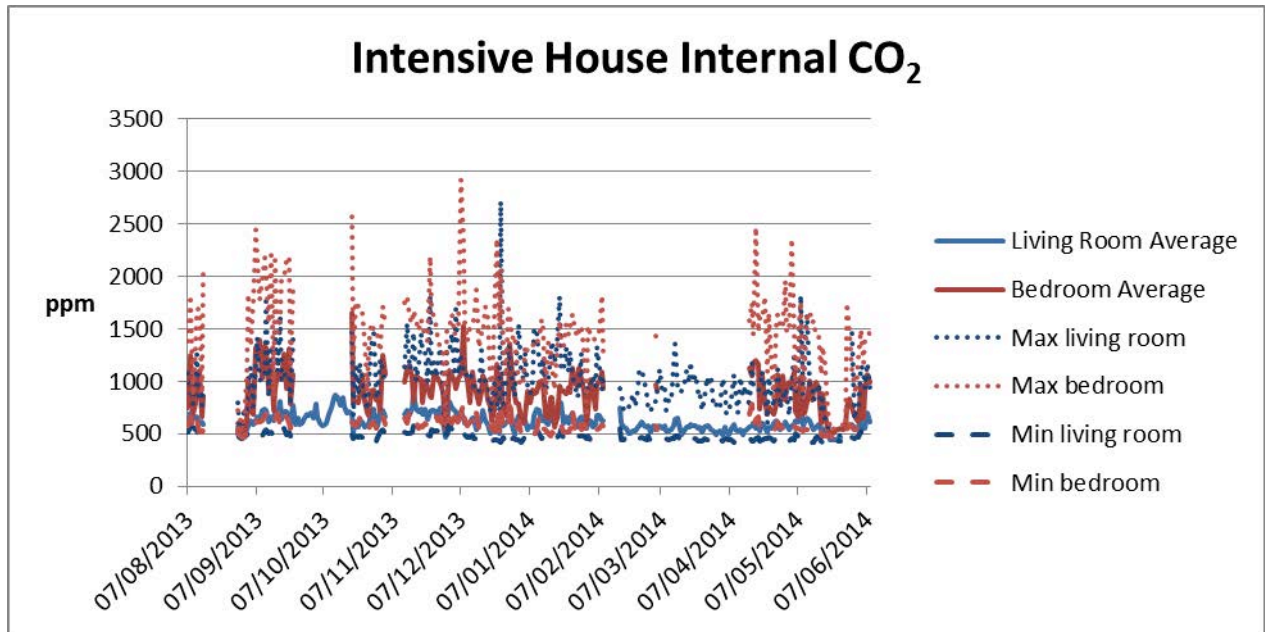
Figure 20 Intensive house (Dwelling 4) internal CO₂.

Internal CO₂ provides an indication of internal air quality, and is particularly relevant when monitoring relatively airtight dwellings such as those at Dormary Court who are equipped with MVHR systems. Figure 20 displays daily CO₂ average measurements with additional data on the maximum and minimum recorded level for each day. Whilst the living room appears to have a normal CO₂ concentration, fluctuating around 600ppm, the bedroom appears to be noticeably higher, with a CO₂ level fluctuating around 800ppm with high daytime peaks.

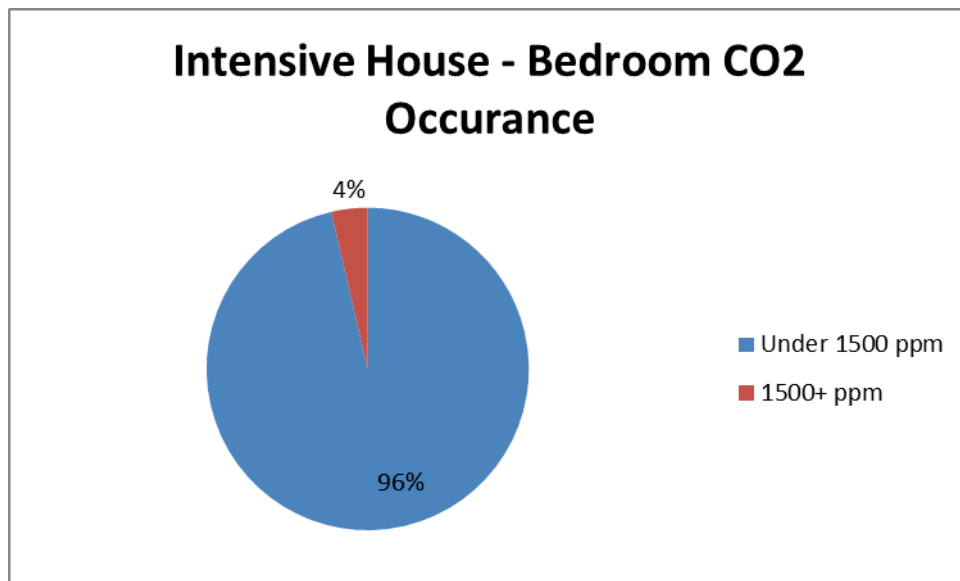
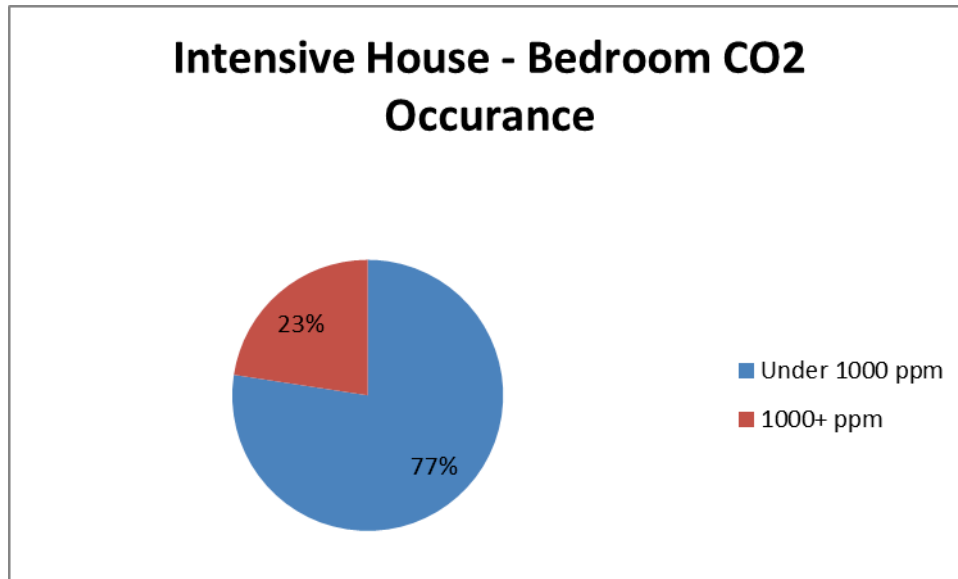
Figures 21 and 22 give an indication of the total time that CO₂ levels were above 1500ppm and 1000ppm during the entire monitoring period. The CO₂ level is recorded as being above 1000ppm for 23% of the time, and the majority of this is during the night when the room is occupied. It is possible that this high concentration of CO₂ is the result of the MVHR system being turned off, leading to fresh air not being supplied to the bedroom. Residents should be advised of the purpose of the MVHR system, and the impact of not using it.

Figure 21 Intensive house (Dwelling 4) bedroom CO₂.

Figure 22 Intensive house (Dwelling 4) bedroom CO₂.

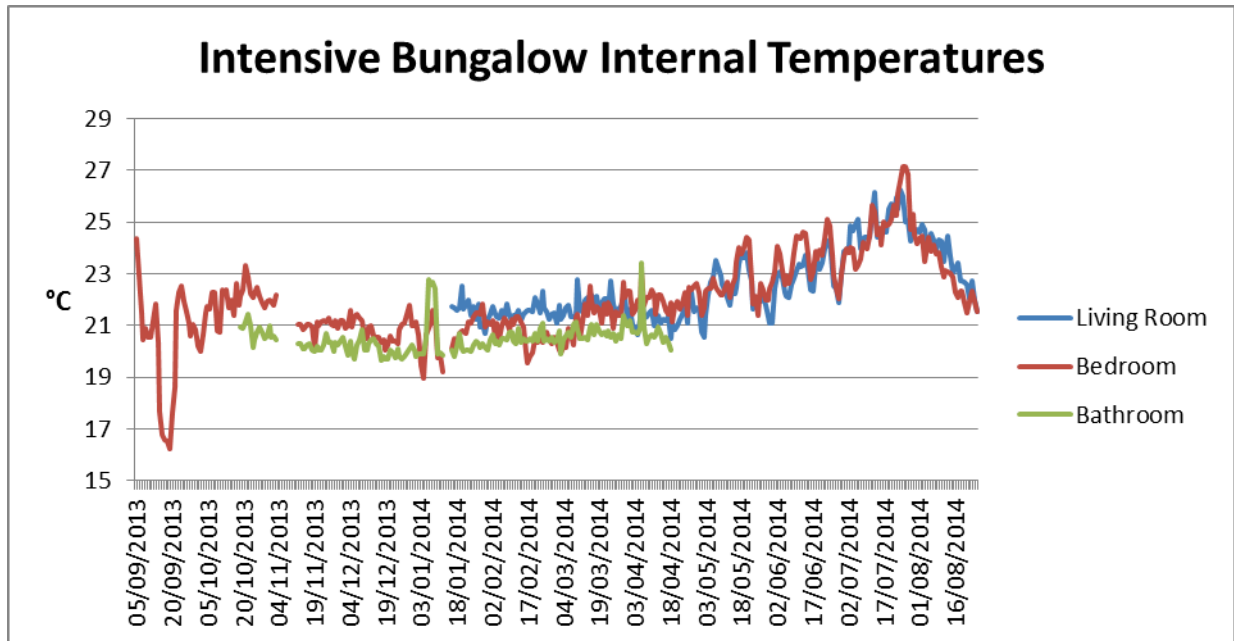
Figure 23 Intensive bungalow (Dwelling 6) internal temperature.

Internal temperature for the intensive bungalow (Dwelling 6) is displayed in Figure 23. Temperature is seen to be consistent at what would be perceived as a comfortable temperature during winter, suggesting that the dwelling heating system is able to sufficiently heat the home. There is a noticeable increase in internal temperature during summer, however, with average temperatures rising to a peak of 27°C on the 25th July. Although the temperature in the living room does not spend a significant time above the comfort threshold of 26°C, the bedroom temperature appears to be above the comfort threshold of 23°C during summer.

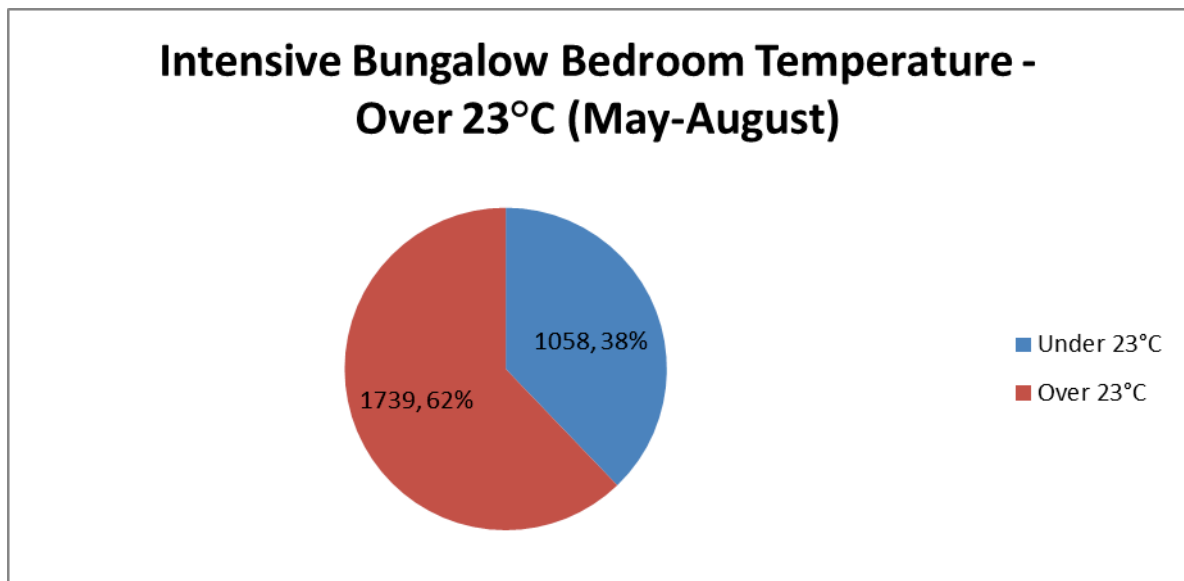
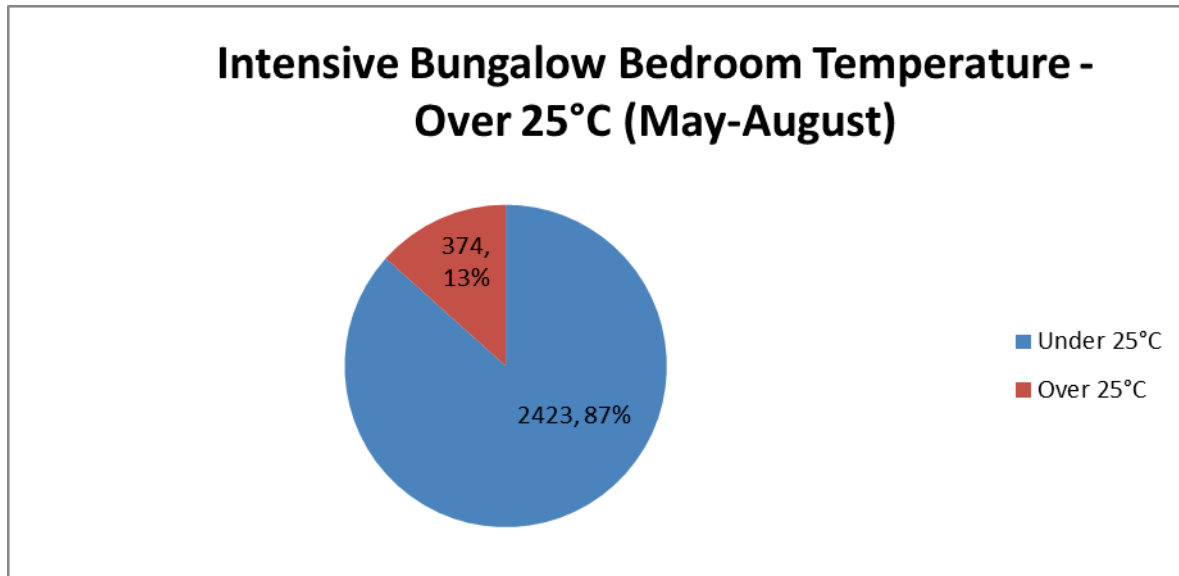
Figures 24 and 25 explore overheating in more detail, with a focus on the period from May-August where temperatures rose. It was noted that the bedroom temperature was exceeding the comfort threshold of 23°C for 62% of the time (1739 hours) during this period and exceeding the overheating threshold of 25°C for 13% (374 hours). Following the high average temperature peak in July, internal temperatures are observed to decline rapidly to a more comfortable level. It is unknown what prompted the rapid decline, although it may be due to a change in external conditions. The presented temperature data suggests that the intensive bungalow is becoming excessively warm during summer, which may be the result of occupants not opening windows to expel hot internal air.

Figure 24 Intensive bungalow (Dwelling 6) – time exceeding comfort threshold (hours and total percentage)

Figure 25 Intensive bungalow (Dwelling 6) – time exceeding overheating threshold (hours and total percentage).

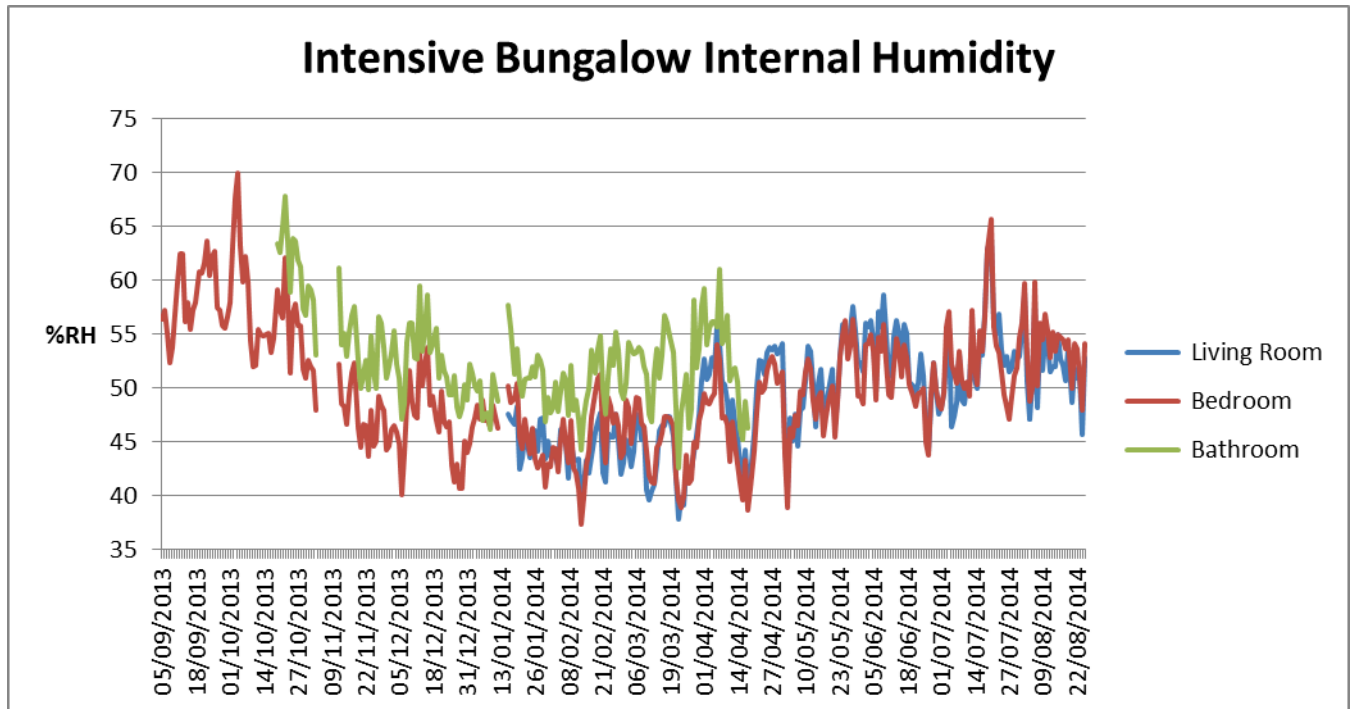
Figure 26 Intensive bungalow (Dwelling 6) internal relative humidity.

Internal relative humidity data is presented in Figure 26 and shows a fluctuation between 40-65% for the majority of the monitoring period, with isolated periods outside this range. As with the intensive house (Dwelling 4), relative humidity appears to decrease during winter, with the most probable cause being a reduction of moist external air entering the dwelling as windows are closed during cold weather.

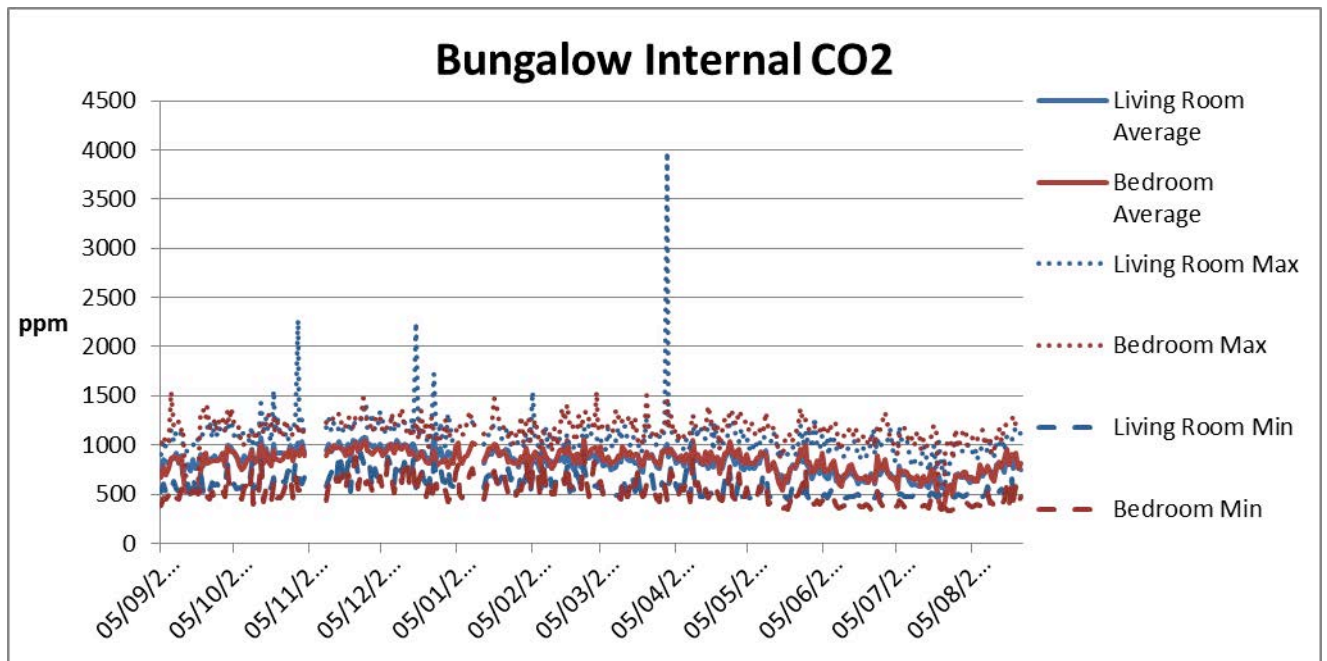
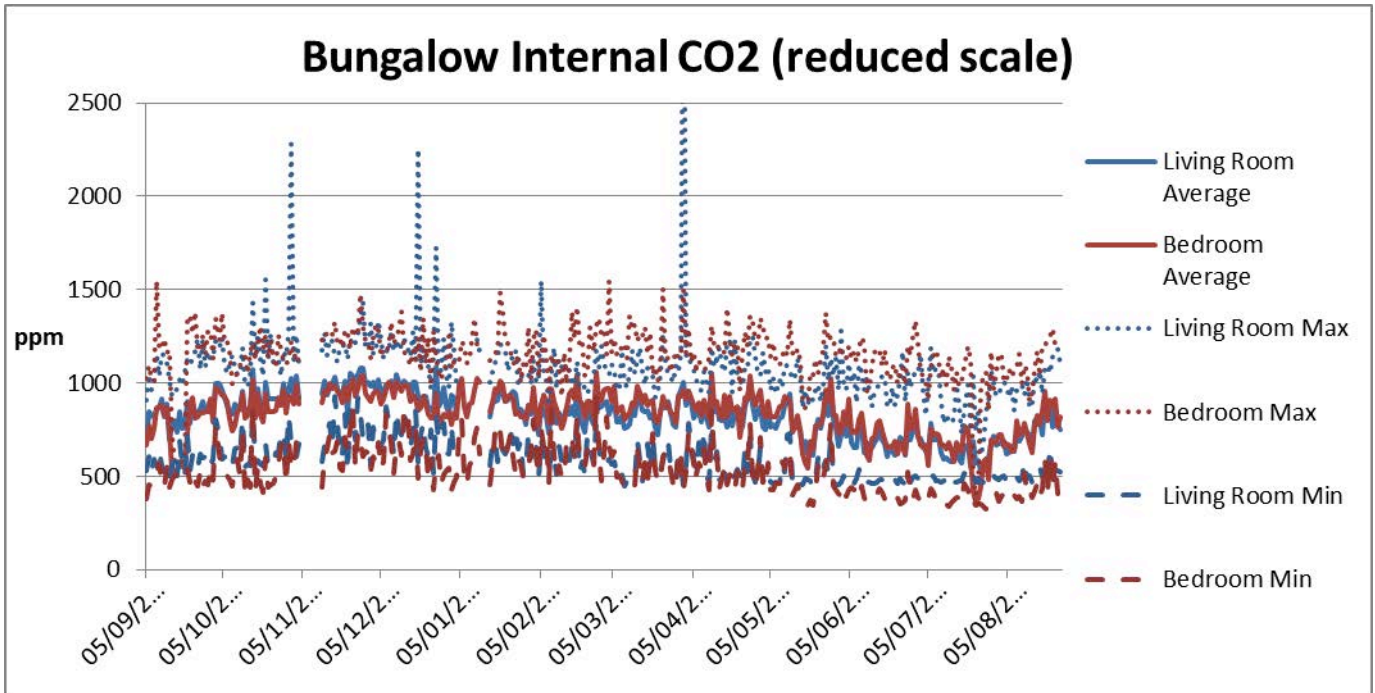
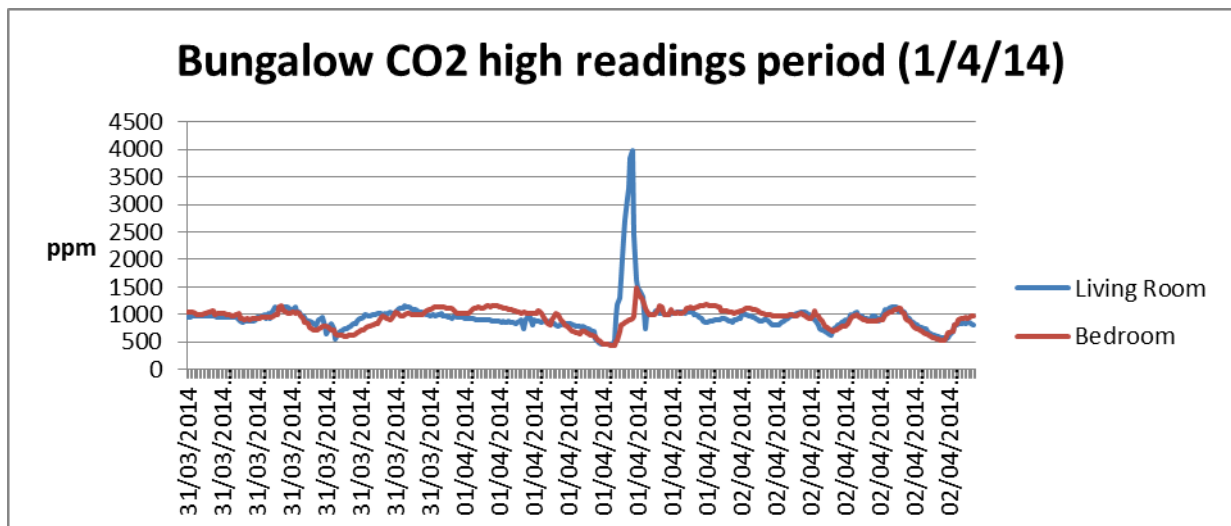
Monitored CO₂ levels in the intensive bungalow are displayed in Figure 27. Due to a single high reading on 1st April, they are displayed on a reduced scale in Figure 28 for better clarity. The period of high reading is explored in Figure 29, and can be seen to be the result of a short term event, and not representative of normal activity. Average level of CO₂ in both zones is very similar, suggesting that air is mixing well within the dwelling. CO₂ concentration is consistently around 750ppm which is slightly higher than may be expected, and may be a result of higher occupancy or a lack of air extraction from the MVHR system.

Figure 27 Intensive bungalow (Dwelling 6) internal CO₂.

Figure 28 Intensive bungalow (Dwelling 6) internal CO₂.

Figure 29 Intensive bungalow (Dwelling 6) internal CO₂.
