This document contains a Building Performance Evaluation report from the £8 million Building Performance Evaluation research programme funded by the Department of Business Innovation and Skills between 2010 and 2015. The report was originally published by InnovateUK and made available for public use via the building data exchange website hosted by InnovateUK until 2019. This website is now hosting the BPE reports as a research archive. Although no support or further information on the reports is available from the host, further information may be available from the original InnovateUK project evaluator using the link below¹.

| InnovateUK project number | 450097 |
| Project author | Glasgow School of Art, Mackintosh Environmental Architecture Research Unit (MEARU) for Dormont Estate |

| Four | Lockerbie | Semi-detached | 2011 |

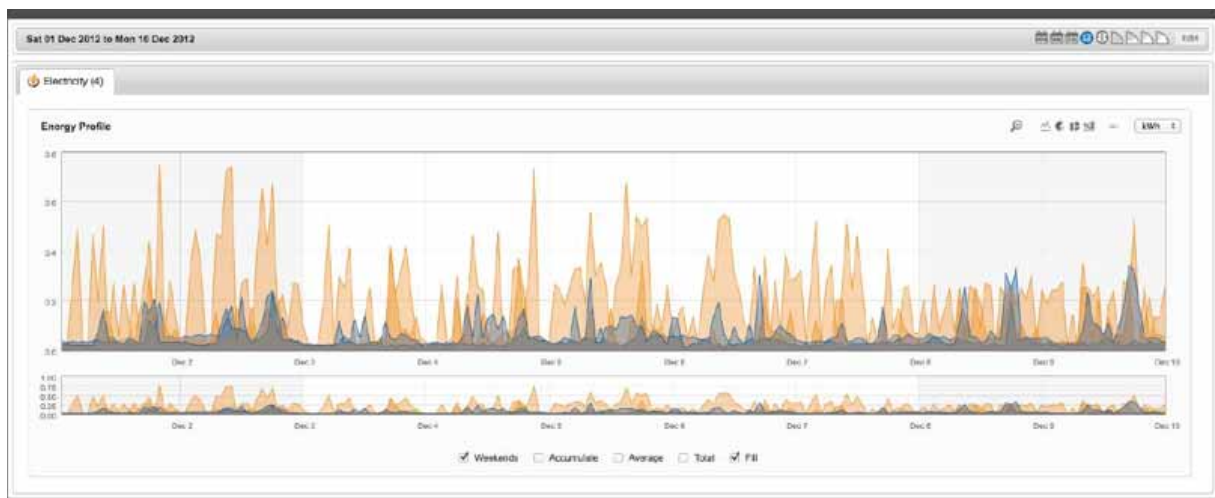
Figure 6.9: Total Electricity Consumption, all houses 2 – 9 Dec 2012

The issue came to light in the first few weeks of monitoring. The graph below, a screen capture from the T-mac monitoring software in December 2012, showed immediately that one house – shown by the light orange line / fill – was consuming substantially more electricity than the other three dwellings.

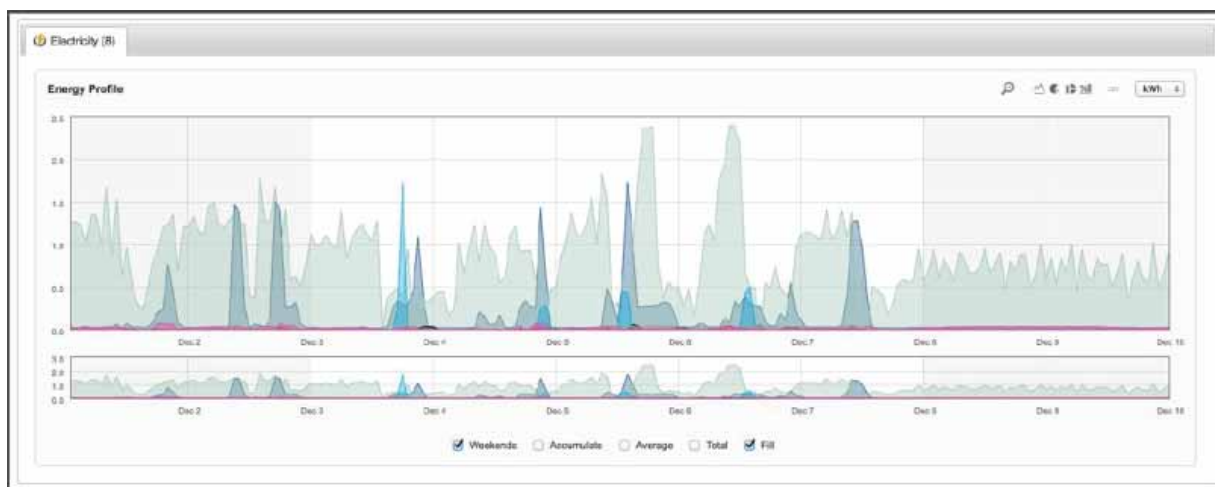
Looking in more detail at cottage DA1 in isolation, it became clear that the vast majority (80%) of this electrical consumption was due to the use of the immersion heater. The water heater is shown in pale green in both graphs shown below.

Figure 6.10: DA1 sub-metered electrical consumption for a typical week in December 2012 – water heating is shown light green

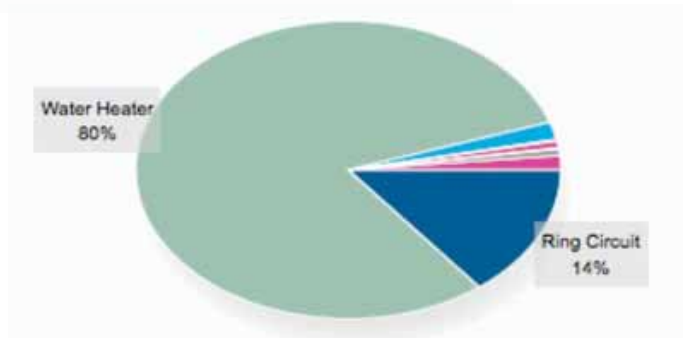
Figure 6.11: DA1 sub-metered electrical consumption for the same week as above, shown as a pie chart, with water heating accounting for 80% of all electrical consumption.

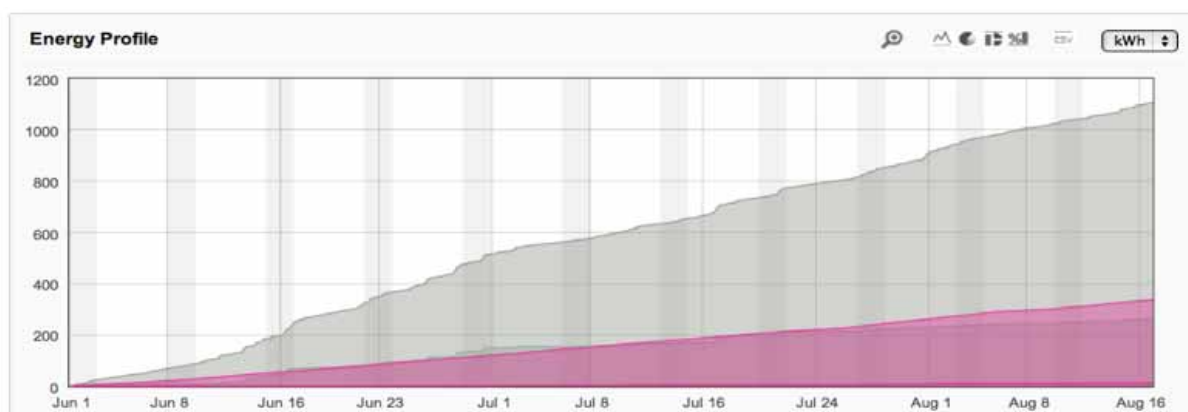
Figure 6.12: June 1st to August 16th 2013. Overall electricity and immerser consumption in cottages DA1 and DA2.

Two things are clear from the graph above. The first is that the use of the water heater in DA1 is almost exactly the same as the total use of electricity in DA2. The total electrical consumption of DA1 is over three times that of DA2 and the use of the electric immerser continues unabated through the summer months despite the supply of hot water from the solar panels. The second thing is that the immerser no longer appears to account for 80% of the electrical use in DA1.

- also, unbeknown to the occupant or the Estate at the time, the post-heater control was not wired correctly and so the post-heater was always 'on', draining the hot water store overnight and leading to constant re-heating of the water using the immerser.

Initial attempts by the Estate to encourage her to use the wood stove more failed. However, the results of this were becoming very expensive and the occupant expressed a desire to reduce costs and start using the wood stove. The Estate brought in both the Electrician and Plumber who maintained the systems to explain how it all worked. By this time, a number of problems had also been resolved so the system worked as intended. The graph below, whilst rather undramatic, in fact shows the occupant starting to use the wood stove and as such represents a significant benefit of the efforts directly and indirectly related to this study.

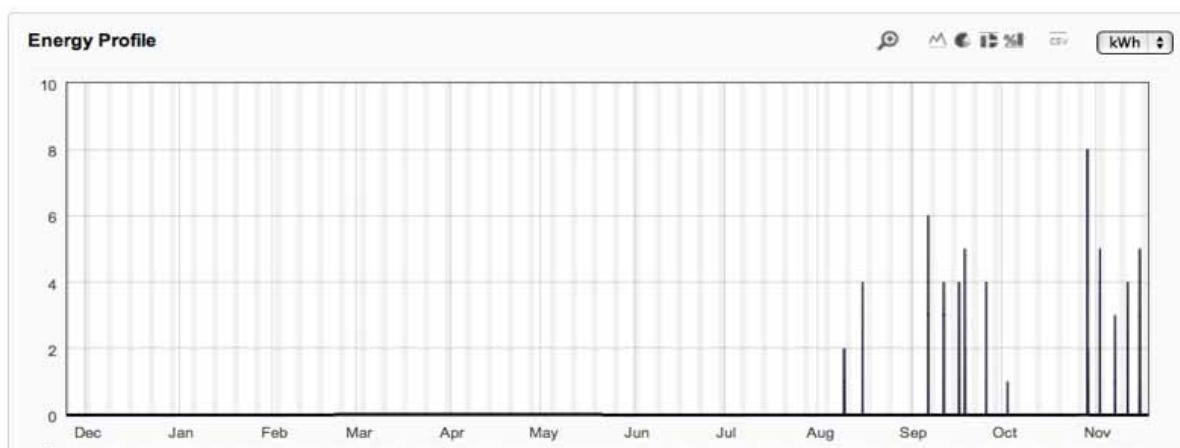
Figure 6.13: DA1. Dec '12 to Nov '13. Use of the wood stove since monitoring began. The peaks indicate hot water 'pulses' from the lit wood stove. Costs of electric bills and ongoing efforts by the Estate have combined to persuade the Tenant to begin to use the wood stove as the cold weather began.

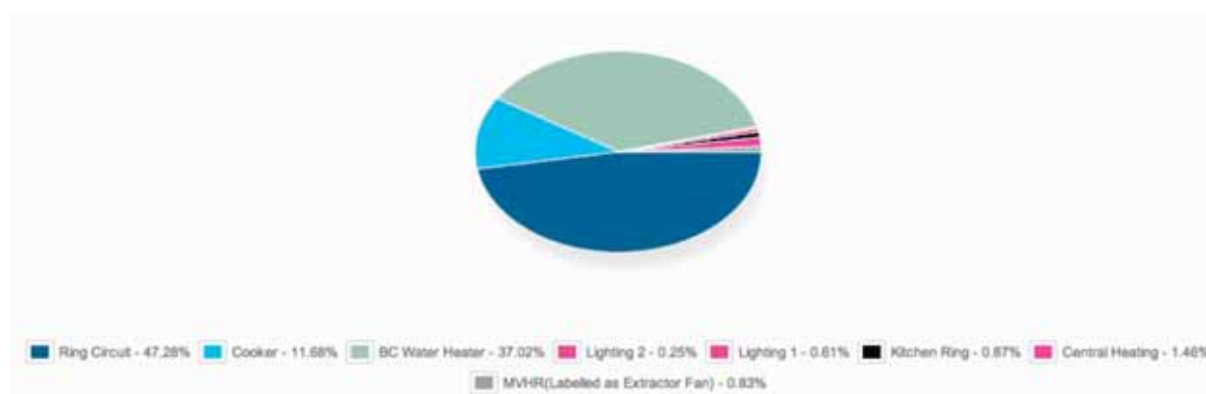
The pie chart below also tells a story. It shows the breakdown of electrical consumption for the period January to May 2014. Although rather small, what can be seen is that in terms of consumption, the largest proportion (47%) is associated with the downstairs ring circuit (dark blue) while the second largest, at 37%, is associated with the immerser. Whilst still a high proportion relative to the other houses, it is nothing like the 80% noted at the beginning of the monitoring.

Figure 6.14: Electricity consumption by type at DA1 Cottage: almost half of the consumption (dark blue) is from the Downstairs ring circuit, likely to be due to the large television and associated gadgetry which tend to be on all the time, while the water heater (light green) still uses a significant chunk at 37%.

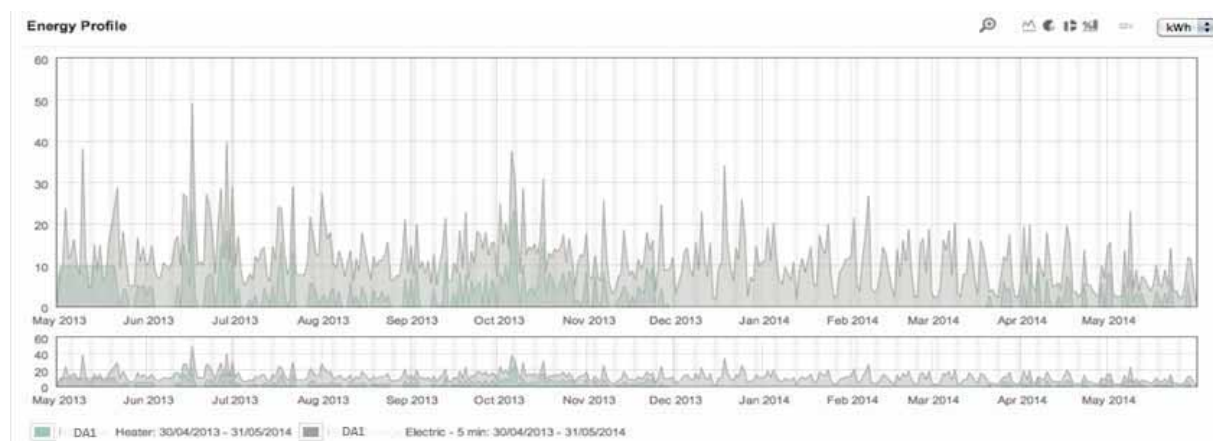
The final graph below, shows the overall electrical use and immerser consumption for the year May '13 to May '14. Whilst sub-metering data is missing for December to March '14, the trend is clear, showing both reduced

electrical consumption overall, and reduced use of the immerser bring both wider environmental benefits and cost savings to the occupant.

Figure 6.15: Overall Electrical consumption (grey) and water heater electrical use (green) for the period May 2013 to May 2014 inclusive in DA1. Sub-metered data is missing for December to mid-March but the trend is clear.

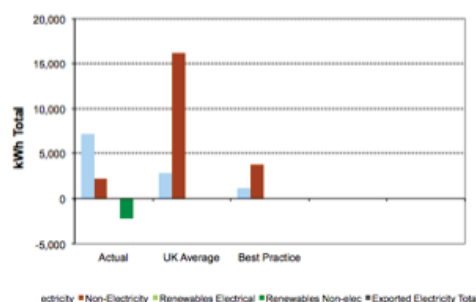
Figure 6.16: DA1: DomEARM assessment: much higher electrical use than UK Average (light blue columns), balanced by far lower heat requirement even than best practice (red columns).

The sheets confirm that electrical use within the houses ranges from low (DA2) to high (DA1), relative to typical usage. There is no renewable generation of electricity. Anecdotally, the MEARU Staff who surveyed the houses at Dormont believe that the number of electrical and electronic gadgets generally in the homes is lower than elsewhere, even where teenage children were present.

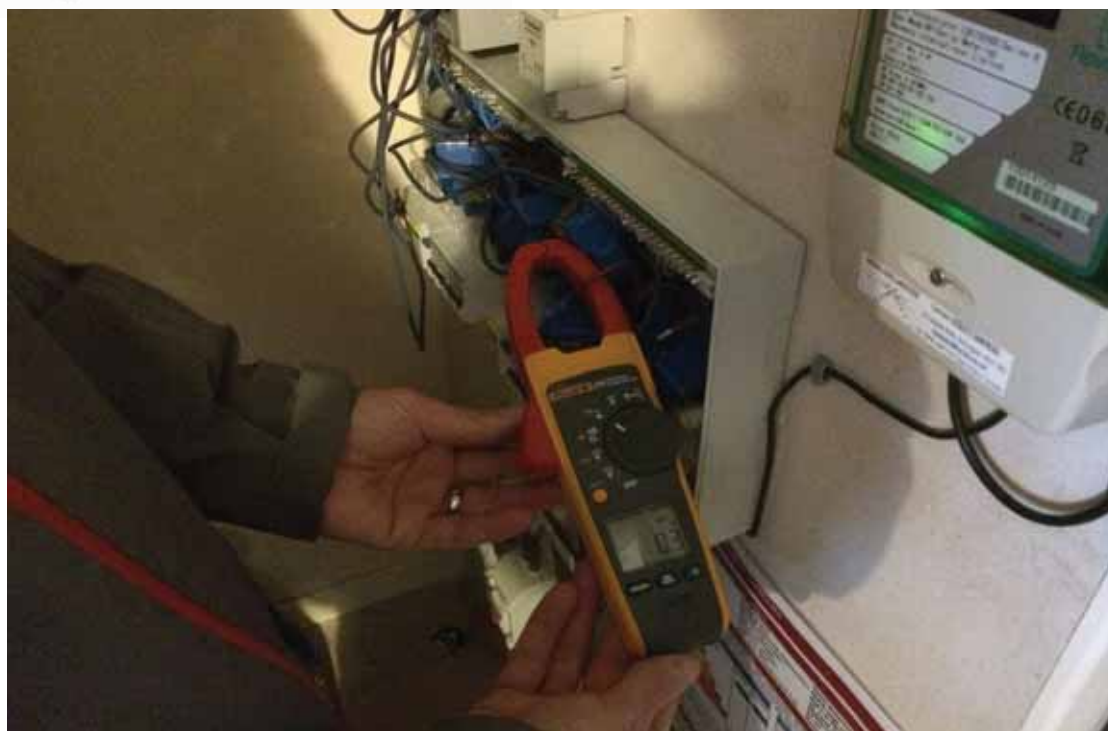
Figure 6.21: Measuring the current flow for the MVHR circuit in DA2 using a range of other amp meters.

A site visit with an Engineer was arranged in March 2014 to resolve the problems with the T-mac readings. The MVHR circuit was identified and tested using a range of amp meters, such as the example shown below. What became clear is that the installed clamps are not accurately picking up the differences in current between the various settings of the MVHR unit despite being an explicit requirement of MEARU and TSB. The clamps are rated at 100 Amps and the current changes between settings range between 0.1 and 0.3 Amps.

Furthermore none of the three amp meters brought by the Engineer could pick up the changes with any greater accuracy. Thus we were not in a position to test the MVHR with accuracy using either the installed clamps or the amp meters brought to site. Nonetheless we did undertake a test using the most accurate meter and obtained results consistent with our expectations, although these cannot be considered to be fully accurate. The results and conclusions are in **MVHR Test Report 3** contained in **Appendix Folder 6.4**

This has a wider significance as it means that individual items rated at approximately 50-100 Watts or less are not being measured at sufficient resolution. It is likely that this will account for any discrepancies found between the fiscal meter readings and the sum of sub-metered data.

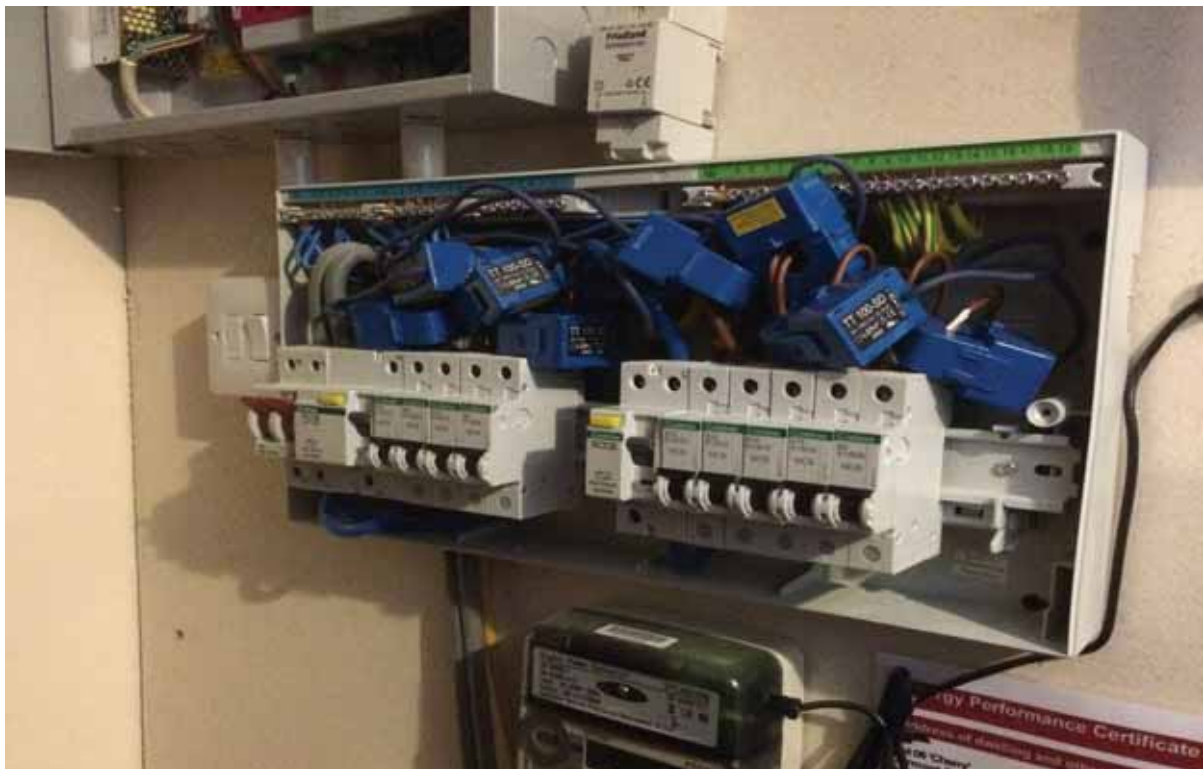
Figure 7.3: Mains Distribution Board in Cottage DA2 showing the 10A clamps which measure the electrical flow through each sub-circuit.

Most importantly, it transpired that the 100amp CT clamps installed by T-mac are not sufficiently accurate to measure the relatively small electrical loads imposed by the various domestic-scaled items. This became clear after failing to record an accurate electrical load for the MVHR system. The report on this issue, primarily intended to report on the **MVHR thermal and electrical testing** is contained with **Appendix Folder 7.2**. While the total electricity demand is accurate as it is linked directly to the fiscal meter, the sub-metering is less than 100% accurate. The major loads are accurately recorded because the clamps are able to pick up the larger loads clearly, and because these major loads comprise the bulk of the energy demand, the totals for electricity demand are close. It is in the finer details and smaller loads that accuracy is lost – a problem which MEARU intend to remedy by installing more accurate clamps for additional and continued monitoring planned for 2015.

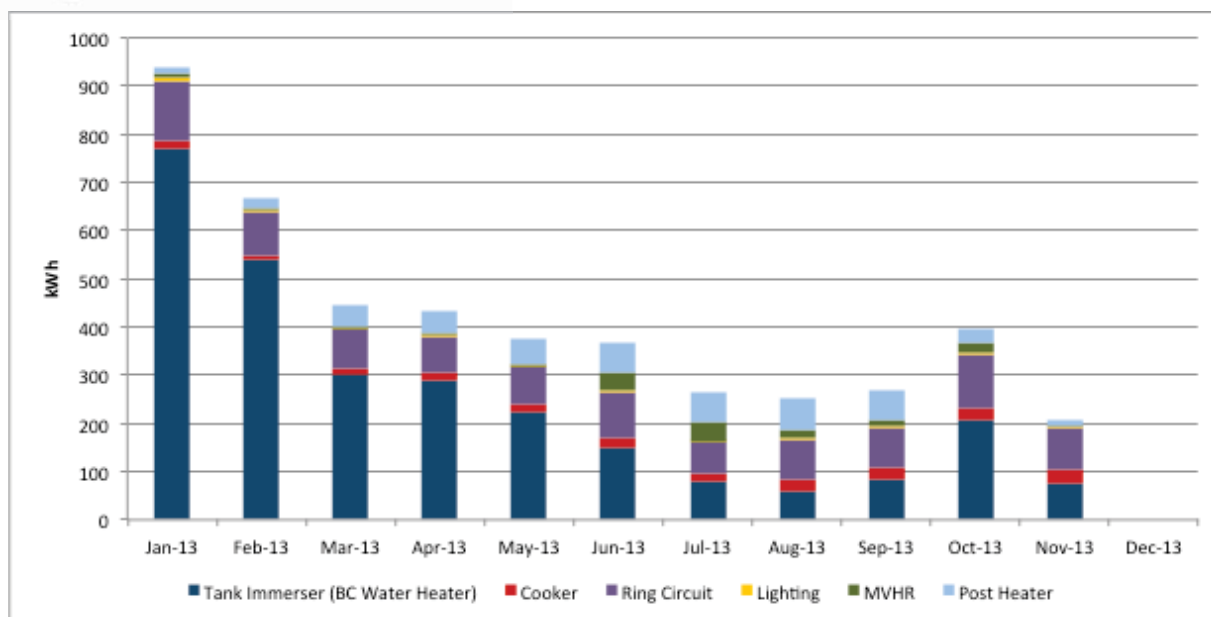
Figure 7.9: Monthly breakdown of energy consumption for 2013 in Cottage DA1

The graph below shows the breakdown of energy consumption on a monthly basis for DA1. Note that there were monitoring issues in December and no results are displayed. What is immediately obvious is the significant percentage of energy consumed by the tank immerser (Dark Grey-Blue). This has been discussed in the previous chapter. However, an intriguing aspect shown here is that the principal demand for the immerser appears to be linked to space heating due to the reduction in demand due to the improved output from the solar thermal system. The corresponding increase toward the end of the year is missing, but this is likely to be due to the monitoring issues experienced.

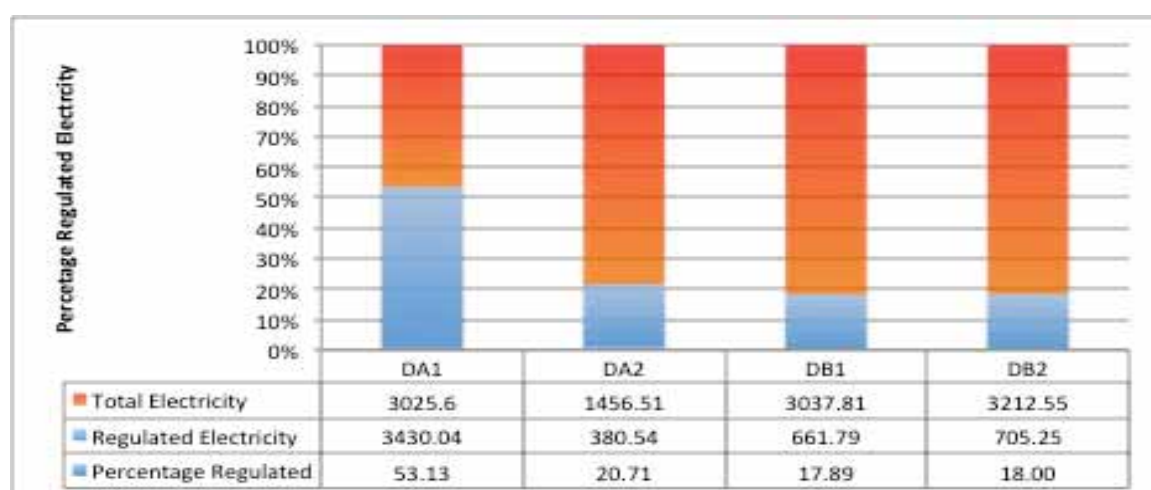
Figure 7.13: Regulated (blue) electricity as a percentage of overall electricity consumption in the Dormont Houses, 2013.

It is immediately striking that the regulated electricity consumption is a small percentage of the total, ranging from 53.13% to 17.89%. Excluding DA1, the vast majority of electrical consumption at Dormont is unregulated. Frequently, this energy evades definitions of zero carbon performance because it is difficult to control. These findings however show the extent to which unregulated energy impacts on the total energy use and in particular the carbon output of buildings because mains electricity is relatively 'carbon dense.'

Although work is already being undertaken by manufacturers to reduce energy consumption of appliances, Figure 7.13 suggests that greater consideration should be given to how to manage this energy consumption. This may be a particular concern in affordable or social housing where occupants may be bringing older, relatively inefficient appliances, as replacement costs would be prohibitive. This is reinforced when considering that a significant portion of space heating in highly insulated houses is likely to come from the use of unregulated devices such as televisions, computer and white goods etc. In some instances this will be beneficial and some use will correspond with occupancy (as appliances are not used when the house is occupied), but heat delivery is always uncontrolled, and throughout the heating season, can contribute to overheating.

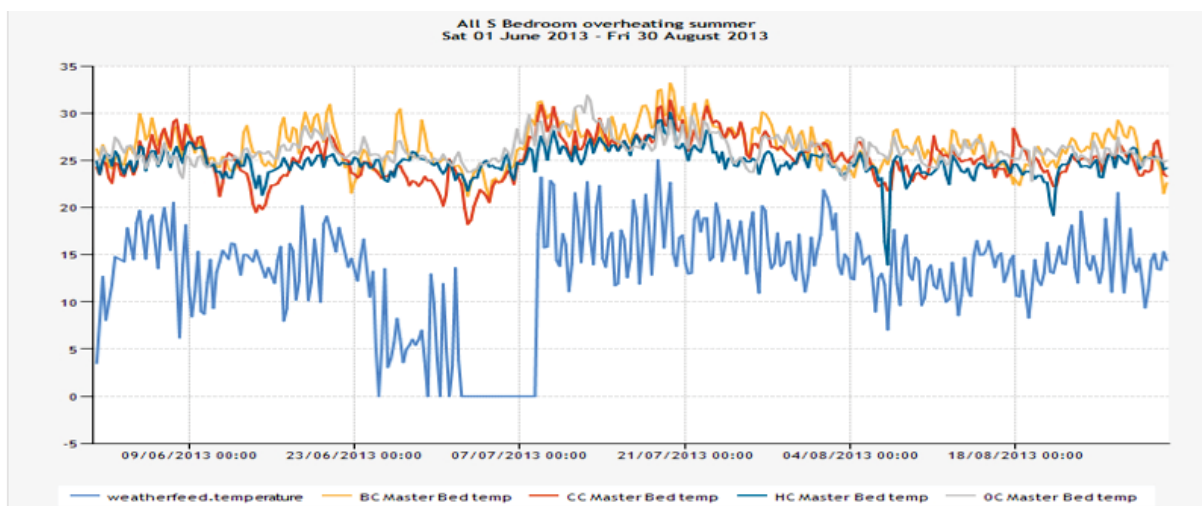
Figure 7.15: Showing the temperature (in $^{\circ}\text{C}$) in all South facing bedrooms for the summer period (June 1st to 26th August 2013) along with the external temperature. (note fault in weather feed from 2nd July to 9th.)

The graph above shows the internal temperatures in the four South-facing bedrooms during an almost 3-month period over the summer in 2013. Whilst external temperatures fluctuate as one would expect, internal temperatures remain generally within the band between 25°C and 30°C . The graph below shows in more detail a 2-week period throughout which the temperatures in all four bedrooms remain above 25°C almost continuously and venture on occasion above 32°C .

There are likely to be a number of reasons for the overheating. The houses are well insulated and the fabric is airtight and has little thermal mass, so the only effective way to remove heat is through ventilation. This will be the case in any season, but will be exacerbated in the summer months, especially to south facing apartments. The bedrooms are relatively small (especially in comparison to German space standards on which the Passivhaus standard is predicated) so heat cannot dissipate as readily, and upstairs rooms tend to gain heat through thermal stratification. In addition, there is no external shading, no high level rooflight to exhaust warm air and in the case of the 2-bed houses, no summer bypass on the MVHR – all standard devices to reduce overheating. All of these are significant aspects and even taken in isolation could lead to overheating.

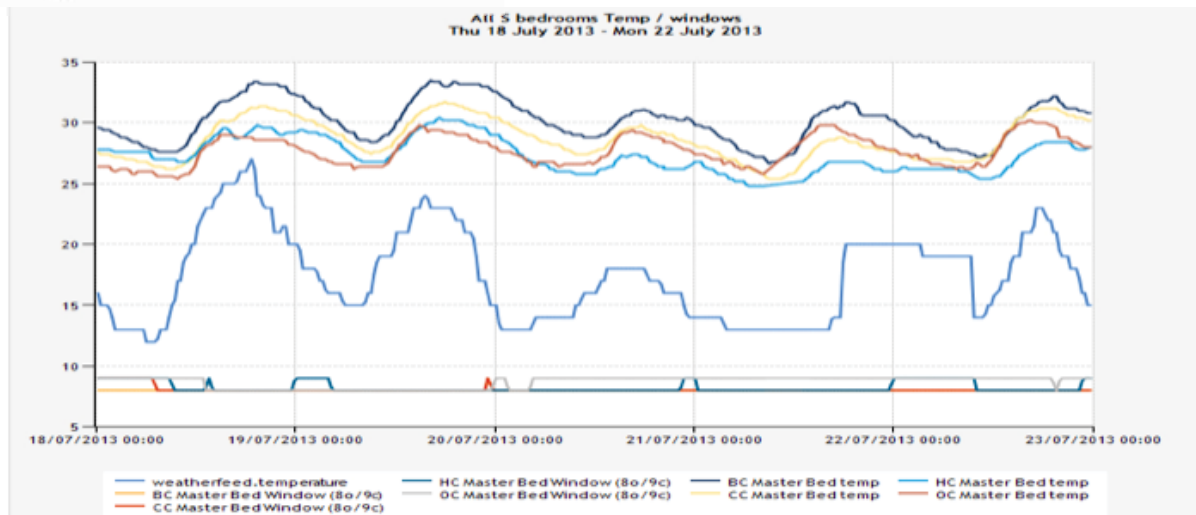
Figure 7.17: Showing the temperature (in °C) in all South facing bedrooms for the 5 day period July 18th to 22nd along with external temperature and window opening.

Window opening appears to have a minimal effect on overheating. “Any overheating can be managed easily by opening windows” reports one occupant in the BUS survey, but the monitoring has not shown much support for this. Examining a 5-day period and comparing temperatures with window opening, we see that in three of the houses, the bedroom windows are kept largely open. In one house – shown in red on the graph below– the windows are closed for the latter three days. This has little effect on the overall internal temperatures in the bedroom, although in relation to the other three bedrooms, it goes from being consistently the lowest temperature, to being second or third, and the switch happens at exactly the time when the window is closed. This would suggest that opening the windows is helping to reduce the temperature, but the effect is marginal. Even with the windows open and a 12°C difference between internal and external air temperatures at the time of opening, the internal temperatures remain high.

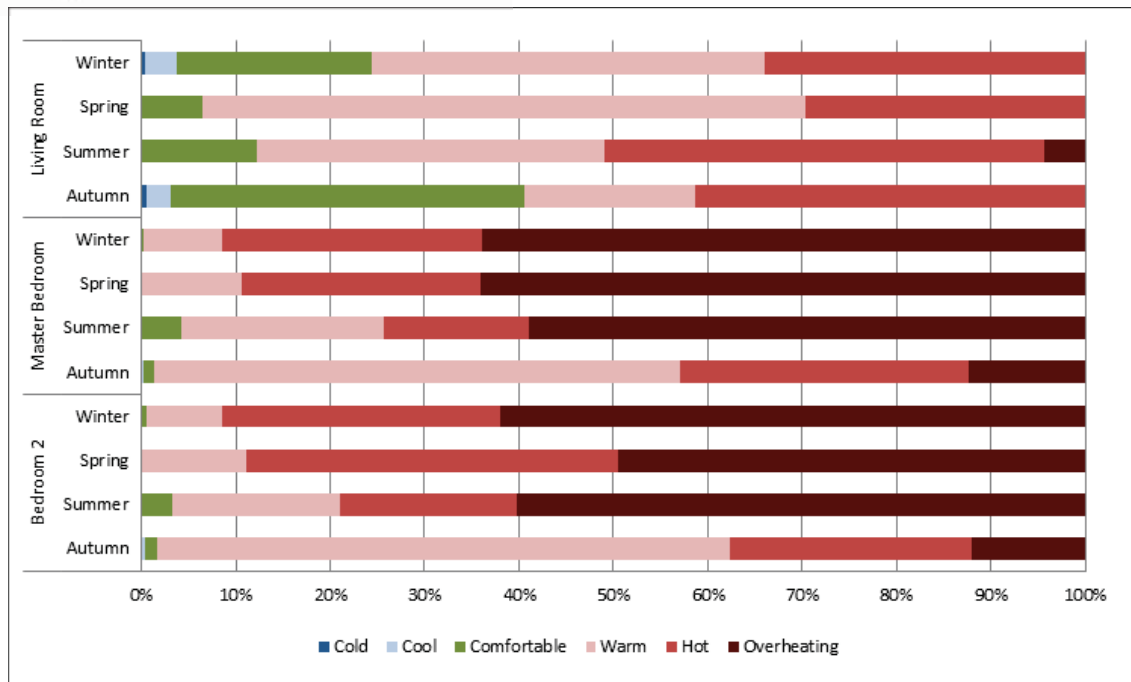
Figure 7.18: Dwelling DA1 – Thermal Comfort by Season during 2013

The most noticeable aspect in DA1 is that there is a worryingly high proportion of warm, hot and overheated periods. The second is that the downstairs Living Room is clearly better than the two upstairs rooms. In the bedrooms, temperatures were above 23°C for most of the year, with significant periods of overheating where temperatures exceeded 26°C in all seasons. The downstairs Living Room remained more regularly in the 'comfortable' range, however, there were incidences of no more than 4% of temperatures below 18°C, rating 'cool' to 'cold'.

One reason for the increased temperatures upstairs might be natural stack effect, although the house is provided with MVHR which tends to even out temperatures across both floor and all rooms – however any cooling effect in bedrooms would be through dilution of delivered air rather than extraction of warm air so is likely to be less effective. We can rule out the use of open windows downstairs as well, for as the graph 7.30 shows, in fact the Living Room windows were kept closed noticeably more than the bedroom windows. Also of interest is the fact that solar orientation does not appear to have any obvious effect, since the Living Room (and Main bedroom) face due South, while the Rear bedroom faces due North and receives little or no solar gain.

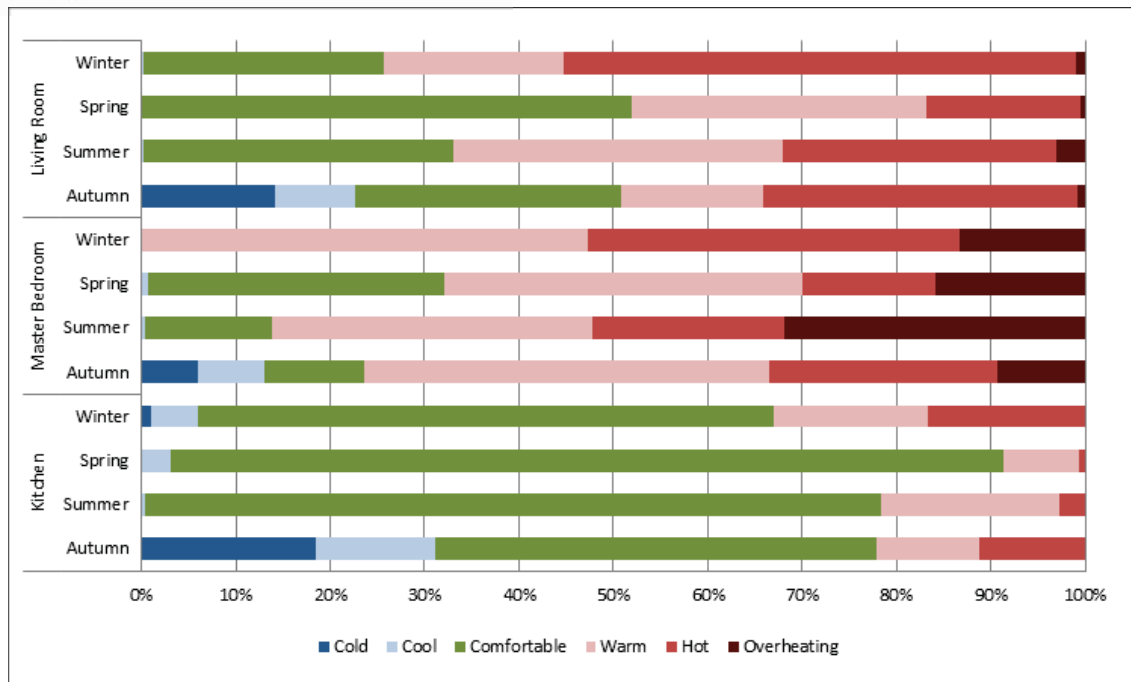
Figure 7.19: Dwelling DA2 – Thermal Comfort by Season during 2013

The temperatures in dwelling DA2 fluctuate significantly between rooms and seasons and this is particularly evident in the Autumn, when temperatures varied between <16°C to >28°C in the Living Room and Kitchen, and <15°C to >26°C in the Master Bedroom. In this case, solar orientation does appear to have some effect as the Kitchen – the only room facing North – is noticeably less prone to overheating.

At first glance, the spread of temperatures in DA2 resemble those from a conventional house which fluctuates more with the external temperatures, window opening and intermittent heating regime. A well-insulated Passivhaus with MVHR should temper internal temperatures more although this depends on small, but regular heat input to maintain temperatures. In this case, the spread in temperatures can be explained by the fact that the occupant switches off the MVHR during the summer (and early Autumn) and tends to leave her windows open for long periods. Thus, the summer and Autumn temperatures indeed reflect the external temperatures more as they would in a 'normal' house without MVHR.

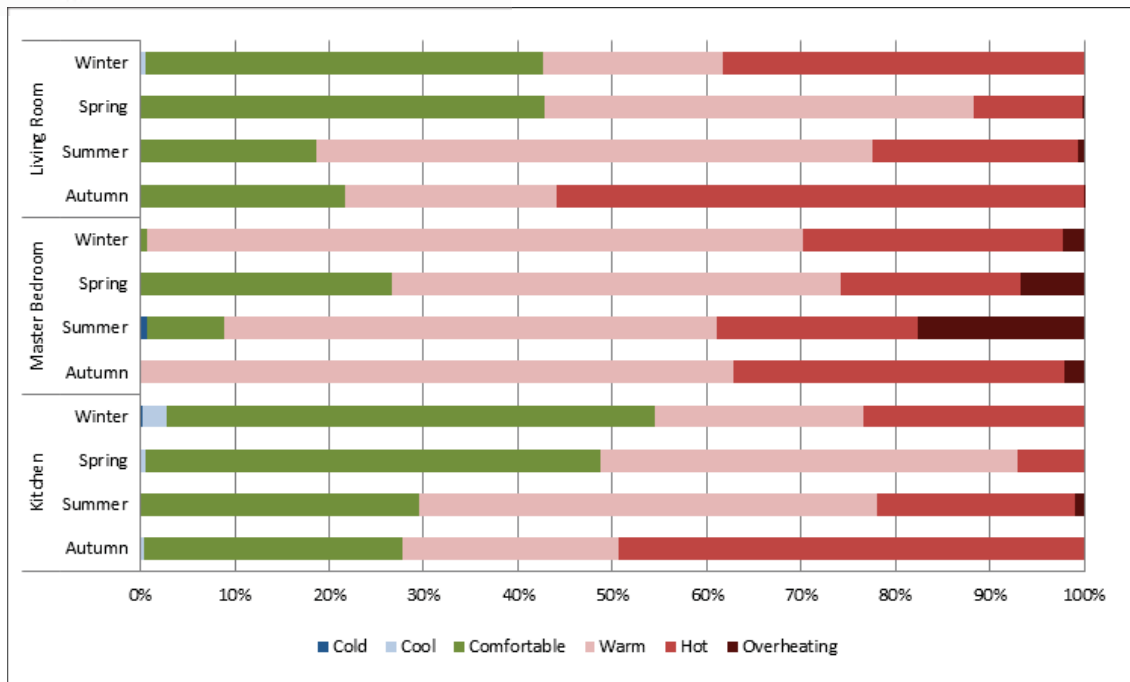
Figure 7.20: Dwelling DB1 – Thermal Comfort by Season during 2013

In dwelling DB1, shown below, the temperatures fluctuated between comfortable and hot throughout the year. This was particularly evident in the Master Bedroom where temperatures ranged from warm to overheating (>26°C) in all 4 seasons. The regulation of temperature and IAQ by opening the window (Figure 7.32) is of a mid-range occurrence in the Master Bedroom, however the Kitchen window was open for 87% of the time in the Summer and 100% in the Autumn. The relative humidity (Figure 7.28) and CO₂ (Figure 7.24) during these months did not appear outside of the midrange in comparison with other rooms, to explain the need to open the Kitchen window for the entirety of Autumn.

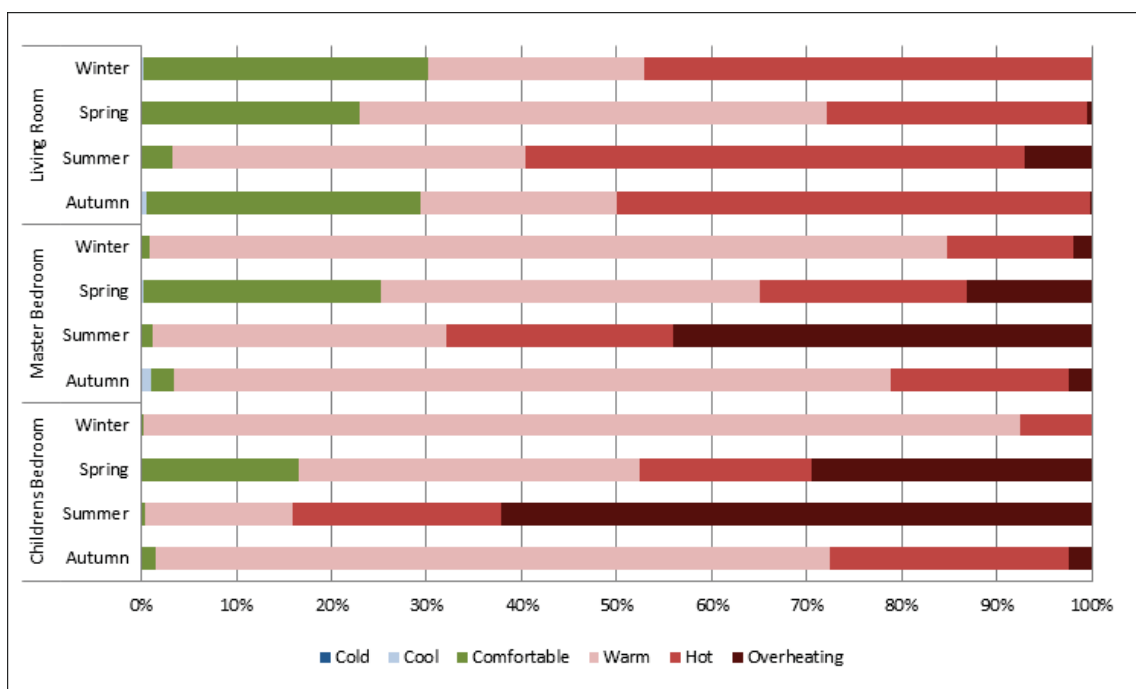
Figure 7.21: Dwelling DB2 – Thermal Comfort by Season during 2013

In dwelling DB2 above, temperatures were predominantly in the warm to hot ranges, with only the Living Room experiencing comfortable temperatures in every season, ranging from 3% in the Summer to 30% of the time in the Winter. However, this room also experienced periods of up to 50% hot temperatures, particularly in the summer when there was a 7% incidence of overheating.

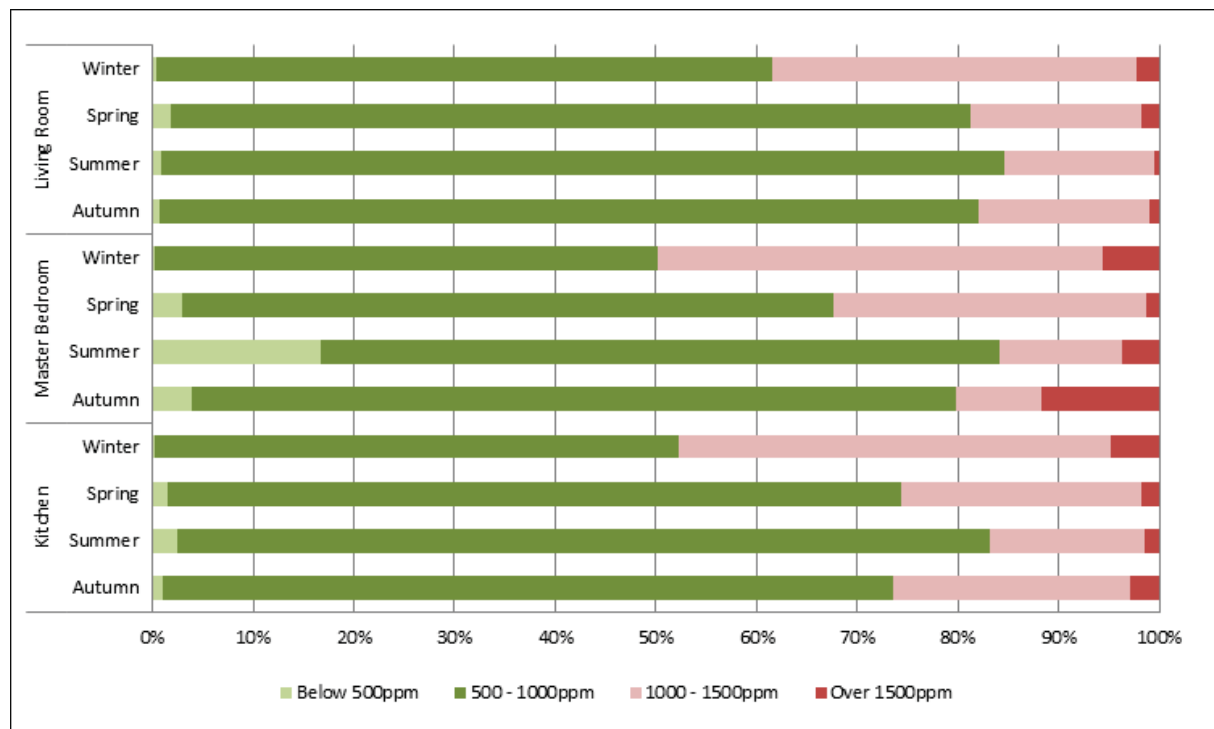
Figure 7.24: Dwelling DB1 –Carbon Dioxide concentrations by Season.

The CO₂ levels in both of the 3-bed houses indicate a greater prevalence of poorer air quality, although there are only rare and insignificant instances of concentration levels over 1500ppm. These raised levels are likely to be associated with the increased occupation of these houses with 5 and 4 occupants respectively compared to 2 (including 1 baby) and 1 (latterly with grandson) in the 2-bed houses. The windows are closed for the entirety of the winter period in the Living Room so the question needs to be asked of the MVHR system. The relationship between occupancy and MVHR is borne out by cross-referencing the MVHR flow rates noted in Section 6.4

(Figure 6.19) in which the whole house flow rates are broadly similar for the 5-person occupied DB1 as they are for the 2-person occupied DA1.

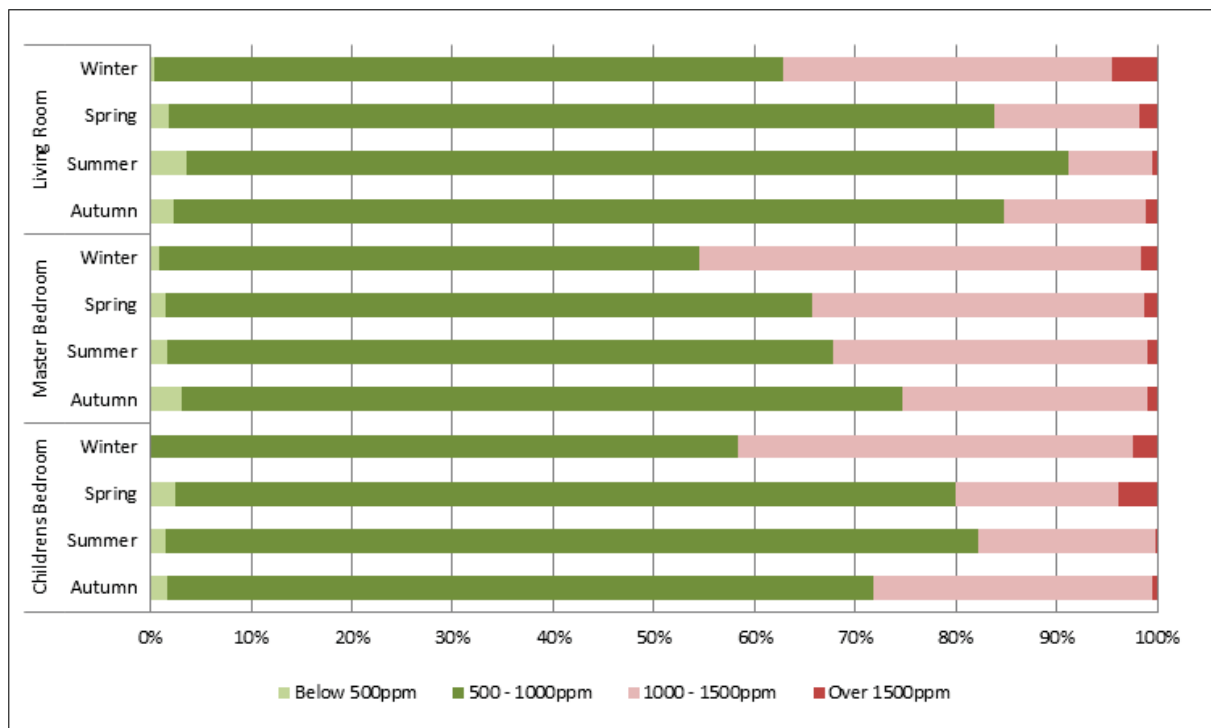
Figure 7.25: Dwelling DB2 –Carbon Dioxide concentrations by Season.

In Dwelling DB2, increased CO₂ concentration levels during the Winter heating months are common across all three rooms. Air is of a 'poor' quality for 44% and 39% of the time in the Master and Children's bedrooms respectively. The windows in all rooms were only opened a few times during the Winter months, registering at 1% or less of the total time. Again, this can be traced to the increased occupation not being matched by a sufficiently increased MVHR flow rate across the whole house.

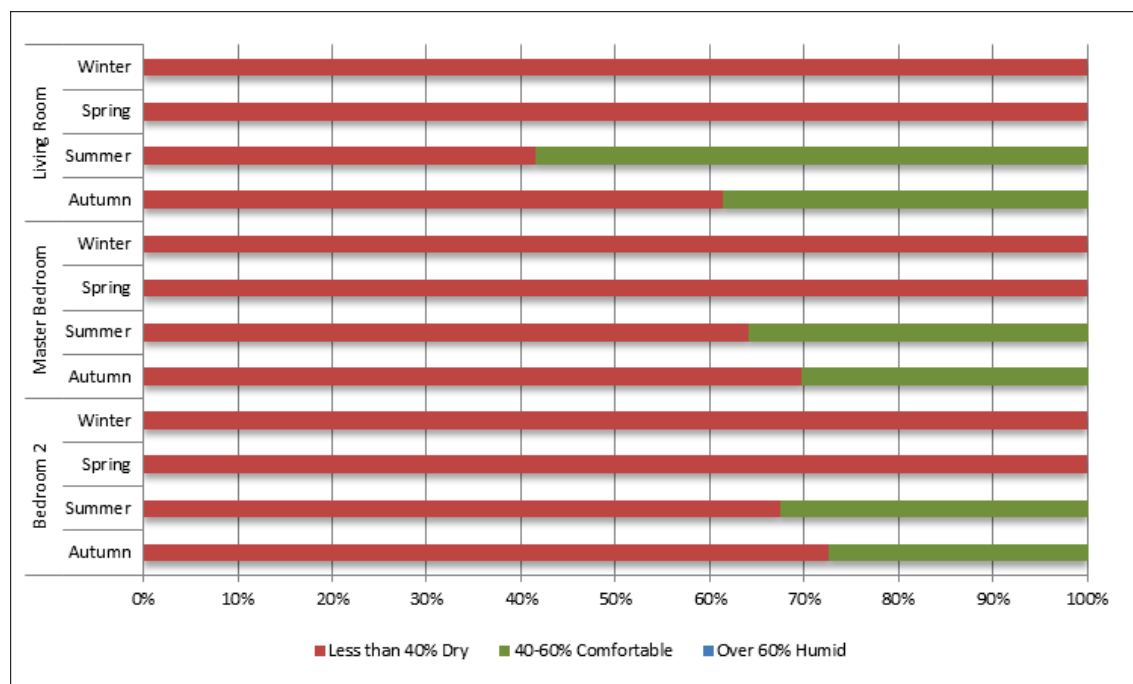
Figure 7.26: Dwelling DA1 – Relative Humidity (RH %) by Season.

Overall, humidity ranged from dry to comfortable, except in the Living Room and Bedroom 2 during the Winter and Spring months. The drier air, particularly in the heating months relates to the higher levels of heating in this dwelling, when there were significant 'hot' and 'overheating' periods. The long periods of time when humidity levels are low could have health implications on the occupants.

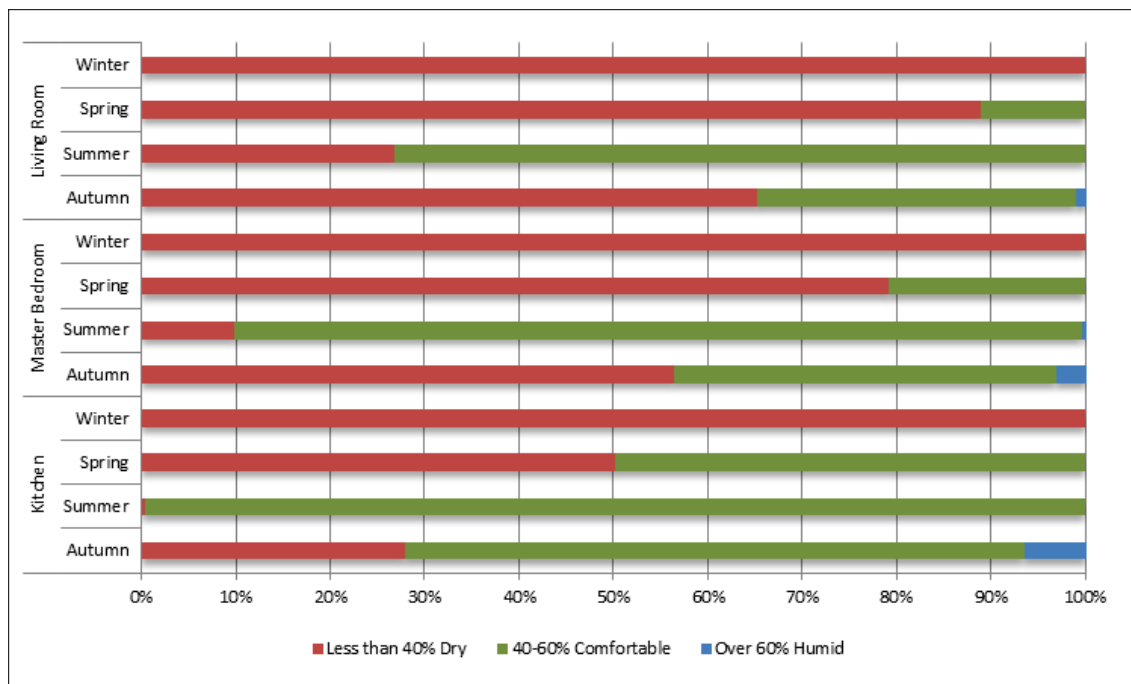
In Dwelling DA2 shown below, there was a wide range of RH levels. The trend in Winter and Spring was predominantly dry air in all rooms associated with a heating regime and MVHR use, whereas the trend in the Summer was towards a more comfortable level of humidity associated with reduced need for heating, less use of the MVHR system and greater window opening.

Figure 7.27: Dwelling DA2 – Relative Humidity (RH %) by Season.

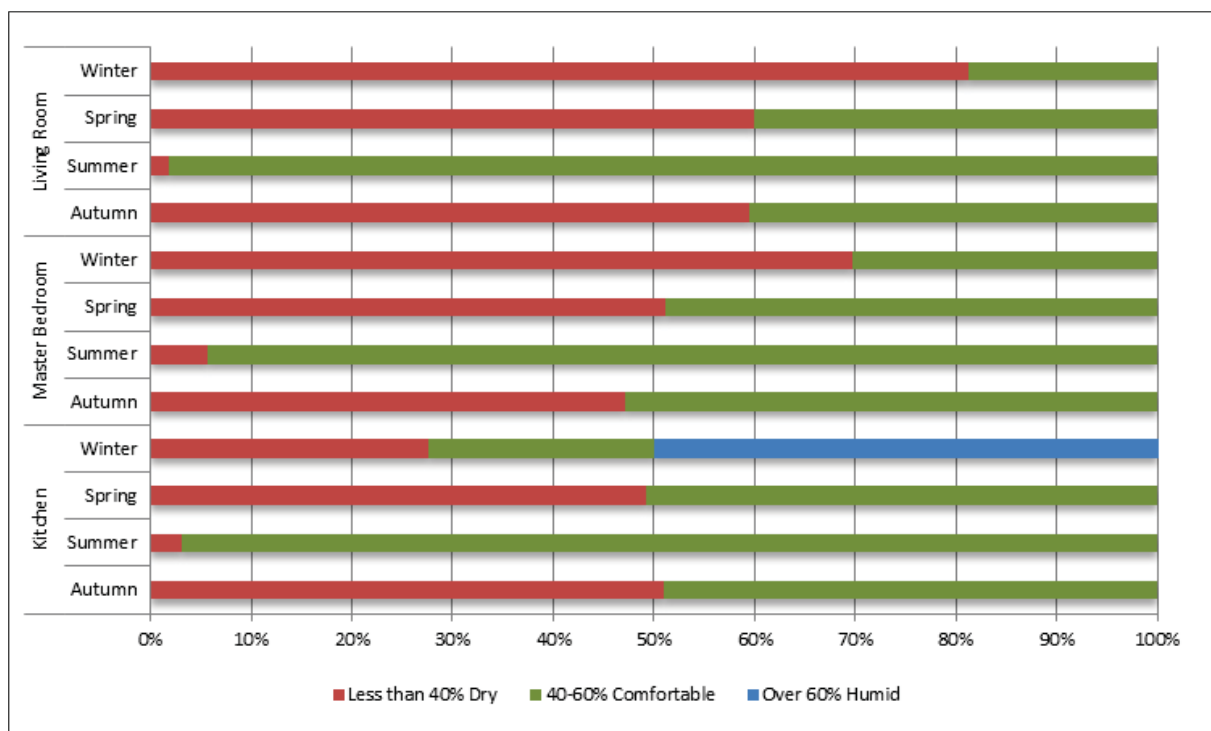
Figure 7.28: Dwelling DB1 – Relative Humidity (RH %) by Season.

In Dwelling DB1 the pattern noted above is repeated with noticeably drier air in the colder months associated both with heating and MVHR use, while summer levels are generally healthier. The 'humid' result for the Kitchen in winter is likely to be associated with insufficient extract rates to the Kitchen.

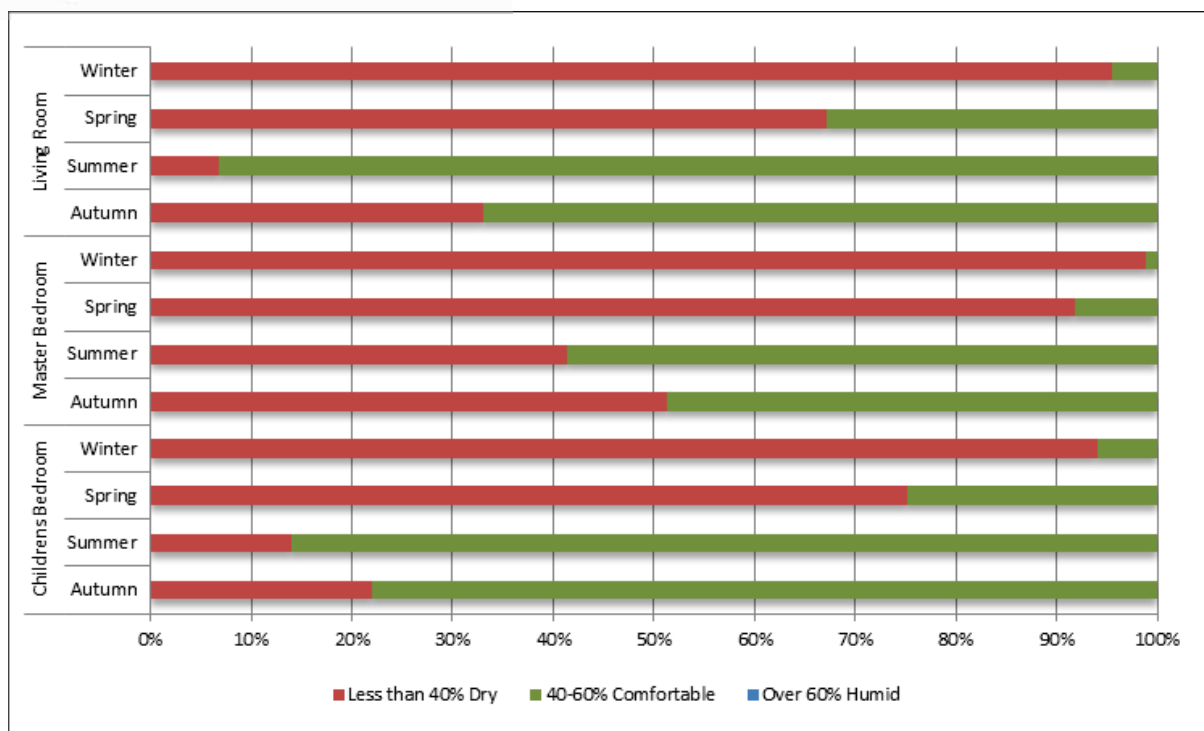
Figure 7.29: Dwelling DB2 – Relative Humidity (RH %) by Season.

In Dwelling DB2 the RH range fluctuates seasonally and by room, ranging between dry and comfortable, with no periods over 60% humidity. The Summer and Autumn months, as expected for non-heating season, have healthier levels of RH: in the 'comfort' range. All three rooms are drier during the winter months, this is related to the heating season, MVHR use and 'warm' to 'hot' internal temperatures achieved at this time.

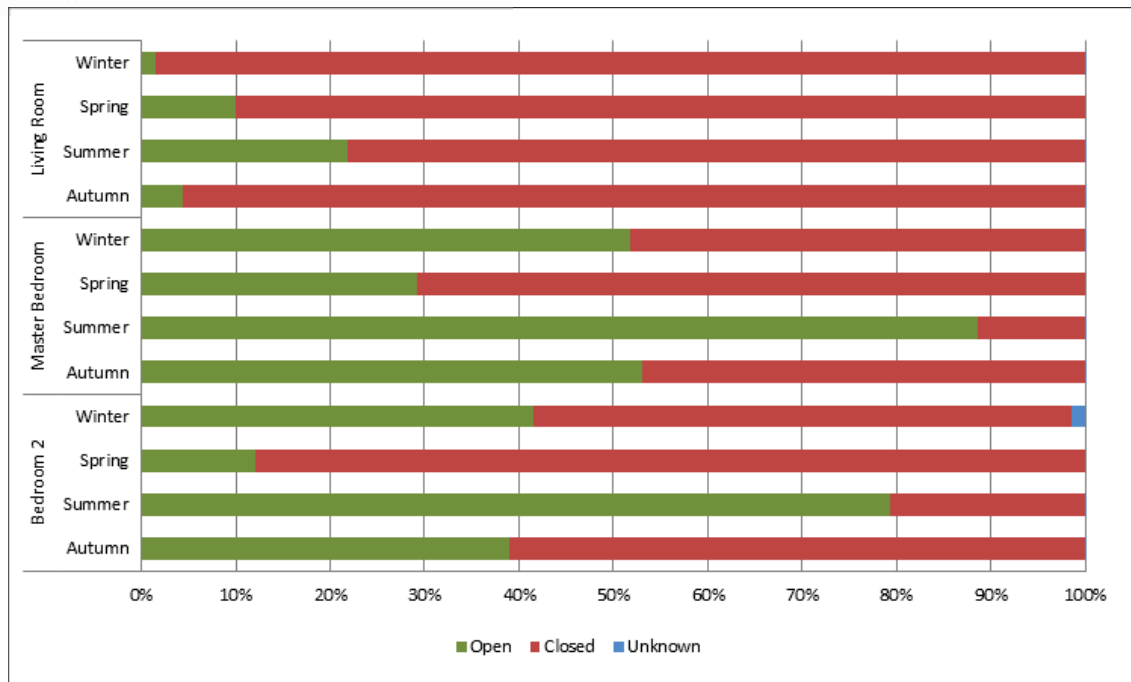
Figure 7.30: Dwelling DA1 – Window opening patterns (Ventilation) by Season.

In all rooms of dwelling DA1 the window opening patterns are fairly consistent with seasonal occupancy. However, **Figure 7.30** above shows that the Bedroom windows were opened more frequently than those of the Living Room, consistent with the occupant feedback about overheating. Window opening in the bedrooms is likely to be related to the more pressing overheating problems and the fact that these are being opened at all can be linked to the lack of a summer bypass in the MVHR.
