This document contains a Building Performance Evaluation report from the £8 million Building Performance Evaluation research programme funded by the Department of Business Innovation and Skills between 2010 and 2015. The report was originally published by InnovateUK and made available for public use via the building data exchange website hosted by InnovateUK until 2019. This website is now hosting the BPE reports as a research archive. Although no support or further information on the reports is available from the host, further information may be available from the original InnovateUK project evaluator using the link below¹.

| InnovateUK project number | 450097 |
| Project author | Glasgow School of Art, Mackintosh Environmental Architecture Research Unit (MEARU) for Dormont Estate |

| Four | Lockerbie | Semi-detached | 2011 |

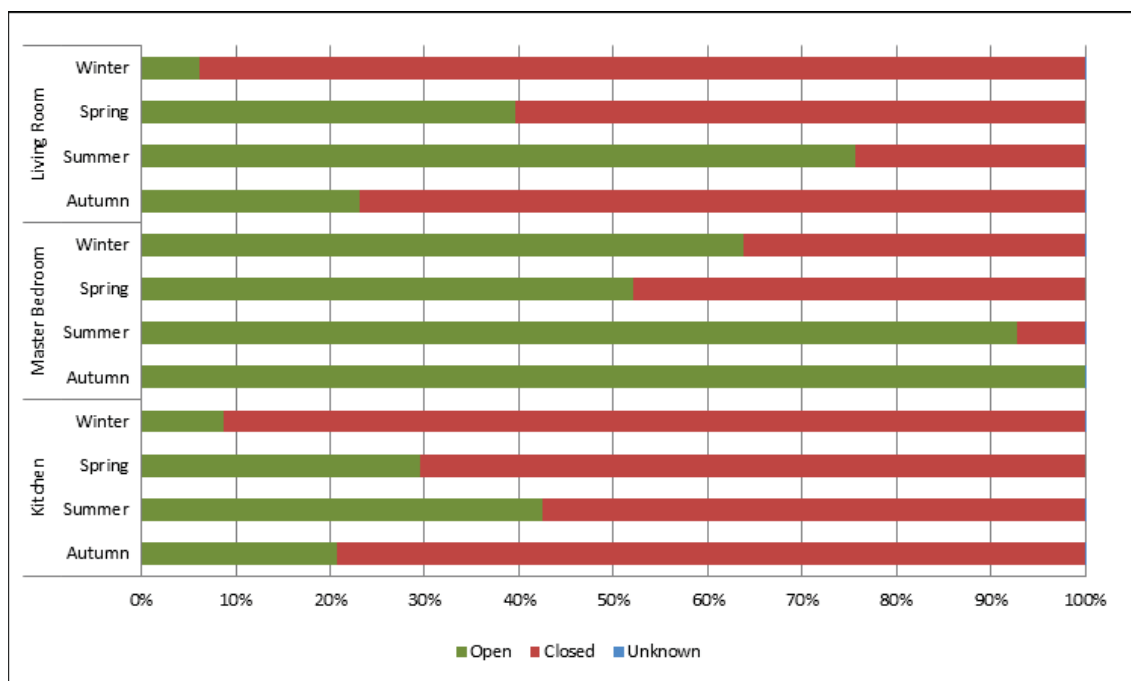
Figure 7.31: Dwelling DA2 – Window opening patterns (Ventilation) by Season.

As with DA1, the window opening patterns of dwelling DA2 indicate that, in all rooms the patterns are fairly consistent with seasonal occupancy. However, it also shows that the bedroom windows were opened more

frequently than those of the Living Room, concurrent with issues identified with overheating, particularly in the Autumn.

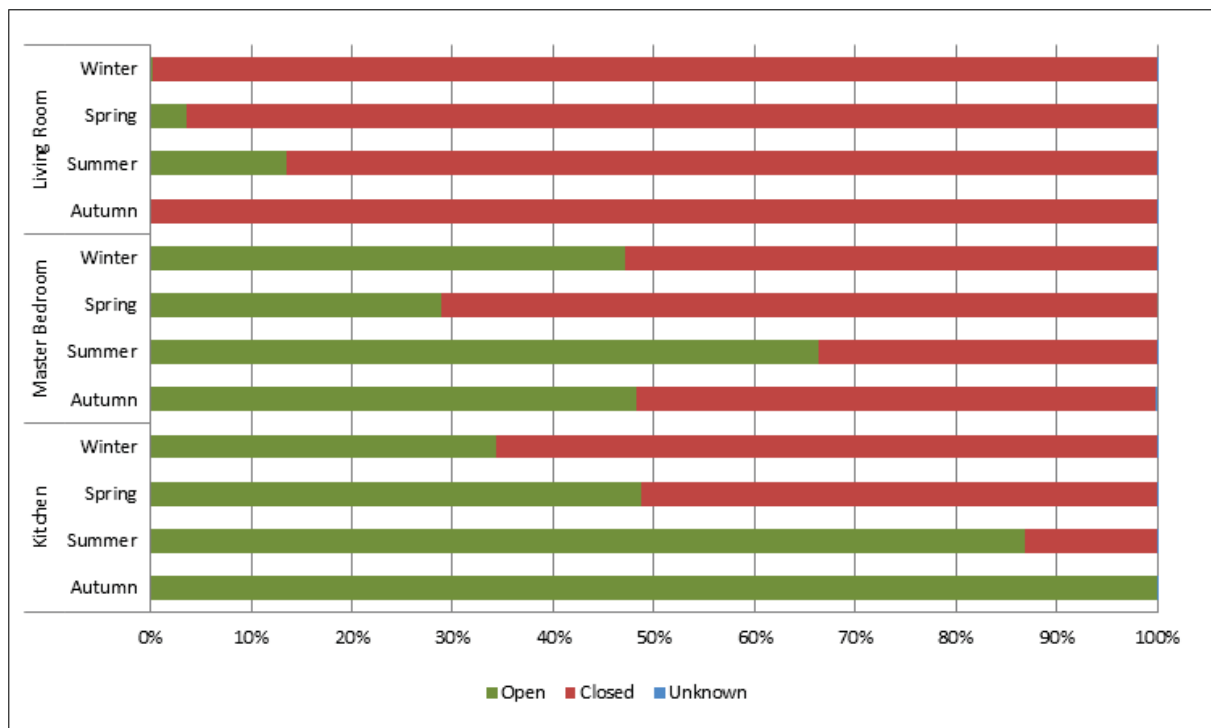
In dwelling DB1, shown below, the temperatures fluctuated between comfortable and hot throughout the year. This was particularly evident in the Master Bedroom where temperatures ranged from warm to overheating (>26°C) in all 4 seasons. The regulation of temperature and IAQ by opening the window (Figure 7.32) is of a mid-range occurrence in the Master Bedroom, however the Kitchen window was open for 87% of the time in the Summer and 100% in the Autumn. The relative humidity (Figure 7.28) and CO₂ (Figure 7.24) during these months did not appear outside of the midrange in comparison with other rooms, to explain the need to open the Kitchen window for the entirety of Autumn.

Figure 7.32: Dwelling DB1 – Window opening patterns (Ventilation) by Season.

The window opening patterns of DB1 are not consistent with seasonal patterns of opening. In the Living Room the windows were rarely open compared to the other two rooms. In the Winter and Autumn they were closed 100% of the time. Whereas in the summer they were only open for 14% of the time. The Master Bedroom opening patterns were more consistent with the seasons, however they were open less in the Spring than in the Autumn and Winter, the window was open for 66% of the summer months, this is not concurrent with the periods of 'hot' to 'overheating' in the temperature analysis.

In the Kitchen the window was open for 87% of the time in the Summer months and 100% of the time in the Autumn. This would suggest a problem with temperatures and thermal comfort during this period.

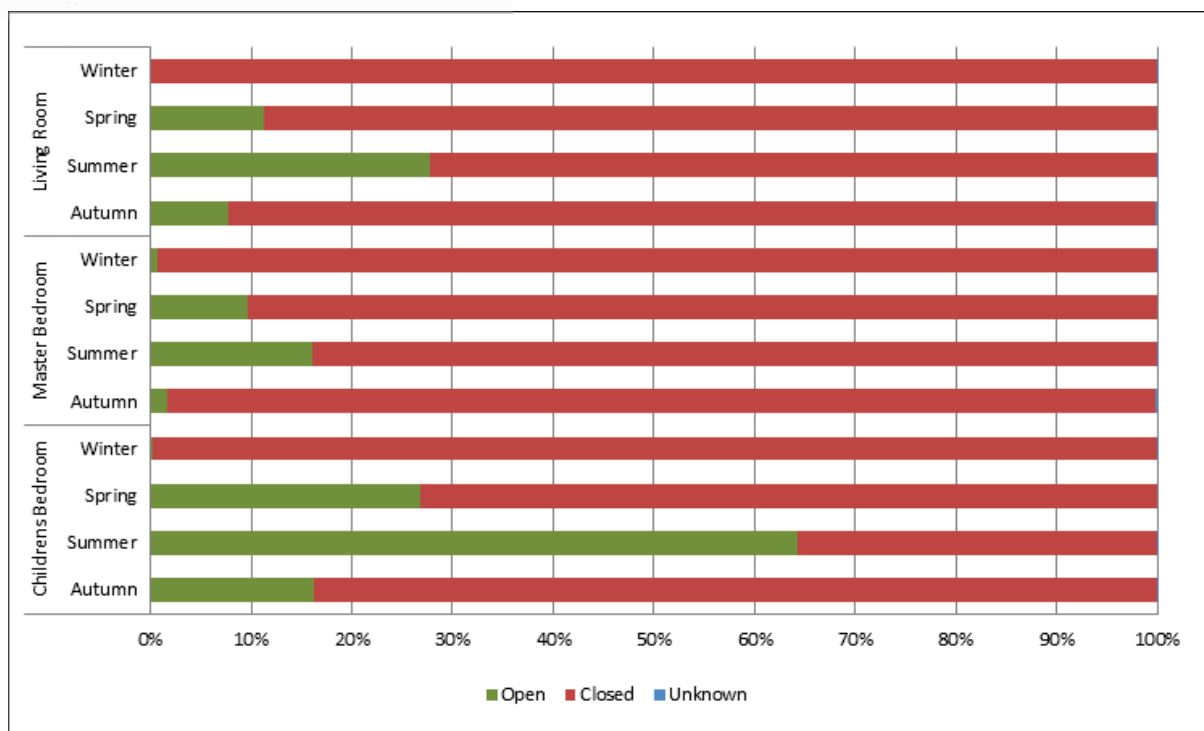
during the summer months. With temperatures at 22% hot for both rooms. The window in the Master Bedroom was only open for 16% of the summer months, whereas the Children's bedroom window was open for 64% (**Figure 7.33**).

Figure 7.33: Dwelling DB2 – Window opening patterns (Ventilation) by Season.

The windows in DB2 are not opened much, the least of all of the dwellings. As expected with seasonal opening patterns, windows are opened in every room during the summer months, but closed throughout the winter.

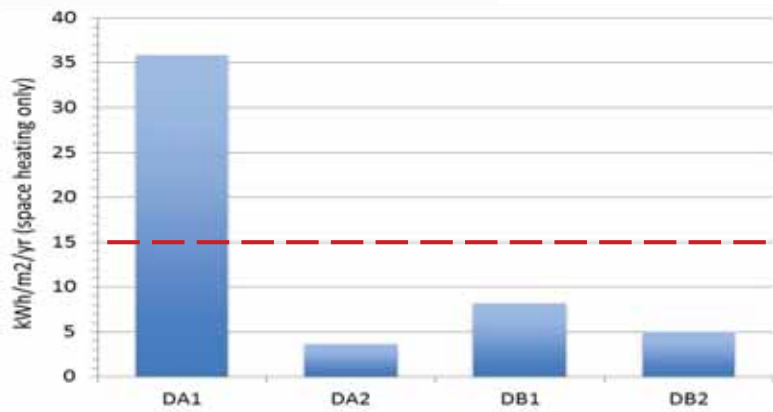
Figure 8.2: Actual annual space heating energy consumption per square metre for Dormont Park in 2013 in blue against Passivhaus threshold of 15 kWh/m²/yr.

It would appear that three of the houses are performing 'in a manner consistent with Passivhaus expectation', and all the more so given that a percentage of the energy expended has contributed to the overheating of the houses, such that energy expended to maintain the houses at 20°C exactly might have been less. The average space heating demand for the four monitored houses is 13.15 kWh/m²/yr which on the basis noted above of averaging the 'real life' performance would reinforce the notion that the buildings are performing as expected.

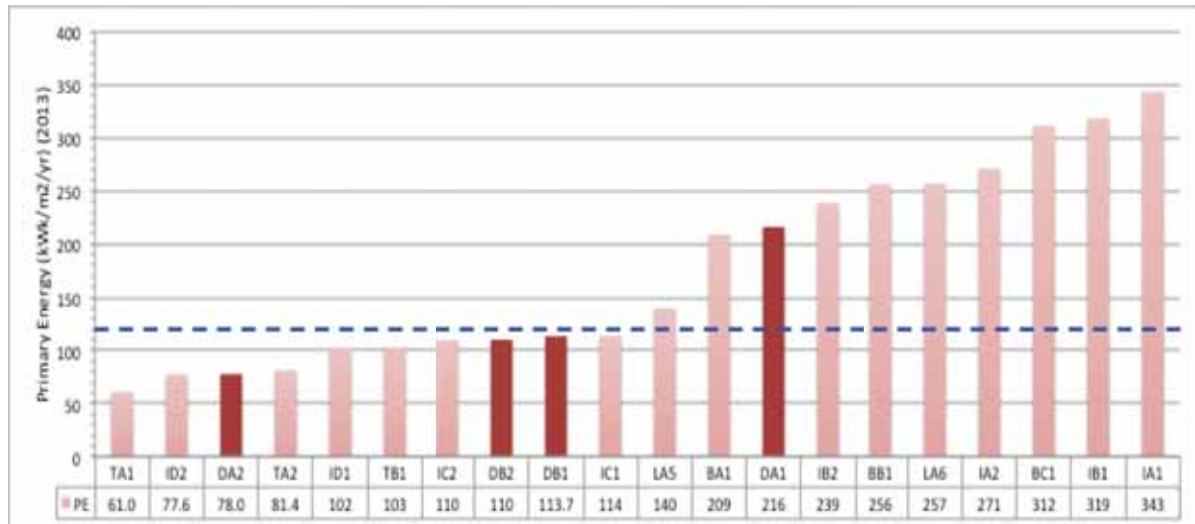
We can see therefore that three of the houses comply with this requirement in reality, while DA1 – with its initially high level of immersion heater use in preference to use of the stove – falls outwith the 120 kWh/a/m² threshold (shown in the blue dashed line).

Figure 8.4: Overall Primary Energy Consumption per square metre in 20no monitored dwellings for the period Dec '12 to Nov '13 inclusive showing the Dormont houses in darker red and the Passivhaus PE threshold in blue dashed line (120 kWh/m²/yr).

This raises the question of design intentions, anticipated or typical use, against actual consumption by real occupants. For example, it could not have been anticipated that the Occupier of DA1 would eschew the use of the wood stove and use the immerser instead. There is no accounting for occupant behaviour and this is not necessarily a fair reflection on the design and construction of the building, but at the same time, it clearly illustrates the need for systems to be understandable and usable.
