Eli Lilly Research Office Building

Innovate UK project number	450058
Project lead and author	AECOM
Report date	2013
InnovateUK Evaluator	Unknown (Contact via www.bpe-specialists.org.uk)

Building sector	Location	Form of contract	Opened
Offices	Windlesham.	Traditional	2012
Floor area	Storeys	EPC / DEC	BREEAM rating
Main building: 2150 m ²	2	B (46) / N/A	Excellent

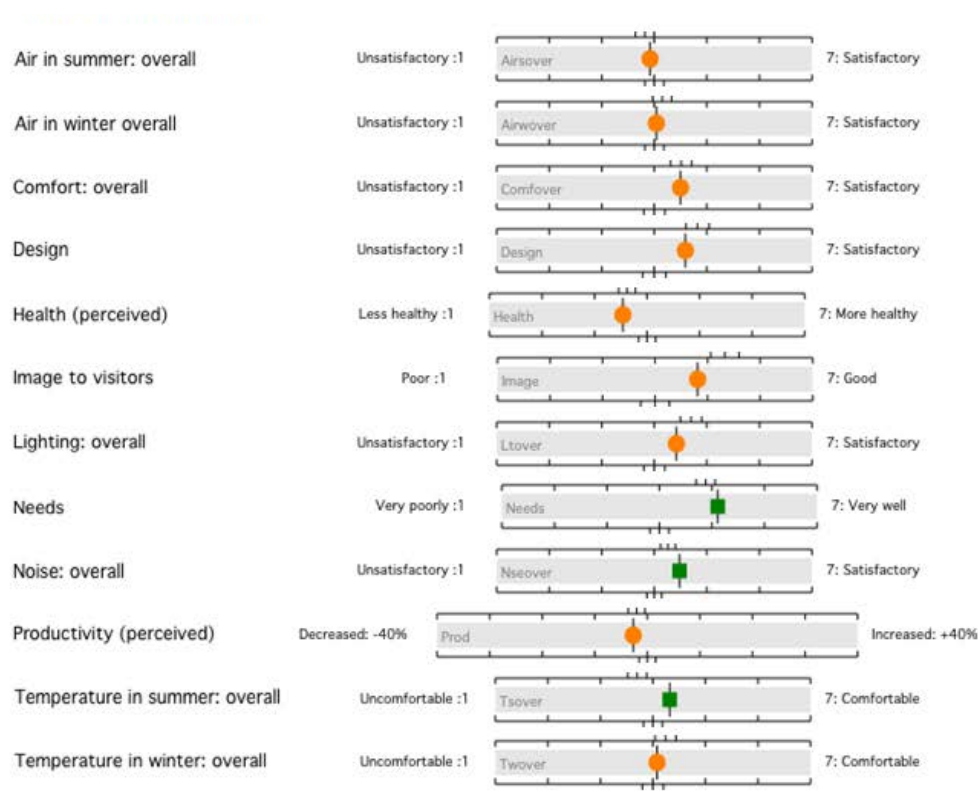
Figure 7 The overall summary from the BUS carried out for the EMC building

The chart in Figure 7 below summarises the main outcome of the BUS carried out on the EMC building. For more details, please refer to report in appendix A18. In general, it can be seen that the occupants were reasonably satisfied with the accommodation provided by the EMC building. The EMC building is shown to be within the typical norm in comparison to the database averages and ranges.

However, there are minor shortfalls that came to light in some of the specific aspects surveyed. Some occupants highlighted undesirable disruption from internal noise and glare from artificial lighting. A proportion of the occupants also indicated that the building was slightly cold in the winter as well as the summer periods. There was a general dissatisfaction with the level of controls available to them for space conditioning set-point, lighting and ventilation.

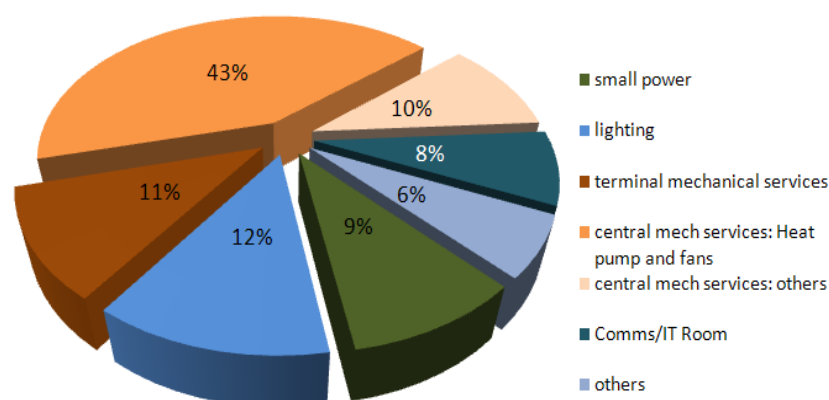
Figure 10 breakdown of energy use in the ROB based on major end-use categories

For this study, the analysis of energy use by the ROB was based on the data extracted from the eSight Energy website between 1st May and 31st December 2012. Figure 10 shows the proportion of energy use in the ROB based on the major end-use categories for this period. A large proportion of energy use is shown to be associated with delivery of space conditioning (heating, cooling and fan energy).

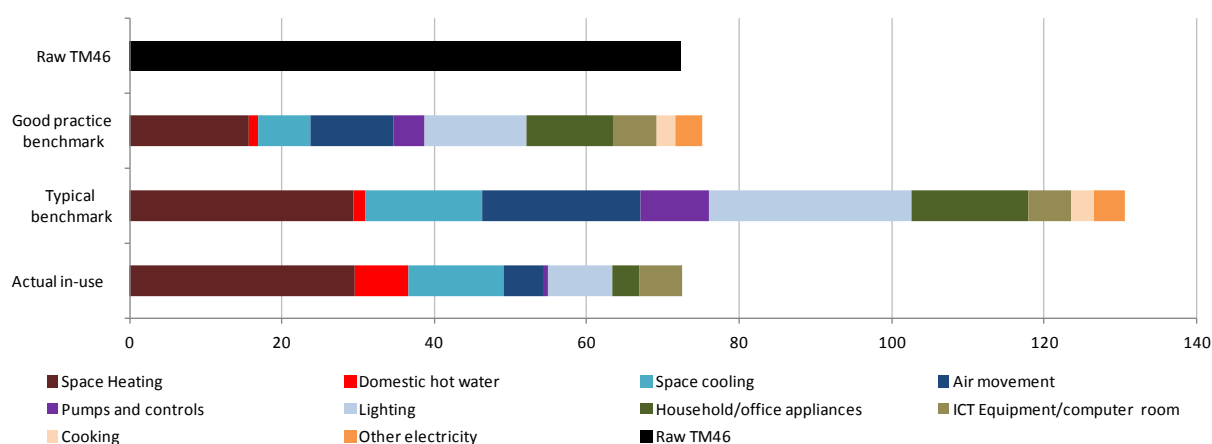
Figure 12: The ROB actual in-use breakdown of energy use by end-use categories, compared against its corresponding benchmarks

It can be seen that the ROB energy use for ventilation is much lower in comparison, an attribute to its mixed-mode strategy. Low energy use for small power was due to low occupancy and low energy use for lighting is a result of good lighting design and associated controls. The chart also highlights relatively high energy use for space heating, cooling and hot water, all with potential for further optimisation. Please refer to Appendix A14 and A15 for more information.
