# Graham Construction Head Office

<b>Innovate UK project number</b>	450087
<b>Project lead and author</b>	GRAHAM Construction
<b>Report date</b>	2014
<b>InnovateUK Evaluator</b>	Unknown (Contact via <a href="http://www.bpe-specialists.org.uk">www.bpe-specialists.org.uk</a> )

<b>Building sector</b>	<b>Location</b>	<b>Form of contract</b>	<b>Opened</b>
Offices	Hillsborough, NI	Design and build	2009
<b>Floor area (TFA)</b>	<b>Storeys</b>	<b>EPC / DEC</b>	<b>BREEAM rating</b>
3106.5 m <sup>2</sup>	3	A / C (unofficial)	Excellent

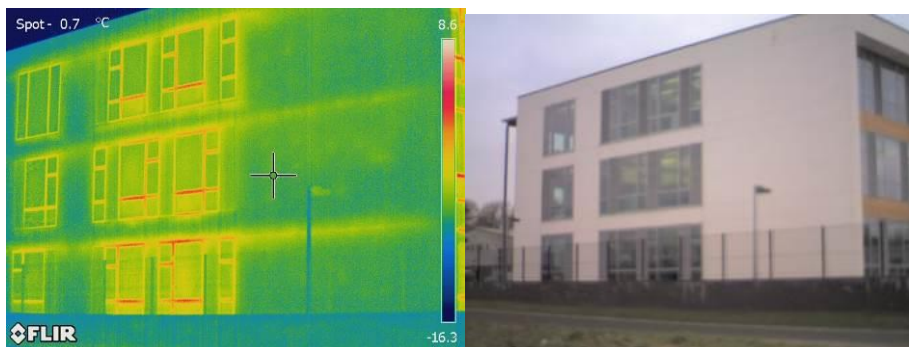
Figure 4.8 Thermal image of external right side gable and location photograph

The thermal image in Figure 4.8 illustrates a consistent and uniform heat loss profile for the right side gable wall of the building. Like the left gable there is evidence of thermal bridging where the floor slabs meet the external wall and this contributes to marginal heat loss which spans across the gable as evidenced by the 'fingers' or 'line' of lighter colour heat loss patterns in the image tracking the floor slabs across all levels.

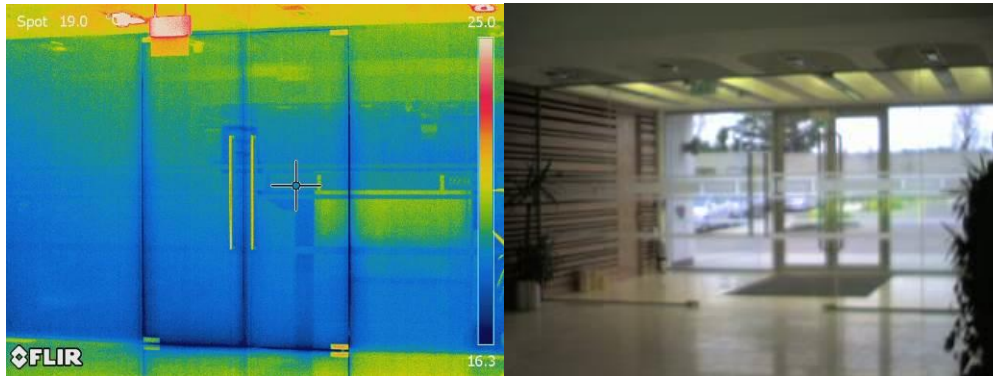
Figure 4.9 Thermal image of internal rear access door exiting to rear car park

The thermal images in Figures 4.9 and 4.10 illustrate the effect of the lobby space on the surface temperatures around the door. In general the doors are effective at minimising heat loss with a small temperature decrease at the bottom of the door which is a result of increased heat loss to the cooler lobby area. The cooler lobby air is clearly illustrated by the open door in figure 4.10 which is typical across all buildings of this nature.

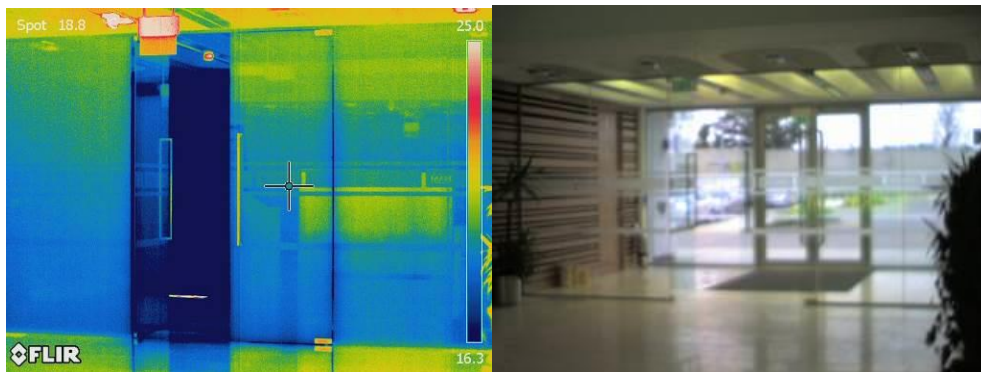
Figure 4.10 Thermal Image of internal rear access door (door ajar) exiting to rear car park

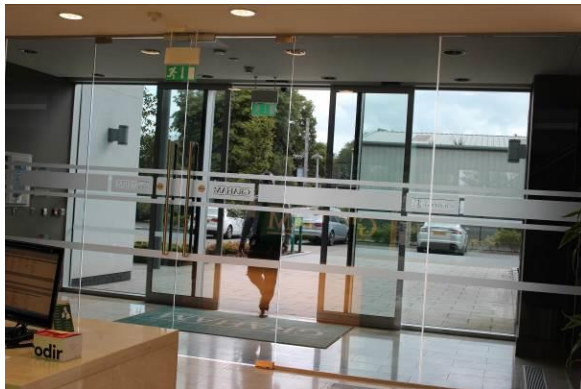
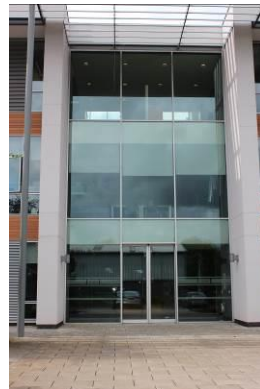
Figure 4.11 Sliding doors at the front reception area

The air tightness test produced a result which is a small improvement on the original test of 4.98 m<sup>3</sup>/hr/m<sup>2</sup>. The building has maintained high levels of air tightness post construction. Following the air tightness test Stroma carried out a smoke test. Results from this have been recorded and a short video clip produced. This has been submitted to TSB. The main findings of the smoke test indicated that there was a draught from the main door when it was closed. The draught was following a curve around to the north west side of the building and rising up beside the lift. This draught intensified significantly when the front door was open. It was recommended that new brushes be installed on the outside door and further draught proofing measures installed on the inner door. Stroma commented that if the main door was properly sealed the air tightness results could have been improved. Possibly a revolving door would have been more air tight but the remedial measures should improve performance.

Air tightness results are slightly better than they were at building handover. This means that there have been no significant changes to the building fabric performance since handover. The smoke test was able to show that drafts are an issue in the building particularly around the entrance foyer, the atrium, the lift and the area to the right of reception on the ground floor. New brushes have been fitted to the exterior door, however the sliding door at the main entrance will still cause increased air flow when it is in use.

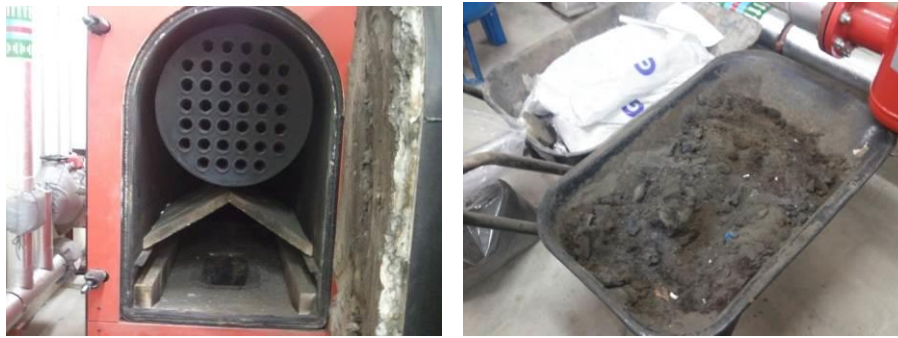
Fig 6.1 Biomass Boiler Maintenance

The biomass boiler needs to be cleaned out every two weeks – this is not a problem and has been added to FM Duties. The oil boiler is serviced twice a year therefore there is no maintenance for FM – this is outsourced. The biomass boiler has only broken down once and this was caused by pellets trapped in the auger.

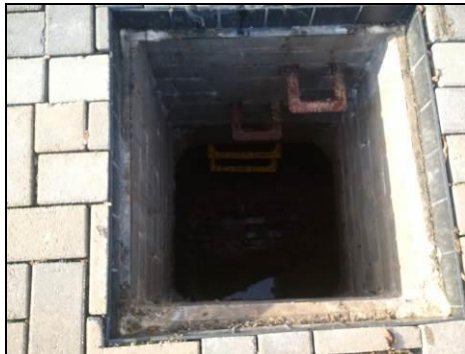
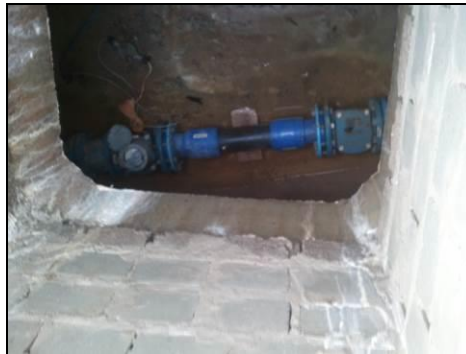
Fig 6.2 Site Mains Water Meter

Accurate data on the site mains water consumption is still not available for the building even though the issue was raised at the beginning of the BPE project. Although sub-metering is in place and connected to the BMS and TEM systems, the readings do not make sense. The site mains water meter is reading less than the water consumed from the entire site. The site mains water meter is located under the external car park and it is difficult to access to take physical readings. A harness and other safety equipment would be required to access it.

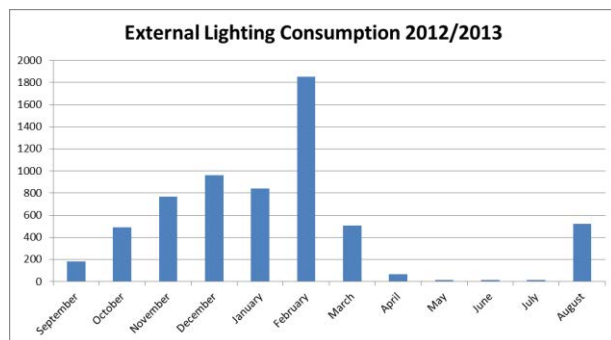
Figure 7.11 External Lighting Consumption Year 1

External Lighting consumption has reduced by 48% from Year 1 to Year 2. The higher consumption in Year 1 was due to a fault with the timer in February 2013. This was repaired in March 2013 and consumption has continued to stay low since then. External lighting load profiles can be viewed on the TEM system and show optimum operating hours in use and seasonal variances.

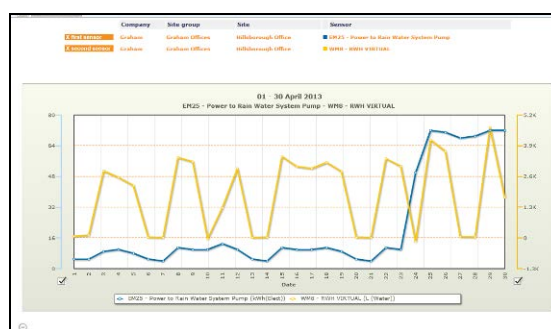
Figure 7.27 April Consumption RWH Pump

The annual energy consumption graphs below for the Rainwater Harvesting pumps show that there was a fault in the pump in May 2013. This fault was causing the pump to run continuously. Facilities management arranged for this to be repaired and normal operation resumed in June 2013. This fault caused consumption to be almost 8 times greater in May 2013 than it would be in a normal month. This can account for some of the increased energy consumption in Year 1. The graph below shows the fault beginning in April 2013 with no change to the amount of rainwater collected.

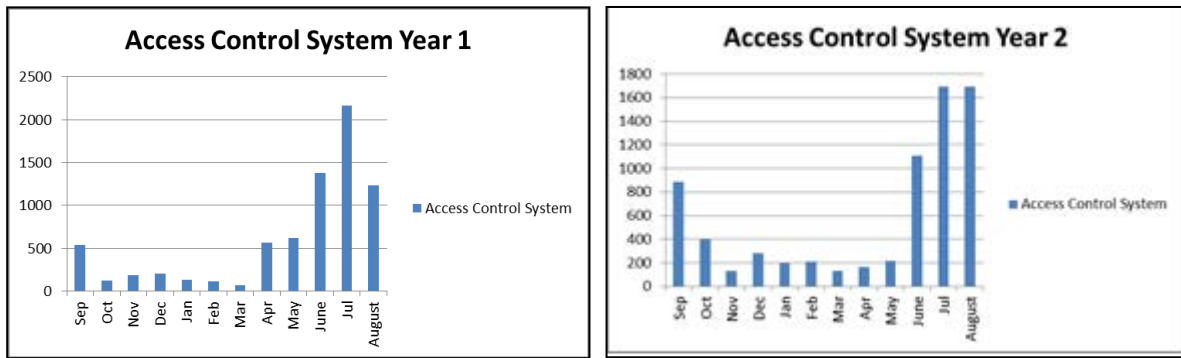
Figure 7.28 Annual Consumption Access Control Panel Year 1 and Year 2

The Access Control System provided some issues with regards to TM22 and in predicting/reconciling loads for sub-meter readings. It was originally thought that the meter was only measuring electricity from the access control system that staff use to gain entry to the building and additionally the security system/cameras etc. However the readings from the sub-meter were quite erratic particularly over the summer months.

From the above graphs it is clear that consumption was increasing over the summer months and decreasing again in winter.

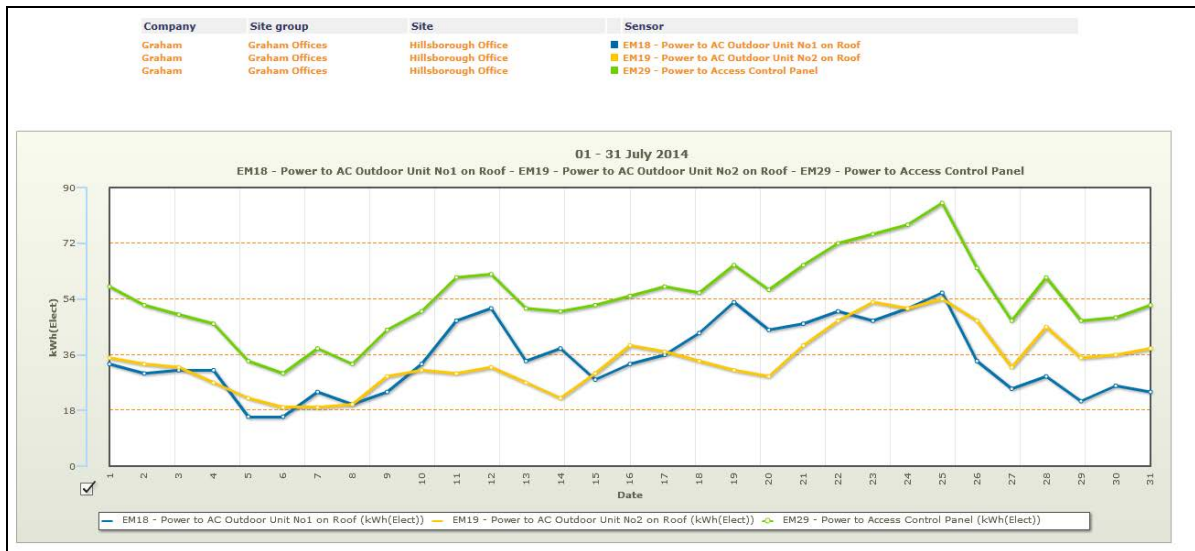
Figure 7.29 Load Profile of Access Control Panel and Air Conditioning Units

From the graph above the green line shows the load profile of the Access Control Panel sub-meter and the blue and yellow lines show the Air Conditioning sub-meters. The load profiles are so similar that air conditioning was suspected to be the additional load on the Access Control Panel sub-meter. Following on from this and after further inspections in the plant room a piece of duct tape had been used to cover over the access control panel switch.

It was deduced from this that the Air Conditioning in the server room is metered from this sub-meter. This was not in the design drawings and is not written down anywhere except for on this piece of duct tape. The load for the Access Control system should probably be added to the Air Conditioning consumption however it is difficult to do this as the Access Control panel has other loads linked to it. The TM22 analysis should be able to pick this up.

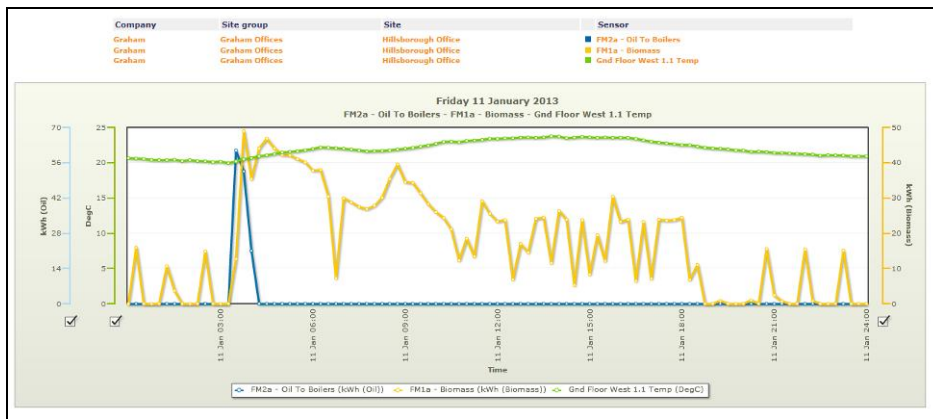
Figure 7.34 Boiler load profiles January 2013

The biomass and oil boilers operate on a pre-programmed boiler optimisation programme which is controlled by the time and temperature targets for the main building programmed into the BMS. See below a graph from the TEM system showing an average 24 hour load profile for the boilers during January 2013. Both the Biomass and the Oil boiler were coming on at 3am in the morning to ensure the building was at an optimum temperature by 7am. Most building occupants arrive for work at 8.30am onwards. FM have been asked to trial moving the set points to see if optimum temperatures can be achieved by firing up the boiler later.

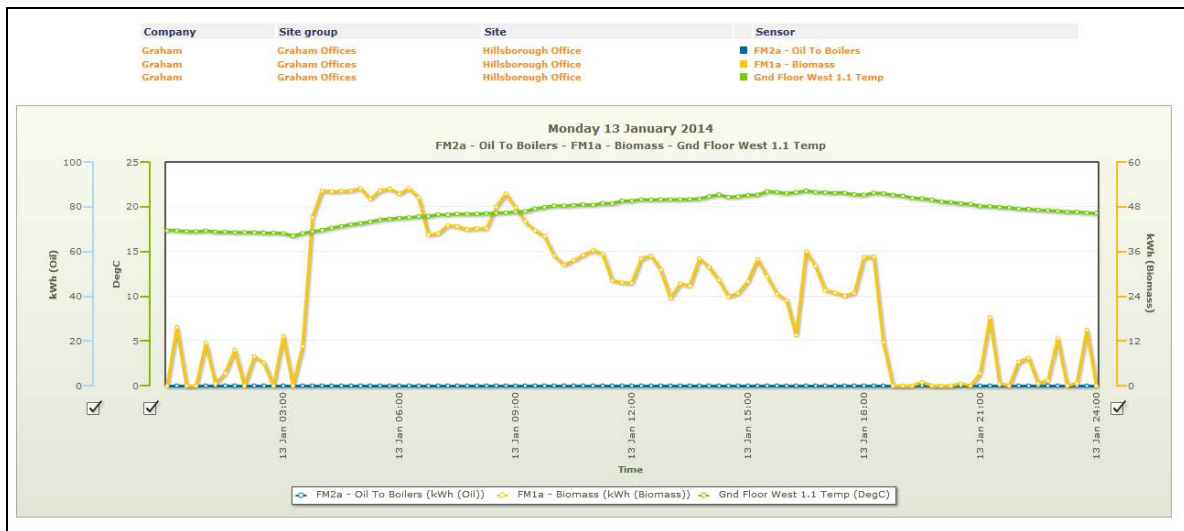
Figure 7.35 24 hour boiler profile January 2014

In addition the oil boiler was coming on at the same time as the Biomass. This was decided as unnecessary and in Year 2 the BMS was programmed so that only the Biomass boiler would be switched on to provide heating. The graph below shows a typical Monday in January. Starting temperatures in the building are typically much lower on a Monday and as such the boiler optimiser could be justified for bringing the boiler on at 3am. However it does not seem efficient to be bringing the boilers on at the same time on other week days when internal temperatures do not require a substantial uplift. Recommend that FM review the boiler optimisation programme to see if further savings can be made.

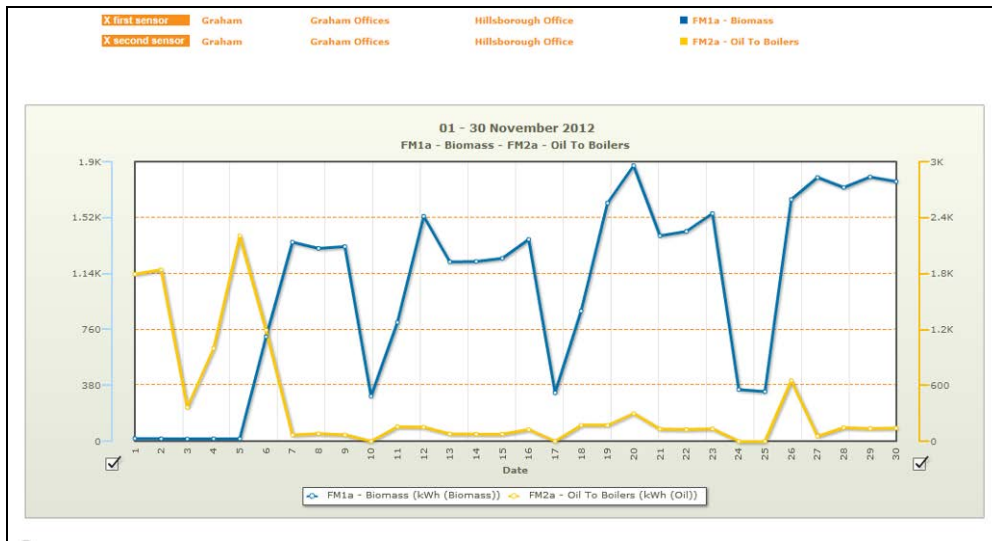
Figure 7.36 Boiler profile November 2012

The graph below shows the biomass and oil boilers load profiles in November 2012. The boilers were coming on on Sundays when they shouldn't have been. This was changed for December 2012 and subsequent savings were made.

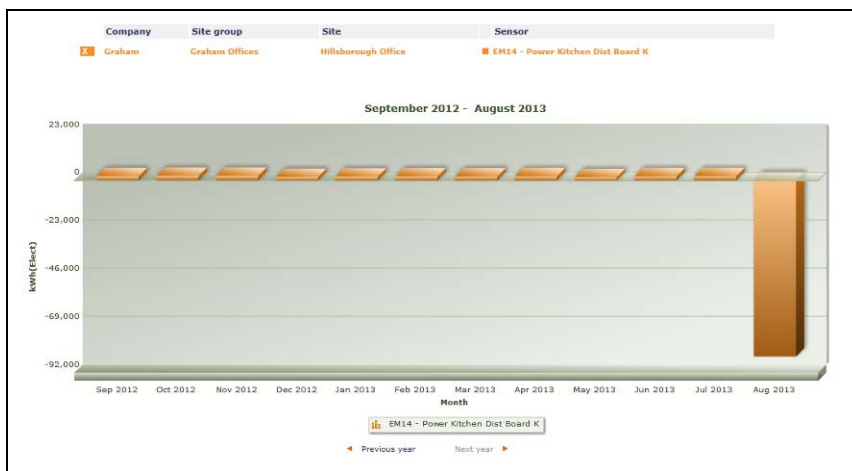
Fig 7.38 Kitchen Monthly Consumption – August figures high negative value

- A number of powercuts and faults with the metering system have resulted in numerous weeks of data being lost. This has happened on six separate occasions. Each time there was no alarm to indicate the system had stopped working. Only when the TEM system was accessed was it apparent that the system had stopped recording.
- The readings from the meters have caused issues in that a high number of them record very low and very high readings as if self-calibrating. Some of these readings make it impossible to use historical graphs and data from the TEM. This has been reported to the metering controls contractor however they have been unable to resolve the issue.

GRAHAM have decided to appoint a new contractor for the maintenance of the BMS and metering systems at the headquarters office. It is hoped that the new contractor can assist in

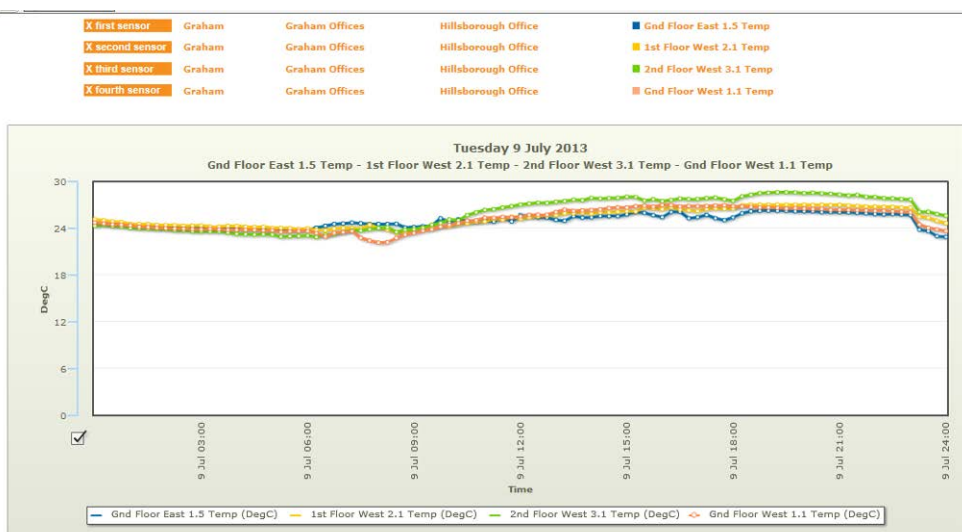
Fig 8.8 24 hour temperatures Summer 2013

One of the warmest days recorded in July 2013 was the 9<sup>th</sup> July. The above graph shows the temperatures inside the building over the 24 hour period. Again the 2<sup>nd</sup> floor seems to be the most susceptible to overheating. However the highest temperatures were recorded after 6pm when the working day was over. Overheating is not prolonged, however this could cause discomfort to occupants located underneath the atrium or in direct sunlight. No substantial complaints have been made about overheating on the 2<sup>nd</sup> floor.

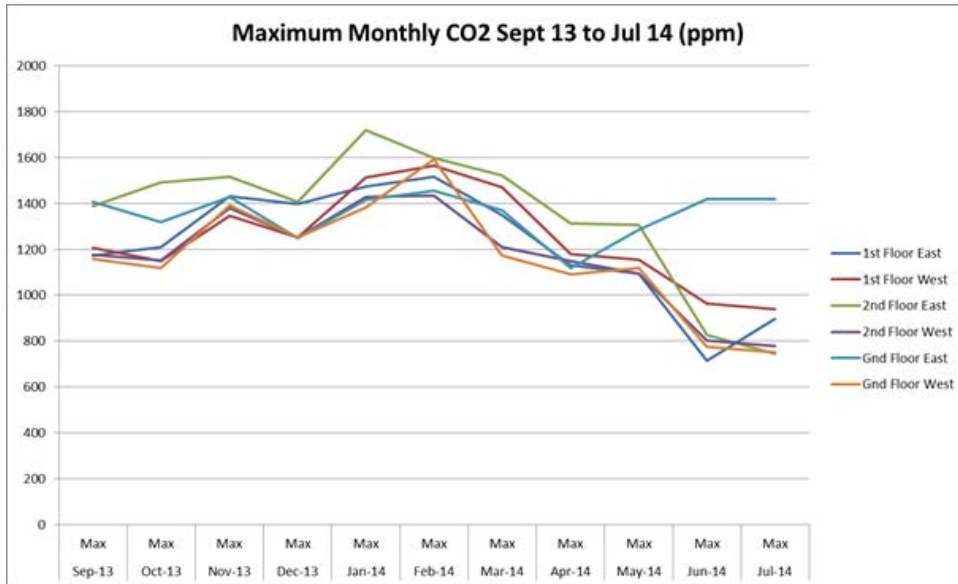
Fig 8.12 Maximum monthly CO<sub>2</sub> Year 2

Year 2 maximums show that the 2<sup>nd</sup> floor east and ground floor east require further investigation. The ground floor east was found to be faulty in July 2014 and requires to be replaced. The winter months have higher maximums on average than the summer months. This would make sense as most occupants prefer the vents closed in winter to keep warm. The mechanical ventilation takes over in winter from the automatic vents.

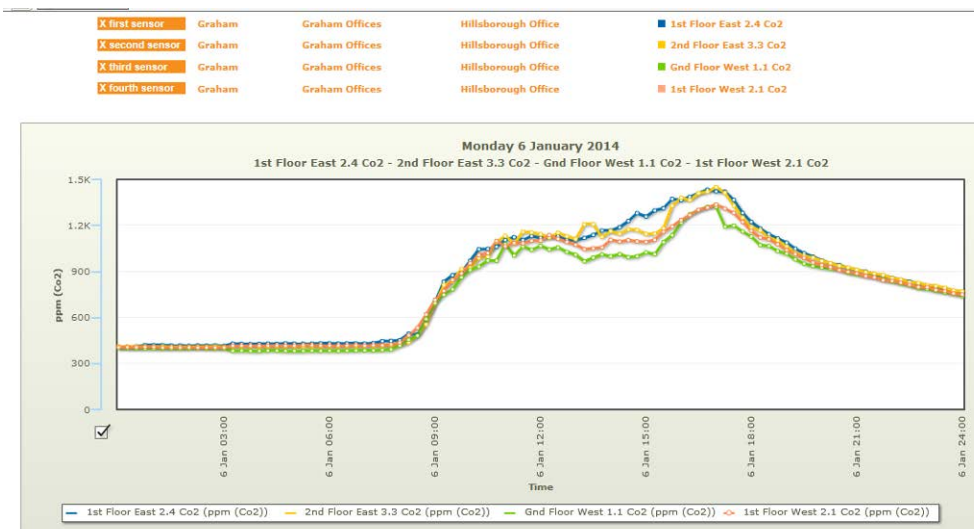
Fig 8.13 Winter Profile CO<sub>2</sub> 24 Hour Weekday Year 2

The graph above is indicative of most winter days and some autumn/spring days. It shows levels of CO<sub>2</sub> building throughout the day and then peaking at the end of the day. Levels always return back to normal overnight. The summertime profiles have much lower CO<sub>2</sub> levels probably because windows and vents are open due to higher temperatures. This means air quality (in CO<sub>2</sub> terms) is typically better in the summer than in the winter. There are also some differences between the different floor although they all follow roughly the same patterns. The 2<sup>nd</sup> and 1<sup>st</sup> floor east locations are slightly worse in winter than the ground floor

however in the summertime the 2<sup>nd</sup> floor east is marginally better ventilated than some of the other floors. Reasons for this could include lower levels of occupancy on the 2<sup>nd</sup> floor and proximity to vents in the atrium which would be open in the summertime but closed in the winter.

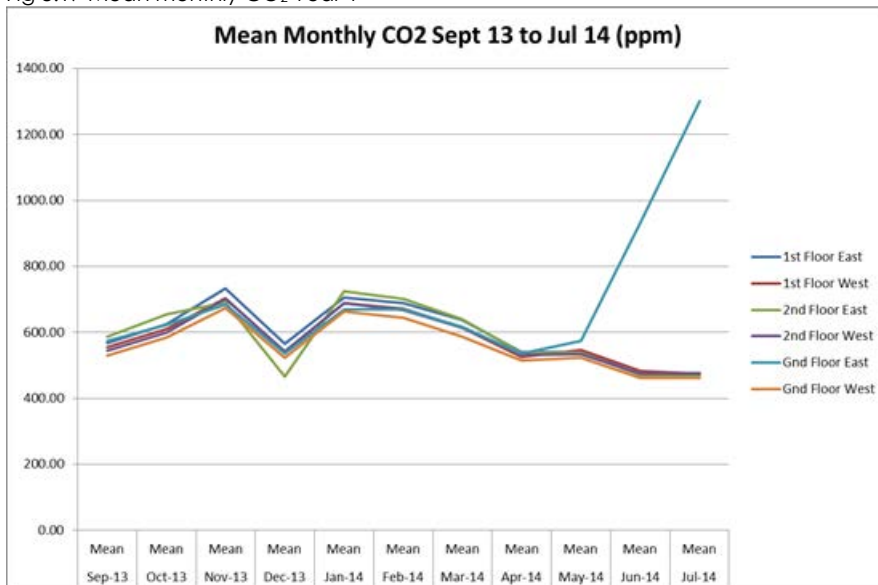
Fig 8.18 Mean monthly CO<sub>2</sub> Year 2

The graph above shows clearly a fault with the Gnd Floor East sensor which is due for replacement.
