<b>InnovateUK project number</b>	450070 Related study: 450014 (Phase 1)
<b>Project author</b>	Leeds Beckett University for the Gentoo Group
<b>Report date</b>	2015
<b><sup>1</sup>InnovateUK Evaluator</b>	N/A

<b>No of dwellings</b>	<b>Location</b>	<b>Type</b>	<b>Constructed</b>
Six	Houghton-le-Spring	Terraced bungalows	2011
<b>Area</b>	<b>Construction form</b>	<b>Space heating target</b>	<b>Certification level</b>
66 m <sup>2</sup>	Pre-fabricated timber-frame	N/A	Level 4 Code for Sustainable Homes

The BPE report outlines the findings obtained from an in-use performance and post-occupancy evaluation study undertaken on six 66 m<sup>2</sup> 2-bedroomed terraced bungalows. All have solar thermal systems installed on their South-facing roof slopes. Dwelling 7 was chosen to be intensively monitored. As it is of the same size, shape and of very similar form to Dwelling 1 studied in Study 450014, the post-construction test results relating to that dwelling were considered likely comparable.

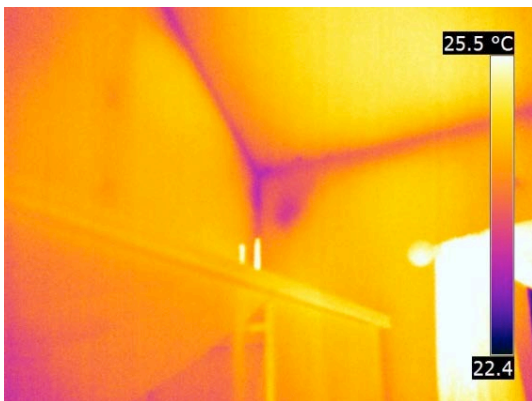
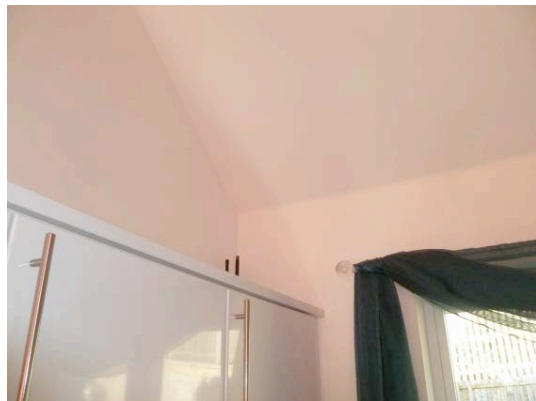
- A small spot, ~70mm in diameter, on the external wall close to the roof/party wall junction in dwelling 7 (see Figure 12). It is not known what is causing this spot on the external wall using the non-destructive test methods available to the research team alone.

**Figure 12 Spot on the external wall of dwelling 7.**

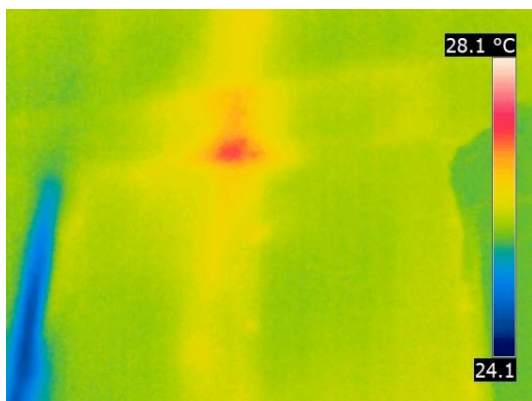
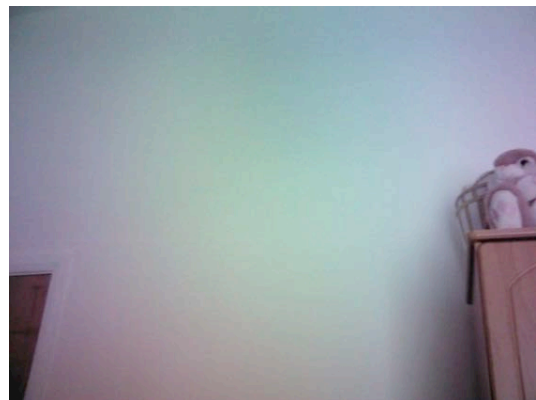
- A small spot on the partition wall between the master bedroom and bathroom in dwelling 2 (see Figure 13). This may be attributable to an uninsulated section of the feed or return pipework to the towel rail which is located on this wall in the bathroom. However, without more extensive investigations, it is difficult to be certain what is causing this hot spot.

**Figure 13 Spot on the partition wall between the bedroom and bathroom in dwelling 2.**

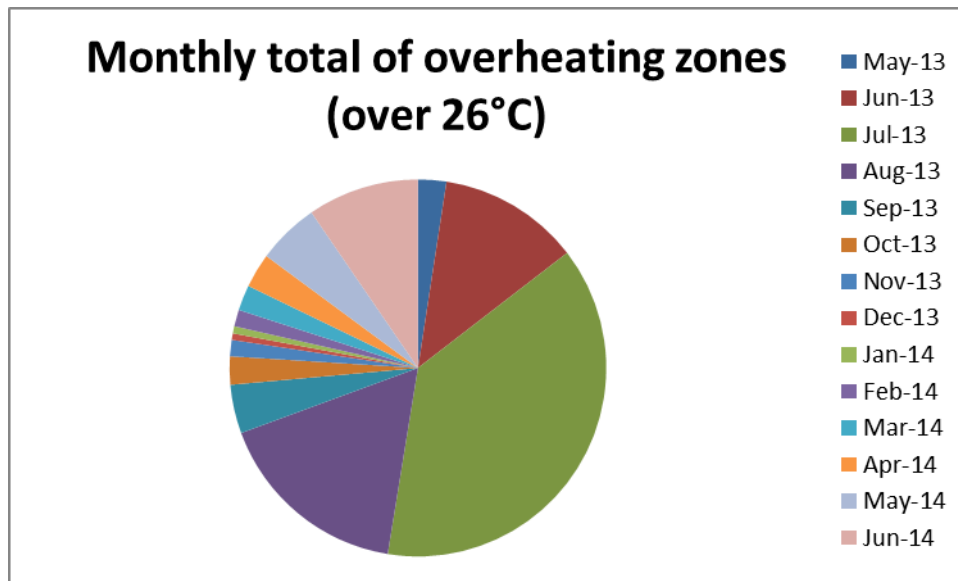
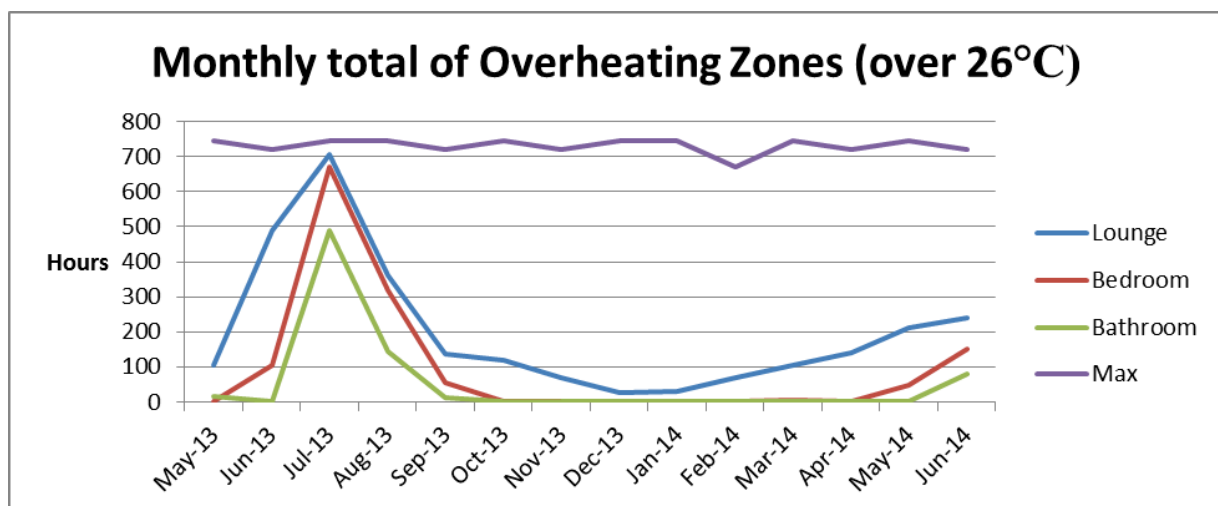
Guidance advises that areas should not be exceeding suggested temperature thresholds for extended periods. With this in mind, Figures 50 and 51 display the total occurrences of overheating in the dwelling as a whole. Internal conditions were logged at 10 minute intervals, and all temperature data logged that was over 26°C has been aggregated to provide a dwelling overheating analysis. Figure 50 shows a high occurrence of overheating periods in June, July and August 2013, with this trend appearing to continue in 2014 as the values for June 2014 are comparable to 12 months earlier. With a variable amount of 10 minute intervals per month due to differing month length, Figure 51 disaggregates the count data and compares it to a 'maximum count' (i.e. all data points collected in the month) and presents in the form of hours. It is surprising to see that in July 2013 almost every instance of 10 minute temperature data logged in the lounge and bedroom was over 26°C.

Figure 50: Total occurrences of overheating

Figure 51: Total occurrences of overheating

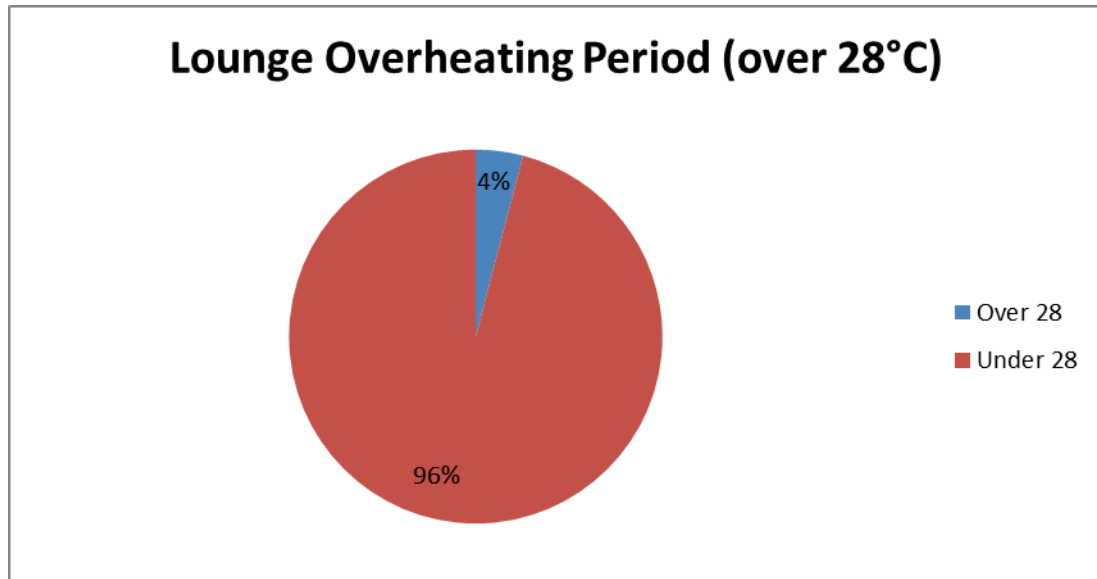
The ASHRAE guidance for comfort and overheating is explored further in Figures 52, 53, 54, and 55. The guidance suggests living rooms become uncomfortable at 26°C and overheat at 28°C, whereas bedrooms become uncomfortable at 23°C and overheat at 25°C. ASHRAE guidance was used for comparison as opposed to CIBSE guidance which no longer relies on thresholds in the most recent guide from the overheating task force. Figures 52 and 53 show overheating in the lounge and bedroom for 4% and 29% of the time, respectively. Perhaps more concerning, Figures 54 and 55 show an uncomfortable temperature in the living room and bedroom 26% and 88% of the time, respectively. Property 7 is one of the dwellings that have returned a completed BUS questionnaire, and feedback directly corresponds with the measured data, with comments stating that the bedroom is 'too hot'.

Figure 52: Lounge overheating period

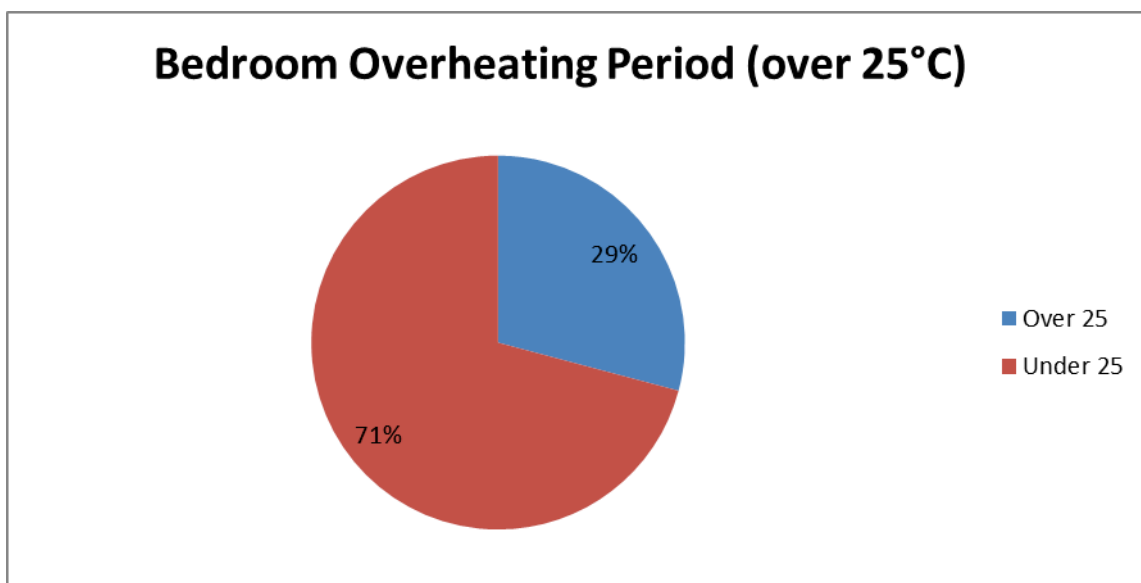
Figure 53: Bedroom overheating period

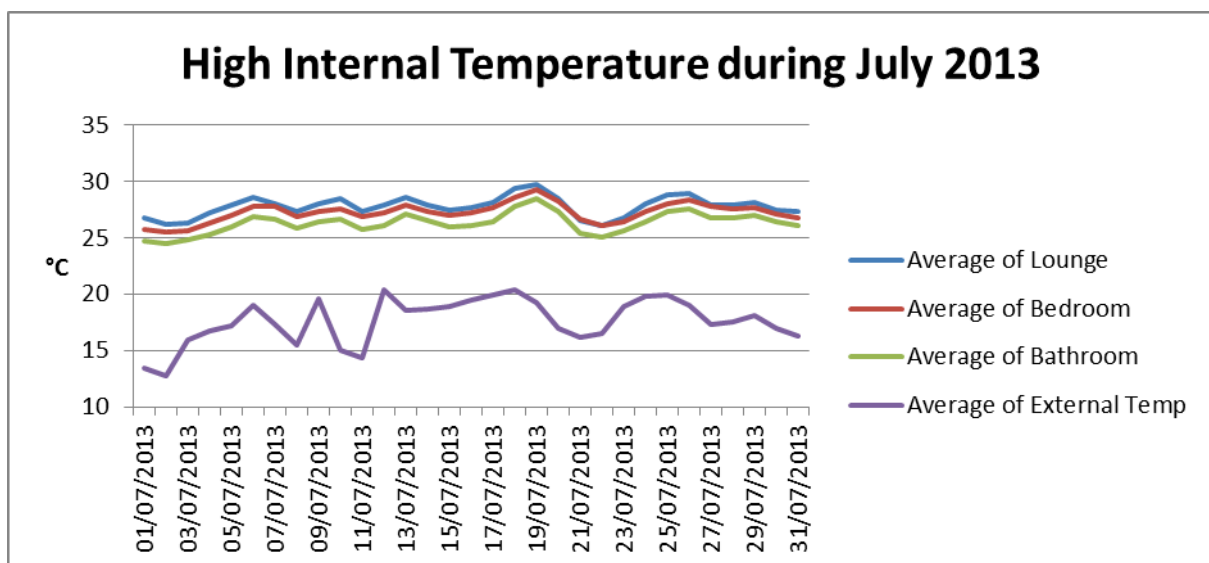
In an effort to explain these high temperatures, the month of July 2013 has been explored further in Figures 56, 57, 58 and 59. Figure 56 shows a relationship between the external ambient temperature and internal temperatures, which is to be expected. Average temperatures in this period displayed in Figure 57 are commonly around 27°C, with peaks of around 30°C and rarely dropping below 25°C.

Figure 56: High temperature period

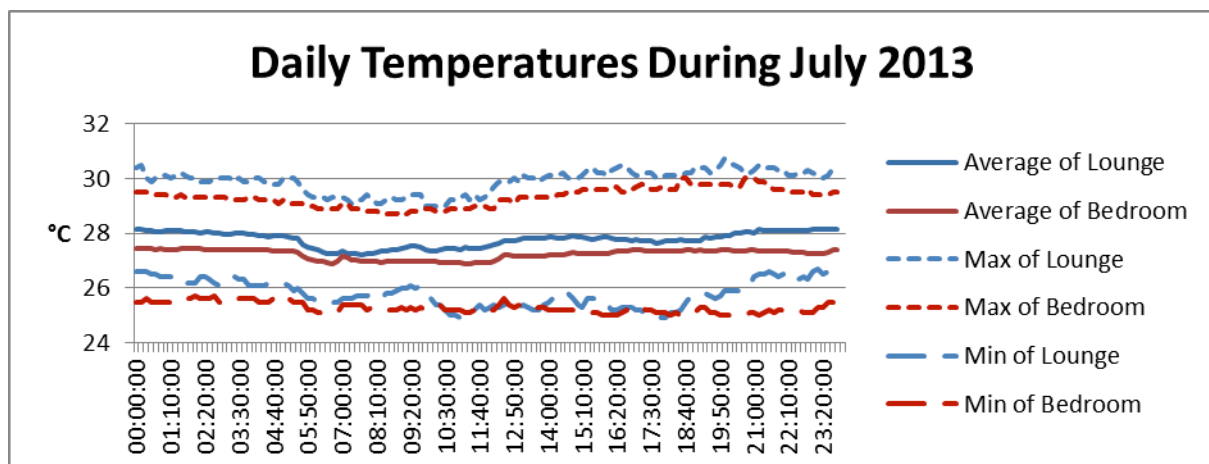
Figure 57: Temperature distribution during high temperature period

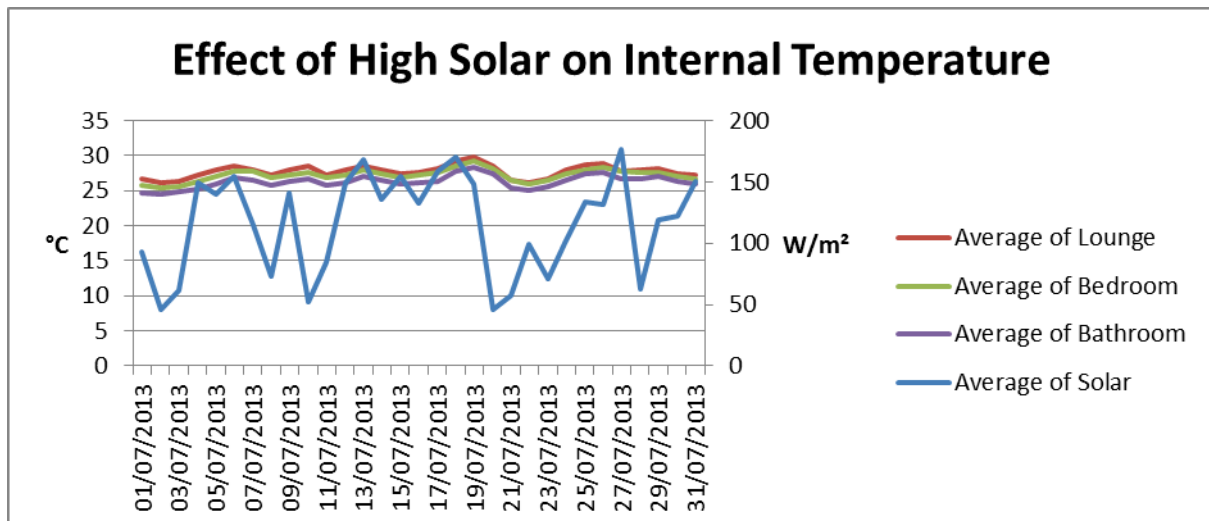
Due to the PassivHaus design and the intention to maximise solar gains, it is the belief of the research team that the high temperature is driven by solar incidence. The relationship between internal temperature and solar gains is not very clear in Figure 58 which covers the entire month, but by focussing on a daily cycle in Figure 59 we can see an interesting apparent pattern. Daily increase in solar incidence cause a step up in internal temperatures. Due to the high level of insulation and airtightness and low thermal mass, internal temperatures are unable to drop to their starting point before the next occurrence of solar, leading to a gradual stepping up in internal temperature over time. These dwellings are designed with a low thermal mass and fast response time, such that they heat up and cool down quickly. This suggests that occupants may not be ventilating their dwellings overnight, as night-time cooling would cause a noticeable decline in internal temperature. If night-time cooling is not done, warm air is trapped inside the house, increasing the overheating risk for the next day. Residents were reluctant to leave windows open overnight due to security concerns, with no fully secure ventilation option available. Resulting from this finding the project architect is investigating the possibility of a secure vent with louvre.

Figure 58: Effect of solar on internal temperature

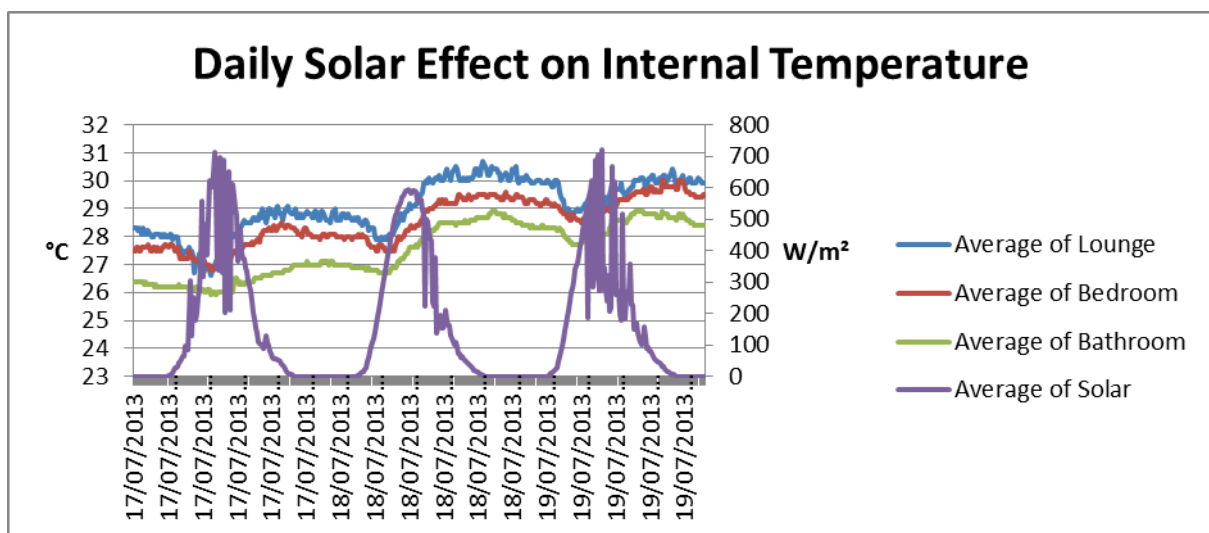
Figure 59: Daily effect of solar on internal temperature
