Mayville Community Centre (aka Mildmay Centre)

Innovate UK project number	450041
Project lead and author	Bere Architects
Report date	2015
InnovateUK Evaluator	Tom Kordel (Contact via www.bpe-specialists.org.uk)

Building sector	Location	Form of contract	Opened
Community Centre	London	JCT SBC/Q05	2011

Purpose of evaluation

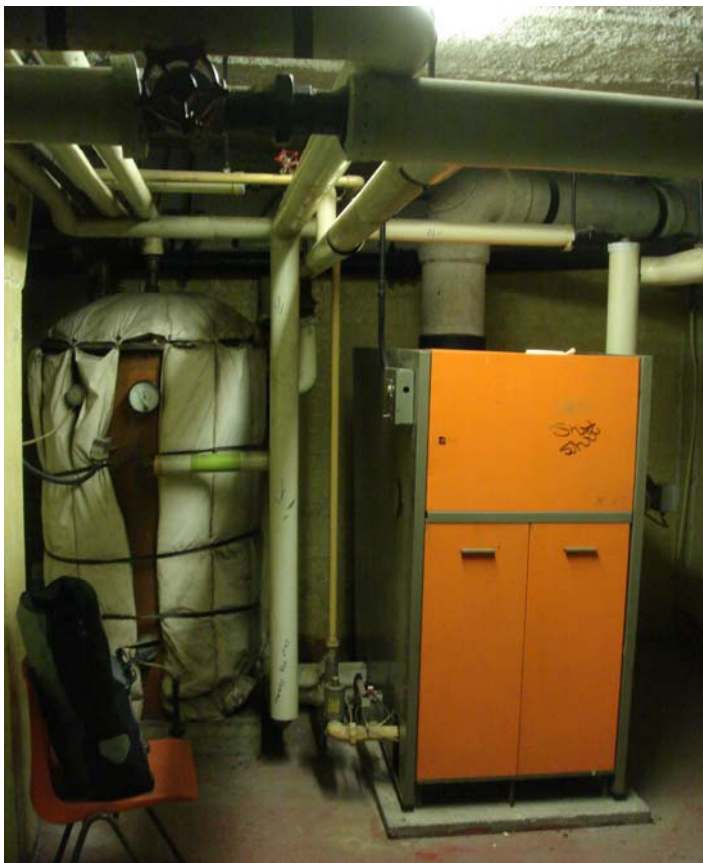
Figure 2-3 Gas boiler and tank in the basement of the Centre prior to refurbishment

very uncomfortable and also suffered from high energy bills amounting to £10,000 a year which formed a large proportion of the total MCP annual turnover of £60,000. Outdated and inefficient mechanical and electrical equipment also contributed to the high use of electricity and gas.

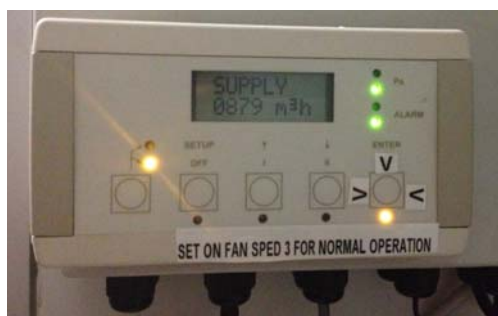
Figure 3-2 Ventilation unit – controls display (plant room)

The controls display for the main ventilation unit is located on the casing of the ventilation unit in the plant room, and the team added labels to explain the commissioned settings:

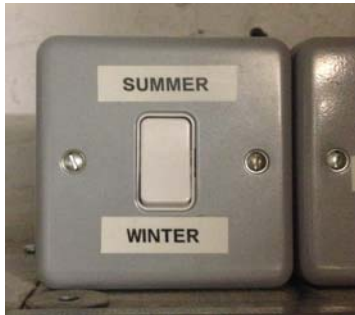
Figure 3-3 Ventilation unit – summer/winter strategy switch (plant room)

The summer/winter damper switch located in the plant room switches between the winter and summer strategies (figure below). There was no label to suggest what the 'summer/winter' switch was referring to, but additional information has now been added by the architects. The Centre does not have a dedicated maintenance team or manager, therefore it becomes important to have labelled switches clearly explaining what such switches do.

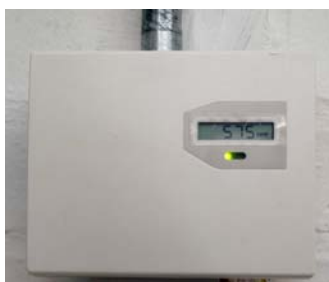
Figure 3-4 CO2 sensor (main hall)

The CO2 sensors in the main hall and the dining area, and the presence sensors in the offices, allow for boost ventilation during the winter mode by opening up supply air valves nearby. The CO2 sensor in the main hall is located next to the heating controls.

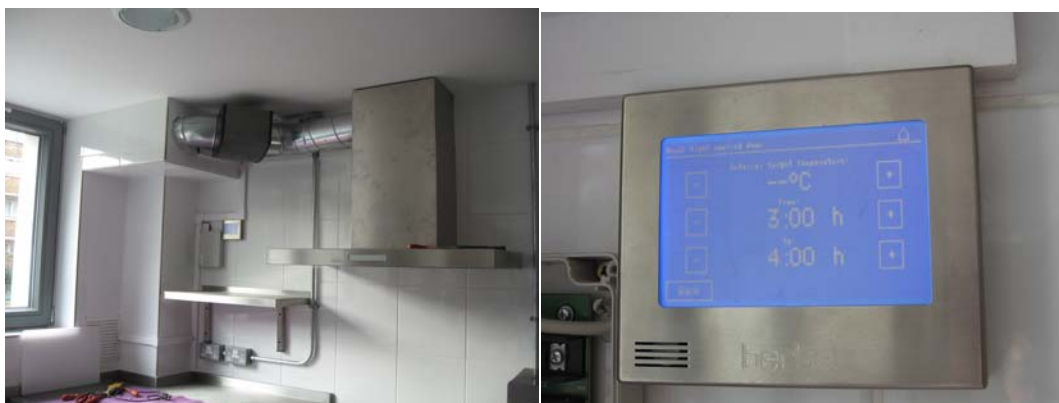
Figure 3-7 Kitchen hood, filter and controls display

The extractor hood in the kitchen is a special extract unit with re-circulation (and therefore heat recovery) in winter conditions, and exhaust in summer. The intake and exhaust valves seal closed when not in use in order to maintain the air-tightness of the building. The installation of the extraction hood was not completed by the contractor due to a general funding shortfall that resulted in a minor dispute between employer and contractor so the design team contacted the German manufacturer in order to be able to explain to an independent electrician (post contract) how to wire up and operate the unit.

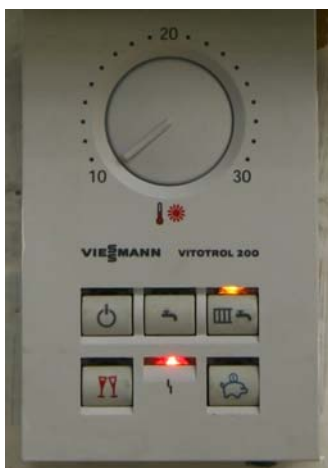
Figure 3-10 Thermostat and DHW & heating controls (main hall)

The design team have deliberately put user-orientated controls (the thermostat and the ventilation boost button) outside the plant room to make them easy to access. However it has been agreed with the centre manager to put the thermostat in a non-accessible perspex box so that adjustments are only made by management, and users cannot make their own adjustments, since incorrect user settings adjustments have caused a few problems from time to time. The Perspex box is currently on order at the time of writing.

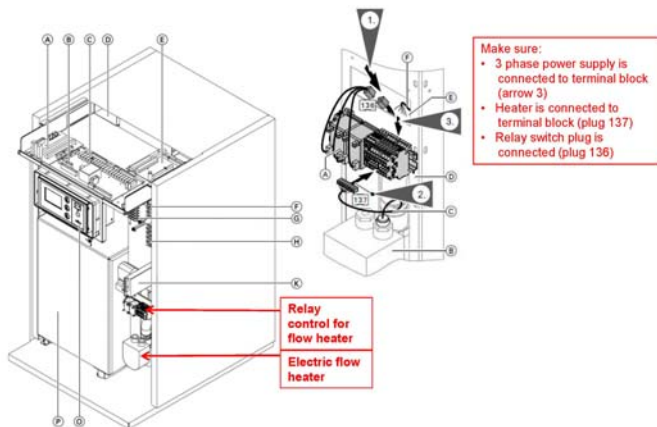
Figure 3-13 Schematic sent by Viessmann technical to show connection of GSHP direct heater

The GSHP was found to be using an small amount of energy overall, and the direct electric sterilisation meter showed zero consumption. An independent advisor on the monitoring team said he thought that the meter showing zero was probably broken and that the building might in fact be using a lot of unmeasured direct electricity on this circuit. However when this hypothesis was investigated in May 2013, it was found that the meter was working and the reason it showed zero was that the direct electric sterilisation circuit was not connected up to make it operational.

When connected up, the direct electric heater is 9 kW, spread over three elements, which can each be enabled so as to provide 3, 6 or 9 kW depending on what is required to take the water storage up to 60°C once a week. The team found that the immersion heater power connection plug was still coiled in the manufacturer's cable tie (image below). As well as providing protection against Legionella bacteria through a once-weekly sterilisation of the domestic hot water, the immersion heater can also support space heating in winter if the heat pump is unable to meet the heat demand.

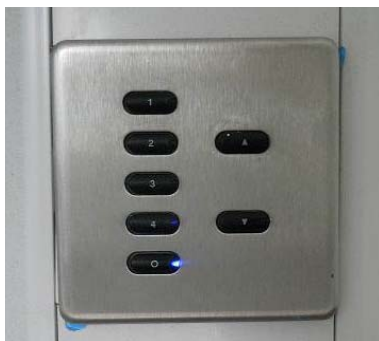
Figure 3-18 Light switches with controls for dimming or selecting pre-set light levels

As part of a cost reduction exercise some of the proposed dimmable lights were replaced by non-dimmable fixtures in office spaces. This affected the commissioning of the lights and where lights are non-dimmable, the installed light switches (remote dimmers with five programmable lighting scenes) are more complicated than they need to have been. There were also a number of additional problems related to wiring and commissioning.

Budget restrictions led to some of the lighting system being reduced to simple on-off controls, with manual on and manual off switching, with automatic off switching occurring if the lights are left on in an unoccupied room. However, the savings were not made until after the multi-function light switches (the iLight standard offering) had already been installed, even though a standard on/off switch would have sufficed in these areas. This has led to occupants becoming slightly confused as to what the buttons do. Further confusion was initially caused by poor programming and incorrect wiring, resulting in lights turning off by themselves when lighting was needed. Re-commissioning, which the manufacturer wanted payment for, eventually fixed most of these problems.

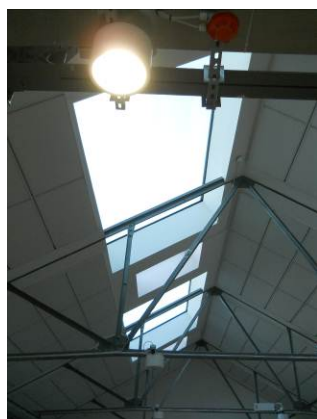
Figure 4-3 Rooflights in the main hall

Other things that the managers thought could be added: blinds across the skylights to block sunlight for presentations; also, at times the sound from the main hall can be heard in reception area due to open staircase well and landing area on 1st floor open towards the main hall.

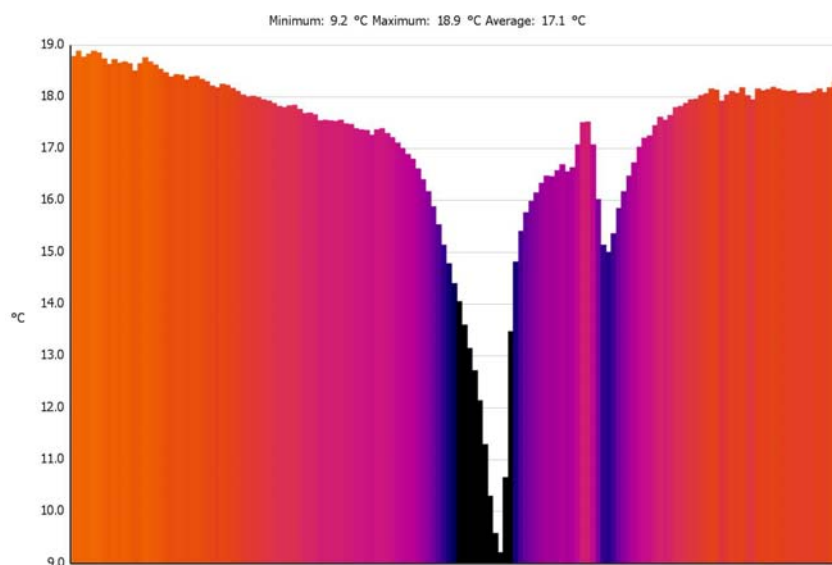
Section P shows that the temperature on the frame and the wall drops below the dew point temperature (usually around 10-12°C, it varies according to internal conditions), and therefore can pose risks of condensation where the heat from inside meets the cold surfaces.

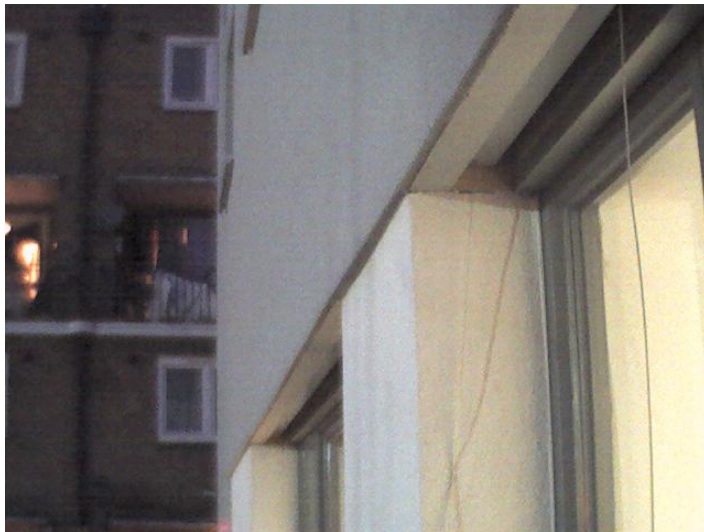
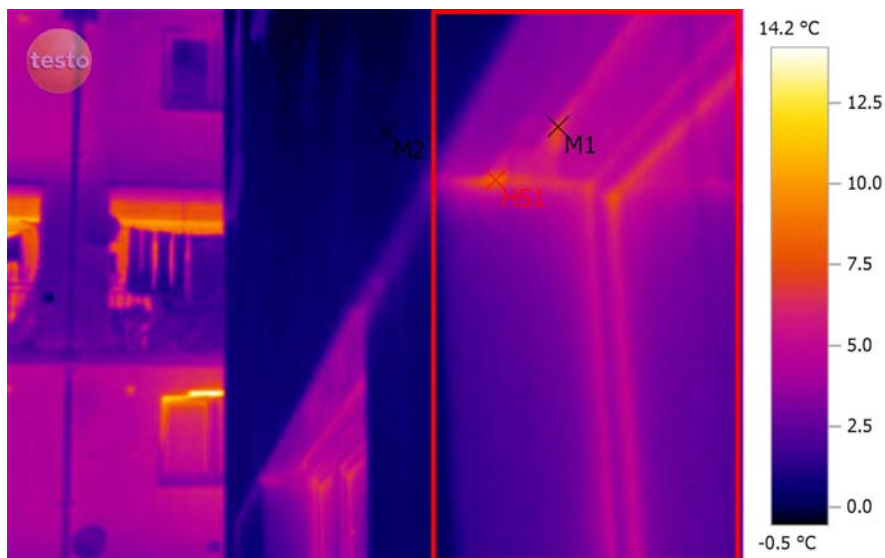
Figure 5-4 External window reveals with blinds pockets – thermographic image

Another sensitive detail are the pockets for the external blinds:

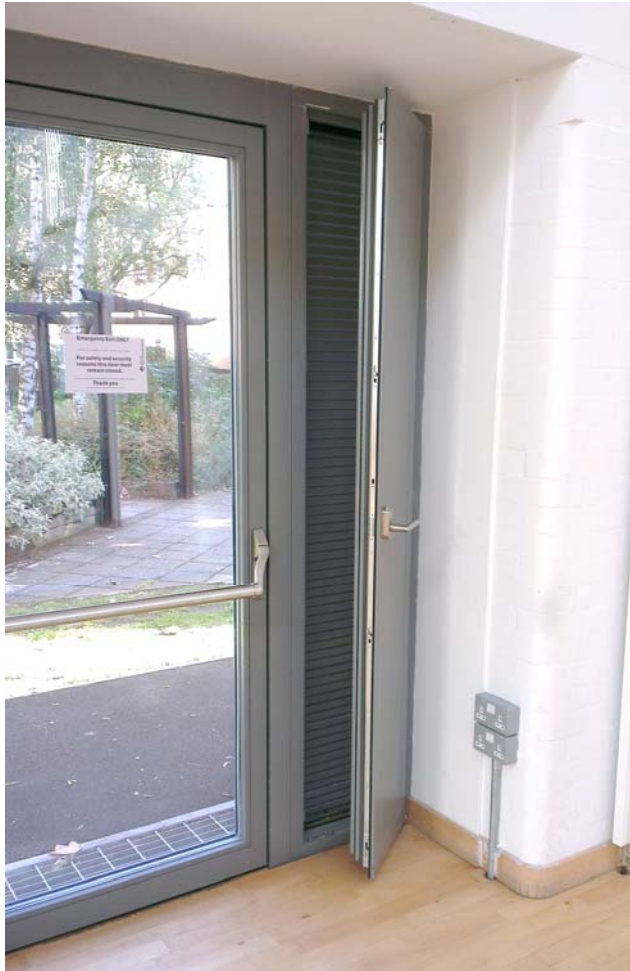
Figure 5-5 Ventilation grille (main hall)

It was found that the users seemed cautious of operating the roof lights or the ventilation grille in the morning or at night in hot weather, even though this would help cool the building. This could be due to the fact that it is expected that the Centre's staff manage the day to day operation of the building and its systems.

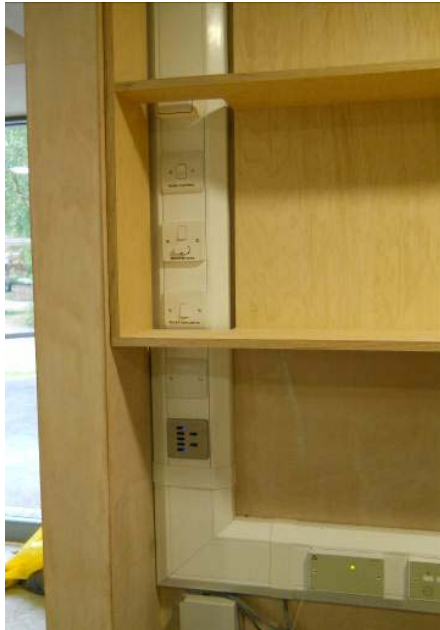
Figure 5-6 Reception desk cupboard

The door access, alarms and lighting controls are grouped on surface-mounted power trunking that runs around the area behind the reception desk. The location of the controls is driven by this trunking - a cost-effective way of distributing LV power and data communications cables. Unfortunately, the location of the controls was not informed by (or did not inform) the client's requirements for fixed shelving and cupboards. The cupboards hide some of the switches – in one case a shelf has been installed by the carpenter right across a switch. The photo above shows the switches before the cupboard doors were fitted. This reflects the fact that the budget did not allow for many of the fit-out works to be carried out until after the completion of the building.

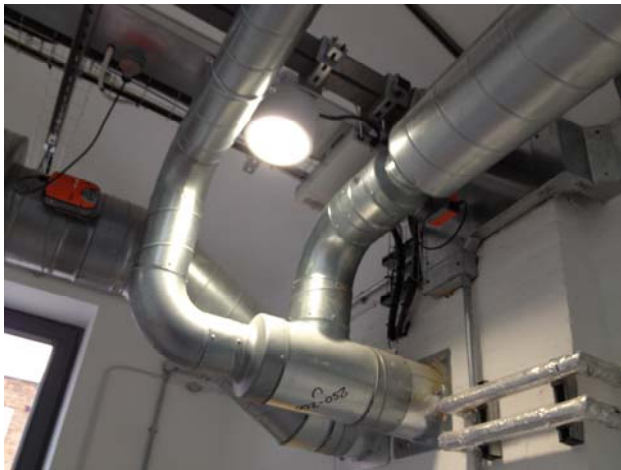
Figure 5-7 First floor ventilation ductwork

Due to the fact that a damper valve became faulty and was subsequently not replaced, the damper for the 1st floor offices remained permanently open on the supply duct, thus providing constant supply to the 1st floor offices in the summer as well as during winter. This means that the energy used by the system will be slightly higher than expected during the summer, however the additional small supply will complement the ventilation through the windows. A detailed analysis of the energy consumption of the ventilation unit during summer and winter is presented in Chapter 6 Energy use and environmental conditions.

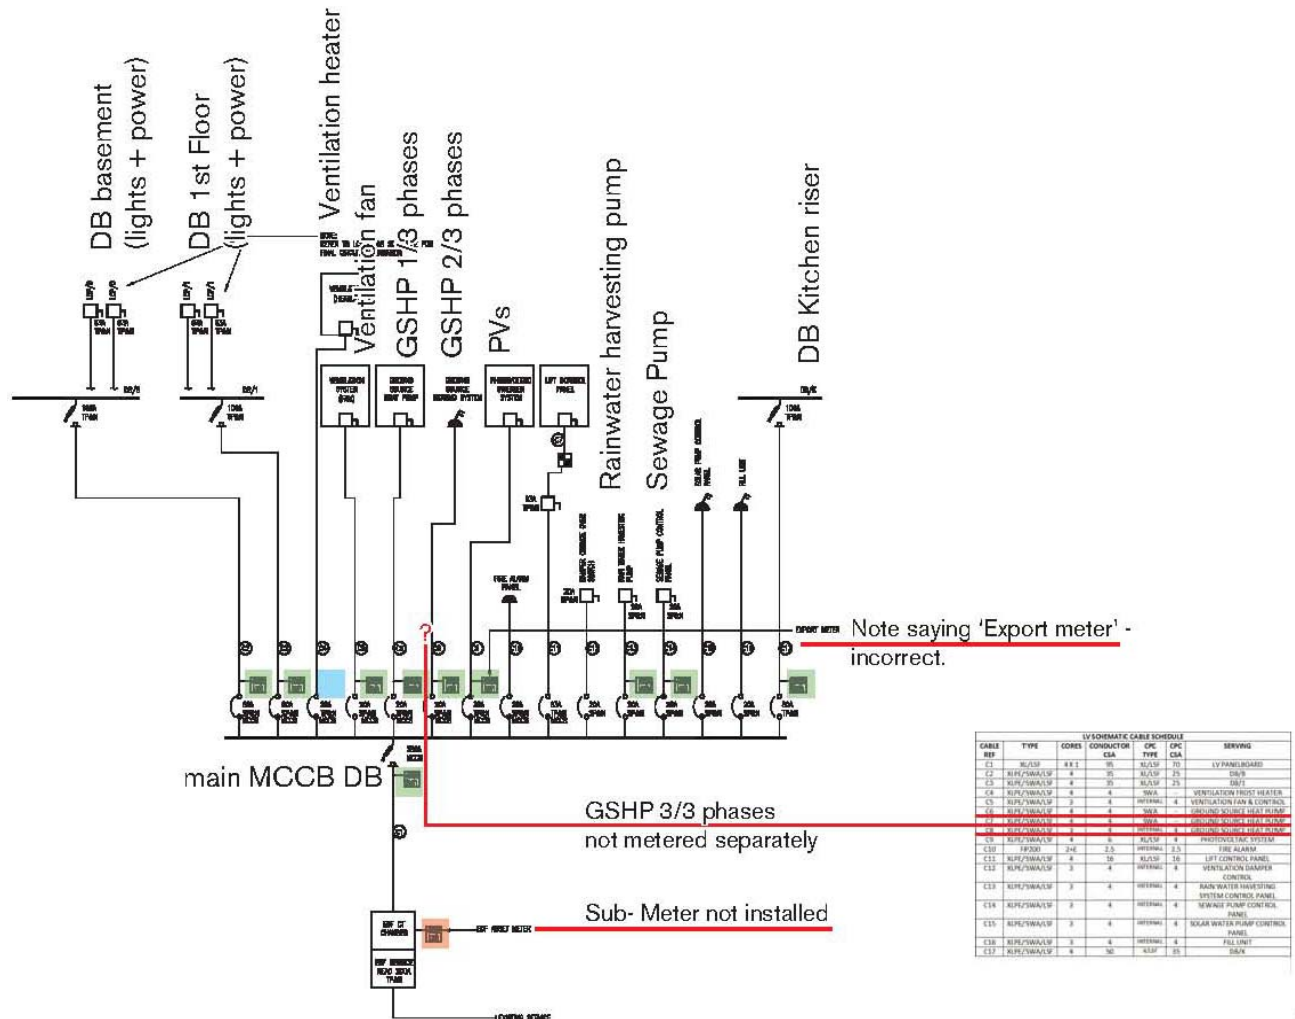
Figure 5-10 M&E subcontractor's 'as built' electrical diagram with b:a notes (in colour)

The design team made some notes on the 'as-built' schematic (above) produced by the M&E subcontractor, indicating:

- existing sub-meters on site, matching the M&E schematic are marked in green.
- there are three GSHP circuits in the table on the side, however only two were sub-metered in the schematic, as well as on site. The 3rd phase is included in the Basement Distribution Board, and therefore metered alongside the basement lights and power.
- the ventilation heater (frost coil) did not appear to be sub-metered on the diagram- when actually on site it is metered. (This has been added to the diagram above – see blue square in diagram above)
- the 'Photovoltaics inverter system' appears metered, however with a note to the side indicating 'Export meter' - the sub-meter actually measures PV generation
- a sub-meter is indicated below at the main EDF meter - the electricity grid import - however this was not sub-metered on site (in red)

The team found on site that the initial set up of the energy monitoring equipment to measure electricity consumption (kWh) did not cover all the renewables (one of the GSHP 3 phases was not metered separately), and did not account for the energy imported and exported back to the grid. Given these findings it was argued that the sub-metering set-up was not compliant with the building regulations requirements. This should have been checked and raised by the main contractor with the electrical sub-contractor who was paid additional money specifically to produce and implement this detailed design.

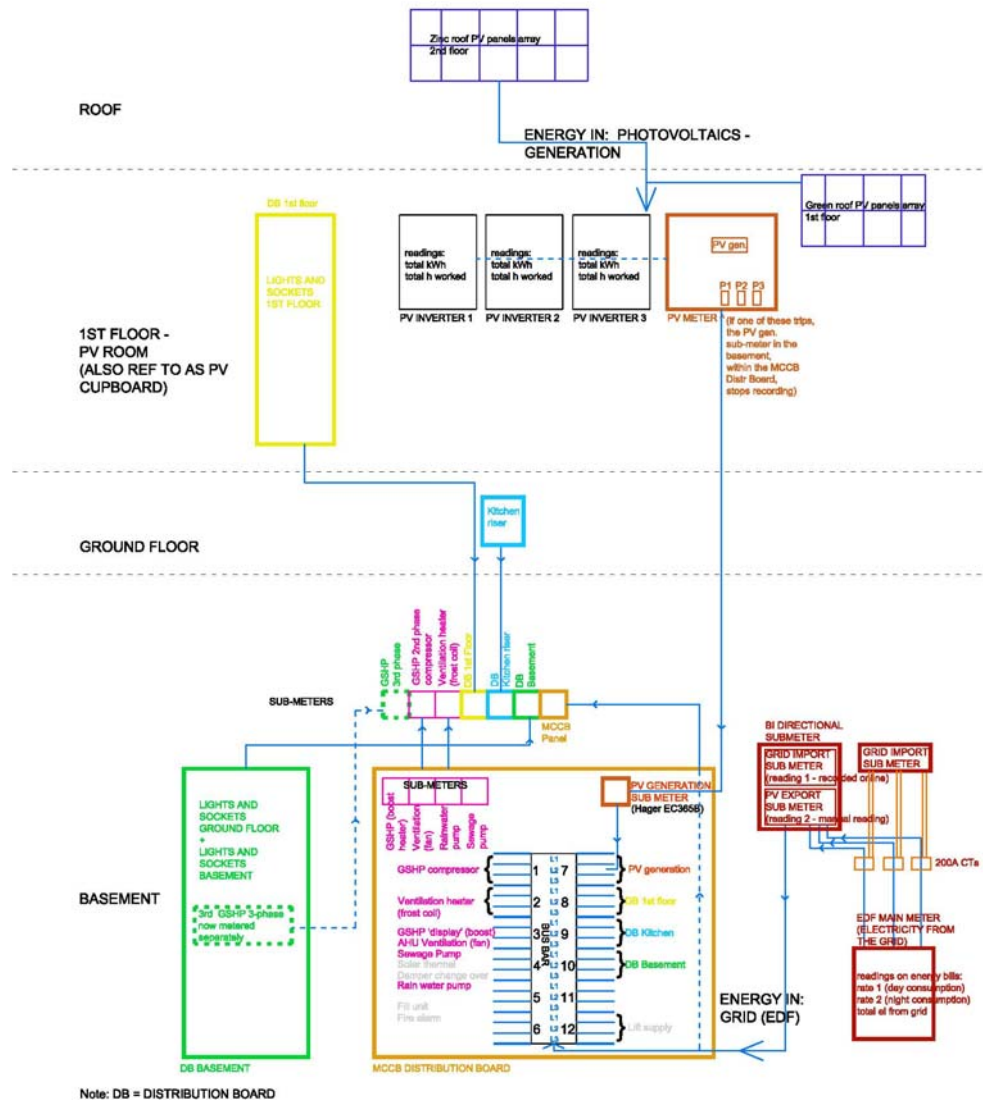
Figure 5-12 Sub-metering schematic

- 2 new sub-meters recording the PV exported back to the grid and the electricity imported from the grid, matching the main electricity meter in the building. The PV export meter has become faulty, was replaced once, and then became faulty again in April 2013.

The design team labelled or re-labelled the sub-meters where necessary and employed an electrician to add new meters as required in order to be able to assess the total energy consumption of the building, and of each of the low energy technologies used.

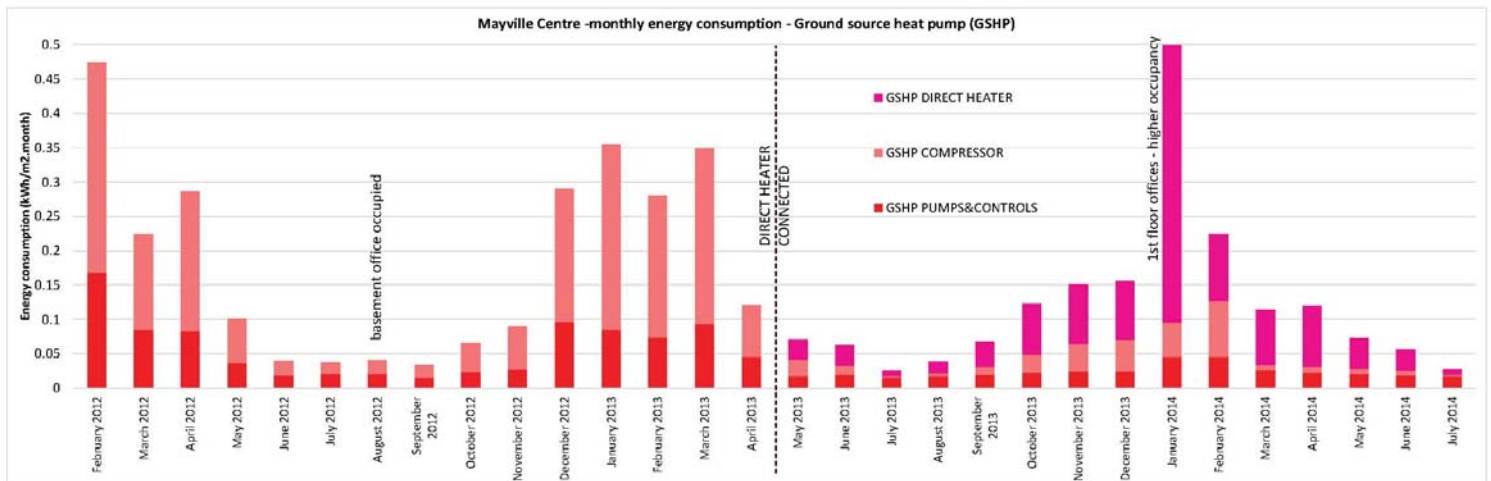
Figure 6-4 GSHP energy consumption

The GSHP provides heating and domestic hot water, and the sub-metering indicates very low energy consumption (2.6 kWh/m².year in the second year of monitoring, ending July 2014). The direct heater which provides top-up electric heating found not to have been connected inside the GSHP in May 2013.

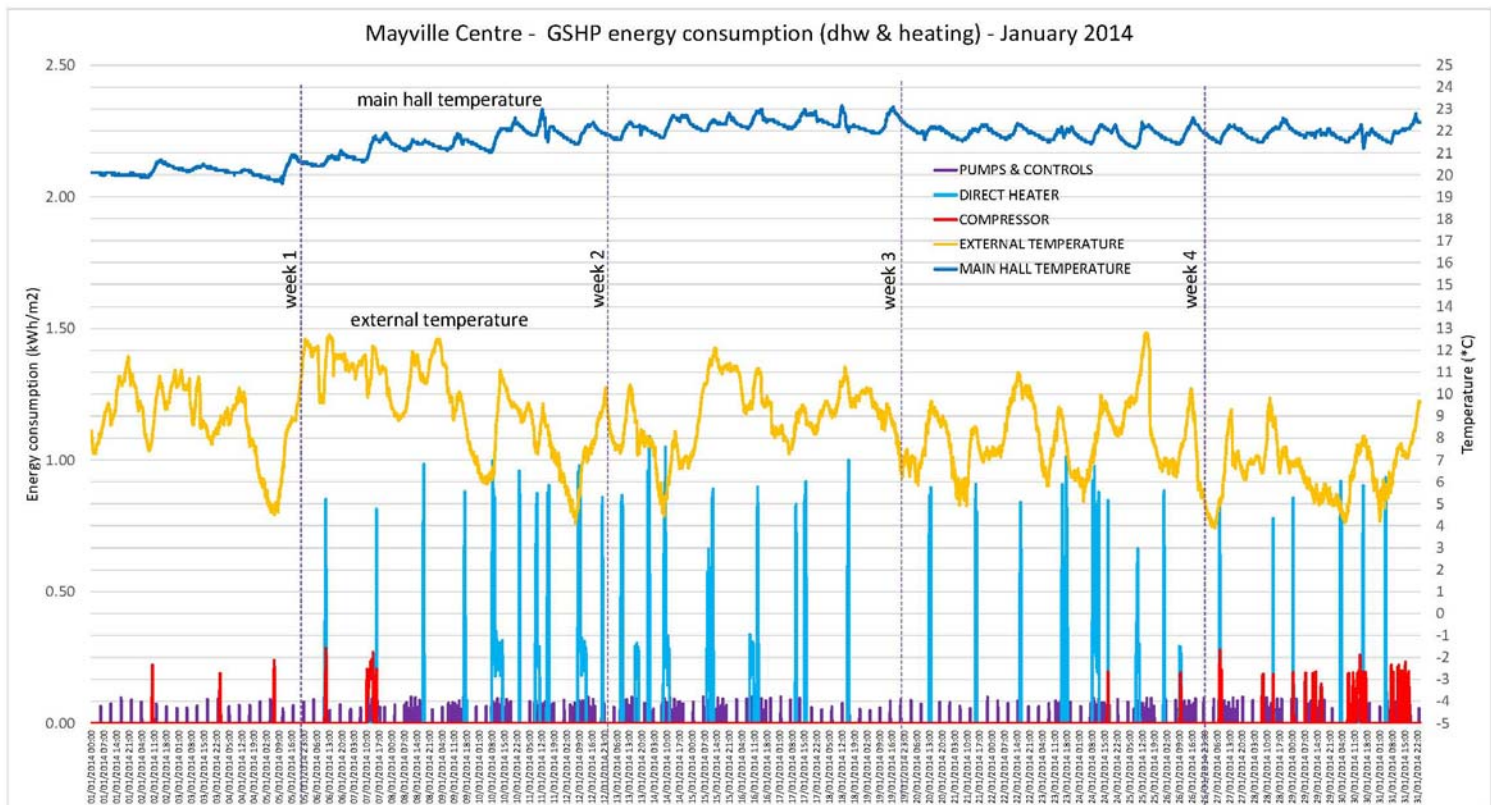
Figure 6-5 GSHP energy consumption (DHW& heating) - January 2014

The readings for January 2014 showed a higher than usual energy use by the direct heater. A detailed analysis (overleaf) indicates that when external temperatures dropped below 5°C, the GSHP direct heater (pink, top bar) was used repeatedly to maintain indoor temperatures in the double height main hall of 21-23°C in January 2014 and a little less frequently in February 2014 in spite of even higher indoor temperatures in the double height main hall of 22-24°C. The results indicate that the thermostat temperature was set to a high indoor temperature, calling the GSHP for a higher temperature than could have been achieved solely by the compressor.

- During events with large numbers of attendees, the entrance door near the reception desk tended to be left on the hold-open setting for long lengths of time, to allow participants in the Centre without staff needing to press the automatic door opener under the reception desk, and to allow staff to smoke without having to open the door with a key to let themselves back in.
- During the winter months the tenants on the 1st floor had more staff joining their offices, and an additional desk was installed on the open-plan upper landing of the stairs, facing the main hall. The area is directly connected to the open staircase and the entrance hall, and therefore can experience draughts when the entrance door is left open.

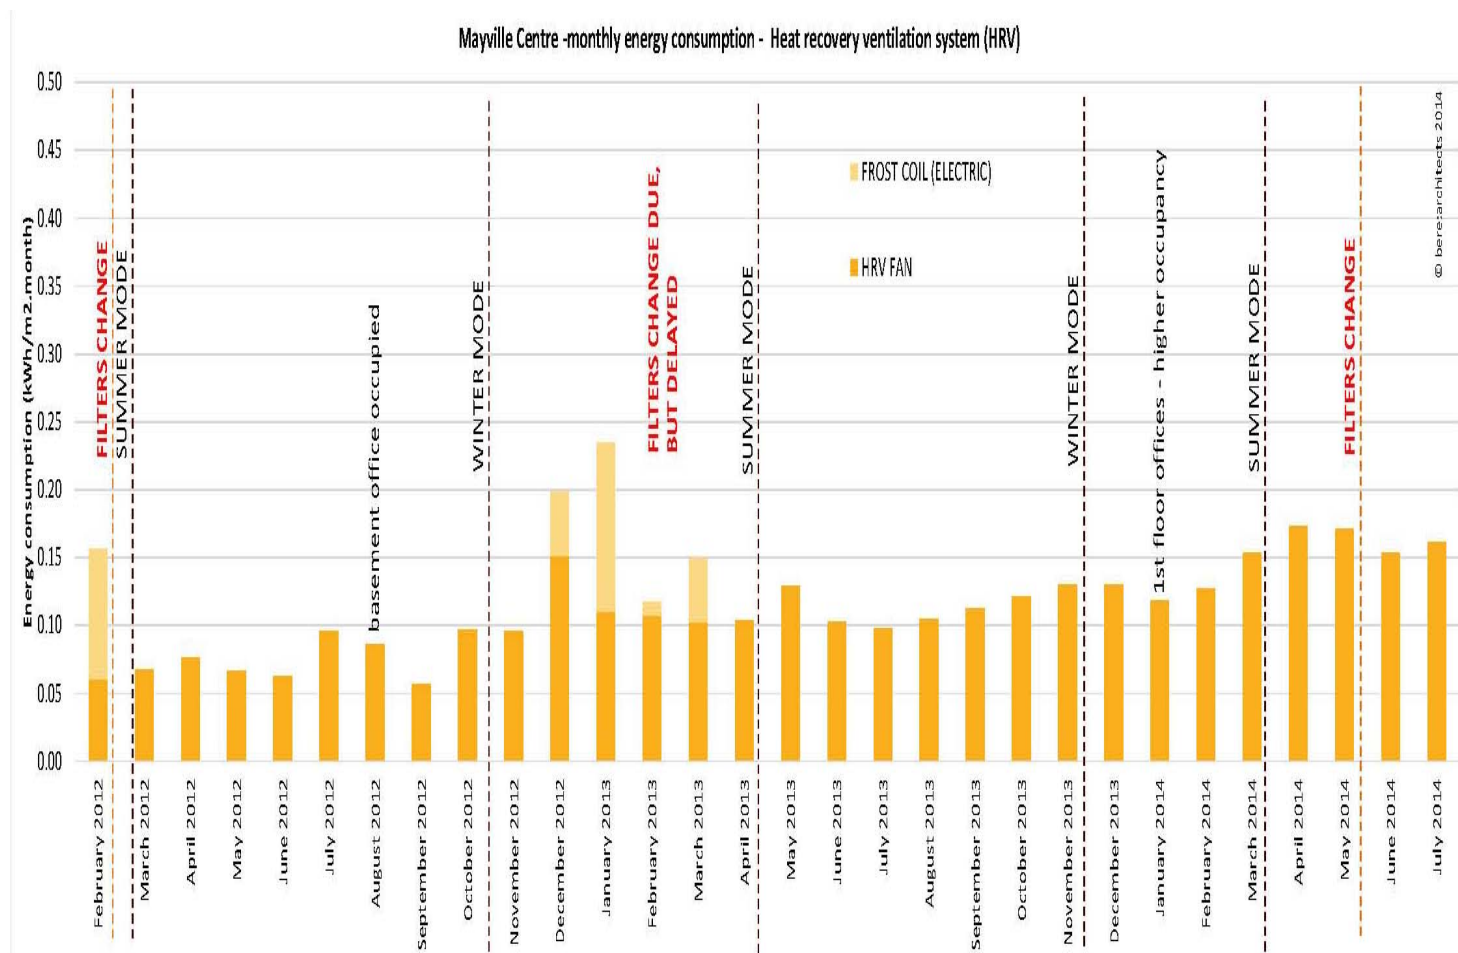
Figure 6-9 Heat recovery ventilation unit- energy consumption

The electricity consumption of the heat recovery ventilation unit was 1.66kWh/m².year during the second year of monitoring (ending July 2014). It can be noted that after the filters were changed in 2012 the difference between the electricity used by the unit during the summer and winter months varied by maximum 0.05kWh/m² per month. The difference was even lower between summer and winter months in 2013, although the overall consumption was higher than the previous year. This could be due to the fact that the filters had not been changed at the recommended time, but also the higher occupancy and increased use of the Centre.

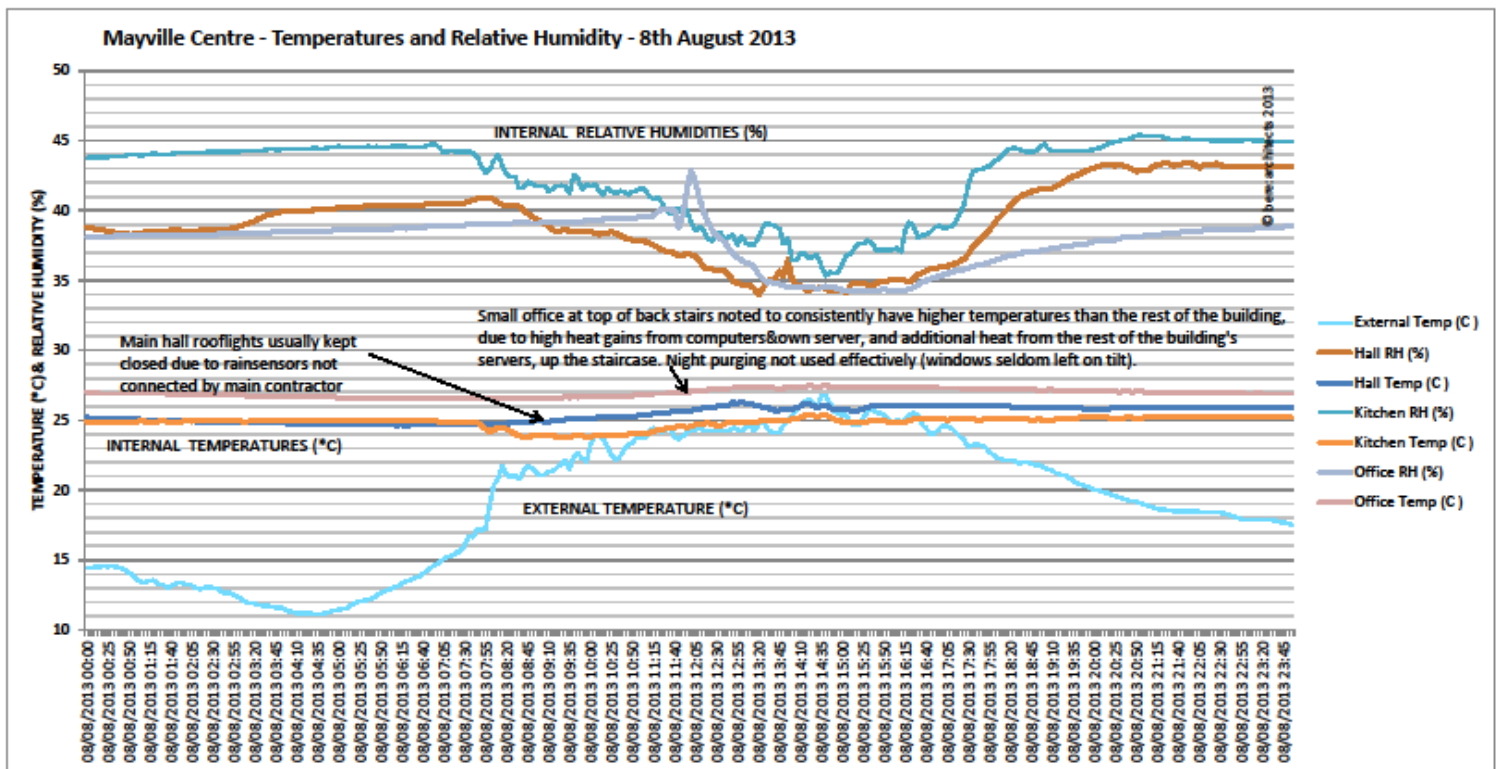
Figure 6-28 Temperatures and relative humidity – 8th August 2013

Summer: During the summer, when the building is used in a mixed-mode strategy, the temperatures indoors follow the fluctuations of external temperatures. During the first summer the cooling strategy was not properly implemented (the rainsensors on the rooflights had not been connected by the contractor so night purging was not used, and the use of blinds was not very effective, as described in Chapters 3 and 5). This reflected in higher indoor temperatures during very hot days in that year.

The occupants in the first floor office at the end of the main hall (which is used approx. 3 days per week) reported high temperatures at times. The team investigated the causes and found that while that office receives solar gains through the fixed window that the office has towards the main hall, it also has high internal gains due to high occupancy and a concentration of office equipment (3 computers and screens, printer, server, microwave, small fridge within the small office space, and heat rising from two servers at the foot of the staircase that it opens on to). The two servers belonging to the Centre's management are located in a small unventilated room in the basement at the bottom of the staircase, which was kept with the door open at all times. The heated air rises up through the staircase to the top floor office, where the occupants used to leave the door open.

The team explained to the occupants and the Centre managers that a significant improvement in their comfort during the summer would be achieved by using night ventilation leaving the windows on tilt, and that a cloud solution to replace the many servers in the building would be advisable. The occupants started to leave the windows on tilt, and the team reminded them again during the second summer that this strategy was effective in providing good levels of comfort during the summer months.

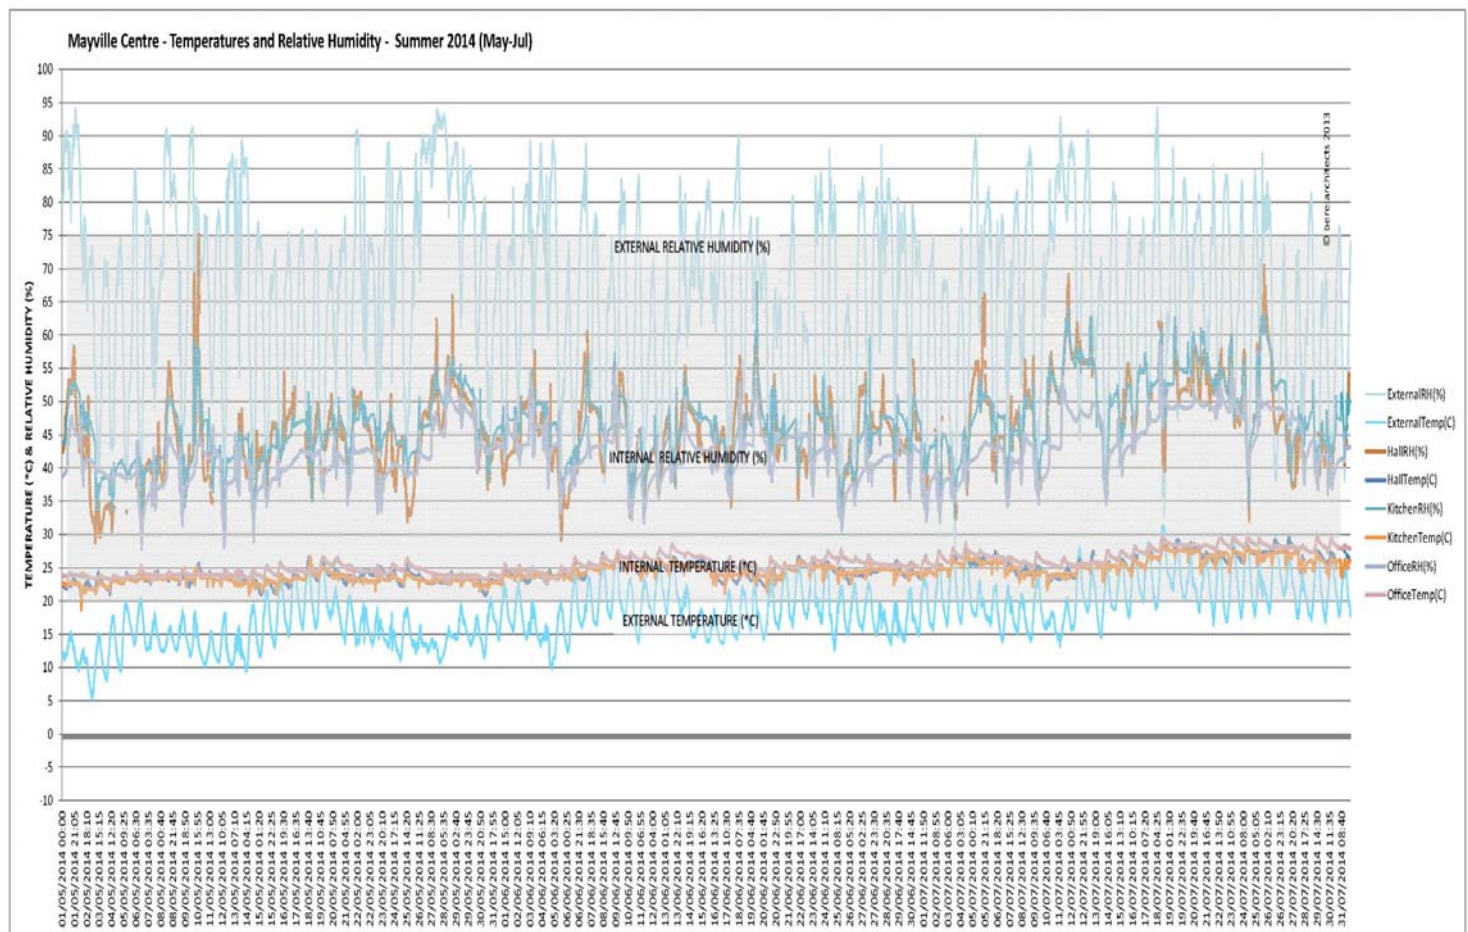
Figure 6-29 Temperatures and relative humidity – Summer 2014

During the second summer (2014, which was warmer than 2013) the rainsensors were operational (they had been connected in October 2013), and the Centre's managers confidently used the rooflights for purge ventilation, cooling the building over night and early morning. Summer temperatures were dramatically improved in 2014.

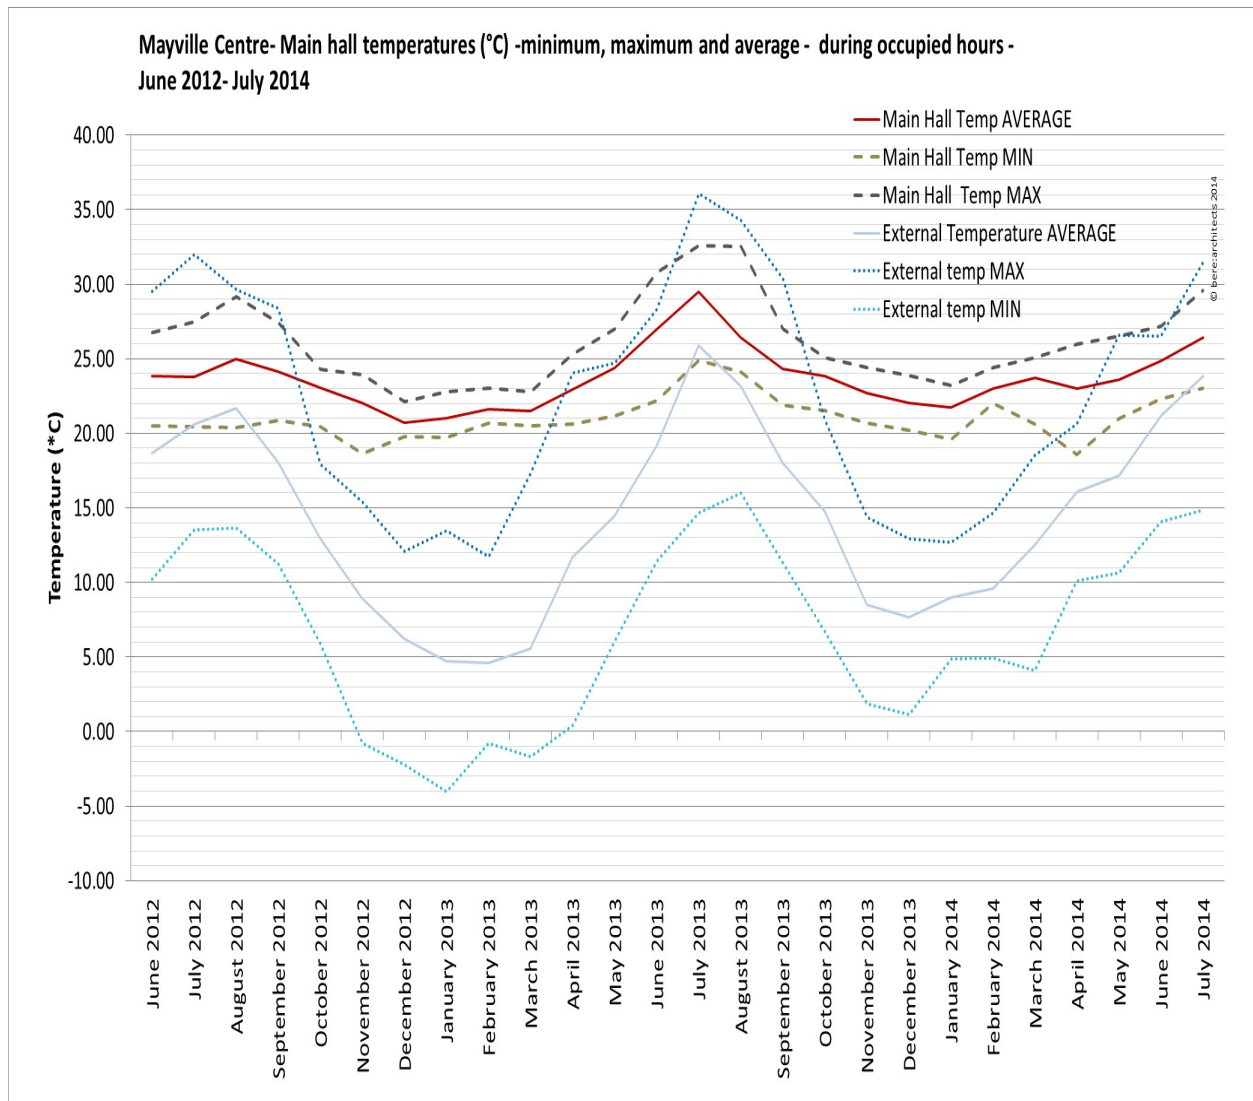
Figure 6-35 Main hall temperatures – minimum, maximum and average – during occupied hours

A comparison between the temperatures inside the main hall between the two summers clearly shows that, even though the second summer was similar or even warmer, the summer temperatures in the main hall were lower by 3-4C in 2014 compared to summer 2013. This indicates that the cooling of the building has improved significantly. This is also supported by the analysis regarding the percentage of time when the temperature, RH and CO2 levels were outside the recommended range, as shown above. This has been also noted by the occupants, as explained in Chapter 4 'Key findings from occupant surveys'.

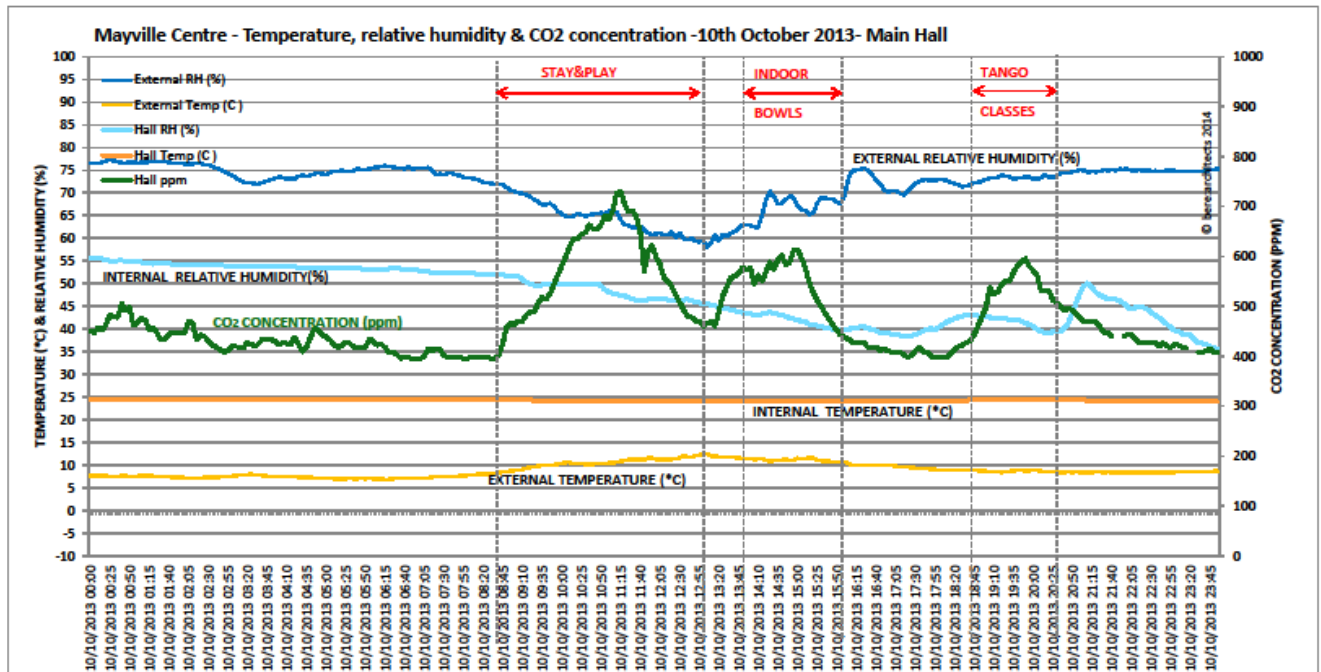
Figure 6-36 The temperature, RH and CO2 concentration in the main hall during 1 day (10.10.2013)

The majority of the readings were significantly better than the recommended maximum of 1500ppm (CIBSE Guide A), with occasional spikes occurring during events with large numbers of people attending. The charts below show how effectively the CO₂ is dissipated in the main hall when several activities are booked in, on typical days: 'stay and play' (25 people), indoor bowls (10 people), and tango (15 people & more dynamic activity than 'stay and play' and bowls):
