Murray Place

This document contains a Building Performance Evaluation report from the £8 million Building Performance Evaluation research programme funded by the Department of Business Innovation and Skills between 2010 and 2015. The report was originally published by InnovateUK and made available for public use via the building data exchange website hosted by InnovateUK until 2019. This website is now hosting the BPE reports as a research archive. Although no support or further information on the reports is available from the host, further information may be available from the original InnovateUK project evaluator using the link below¹.

InnovateUK project number	450104
Project author	Hanover Housing Association
Report date	2014
¹InnovateUK Evaluator	N/A

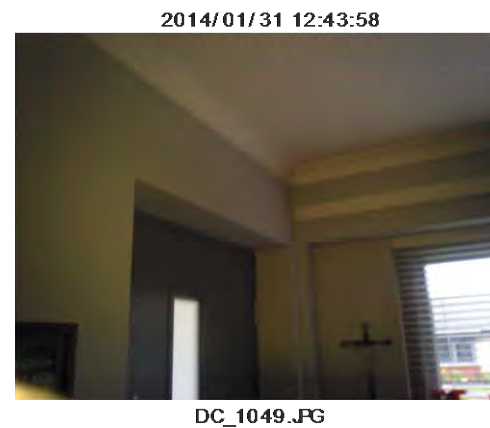
Outwith the confines of the courtyard development a significant wind was prevalent at the time of testing which may have created limitations in identifying instances of external heat loss. The general fabric construction generally appears to be of good quality with few obvious defects affecting thermal integrity. There was no evidence of slumping of the cellulose insulation, which had been a concern; however further testing over time is required to verify this. It is clear that openings are a clear source of thermal weakness, and thermal weakness at door and window frames were noted in all of the properties.

Figure 26: Thermal weakness at BA1 doors and windows.

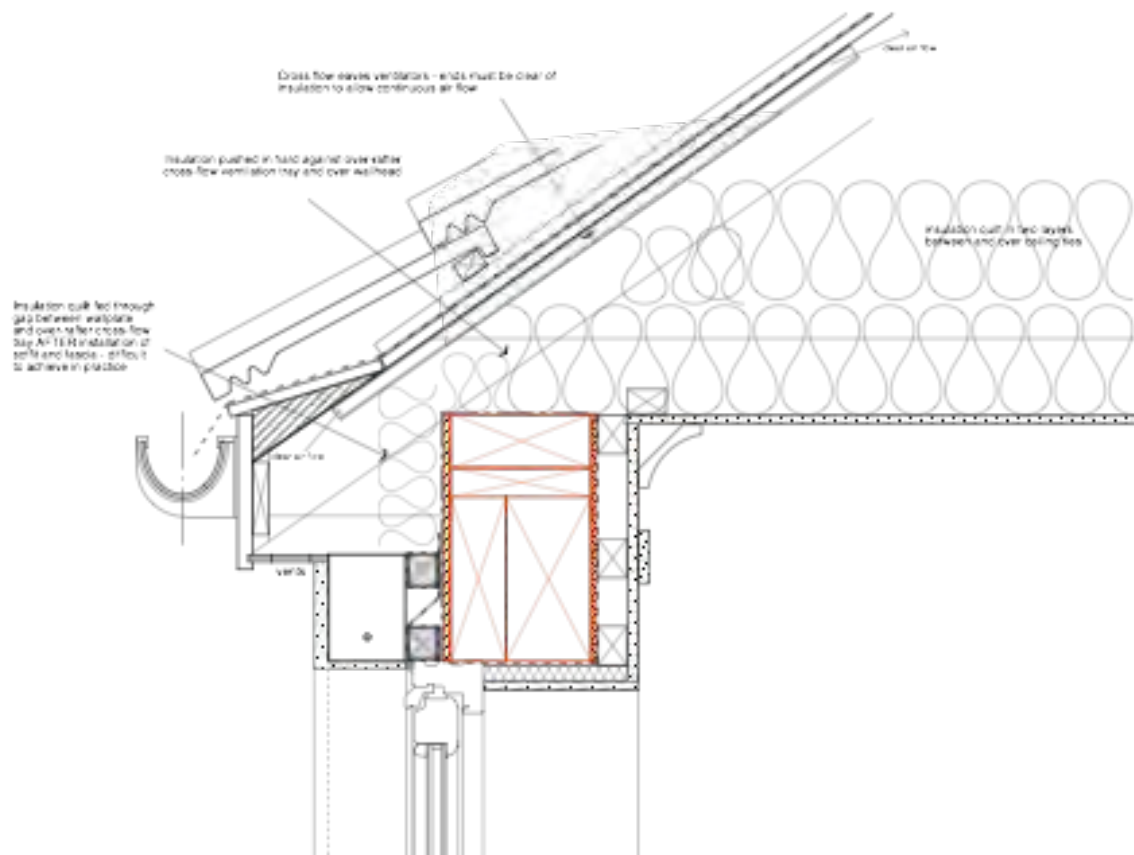
The ceilings in all the dressing rooms were inspected by the contractor and their report found that insulation had been omitted in BB1, this was the only one that was defective. As a result

Analysis of this problem raised the practical difficulty of placing insulation in roof spaces, particularly at eaves. This has now been addressed by the architects who have amended their standard details and the revised detail is shown in Figure 32.

of this survey, remedial work was undertaken to fit insulation in the ceiling of the affected room.

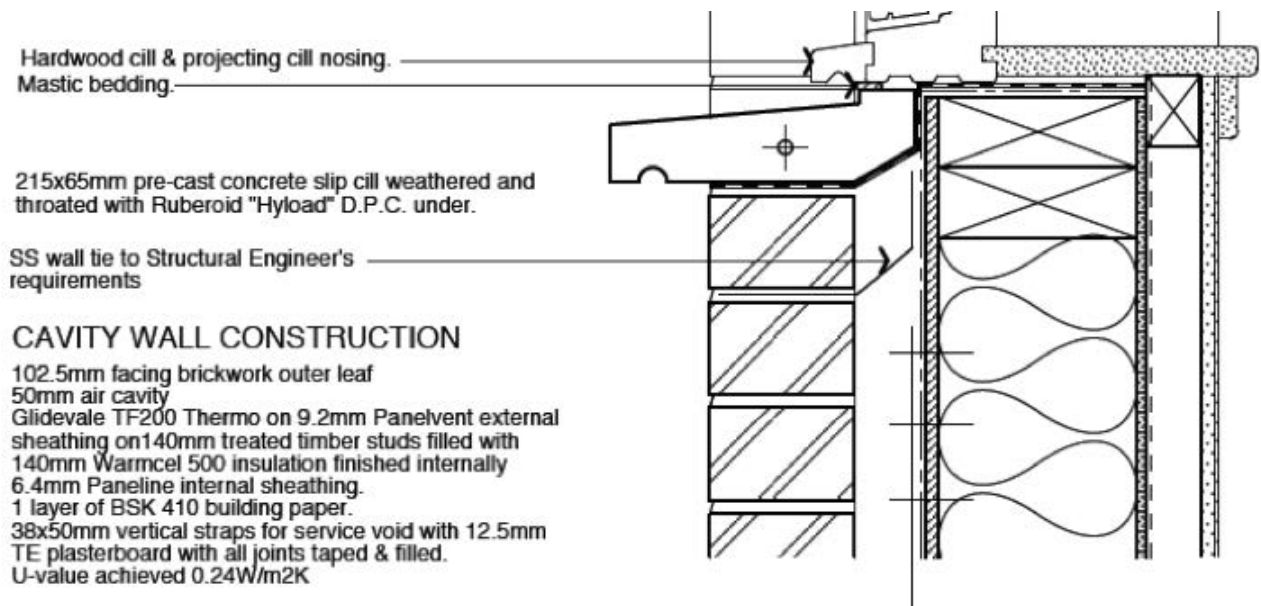
Figure 33: Original external wall construction detail

A key component of the environmental strategy and resultant construction is the use of a vapour permeable construction of the walls in the timber framed houses. This construction involves replacing the conventional – vapour impermeable – outer sheathing with a vapour permeable sheathing ('Panelvent', a medium density fibreboard), which allows day-to-day levels of moisture in the construction to escape safely. The permeable outer sheathing is complemented with a relatively vapour-tight internal sheathing ('Paneline', a type of hardboard) and hygroscopic insulation that in this case is recycled cellulose fibres known as 'Warmcel'. To add further resistance to vapour movement through the wall (without preventing it altogether) a layer of BSK 410 Building Paper was specified inside the Paneline. The construction detail is shown below.

An issue that was encountered on site was that the Contractors did not install the BSK Building Paper on the inside of the wall, but instead another layer of the external breather membrane, the Glidevale Protect 'TF200 Thermo'. In theory that means that there is insufficient resistance to vapour entering the construction which could lead to excess moisture build-up in the wall and increased risk of decay.

A revised graph (Figure 35) was produced which continued to show no risk of condensation within the construction. However, to be on safe side, the Architect instructed the Contractor to provide a remedy and it was agreed that the Contractor would coat the plasterboard internally with a sealant to provide additional resistance to vapour from the inside.

The revised instruction was as follows: “18.1.1 In accordance with the contractor’s proposals to achieve the requisite level of the vapour barrier following the deviation from the specified material on site, external walls of timber frame construction to receive two coats of Gyproc Drywall Sealer. Note:- this work is to be at no cost to the contract. This is solely a record of the incorporation of the contractor’s proposal in respect of the vapour barrier.”

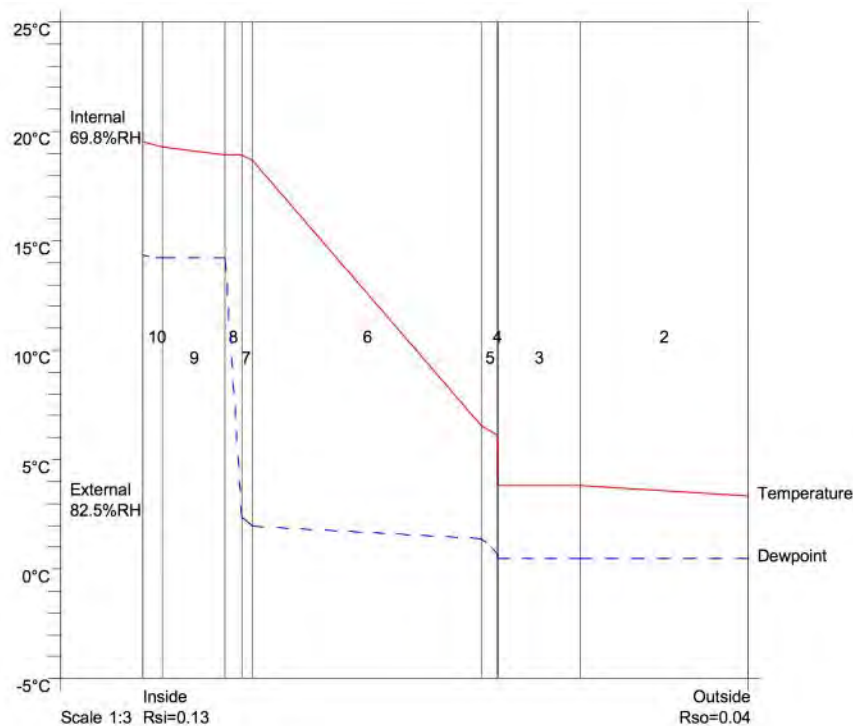
Figure 34: Original condensation risk analysis

The graph below displays the results of the condensation risk analysis, which indicates no risk of condensation within the construction. It is possible to see however that this is largely related to the large drop in vapour pressure across the vapour control layer, the BSK 410 Building Paper (layer 8 in the diagram).

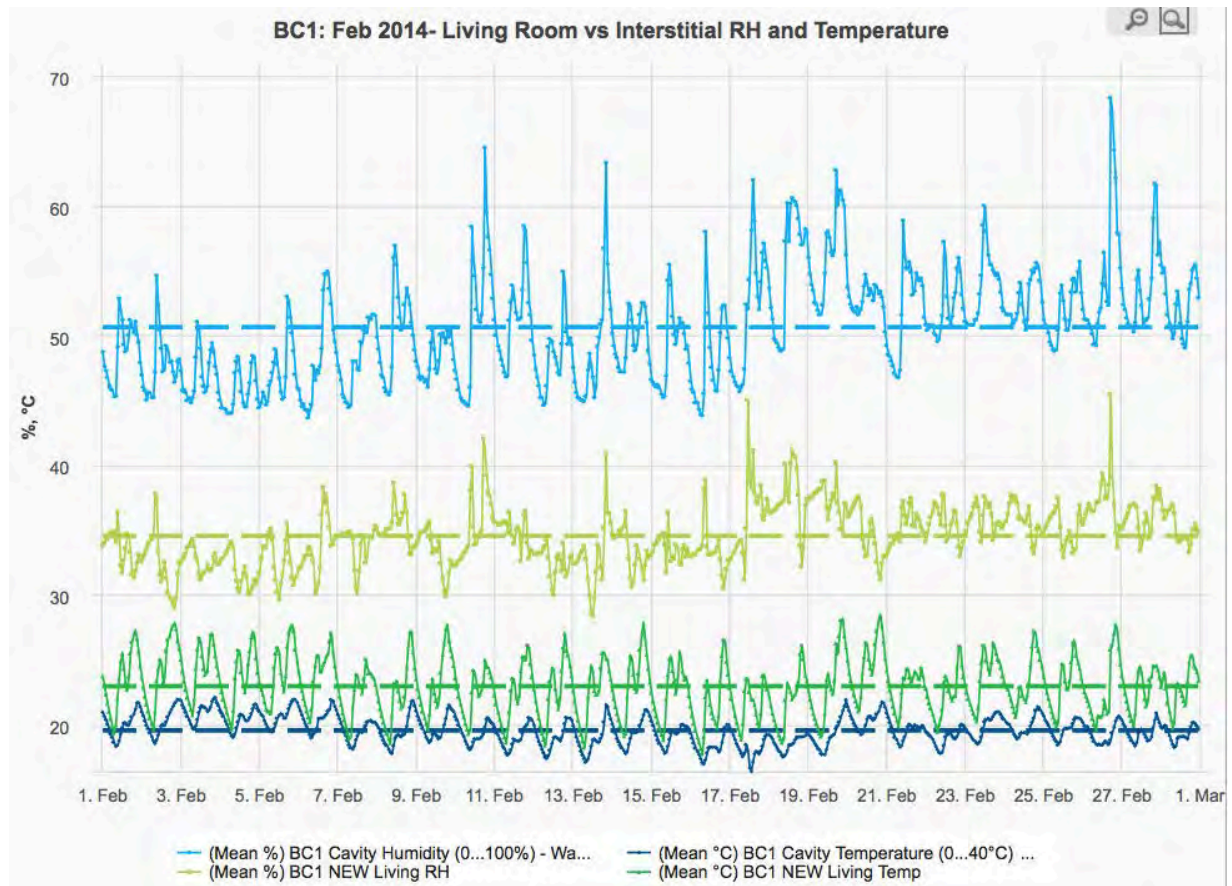
Figure 36: BC1, February 2014. Living room RH and temperature vs interstitial RH and temperature

The interstitial conditions have been monitored over the course of the project and Figure 36 and Figure 37 show conditions in the wall and the adjacent living room over a typical month (February 2013). It is apparent that, as might be expected, temperatures are lower within the wall, and humidity levels are higher; however at no point has dew point been reached.

Comparing the living room and interstitial RH demonstrates that interstitial moisture levels are a function of the internal conditions. Spikes in moisture levels are reflected in the interstitial conditions - of interest is that RH levels decline slowly after peak conditions,

indicating some hygroscopic buffering effect. In this example, humidity spikes are the result of social events held in the room.

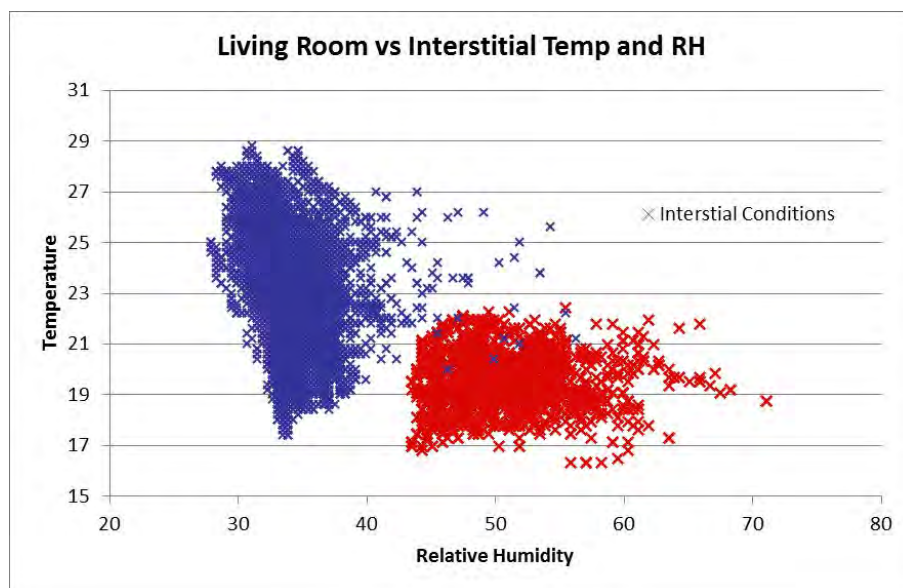
Figure 38: BC1, February 2014, comparison of living room RH and temperature vs interstitial RH and temperature.

The scatter plot of temperature and RH in the living room and wall is shown in Figure 38. As can be seen the temperature range is lower, and RH is generally higher but would appear to be no cause for concern. Whether this construction is having beneficial effects on the internal conditions is discussed in Section 7.

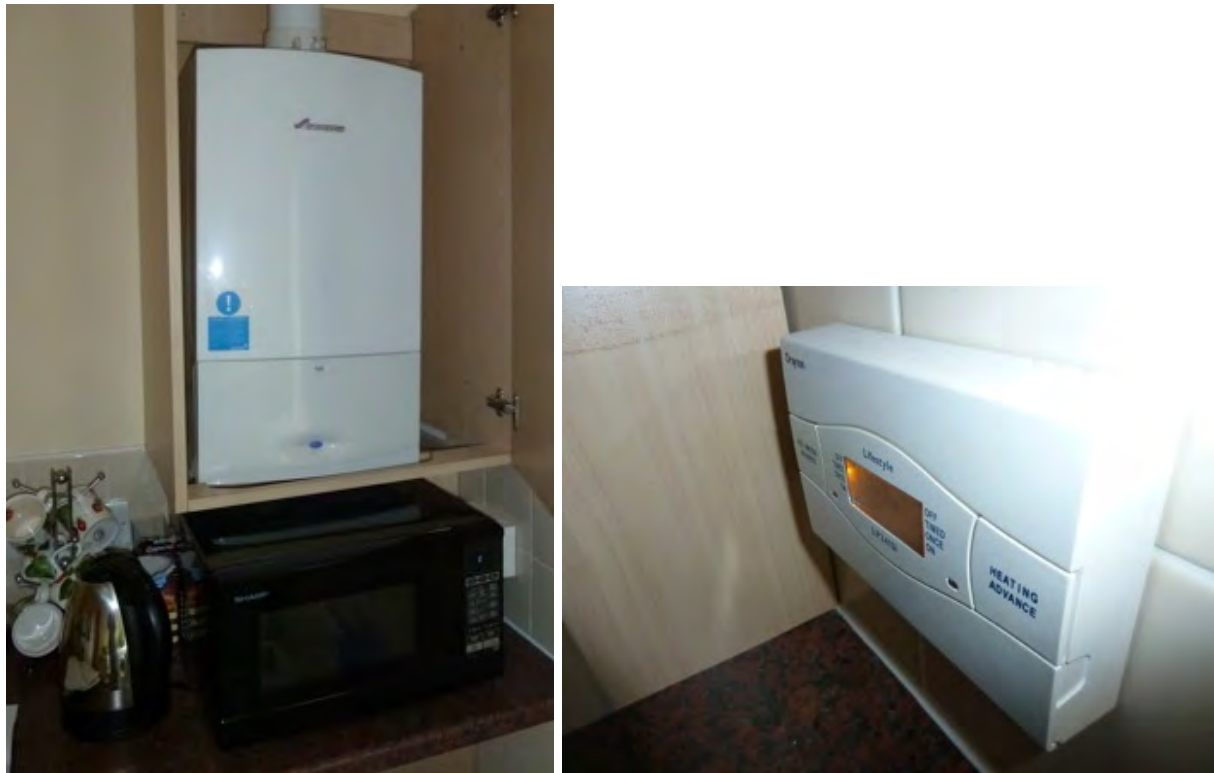
Figure 49: Boiler located in the kitchen (left); programmer located below the boiler (right) - note access to programmer (blocked by the location of Microwave oven).

There were problems identified with the users' understanding and knowledge of the controls, this is also discussed in Section 5. The controls are very standard to wet central heating systems, but it was apparent that users were having some difficulty understanding and using these. There was no specific handover process for controls and they are basic digital units that users find hard to understand. They have been located in spaces, which are difficult to access (see Figure 49) and this combined with the size of the screen and information is likely to be a challenge for users with poor eyesight.

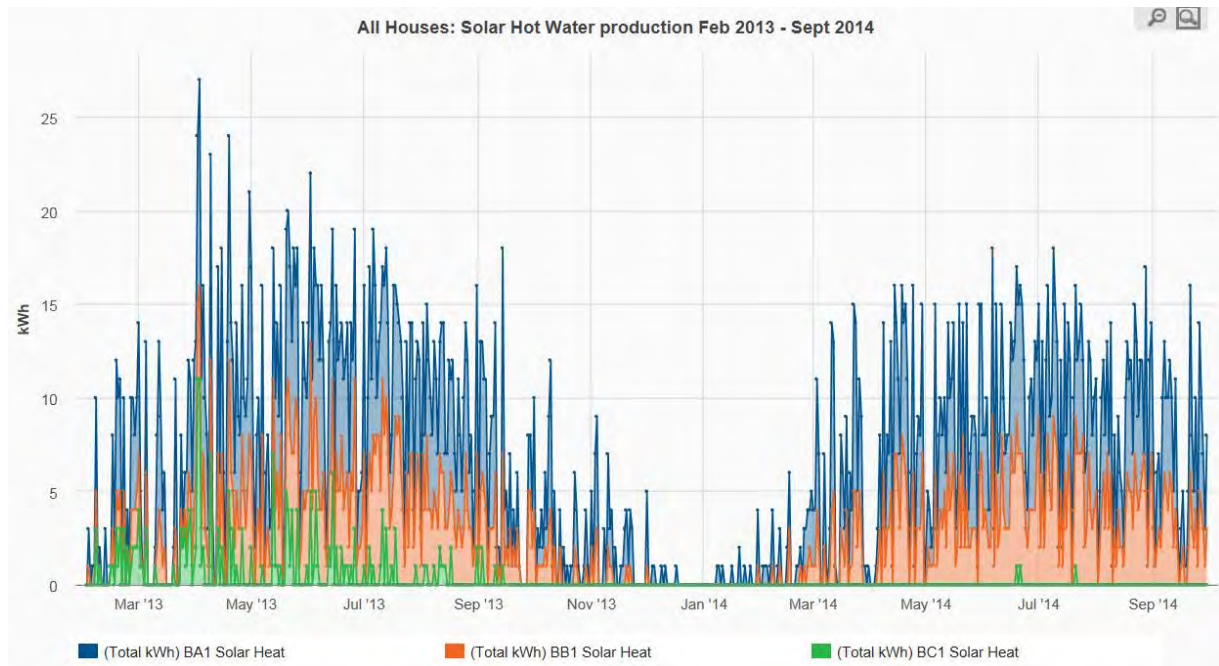
Figure 51: All houses, solar hot water production Feb 2013 - Sep 2014.

The overall output of the solar thermal systems is shown above. There are several features to note. In spring 2013 there was output from the system in BC1 but this was intermittent and corresponded with difficulties including the leak from the system. Output appears to have ceased in the winter of 2013, and did not pick up again in summer 2014. The output from BC1 has been consistently poor throughout the period.

The reasons for this have yet to be fully established. At the time of writing the solar thermal maintenance contractors are claiming the system is functional and the error is due to a leak from the monitoring heat flow meter, but this is disputed by the plumber who fitted these. Comparing summer gas use of the houses to see if there is greater gas use in BC1 strongly suggests that there is a defect.

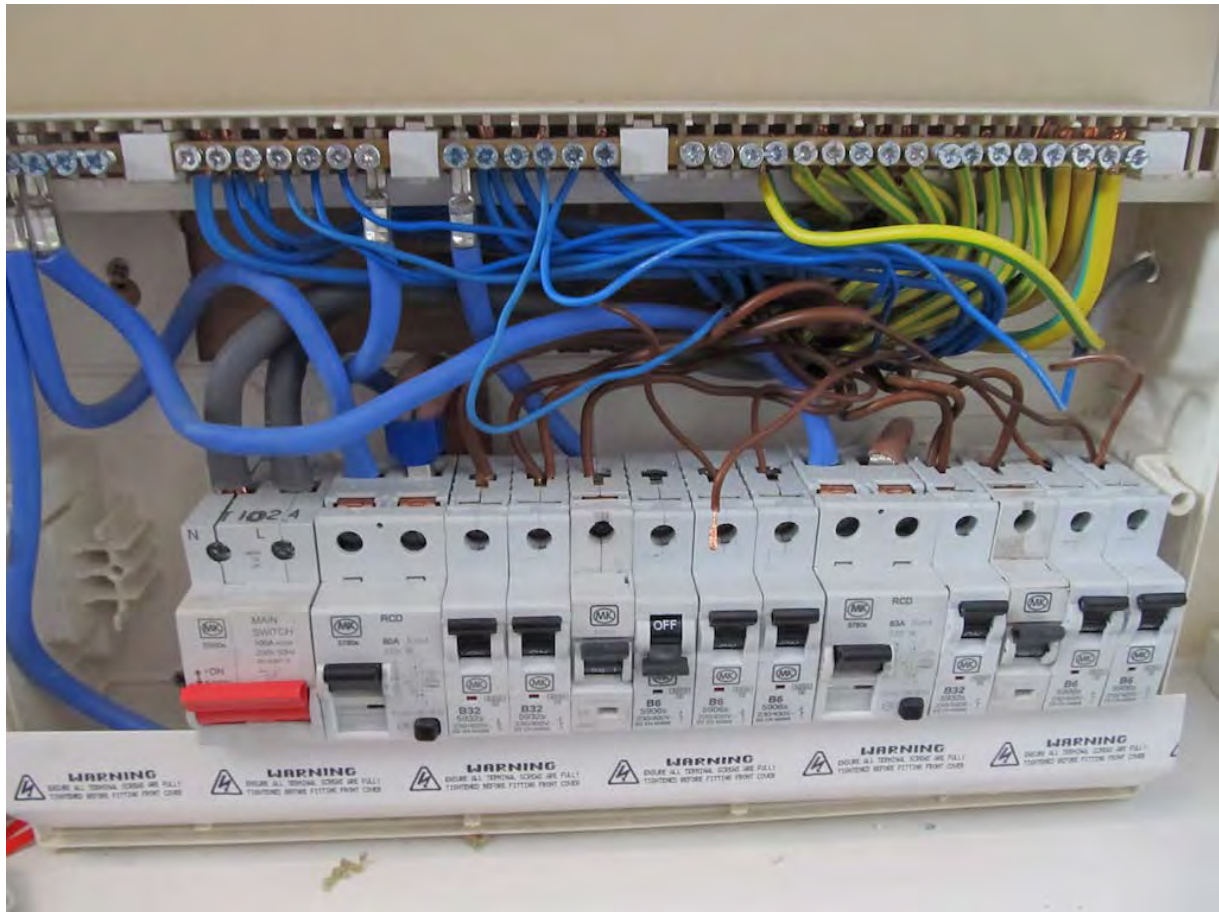
Not all of the sub-circuits were monitored, for two reasons. Primarily, there was very limited space in the consumer unit in which the CT clamps were fitted. The tails for the sub-circuits had to be extended to provide enough accessible cable on to which the clamp could be placed. The bulk of these clamps meant that only 5 or 6 clamps could be placed whilst allowing the consumer unit to be closed for safety. The second reason was an attempt to provide some consistency between what was being metered in the different properties. A judgement was made on site about which circuits were appropriate to measure.

Figure 57: Inside a consumer unit showing the amount of cabling and tails for sub-circuits being extended.

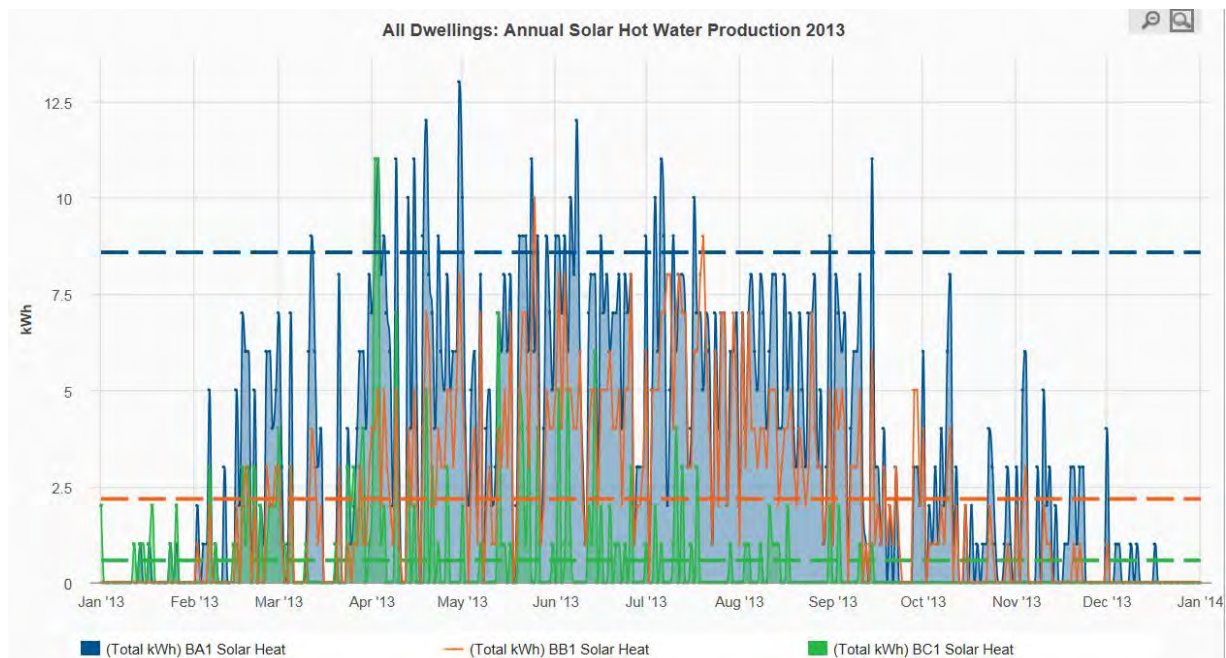
Figure 83: Solar Hot Water production Jan 2013 – Dec 2013.

The overall output from the systems over the entire monitoring period is shown in Figure 83. The output from BC1 has deteriorated during the second part of 2013 and remains poor. Further visits from the maintenance contractor have not yet identified any issues. Whilst there is a possibility that the error is due to monitoring, given that early monitoring did give an output similar to the other panels this is thought unlikely.

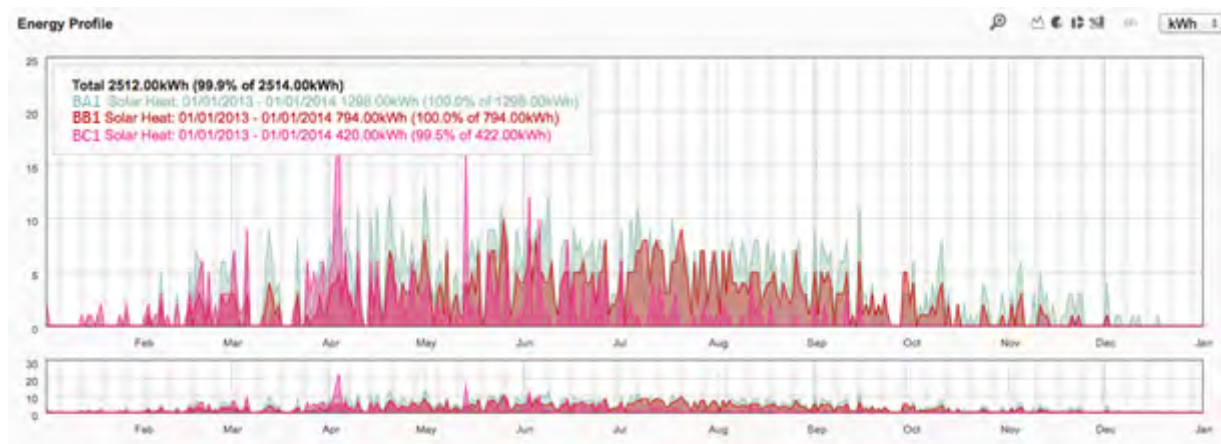
Figure 84: Annual solar thermal output 2013 for all three dwellings

Looking specifically at 2013, the overall production for 2013 is shown below, with 1298 kWh from BA1, 795 kWh from BB1 and 422 kWh from BC1.

For BA1 the hot water output of 1298 kWh exceeded the SAP figure of 1119 kWh, but both figures are below the commissioning sheet figure of 2340 kWh. The figure for BB1 was initially thought low at 794 kWh, but as this is a single panel the output for the area is actually higher. Although the panel in BB1 is half the size, the contribution is some 63% of the output from BA1. There is no obvious explanation for the differences in these results. Orientation and angle are the same (see Figure 48), the only key difference being the positioning of the panels, with the BB1 panel having a vertical position, it is therefore possible that this is resulting in higher gains as the temperature gradient between top and bottom is greater. The most obvious cause would be the relationship between hot water supply from the ST system and hot water demand. As the hot water demand is lower than the ST supply the system in BA1 will ‘stall’ more frequently as hot water is not being drawn off. The smaller ST supply from the panel in BB1 is more ‘useful’ as it is topping up actual demand.

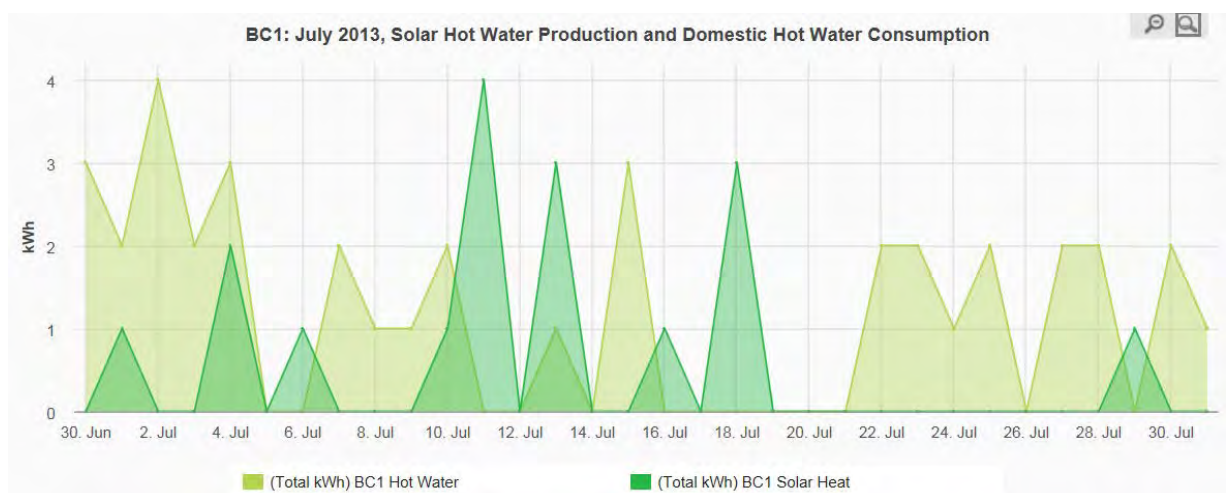
Figure 87: BC1, solar hot water production and domestic hot water consumption.

Taking July 2013 as a sample month, both BB1 and BC1 consume 78 kWh of hot water and BA1 consumes 134 kWh. In the same period the ST systems produce 192 kWh in BA1, 170 kWh in BB1 (remembering the smaller panel size) and only 32 kWh in BC1.

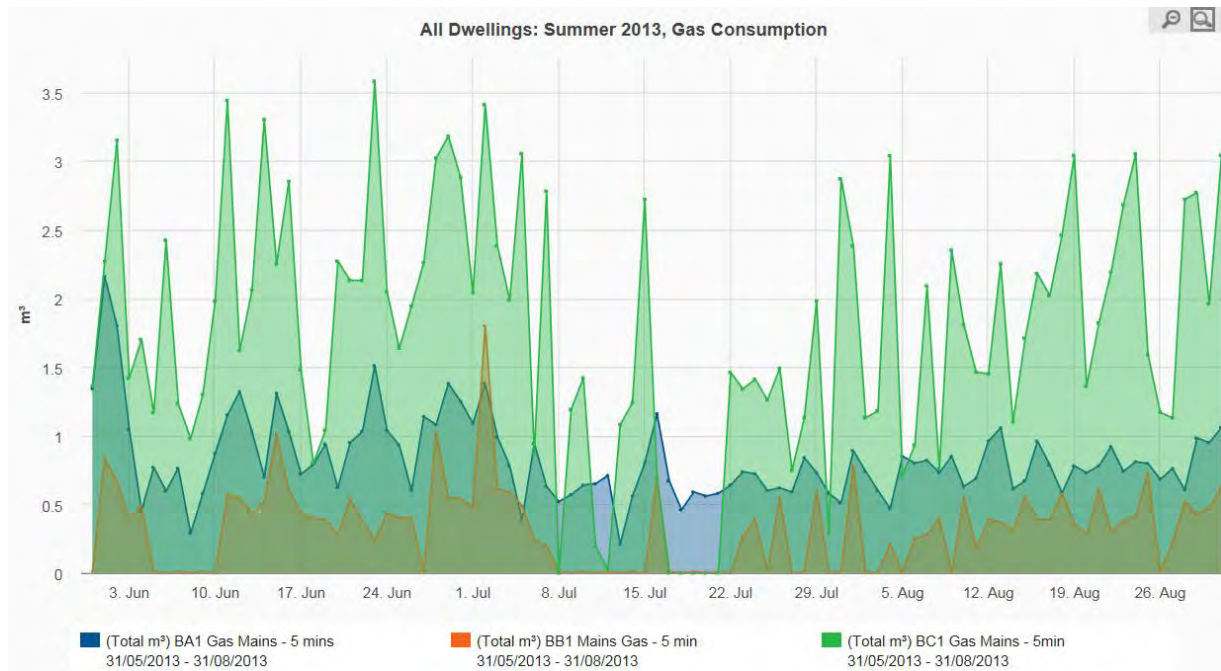
Figure 89: Gas consumption in all houses, Summer 2013

Overall gas consumption was higher for BC1, partly due to the higher temperatures being delivered. However, analysis of gas consumption for the summer months (Figure 89), when space heating requirements would be small, shows a significant difference, with BC1 consuming 1820 kWh compared to 846 for BA1 and 337 kWh for BB1. On a very rough estimate, and allowing for the relatively low hot water use in BC1, this could result in an additional cost of around £40 a year.

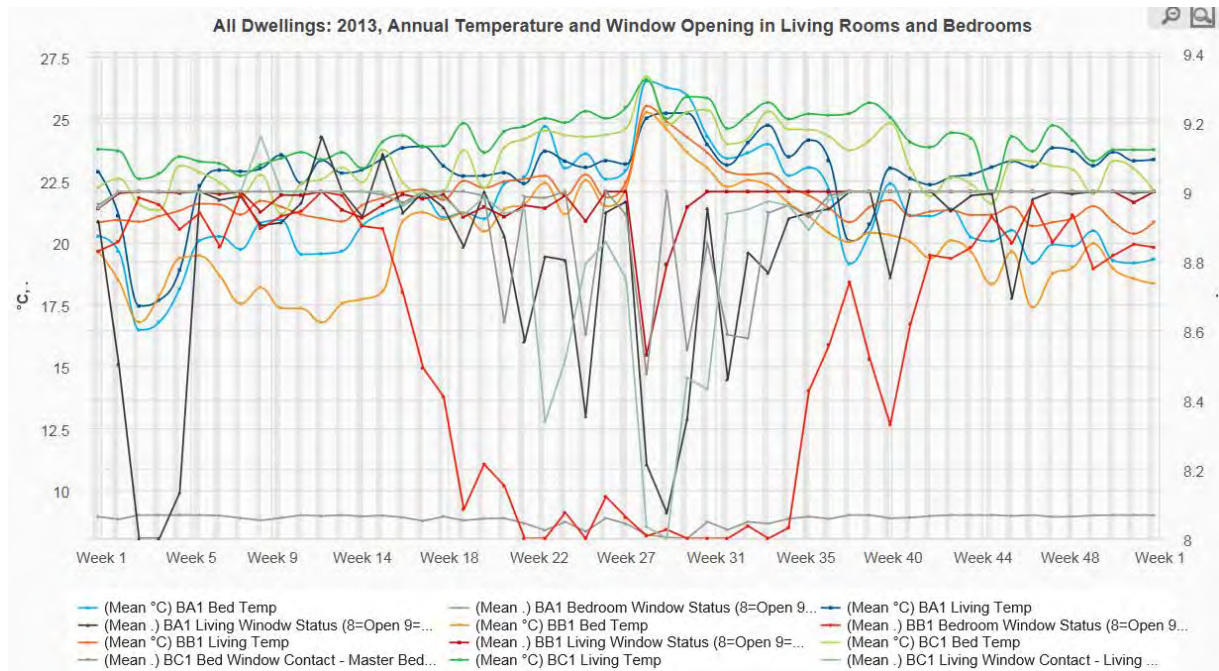
Figure 91: Annual Living room and Bedroom temperature, window opening (averaged weekly data – 9=closed, 8=open)

The relative window opening habits and temperatures in the houses are shown in Figure 91; the following analysis aims to identify the effects of this. Looking at average temperatures over the course of the year shows that temperatures generally remain stable even during the coldest conditions, only dropping significantly during absences, and even then not to set back levels. There is a clear difference in levels of temperature being achieved in the different dwellings. BC1 has the highest temperatures by a significant margin, this is reflected in the overall gas consumption for space heating.

In these dwellings it is difficult to be prescriptive about demand temperatures as the occupants are older, with a number of health issues, and greater periods of occupancy, higher temperatures are not unreasonable. Nevertheless, temperatures achieved in BC1, even during periods of low external temperatures, are beyond comfort conditions (CIBSE seasonal comfort zones), resulting in additional heating costs. In the occupant surveys the BC1 occupants identified overheating in the summer, citing heat from the flat screen TV for example.

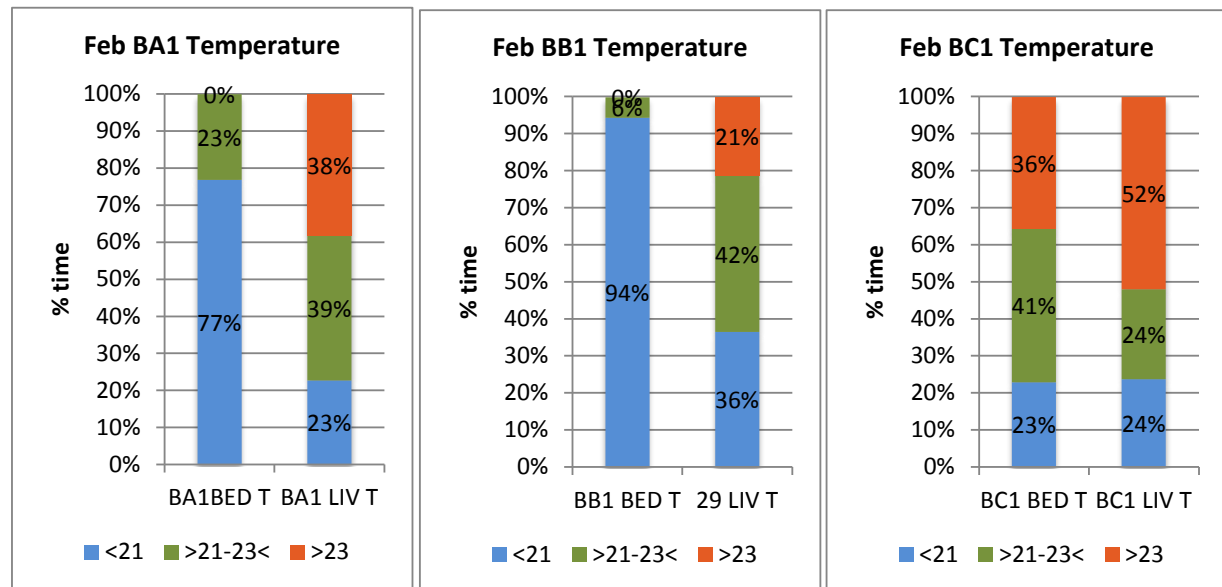
Figure 92: February summary temperature distribution

The average external temperature during February 2013 was 2.33 °C, max 12.00°C and min -5 °C. The clear difference is in BC1 in which the living room is 23 °C for more than 52% of the time with an average temperature of 23.01 °C. Although the mean temperature is only slightly above that of BA1, the standard deviation is much higher, demonstrating a relative lack of control and tendency to overheat. The bedroom is equally warm with a peak of 26.60°C and an average of 22.32 °C, much higher than the other two houses.

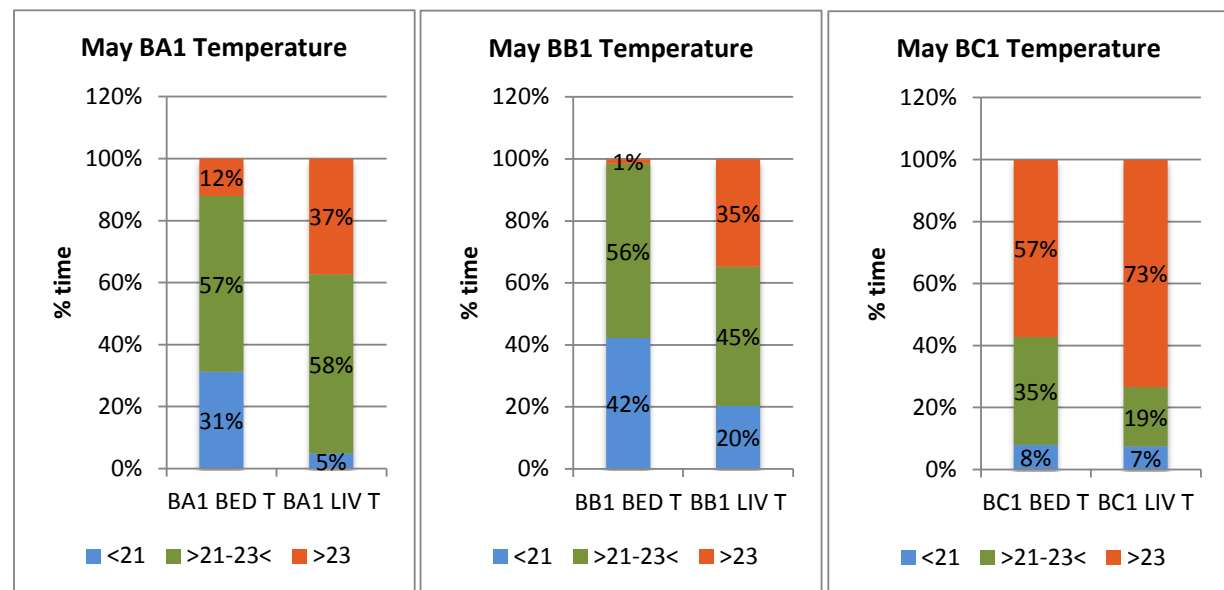
Figure 93: May summary temperature distribution

Of interest here is the greater propensity for overheating. The average external temperature this month was 9 °C, still reasonably cold and well within a heating regime. In this period BB1, which has thermal mass and a night-time window opening regime, is performing well, but there are still periods of overheating (over 26 °C in bedrooms, over 28 °C in living areas). However in all the houses average temperatures were higher. This represents a seasonal lag where heating and ventilation regimes established during the winter persist into the spring. However, it may also reveal deficiencies in the control systems, whereby stable temperatures that should be provided by thermostats and TRV's are not being achieved. The difference in temperature in BA1 which has a more liberal window opening regime in the bedroom is clear.

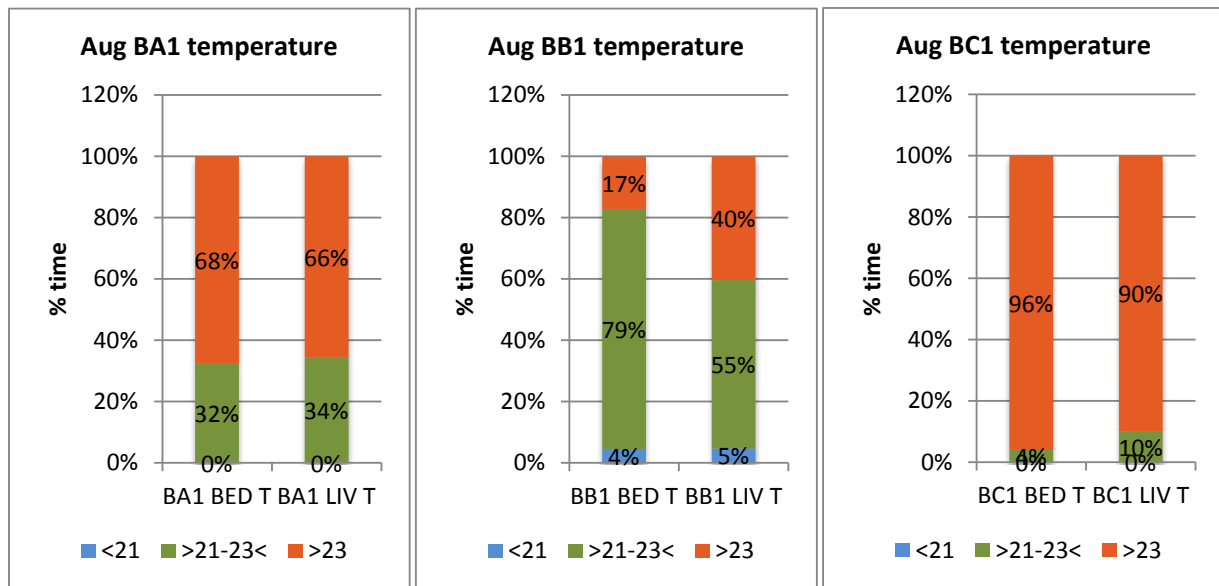
Figure 94: August summary temperature distribution

Average external temperatures during August were 17 °C with peaks of 23 °C. There was some overheating in all three dwellings, with average temperatures in BC1 Living Room of 25.26 °C and 24.69 °C in the bedroom. Once again BB1 has the most prevalent comfort conditions. Of note is the lack of living room window opening, but almost continuous bedroom window opening. Keeping the living room window closed does help to avoid ambient external gains, whilst the open bedroom window at night assists with the purging of the thermal mass.

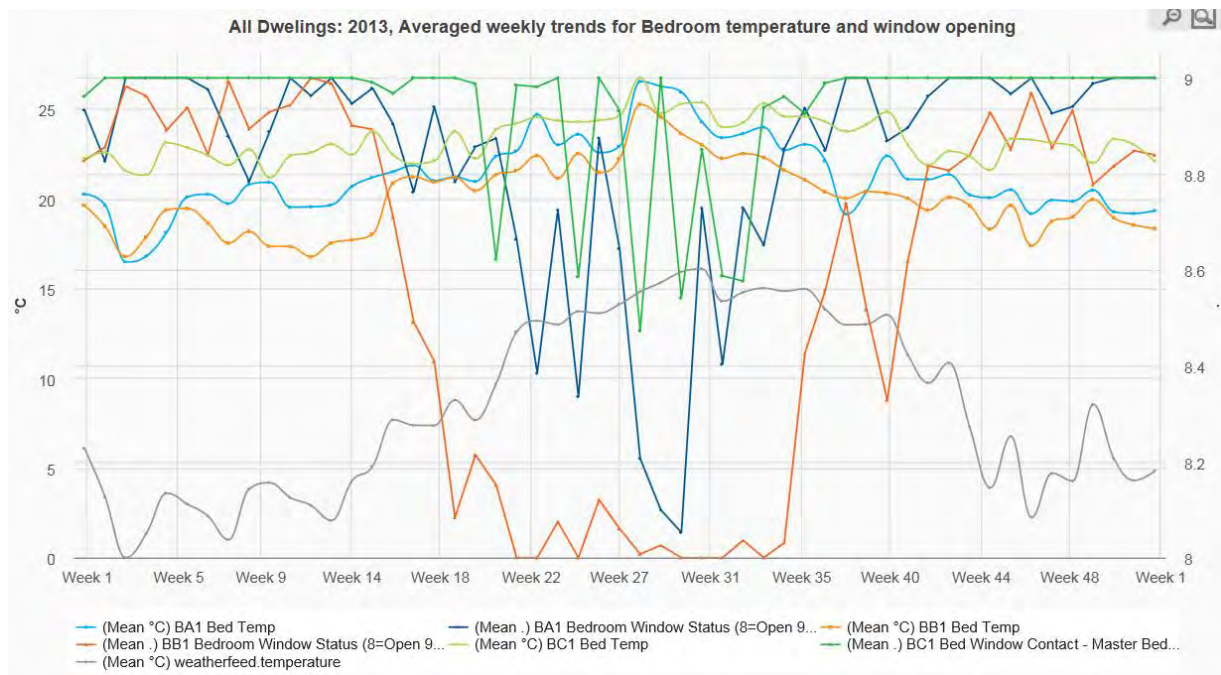
Figure 96: Averaged weekly trends for Bedroom temperature and window opening all bedrooms, 2013

Looking specifically at bedroom data in Figure 96 shows the general pattern of window opening and bedroom temperatures across all three houses. Several things are apparent. Firstly, BB1 has the most frequent window opening and temperatures are also the lowest. The occupants of this dwelling prefer to keep the bedroom windows open at night and this clearly impacts on temperature but also CO₂ (discussed in the next section). In the autumn, BC1 remains consistently warm to hot despite falling ambient conditions.

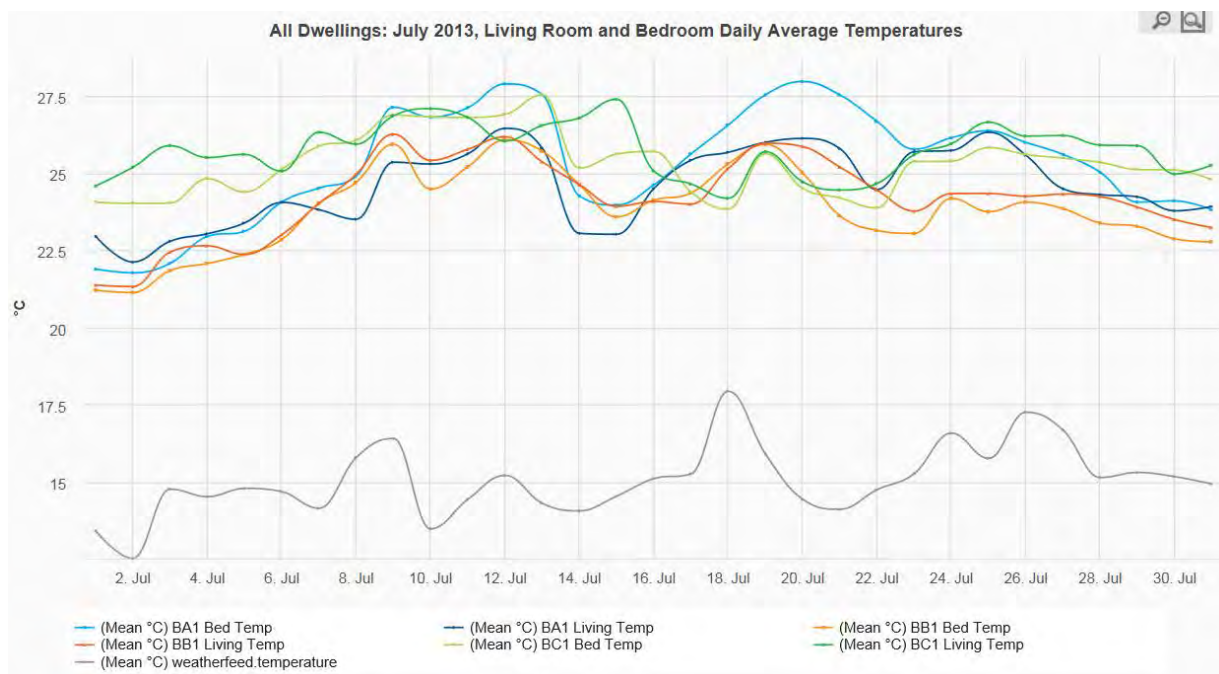
Figure 100: Living room and bedroom daily average temperatures, across all three house, July 2013

In the summer windows are opened much more frequently, there is a clear comparison between frequency of window opening and the temperature. The only negative temperature issue encountered during the study was that of overheating. During the summer months, high temperature consistently about 25 °C are seen in all houses, well above ambient.

When comparing the temperatures monitored in all three houses, of note are the relatively high temperatures of BC1. Also of interest is the relatively high temperature of the bedroom of BA1. This dwelling is two storey and the temperature differential is likely to be due thermal buoyancy. The south facing windows in BA1 are well protected by the external shading and there is also considerable internal protection in the form of permanent blinds and curtains.

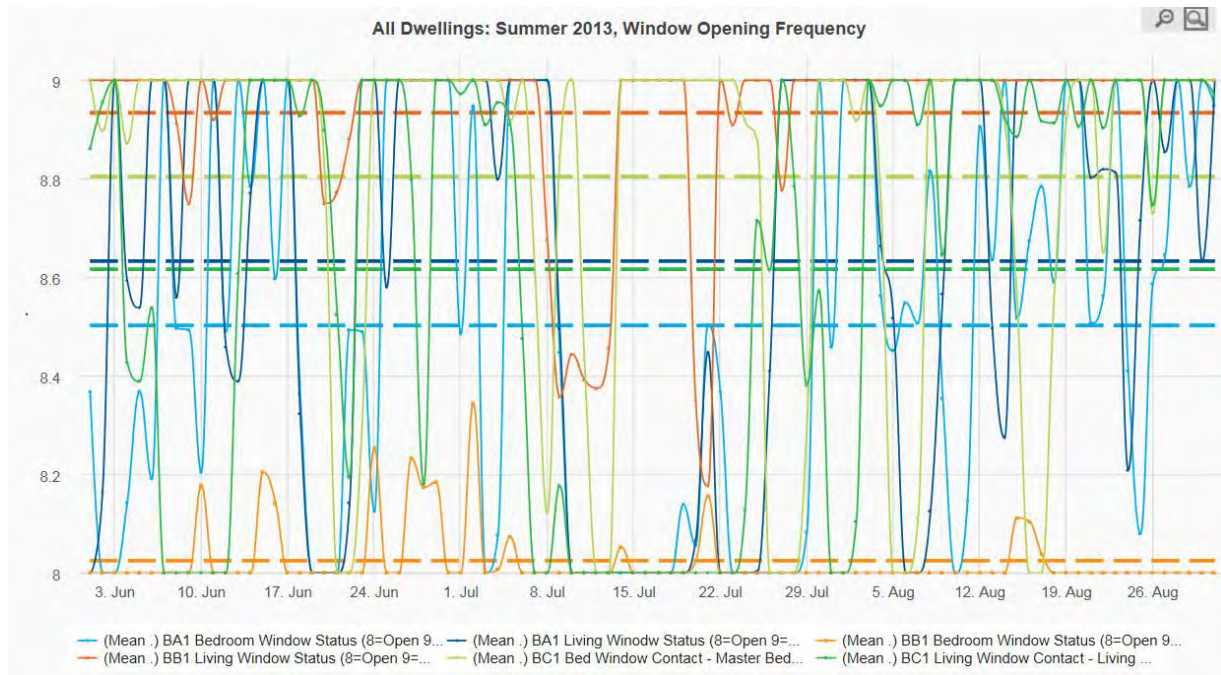
Figure 102: Window opening frequency – Summer 2013 (9=closed, 8=open)

Looking at the propensity of window opening during the summer reveals some interesting characteristics. In BA1 the living room and windows are open similar amounts, but in BB1 there is a big difference, with the bedroom window open almost all the time, but the living room window hardly ever. In BC1 both living and bedroom windows are closed relatively often and this contributes to the very high temperatures being experience in this dwelling.

This would indicate that the effects of incidental gains, particularly for longer periods of occupancy are significant, and also that ventilation provision and strategies are not effective. During these periods windows were opened more frequently, with BB1 having the most frequent window opening and lowest temperatures. Night-time opening would be an important strategy with regards to the thermal mass.

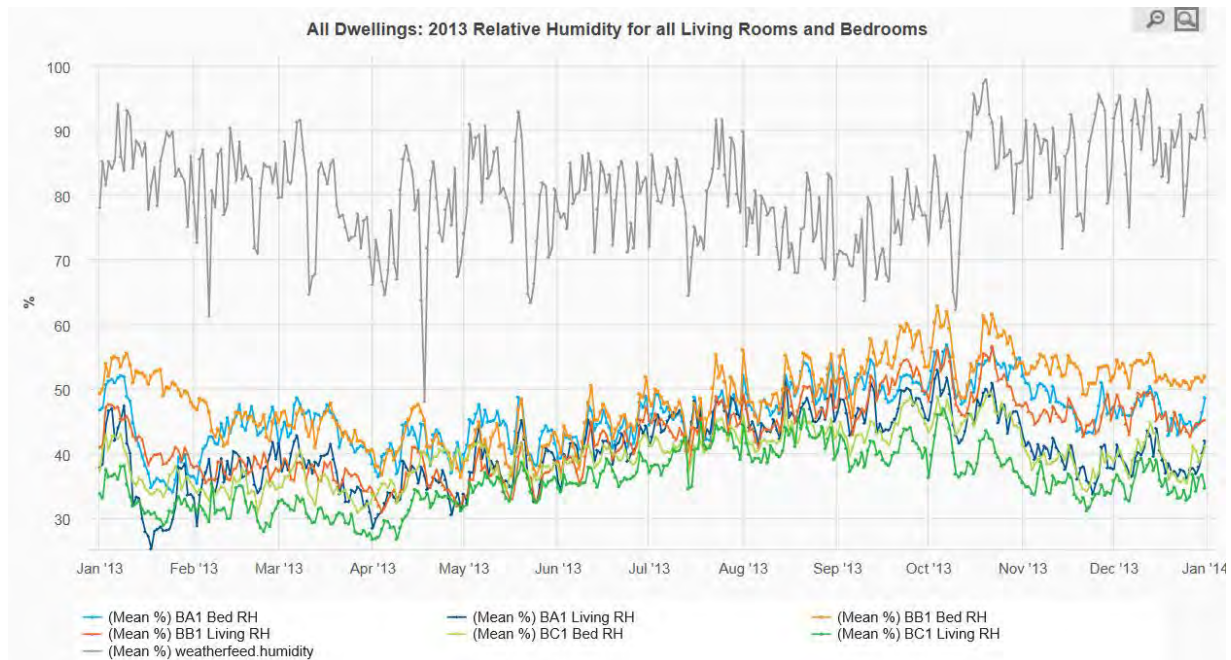
Figure 103: Annual (2013) RH for living rooms and bedrooms

The overall picture is one of low relative humidity, conditioned primarily by temperature. Thus the bedroom in BB1 has the highest RH and the living room at BC1 has the lowest. The distribution of RH does not follow ambient conditions, but is more affected by heating regimes. Lowest RH is seen in spring, when temperatures tend to be highest, and highest RH occurs in autumn, where summer window opening and (lack of) heating regimes persist into the start of the heating season.

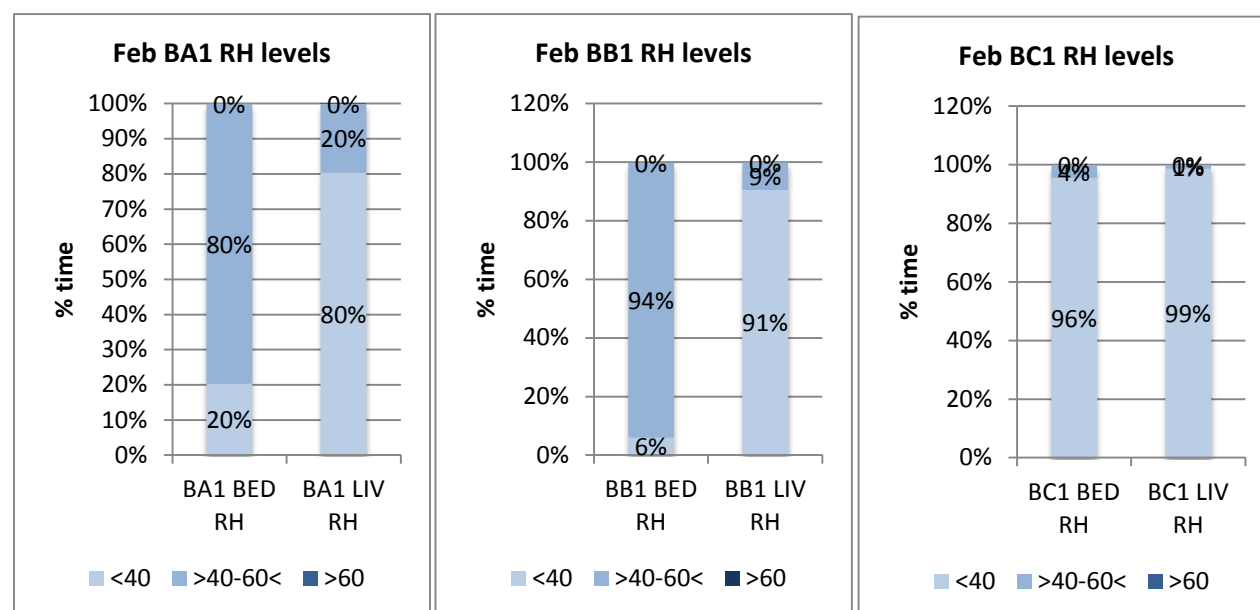
Figure 105: February summary RH distribution

The RH levels in this period are generally low, the only exception being the bedrooms of BA1 and BB1. Although there are some peaks these are very short-lived. For BA1 and BB1 bedrooms are within acceptable ranges, but the bedroom in BC1 and all living rooms are below 40% average RH.

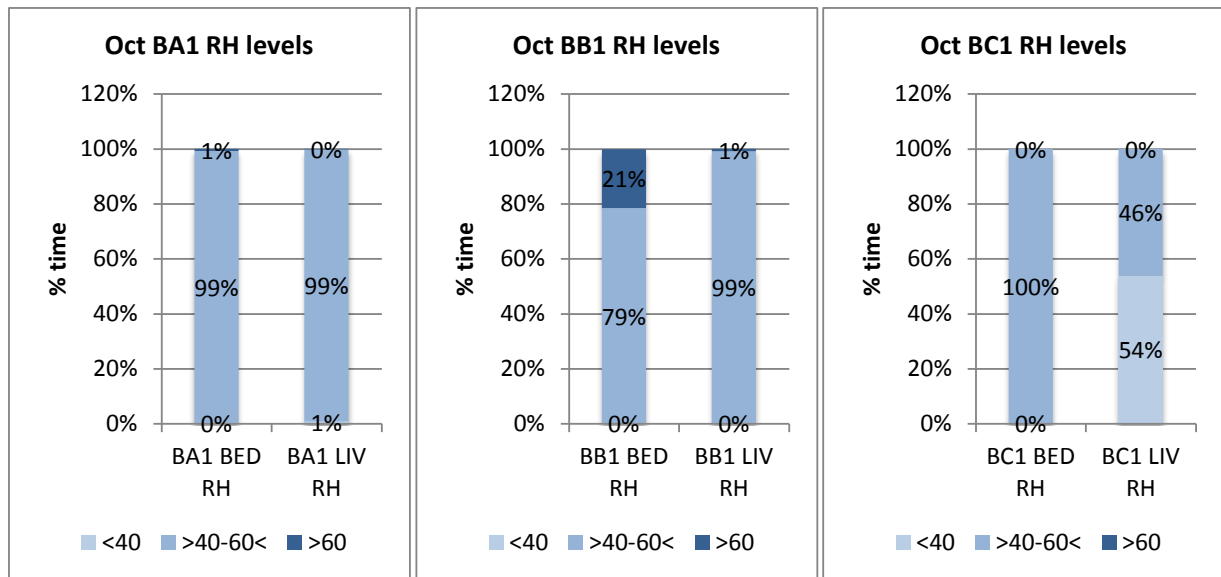
Figure 108: October summary RH distribution

In the autumn period, RH levels are more consistently within acceptable limits. The effect of bedroom window opening can be seen in BB1. In this case, summer window opening behaviors in the bedroom persist into autumn leading some periods of high moisture, above 60% RH.
