Murray Place

This document contains a Building Performance Evaluation report from the £8 million Building Performance Evaluation research programme funded by the Department of Business Innovation and Skills between 2010 and 2015. The report was originally published by InnovateUK and made available for public use via the building data exchange website hosted by InnovateUK until 2019. This website is now hosting the BPE reports as a research archive. Although no support or further information on the reports is available from the host, further information may be available from the original InnovateUK project evaluator using the link below¹.

InnovateUK project number	450104
Project author	Hanover Housing Association
Report date	2014
¹InnovateUK Evaluator	N/A

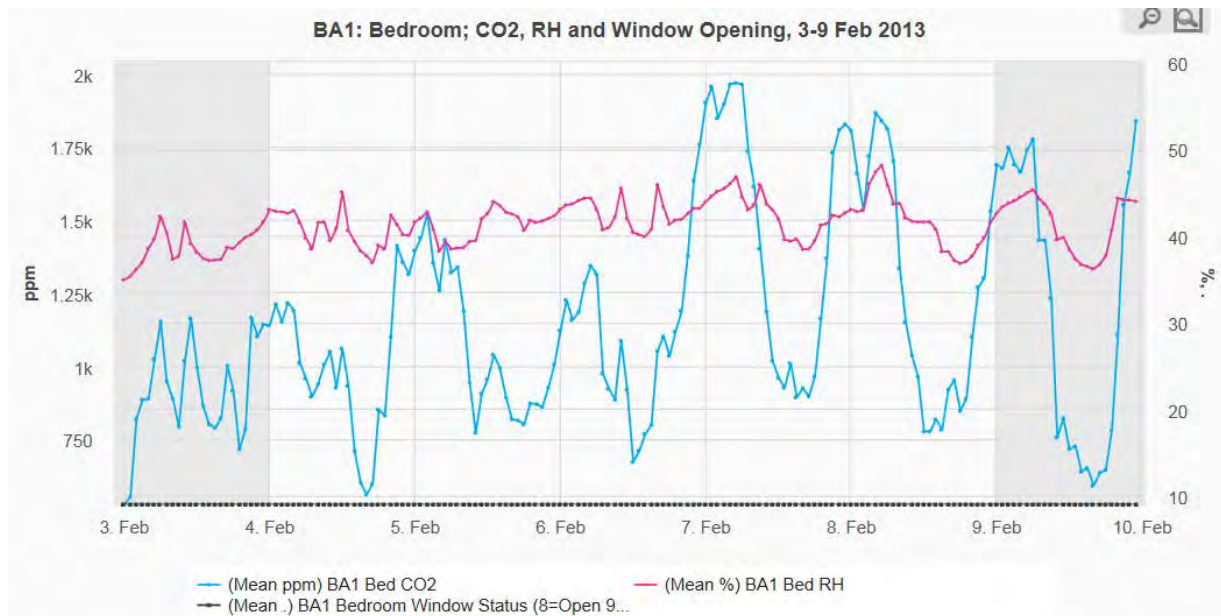
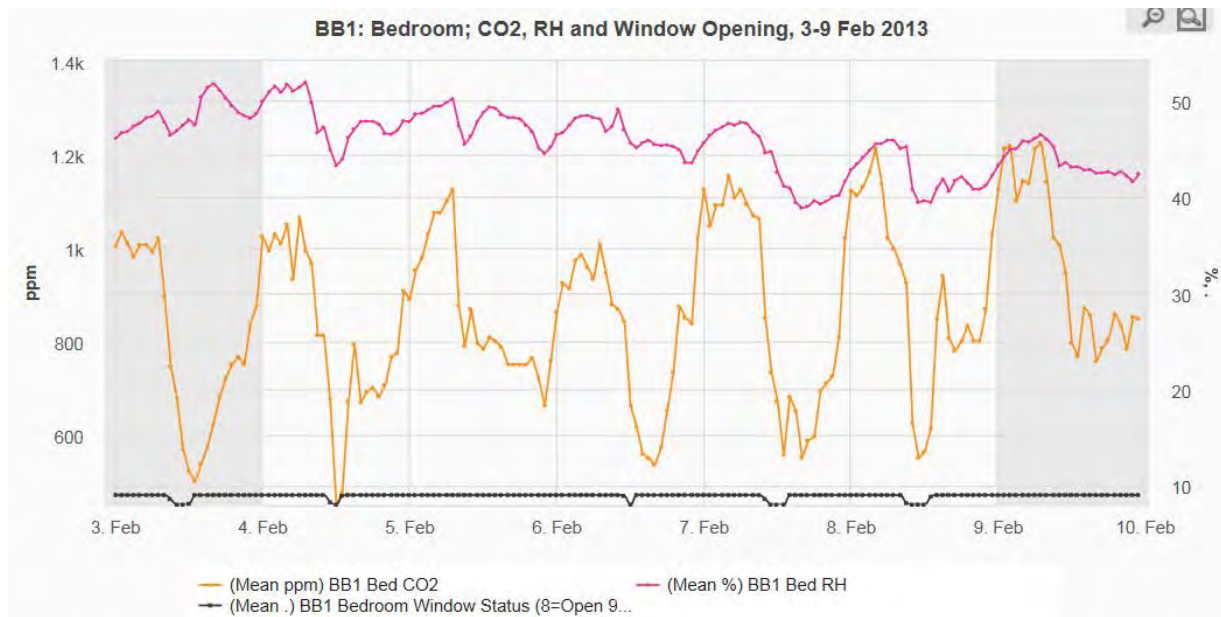
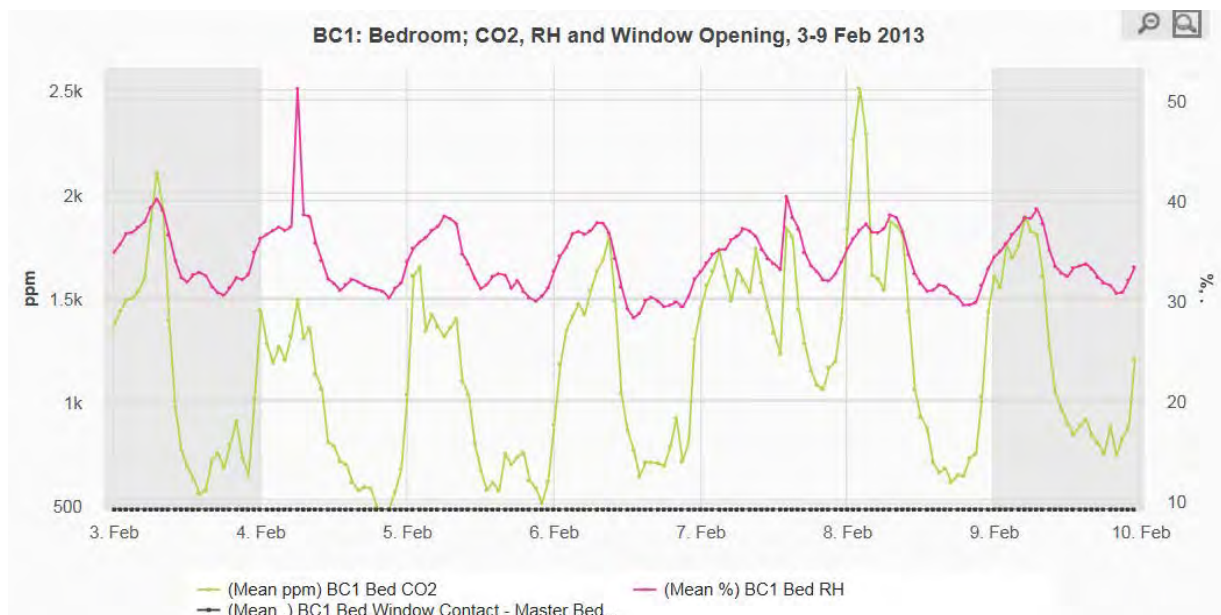
It is evident from the monitored data and specific studies that ventilation rates in the bedrooms are poor. The conditions are considerably mitigated in BB1, which undertakes more frequent bedroom window opening. It also clearly demonstrated the relationship between CO₂ and RH levels. Looking at temperature and RH during this period indicates the effects of temperature on RH.

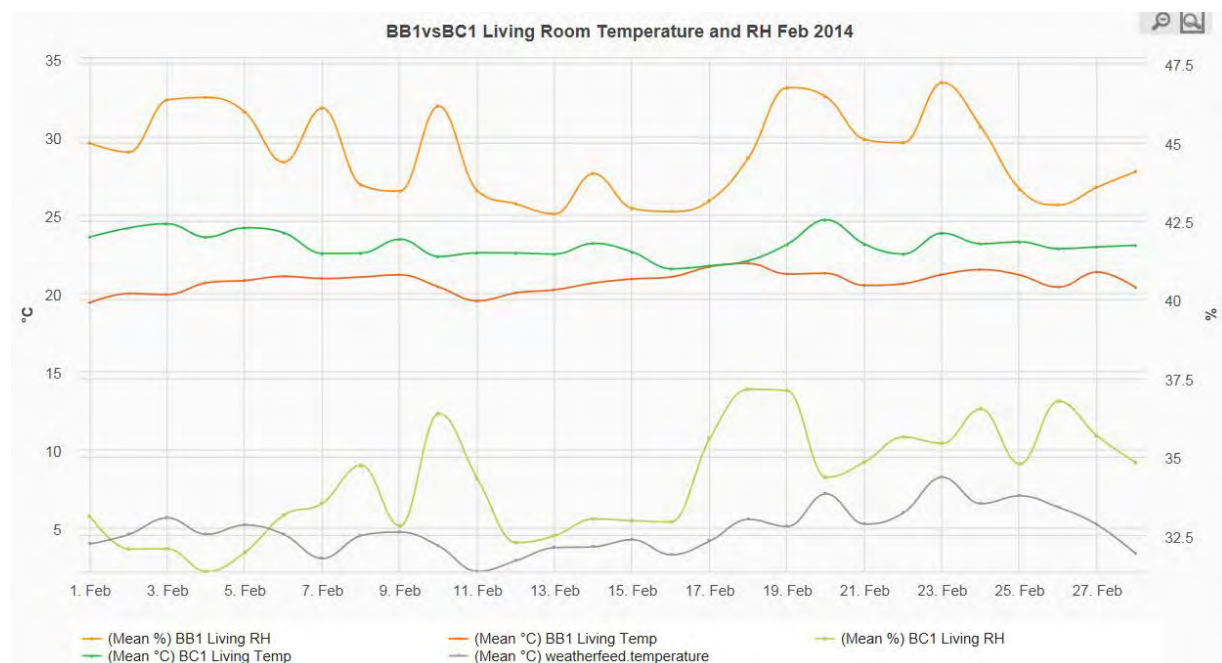
Figure 125: Comparison of temperature and RH in February 2014, BB1 Living room vs BC1 Living room.

Figure 125 shows the temperature and humidity for February 2014 and Figure 126 is a scatter plot the temperature and relative humidity over this period, in which occupancy is similar, and there is little or no window opening. The differences are quite apparent, the respective figures for relative humidity are: 34.53% for BC1 and 47.20% for BB1. When read in conjunction with the interstitial analysis discussed in Section 3.4, in which interstitial moisture levels follow room conditions but decline more slowly, it would appear that the vapour permeable construction is having a positive effect of levels of relative humidity.

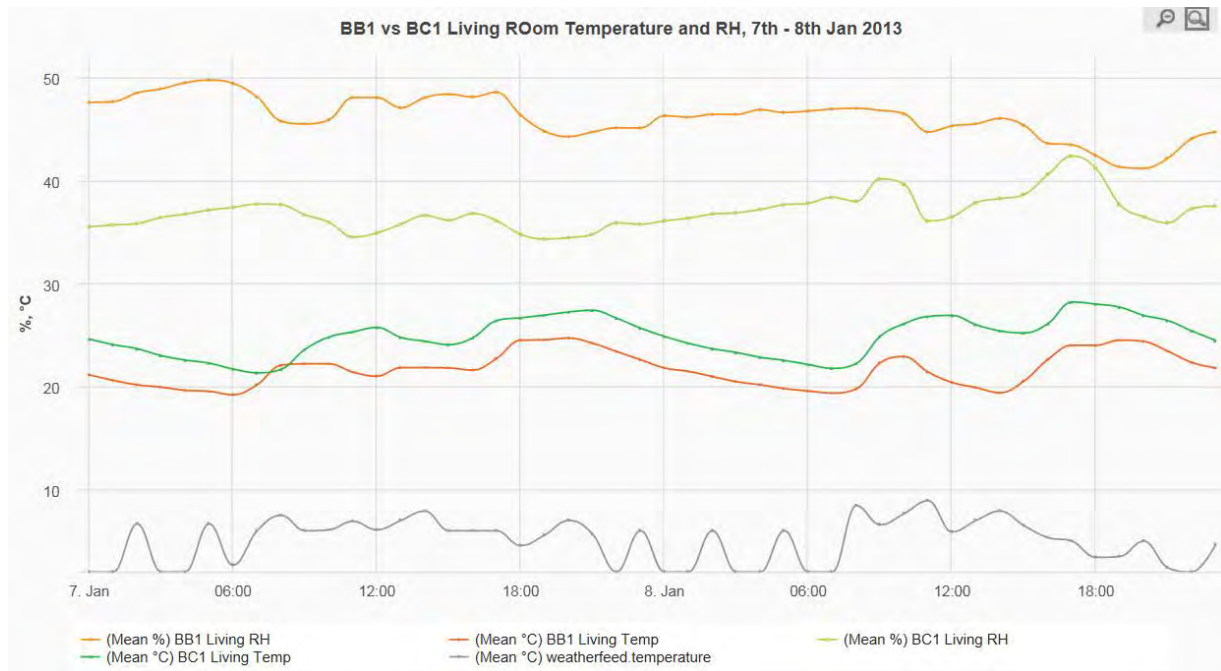
Figure 127: BC1 Living room vs BB1 Living room: Temperature and RH, 7-8 Jan 2013.

The effects of temperature are therefore relevant in relation to the relative humidity levels. Examining this in more detail, but taking a day when temperatures are broadly similar shows that when temperatures are very close, the RH in BB1 remains lower.

This would appear to present a dilemma in terms of future decision making. On the one hand, the thermally heavy house uses less energy, and does not have the peaks and swings in temperature. On the other, there does appear to be a beneficial effect of the vapour permeable construction on moisture levels. Conversely, moisture levels in the block house are not at worryingly high levels and relative humidity does not exceed 60% in either dwelling. Peak RH in BB1 is 64%, and exceeds 50% RH for 12% of the time. Of perhaps greater concern are the very low RH levels in BC1 which are below 40% for 98% of the time.

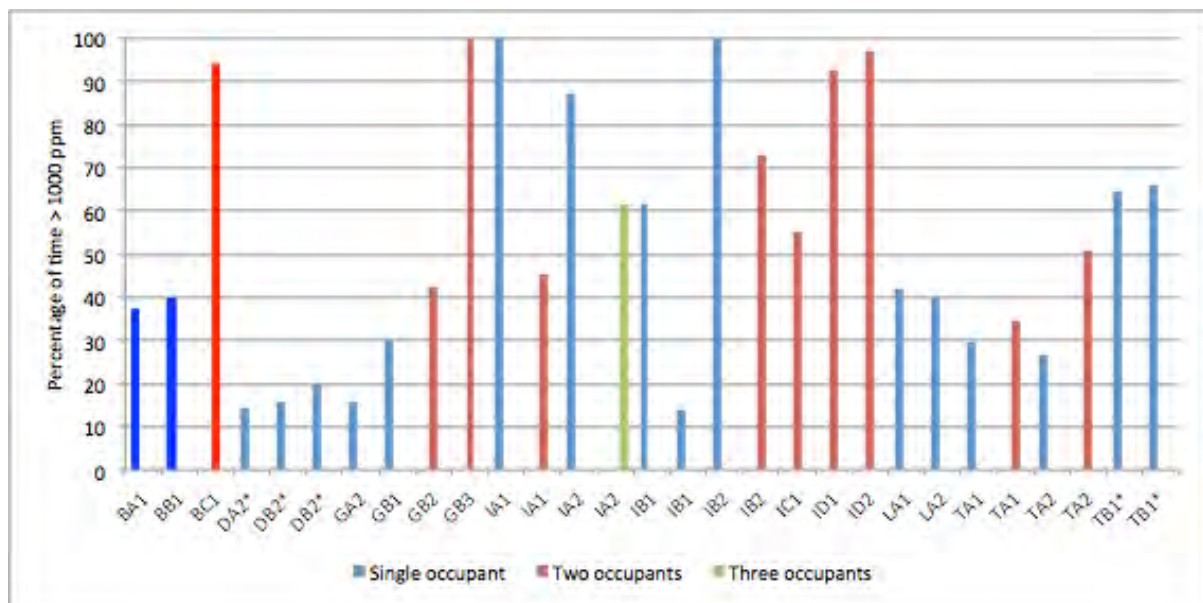
Figure 128: Variation in average CO₂ levels and % of time >1000 ppm CO₂ for number of occupants and door opening.

exceeded 1000 ppm. Over the course of the week all of the bedrooms experienced some period when CO₂ exceed 1000 ppm, with an average of 53% of the time (about 4 hours a night) when these levels occurred. Keeping windows open at night was the only strategy that resulted in reasonable levels of CO₂.

Despite similarities of design features, is apparent that some properties are performing at different levels than others. There are a great many variables that might affect ventilation rates, but (excluding window opening) three areas: number of occupants, door opening and external wind speeds were examined. Examination of relative CO₂ levels in relation to these factors reveals some interesting data.

any door state		doors open		doors closed	
No of occupants	avg CO2 ppm	% > 1000 ppm	avg CO2 ppm	% > 1000 ppm	avg CO2 ppm	% > 1000 ppm
any occupants	1224	52	1162	42	1288	60
1	1161	43	1099	26	1232	49
2	1286	60	1226	57	1478	72

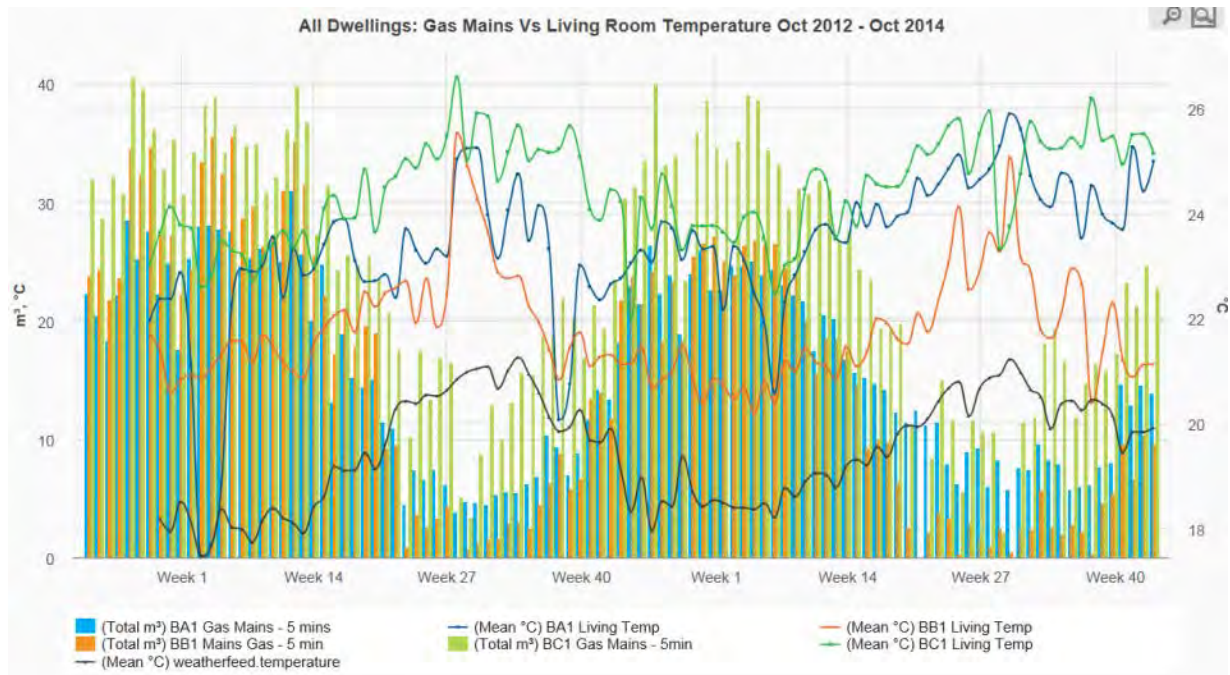
Figure 130: All Dwellings: Gas consumption (m3) and Living Room temperatures Oct 2012 – Oct 2014

There is some evidence emerging of a reduction in energy use, with generally lower energy consumption in 2014 compared with 2013; however further monitoring is required to have two full year comparisons.
