This document contains a Building Performance Evaluation report from the £8 million Building Performance Evaluation research programme funded by the Department of Business Innovation and Skills between 2010 and 2015. The report was originally published by InnovateUK and made available for public use via the building data exchange website hosted by InnovateUK until 2019. This website is now hosting the BPE reports as a research archive. Although no support or further information on the reports is available from the host, further information may be available from the original InnovateUK project evaluator using the link below¹.

InnovateUK project number	450088
Project author	ECD Architects for Fife HARCA
Report date	2014
¹InnovateUK Evaluator	N/A

Building sector	Location	Type	Constructed
Commercial	Lochgelly, Fife	Tenanted offices	2011
Floor area	Storeys	EPC / DEC	BREEAM rating
1450 m ² (GIA)	Four	N/A	N/A

The Ore Valley Business Centre Lochgelly Business Centre (also known as Lochgelly Business Centre) was designed as an energy efficient building which would be economical to run, as the commercial rent to tenants was to include all energy costs. The environmental design used the Te

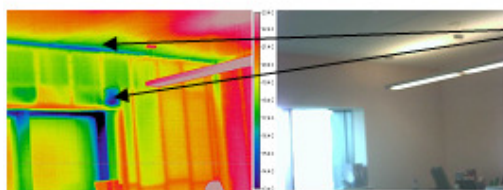
These images highlight the main points of air entry to Room 7, which were around the floor and at the bottom of the centre column. The images may also highlight the ability of cooler air to flow within the wall along the path of the upright framing.

Cold spots may identify source of cool air (from outside) into the warm side of the wall insulation

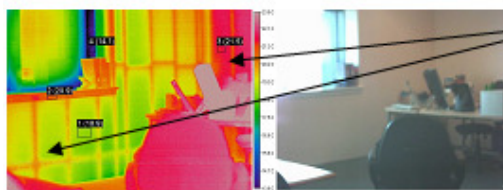
Relative temperatures and thermal pattern of external wall may highlight that cool air is able to cool the plasterboard lining of the external wall from inside the wall. This may be resulting in a thermal bypass negating to some extent the benefits of the wall insulation.

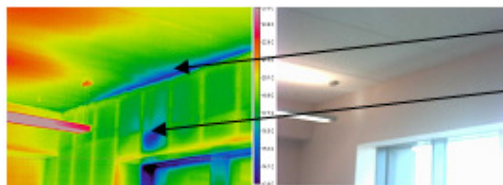
1. Cold spots may identify source of cool air (from outside) into the warm side of the wall insulation
2. Pattern on ceiling may also highlight ability of cool air to flow above Termodeck panel

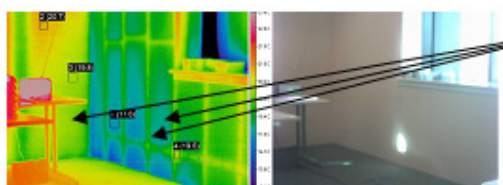
Relative temperatures and thermal pattern of external wall may highlight that cool air is able to cool the plasterboard lining of the external wall from inside the wall. This may be resulting in a thermal bypass negating to some extent the benefits of the wall insulation.

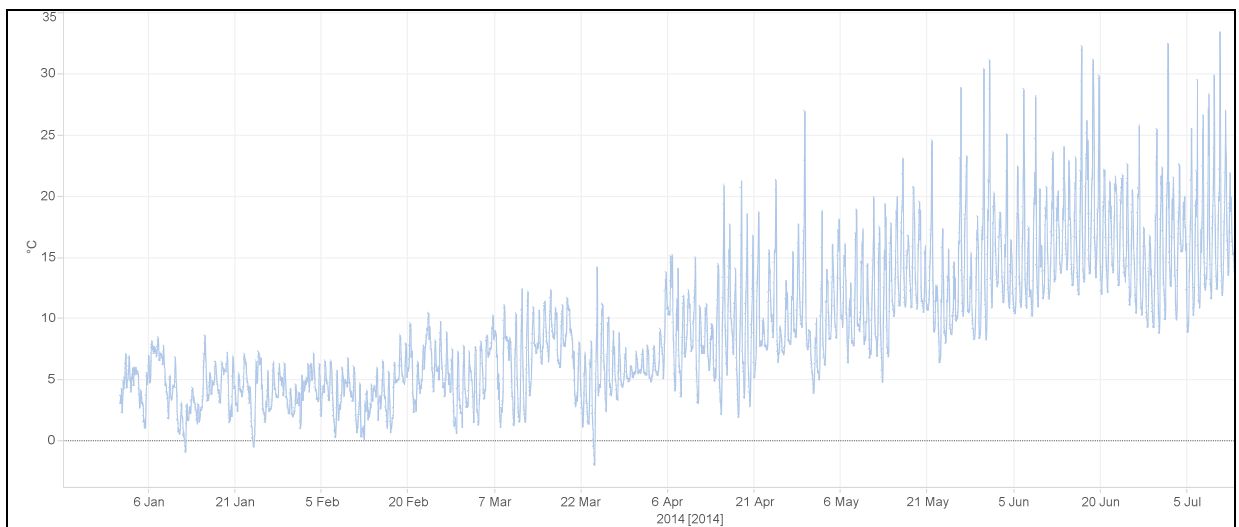
Figure 6.1.2: External temperature condition for Ore Valley Business Centre January – July 2014

The external temperature in 2013 indicates few occasions where the temperature fell below 0°C, which is unusual for the Scottish climate. There were occasions in June and July where the external temperature was unusually high, peaking at over 30°C. The data for 2014 indicates a very similar temperature pattern with warm temperatures for each season. A review of summer temperatures, indicate large diurnal temperature swings which are favourable for pre-cooling of the Termodeck thermal mass. However the high temperatures were not sustained on a daily basis and cooler daytime temperatures followed high temperatures; at these times there is a high probability that the thermal mass had been overcooled.

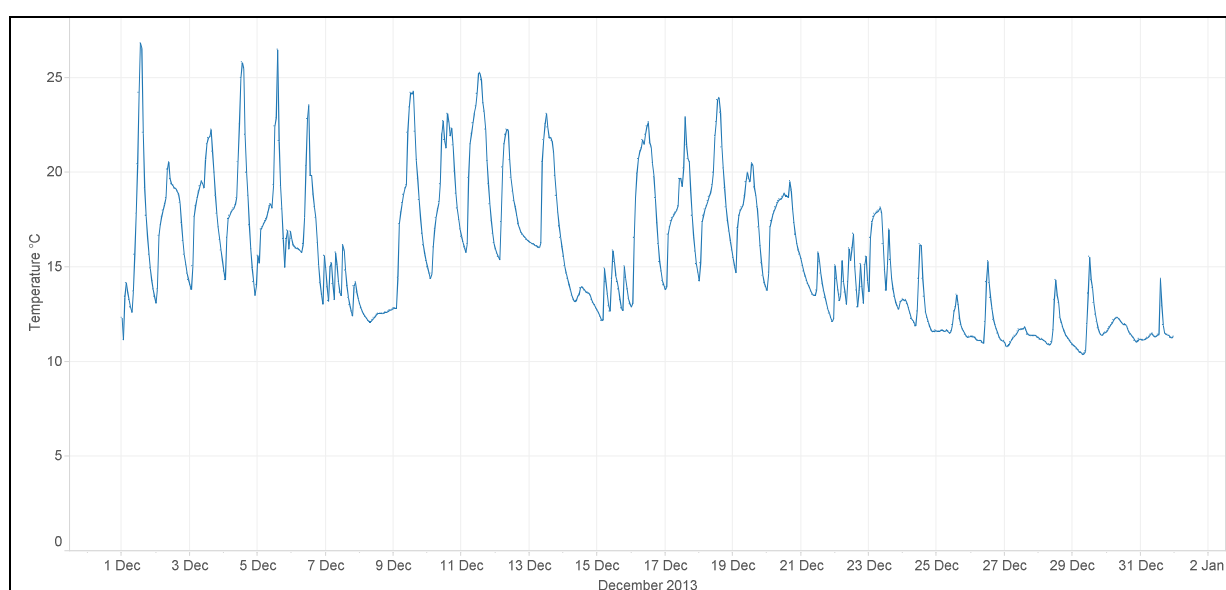
Figure 6.2.4: Recorded Temperature in Conference Room December 2013

Each room exhibits low minimum temperatures; these occurred in early December 2013 and coincide with a boiler breakdown and a broken motor drive belt on the supply side of the air handling unit. Low temperatures were experienced for a period of around eight days and are below the HSE (Health and Safety Executive) minimum working temperatures. While maximum temperatures reach values higher than the recommended CIBSE comfort conditions, the critical value of 28°C (used at the time of design to benchmark overheating) was exceeded in two of the monitored rooms; these are room 19 and the conference room. Reviewing the overheating for room 19, in 2013 the critical temperature exceeded 28°C for 0.01% (15mins) of the year, this occurred in the spring of 2013. During 2014, room 19 overheated 0.05% (35mins) of the time during April 2014. This room has a large area of inoperable north facing windows. The tenant frequently complains of feeling cold and uses a portable fan heater to supplement the heating supplied through the Termodeck. The average hourly air change rate (ACH) due to infiltration is circa 9ACH and one could infer a sedentary occupant is feeling some discomfort due to drafts.

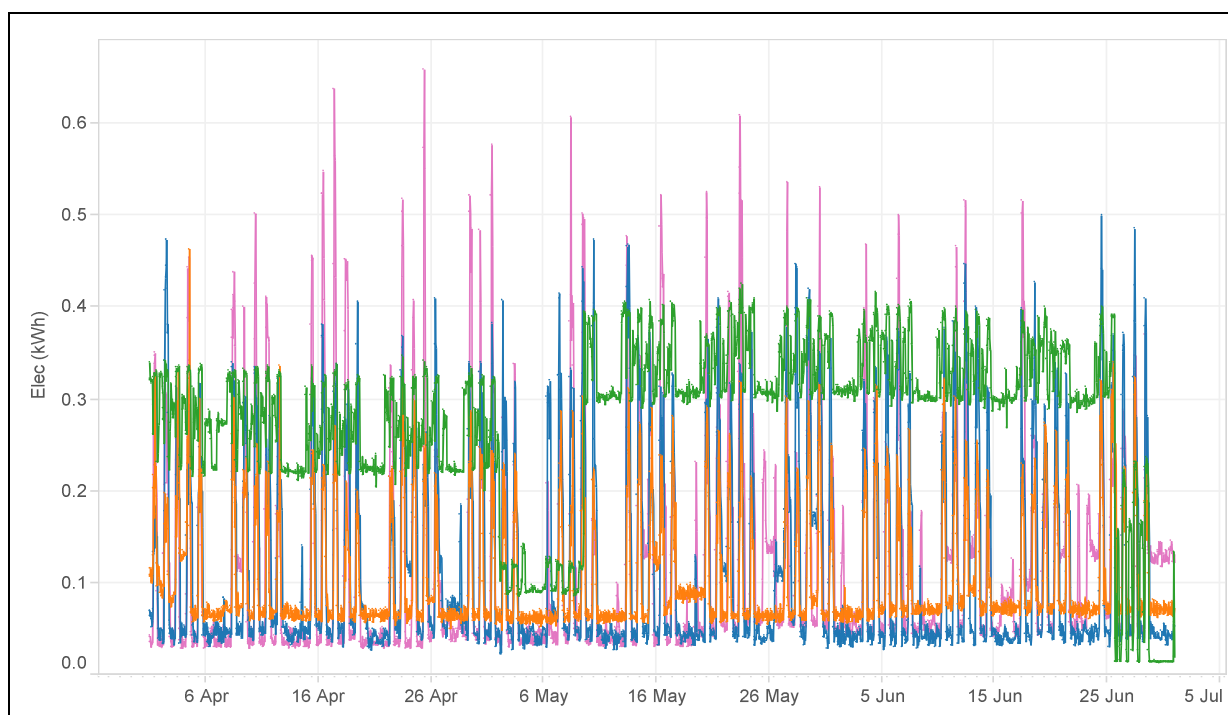
Figure 5.1: Electrical Energy by Zone in Ore Valley Business Centre, Lochgelly

8.3.2 Electrical Energy Consumption by Floor: Data for three months electrical energy consumption is plotted in figure 5.1, it shows that the energy demand at the MCP in the basement to consume significantly more energy than any other circuit, with the ground floor having a higher base load than the other floor levels. High peaks are shown for both the first and second floors. For clarity this data has been plotted by month and discussed below. Data for each circuit has been averaged over an hour to provide legibility to the data.

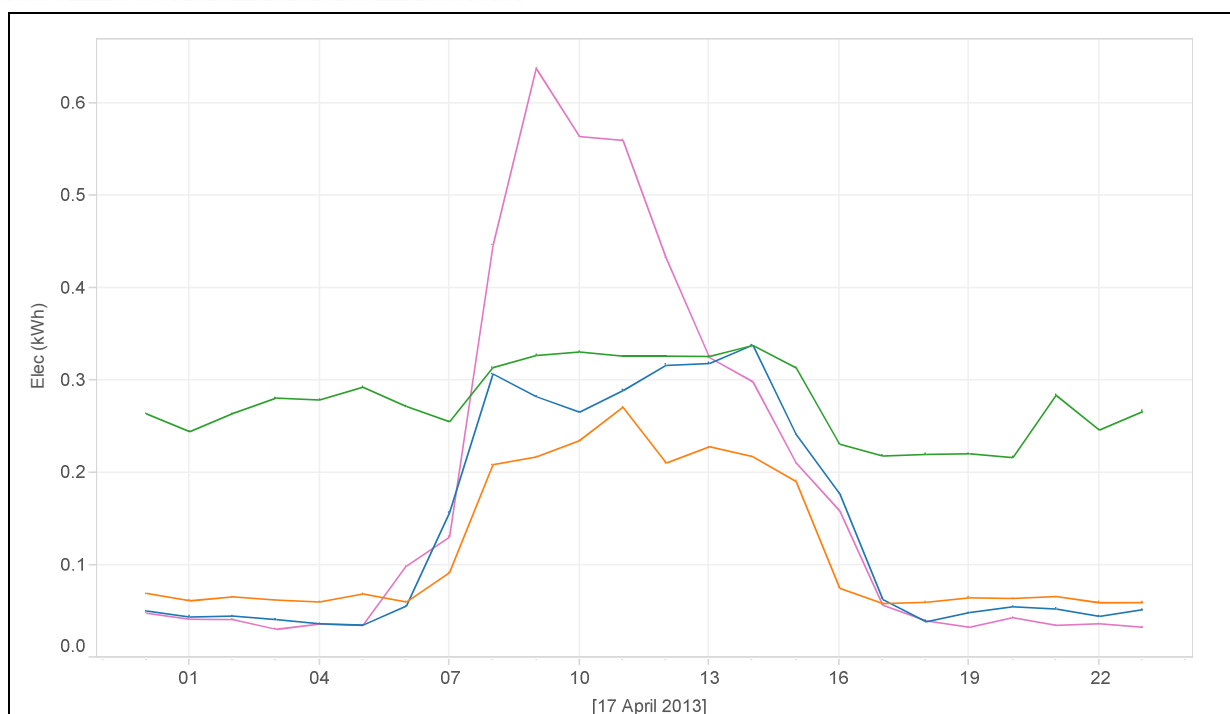
Figure 5.3: Electrical Energy Consumption by Zone, 17th April 2013 in Ore Valley Business Centre, Lochgelly

While the office building is unoccupied during the night and over weekends, it shows the base load of the plant to be higher than all floor levels, however comparing the floor levels, the ground floor has the largest base load, which may be for the server in one of the offices and associated comfort cooling in the ground floor server room.

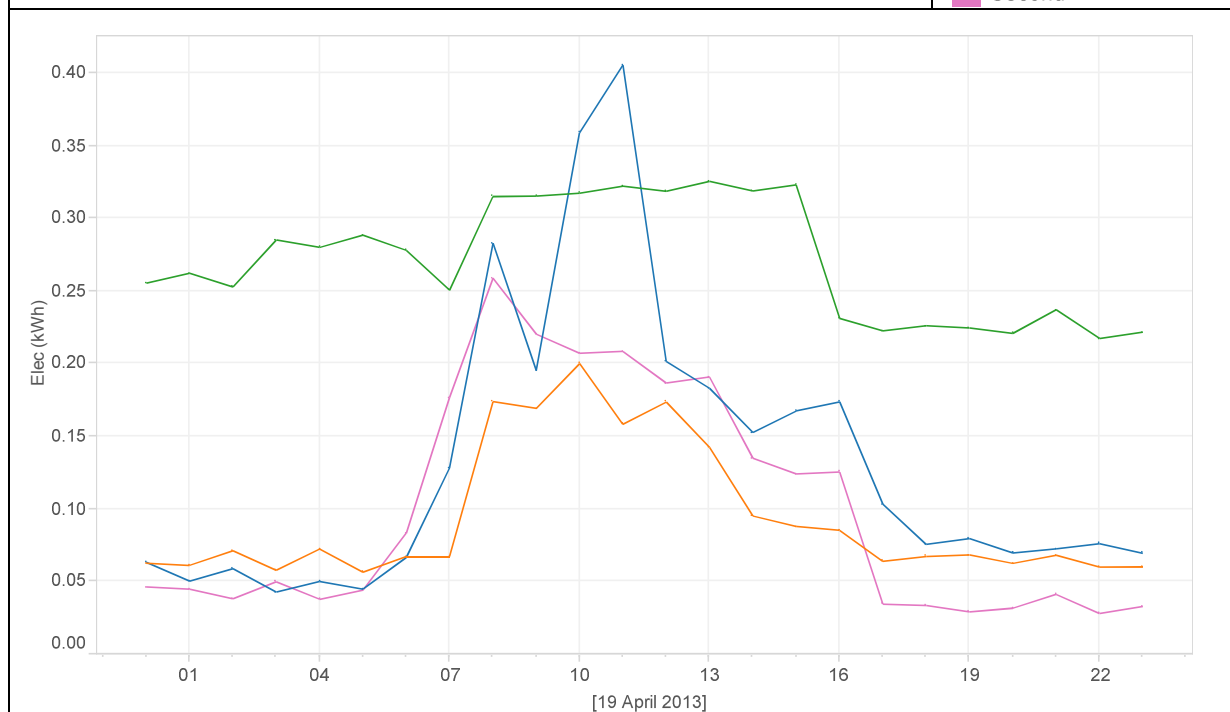
Figure 5.4: Electrical Energy Consumption by Zone, 19th April 2013 in Ore Valley Business Centre, Lochgelly

The data for April shows the base load consumption for MCP (plant) circuit to be consistently higher than any other sub-circuit, with weekend periods being clearly identifiable. The peaks in the graph identify the consumption to increase per floor during office hours when lighting and small power are being used in each of the offices. Even though occupancy of first and second floor levels are identical the chart exhibits the second floor to consume considerably more electrical energy than the first floor offices, however it appears that the second floor consumption reduced considerably on a Friday. Figure 5.3 details the profile over a typical weekday, 17th April, which clearly shows the peak consumption in the second floor over all other consumption in the building. Figure 5.4 illustrates the typical pattern on a Friday, 19th April 2013.

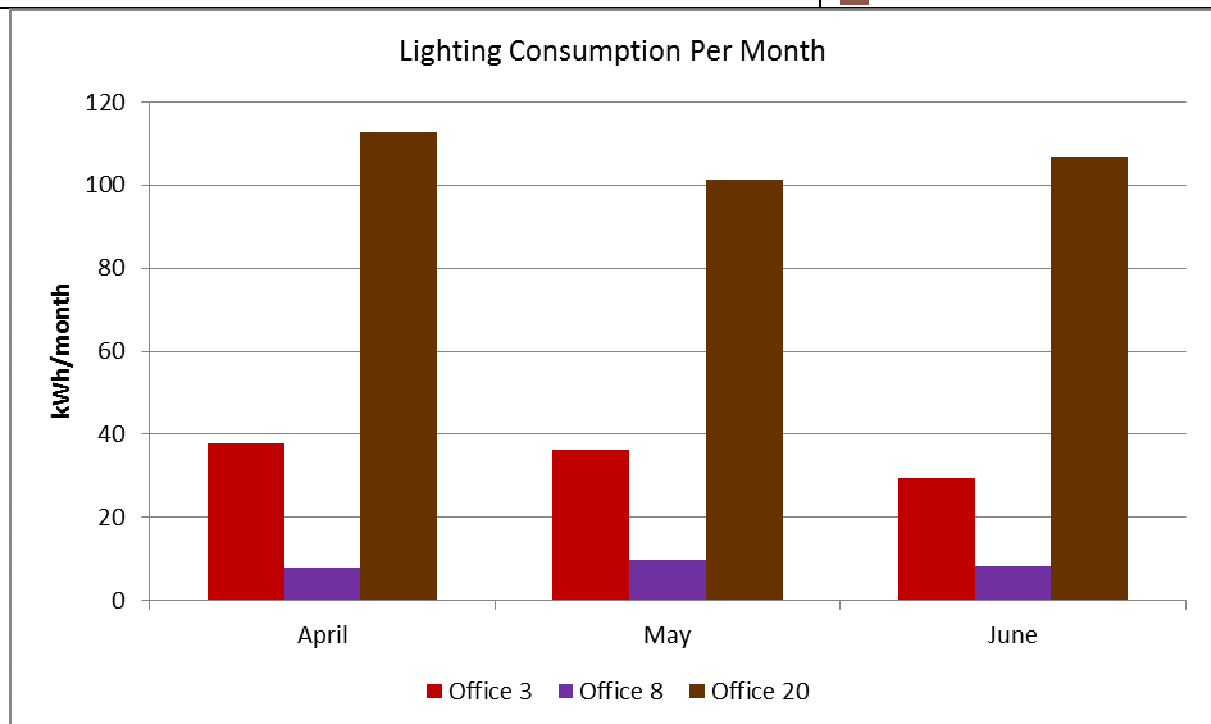
Figure 5.11: Electrical Energy Consumption for Artificial Lighting, by Month, April – June 2013 in Ore Valley Business Centre, Lochgelly

Figure 5.11 illustrates the consumption per month for the lighting circuits in each of the offices; it clearly demonstrates the increased use in room 20 over the other two offices.

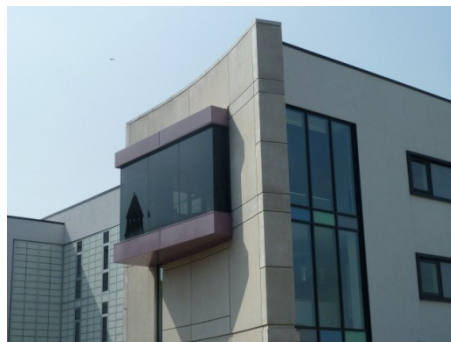
The building owner had complained of overheating of the Conference Room located on the second floor (figure 1) of the business centre. A standalone electric fan was used as a result. The room projects out from the external façade with three elevations (east, south and west) comprising of floor to ceiling curtain wall glazing, with no opening windows (figure 2).

Figure 2: External view of conference room, south and east facing glazing in view.

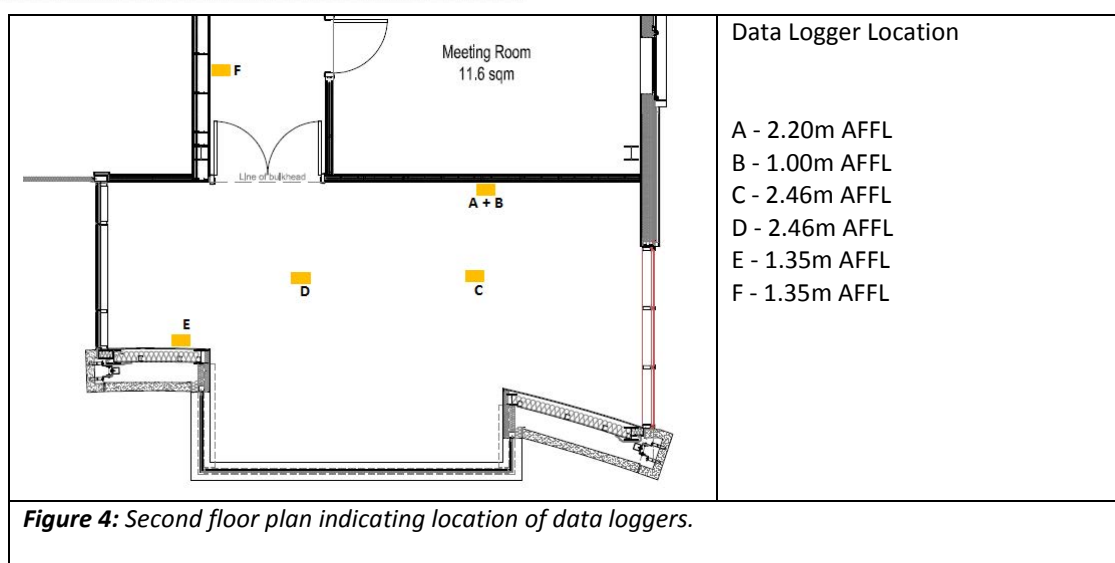
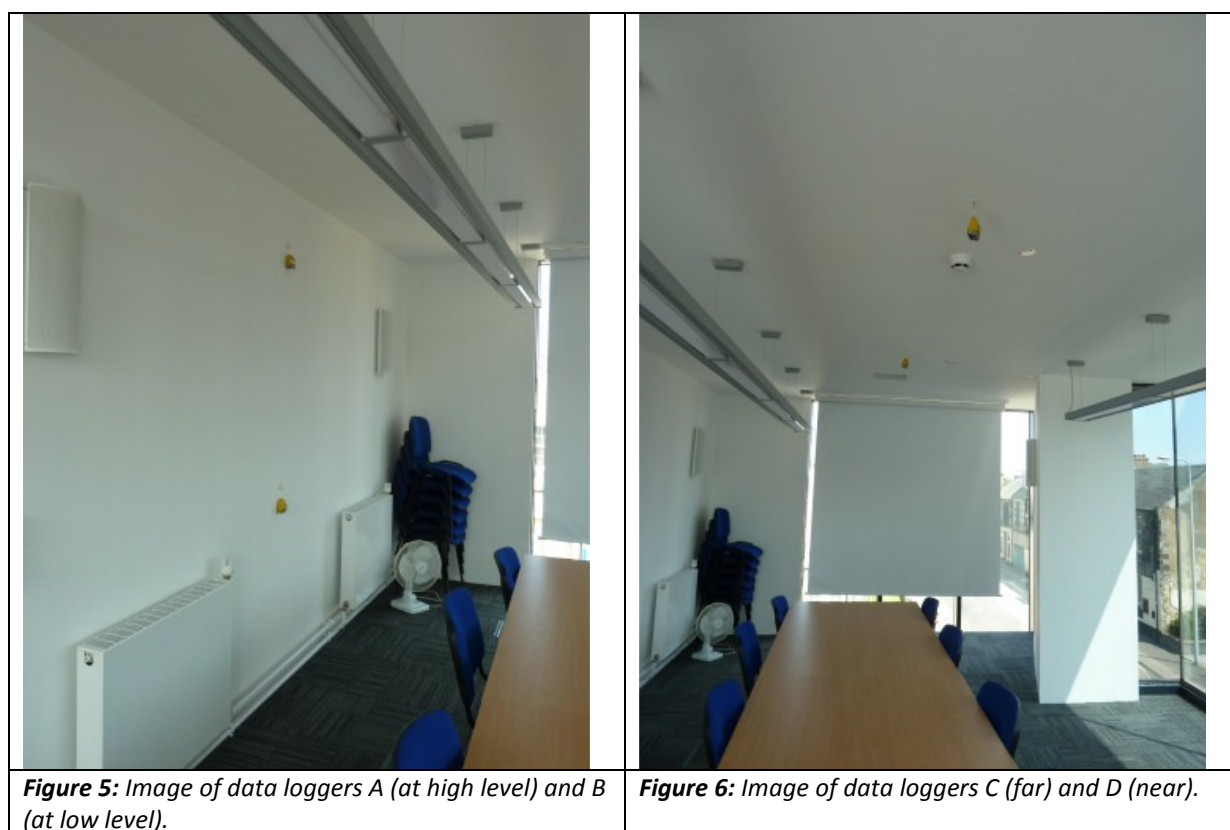
The room is ventilated by two mechanical extract fans each with a design flow rate of $0.105\text{m}^3/\text{s}$ (105 litres per second), with local manual control for each fan. Make up air is drawn from the adjacent corridor; refer to figure 3 for floor plan.

Figure 3: Second floor plan indicating location of conference room.

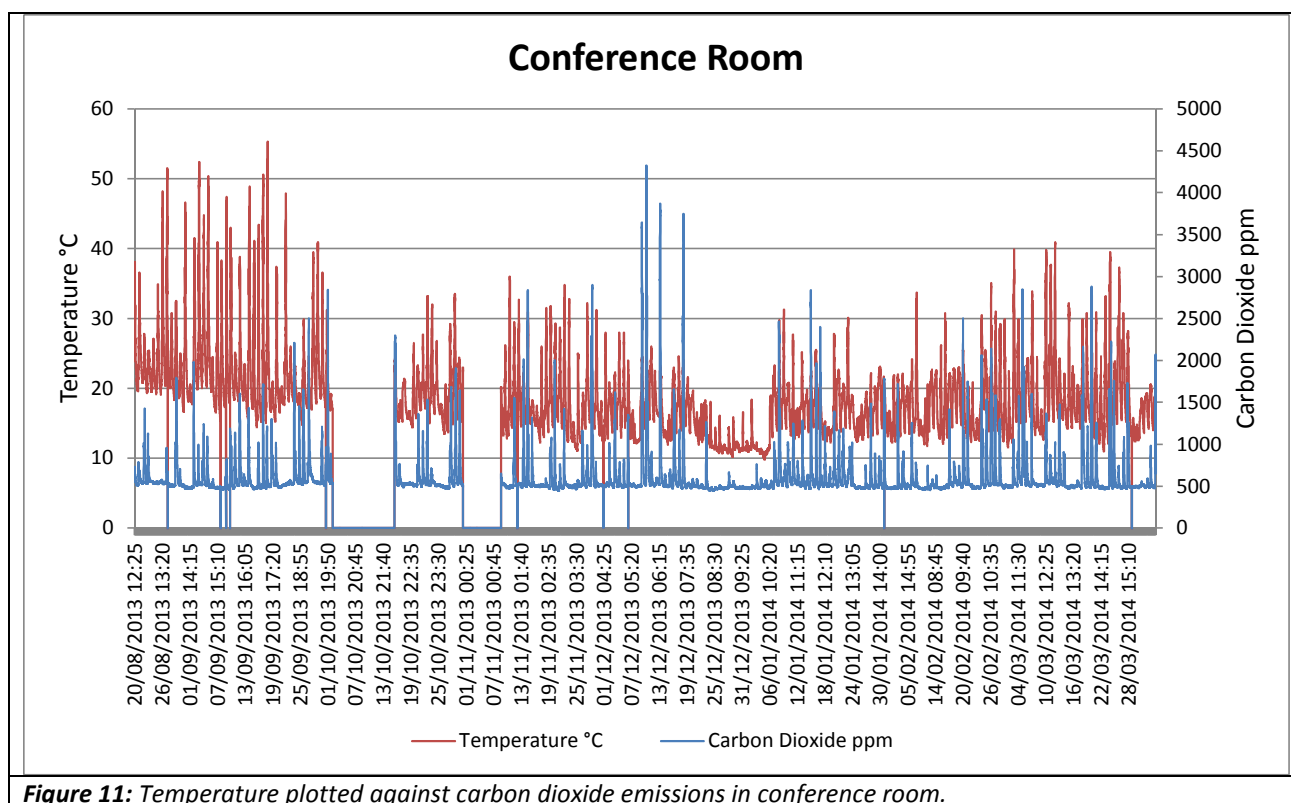
The mean values of the internal space temperature for the conference room were calculated and plotted against the temperature in the hall and external temperature. It can be seen in figure 9 that while the temperature increases with a rise in external temperature, the temperature in the room also rises to uncomfortable levels when the external temperature is relatively low. This indicates that the room is subjected to solar gain. For example on 21st September 2013 the external temperature is around 19°C while the internal temperature was seen to rise to around 28°C. To determine the extent that the room is occupied a sensor was placed in the room during August 2013 to monitor temperature, relative humidity and carbon dioxide concentrations (CO₂) (figure 10). A shroud was fitted to the sensor in an attempt to shield the sensors from the sunlight. Figure 11 details the internal temperature against CO₂ concentrations, while the temperature recordings are higher than expected, it is anticipated that the shroud is not shielding the temperature probe sufficiently or the sensor is in direct view of solar gains. However, the CO₂ concentrations are independent and indicate the room is well used, with a maximum CO₂ concentration of over 4000ppm. There are numerous instances where CO₂ concentrations reach over 2000ppm, indicating there may be inadequate ventilation in the room.

Figure 11: Temperature plotted against carbon dioxide emissions in conference room.

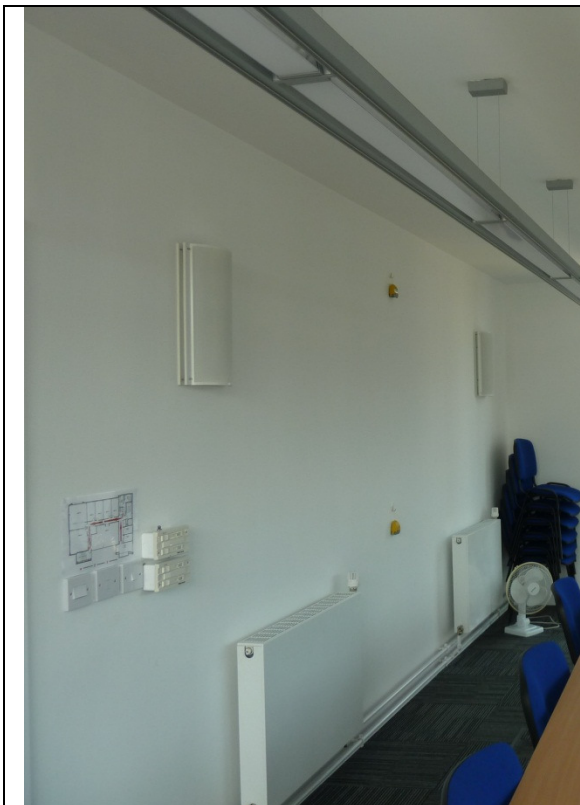
The extract ventilation in the room was measured using a power flow hood, this revealed that the two identical fans are operating at different flow rates and fall short of the design value 105 litres per second each. Table 1 provides fan flow rates of each extract fan under each fan speed. A restriction in door opening to adjacent hall was also observed while the fans were operating on medium and high speeds. This indicates an imbalance of pressure between each side of the door and appropriate transfer grilles in the door (or elsewhere) would need to be fitted to ease opening when fans are operating at full design flow rate.

Figure 12: Extract fan controls to right hand side of light switch.

As temperature and CO₂ builds up in the room it is recommended that each time the room is occupied, even for short periods, the extract fans are operated to provide ventilation to the room. The controls are located beside the light switches and are operated using the sliding controls, figure 13, details the fans both set to speed 3. It is important to remember to check the isolator beside the controllers is in the 'on' position and turn off the extract fans when vacating the room.

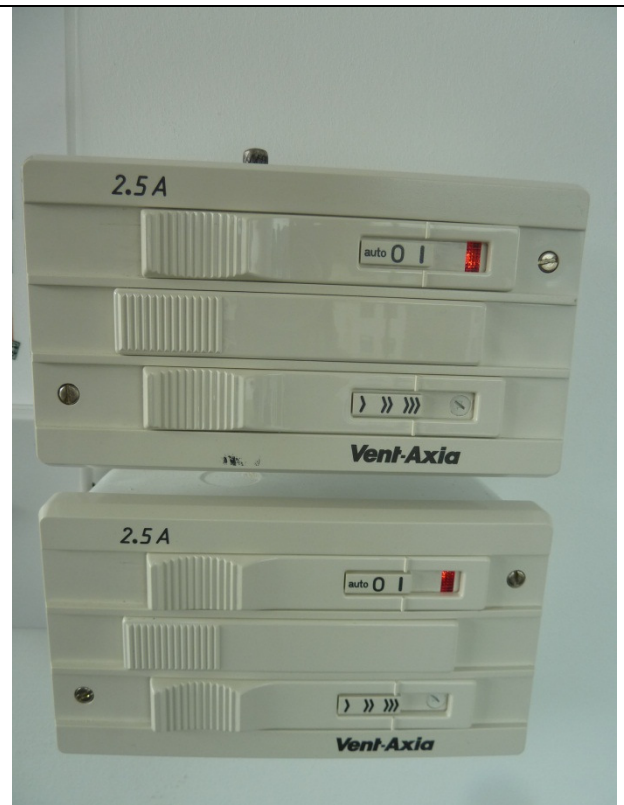
Figure 13: Extract fan controls shown operating at high speed.

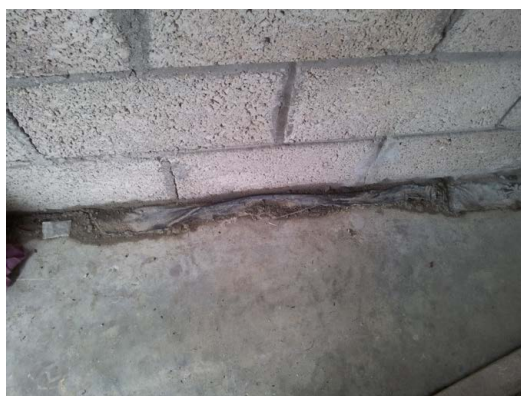
Photograph 2 Electrical room

On inspection the water has forced its way between the column base infill and column concrete. Duct tape has been used as jointing between upper insulation board and pieced insulation beneath. It is also clear that the DPM has not been lapped over the wall dpc which would suggest this is the weak point of construction giving way to any hydrostatic pressure.

Further images of upturned DPM indicating a clear line of water ingress along same gable wall

10.1.3 Basement Leak: Heat loss in the basement is higher than it should be due to the water ingress problems, with associated condensation risk. It contributes significantly to air permeability problems. This needs to be addressed as a matter of urgency. At the very least a temporary solution would restrict heat loss until a complete solution can be achieved.
