Plummerswood House

This document contains a Building Performance Evaluation report from the £8 million Building Performance Evaluation research programme funded by the Department of Business Innovation and Skills between 2010 and 2015. The report was originally published by InnovateUK and made available for public use via the building data exchange website hosted by InnovateUK until 2019. This website is now hosting the BPE reports as a research archive. Although no support or further information on the reports is available from the host, further information may be available from the original InnovateUK project evaluator using the link below¹.

| Project author | Gaia Research |
| Report date | 2015 |

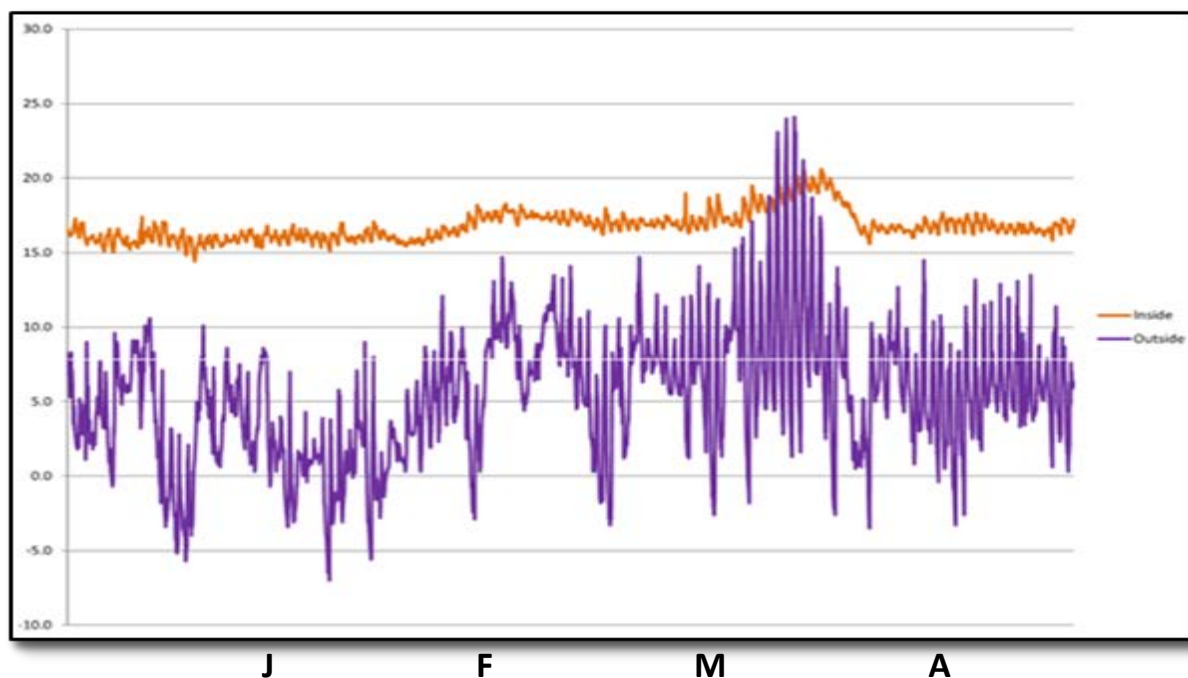
Graph 9: Temperature Profile Dining Room - January to April 2012

A review of the temperature being achieved internally compared to the external temperature was undertaken to assess how the building is performing against the theoretical heat losses for the period January to April 2012.²³ During most of this time the building was operating using the MVHR. Notably during a warm period in March the internal temperature remains comfortable suggesting that the building benefits from thermal mass.

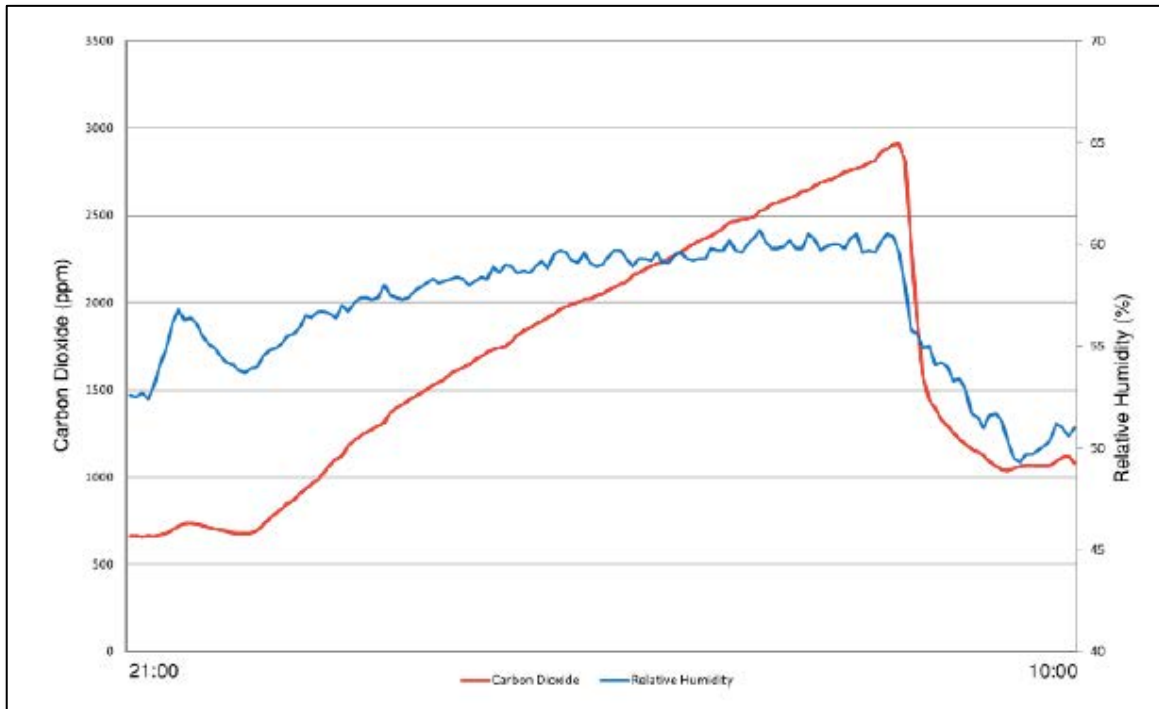
Graph 21a): Bedroom CO₂ concentration and RH with MVHR Off – Room sealed

Assuming the CIBSE AM10 release rate of CO₂ - $5.56 \times 10^{-6} \text{ m}^3/\text{s}$ - for occupants with sedentary activity - we would anticipate the increase in CO₂ would be in the order of 3200ppm over 9 hours. This compares very well with the measured increase from 680ppm to 2800ppm over this time and suggests that the space is highly sealed. Some infiltration is occurring creating a drop of 400 ppm for the measured CO₂ compared to the predicted. Clearly some form of ventilation above infiltration would be essential to maintain suitable conditions in the bedroom. Over the same period the Relative humidity increased from around 55 to 60%.

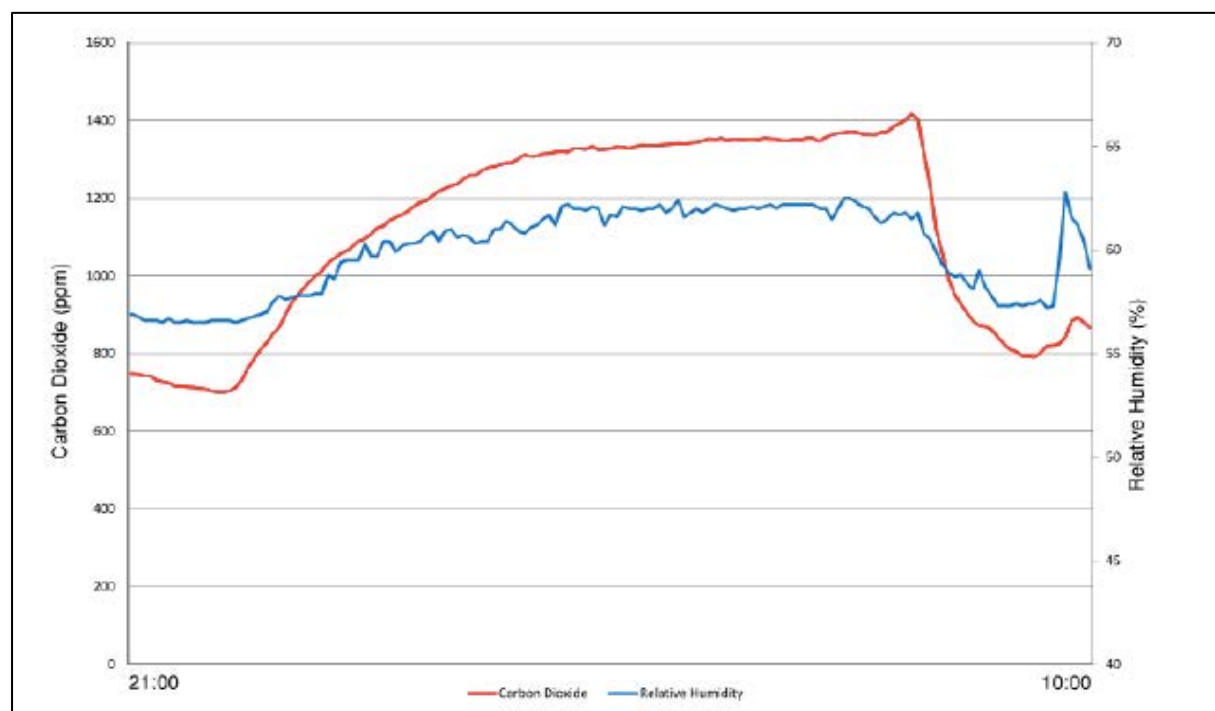
Graph 22: Bedroom CO₂ and RH with MVHR On at Recommended Speed – Room sealed

The CO₂ concentration increases from 700ppm to 1400 ppm, which closely matches the prediction. CIBSE guidance suggests that CO₂ concentration is ideally kept to an upper limit of 1000ppm. The use of the low speed setting would therefore be contingent on the occupants having the door to the rest of the house open to allow for air circulation into the

bigger volume of the house as is their normal pattern. Over the same period the Relative humidity again increased by around 5%.

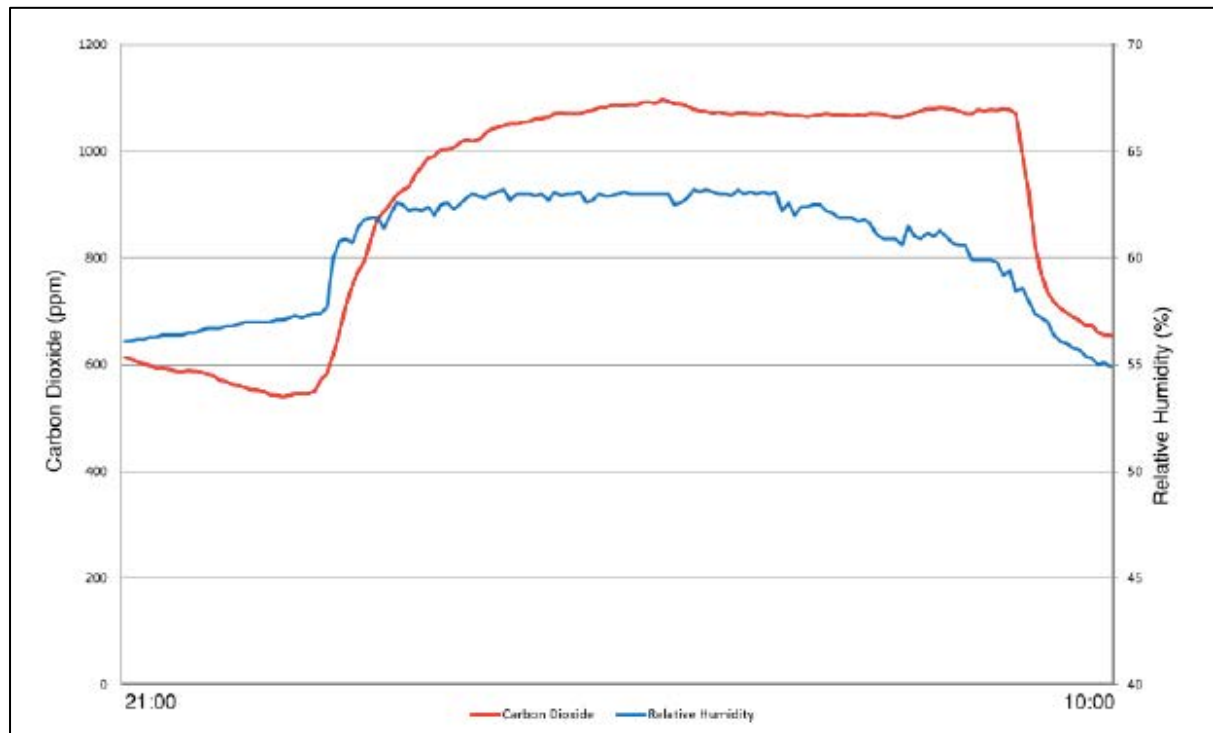
Graph 23: Bedroom CO₂ and RH with Trickle Ventilation Simulated - Summertime

The use of natural ventilation as the means to control CO₂ is very effective in this test and performs better than the MVHR. As the MVHR ventilates the whole volume overnight, if a trickle ventilation strategy could be applied instead this might be a significant energy saving.

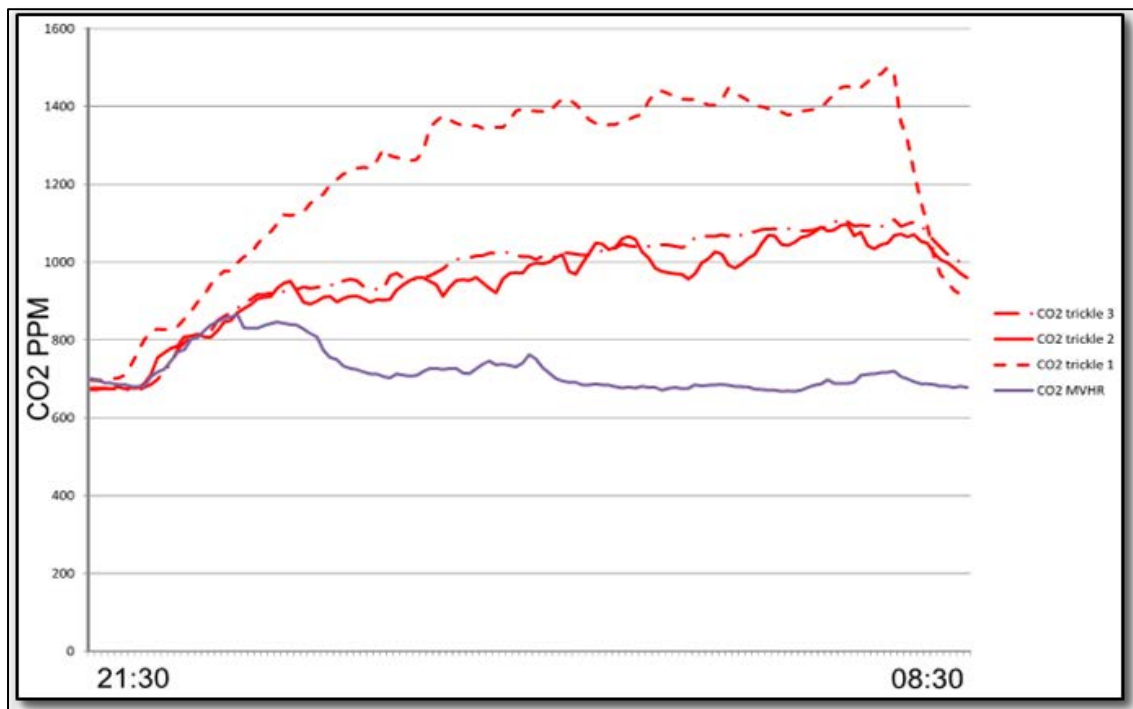
Graph 26: CO₂ Concentration during winter trickle ventilation test

The CO₂ concentration was consistently higher in trickle ventilation mode as compared with the MVHR, however the period with the MVHR on also involved the door between the bedroom and the rest of the house being open and the CO₂ being buffered by the whole house volume. The openness to the house volume is clearly an important aspect but may not be suitable for all lifestyles. Further experimentation would be required to optimise and control the size of the trickle ventilation openings.

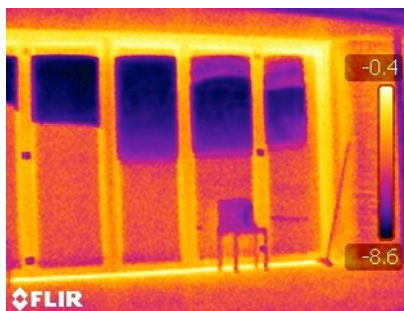
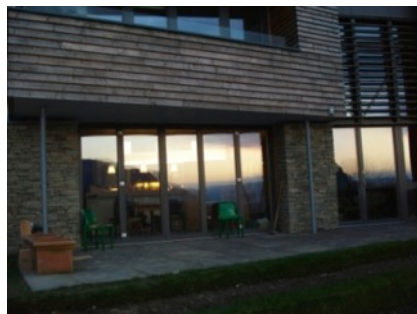
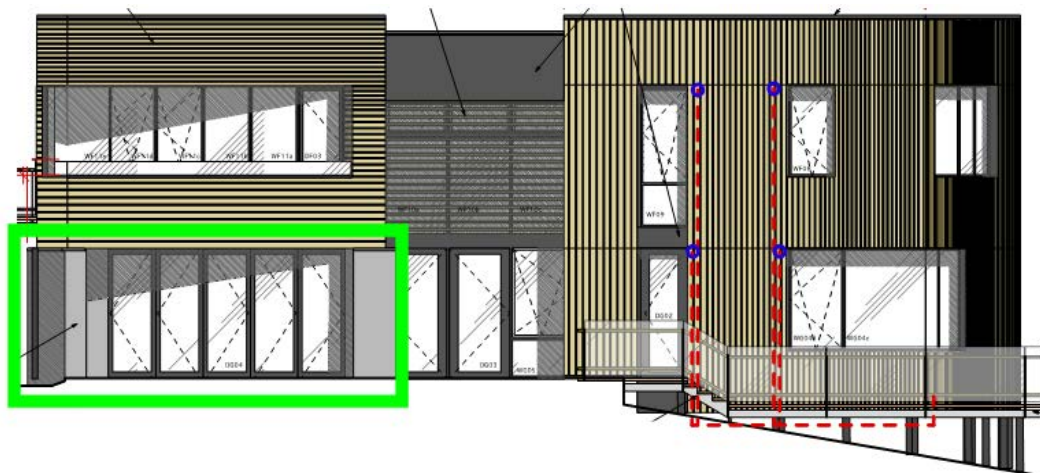
First Floor Bedroom Windows

Air Leakage: No evidence
Thermal Bridge: Minor at window frame as expected
Missing Insulation: No evidence

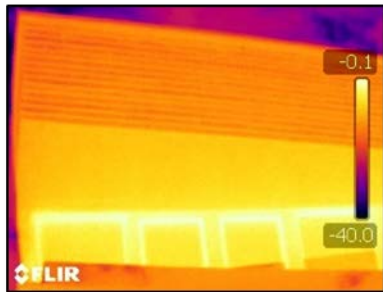
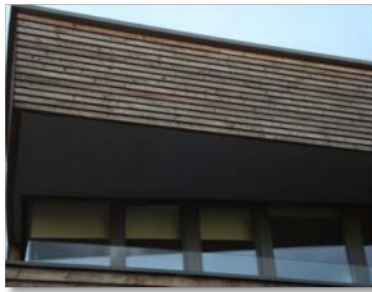
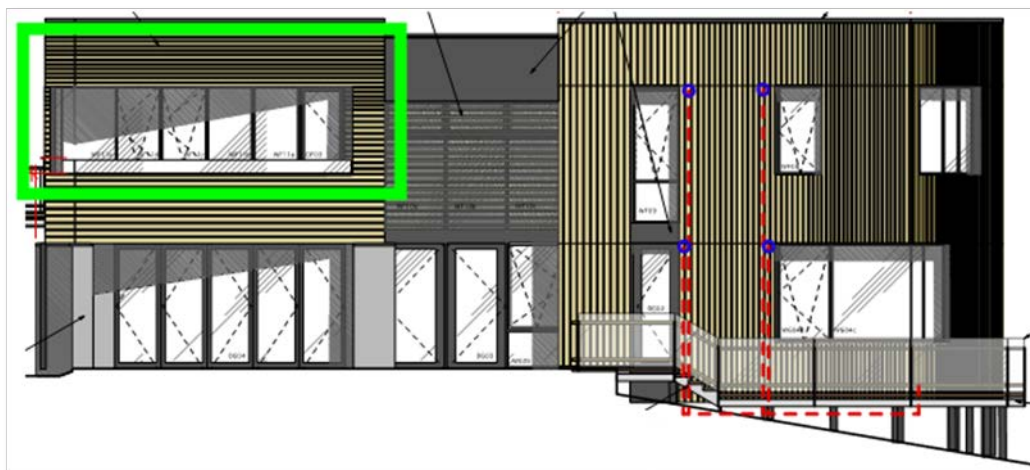
First Floor External Bridge Link Access (West)

Air Leakage: Possible breaching of the air tightness layer for the installation of the wiring associated with the security alarm. More likely to be a heat source within the security alarm fitment.

Thermal Bridge: Minor at window frame as expected

Missing Insulation: No evidence

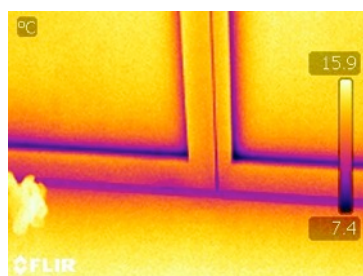
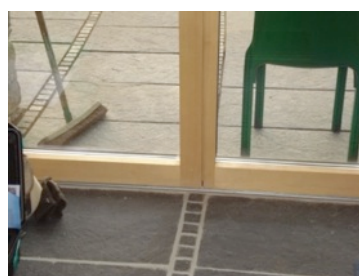
Thermal Bridge: Minor at window frame as expected

Missing Insulation: No evidence

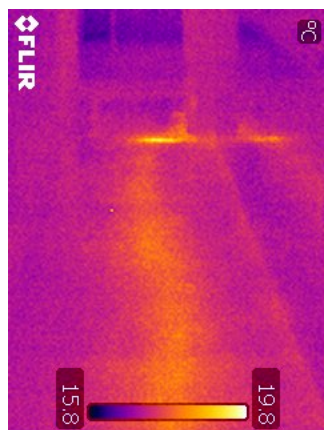
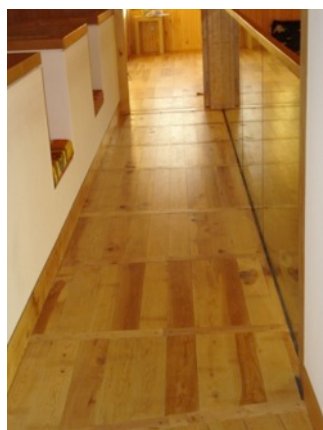
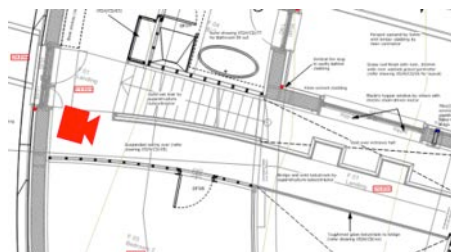
First Floor Corridor

| Air Leakage: | No evidence |
| Thermal Bridge: | No evidence |
| Missing Insulation: | No evidence |

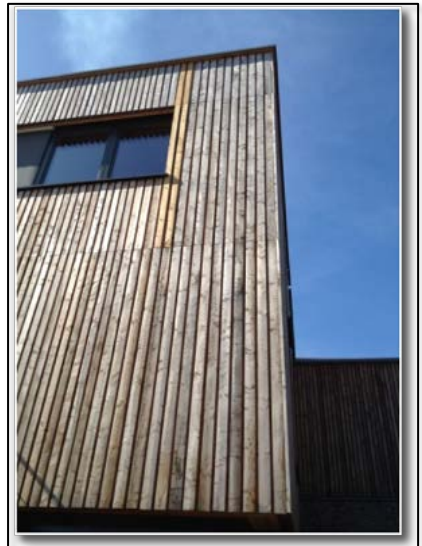
Cladding adjacent to damaged blind

Cladding to the right of the window was removed to allow access to remove damaged blind however the cladding boards were then lost and the replacements are the incorrect size and differentially weathered.

The occupiers noted that two external rain cladding panels were removed from the cladding because of the issue with the blind. These panels were left in the garage of the property amongst what looked like construction waste and subsequently found their way into the wood burning stove. A temporary fix was provided with panels lighter in colour than neighbouring panels as they have not had the same time to age. The panels are also not as wide as the other adjacent boards and need to be replaced. The issue has been resolved with the assistance of a local blind installer.

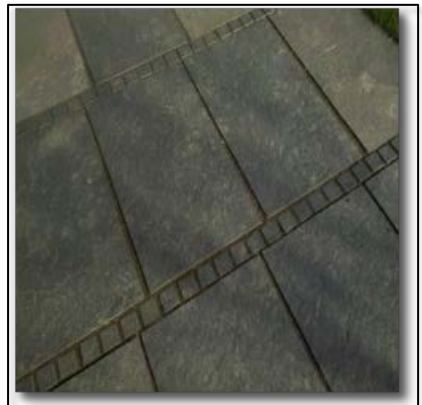
Caithness slate to outside terrace

The slate to the external terrace has not been grouted and is collecting debris and is hard to clean.

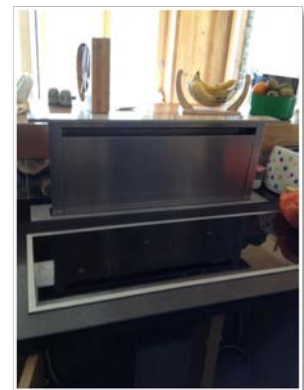
4.5.3 Grease Extract System at Induction Hob

The occupiers demonstrated the operation of the grease extract system provided for the induction hob. The system appears to extract successfully during cooking however there is concern about the location of the discharge air into the cupboard below the hob. The hob manufacturer informed the occupiers that this discharge would adversely affect the induction hob. As a result the occupiers have modified their eating habits to exclude greasy food.
