Innovate UK project number	450043 A
Project lead and author	AHR (formerly Aedas Architects)
Report date	2013
InnovateUK Evaluator	Roderic Bunn (Contact via www.bpe-specialists.org.uk)

Building sector	Location	Form of contract	Opened
Offices	Pool, Cornwall	Design and build	2010
Floor area (GIA)	Storeys	EPC / DEC	BREEAM rating
3747 m ² (3785 m ² on DEC)	3	A (23) / N/A	Excellent

Pool Innovation Centre is a three-storey building in Cornwall, configured as two wings around a central atrium. The rentable floor space provides flexible workspace and business support for start-up and innovation businesses. The performance evaluation covered the building's fabric performance, energy consumption, and occupant satisfaction.

Tremough Innovation Centre

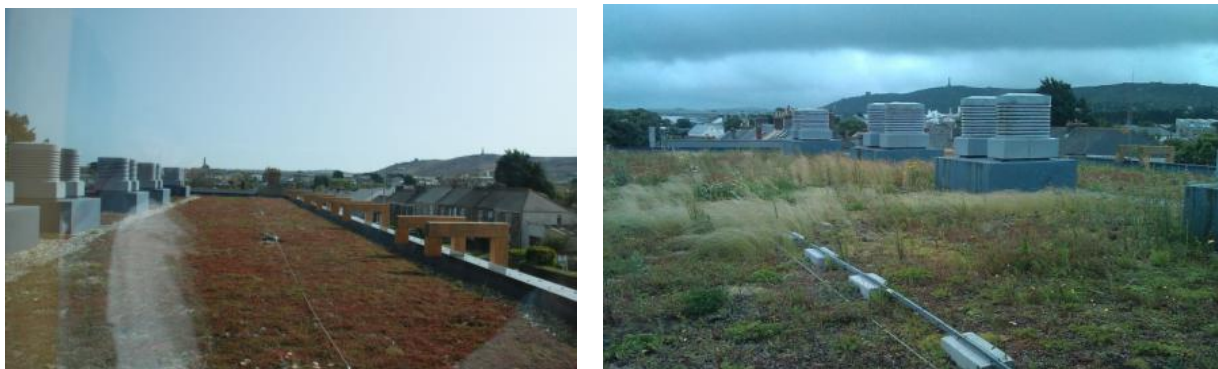
Figure 8 Extensive sedum roof and wind-catcher vents, six months apart

PIC has an extensive sedum roof which is doing very well as can be seen by the two pictures taken approximately six months apart. A large number of species seem to have colonised the roof in that time.

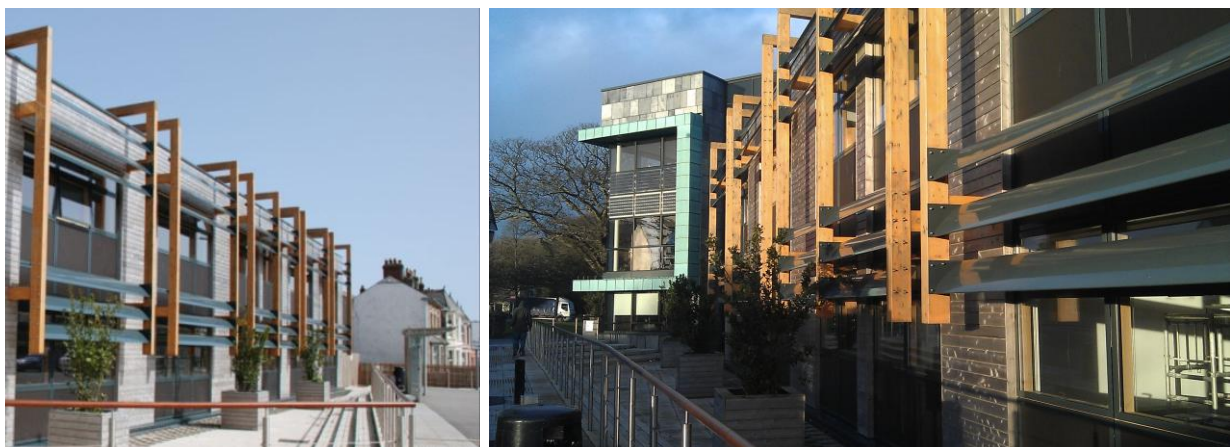
Figure 9 Brises soleil on the south-east façade

The horizontal brise soleil at PIC are effective at reducing excessive solar gain in the non-air conditioned offices on the SE and SW facades.

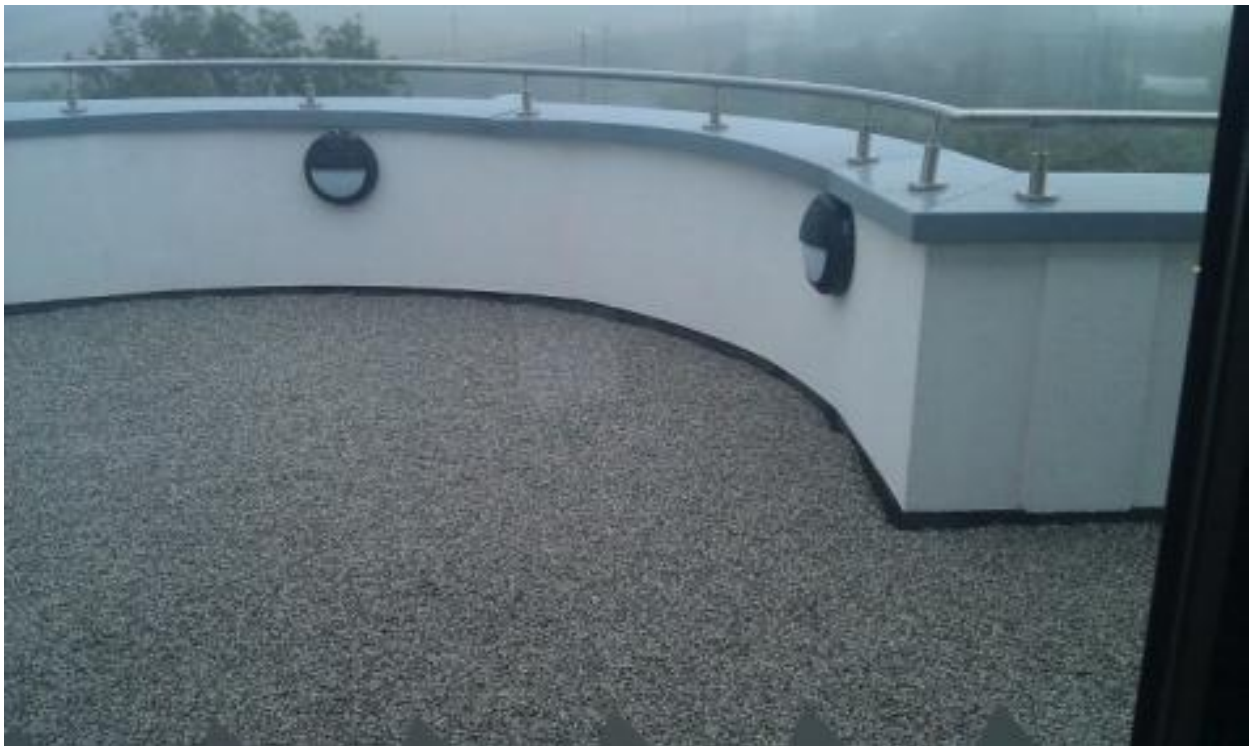
Figure 16 Roof

The roof is an aluminium standing seam pitched roof. It was not possible to access the roof during the survey due to health and safety issues (the building manager had not undertaken training on the mansafe system). The only access possible was to the walkway area of gravelled flat roof accessible from the second floor.

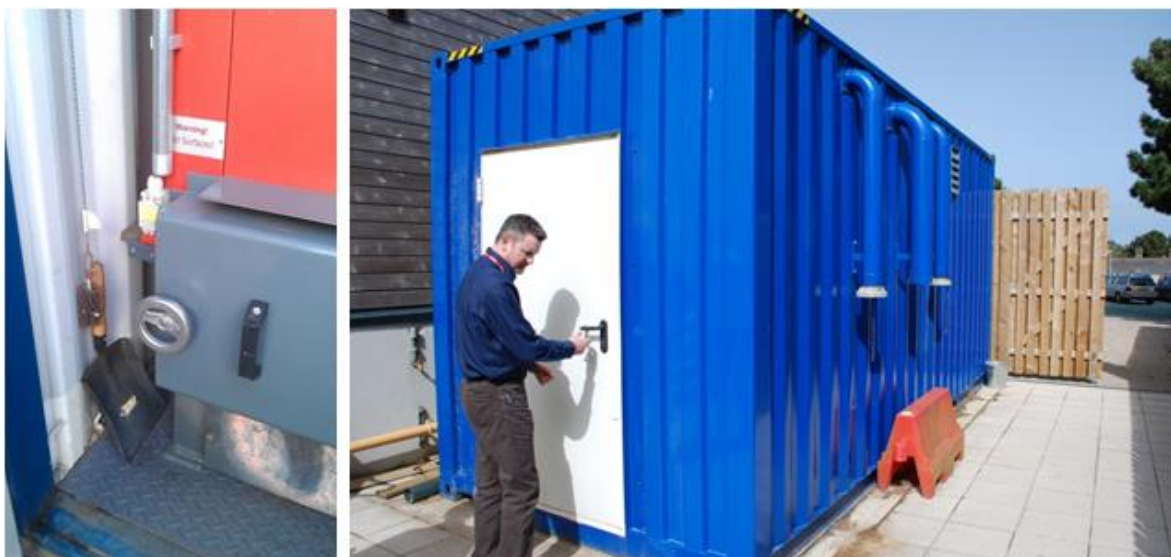
Figure 18 Tools required for manual de-ashing and the containerised woodchip store and boiler house

The biomass boiler is a Binder RRR149 145 kW model. It is housed in an external container which has pipes for blowing in fuel deliveries. Three 85kW gas boilers are located in the plant room. The accumulator tank at PIC is significantly smaller than that at TIC, due both to the smaller size of the building and the lower wall U values.

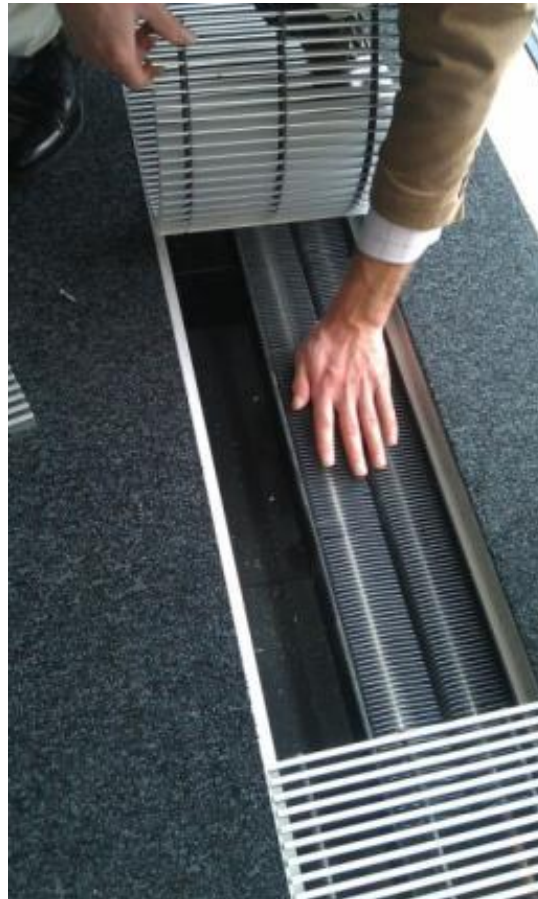
Figure 31 Trench heaters in meeting rooms

Although most offices at TIC are heated with radiators, several offices have trench heaters instead. These offices have floor-to-ceiling glazing and so cannot have below-window radiators. These heaters do not appear to provide enough heat to offset the losses from the large area of glazing and negative feedback has been received.

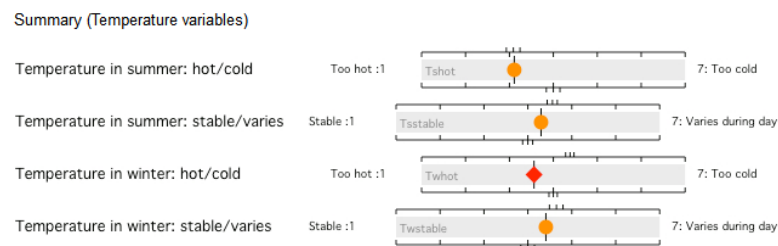
Figure 36 Temperature variables

With regard to the BUS benchmark the building is around the 90th percentile for control of both heating and cooling. Temperature in winter, is outside the benchmark optimum range as illustrated in Figure 36.

Our advice to the building managers was to lower wintertime set points, monitor occupant satisfaction and consider removing the radiator valve stops in the rooms where occupants are cold.

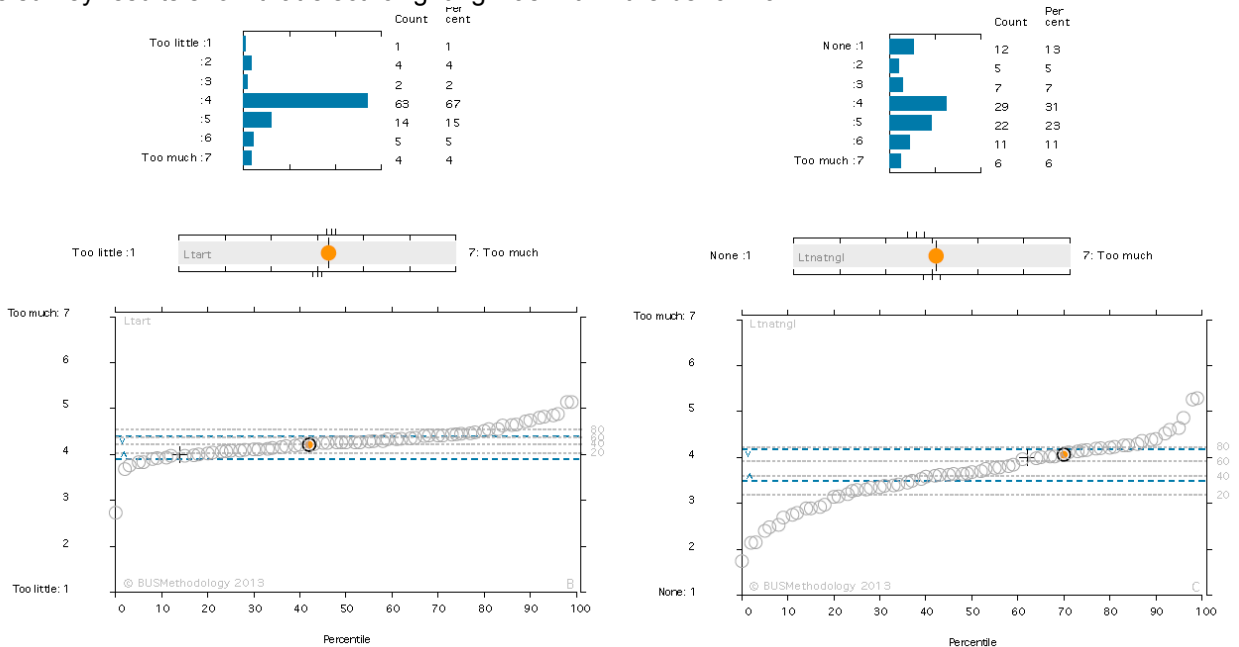
Figure 40 Electric lighting and glare results

The survey results show that electric lighting was within the benchmark:

The team recommends agreeing with the tenants on the time lag for absence control on a room by room basis. The blinds should be examined and a change in system considered at the system's end of life. It is not clear whether glare is a problem during the summer or the winter and we suggest further discussions with the tenants around this.

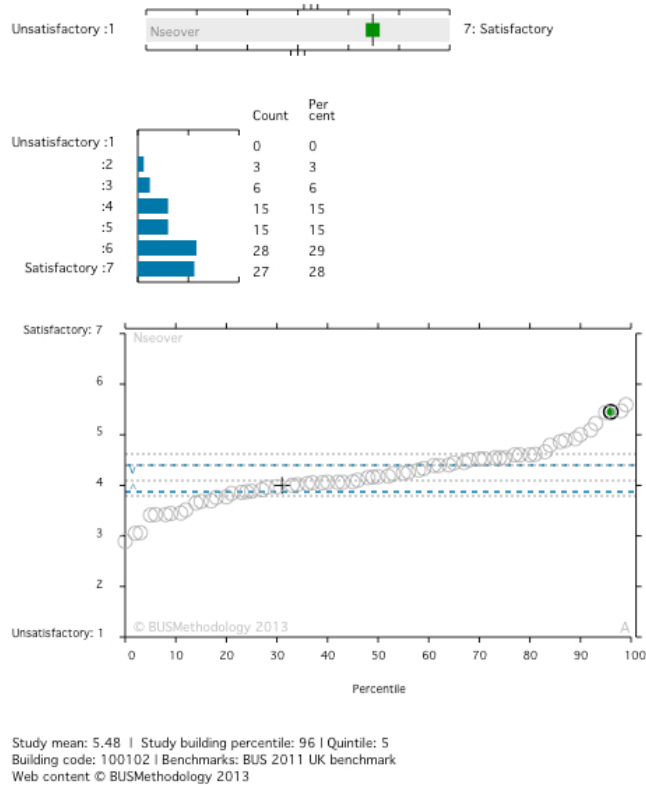
Figure 41 Noise control results

Occupiers scored noise overall in the 96 percentile of the study buildings with 72% rating the conditions above scale mid-point and the reference benchmark dataset. Negative feedback arose from the extensive construction works undertaken on one side of the building, with occupiers finding the construction noise disruptive. The survey results show that control over noise was generally satisfactory.

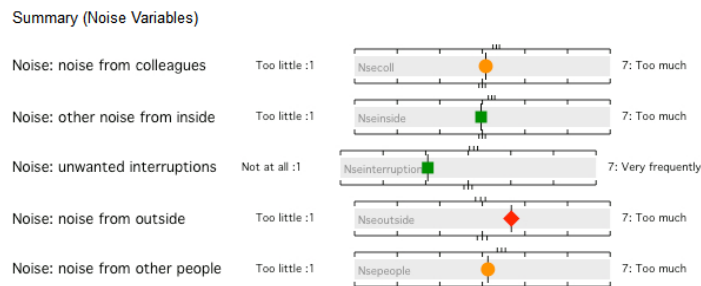
Figure 42 Noise Variables

The detailed scores however highlight noise from the outside being somewhat too much while noise from other people and noise from colleagues being close to the scale mid-point and within benchmark. These do not seem to cause unwanted interruptions.

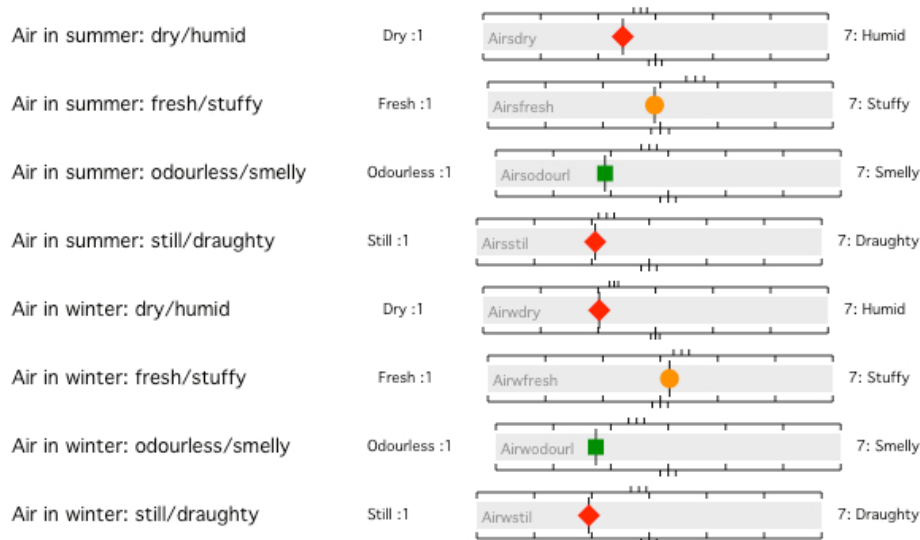
Figure 50 Air quality variables

The data histograms behind the variables below indicate that the air is perceived to be towards the drier end of the scale for more than a third of occupants during summer and winter. There were no comments on this point from the occupants. Air was also perceived to be too still and too dry in summer and winter and some tenants requested better flow of air.

Issues with window controls may be the key cause of the perception of dry and still air. Yet the distribution of responses regarding control over ventilation show that the distribution is normal around the mean:

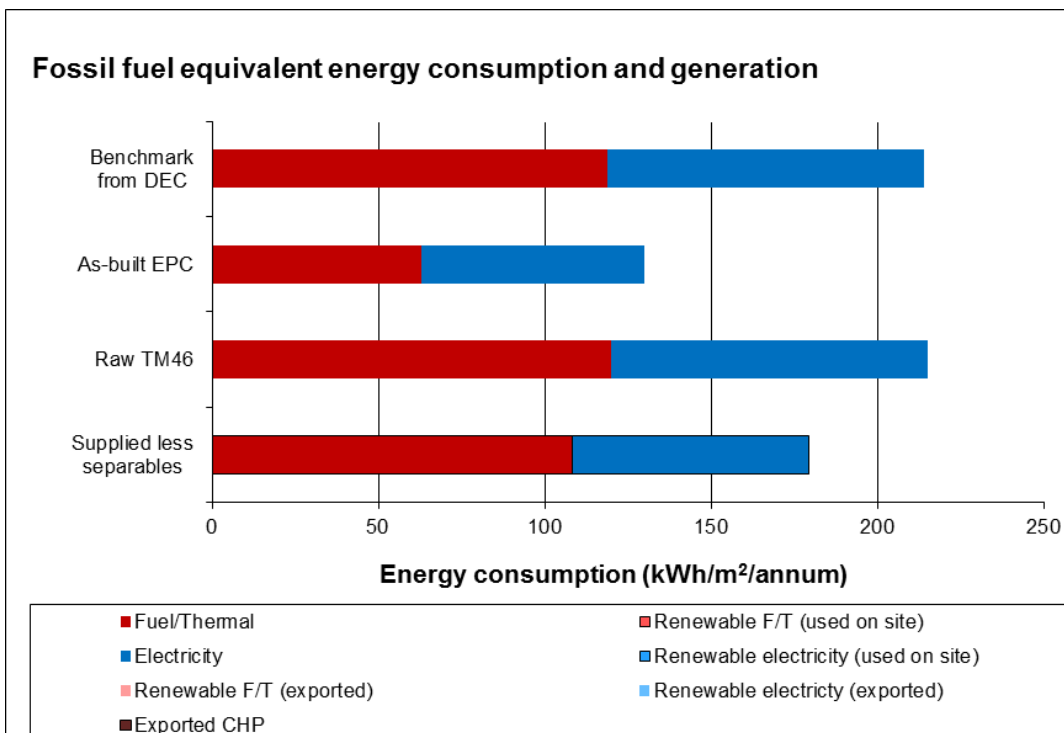
Figure 6.1: TM22 simple assessment for TIC: energy consumption

These graphs show that TIC’s thermal energy use is lower than DEC/TM46 benchmarks, but around 70% higher than what was derived from EPC calculations. As a large proportion of thermal energy is provided by biomass boiler, building performance scores better when the CO₂ emissions metric is used; the CO₂ emissions associated with thermal energy use at TIC are lower than all benchmarks reported in Figure 6.2. The electricity use is lower than DEC/TM46 benchmarks, but around 6% higher than the User Specified benchmark. It should also be noted that the building has not reached its full design occupancy yet, and the average occupancy of the tenant areas during the measurement period was 70%.

Overall, the main conclusion derived from the simple assessment is that, while thermal performance of TIC is better than the median of existing building stock, it is significantly higher than the design estimation. It should be noted that the EPC calculations were carried out under standardised NCM operating conditions that are not necessarily consistent with the actual operation. However, TIC’s operation follows typical operational pattern of office buildings with core occupancy hours of 8:30-17:30, Monday to Friday, and occasional out-of-hours use. Therefore, the EPC result for thermal performance, which reflects the as-designed U values and tested air permeability, is a good yardstick to assess the thermal performance of this building.

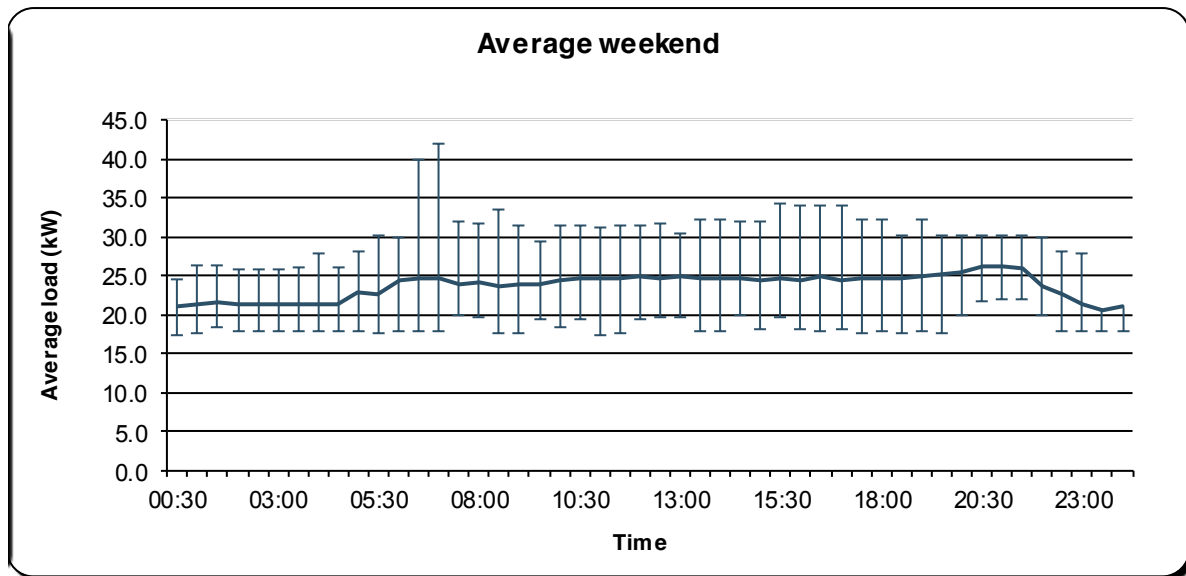
The daytime average electrical power demand of TIC during weekends is around 3-4 kW higher than the baseline load (Figure 6.4). The peaks in average electrical power observed around 6:30 am and 8:30 pm are consistent with the beginning and end of the operation of heating system. This suggests that the weekend average electrical load during daytime follows the operation of the HVAC system set up for occasional out-of-hours use of tenants. Wider variations in daytime electrical power demand than night-time in Figure 6.4 also confirm occasional out-of-hours use of tenanted spaces. However, the average power during daytime is almost on a par with peaks associated with the HVAC system suggesting that out-of-hours use during weekends is not significant. Our interviews with the building management and tenants also confirm that the pattern of out-of-hours building use is highly irregular and cannot be fully captured in a normative calculation. An allowance was made for weekend operation of a typical tenant space as a proxy for occasional weekend operation.

Figure 6.4: Annual electrical power demand for TIC during weekends (2013)
(The peaks around 6:30 am and 8:30 pm are consistent with the beginning and end of the operation of heating system.)

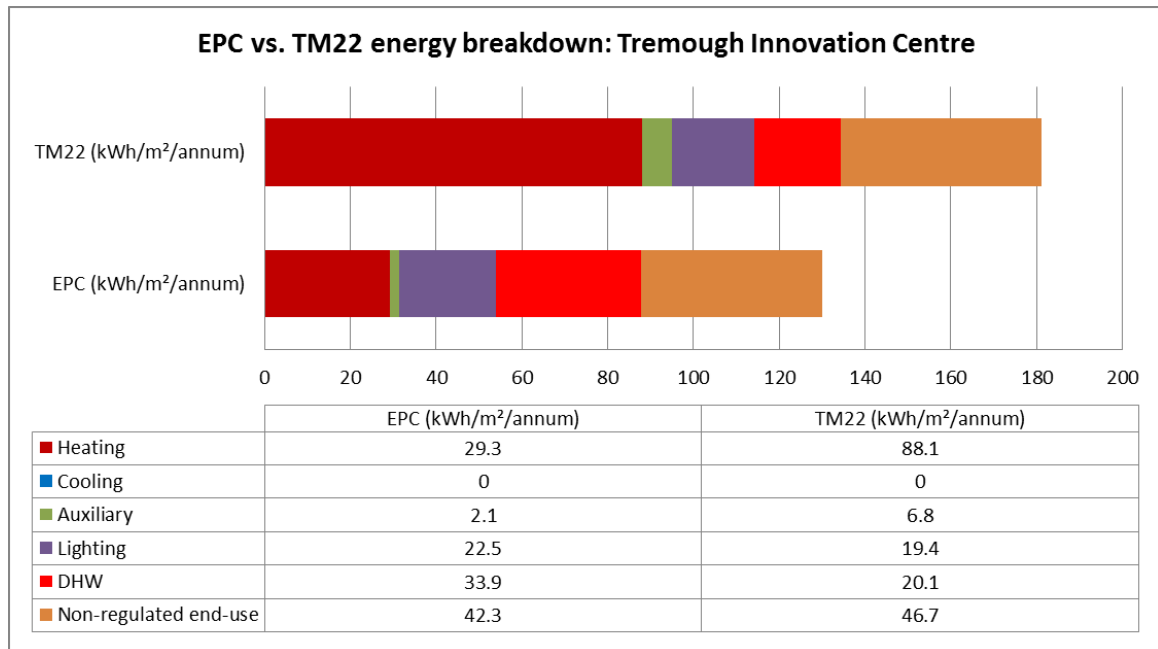
Figure 6.5: EPC vs. In-use TM22 energy analysis for TIC

Heating: actual heating energy is significantly higher than the EPC estimation. This is, to some extent, the result of extended operation of the heating system over the weekends to allow for occasional out-of-hours use that is not reflected in the EPC calculations. Furthermore, the natural ventilation strategy causes heat loss in winter that, again, is not necessarily reflected in the EPC calculations. However, the difference between the actual and estimated heating energy suggests there might be other root causes for this significant gap.

- Auxiliary (Fans, Pumps and control):** auxiliary energy use of the building is significantly higher than the EPC estimation. Apart from the differences in operational profiles that stem from building's out-of-hours use, it should be noted that EPC calculations do not take into account actual pump ratings in the low temperature heating loop. EPC calculations use default pump power densities defined based on a broad definition of HVAC system type and control strategy⁴. These calculations do not take into account building geometry, the length of the heating loop index run and actual pressure drops. Maximum pump power density used in EPC calculations for low temperature heating loop is 0.6 W/m². Actual installed pump power density for the low temperature heating loop at TIC is 1.5 W/m².

- **Lighting:** TM22 estimation for actual lighting energy use is slightly lower than the EPC estimation. It should, however, be noted that not all tenant spaces were occupied throughout the measurement period.

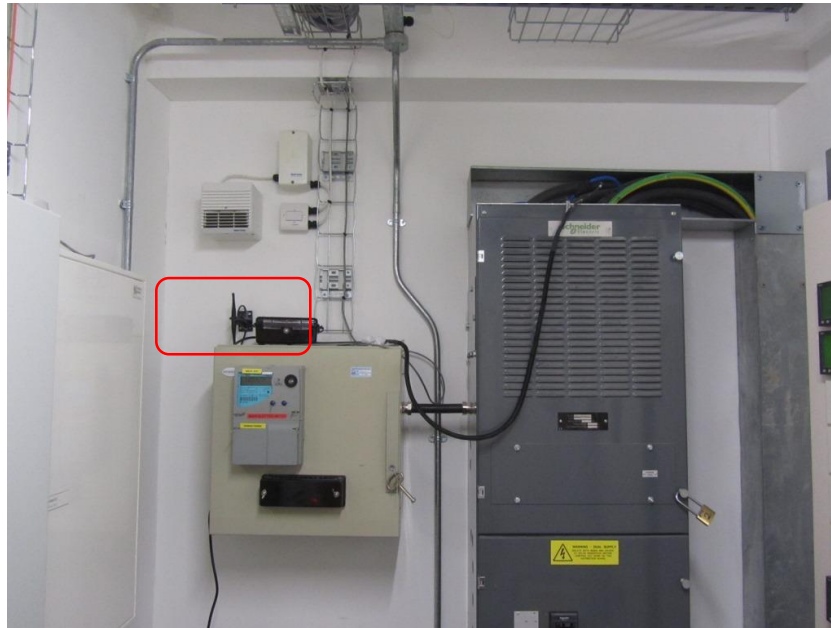
An Elcomponents SPCPro clamp meter unit was installed as part of the BPE project to record the building’s electrical demand and electricity use every five minutes (Figure 6.8). Records of wood pellets delivery and gas meter readings were also used to establish the building’s thermal energy performance.

Figure 6.8: Clamp meter installed to record electrical power demand and electricity use at PIC

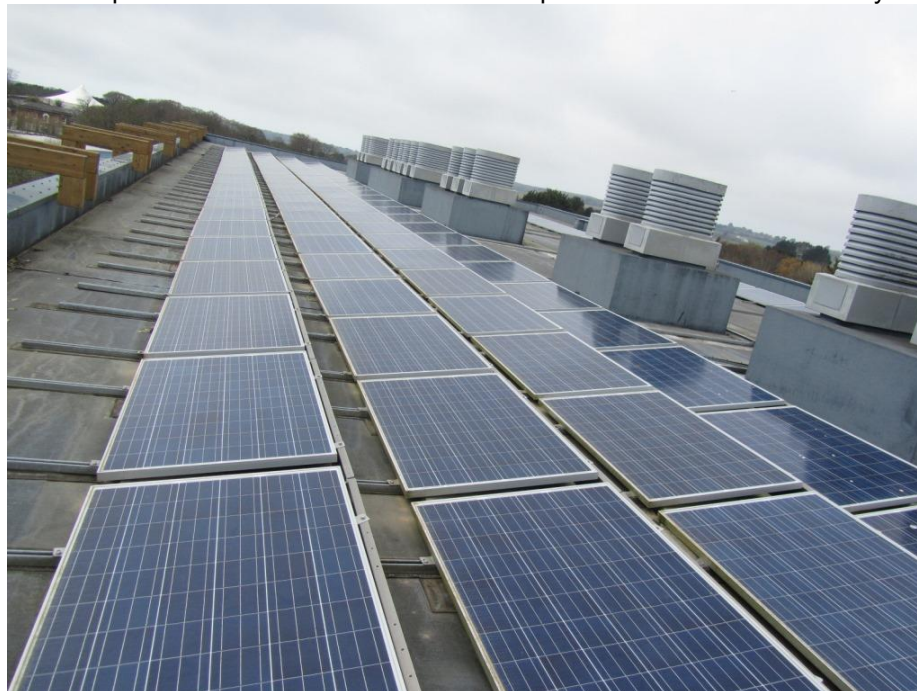
PIC’s design philosophy and operational profiles are very similar to TIC. One of the major differences between these two buildings is the installation of Photovoltaic arrays with maximum power output of 28.2 kWp on the PIC’s roof which took place in December 2011, less than 2 years after building completion (Figure 6.9). The estimation of the potential energy yield of the PV panels provided by the system installer, using SAP 2005 calculation methodology, was 21,048.5 kWh per year (5.6 kWh/m² per year). The actual annual contribution of these panels according to the installed sub-meter has been very close to this estimation at 19,041.0 kWh per year (5.1 kWh/m² per year). The generated electricity is significantly lower than the building’s baseline demand and the exported electricity is negligible, 0.07 kWh/m²/yr. This does not affect the TM22 graphs generated via the simple assessment (Figure 6.10).

Figure 6.9: PV arrays installed on the roof (maximum design power output: 28.2 kWp)

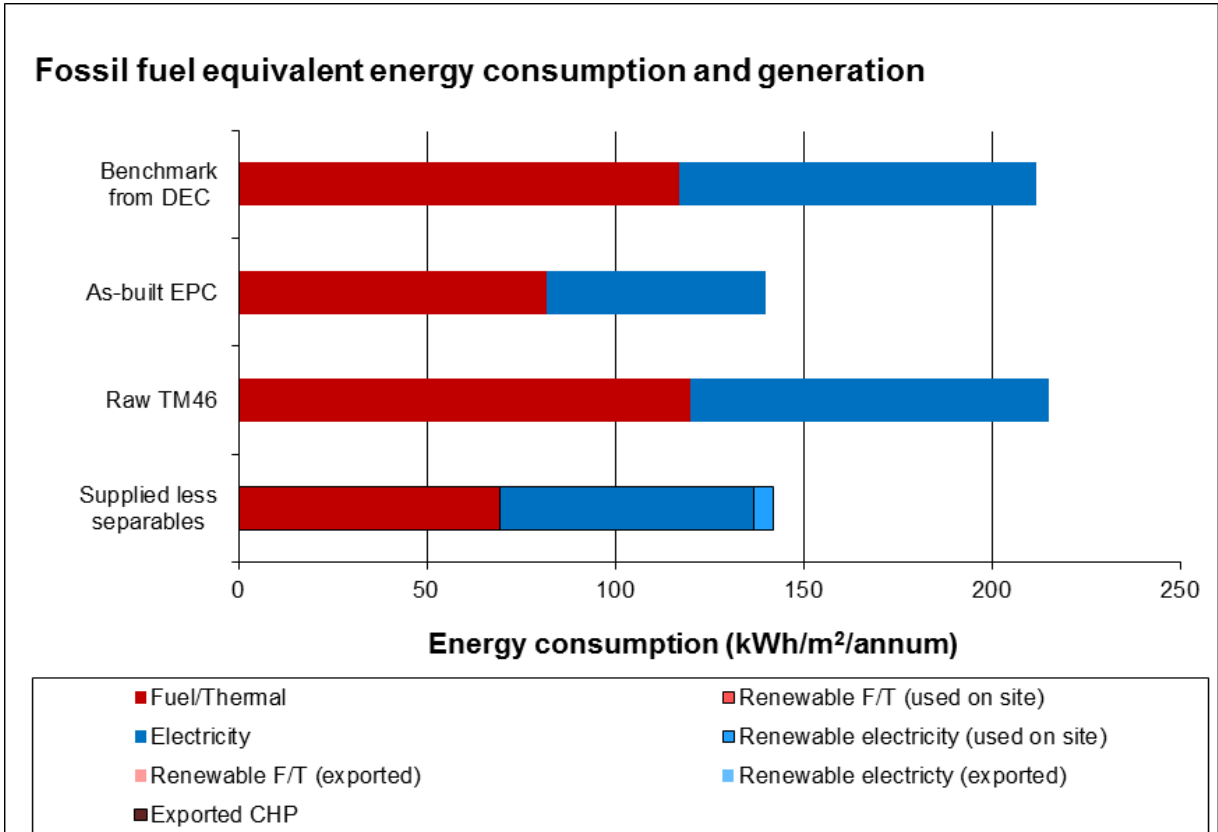
Figure 6.10: TM22 simple assessment for PIC: energy consumption

Figure 6.10 shows that thermal energy performance of the building over the TM22 measurement period (3-4 years after building completion) has been better than all benchmarks. Furthermore, 70.9% of total fuel thermal use has been provided by biomass and, therefore, CO₂ emissions associated with thermal energy performance are significantly lower than benchmarks. Electricity use is also better than DEC and raw TM46 benchmarks, but 16.4% higher than the EPC estimation. However, it should be noted that the building has not reached its full design occupancy level yet. On average, 85% of the tenant areas were occupied during the measurement period.

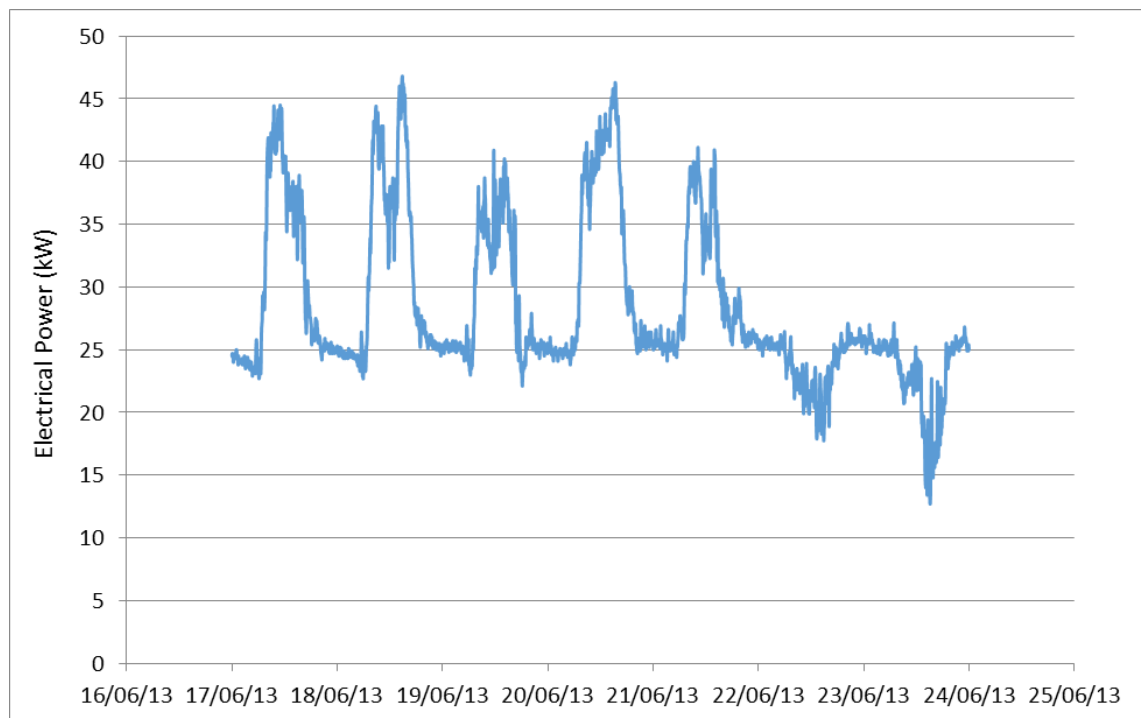
Figure 6.12: Profile of PIC electrical load in summer (typical week: 17/06/2013-24/06/2013)

The decline in daytime electrical load over the weekends indicates the contribution of PV arrays that is more effective in summer as expected. This can also help estimate the peak demand during weekdays. PIC's baseline electrical load is slightly higher than TIC. This is partly because the net lettable area in PIC is higher than TIC (2,245 m² vs. 2,200 m²) with more equipment in tenant spaces, and there is also a tenant with regular out-of-hours activity on the first floor.

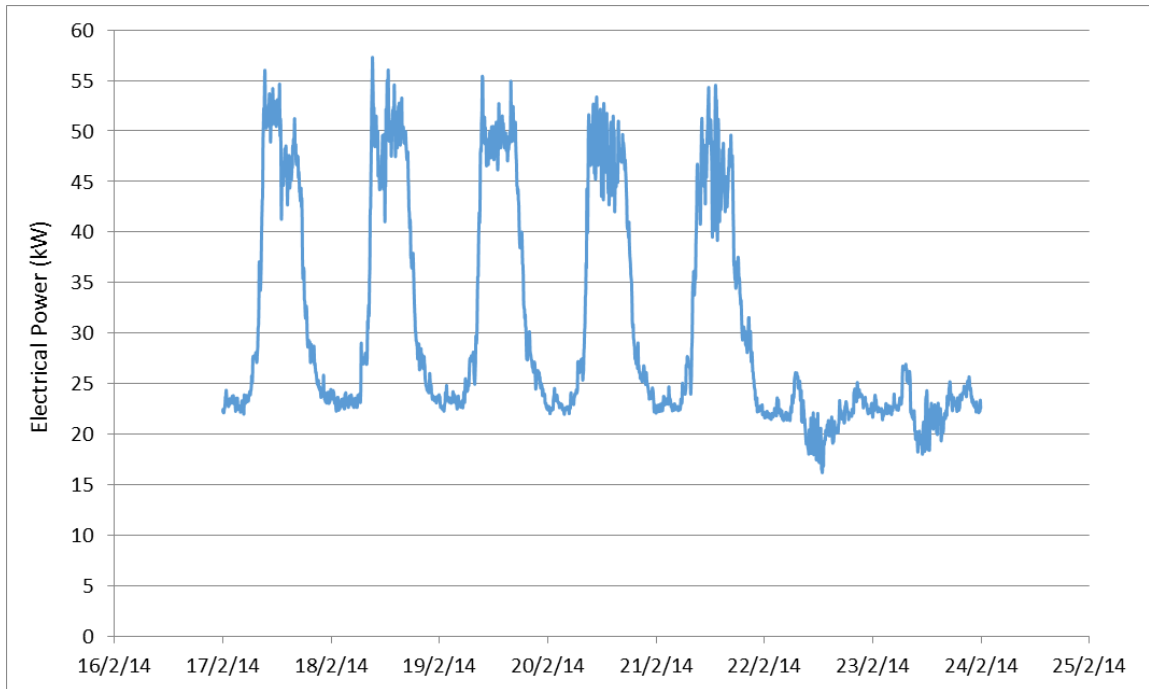
Figure 6.13: Profile of PIC electrical load in winter (typical week: 17/02/2014-24/02/2014)

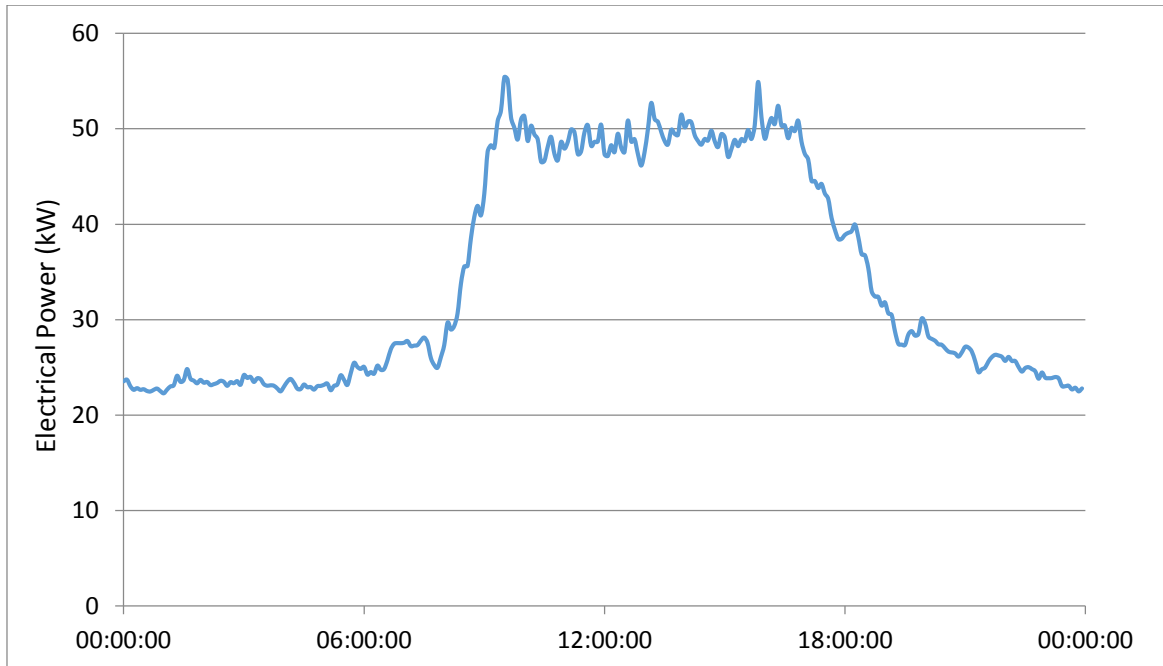
PIC's electrical load during weekdays confirms that its operation follows the operation of typical office type buildings with core office hours between 8:30 am and 5:30 pm and some activities related to building management and cleaning time (Figure 6.14).

Figure 6.14: 24-hour electrical load in PIC (typical weekday: 19/02/2014)

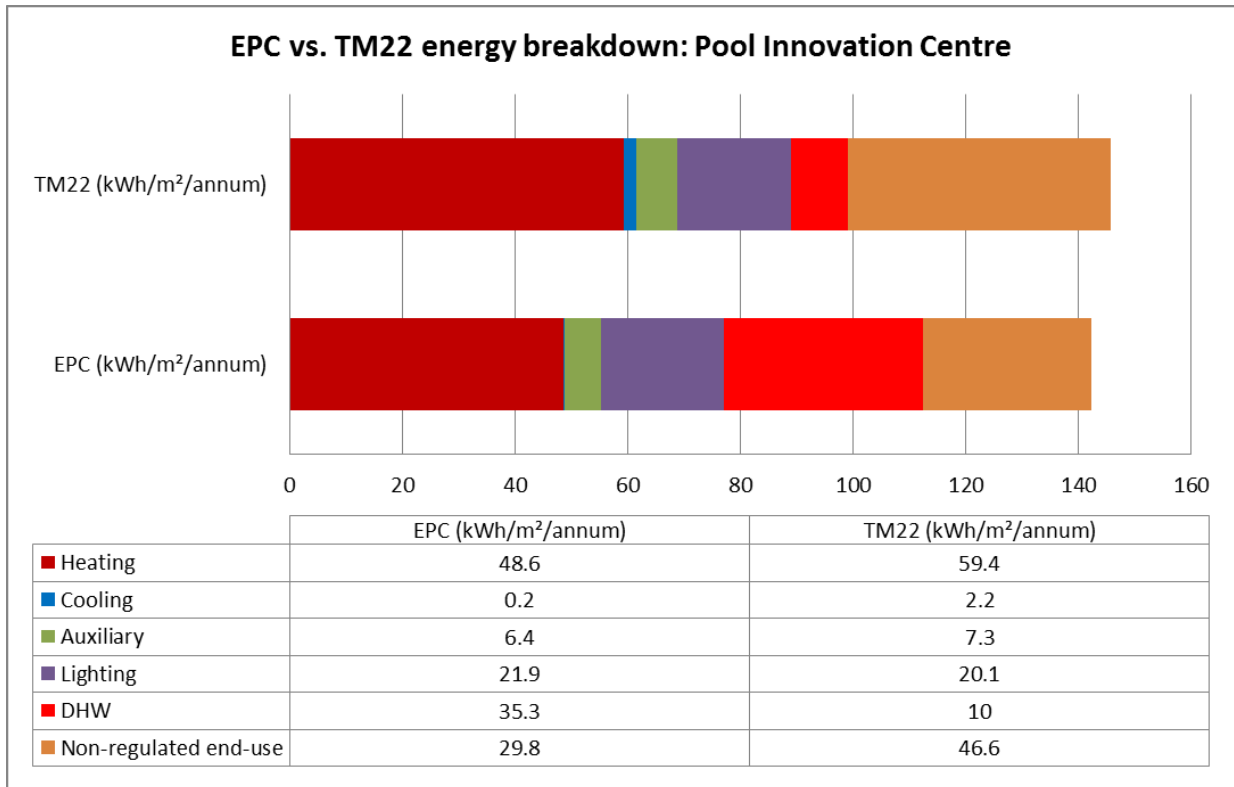
Figure 6.15: EPC vs. In-use TM22 energy analysis for PIC

- Heating:** Actual heating energy use is around 22% higher than the EPC estimation. While this discrepancy is much lower than what was observed at TIC, and differences in actual operating conditions and operational profiles assumed in EPC can also explain part of this discrepancy, there is still room for improvement. Figure 6.16 shows a photograph of the biomass boiler buffer vessel installed for PIC. The sensory equipment installed for the buffer vessel pass through metal bars installed on the surface of the vessel which are not insulated and, therefore, feel quite hot. These can lead to high standing heat loss for the buffer vessel.

- **Lighting:** TM22 estimation for actual lighting energy use is slightly lower than the EPC estimation. It should, however, be noted that not all tenant spaces were occupied throughout the measurement period.
