This document contains a Building Performance Evaluation report from the £8 million Building Performance Evaluation research programme funded by the Department of Business Innovation and Skills between 2010 and 2015. The report was originally published by InnovateUK and made available for public use via the building data exchange website hosted by InnovateUK until 2019. This website is now hosting the BPE reports as a research archive. Although no support or further information on the reports is available from the host, further information may be available from the original InnovateUK project evaluator using the link below¹.

| InnovateUK project number | 450073 |
| Project author | Glasgow School of Art, Mackintosh Environmental Architecture for Research Unit (MEARU) Architecture + Design Scotland |

| Eight | Milton of Leys, Inverness | Various (see p.13) | 2010 |

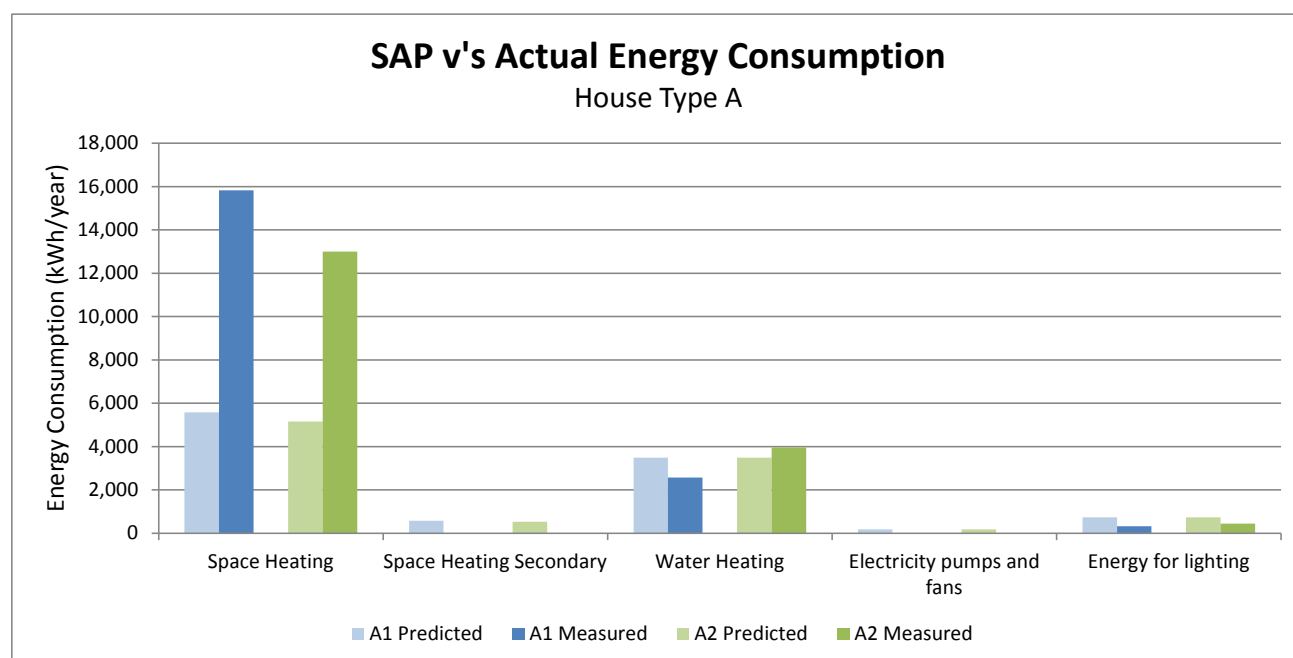
Overall the regulated energy consumption in this house type exceeds the SAP prediction with actual consumption for space heating being considerably greater (Figure 2:2). The water heating consumption was close to the SAP prediction and the measured lighting consumption was slightly lower than the SAP prediction.

Figure 2:2: SAP prediction v's measured energy consumption - House Type A

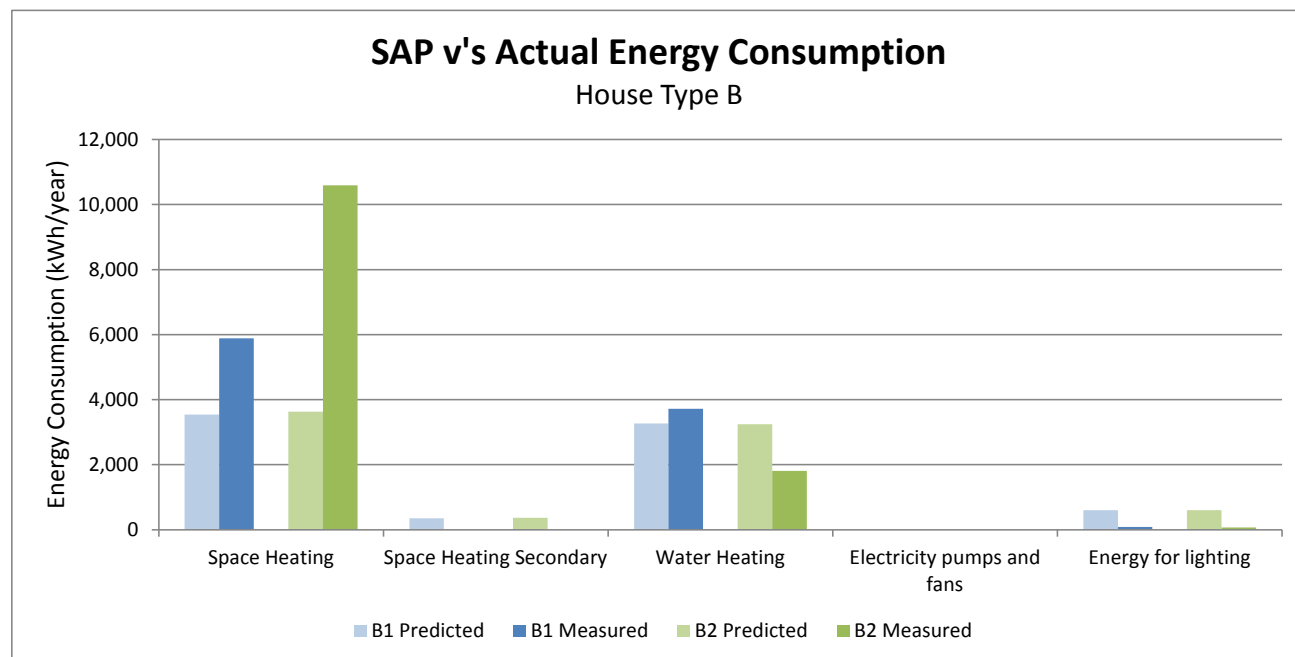
A review of the energy consumption (Figure 2:3) indicates a smaller performance gap for space heating, compared to House Type A, especially in House B1. The occupiers in this dwelling are normally at home during the day and the lower space heating consumption (45%) is unexpected. The water heating in dwelling B1 is around the SAP assumption but dwelling B2 is around 50% lower than SAP. However, the lighting loads in both households are significantly lower than the SAP standard predictions.

Figure 2:3: SAP prediction v's measured energy consumption - House Type B

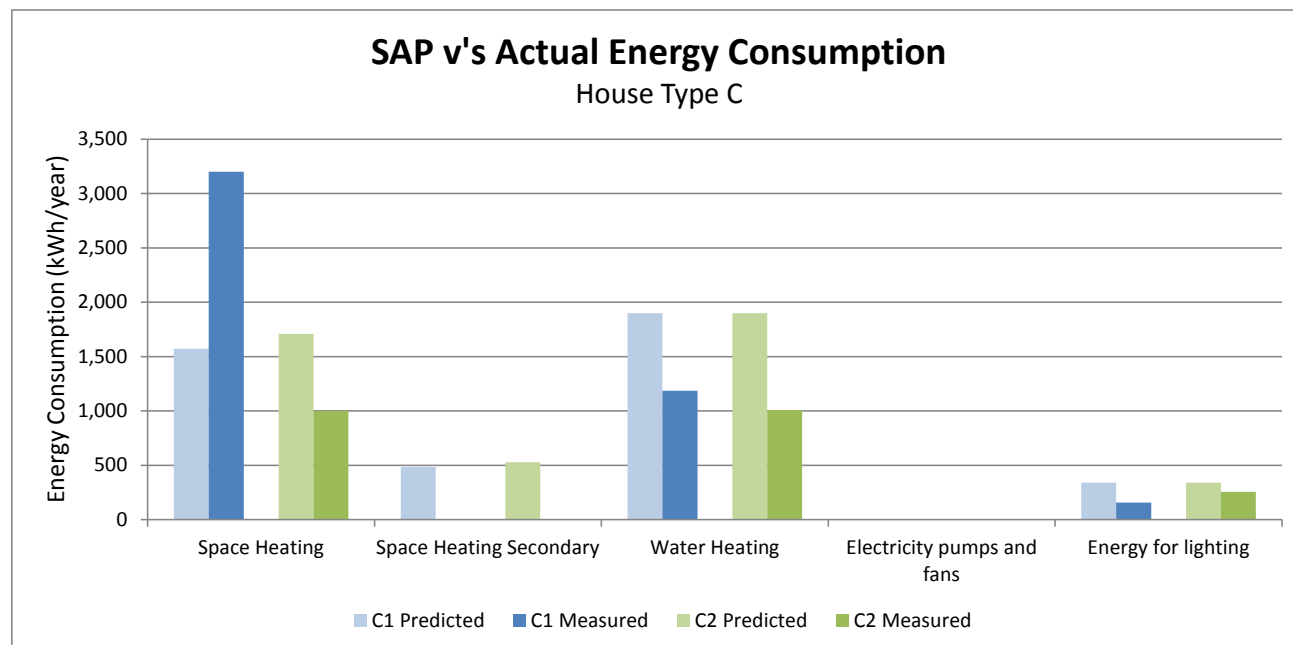
Figure 2:4 indicates a large difference in space heating consumption between SAP and actual consumption of each of the properties. Consumption in dwelling C1 is around double that of the SAP assessment and consumption in dwelling C2 is around 30% lower than the SAP prediction. The difference in occupant behaviour is clear when comparing these two dwellings, as the occupant in C1 (at this time) used the electrical heating only to satisfy their space heating needs, while C2 use the secondary heating source (wood burning stove) more than the electric panel heaters. While there is no data available for the amount of fuel used in the stove the occupants (C2) advised they spend £80 a year on wood

Figure 2:4: SAP prediction v's measured energy consumption - House Type C

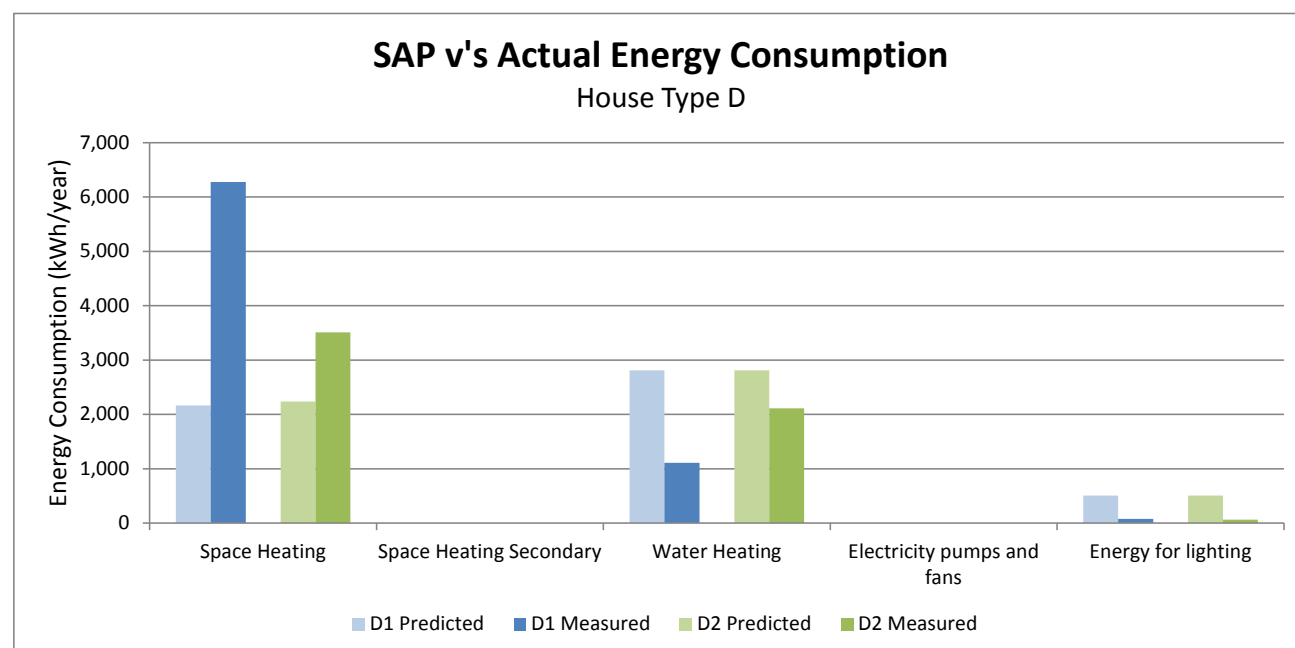
Figure 2:5: SAP prediction v's measured energy consumption - House Type D

The comparison of regulated loads (Figure 2:5) indicate the SAP prediction for space heating to be lower than the measured consumption in both dwellings. However, the actual annual consumption of dwelling D2 is nearly half that of the neighbouring dwelling. The water heating and lighting consumption in both dwellings is lower than the predictions.

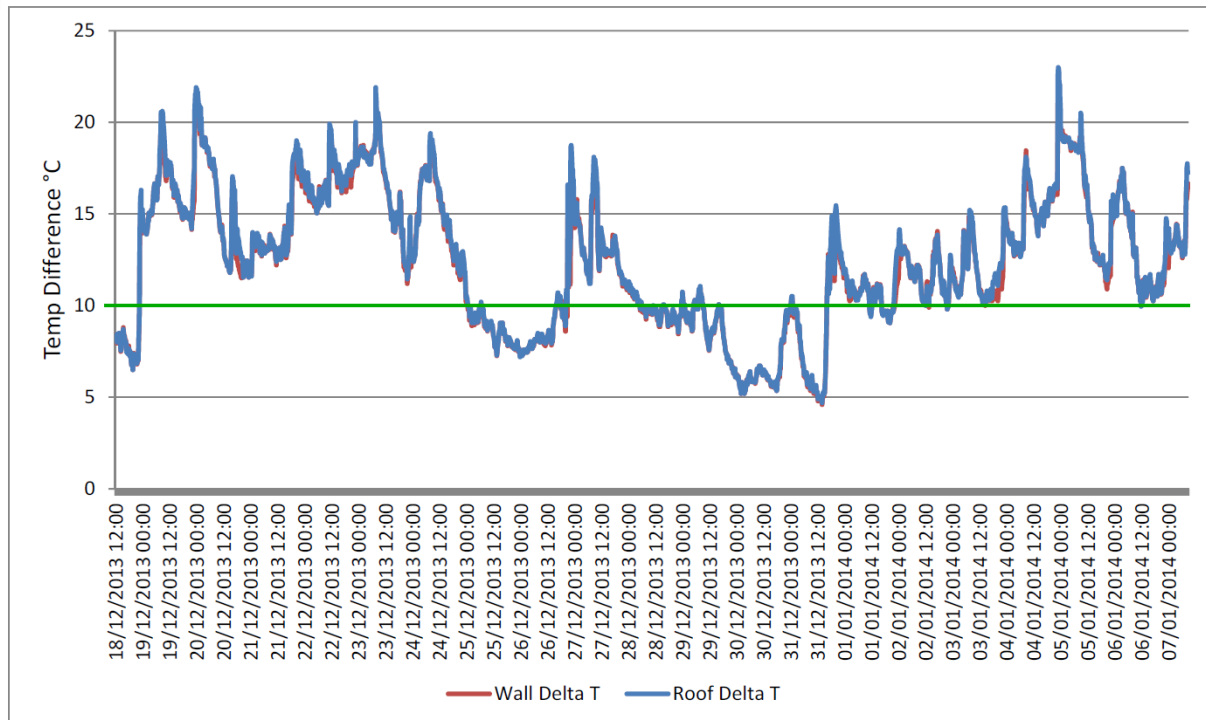
The apparatus was set up in a bedroom that is occupied overnight and heated by an electric panel heater operated on an intermittent basis. The equipment was set up on 17th December and demounted on 7th January 2014. During the measurement period the internal space temperature dropped to 10°C . This corresponds to the dwelling being unoccupied and unheated for extended periods over the Christmas and New Year period. This resulted in the temperature difference ('Delta T') between inside and outside dropping to less than 10°C (Figure 3:5), which affected the rate of heat loss through the building fabric and corresponding accuracy of the measurements.

Figure 3:5: Temperature difference between inside and outside during the measurement period, data below the green line correspond to reduced analysis accuracy.

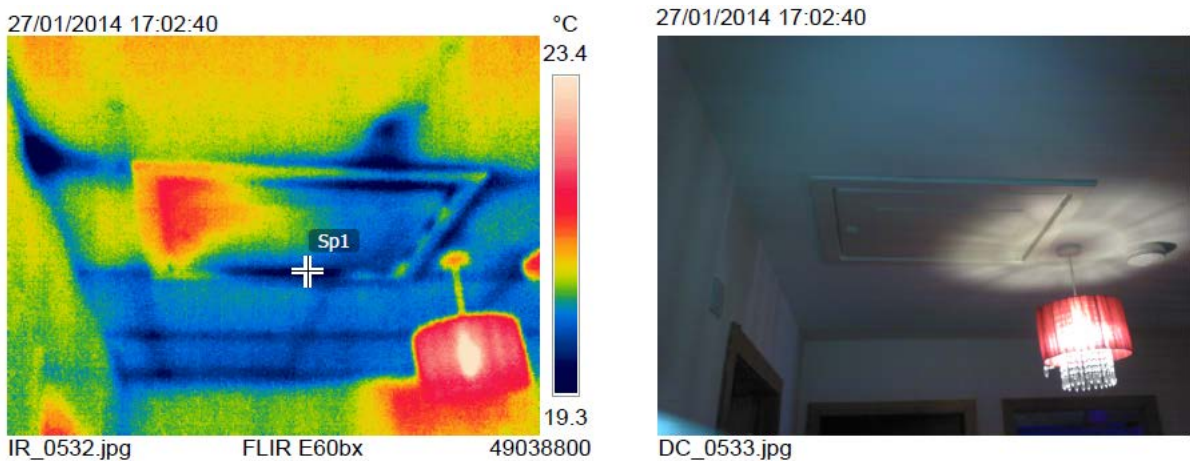
Figure 3:8: Thermal image of wall under test, highlighting location of non-repeating thermal bridge in first floor hall ceiling.

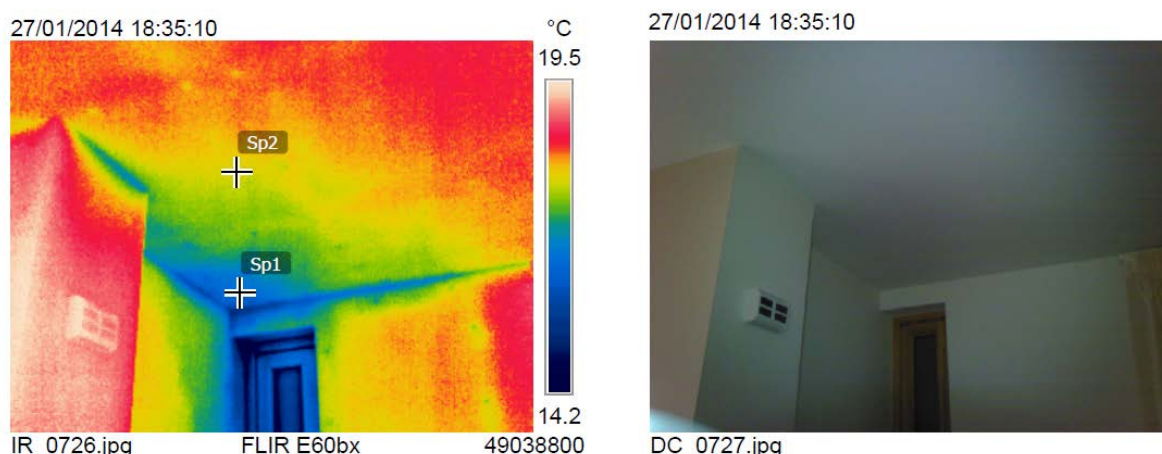
Figure 3:12: Thermal image of wall and ceiling, an area of non-repeating thermal bridge is detected at the ceiling and to the left of window.

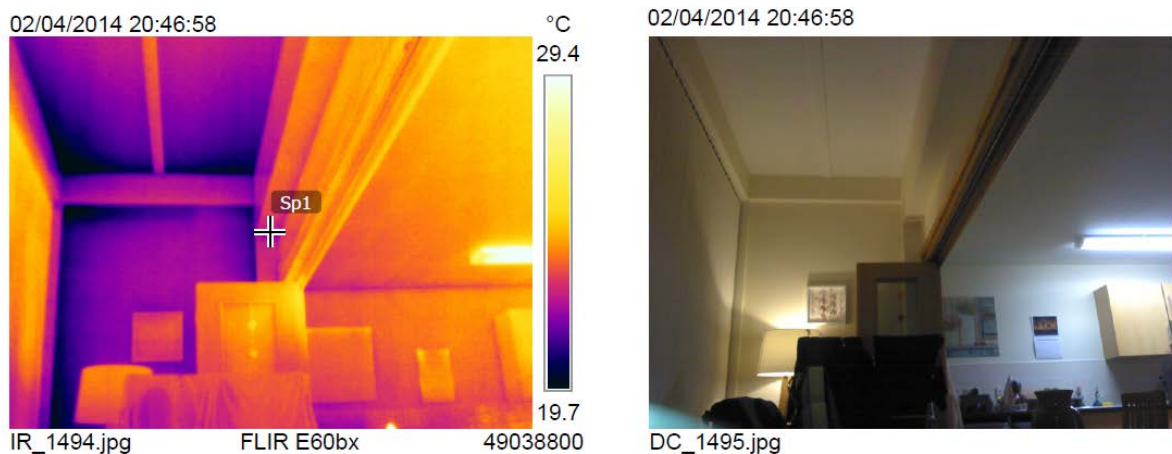
Figure 3:14: Thermal image of wall/ceiling junction in sunspace (within insulated envelope), an area of non-repeating thermal bridge is detected at the junction, also note cooler sunspace surface temperatures essentially cooling the adjacent living space.

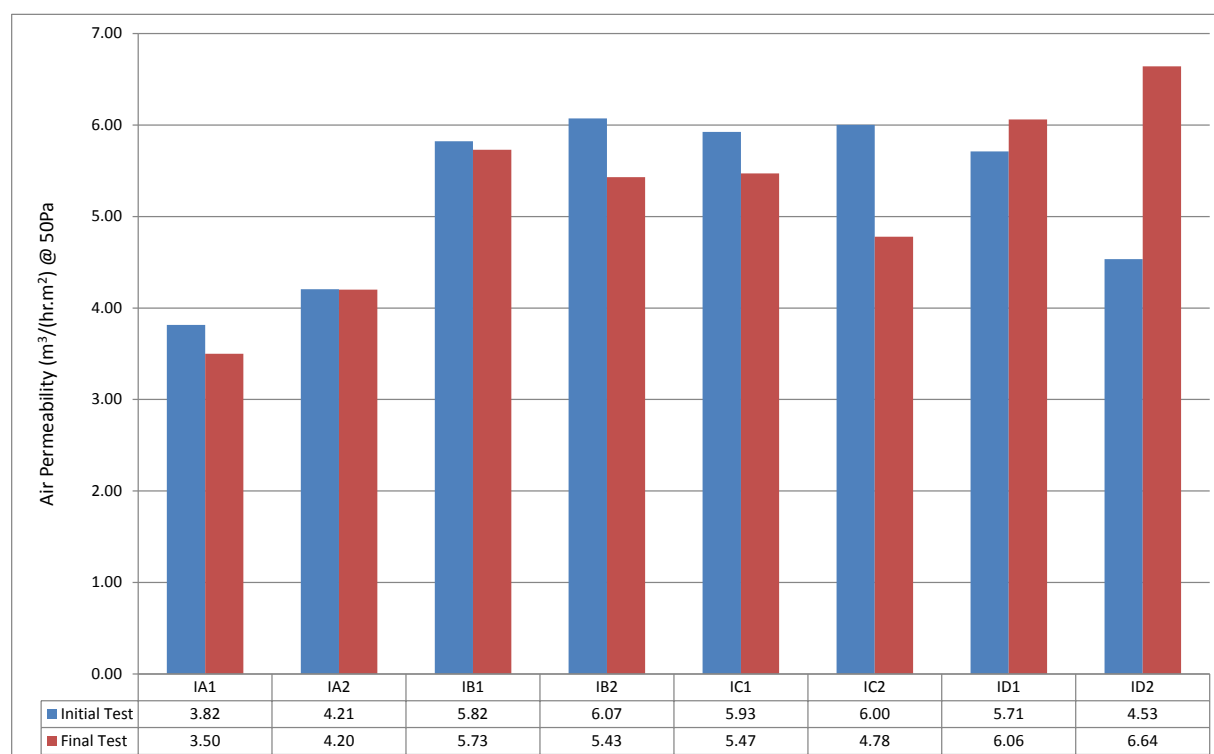
Figure 3:15: Comparison of Initial and final air permeability results (dwelling depressurised).

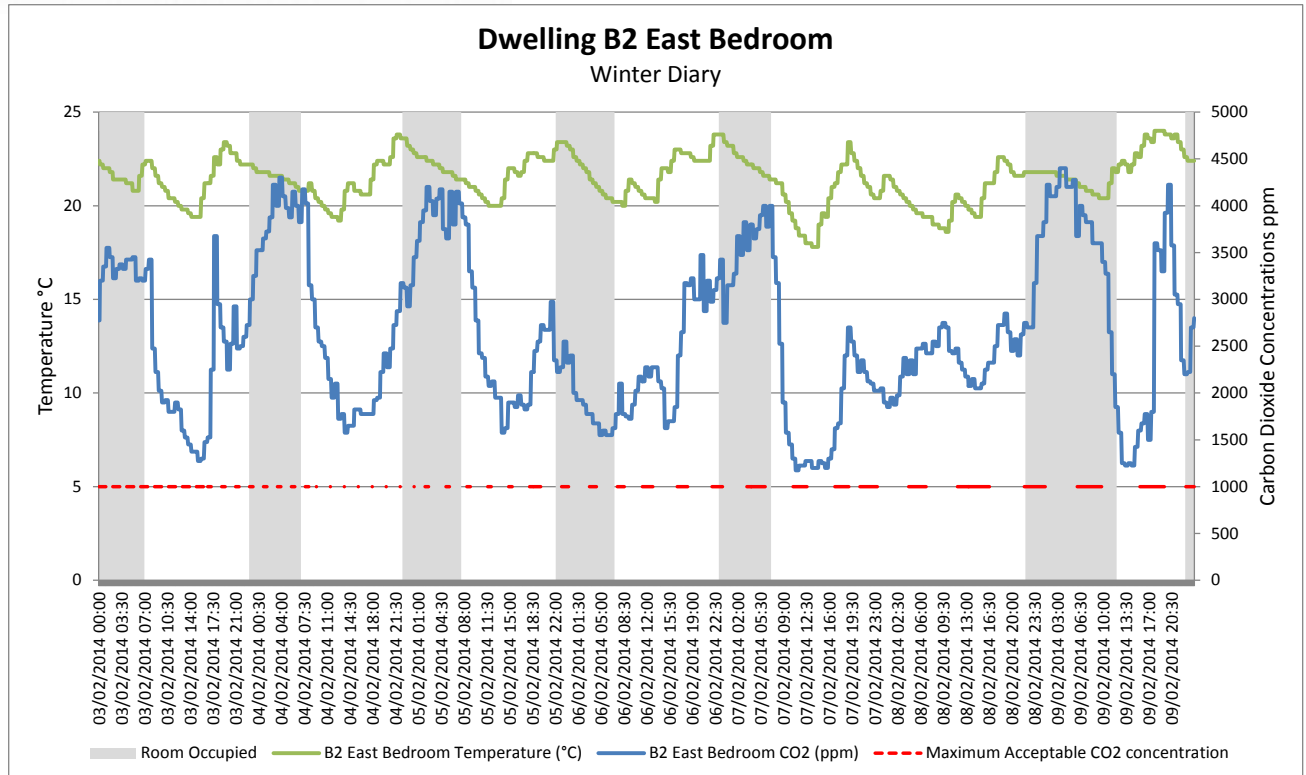
Bedroom 1: The winter diary week for east bedroom in dwelling B2 was selected for analysis as it was known to have high CO₂ concentrations, be occupied by one single occupant of teenage years who keeps the window in a closed position at all times. The hours when the occupant indicated they were in the bedroom are represented with grey shading in Figure 5:3. It indicates that there were times that the bedroom was occupied prior to retirement for bed on at least four occasions. The night of 5th February the occupant indicated presence in the bedroom, however, the CO₂ peaked around 3000ppm which was and similar to the night of 7th February when the bedroom was unoccupied. The occupant indicated that the bedroom door is normally 'open' through the night. The CO₂ concentrations through the week were continually over 1000ppm and space temperature rarely fell lower than 20°C. This indicates the room is under ventilated and continually heated, these conditions could affect sleep patterns of the occupant and cause headaches. The reason for CO₂ peaks when the bedroom was unoccupied and occupant absent from the dwelling are unclear, however it is clear the occupant spends long periods in the evening in the room and the family have a large dog which could be sleeping in the room.

Figure 5:3: Plot of east bedroom environmental conditions against winter diary data for Dwelling B2.

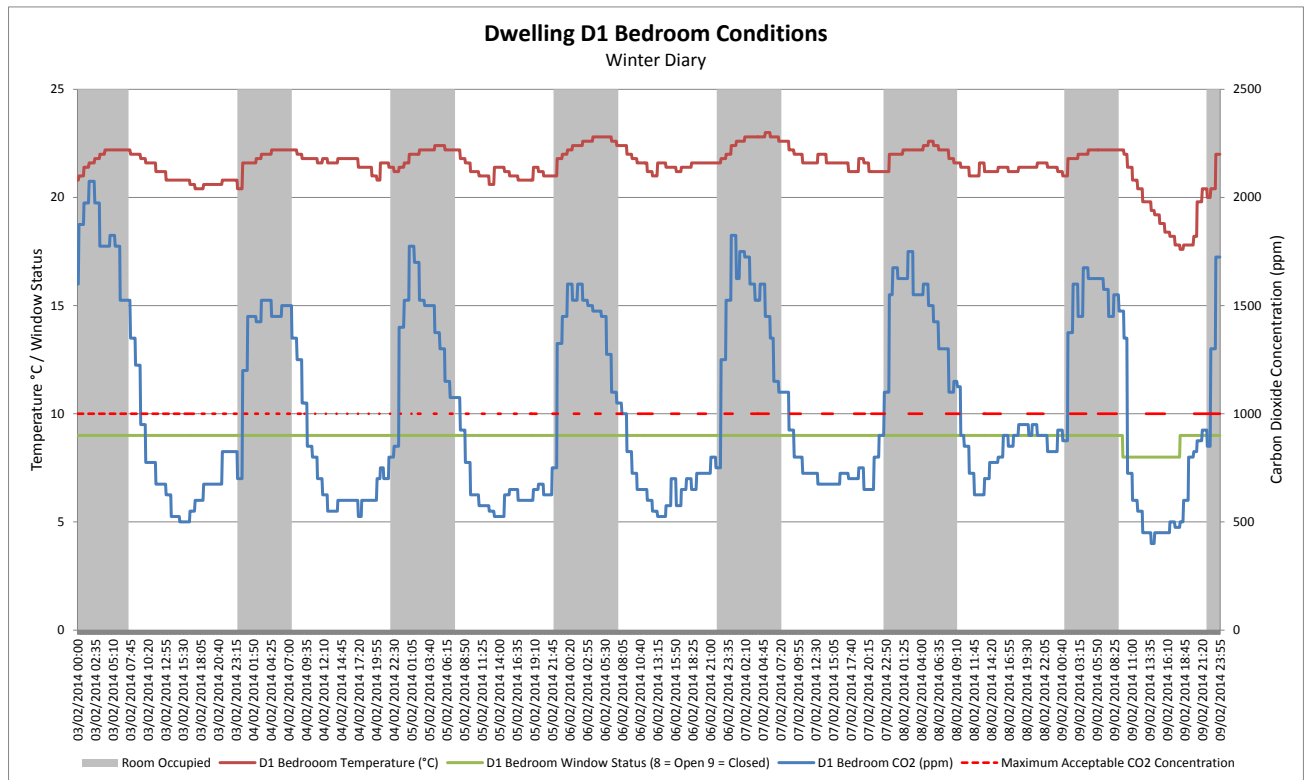
Bedroom 2: Dwelling D1 returned both diaries, the data for winter and summer are plotted in Figure 5:4 and Figure 5:5 respectively. The bedroom is occupied by two adults, they sleep with the door closed and have seasonal window opening patterns. During both seasons the bedroom temperature is maintained between 20 and 25°C, there is however a drop in temperature in the winter when the window is opened. During the night when occupied (indicated in grey) CO₂ concentrations consistently rise to above 1000ppm, this is seen in both winter when the window is closed and in the summer when the window is open.

Figure 5:4: Plot of master bedroom environmental conditions against winter diary data for Dwelling D1.

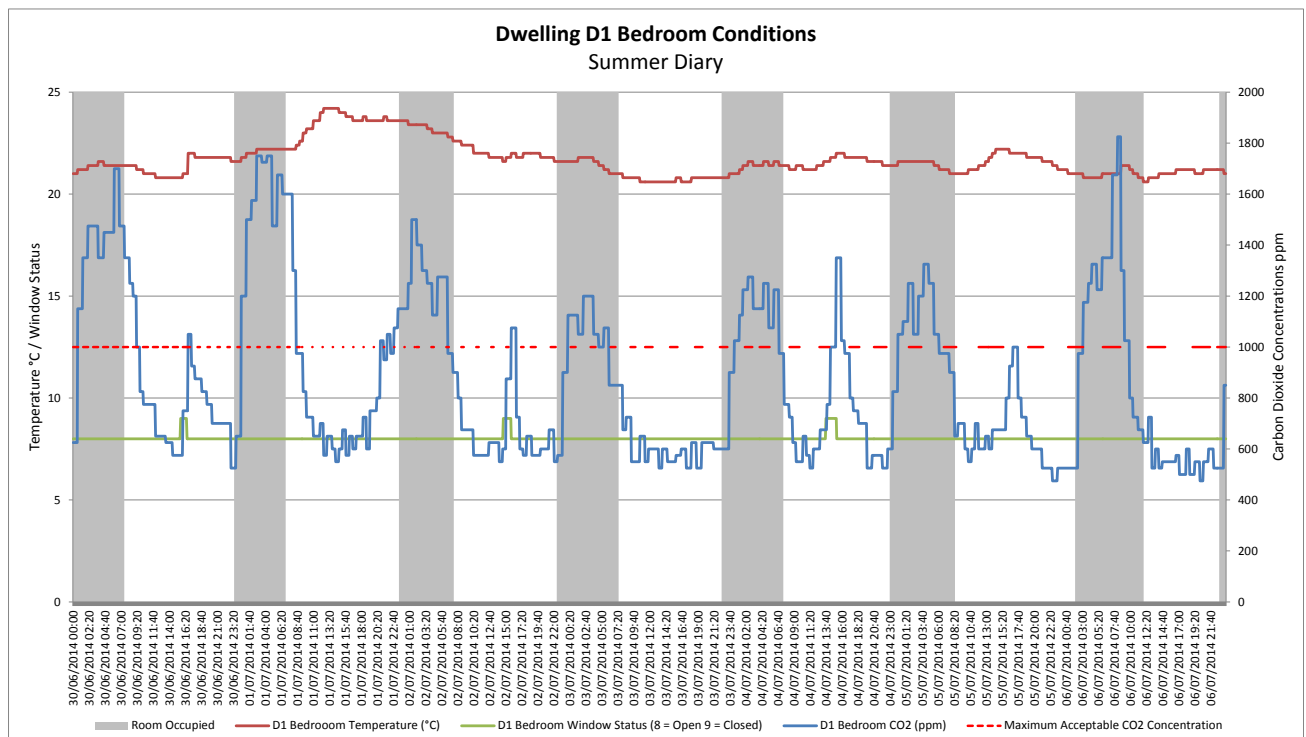
During the summer it was also evident that the bedroom is occupied during the daytime one at least four occasions where the CO₂ concentrations rise to around 1000ppm, this is thought to be one of the occupants sleeping during the day as one occupant rises at 04.30hrs during the weekday in the summer diary week. There are frequent lower night time CO₂ peaks during the summer week which could be due to higher external wind speeds; however this data was not collected due to a failure of the external weather station. During both diary periods the room CO₂ concentrations decay to below 1000ppm.

Figure 5:5: Plot of master bedroom environmental conditions against summer diary data for Dwelling D1.

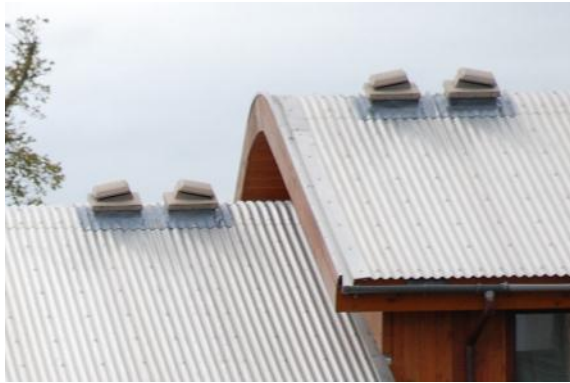
A visual inspection of the passive stack extract system serving the ground floor WC and first floor bathroom in each dwelling was made. Grilles are wall mounted and were found to be moderately soiled, particularly in the first floor bathrooms where access for cleaning requires use of a step ladder. All but one grille was found in a partially open position and providing a contract extraction rate. Duct routes were not inspected due to being boxed in. Mould growth on tile grout and silicone sealant was identified in the bathroom of dwelling B2. Flow measurements indicated that this bathroom has lower extract rates than the neighbouring property. The roof mounted exhaust points on dwelling B2 are slightly sheltered from the wind by the neighbouring roof. This could affect extract performance in this bathroom. It is of concern available guidance states there is no requirement to test or commission passive stack systems as BRE studies have concluded a well-designed passive stack system could be ruined by poor installation.

Figure 6:3: Outlets of passive stack ventilation systems.

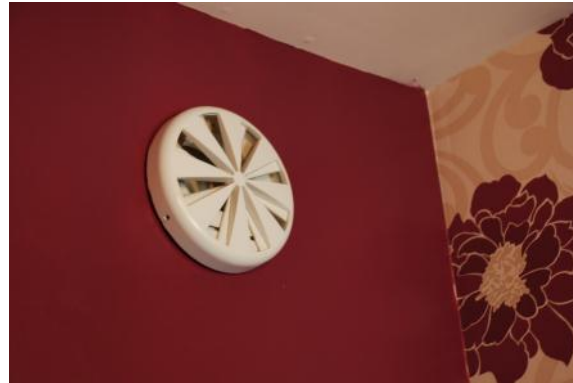
Figure 6:4: Typical inlet grilles of passive stack ventilation system, humidity activated. (WC in B2).

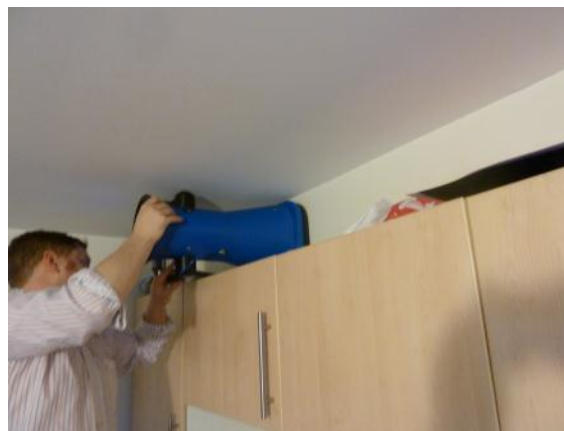
Figure 6:8: Flow measurement in kitchen, dwelling C1, access to grille above wall mounted cupboards with measurement apparatus was difficult.

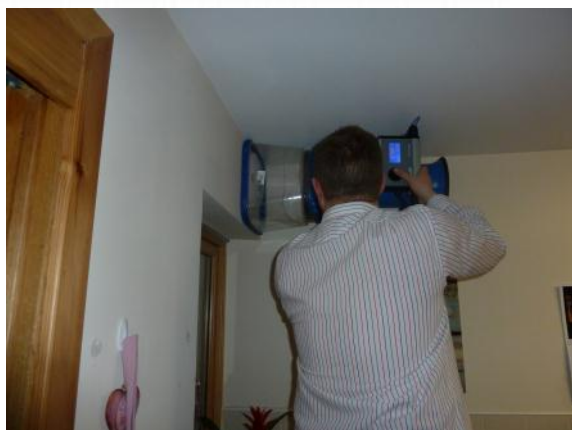
Air flow measurements were made for kitchen and bathroom extract fans in dwelling D2. The kitchen extract unit is located in a position away from the hob and is manually switched, the measurements of 26 l/s, 56% lower than the Building Regulation recommendation. The bathroom extract unit is light switch controlled and has been set with a run-on time of around two minutes. The average air flow rate of this unit was 6.9 l/s, 54% lower than the extract rate recommended in the Building Regulations. The occupants advised the daylight levels in this room were frequently sufficient to allow showering without switching the light on and they are unable to reach the handle to open the window. The bathroom trickle vent was found to be broken and airtightness testing indicated a significant amount of air leakage from this room, it is therefore the infiltration in this room which is helping to keep it mould free.

Figure 6:9: Flow measurement testing in kitchen, dwelling D2.
Note how the apparatus just fits.

The occupants advised of their intention to read their owners handbook to establish if the run-on of the fan could be increased and to fit a replacement screw in the trickle vent.

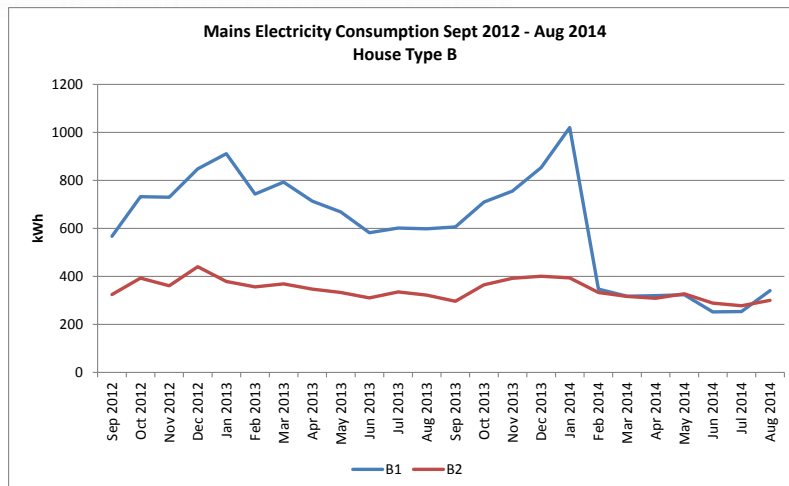
There is a clear summer/winter pattern of usage in both dwellings, however year two data for dwelling B2 is erroneous due to battery failure around November 2013, battery was replaced during March 2014 once the fault was detected.

Figure 7:17: Electrical consumption for two monitored dwellings in House Type B.

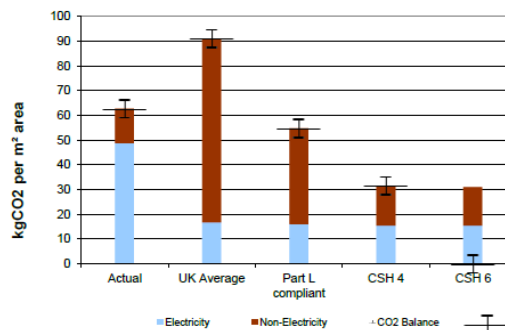
Figure 7:20: DomEARM results output dwelling B1.

In dwelling B1 (Figure 7:20) the electrical consumption was found to be significantly higher than all benchmark data used in DomEARM, while the gas consumption was lower than the benchmark data. It was later discovered while reviewing sub-metered data that the dwelling occupants were heating their domestic hot water using the electrical immersion heater, which has also impacted the overall annual dwelling emissions.

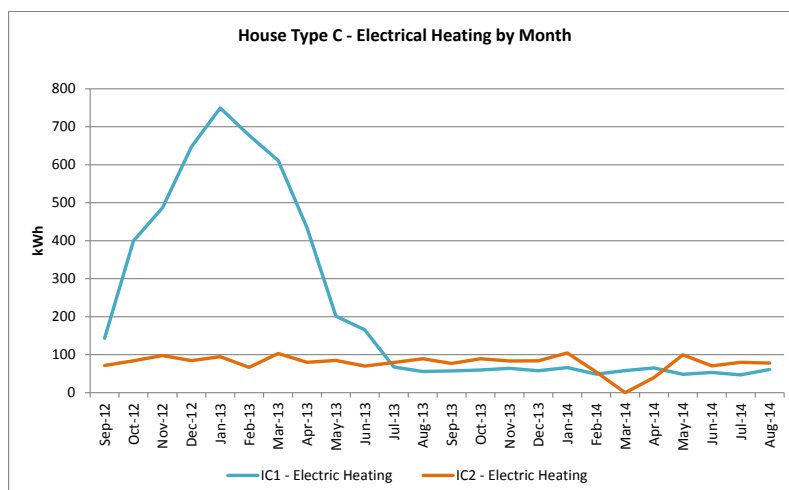
Figure 7:24: Electrical heating energy consumption for two monitored dwellings in House Type C.

Figure 7:24 illustrates the significant impact electrical heating can have on electrical consumption and associated cost. The newer occupants in C1 prefer to use the wood burning stove due to a free supply of wood, and the occupants of C2 use a mix of electric heating and the wood burning stove. However, both occupants complained over lack of external storage for the wood fuel.

The chart illustrates the higher usage pattern in dwelling C1 before and after the change of occupants. Dwelling C2 shows a constant heating load throughout the two year period.

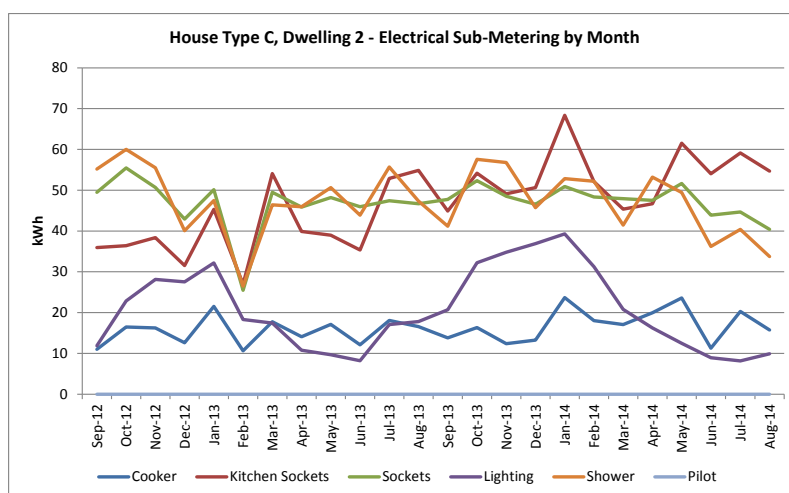
Figure 7:26: Electrical consumption by sub-circuit for two years in dwelling C2.

In dwelling C2 the sub-circuit metering (Figure 7:26) illustrates a more or less equal consumption for the shower, kitchen sockets and sockets in the dwelling, with the cooker being the lowest consumer. The usage pattern for electrical lighting clearly identifies a dip in consumption during the summer period, however during the winter the lighting consumption is greater than the cooker.

The hot water in these dwellings is heated by electrical immersion, however due to the way in which the cables had been installed it was not possible to connect a meter to allow separate monitoring.

Electrical heating is not included. In this dwelling the shower, kitchen and equipment plugged into plug sockets are the highest electrical consumers. The cooker uses less energy than the electrical lighting.

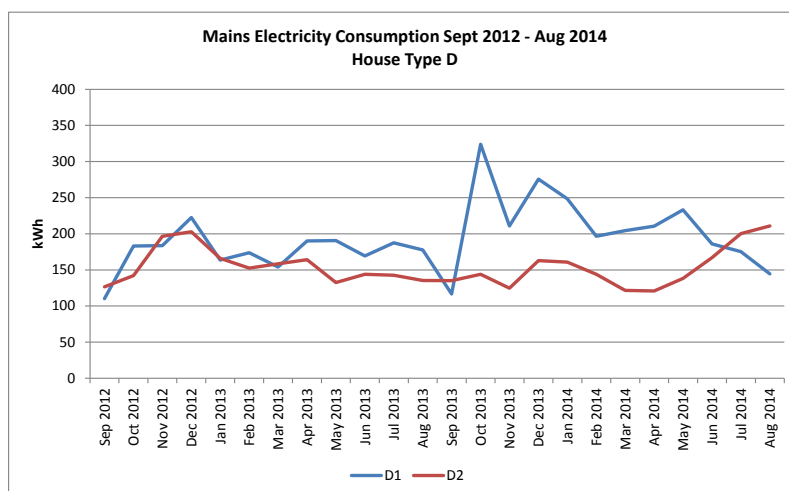
Figure 7:31: Electrical consumption for two monitored dwellings in House Type D.

The electrical consumption of dwelling D1 (Figure 7:31) indicates a large difference in consumption between year one and two, however there were some technical issues with a sub-circuit not being physically connected. While initially the electrical consumption on dwelling D2 was high it settled to be relatively stable until June 2014 which coincided with the birth of the occupants' first child.

The chart illustrates a relatively large increase in consumption in dwelling D1, the reason for this increase is unclear. After an initial peak in comparable dwelling D2 the electrical consumption settled to be relatively stable throughout. The consumption has increased since June 2013 which corresponds to the recent birth of the occupants first child.

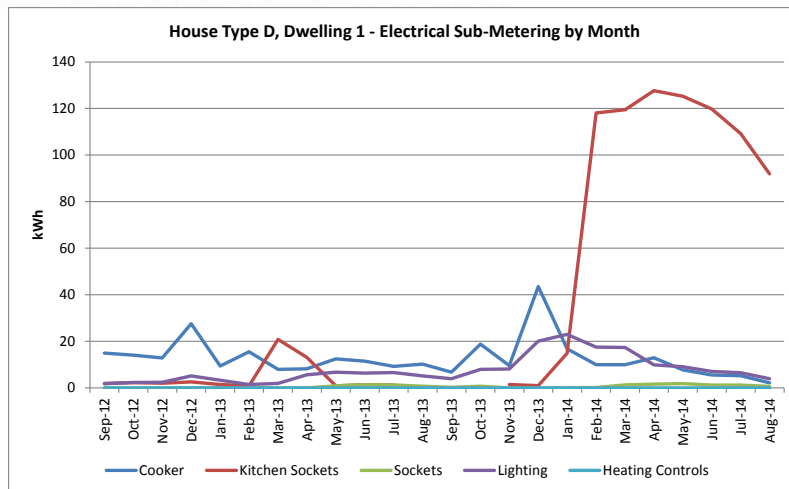
Figure 7:32: Electrical consumption by sub-circuit for two years in dwelling D1.

Figure 7:32 illustrates D1's electrical consumption by sub-circuit, this chart is difficult to interpret as there had been an initial problem with the quality of data for sockets and upon investigation t-mac deleted a sockets sub-circuit from the monitoring as they considered the loads to be too low. After investigation it was found the low load was a real consumption as one bedside lamp (fitted with low energy light) was plugged into the circuit, the occupants informed us that this was rarely used. Due to the open plan nature of the living space, location of sockets and furniture placement all electrical items within the household were plugged into the kitchen sockets sub-circuit on our visit. This increases the risk for electrical fires within the home from overloaded circuits. However, initially the furniture was arranged differently and was using the living room sockets. While in D2 the sub-metering (Figure 7:33) indicates a clearer hierarchy with kitchen sockets still heavily loaded and few electrical items drawing from the remaining sockets in the dwelling; the lighting load is higher than the remaining sockets.

There were significant issues with the monitoring of socket sub-circuits within this dwelling. Due to the layout of the dwelling it was found that most electrical consuming items were plugged into the kitchen socket circuit. It is of interest that during the winter the lighting loads exceed the electrical consumption of the cooker.

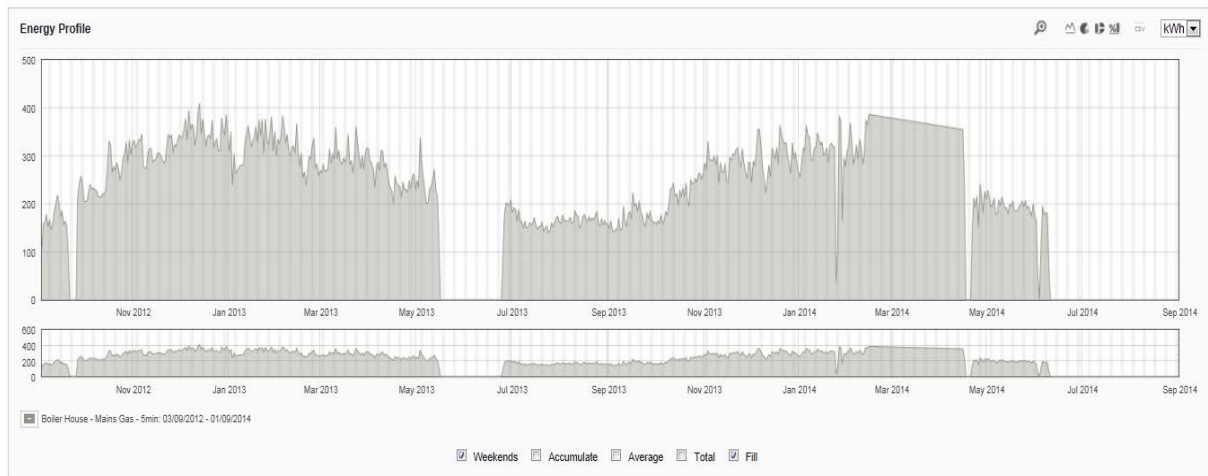
Figure 7:34: Gas boiler operation for two year monitoring period.

There have been reliability issues with the continued operation of the biomass boiler due to a flue gas sensor being missing or faulty. This meant the gas back-up has been in use more frequently than intended, the gas consumption profile (for two years) is illustrated in Figure 7:34. During this time 157,837 kWh of gas has been consumed by the back-up boiler which we estimated to be amount to £5,023. The monthly consumption illustrated in Figure 7:35 highlights the gas consumption of the back-up boiler, the only full months where gas-back up has was not used is July and August 2014. At this time the heat demand would have been met by the biomass boiler.

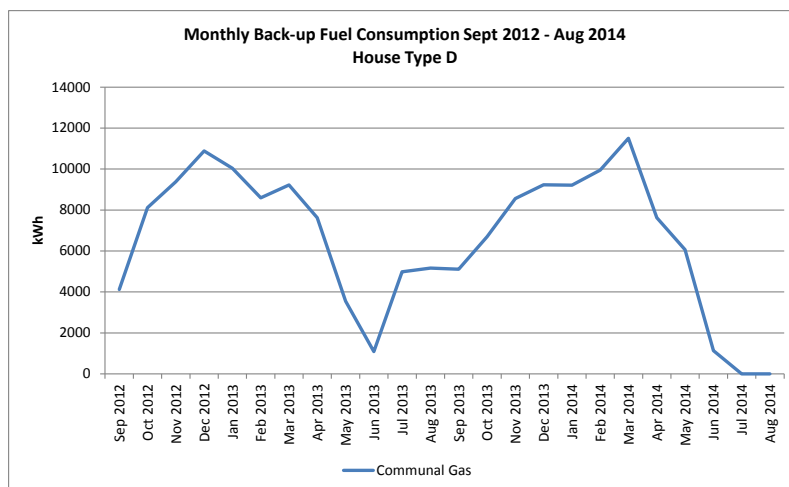
Figure 7:35: Communal back-up gas boiler consumption September 2012 – August 2014.

The chart illustrates constant gas consumption from September 2012 through to mid June 2014 due to a continued fault with the biomass boiler.

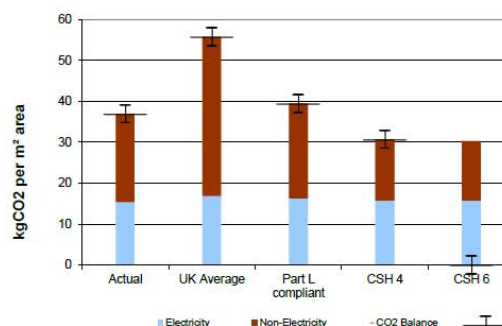
Figure 7:36: DomEARM results output dwelling D1.

The electrical consumption in dwelling D1 (Figure 7:36) indicates an actual consumption slightly lower than the benchmark data, the heating consumption is lower than the UK average and similar to the Part L Compliant predicted dwelling but greater than the Code for Sustainable Homes (CSH) benchmarks. However, the emissions indicate overall emissions to be between Part L and CSH benchmarks. Should the biomass boiler been functional then the emissions relating to space heating and hot water would have been lower.

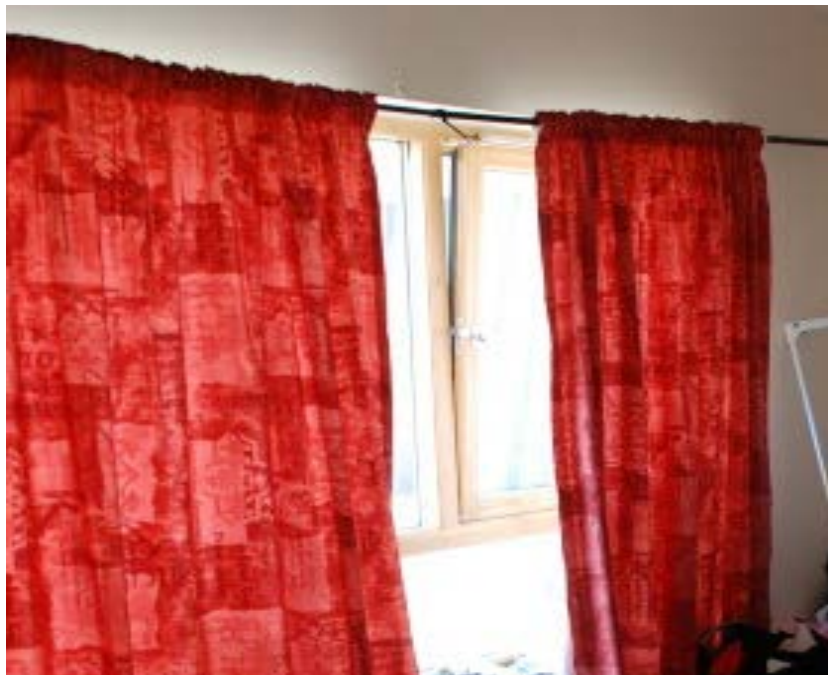
Conditions in the east bedroom were an improvement over the west facing bedroom, however there is normally one occupant in the room. Temperatures tend to be towards warm to hot with night time temperatures exceeding 24°C (the temperature at which sleep can be affected). Peak space temperature in this room was 27°C (winter), 29.6°C (spring), 30.8°C (summer) and 31.8°C (autumn) indicating occurrence of overheating throughout the year. In winter the high space temperature is indicative that heating set points are too high. In respect to air quality, CO₂ concentrations were poorest in winter despite the windows being constantly open Figure 7:40; this suggests the ventilation path is being obstructed, perhaps by closed curtains and the relatively small aperture of the window. The window sensor was removed from the window during the summer season.

Figure 7:40: East bedroom Dwelling A1 indicating extent of aperture when using 'tilt and turn' mode of operation.

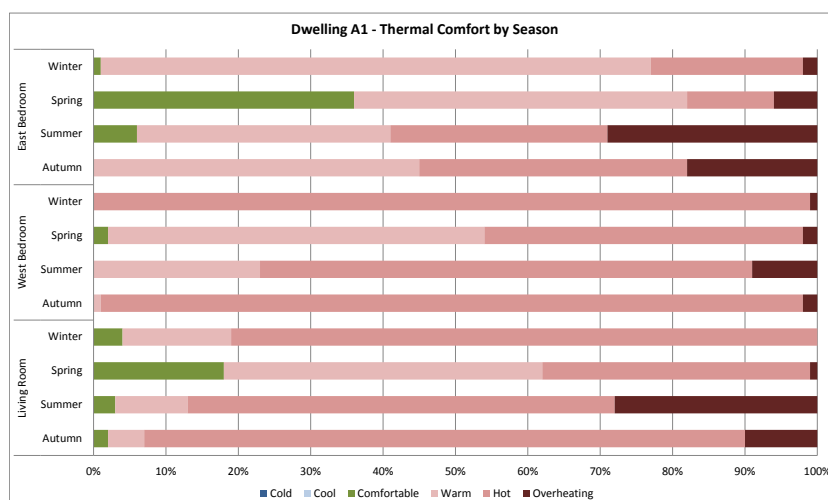
Figure 7:41: Temperature profile by season for dwelling A1.

In dwelling A1 the internal temperature conditions (Figure 7:41), CO₂ concentrations (Figure 7:42) and window opening patterns (Figure 7:43) indicate internal conditions vary considerably with season. Overheating is seen to occur year round (except living room in winter) and is more prevalent during the summer months, followed by autumn. During the summer living room space temperatures peaked at 33.8°C, some 10°C above summer comfort temperatures recommended by CIBSE. The living room temperature tends to exceed 23°C for most of the year with the longest period in the comfort range occurring in the spring. However, in this room, the indoor air quality through each season was below 1000ppm for more than 70% of each season. The windows are frequently opened which assist in dilution of CO₂, however, the separating door between the living room and the remainder of the ground floor is usually open to the hall, stair and kitchen, allowing migration of pollutants through the dwelling.

This figure indicates the dwelling is maintained at a temperature over 23°C for most of the year, with spring having temperature considered to be more inline with comfort conditions. Each room is overheating throughout the year. Warm temperatures can affect health and sleep patterns.

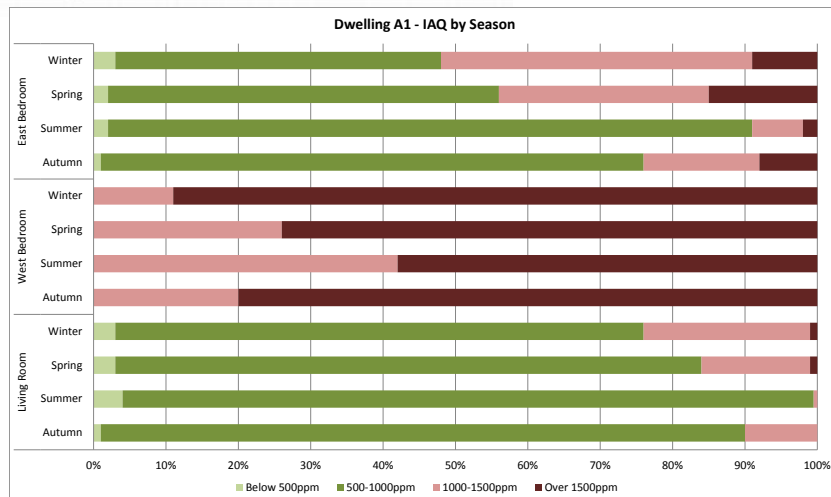
Figure 7:42: CO₂ concentrations by season – Dwelling A1.

The CO₂ concentrations provide an indication of ventilation rates, concentrations shown in pink and red indicate poor and very poor indoor air quality and corresponding low ventilation rates. While CO₂ at these levels are not known to be a threat to health it indicates poor ventilation regimes which allow contaminants such as VOCs, formaldehyde moisture, dust mites etc. to also remain in the property and potentially affect health.

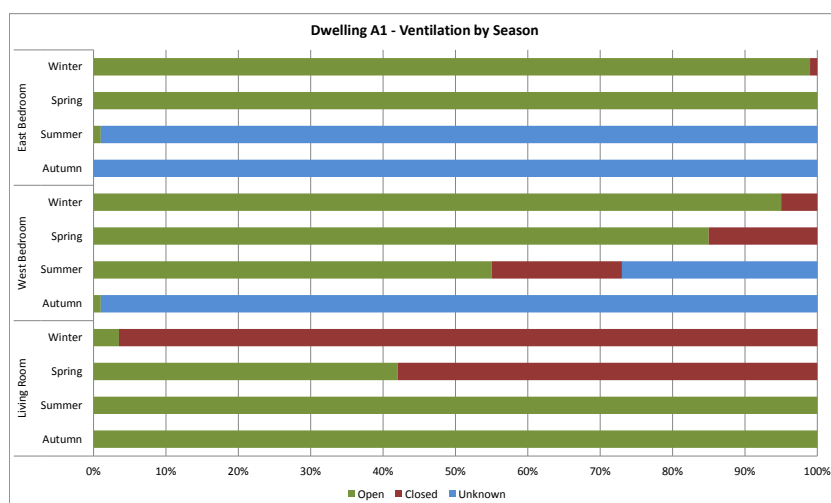
Figure 7:43: Annual window opening expressed as percentage – Dwelling A1.

This indicates the bedroom windows were frequently opened, until the removal of the sensors. However, the living room window opening increased through summer and autumn and was less frequent in winter and spring. The data also suggests the extent of window opening in the bedrooms during the heating season could impact on the gas usage and energy efficiency in the dwelling.

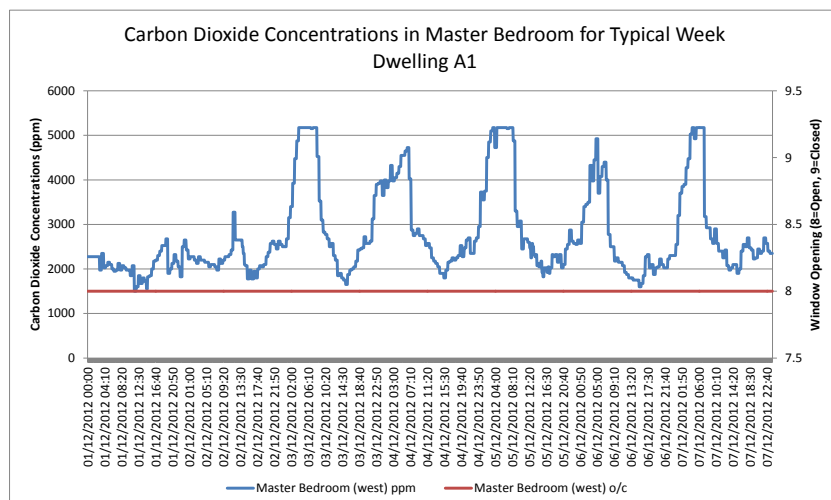
Figure 7:44: CO₂ concentrations in West Bedroom for a week Dec 2012.

The chart illustrated that although the window is open throughout the week the CO₂ concentrations do not fall below 1500ppm. Occupancy pattern is clearly identified where 5000ppm are exceeded on three occasions and concentrations exceed 4500ppm on two nights during this seven day period.

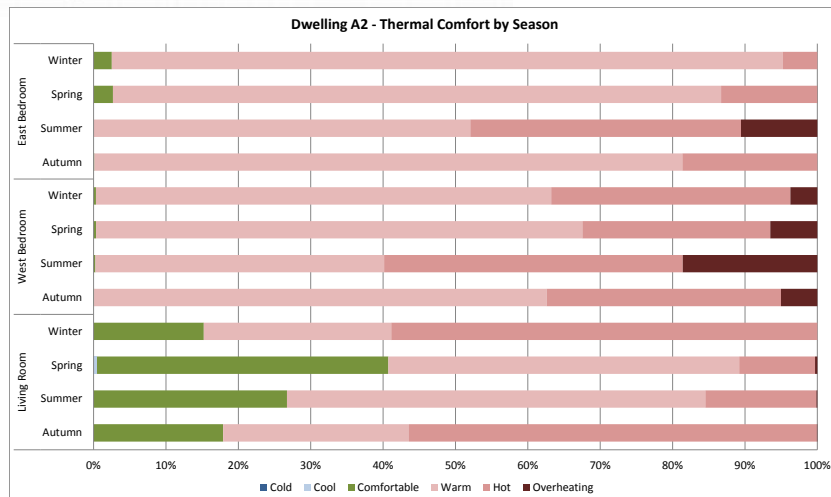
Figure 7:46: Temperature profile by season for dwelling A2.

The living room thermal comfort conditions (Figure 7:46) indicate that this room was not subject to overheating at any time through the year. However it was noted during springtime the temperature range was between 16.4 - 29°C. Although the cool periods were limited to times during the early hours of morning, this indicates the heating could be off at this time and the living room slowly cooled through the night. Spring temperatures are normally maintained between 21 - 25°C and exceeded 28°C for 0.3% of the season. Interestingly the temperature peaks all occurred between 17:00-18:30hrs on separate days; however this could indicate the effect of solar gains from the setting sun through the west facing glazed doors. The CO₂ concentrations appear to be below 1000ppm for around 70% of the year despite infrequent window opening.

This chart indicates the bedrooms are maintained at a temperature over 23°C for most of the year, with overheating occurring in the east bedroom during summer. The west facing bedroom indicates overheating during each season. There is a period through the year where the living room temperatures were lower than 23°C, this is more noticeable in spring, where there were also a few instances of temperatures between 16-18°C, these were found to be limited to overnight and early morning times.
