This document contains a Building Performance Evaluation report from the £8 million Building Performance Evaluation research programme funded by the Department of Business Innovation and Skills between 2010 and 2015. The report was originally published by InnovateUK and made available for public use via the building data exchange website hosted by InnovateUK until 2019. This website is now hosting the BPE reports as a research archive. Although no support or further information on the reports is available from the host, further information may be available from the original InnovateUK project evaluator using the link below¹.

| InnovateUK project number | 450073 |
| Project author | Glasgow School of Art, Mackintosh Environmental Architecture for Research Unit (MEARU) Architecture + Design Scotland |

| Eight | Milton of Leys, Inverness | Various (see p.13) | 2010 |

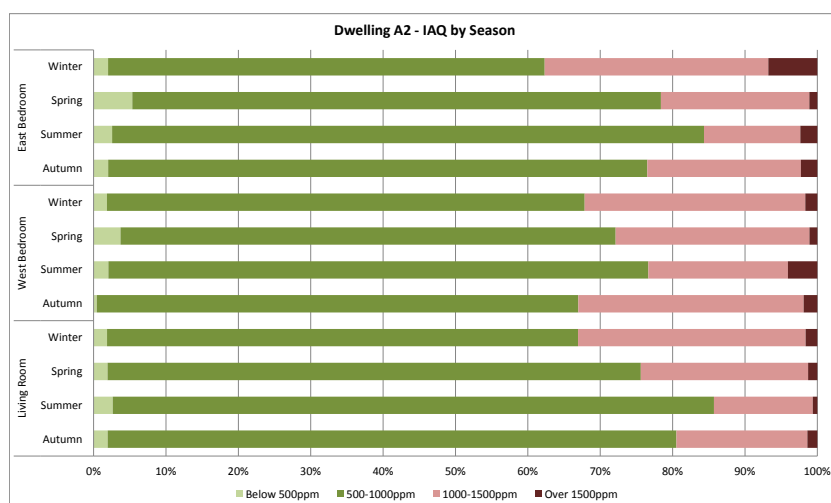
Figure 7:47: CO₂ concentrations by season – Dwelling A2.

The CO₂ concentrations provide an indication of ventilation rates, concentrations shown in green indicate good indoor air quality, the pink and red indicate poor indoor air quality and corresponding low ventilation rates. In this household there are few instances of high CO₂ concentrations.

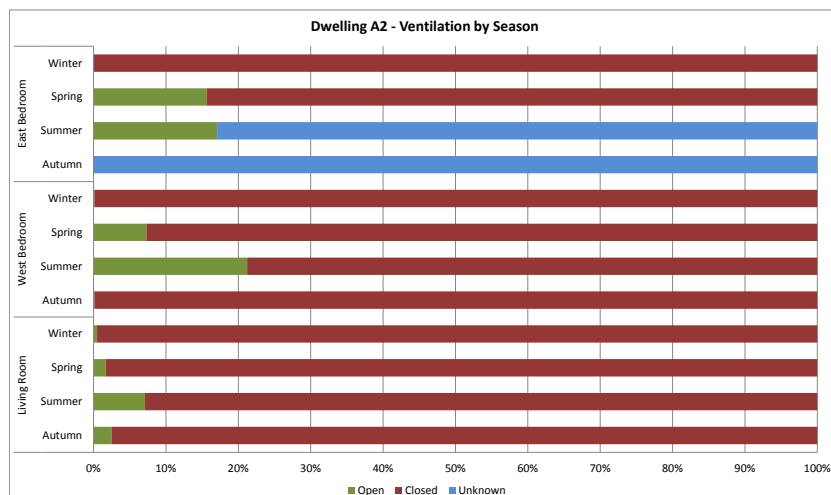
Figure 7:48: Annual window opening expressed as percentage – Dwelling A2.

The chart illustrates the windows are rarely opened during the winter and are opened more frequently during spring and summer. It would have been expected that windows, particularly in the living room would have been opened more frequently.

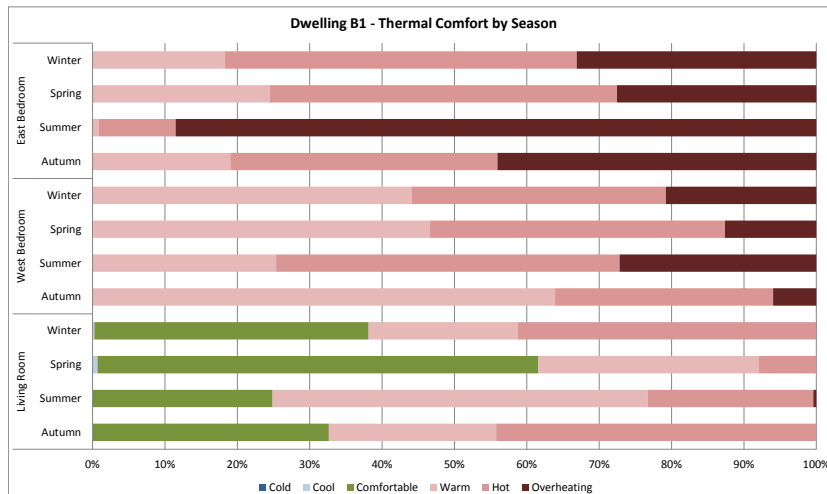
Figure 7:51: Temperature profile by season for dwelling B1.

In the east facing bedroom, the thermal comfort is consistently high with severe overheating occurring through the year. The concern here is the extent of overheating during the summer, even with the window constantly open. The research team observed that the windows are normally opened on the 'tilt' mode which clearly does not provide enough ventilation to reduce temperatures, and should be opened wider (if safe to do so) to assist with cooling.

In this dwelling, it was found that the thermostat in the hall was routinely set to 25°C and all TRVs were set to their maximum output.

This chart indicates the bedrooms are maintained at a temperature over 19°C all year with severe overheating in both bedrooms.

The living room temperature is more stable and cooler than the first floor of the dwelling.

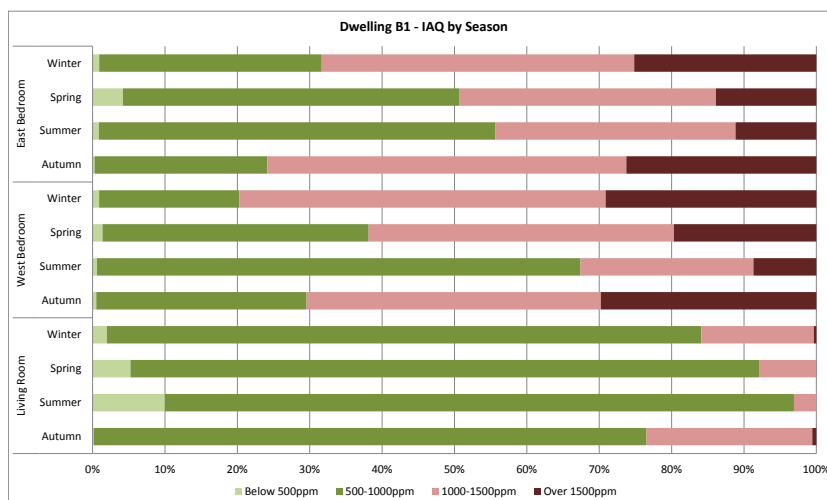
Figure 7:52: CO₂ concentrations by season – Dwelling B1.

The CO₂ concentrations provide an indication of ventilation rates, concentrations shown in green indicate good indoor air quality, the pink and red indicate poor indoor air quality and corresponding low ventilation rates.

Generally the living rooms conditions are acceptable, while the ventilation rates in the bedrooms could be improved upon to provide better indoor air quality.

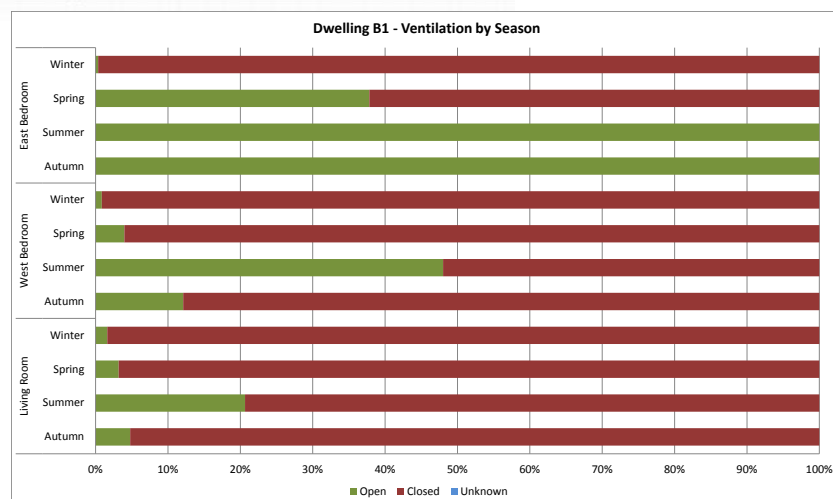
Figure 7:53: Annual window opening expressed as percentage – Dwelling B1.

The chart illustrates the windows are rarely opened in the living room. Bedroom windows are opened more frequently, more often in the east facing bedroom.

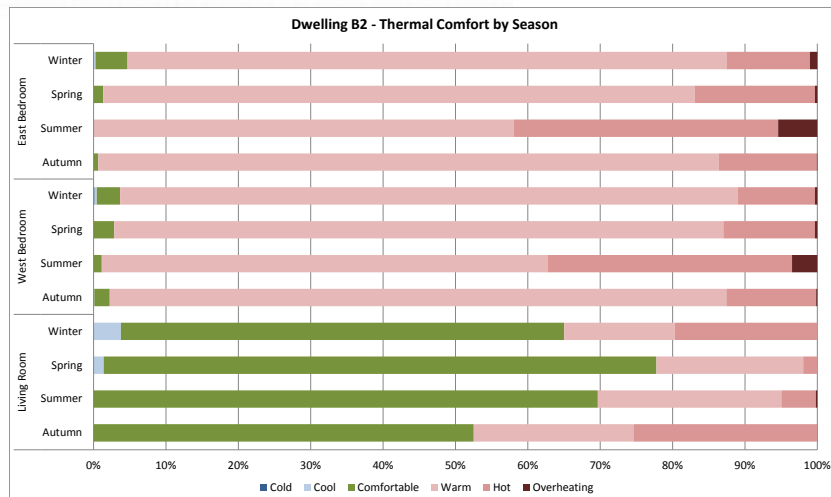
Figure 7:54: Temperature profile by season for dwelling B2.

This chart indicates the living room thermal comfort meets with the comfortable range (18-23°C) for most of the year. The bedrooms were maintained below 24°C for the majority of time, with warmer conditions and overheating during the summer period.

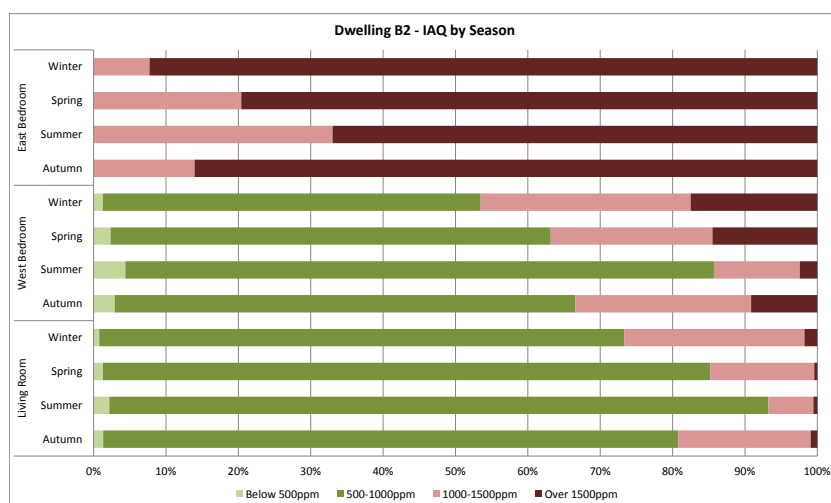
Figure 7:55: CO₂ concentrations by season – Dwelling B2.

Conditions in the east facing bedroom are concerning, while there are few instances of overheating and temperatures over 24°C the CO₂ concentrations were constantly above 1000ppm with a peak of 4825ppm in summer and 4775ppm for the remainder of the year. The casual window opening pattern was observed until the contact sensor was lost. In conversation with the occupants it transpired that the window was not opened due to a fear of spiders entering the room. The negative effects (poor sleep patterns, waking tired, lack of concentration and potential for dust mite population growth) of high CO₂ concentrations and the 'bad company' were explained to occupants, since this time the occupant reported the window opening has become more frequent, using the 'tilt' mode.

The CO₂ concentrations provide an indication of ventilation rates, concentrations shown in green indicate good indoor air quality, the pink and red indicate poor indoor air quality and corresponding low ventilation rates.

In this dwelling the living room and west facing bedroom both have acceptable CO₂ concentrations, however the conditions in the east facing bedroom are extremely poor.

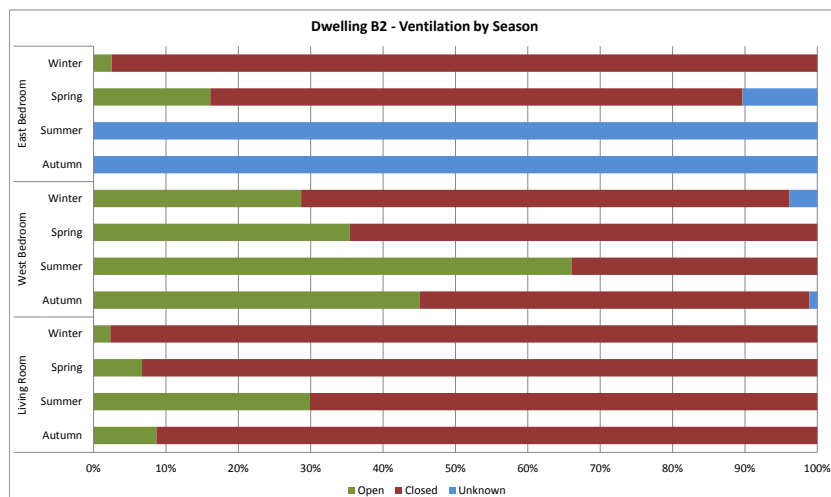
Figure 7:56: Annual window opening expressed as percentage – Dwelling B2.

The chart illustrates a clear window opening pattern in the living room and west bedroom where occupants' window opening increased as the external weather became warmer. However, the windows in the east bedroom were rarely opened and the contact sensor was removed during the spring.

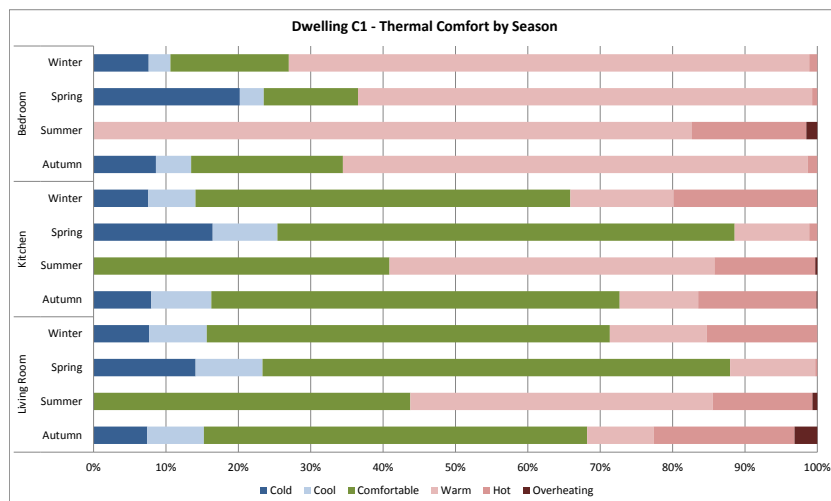
Figure 7:58: Temperature profile by season for dwelling C1.

The temperature profile (Figure 7:58) in this dwelling varies considerably through day and night. Internal space temperatures drop to below 16°C frequently when external temperatures are low and the heating is off. For the period analysed, the occupants heating preference was for use of their electric panel heaters as and when heating was required. This meant during colder periods the occupant woke up to and came home to a cold home. There are health effects of cold indoor environments, these include; condensation and mould growth and an increase in dust mite population on increase of air temperature. Internal space temperatures in the living room and kitchen were broadly similar given they are open to one another, however, some overheating occurred in the autumn in the living room and not in the kitchen. This could be due to solar gains through the large area of south facing glazing. The CO₂ concentrations (Figure 7:59) are relatively poor in the living room, but acceptable in the kitchen, despite lack of window opening (Figure 7:60) in both rooms.

This chart indicates periods through the year when the internal space temperature drops below 16°C, except during the summer. There are frequent periods in the living room and kitchen where the space temperature aligns with CIBSE temperature recommendations. However the bedroom is a little warm during the winter. Overheating is seen to occur in the bedroom and living room.

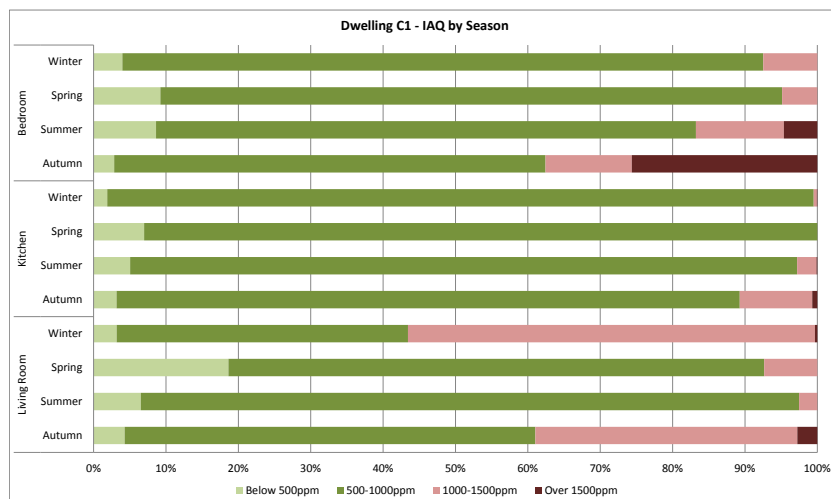
Figure 7:59: CO₂ concentrations by season – Dwelling C1.

The CO₂ concentrations provide an indication of ventilation rates, concentrations shown in green indicate good indoor air quality, the pink and red indicate poor indoor air quality and corresponding low ventilation rates.

For the majority of the year the CO₂ concentrations are acceptable, however, there is a period of time where the bedroom air quality in autumn has an extended period of poor air quality peaking at 4550ppm.

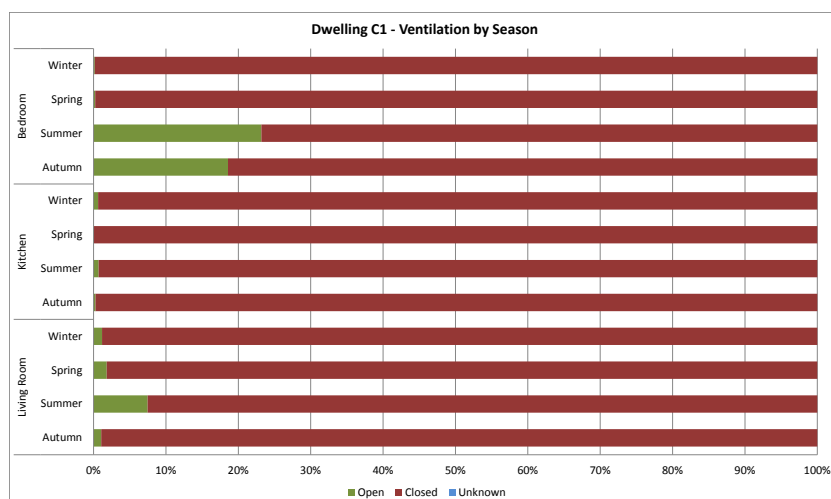
Figure 7:60: Annual window opening expressed as percentage – Dwelling C1.

The chart illustrates the windows are rarely opened during in the dwelling. Bedroom windows are opened more frequently during summer and autumn, living room windows are opened less often, however there is a clear pattern where summer window opening is greater than other seasons.

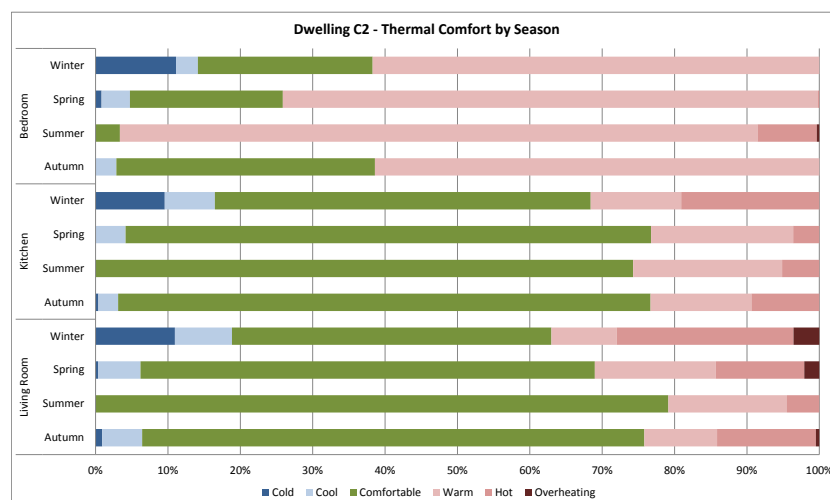
Figure 7:61: Temperature profile by season for dwelling C2.

This chart indicates extended periods where the living room and kitchen are at a comfortable temperature (18-23°C) while the bedroom is mostly heated to similar temperature (19-24°C) however this temperature is considered too warm for comfortable sleeping.

During the winter there are frequent instances when the internal space temperature drops below 16°C.

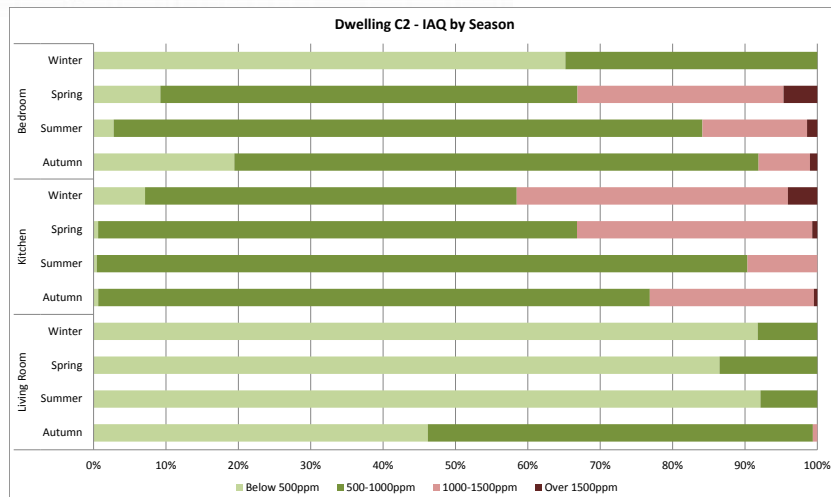
Figure 7:62: CO₂ concentrations by season – Dwelling C2.

The thermal comfort range in the kitchen is similar to the living room, cold during winter when heating is off and relatively warm when the heating is on. The summer conditions appear to have been comfortable for over 70% of the year. The indoor air quality (Figure 7:62) is sometimes reaches 1500ppm and borders on poor air quality during each season. This is surprising as the window is permanently open to allow an electrical extension cable to provide power to an external shed.

The CO₂ concentrations provide an indication of ventilation rates, concentrations shown in green indicate good indoor air quality, the pink and red indicate poor indoor air quality and corresponding low ventilation rates.

This dwelling demonstrates a relatively good indoor air quality in the living room, while the CO₂ concentrations are higher in the kitchen and bedroom.

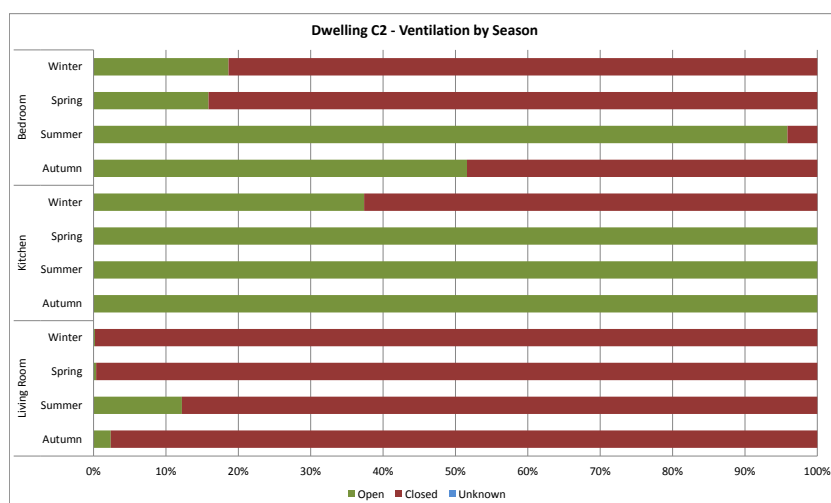
Figure 7:63: Annual window opening expressed as percentage – Dwelling A2.

The chart illustrates bedroom and living room windows are rarely opened during the winter and are opened more frequently during spring and summer. The kitchen windows indicate it is permanently open, through spring, summer and autumn and open around 38% of the time during winter.

However, it would have been expected that windows, particularly in the living room would have been opened more frequently.

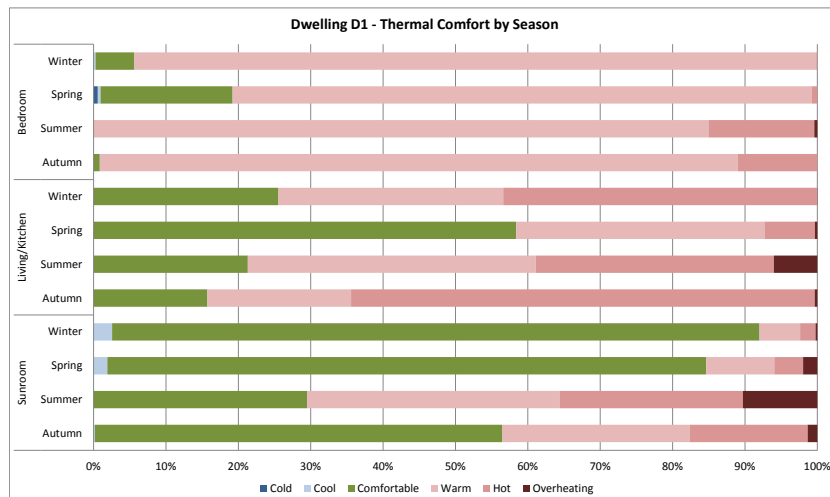
Figure 7:65: Temperature profile by season for dwelling D1.

In the bedroom, the space temperature is generally below 24°C for most of the year and overheating did not occur refer to Figure 7:65. However, indoor air quality (Figure 7:66) is compromised due to low airchange rates as a result of infrequent window opening (Figure 7:67). When conducting the exit interview (Chapter 5) the occupant had commented the biggest change they have made due to the project was opening the bedroom window at night, and felt the room was less stuffy.

This chart indicates the bedroom was maintained at a temperature between 19-24°C for most of the year, while both the living room and sunroom show relatively comfortable temperatures during the year and exhibit overheating in summer and spring (sunroom only). All rooms exhibit temperatures in the 'hot' category (23-28° living room and sunroom and 24-26°C bedroom) for long periods.

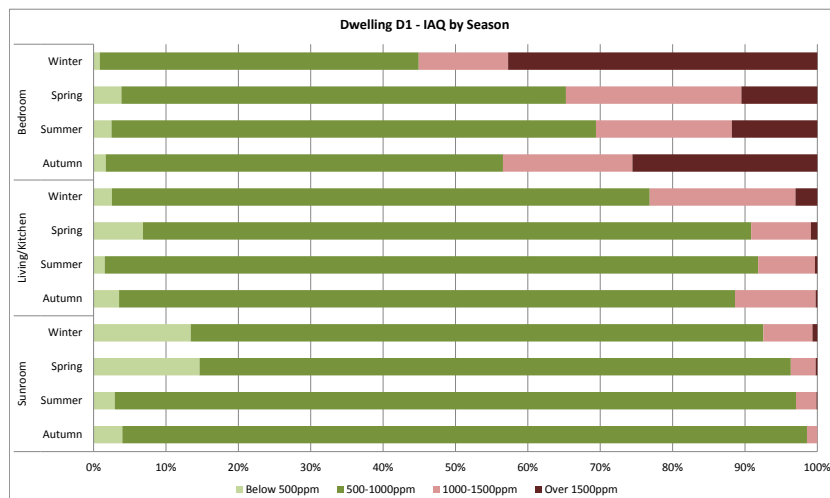
Figure 7:66: CO₂ concentrations by season – Dwelling D1.

The CO₂ concentrations provide an indication of ventilation rates, concentrations shown in green indicate good indoor air quality, the pink and red indicate poor indoor air quality and corresponding low ventilation rates.

The CO₂ concentrations in the living room and sunroom are predominately good through the year, while there are periods when the bedroom CO₂ levels rise considerably providing poor indoor air quality.

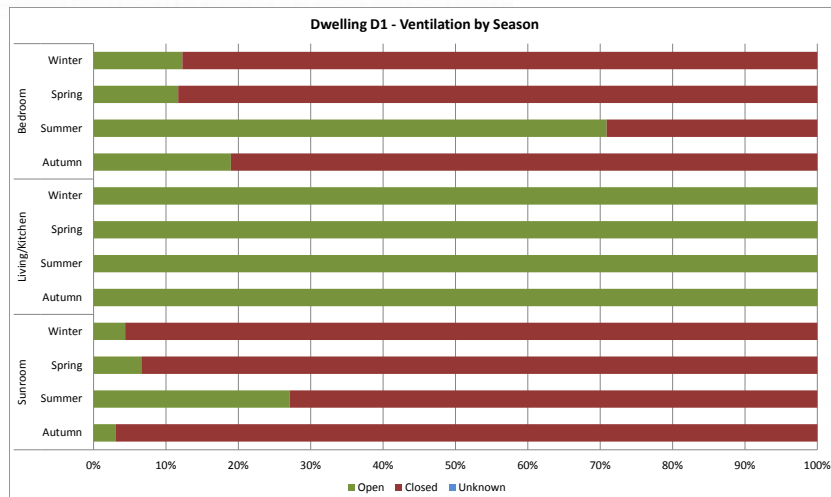
Figure 7:67: Annual window opening expressed as percentage – Dwelling D1.

The chart illustrates windows are opened more frequently during the summer. The bifold doors to the sunroom are constantly open to the living space.

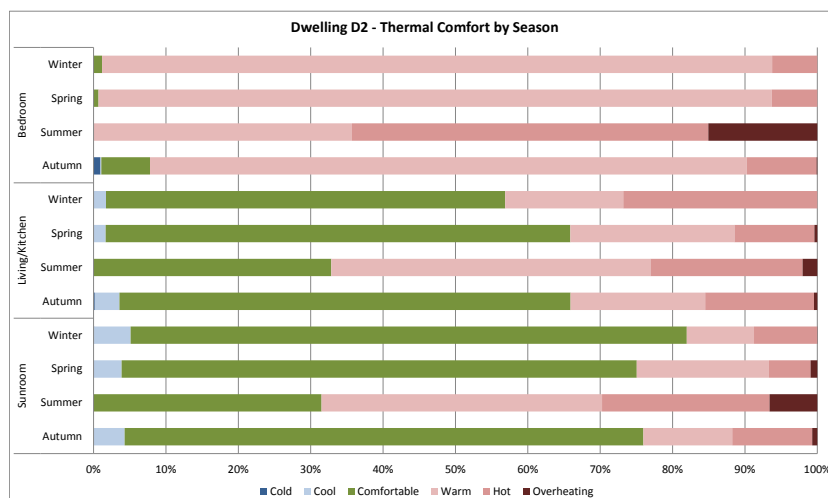
Figure 7:71: Temperature profile by season for dwelling D2.

This chart indicates the bedrooms are maintained at a temperature between 19-24°C for most of the year, except summer where temperatures that exceed 26°C were recorded. There are frequent periods of temperatures lower than 18°C in the living room and sunspace.

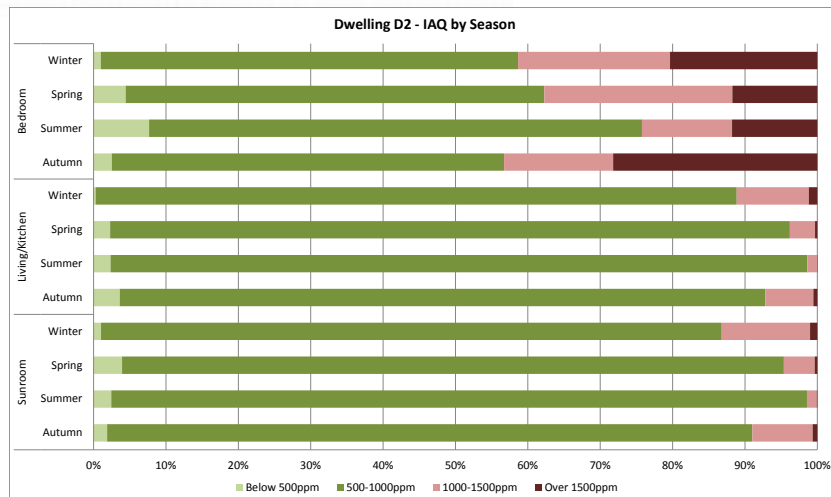
Figure 7:72: CO₂ concentrations by season – Dwelling D2.

The CO₂ concentrations in the living room and sunroom indicate good air quality, however, the bedroom concentrations tend to be high.

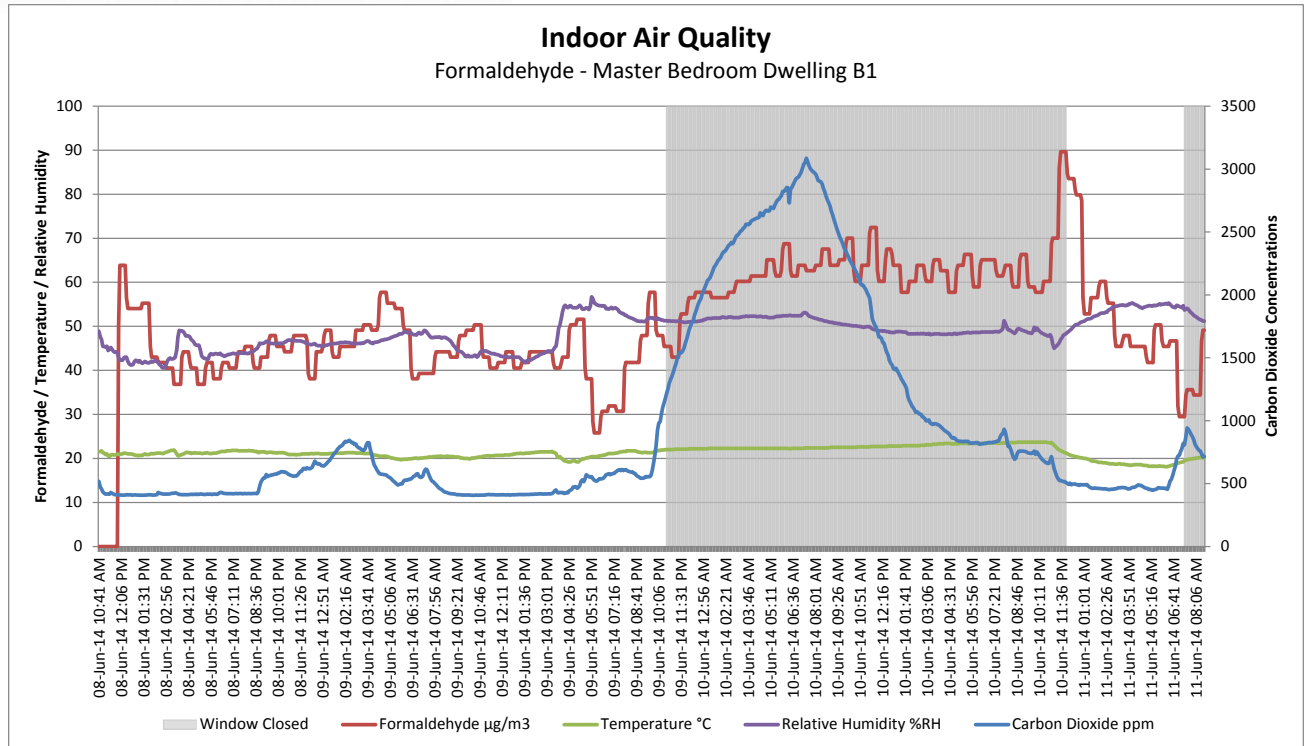
Figure 8:2 illustrates the monitored conditions in the master bedroom in dwelling B1, between 8th – 11th June 2014. The bedroom window was open during the day and the first night of the IAQ monitoring, on the second night the bedroom window was closed (indicated by grey shading). During the first night with windows open the CO_2 concentrations remained below 1000ppm. The formaldehyde concentrations also increased but lagged behind the rise in CO_2 . On the second night of monitoring the occupant closed the window at 22.35hrs for a 25 hour period, the CO_2 concentrations increased rapidly peaking at 3086ppm. The formaldehyde concentrations increased after the window was closed and the peak lagged behind the CO_2 , as before. However when the bedroom was vacated the chart illustrates a quick drop off in CO_2 levels however background levels of formaldehyde remained around $60\mu\text{g/m}^3$ (0.06mg/m^3) until the window was opened. Prior to the window being opened there was a rapid rise in formaldehyde concentrations.

Figure 8:2: Measured indoor air quality in master bedroom in dwelling B1.

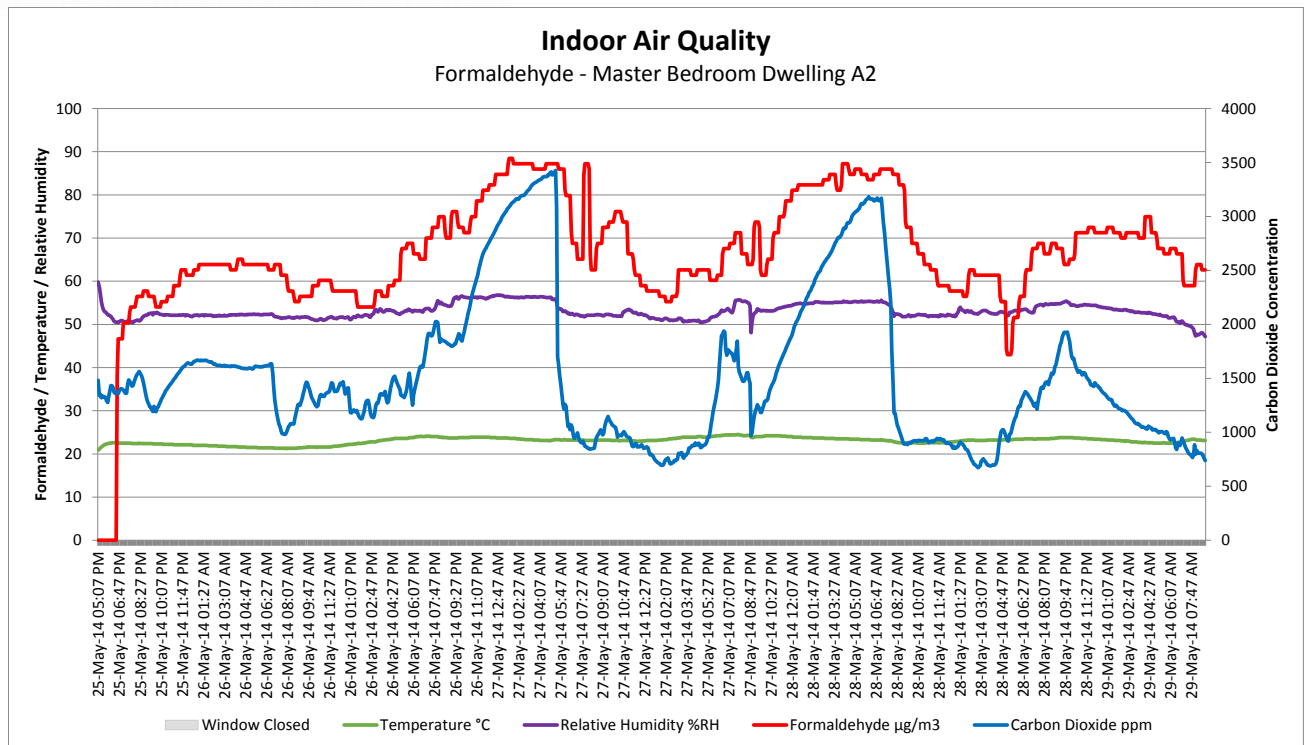
In dwelling A2, as with dwelling B1, formaldehyde levels increased as CO₂ concentrations increased, however the data indicated the bedroom window was open for the duration of the IAQ monitoring (Figure 8:3). The CO₂ concentrations were mostly over 1000ppm indicating that the natural ventilation air flow was insufficient to dilute the CO₂ and formaldehyde concentrations. However, the formaldehyde levels are seen to drop off when the room is unoccupied.

Figure 8:3: Measured indoor air quality in master bedroom in dwelling A2.

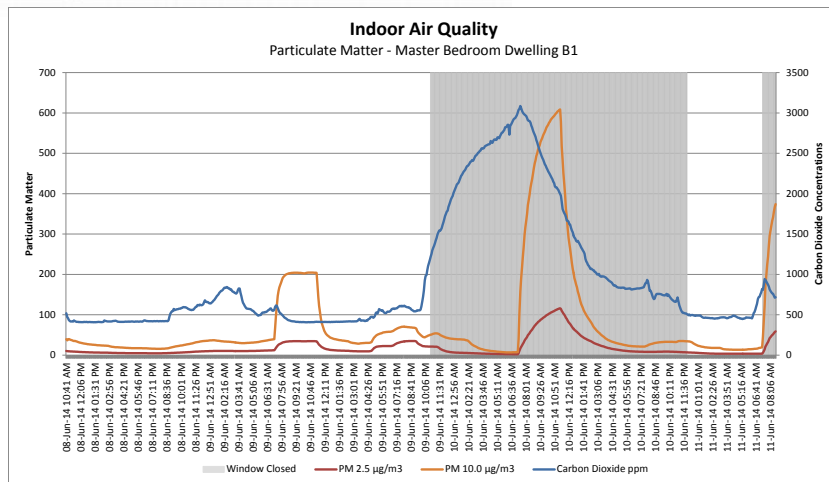
Figure 8:5: Measured indoor particulate matter and carbon dioxide concentrations in master bedroom in dwelling B1.

This room was initially monitored with the window open and then closed as indicated. The plot illustrates the particulate matter lags behind CO₂ concentrations, however the concentrations rise rapidly when the window was closed. PM₁₀ concentrations are greater than PM_{2.5}.

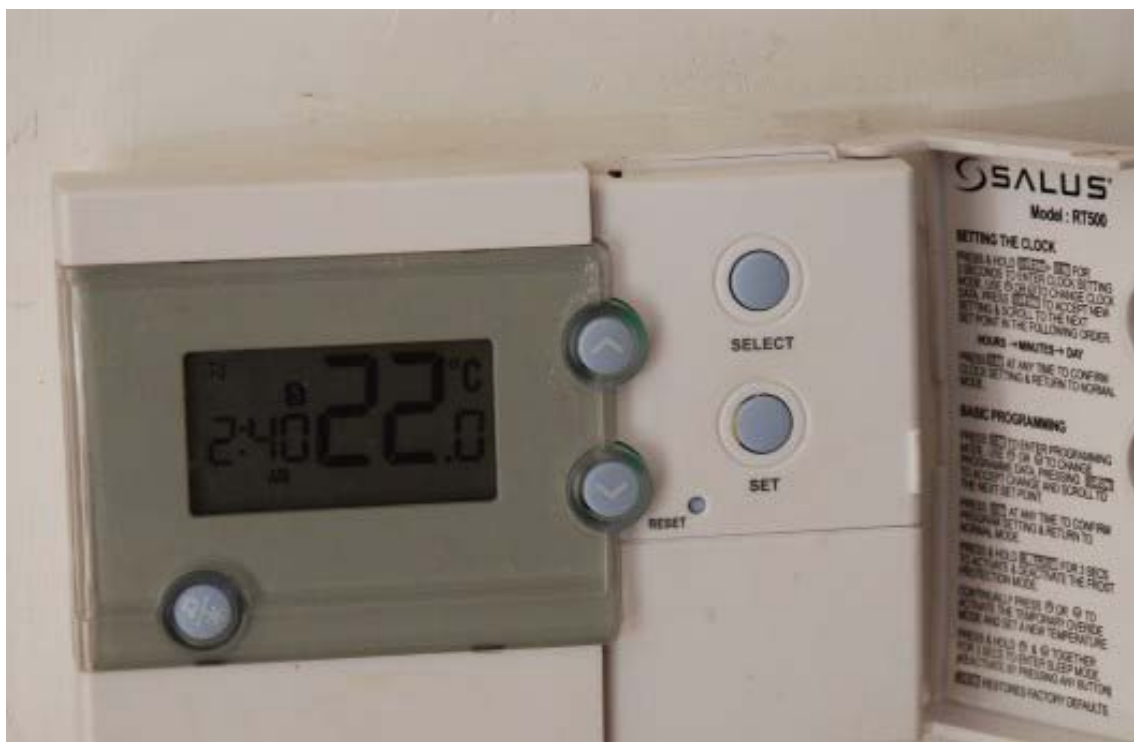
There was an example in one household (A1) where the occupants were adamant the setting of the programmer for underfloor heating was easy, however the day and time on the programmer clock were found to be set 12 hours ahead of the actual time, as illustrated in Figure 8:9.

Figure 8:9: Underfloor heating programmer with date and time incorrectly set Dwelling A1.

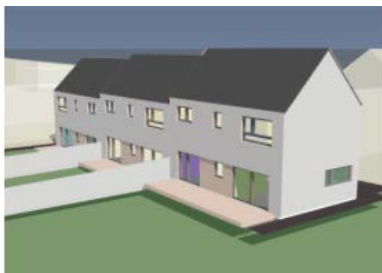
House Type A: The Shed House (terrace of 3 No. 4-bed 2 storey houses) for Cairn HA.

Occupants of both of these houses were more than satisfied with the quantity and quality of the accommodation that had been provided for these two large families. Neither used the upstairs bathroom much and preferred to use the downstairs shower room. This could be worth noting for two reasons -

1. The upstairs bathroom in both cases was pristine hardly used whereas both families had problems with condensation due to poor ventilation and (arguably) over-use of the downstairs shower room. The study confirmed that the shower room fan was inadequate and although replacement more powerful alternatives were supplied, these were reported to be unacceptably noisy and the method of control became an issue.
2. It is worth considering supplying a choice of two showers rather than a bath for large families to help with load sharing.

The rear gardens become saturated after wet weather and due to a lack of drainage remain waterlogged for extended periods. It appears that garden landscaping and drainage was compromised by the 'value engineering' process.

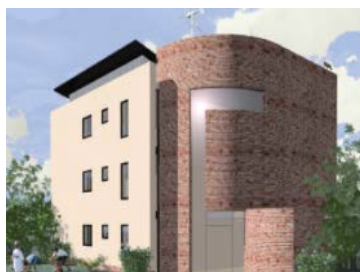
House Type D: The Apartments: (3 storey block of 6 no. 2-bedroom flats). Shared ownership with Albyn HS.

Both sets of occupants noted impact noise transfer issues from the upper floors, this has caused some tension between individual flat owners in the block. During the thermography undertaken during the second airtightness testing it appeared there may be a lack of sound insulation in the separating ceiling. However, due to warm external temperatures the required temperature difference between inside and outside was not achieved and therefore it was unable to be confirmed; further investigations and sound impact testing are required. The research team were concerned this type of testing was outside the scope of BPE funding and due to anxiety and ill-health that can be caused by noise transfer, the research team hope to secure funding from another means to investigate the noise issues experienced by the residents.
