Seager Distillery Housing

Innovate UK project number	450102
Project author	AECOM for Galliard Homes
Report date	2014
¹InnovateUK Evaluator	N/A

No of dwellings 20 (3 detailed, 9 in less detail)	Location Deptford, London	Type Apartments	Constructed 2011
Apartment area Various: 35 - 74 m ²	Construction form Reinforced concrete	Space heating targets Various (see SAP analyses)	Certification level Building Regulations, 2006

Background to evaluation

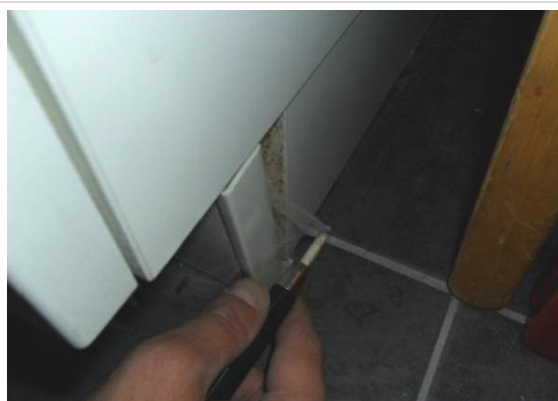
b) Penetration under the sink in kitchen

The smoke tests were carried out around the three flats at the same time as the initial air tightness tests. They revealed some sources of air leakage (see Figure 3.1 for some examples). The most significant air penetrations identified were as follows.

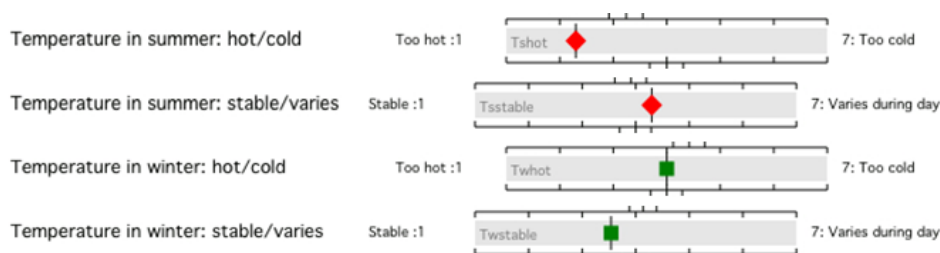
Figure 5.2 shows the more detailed results for the space temperature. Interestingly, whilst the overall temperature in summer was amber the individual space temperatures results in summer were red. The results suggest that the occupants perceived the flats to be too hot which aligns with the temperature measurements during the first summer in the three most detailed apartments. We note in Section 6 that the MVHR units do not appear to have a summer bypass capability and the ventilation rates were lower than designed. See also comments below regarding the control of cooling.

The variability in temperature was also red, although we do note that the results are still relatively close to the average of the scale and only just above both the upper range of benchmark data and what is judged to be acceptable. In contrast, space temperatures in winter appear to be relatively comfortable overall.

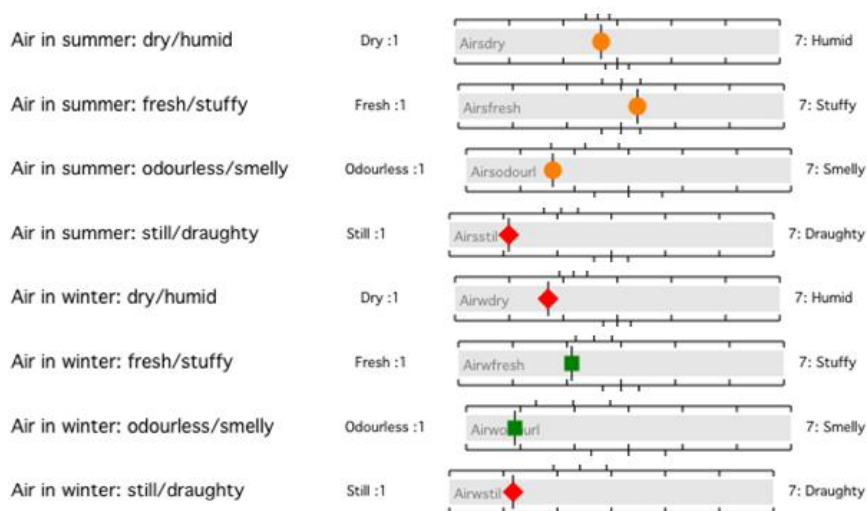
The survey of air conditions is shown in Figure 5.3. The occupants particularly rate their airflow as being still in summer and winter as well as the air being quite dry during the winter. We note in Section 6 that the mechanical ventilation systems in the flats tested delivered lower flow rates than recommended by Part F of the Building Regulations which may contribute to these ratings.

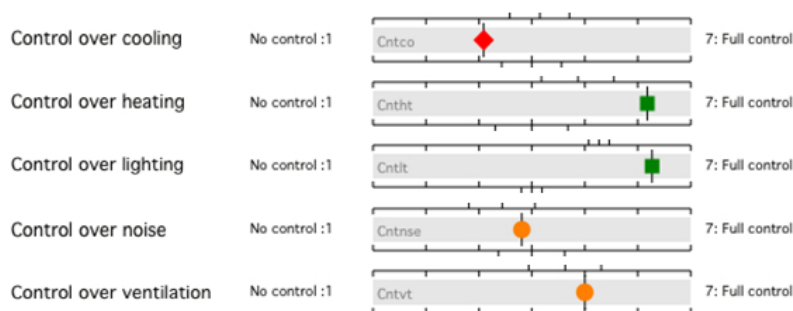
Figure 5.6 shows occupant's perception of their control over the environment. In particular, it suggests that residents have insufficient control of cooling. This response may well link to the previous feedback on overheating during the summer. More so, it may link to issues raised on external noise and residents may be unwilling to leave windows open. It is not fully why the other responses are amber. In particular, there is an amber rating as a result of residents having a high-level of control over their ventilation.

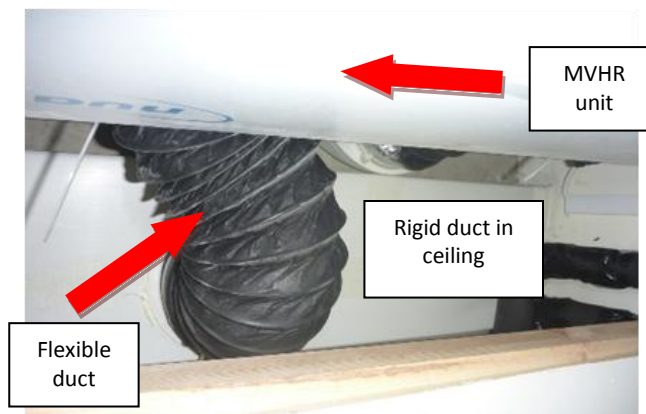
- All MVHR boxes were installed too high into the false ceiling to allow the full use of rigid ducting. Flexible ducts were required for ease of installation between the four spigots on the MVHR box and the rigid ducting in the false ceiling. This is shown in Figure 6.2 and is consistent with as-installed drawings for all the flats surveyed. Flexible ducting was also used to connect to the supply and extract terminals. Whilst the use of flexible ducting in these cases is acceptable, we were not able to view the ceiling voids to confirm that rigid ducting was used throughout the rest of the system (although we could see that the flexible ducting from the spigots did connect into rigid ducting in the ceiling void).

Figure 6.2: Flexible duct used to connect the MVHR spigots to the rigid ducts in the false ceiling (the photo was taken looking upwards)

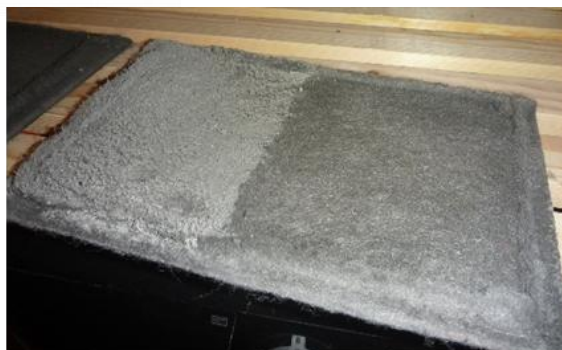
- We reviewed the filter in Flat 1 and this does not appear to have been changed or cleaned since the start of occupancy as the filters were quite dirty (see Figure 6.5). We do note that Flat 2 has had its filter changed as they reported problems with their ventilation system.

Figure 6.5: The MVHR extract side filter showing the difference between before and after cleaning, illustrating the extent of dust clogging up the MVHR at the time of the survey.

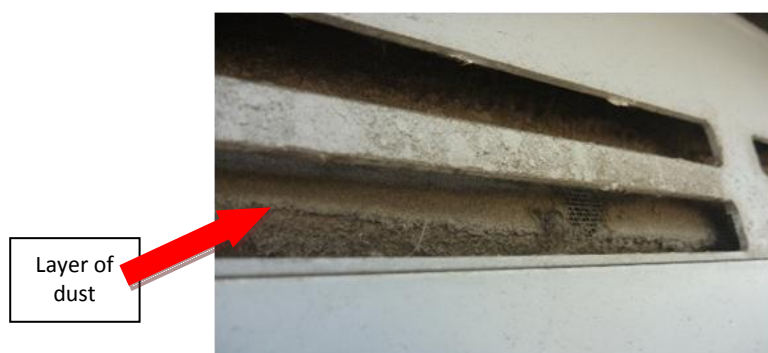
- Inlet and outlet grilles on the external side wall were observed to be generally clogged up with dust. The location of the grilles does not appear to allow easy access for cleaning. For some flats, the grilles are placed on the side of the flat where access is only through the use of a cherry picker, whilst others have the grilles on the balcony side, which will facilitate access to the grilles. Furthermore, it appears difficult to remove the insect grille mesh for cleaning. Please see Figure 6.6.

Figure 6.6: The MVHR inlet grille insect mesh heavily clogged up with dust. There is no clear way to remove the mesh for cleaning apart from via vacuum cleaning

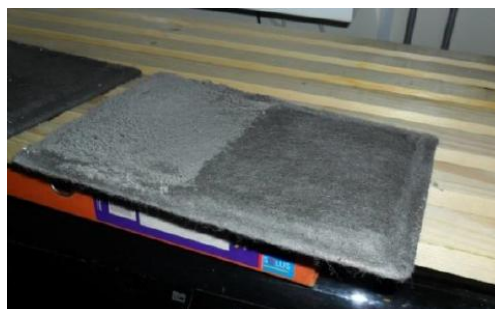
This test took place on 22nd July 2013. Figure 6.7 shows the “as-found” condition of the two filters. The filter on the right filters the extract air from the flat, where it was heavily clogged up with dust. The cleaner filter on the left filters the intake air from outside. Figure 6.8 shows the impact of partially cleaning the extract filter using a vacuum cleaner on-site. The extract filter was fully cleaned with the vacuum cleaner for the “clean” test. To carry out a simulated blocked filter, tape was wrapped around half of each of the filters to achieve a “50% blocked filter” test (see Figure 6.9).

Figure 6.8: The extract side filter partially cleaned to illustrate the before-after change

Table 6.1 summarises the test results under the three different test conditions. The extract flow rates, in particular, significantly increase with the extract filter cleaned. There is a smaller reduction with 50% of the filter blocked. Given the significant difference between the “50% blocked filter” and the “as-found” results, it does question how well the “50% blocked filter” test represents a dirty filter. The normal supply rate approximately achieves the commissioning data for all three tests. The clean and 50% block filter extract overall achieve the commissioning data results and the clean filter approached the boost commissioning results. This does suggest that with new filters, the results may well achieve the commissioning test data.

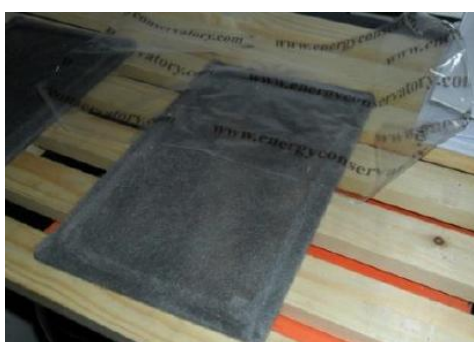
Figure 6.9: Tape being placed across 50% of the filter to simulate a 50% blocked filter

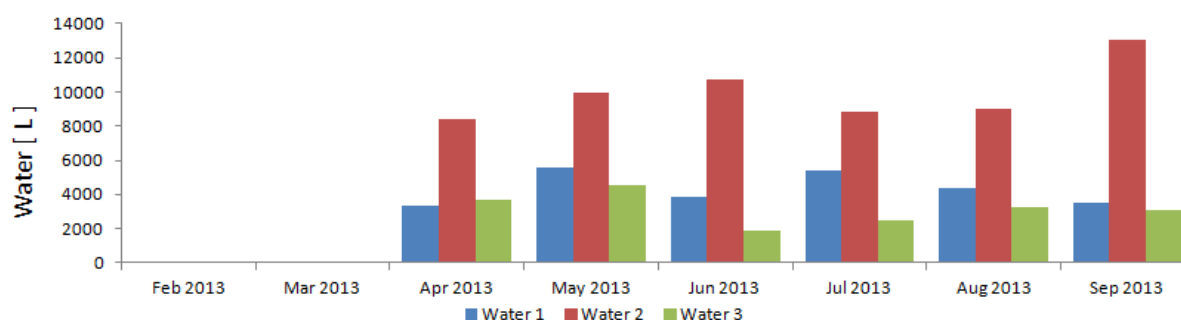
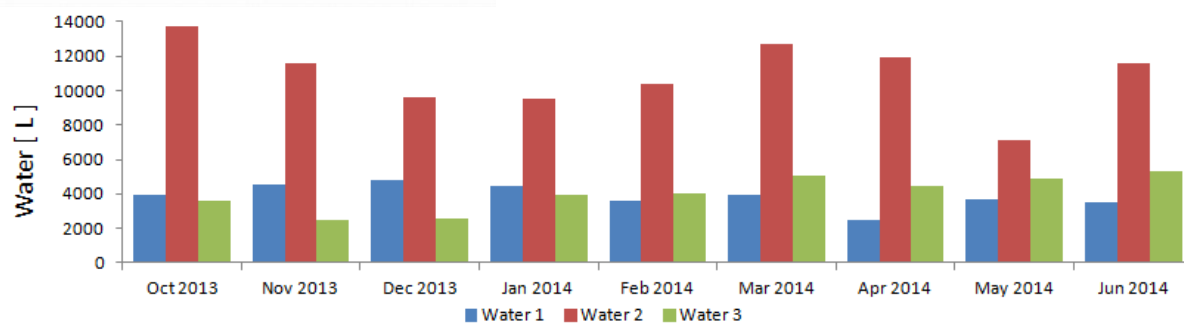
Figure 7.9a: Monthly water consumption (L) April 2013 to 30th September 2013

Figure 7.9 shows the monthly total water consumption in each of the three flats. Data collection started 5th April 2013. The water consumption of the three flats also showed significantly higher results for Flat 2 and is possibly explained by the frequent and long use of showers by the lodger as included in the heat consumption discussion above. It is also noted that there was only one occupant in Flat 3 during much of the study and it is plausible that the results from Flat 1 are relatively low to make Flat 2 appear high. To provide a wider comparison, the average consumption in Flat 2 was determined as 183 litres per person per day. By comparison, Part G 2010 of the Building Regulations subsequently set a requirement of 125 litres per day per person determined using the Government's water calculator.

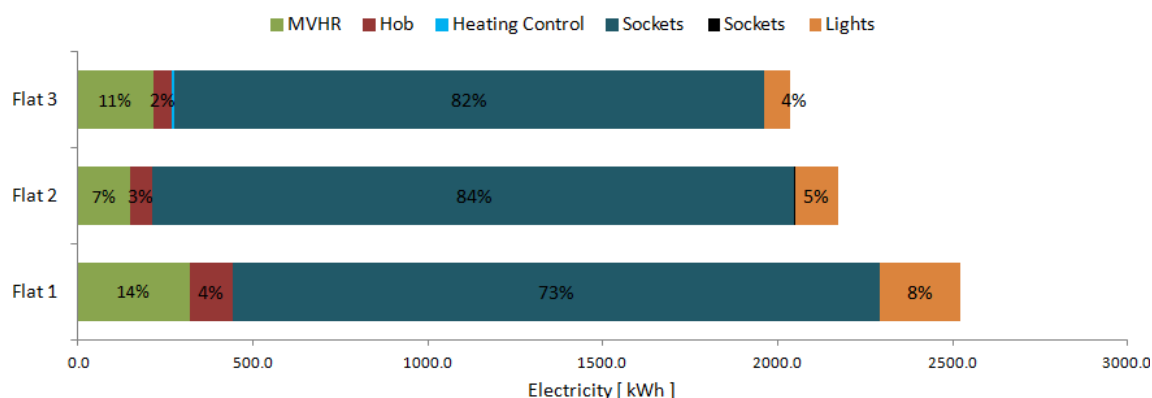
Figure 7.10: The comparison of total electricity consumption between the three Flats and their respective split in sub-metered uses for 13th March 2013 to 30th June 2014

Figure 7.10 shows the total electricity consumption for the three flats and their breakdown of the percentage energy use between each end-use category. Overall, Flat 1 consumed the most and Flat 3 the least during the study. Consistently, the sockets use the most energy followed by the MVHR unit.

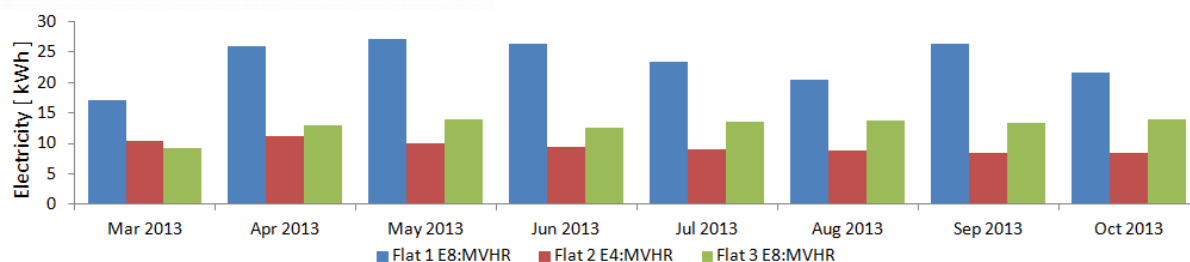
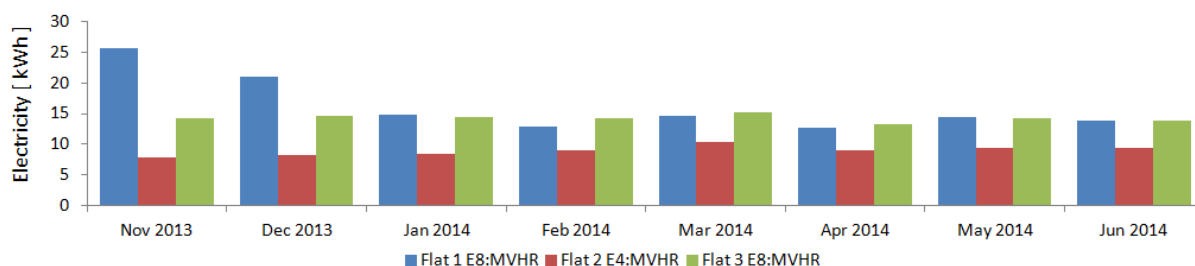
Figure 7.11a: Monthly MVHR electricity use for the three Flats for 13th March to 30th September 2013

Figure 7.11 shows the monthly MVHR electricity consumption for the flats. Flat 1 exhibits the highest MVHR energy use.

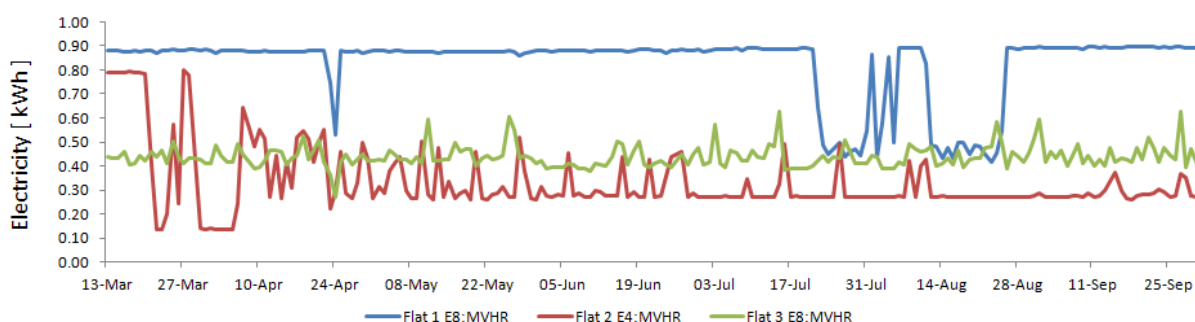
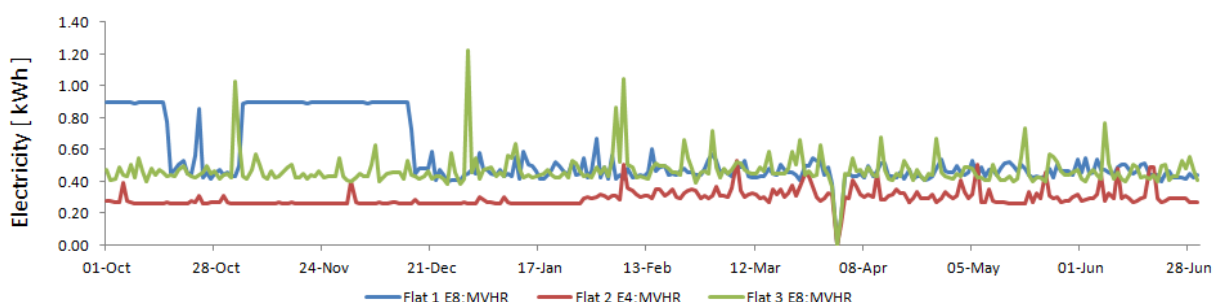
Figure 7.12a: MVHR daily electricity use for the three Flats for 13th March to 30th September 2013

Figure 7.12 shows the daily total electricity use on the MVHR circuit for the three flats for 13th March 2013 to 30th June 2014. It shows a relatively constant, but higher electricity use by the MVHR unit in Flat 1 compared to Flat 2 and Flat 3 during 2013. Furthermore, the results from Section 6 suggest under boost Flat 1 should use 0.87 kWh per day which is approximately that shown in the figure.

During a site visit on 22 July 2013, it was established that the occupant in Flat 1 has unknowingly had the MVHR set to boost continuously. The boost was set back to normal rate. However, the collected data does suggest that the MVHR was left continuously at boost rate for much of the period until towards the end of December 2013, at which point the boost rate was used intermittently.

Flats 2 and 3 do show variations over time. Based on the results in Section 6, the normal flow rates should result in a daily energy use of 0.28 kWh and 0.38 kWh respectively which is approximately what is shown here. The fluctuations can reasonably be expected to reflect the use of boost intermittently.

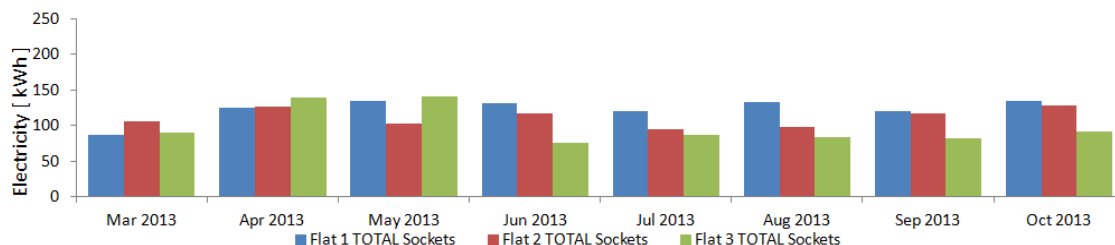
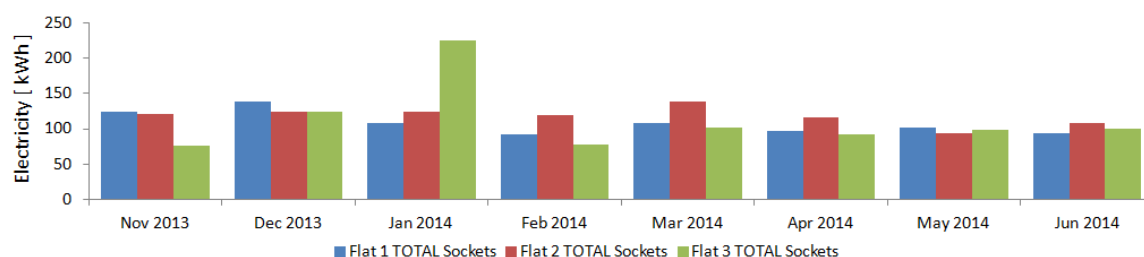
Figure 7.13a: Monthly socket electricity use for the three Flats for 13th March to 30th September 2013

- All flats had similar monthly consumption via sockets. As part of the mid-point discussions, Flat 3 noted the subsequent use of two electric de-humidifiers to remove moisture after a leak through the roof in December 2013. This may explain the particularly elevated socket consumption in January 2014.
- Flat 1 consistently consumed the most electricity amongst the three flats for lighting, with Flat 3 typically the least. This may be explained by feedback during the walkthrough and interview with the occupants of Flats 2 and 3. The occupants expressed preference for standalone lighting, which uses

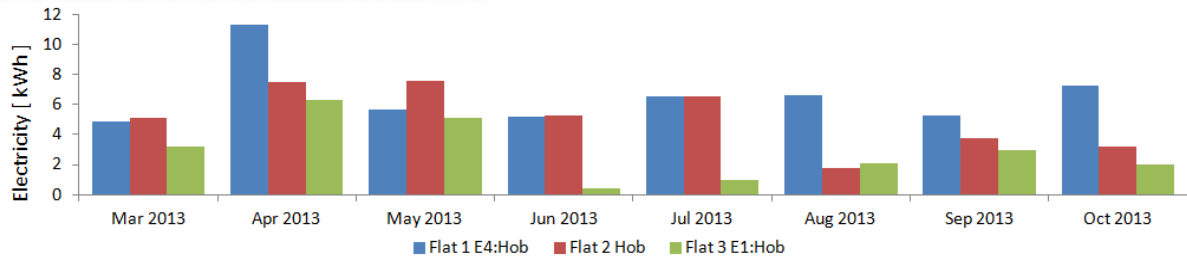
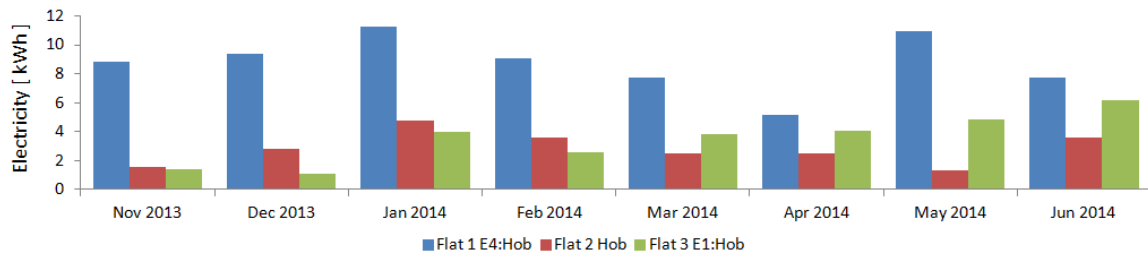
Figure 7.15a: Monthly cooker electricity use for the three Flats for 13th March to 30th September 2013

- Flat 1 tended to use the larger amount of electricity for cooking. This could be explained by the shift working patterns of one of the occupants in this flat and hence the occupants having meals at different times resulting in more frequent and potentially greater use of the cooker.

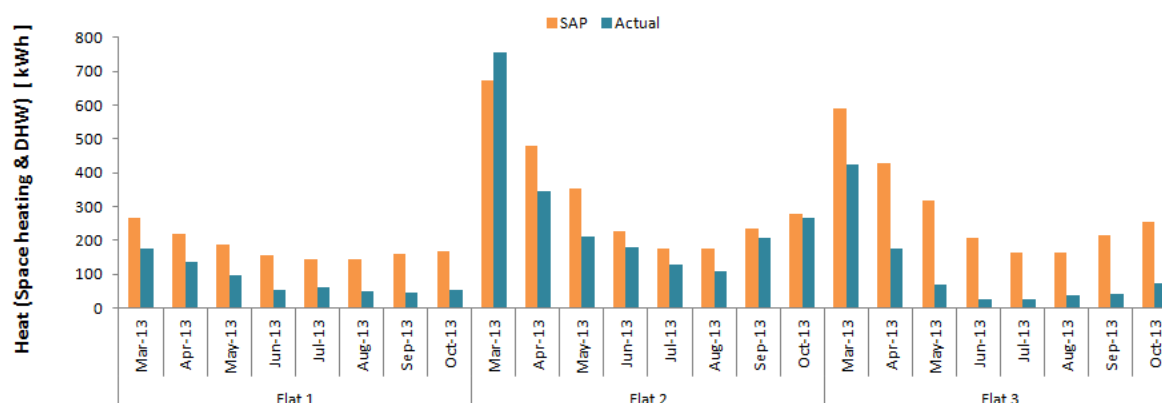
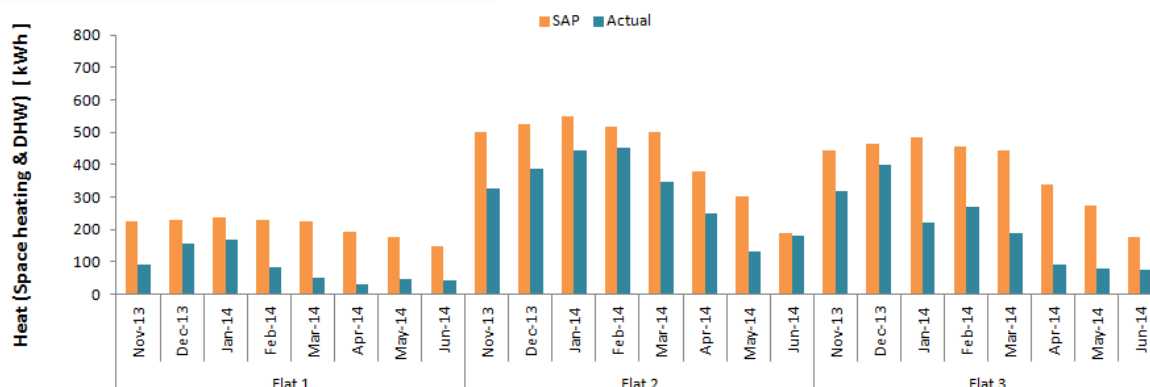
Figure 7.16a: SAP and actual heating energy use for the three flats for March to September 2013

Figure 7.16 shows the comparison of heat energy consumption for space heating and hot water in the three flats.

- The results show the significant lower heat usage of the mid-floor Flat 1 vs the top-floor Flat 2 and Flat 3.
- The adjusted SAP data tends to over-predict actual consumption. Key explanations could be that both the actual air tightness and observed ventilation rates are less than assumed by the SAP assessment and this would tend to reduce the heat load in the flats. A further contribution is that there were additional heat gains arising from the distribution system heat losses from the district heating system (see Section 7.6).

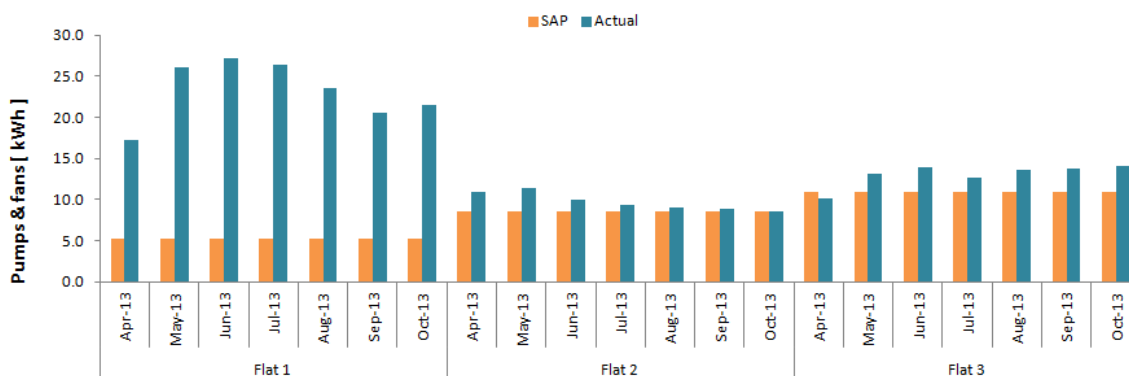
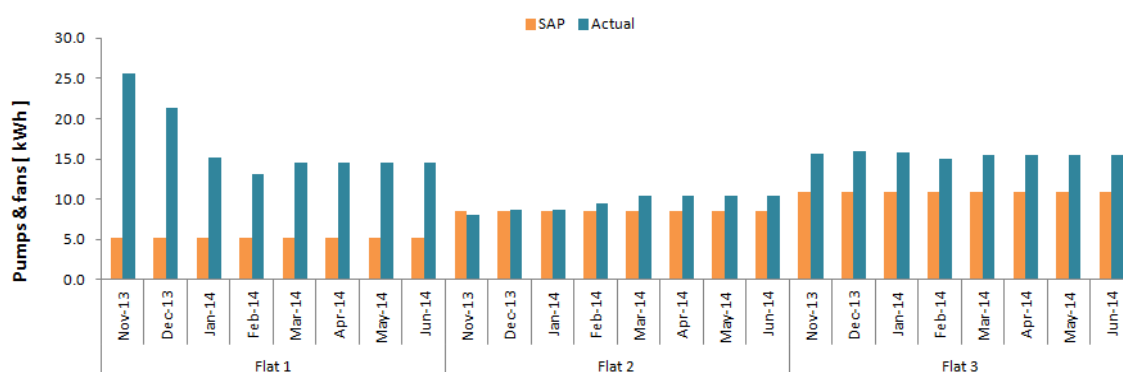
Figure 7.17a: SAP and actual fans and pumps energy use for the three Flats for March to September 2013

Figure 7.17 shows the energy use for fans and pumps in the flats. The actual consumption is consistently higher than predicted by SAP.

- In particular the results for Flat 1 are significantly higher than the SAP prediction. One key reason is the use of MVHR on boost setting (impact estimated of around 9 kWh per month from data in Section 6) and hence the difference reduces at the start of 2014. Another key reason is that even at normal use the MVHR energy use is higher than predicted as the actual flow rate is similar to that recommended in Part F whilst the SFP is over 100% higher than that included in SAP.
- Given that all actual SFPs were 120-130% higher than assumed in SAP, it may be expected that the actual energy use would be significantly higher than predicted by SAP. It may well be that the higher SFP are balanced at least to some degree by the fact that the ventilation rates were lower for Flat 2 and Flat 3 than recommended by Part F.

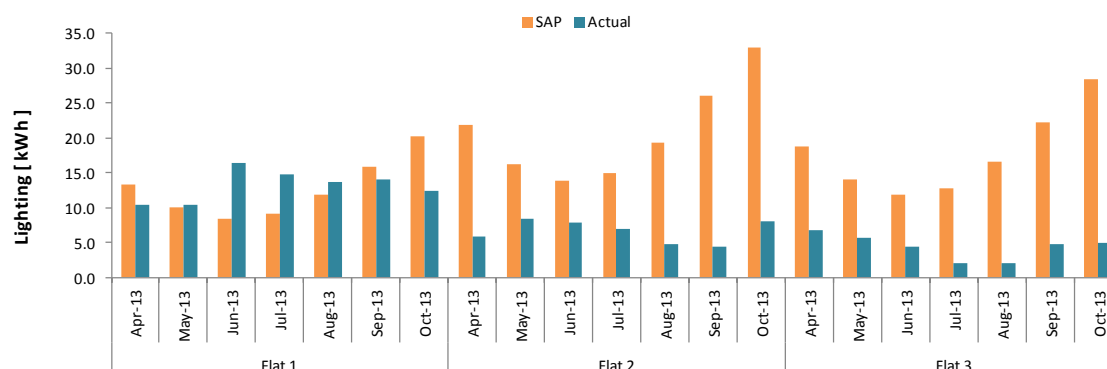
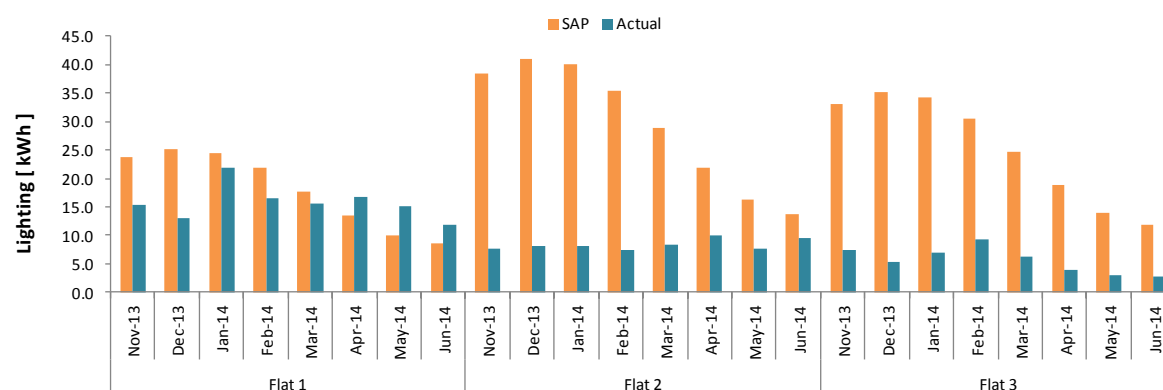
Figure 7.18a: SAP and actual Lighting energy use for the three Flats for March to September 2013

Figure 7.18 shows the lighting for the flats. Flat 1 demonstrated a more comparable usage with SAP prediction. However, Flat 2 and Flat 3 used significant less lighting than predicted by SAP. This may be explained by feedback during the walkthrough and interview with the occupants of Flats 2 and 3. The occupants expressed preference for standalone lighting, which uses power from the wall sockets. This reduces the need, and thus energy consumption, for ceiling lights which are on the lighting circuit. It was also noted during the final meeting with Galliard Homes that 100% low energy lighting was installed which is greater than that assumed in SAP.
