South Place Hotel

Innovate UK project number	450112
Project lead and author	Hoare Lea and Partners Ltd.
Report date	2015
InnovateUK Evaluator	Robert Cohen (Contact via www.bpe-specialists.org.uk)

Building sector	Location	Form of contract	Opened
Hotels	London	Design and build	2012
Floor area (NIA)	Storeys	EPC / DEC	BREEAM rating

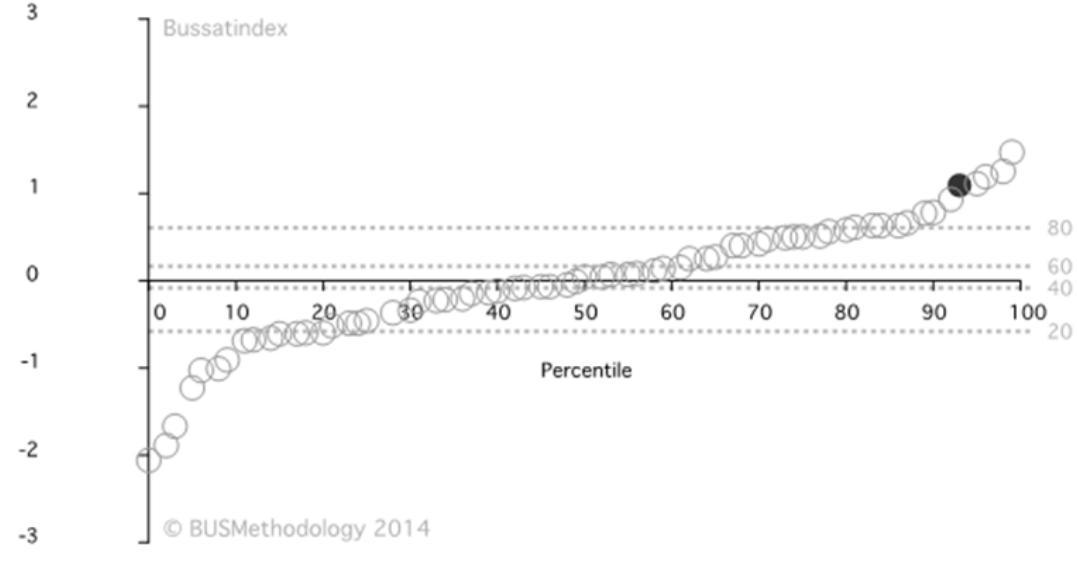
Figure 1.1 – Staff satisfaction survey: overall satisfaction (BUS surveys): the analysis shows that the hotel is rated among the top 10% 'overall satisfaction' performers, when compared to the BUS database of similar buildings.

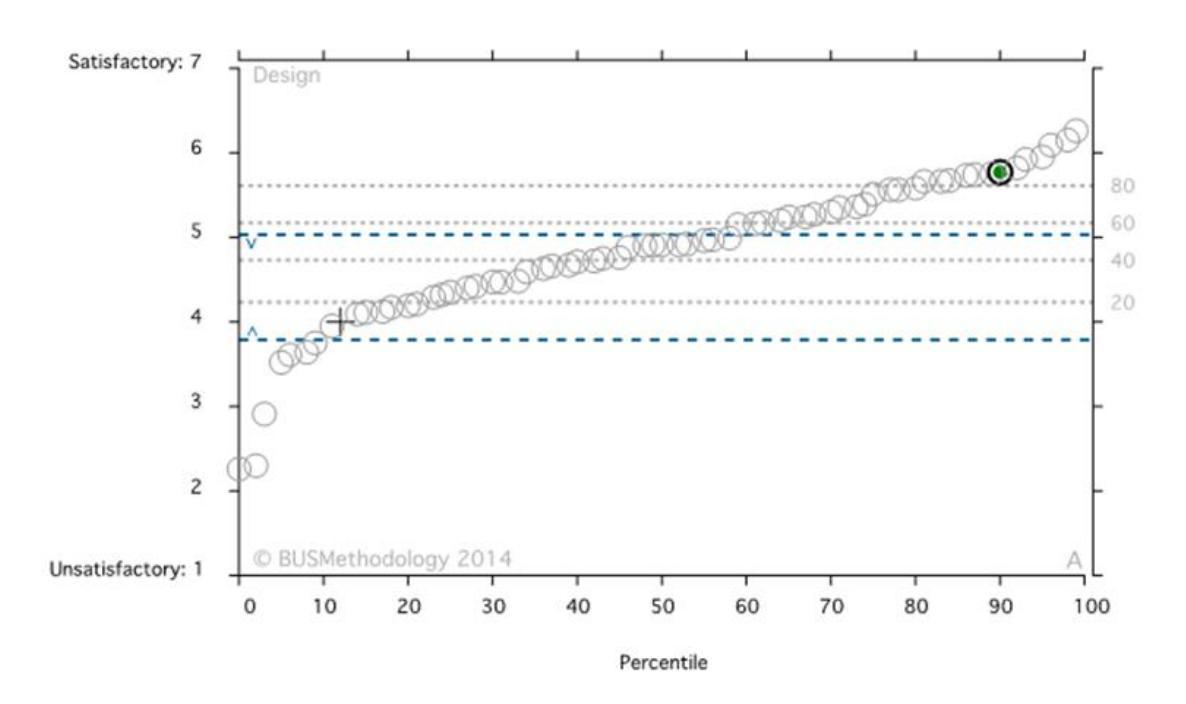
Figure 1.2 – Staff satisfaction survey: overall design (BUS surveys): the analysis shows that the hotel is rated among the top 10% 'overall design' performers, when compared to the BUS database of similar buildings.

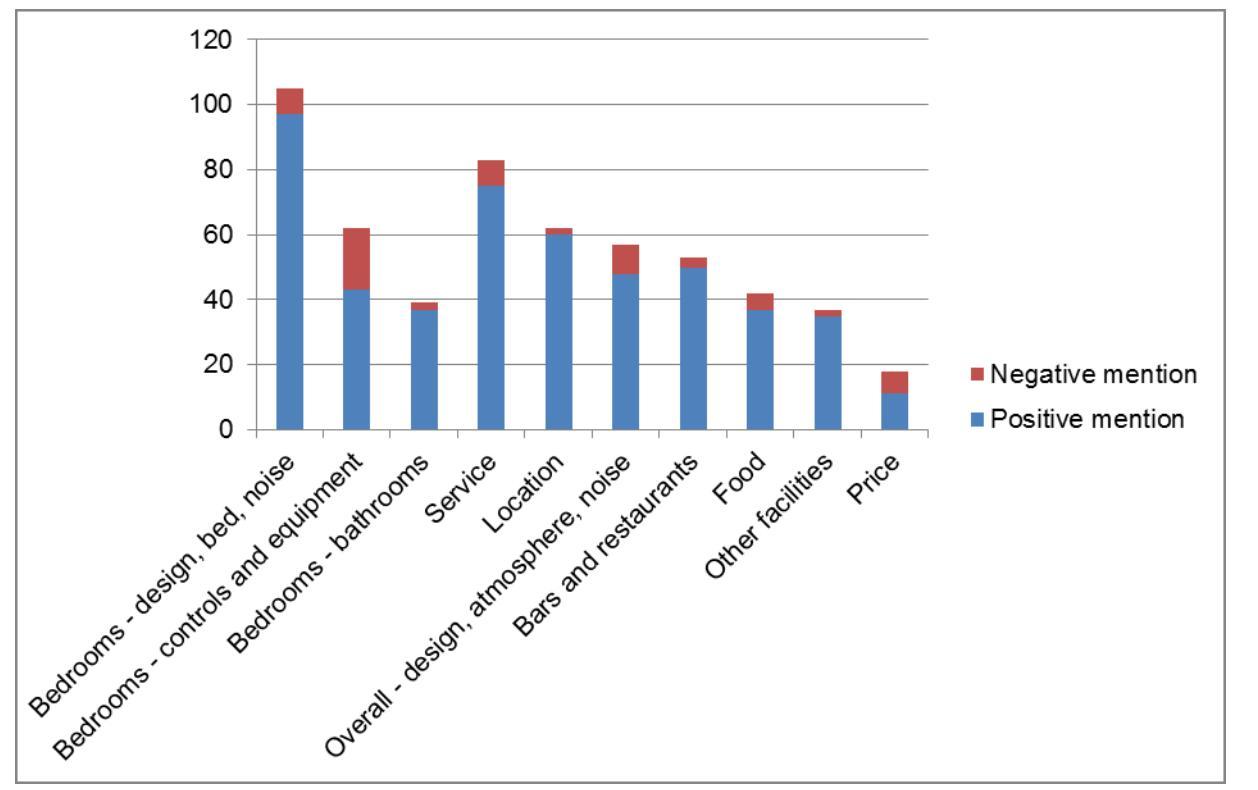
Figure 1.4 - Number of mentions in guest reviews, out of 88 reviews [sample Trip Advisor reviews, from September 2012 to September 2013]

More specifically in the bedrooms, the bed and bathrooms were singled out by quests as particularly positive features - with 'huge beds', 'rain showers' and 'huge bath' (mentioned in 20 out of 88 reviews) particularly appreciated. This feedback needs to be accounted for by design teams as a clear challenge to sustainability and water consumption objectives.

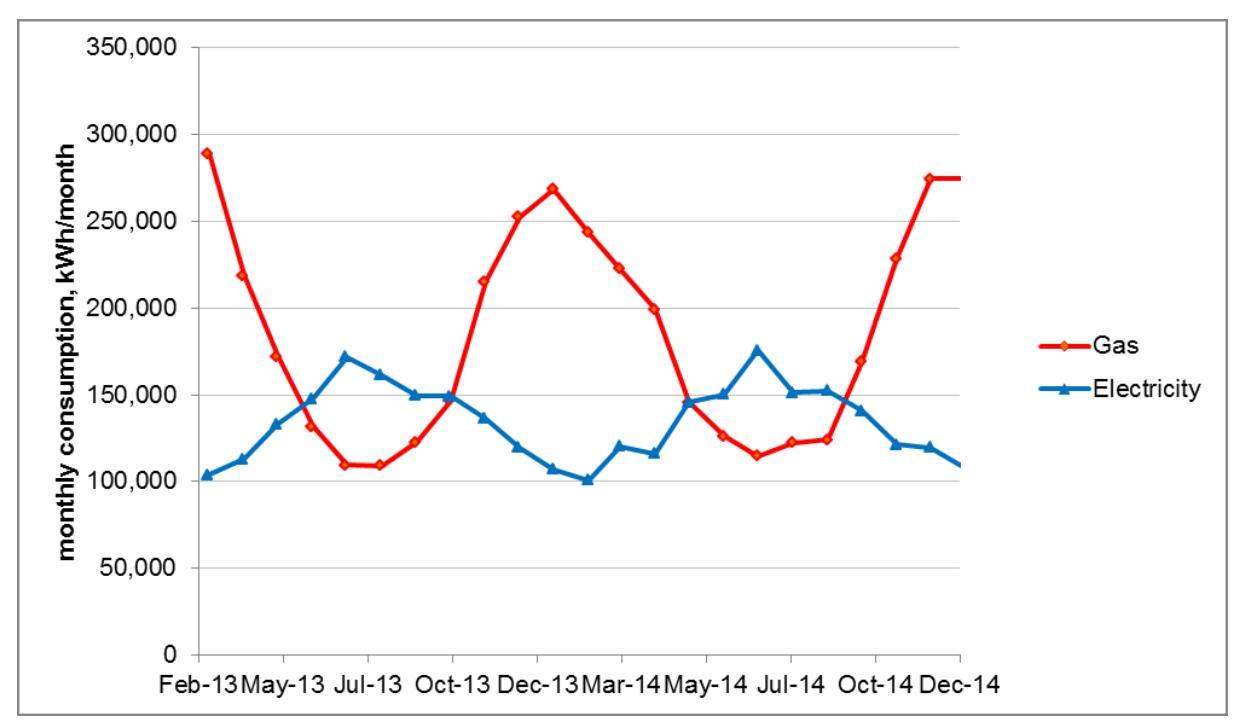
Monthly consumption over 2 years (March 2013 - February 2015) is shown below, from manual readings taken by the FM team. This excludes the first six months of operation of the hotel (September 2012 – February 2013). Consumption is similar in the 1st and 2nd years, and with marked seasonal variations, with gas consumption peaking in winter and electricity peaking in summer.

Figure 1.5 – Monthly gas and electricity consumption, Mar 2013 – Feb 2015

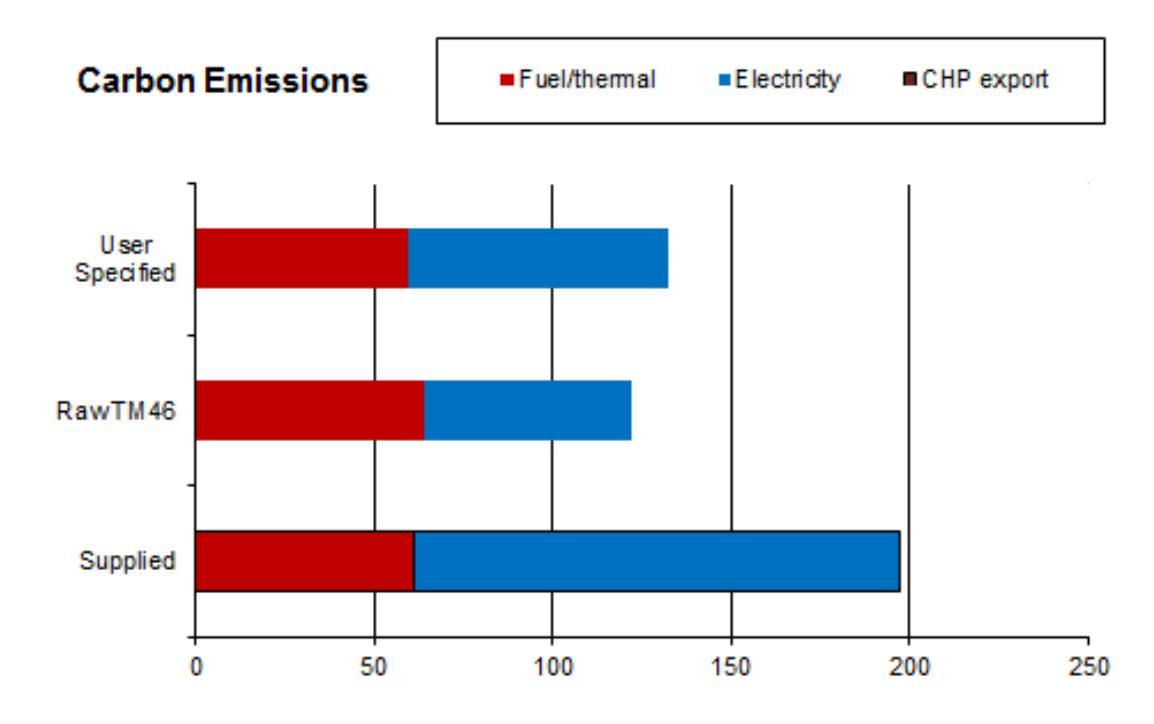
Figure 1.7 – Overall annual CO₂ emissions against CIBSE benchmarks, July 2013 – July 2014.

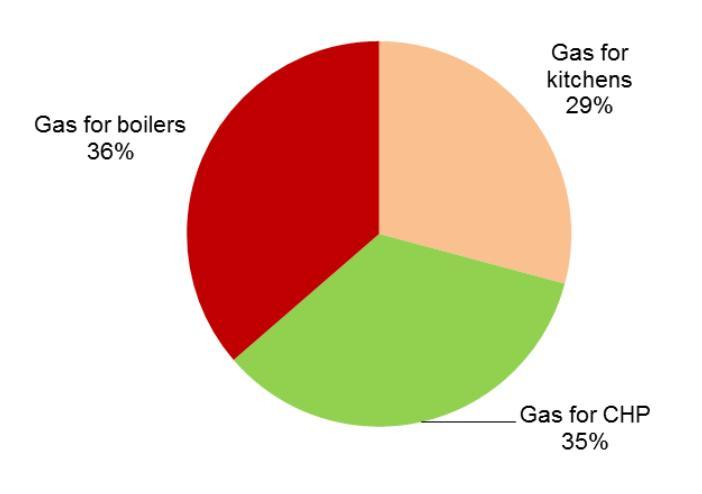
Figure 1.8 – Annual split of gas consumption (June 2013-June 2014)

Gas consumption is split into about 2/3rd for space heating and domestic hot water (i.e. regulated), and 1/3rd for catering gas. Over 50% of the regulated gas is used by the CHP, and this would be expected to grow if remaining issues with the operation of the CHP, particularly in the summer, allowed increased running hours.

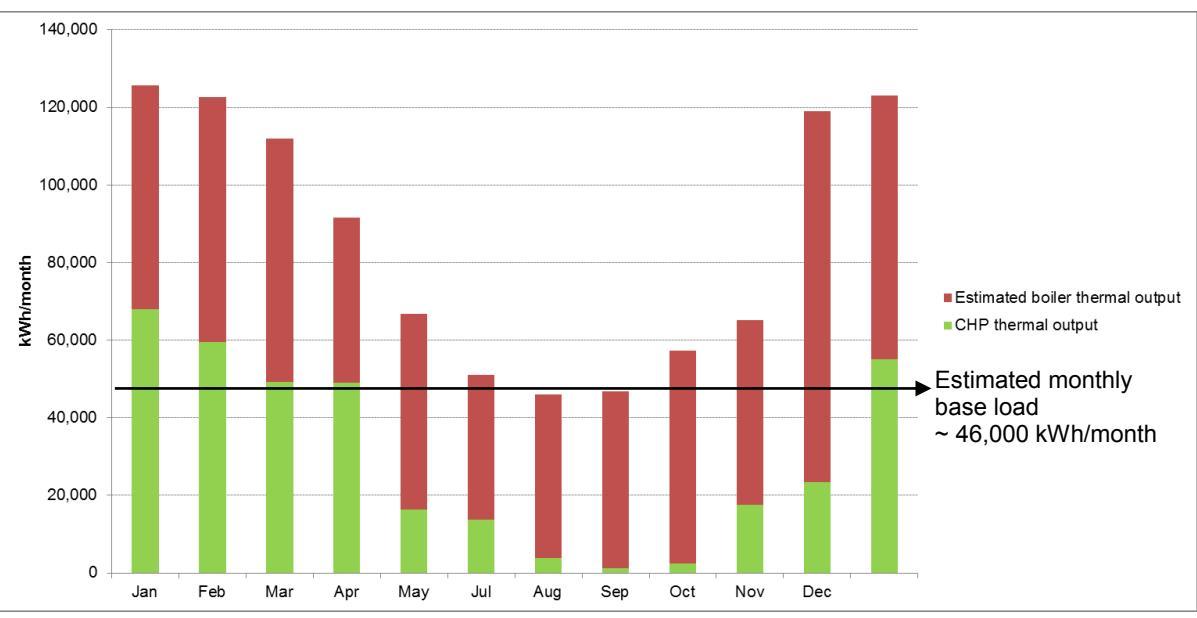
The thermal load (i.e. non-catering) is split evenly between hot water and space heating, as highlighted below. The profile of monthly thermal loads over the year can provide an estimate of the base thermal load, at about 46,000kWh/month. This is could in theory support, if thermal storage had been provided as intended at the design stage and even in the summer, approximately 13 running hours (full load equivalent) of CHP operation.

Figure 1.9 – Annual profile of monthly estimated thermal loads met by CHP and gas boiler (June 2013-June 2014, shown against Jan-Dec year)

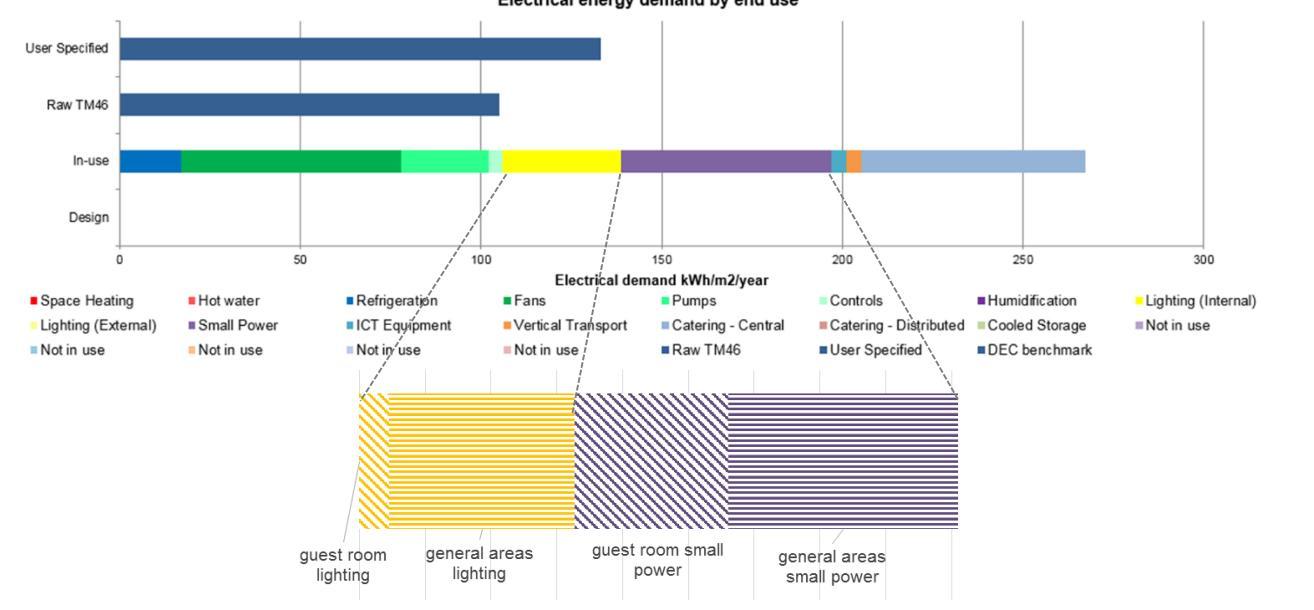
Figure 1.10 – CIBSE TM22 breakdown of electricity uses, including breakdown of lighting and small power into guest rooms and communal areas (June 2013-June 2014, shown against Jan-Dec year)

The building's base load was estimated at ~150kWe (~22W/m²) occurring between 2 and 4am, and similar on weekdays and weekends, resulting in approximately 75% of the annual electricity consumption. This is higher than the design stage estimate and, while it may be partly explained by the 24/7, air conditioned nature of the hotel, may also indicate an area of potential energy savings. The main components of this base load are MCC power, general lighting and small power, kitchen equipment, fans, and guest room lighting & small power (20kW, i.e. 250-300W per bedroom). The large contribution of MCC to overall consumption is also reflected in the overall 'fans and pumps'

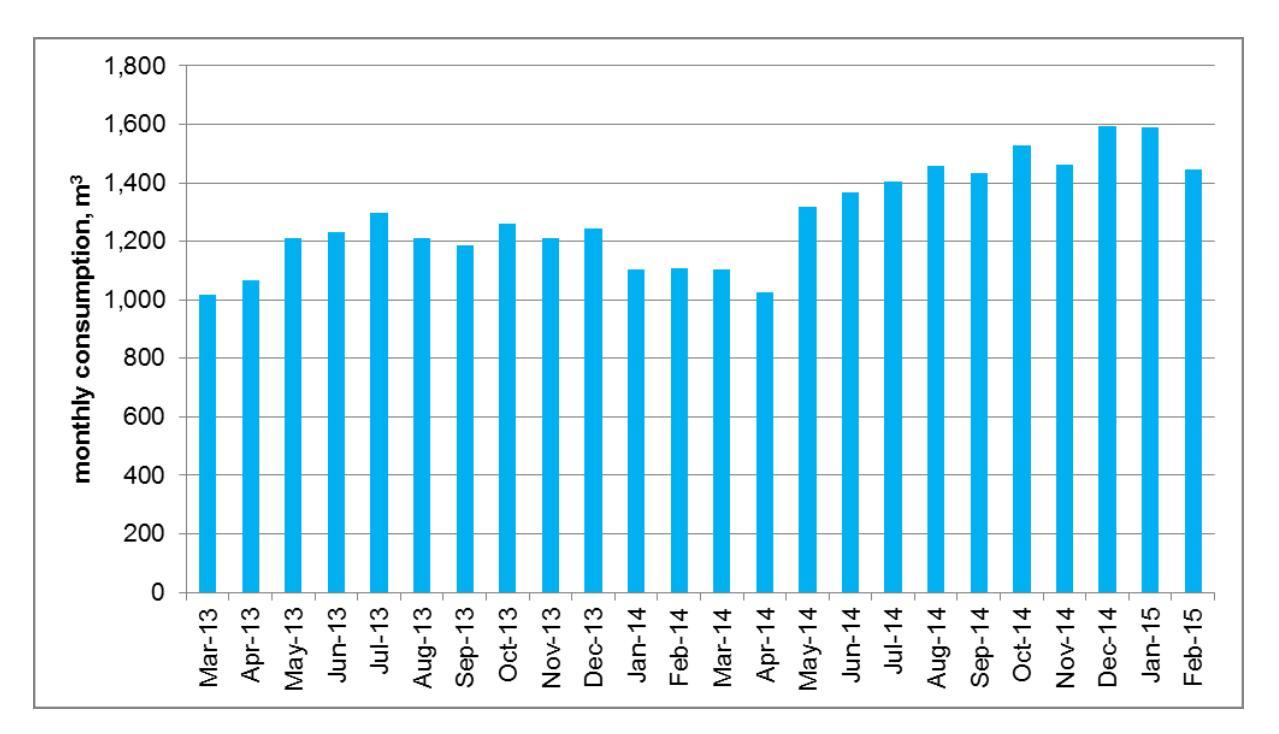
The following figure shows monthly water consumption over 2 years, from March 2013 to February 2015, which excludes the 1st six months of operation. The hotel's management team implemented efficiency measures at the start of the 2nd year but there is an upwards trend in water consumption, which without more accurate data on bedroom and restaurant uses cannot be explained by the BPE team at this stage.

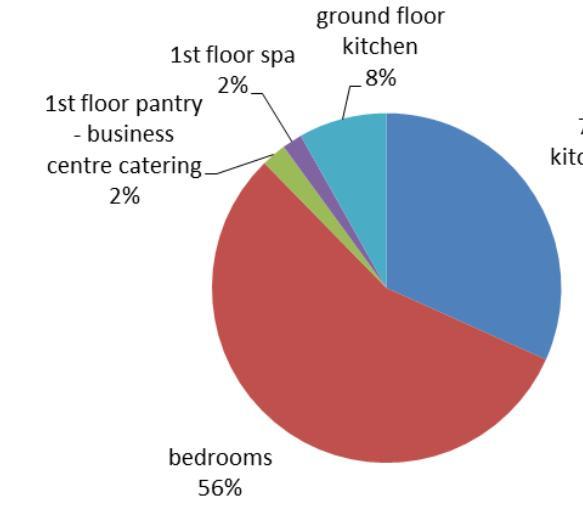
Due to remaining defects in the water metering, an accurate analysis of water consumption into individual uses cannot be made, however the following was estimated (see section 11 for details).

Figure 1.12- Estimated Water consumption breakdown into uses [total from opening i.e. Sept 12 - Mar 15]

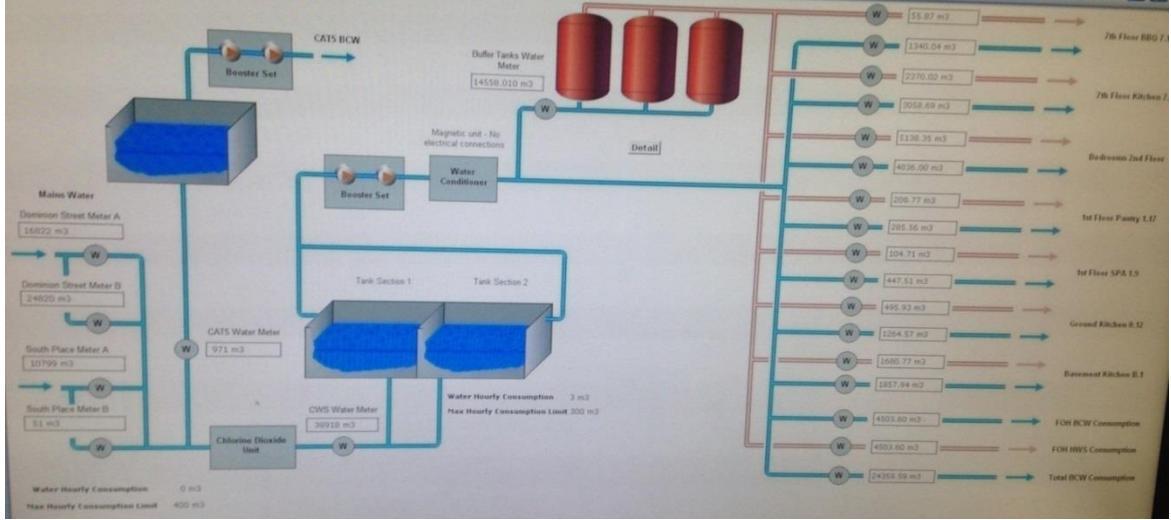
- Mains water meter: one of the meters can be read manually, and readings are taken daily by the FM team, however the data available on the BMS is widely inaccurate.
- Cold water sub-metering: while total cold water consumption is available, the breakdown into submeters available on the BMS does not add up and this is a significant constraint in identifying restaurant vs hotel bedroom use. This is discussed in more detail in the water consumption analysis section 11.

Figure 5.2: Illustration of water sub-metering strategy: BMS interface (as of early March 2015)

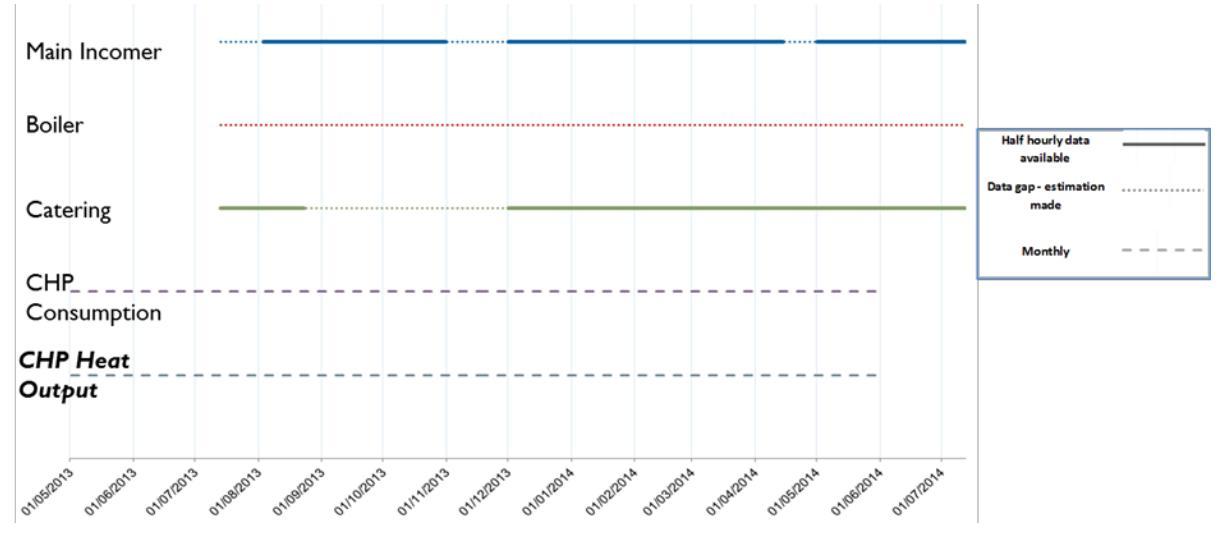
Figure 5.3: Gas – Data Availability From June 2013

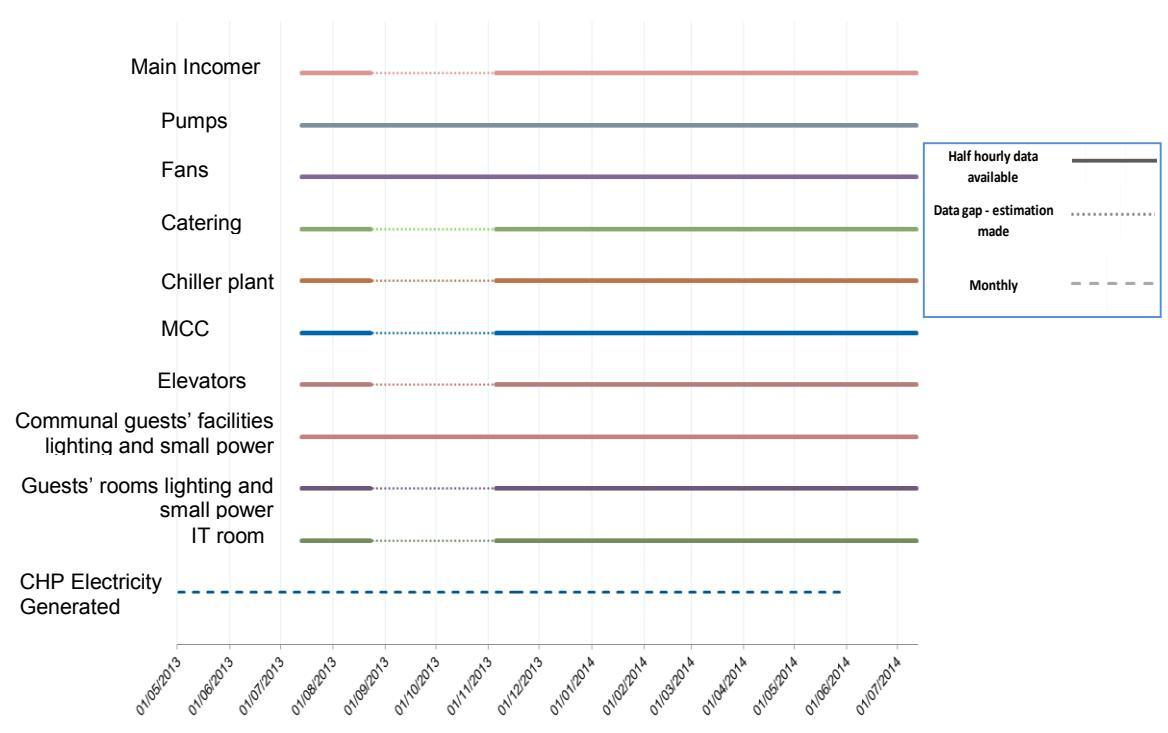
Figure 5.4: Electricity- Data Availability From June 2013

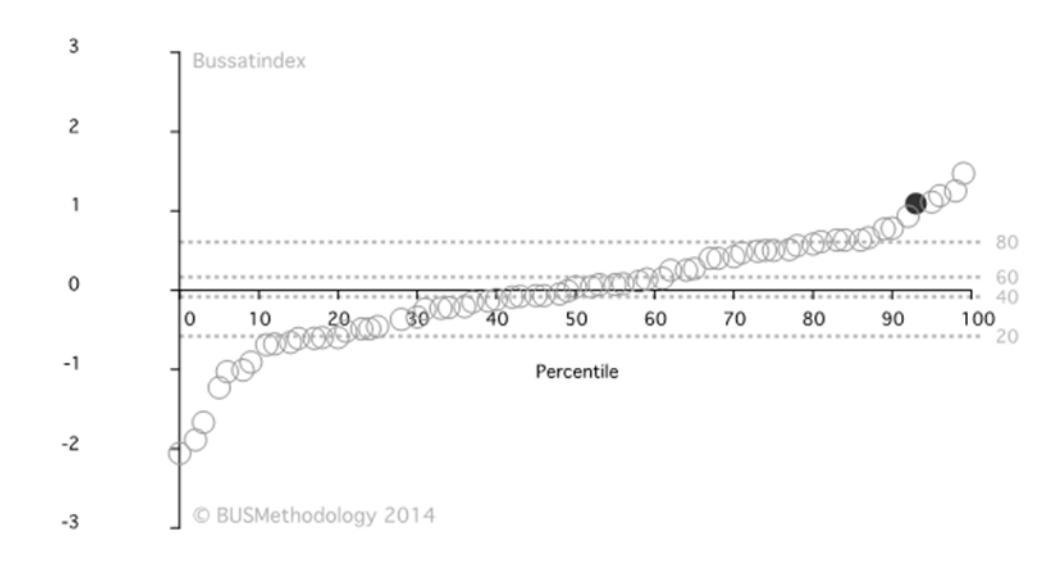
Figure 8.1 – Staff satisfaction survey: overall satisfaction (BUS surveys)

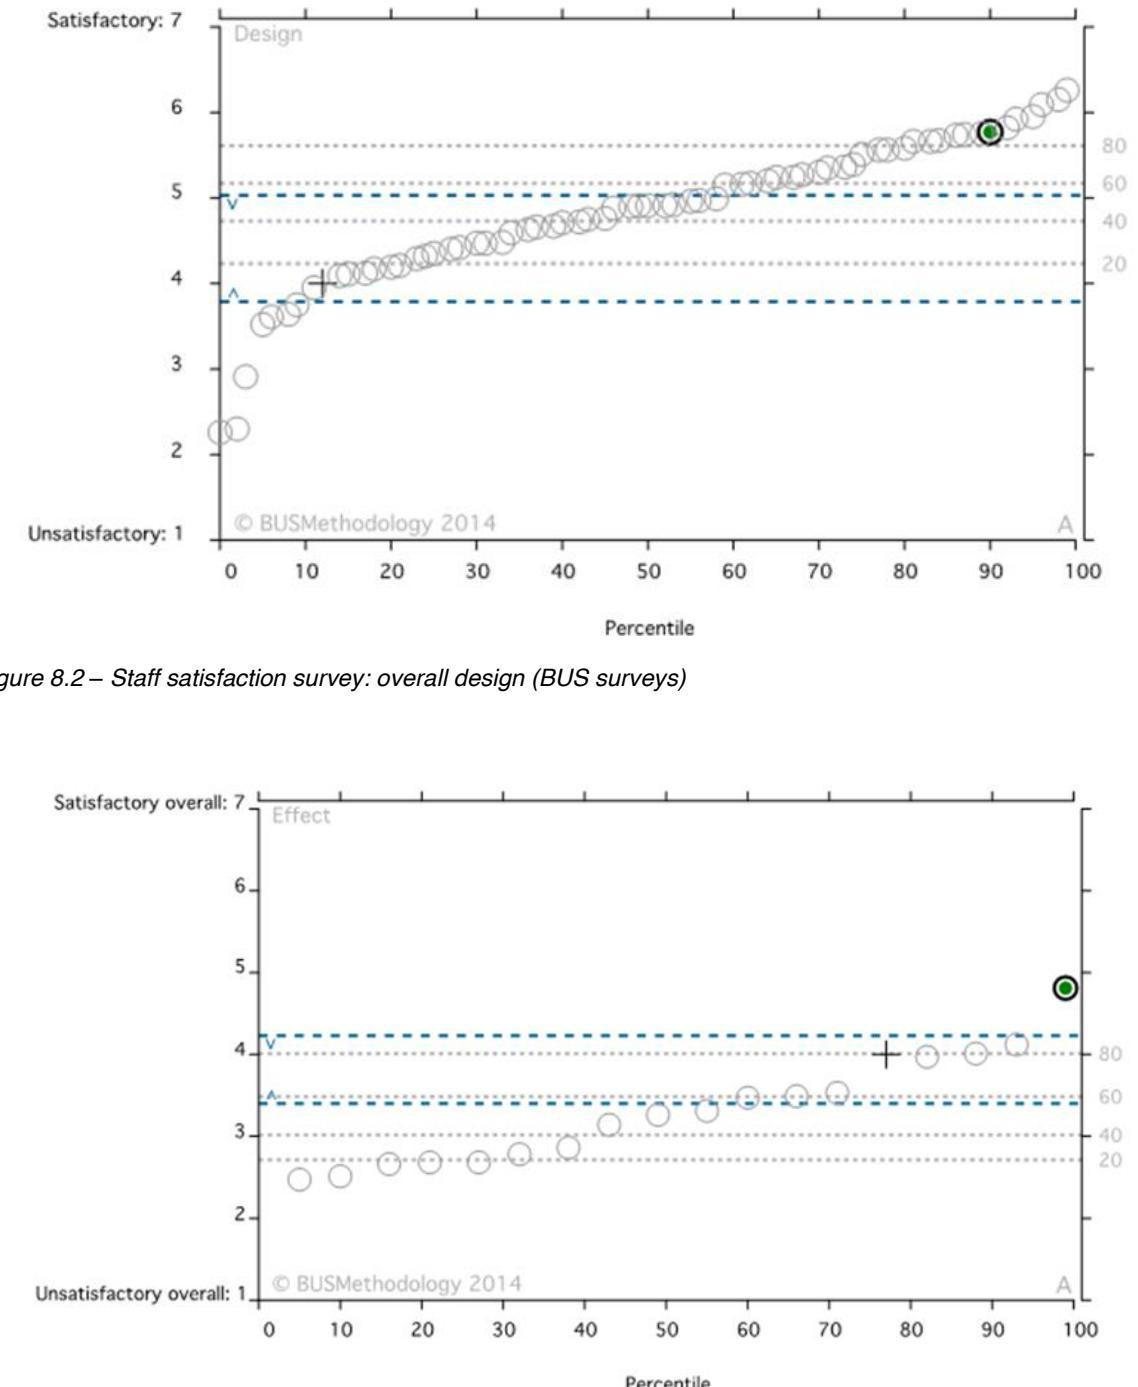
Figure 8.3 – Staff satisfaction survey: Effectiveness of response to request for changes (BUS surveys)

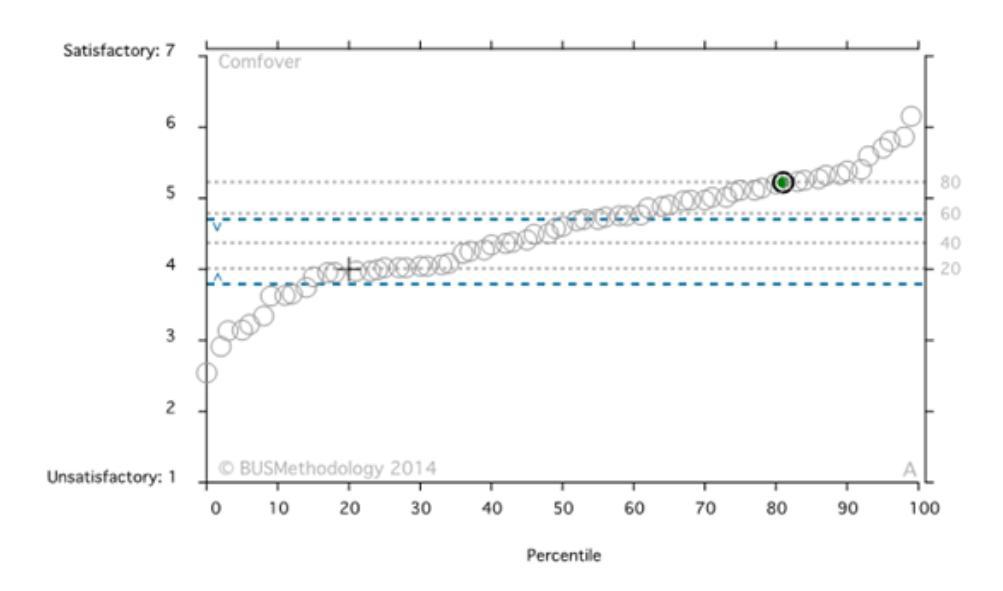
Figure 8.6: BUS survey results - Overall Comfort: high overall comfort, in the top 20% of surveyed buildings

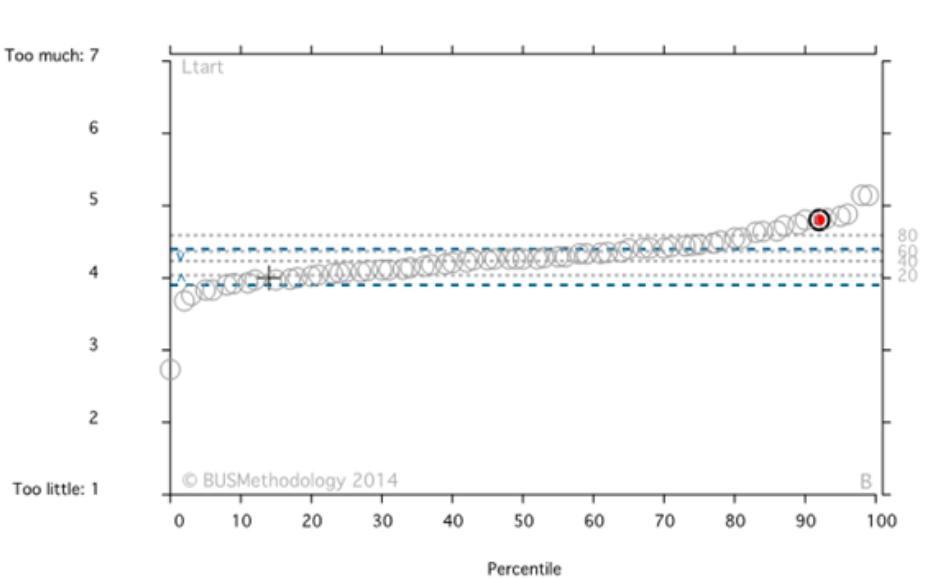
Figure 8.8: Artificial Lighting: staff noting 'too much' artificial lighting in the back-of-house office, located in the basement

The low scores on daylight and artificial lighting accords with a number of comments made related to the basement offices, particularly related to headaches. This was highlighted to the hotel developer and FM team.

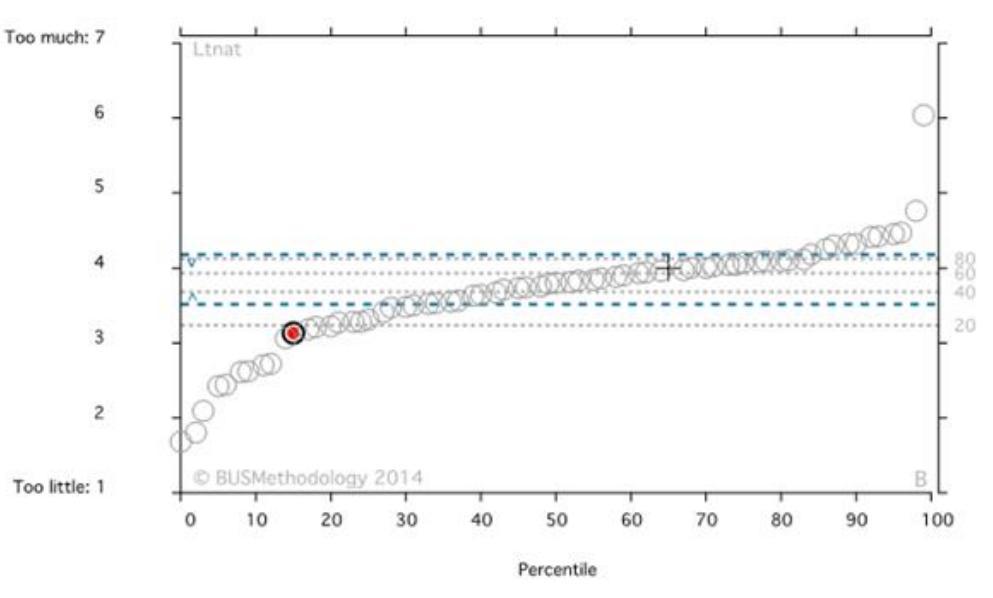
Figure 8.9: Daylighting: staff noting 'too little' daylighting in the back-of-house office, located in the basement

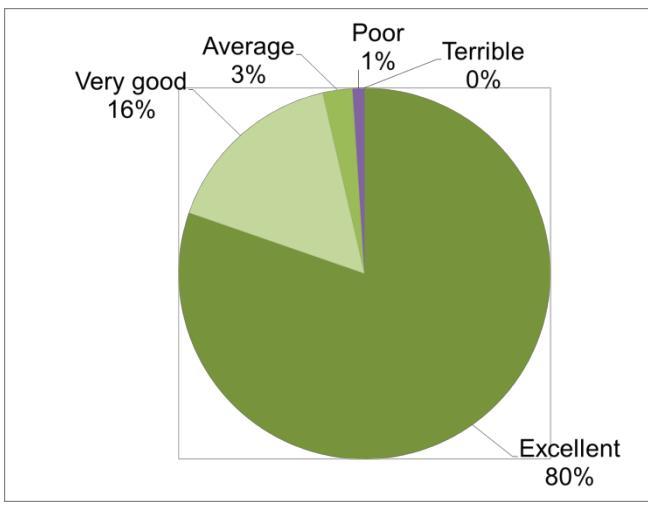
Figure 8.10: Guest reviews: Overall feedback after 1st year of opening [193 Trip Advisor reviews]

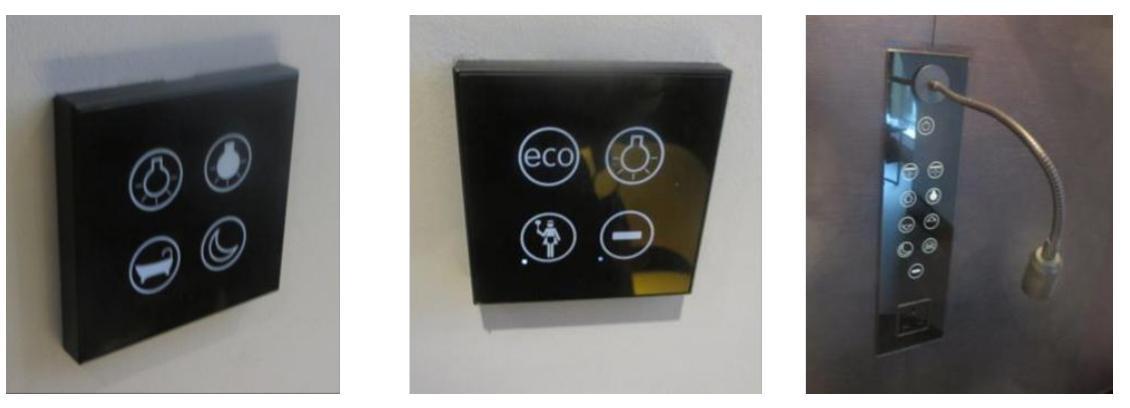
Figure 8.13: Bedroom controls

The high-tech or complexity of bedroom equipment, specifically the TV remote and media hub, as well as the complexity and reaction time of controls over lighting and blinds were often commented on by guests with negative feedback very much tempered by a larger number of very positive reviews on the 'gadgets' and 'modern feel'.

'Some of the technology in the room (the switches for the lights) are a little difficult to figure out' 'Touch panels weren't always responsive enough, though I like the idea very much' 'We struggled a bit with the touch-pad by the bed for the light' I did get rather confused with the key pass for the door. When you scan the card it unlocks the room but doesn't allow the handle to turn (you just push the door forwards) which confused me a bit. I had to ask a member of staff then felt a bit daft'

The hotel operator was aware of this from early on and investigated it in collaboration with the interior designer and controls manufacturer, with adjustment to the sensitivity of the controls. These improvements seem to have had appositive impact, as Trip Advisor reviews in the later quarter show much fewer occurrences of negative than those of the first two quarters - see following figure, which shows the breakdown of guest mentions about bedroom controls into negative and positive ones, after 6 months (March 2013, 48 reviews) and after 14 months (December 2013, 193 reviews). This highlights the importance of fine-tuning controls, as well as, probably, staff improving the 'room in' service when guests check in, with an explanation on controls.

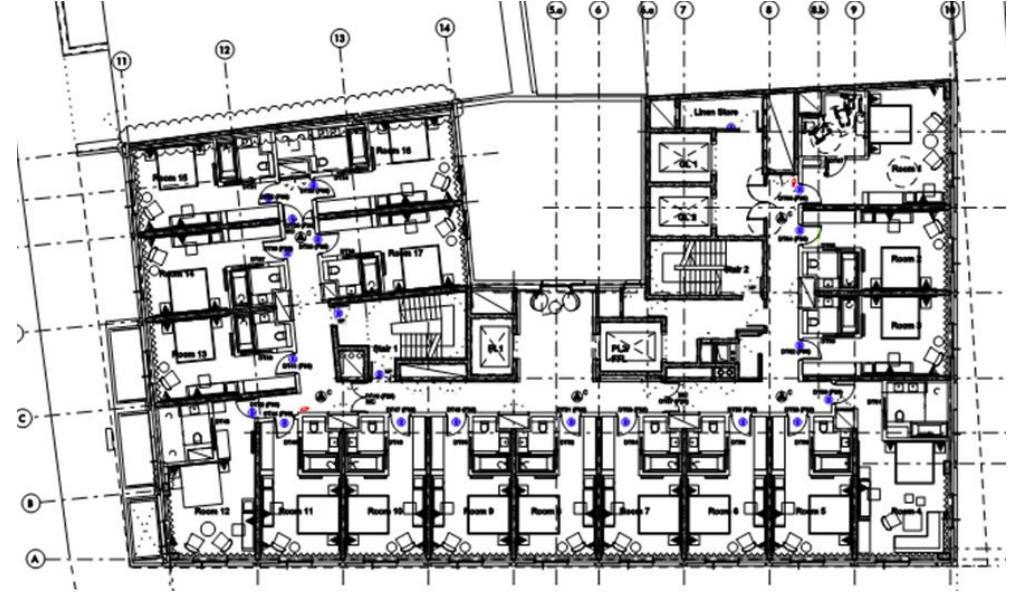
Figure 8.15: Second to Fourth floor plan, showing bedrooms located around the courtyard

Courtyard bedrooms: The issue of acoustics in bedrooms located around the internal courtyard was identified in the first few weeks of operation and was partially related to construction defects. (During a 'test' weekend stay by a member of the BPE team, they were woken up at night by a relatively quiet conversation in the courtyard.) Following complaints by guests, investigations were carried out including site visits by the acoustician and cross-referencing with the thermography surveys (see section 5.4). Defects in the quality of the sealing around the window frames were identified and have been remediated.

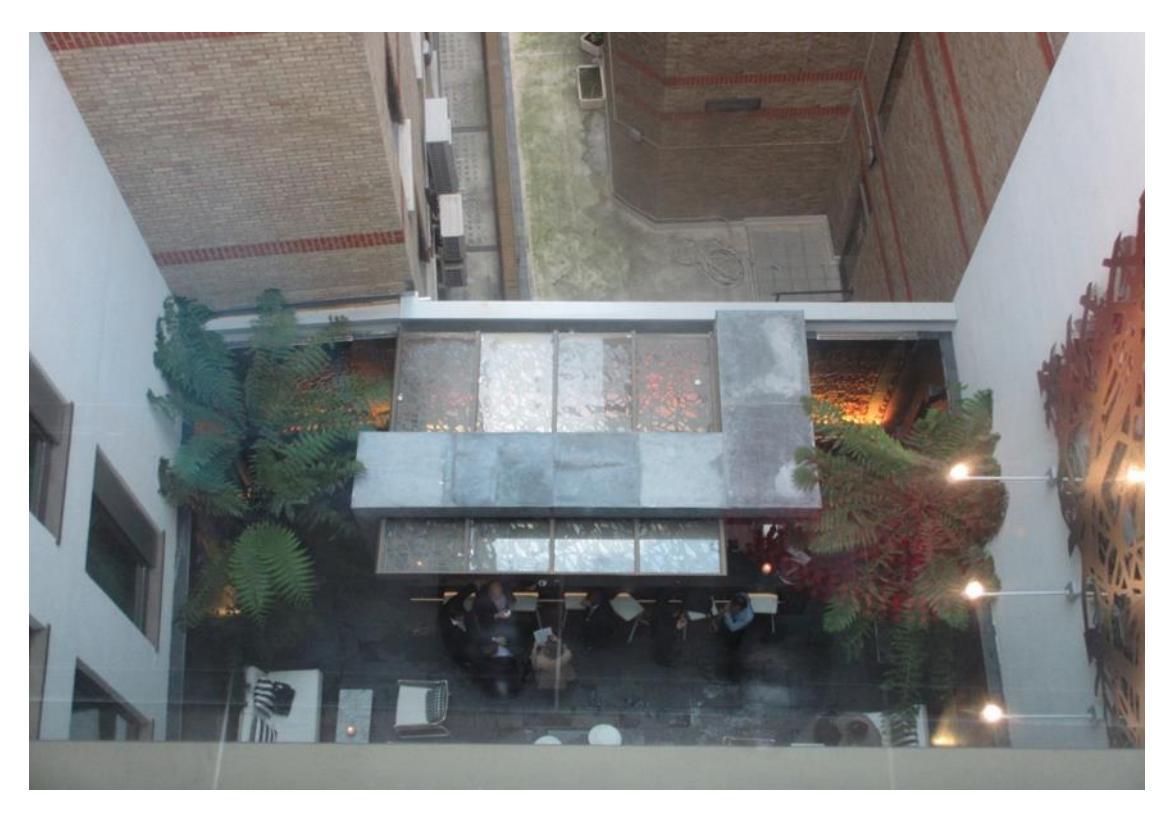
Figure 8.16:View of first floor courtyard bar, from 4th floor (before installation of canopy roof)

In addition to this, noise issues are related to the success of the hotel and the use of the bar for a large number of events, not initially expected by the hotel and not part of the initial brief. In addition to remedial measures, a canopy was installed on the bar: this was largely driven by a desire to increase revenues, but a higher-specification canopy with acoustic attenuation was purchased in order to reduce noise impact on the surrounding bedrooms. Incidentally, a similar canopy (not necessarily acoustically-treated) is expected to be installed on the top floor terrace bar, also to increase revenues.

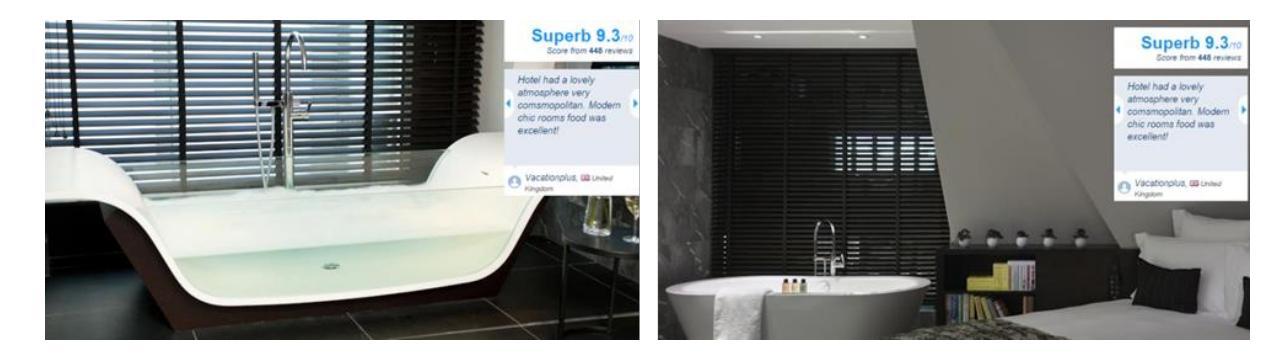
- Showerheads: from 9l/min (hand shower), 14l/min (bath / shower filler), 18 l/min (main overhead plate showerhead), and 4 No. 40l/min showerheads in the spa (for reference: 9l/min would be the limit for a BREEAM credit to be achieved)
- Bath tubs: capacity of 164 litres, 252 litres, and 301 litres (for reference: 100 litres would be the limit for a BREEAM credit to be achieved).

Figure 11.4 – Illustration of bathroom appliances

The estimated consumption of 390 litres per bedroom could therefore, in theory, be easily met through shower and bath use alone, e.g.:
