<b>Innovate UK project number</b>	450030 B
<b>Project lead and author</b>	Feilden Clegg Bradley Studios
<b>Report date</b>	2014
<b>InnovateUK Evaluator</b>	Peter Tse, BSRIA

<b>Building sector</b>	<b>Location</b>	<b>Form of contract</b>	<b>Opened</b>
Schools (Secondary)	Brighton	Design and build	2011

The study at Brighton Aldridge Community Academy (BACA) examined the handover and initial occupation of the building. Energy and occupant surveys were conducted. Both schools took a similar route to servicing the buildings, using mixed-mode ventilation with biomass heating. In both schools the BMS has been largely overlooked due to issues with the systems. **Note that the energy assessment in the report was based on an NIA of 8,883 m<sup>2</sup>. The energy consumption data have therefore been modified below to account for the revised floor area. The figures below override the data reported in Section 6.2.**

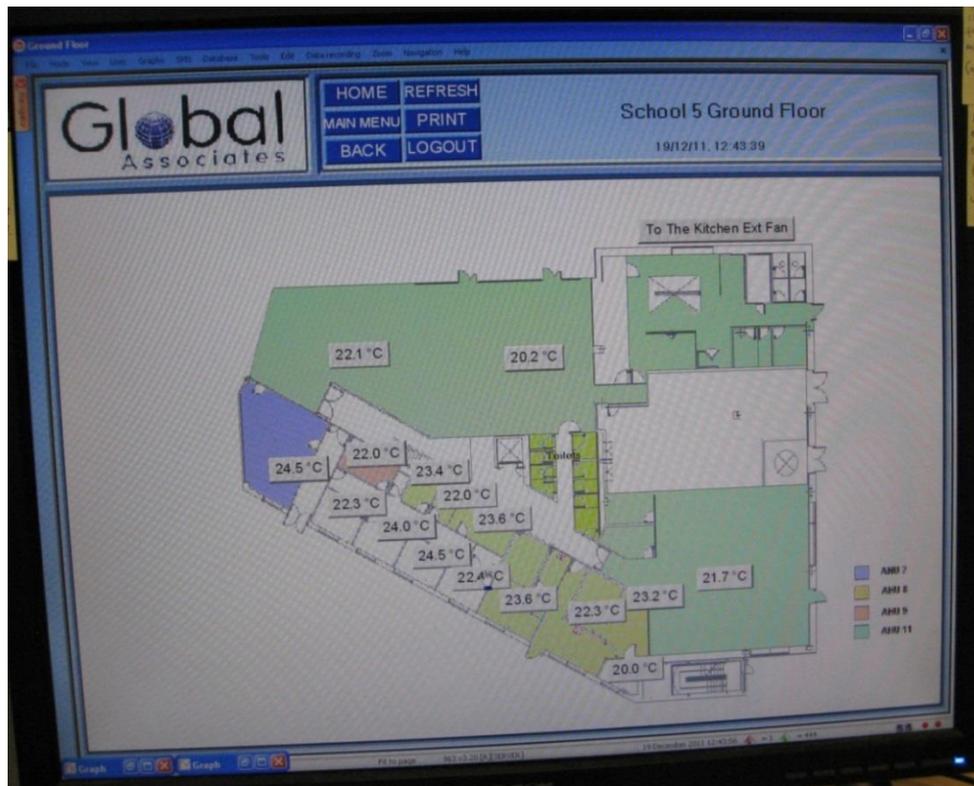
**Figure 3.2 – Screenshot of Thamesview BMS showing the layout plans and colour-coded AHU zones**

The BMS at Thamesview School is generally operating well, with much of the basic functionality expected of the system incorporated and operational. Many of the items of equipment connected to the services can be controlled directly by the BMS, such as the pumps or AHUs, with the status of each item connected visible. Where sensors are located within the building, either in the systems or in the spaces, these are addressable and open a log of 15-minute records for the previous week. The plant is interrogatable from the BMS, with the AHUs for each zone accessible from the layout plans, ensuring that the correct AHU is selected (see Figure 3.2). Through these layout plans, the space temperatures for each area can be quickly determined, although each thermostat does not directly control the AHU. Instead, the AHU is controlled through an average of the temperatures recorded, which causes issues when one space within the zones is significantly different from the others.

Reviewing the metering from within the BMS, it is apparent that the energy/water meters log according to a different algorithm to the thermostats, with the 15-minute usages over-writing the previous days usage. This creates a log of daily usage, with no profiles within the day possible. This would appear to be a simple fix (given it works correctly for the thermostats), but continued throughout the period of the BPE study. The metering did not meet the same standard as the thermostats in terms of accuracy either, with validation of the heat, gas and water sub-meters difficult, due to non-intuitive location of some of the meters (see Figure 3.3) or the initial problems with the BMS monitoring (see Figure 3.4) which Kier have since resolved. As such, only the electrical sub-meters were able to be robustly monitored.

In order to retrieve historical meter readings, it was found to be prohibitively difficult, with a number of alarming and misleading sub-menus preventing all but the most determined user. A majority of the FM staff at Thamesview School are not familiar with the installed BMS and rely on the few members of staff that do or the specialist contractor. The lack of confidence of the staff when using the system relates to the inaccuracies they have spotted and the potential to cause considerable changes to the

Time clocks for each zone are specifiable for days of the week, and can be pre-set for future periods of different use (regularly used for the school holidays). However, these were difficult to access, with significant prior knowledge required to access these settings. As with the access to the meter logs, access should be improved to the timeclocks, improving the flexibility of the systems, particularly out-of-hours use. This should be enable though the use of differing levels of access, enabling only those with prior knowledge to access the underlying settings, but the monitoring aspects and simple time clocks could be readily examined by those with less training.

systems. It has been advised that the inaccuracies of the system be rectified (currently being undertaken) and different levels of access be provided, preventing accidental changes to fundamental properties (flow set points for example). By enabling the differing levels of access, users would be confident to interrogate the BMS without the danger of changing key properties (low-level access personnel), but the necessary functionality would remain for those with the knowledge (high-level access personnel).

As a consequence of the BPE programme and through the increasing need to efficiently run the building, a new BMS is being installed at Thamesview with increased remote monitoring capability. This will also include remote logging fault alarms, allowing the remote help desk (located at the nearby Northfleet Academy) to easily monitor Thamesview School. This also has the advantage of storing the data in the cloud, negating any issues with hard-drive failure or running out of memory.

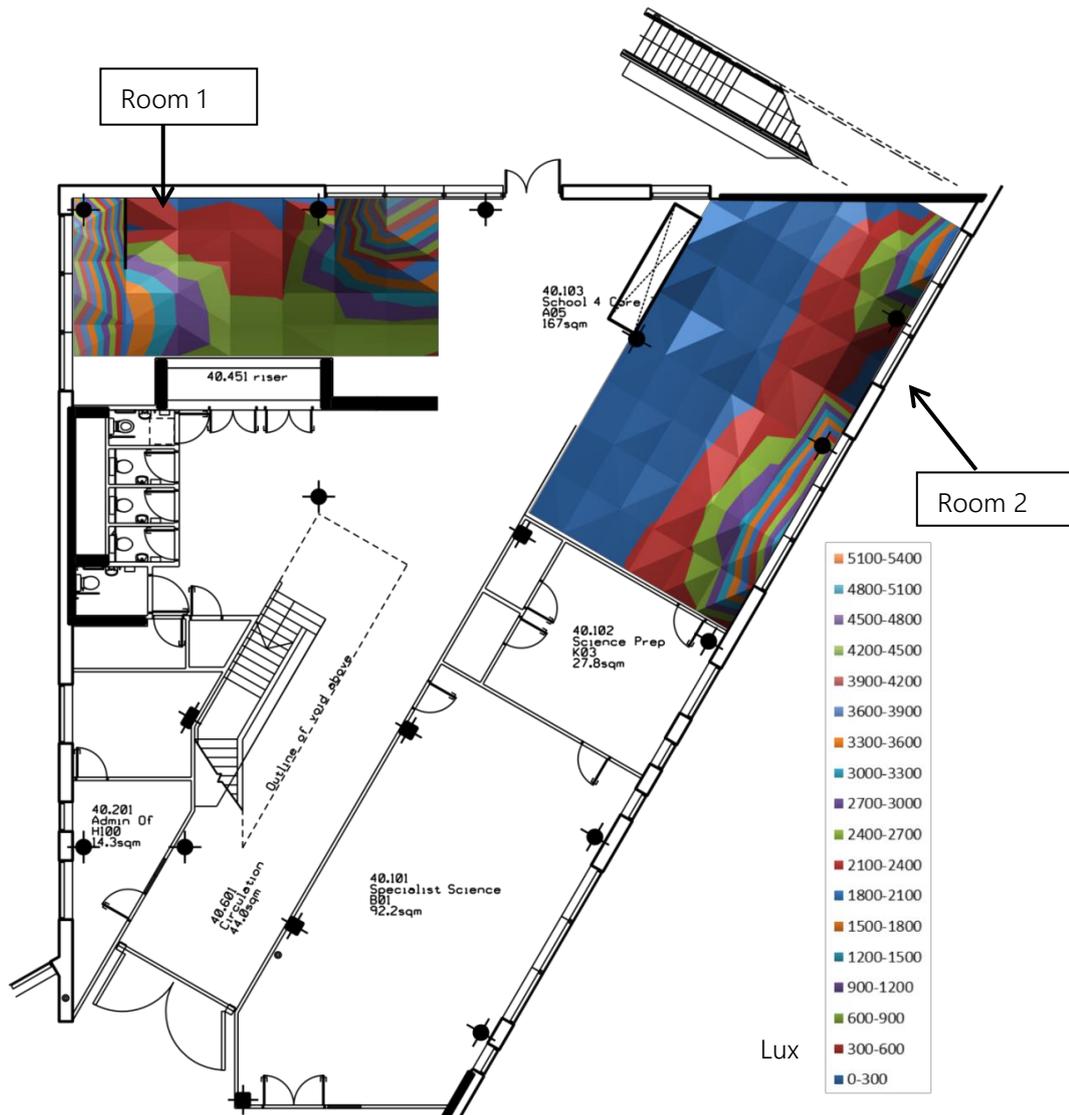
Figure 3.5 – Daylight analysis of the ground floor at Thamesview School, with rooms 1 & 2

The daylighting survey of Thamesview School examined the available daylight in the open plan teaching areas of the Discovery teaching wing (see Figure 3.5, Figure 3.6 and Table 3). Three spaces were tested, with the results showing the importance of the room layout and ceiling height. Rooms 1 and 3 both good daylight factors (over 5%), assisted by the double aspect glazing, which largely negates the impact of the interactive white boards partially blocking windows. Within Room 2, the daylight factor is much lower than the recommended 5% from Building Bulletin 90 to enable the space to be solely lit by daylight, but still higher than the minimum of 2% at 2.6%. Despite the large amount of glazing, the light penetration is poor, significantly hampered by the low ceiling, large depth of the space, and neighbouring School 5 block overshadowing the Discovery block.

Uniformity in all three spaces tested was above 11%, with the Rooms 1 and 3 showing good uniformity due to the double aspect glazing. In Room 2 the low uniformity and poor daylight factor combines to prevent the glazing from effectively lighting the space, with blinds used to prevent glare close to the windows and lighting necessary elsewhere. None of the rooms benefitted from the additional daylight available from the central atrium, with Room 2 in particular separated via large furniture to create a more typical teaching space.

In all spaces, prior to the survey all the blinds had to be raised, indicating that even in Rooms 1 and 3 the amount of daylight was producing issues within the teaching spaces, particularly with the interactive whiteboards. The full daylighting report is available in Appendix C1.

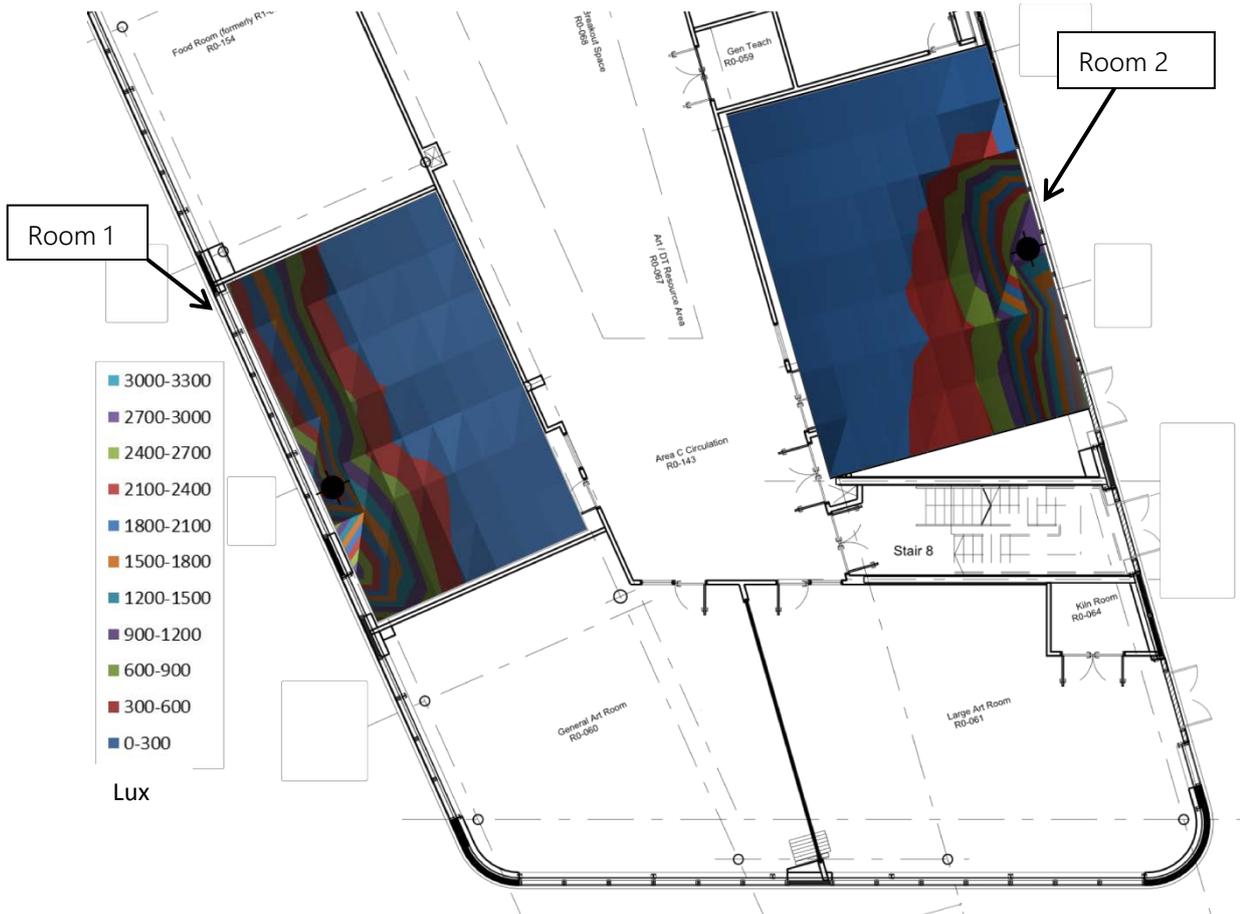
**Figure 3.9 - Ground floor daylighting levels at BACA**

Overall, the daylighting study has revealed mixed results for BACA, with the daylight plots shown in Figure 3.9 and Figure 3.10, and the room details summarised in Table 4. The ground floor rooms examined had average daylight factors lower than the guideline of 5% in Building Bulletin 90 needed for a fully daylit space, but still above the minimum 2%, whereas the first floor rooms had daylight factors over 5%. The ground floor rooms at BACA both had low daylight factors due to the lack of light penetration across the space. This has been caused by a combination of influences; neighbouring parts of the building blocking light, and the lower ceilings. In these spaces it will be necessary to use artificial lighting to supplement the daylight to ensure the correct working light level. The first floor rooms monitored have sufficient levels of light, all over the 5% recommended enabling fully daylit rooms, with room 3 in BACA having a particularly high daylight factor.

One issue that has afflicted all the rooms investigated is low uniformity of the daylight within all the spaces monitored. As before, this is symptomatic of the poor light penetration within the space; the higher lux levels near the window tail off sharply before reaching the middle of the room. Room 4 in BACA had the uniformity at 20.9% enabled by the lack of the over-shadowing by nearby objects (particularly trees and the rest of the building). Additional light from the day-lit circulation area would have benefited the rooms at BACA as this central area could provide daylight into the darkest part of the rooms.

It should be noted that all the spaces had the blinds closed or partially closed prior to this survey. From discussion with the teachers it became apparent that the main reason this blinds were closed is to ensure the students could see the interactive white boards. It was noted that in BACA the white boards on the first floor would have to overcome significant daylight to be readable. Through careful use of the blinds, closing only the ones near the board, this affect can be minimised, but future projects should carefully integrate the location of these boards into the scheme design. During visits to the school, it was noted that many of the teachers regularly use artificial lighting in preference to the daylighting, largely due to the blinds being down to prevent glare on the white boards. The full daylighting report is available in appendix C1.

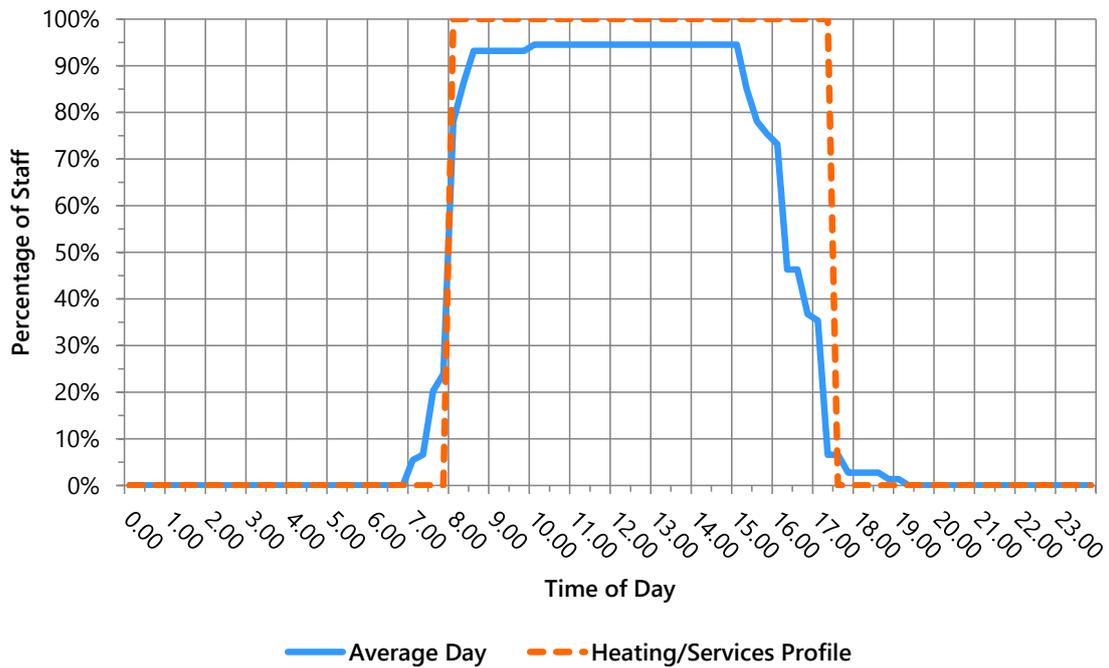
In spite of the lack of interaction with the BMS, the services timeclocks are setup to closely resemble the occupancy pattern found from the occupant questionnaire (see Figure 5.1). These timeclocks controls all the mechanical services; constant temperature and variable temperature heating, hot water and ventilation, with each teaching wing and central plant set to the same profile. It should be noted that although the different zones are set to the same profile, they are not linked, with each zone able to be set to a different profile. In practice, this has not been implemented, with any effective zoning of the heating system preventing the zones to be run truly independently. Outside of the heating season, when the external air does not need tempering, this zoning could be implemented to reduce the energy consumption. In addition, the services profile could be reduced to switch off at 17:00, rather than the current 17:30, reducing heating use by up to 5%. The temperature profiles of the building show that the temperature typically only drops by 2°C overnight (see Figure 5.2), thanks in large part to the good insulation and air tightness, so a reduction in heating operation by half an hour would have no adverse effects.

Figure 5.1 – Graph illustrating the occupancy profile from the occupant questionnaire compared to the BMS services profile

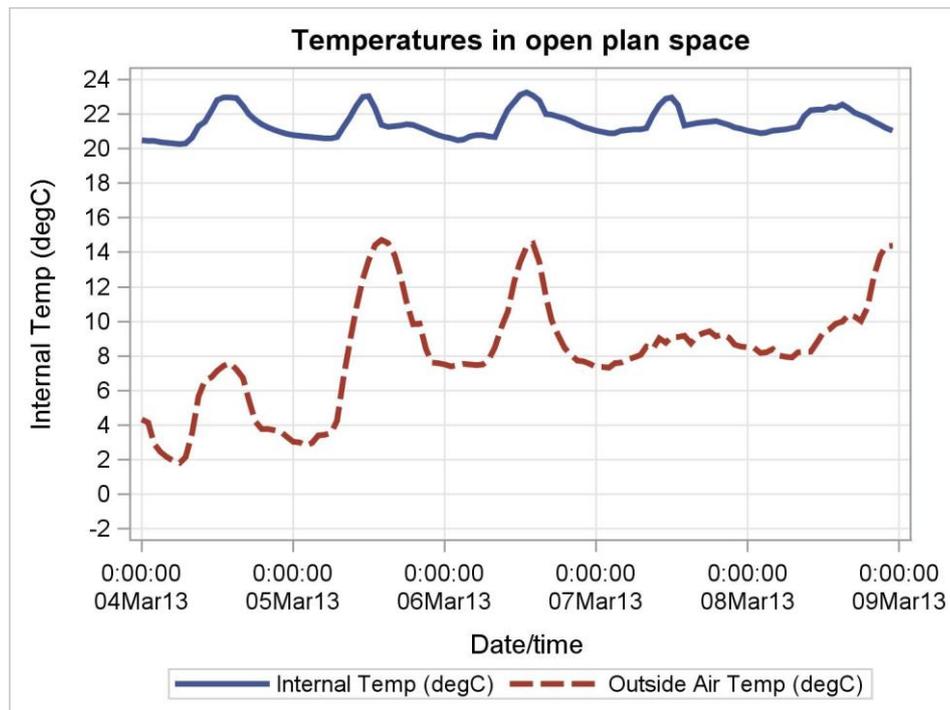
Figure 5.2 – Typical temperatures across a working week within an open plan teaching space

As part of the investigations into the internal temperatures, it became apparent that the timeclock profile is for the occupied time, with an optimiser to ensure that the building is up to temperature by the occupied time. However, the optimiser has been operating the ventilation systems and heating

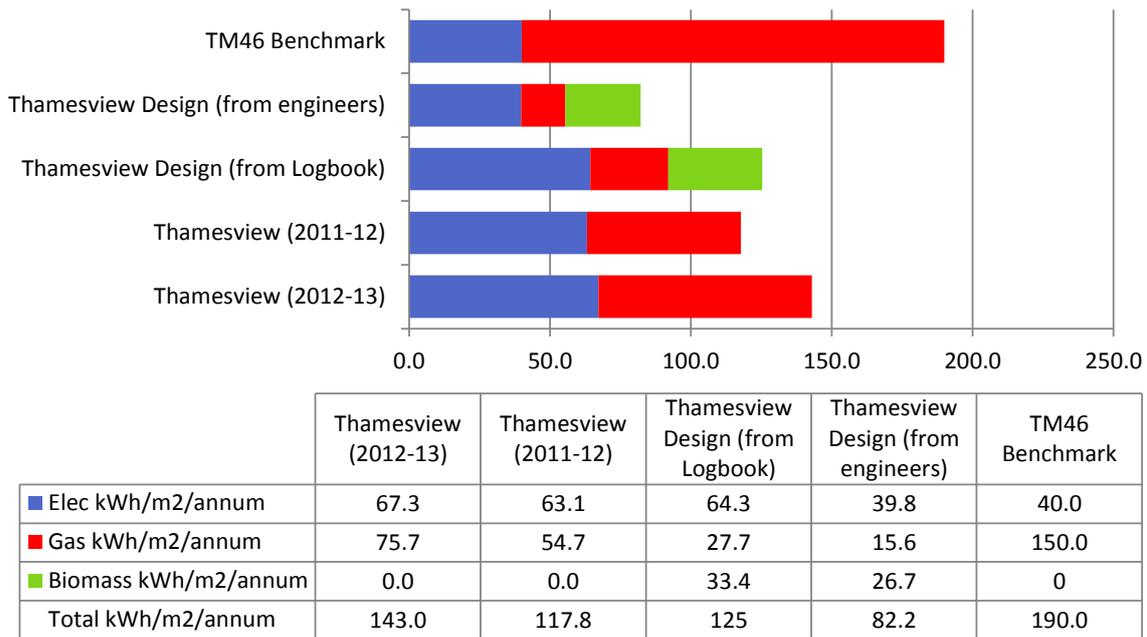
At Thamesview School, energy data was collected for two year, covering the period of the DPE study. Figure 6.1 shows how Thamesview School compared against the CIBSE TM46 benchmark, used within the Display Energy Certificate (DEC) methodology, and the design calculation from the engineers and logbook. In both years of the study, Thamesview School used less energy than the benchmark, but more than the engineers designed energy use. Two sets of design data were provided; one from the logbook (their operational targets), and one from the M&E engineers. The initial design data from the engineers showed substantially lower energy use than the data from the building logbook. It is not known where this discrepancy has arisen from, although the design data from the engineers was from dynamic simulation, whereas the logbook broke down the energy by sub-meter, indicating that it had been calculated using a different method. It is also noticeable that during this study, the energy consumption of Thamesview School increased compared to the initial year, largely caused by the harsh winter during the second year.

**Figure 6.1 – Graph showing the actual and design energy use for Thamesview School**

In the period July 2011-12, there were 1880 heating degree days, compared to 2369 heating degree days for the period July 2012-2013 for the South East. Assuming 20% of the gas is used for domestic hot water, a predicted gas usage of 66.1 kWh/m<sup>2</sup>/annum, still lower than the actual usage of 75.7 kWh. This additional gas usage was not reconcilable due to the lack of metering within the building, but is believed to be linked to the difficulty in balancing the LTHW system following some changes to radiator layouts. The system has since been recommissioned to ensure all the areas do get hot, as required.

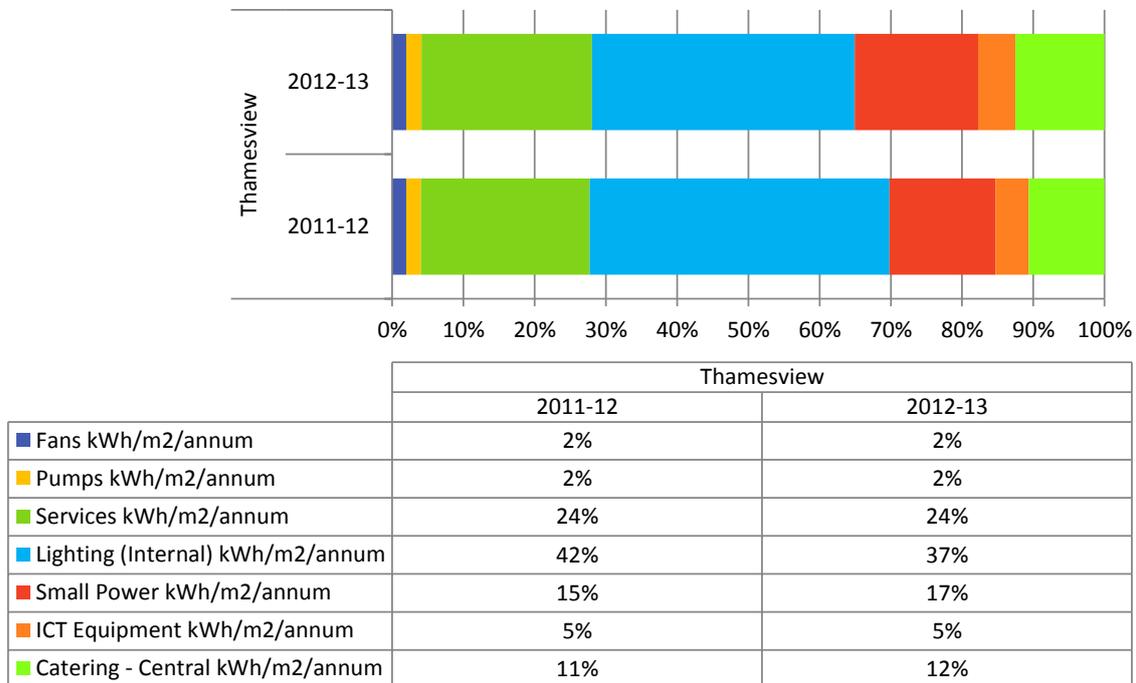
In both years of Thamesview School's data, it clear that the largest end use of energy is lighting, followed by services and then small power, as seen in Figure 6.2. Given that very few of rooms have no access to natural light, and circulation areas being well served by roof lights, it is somewhat surprising that the lighting is the main energy use. However, each circulation space is controlled by daylight monitoring and presence detection which is not correctly set-up, with lighting being operational when not needed. In addition, some of the rooms do not have over-rides for the lighting circuit, relying on the presence detection to control the lights, as per the design brief. In the open plan areas, which are very deep plan, many of the teaching areas are separated by large screens and furniture, inhibiting the daylight in those spaces.

**Figure 6.2 – Electrical energy use by end-use at Thamesview School**

The services, along with the fans and pumps, use 28% of the overall energy use. This is largely due to the mechanical ventilation system and its associated components. It should be noted that there was

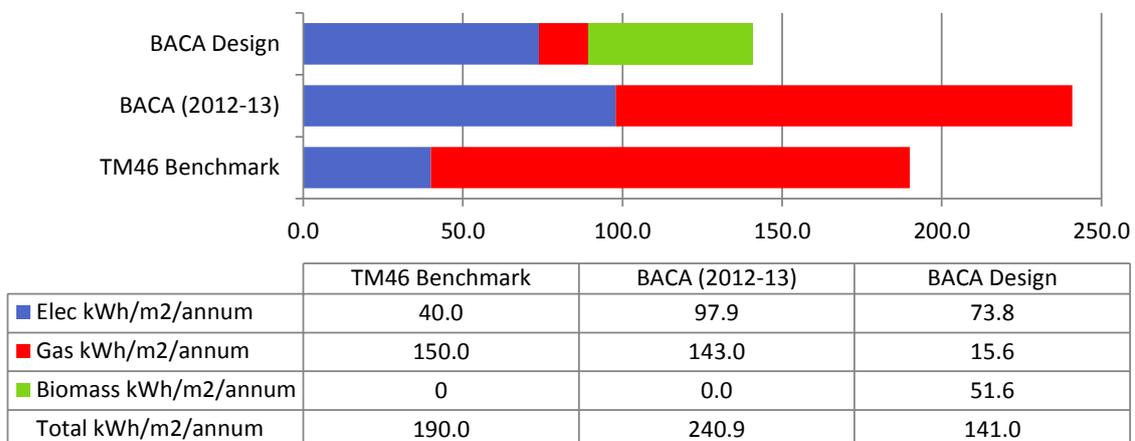
Energy data for BACA was collected during this BPE study with one year for BACA of electricity and gas data collected. Figure 6.3 shows how BACA compared against the CIBSE TM46 benchmark, used within the Display Energy Certificate (DEC) methodology, and the design calculation from the engineers. BACA was found to be using substantially more than both design and the benchmark, caused by the significant gas usage compared to the design (compounded by the lack of available biomass for much of the operation period). This high gas usage is due to the necessity to run the underfloor heating for extended periods, while at the same time the rest of the constant temperature circuit is heated.

Figure 6.3 - Comparison of actual and design energy use

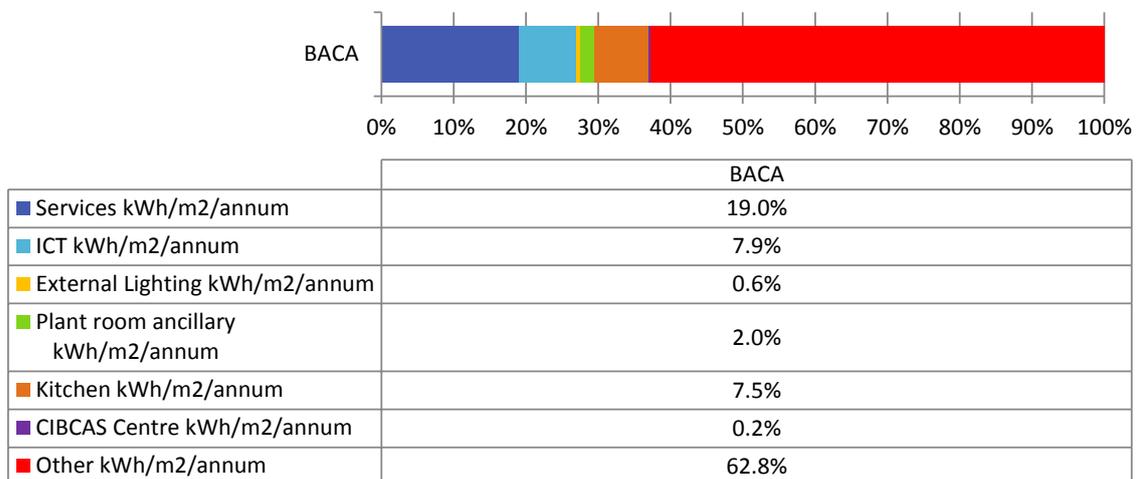
Energy usage at BACA has been difficult to understand given the nature of the metering strategy, with no separation of the lighting and small power. Figure 6.4 shows that almost 63% of the energy is unaccounted for, being split between small power and lighting. At Thamesview school a similar figure of 66% of the energy use was for small power and lighting, so it not unusual for such a high energy load to be associated with these systems. Again, BACA uses automatic controls (both daylight and occupancy sensing), so it has the same control issues. With the large amount of external glazing and rooflights, it is unfortunate that the lighting is using so much energy. Throughout the school are a large number of PCs that remain on throughout the day and evening, with no automated shutdown. There are four ICT server rooms, each with air conditioning and large server racks, supplying the intensive ICT requirements of the school. Given the scale of the ICT, it is apparent just how much the rest of the building for this to be such a small contribution.

**Figure 6.4 – Electrical energy use by end use at BACA (It should be noted that the CIBCAS centre is a neighbouring centre that provides adult education)**

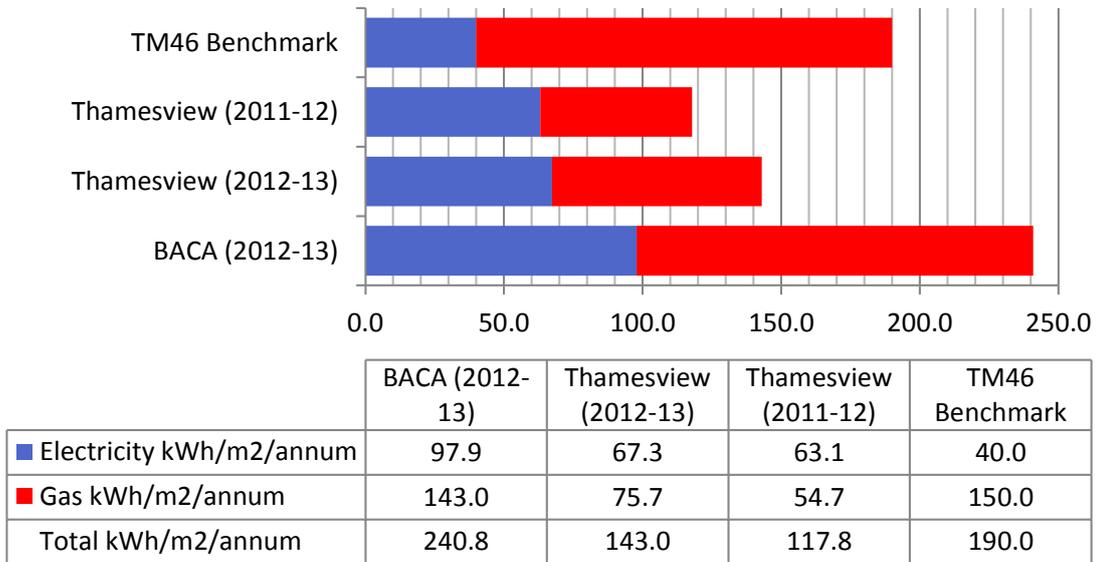
Figure 6.6 below shows how both schools compare against the CIBSE TM46 benchmark, used within the Display Energy Certificate (DEC) methodology, showing that Thamesview School in both years performed better than the benchmark, and BACA performed worse. It is also noticeable that during this study, the energy consumption of Thamesview School increased compared to the initial year, largely caused by the harsh winter during the second year. The energy data was sourced from the incoming utility meters at both schools, ensuring relative accuracy.

**Figure 6.6 – Bar chart comparing energy performance relative to the TM46 benchmarks for schools**

Both buildings were found to be consuming more electricity than the benchmark. Likewise, both schools were found to be consuming less gas than the benchmark (although only marginally in the case of BACA). The benchmark itself was based on a limited number of schools, but includes a range of schools of different types and construction age. However, since the latest version of TM46 was published in 2008, it excluded recently completed school buildings. In order to compare how the buildings performed relative to a larger dataset, the DEC dataset from 2009-10 was analysed with the results shown in Figure 6.7 below. While the dataset is not for a corresponding year and no correction for weather has been undertaken, it does indicate how the two schools compare to the larger set of schools (1091 of roughly 3500). This is of particular importance for the heating at both schools as they are non-electric heating systems and the winter of 2012-13 was particularly harsh compared to previous years.

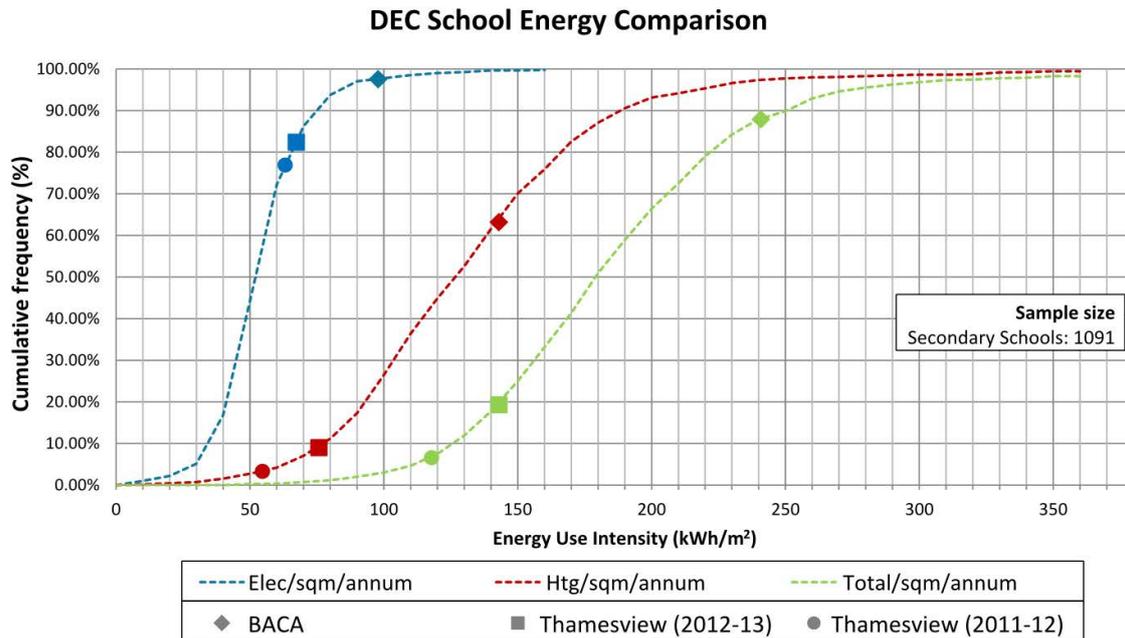
**Figure 6.7 – Comparison of studied schools compared to the DEC dataset from 2009-10**

As can be seen, the electricity use of both schools is in a very high percentile of electricity use, over the 75<sup>th</sup> percentile, with BACA ranked as 97.5%. Heating energy for Thamesview is in the best 10%, and BACA is 63%. This shows that at BACA, there is clearly an issue with the heating control strategy, particularly given the high-performance building fabric compared to the wider building stock of secondary schools. Although both schools were using less than the TM46 benchmark for heating, it is clear that BACA is using more than the mean of the DEC dataset.

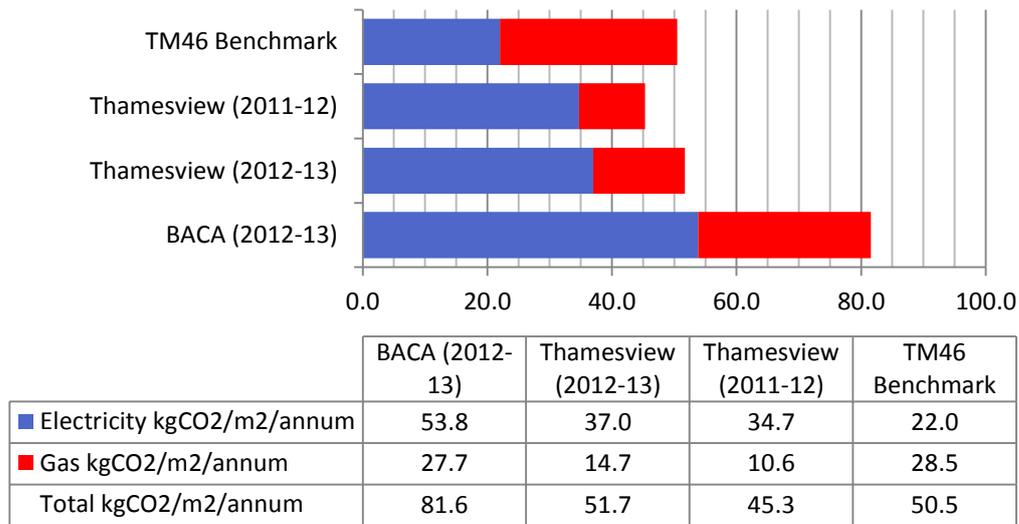
With the high electricity use at both schools, it is clear that both schools will have a large carbon footprint, given the higher CO<sub>2</sub> emission rate for electricity than gas. Figure 6.8 shows that although Thamesview School consumes much less energy compared to the benchmark (see Figure 6.6), its carbons emissions are similar to those of the benchmark. This is solely down to the much higher amount of electricity usage. BACA, not surprisingly emits considerably more CO<sub>2</sub> than the benchmark, with both gas and electricity usage more than the benchmark. However, both schools have biomass boilers installed that were not operational during the study period, which if used would reduce the amount of CO<sub>2</sub> emission resulting from heating and hot water generation (see Figure 6.9).

Figure 6.8 – Bar chart comparing CO<sub>2</sub> emissions relative to the TM46 benchmarks for secondary schools (carbon Emission rates used; electricity: 0.55 kgCO<sub>2</sub>/kWh, gas: 0.194 kgCO<sub>2</sub>/kWh)

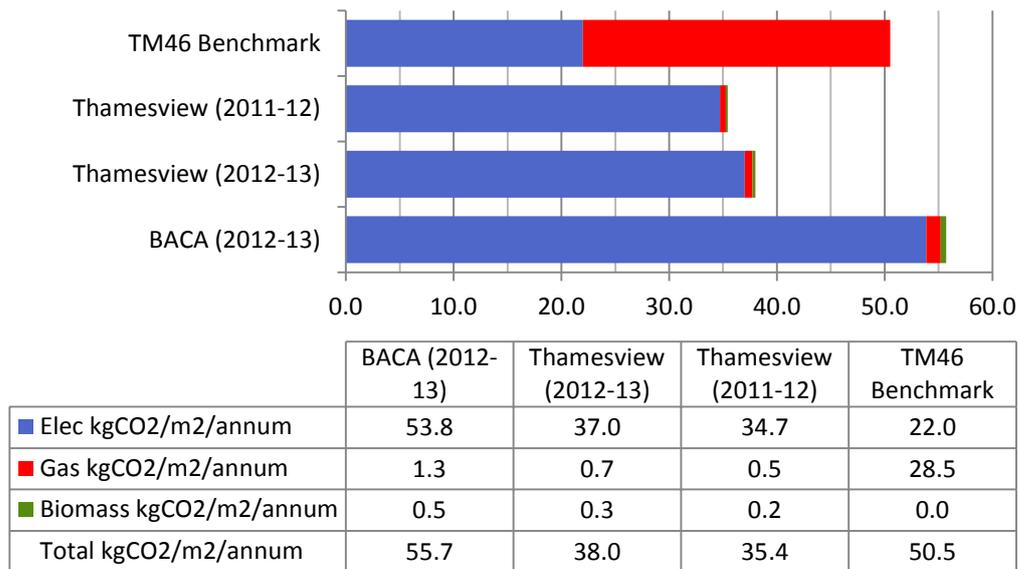
Figure 6.9 – Bar chart showing the CO<sub>2</sub> emissions relative to the TM46 benchmarks if the biomass was used for 75% of heating (carbon Emission rates used; electricity: 0.55 kgCO<sub>2</sub>/kWh, gas: 0.194 kgCO<sub>2</sub>/kWh, biomass: 0.025 kgCO<sub>2</sub>/kWh)

By using the biomass boiler for 75% (as per the design intent) of the heating load, the CO<sub>2</sub> emissions for BACA could have been reduced by 32%, and up to 27% for Thamesview. It is immediately obvious that although the emission rate could substantially be improved by using the biomass, the electricity usage is the key to reducing the CO<sub>2</sub> emission rate effectively. The high use of gas at BACA is caused by the requirement to operate the underfloor heating at 3am to ensure that the temperature reaches the optimum level by occupation. However, due to the initial control difficulties, the rest of the

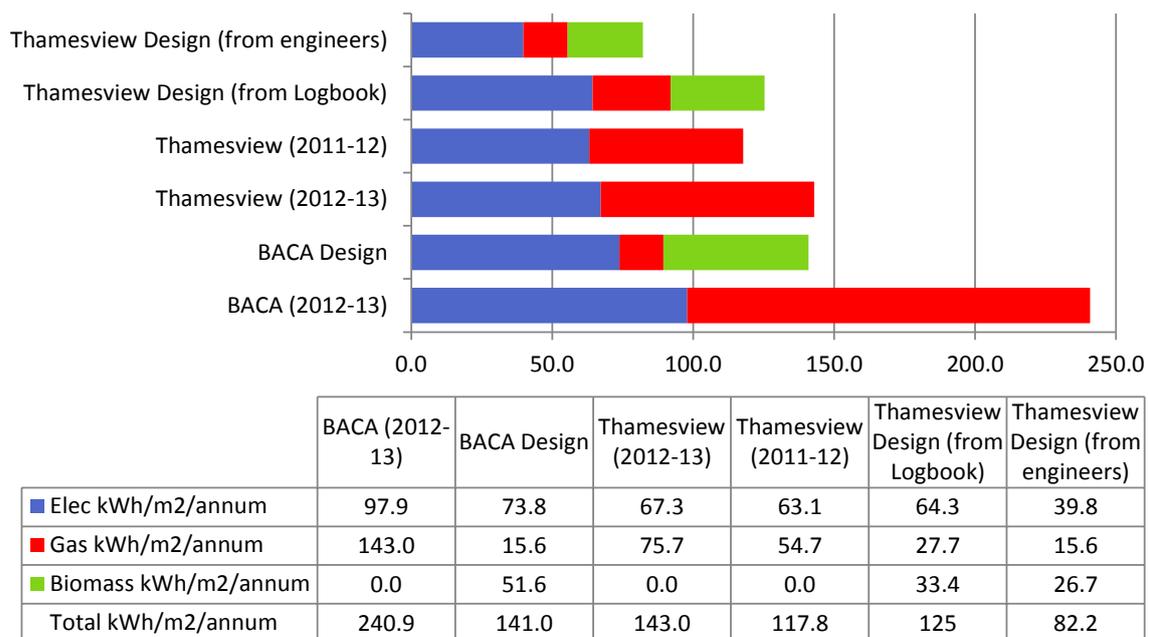
Both schools had full analyses undertaken by the design team to determine the operational energy use. Figure 6.10 and Figure 6.11 show the relative performance of the school compared to their designs, with both schools using considerably more than designed. This is not surprising given that few buildings in the CarbonBuzz<sup>1</sup> database use less energy than designed, with many using 2-3 times the designed amount. The design data for BACA was received from the engineers, generated from their dynamic simulations of the building. At Thamesview School, two sets of design data were provided; one from the logbook (their operational targets), and one from the M&E engineers. The initial design data from the engineers showed substantially lower energy use than the data from the building logbook. It is not known where this discrepancy has arisen from, although the design data from the engineers was from dynamic simulation, whereas the logbook broke down the energy by sub-meter, indicating that it had been calculated using a different method.

**Figure 6.10 – Bar chart showing design and actual energy use at BACA and Thamesview**

As noted above, without using the biomass boilers at each school, there is a significant increase in the CO<sub>2</sub> consumption at each school, with BACA producing 82% more than designed, and Thamesview using 77% and 102% more than designed by the engineers. The heating aspect of the energy consumption should be closer to the design than the electricity usage, with the heating controlled centrally by the respective BMS systems. At Thamesview School, the heating energy is similar to the overall heating energy from the logbook (adding the biomass and gas usage together), but this

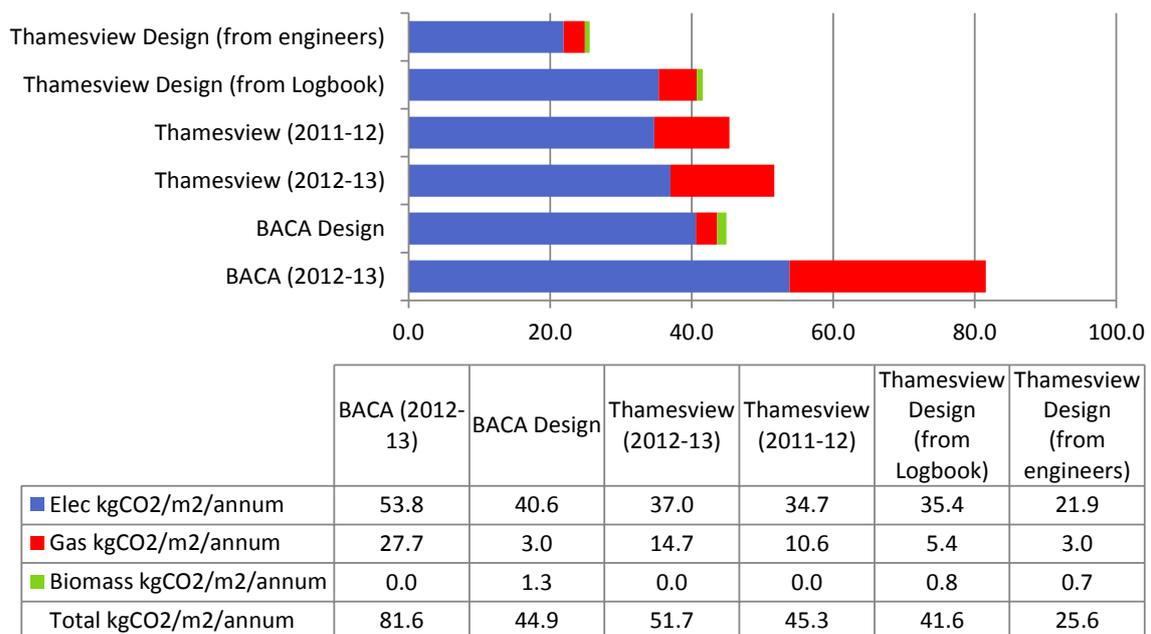
When examining the CO<sub>2</sub> emissions of both schools, it is quickly apparent that the lack of biomass has a significant impact on the sustainability, particularly at BACA where the heating load is already considerably higher than design.

Figure 6.11 – Bar Chart showing design and actual CO<sub>2</sub> emission at BACA and Thamesview
